## **Rapid Airfield Damage Recovery Next Generation Backfill Technologies Comparison Experiment**

Technology Comparison Experiment

Mariely Mejias-Santiago, Lyan Garcia, and Lulu Edwards

February 2021

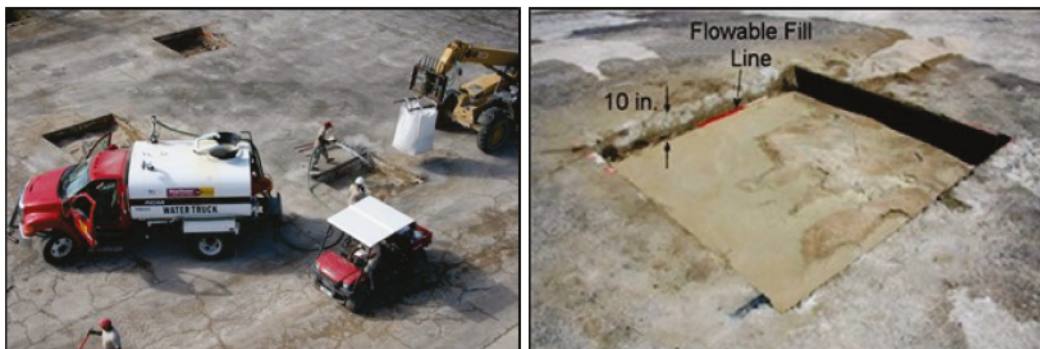
**Figure 1.1. RADR backfill method of flowable fill capped with rapid-setting concrete.**

Once the repair is excavated, it is backfilled, typically with rapid-setting flowable fill (Figure 1.1) or compacted crushed stone. The main purpose of the backfill is to fill the void and provide enough support to the repair cap to withstand the loads from aircraft traffic. Rapid-setting flowable fill has proven to be the best backfill alternative for RADR.

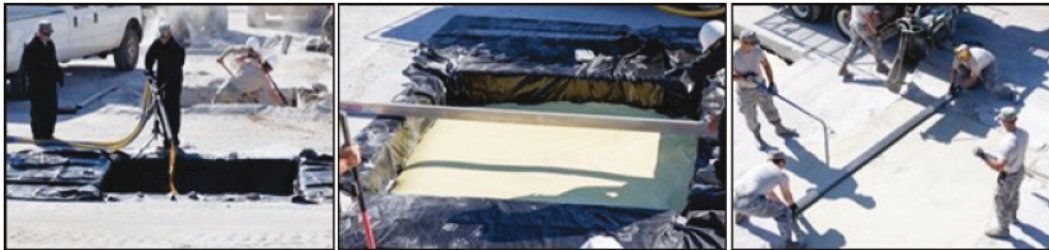
**Figure 1.2. Foam backfill demonstration.**

Previous research efforts and end-user demonstration exercises showed two main issues associated with this technology, i.e., (1) material sensitivity to moisture and (2) clogging of the reacted foam material within the mechanical distribution system (Priddy et al. 2013). This technology was recently refined by redesigning the foam distribution equipment, improving foam material formulations, and upgrading the foam backfill placement procedures (Figure 1.2) (Johnson et al. 2017). The refined technology was successfully demonstrated at the Silver Flag Exercise Site at Tyndall Air Force Base in 2016, where ten airmen evaluated the

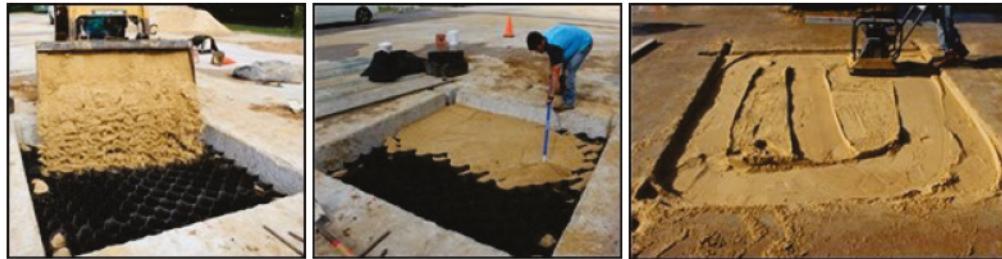
**Figure 1.3. Geocell mechanical stabilization method.**

Formerly known in the Department of Defense (DOD) community as “sand grid,” geocell is a geosynthetic cellular confinement system used to reinforce geotechnical materials (Figure 1.3). Within the scope of ADR, geocells have been used to reinforce backfill materials for expedient crater repairs (Read and Dukes 1988, Webster 1986). One of the primary benefits of using geocells is that lower quality backfill materials can be used rather than the traditional well-graded crushed limestone material. This application is particularly beneficial at deployed locations where the use of indigenous materials is desired since large stockpiles of quality materials are not routinely available. At permanent installations, the use of geocells to reinforce lower quality geotechnical materials minimizes the requirement for prepositioned stockpiles of high-quality aggregates. The original TTPs for the use of geocells (sand grid) were developed in the 1980s, and the original geocell material has significantly changed. New commercial geocell products have emerged since the expiration of the original government patent, and many of the new products were evaluated against desired performance standards. In addition, the performance of different soil types reinforced with geocell for RADR missions had not been adequately quantified and documented. Investigations performed in 2016-2017 were aimed at addressing these gaps and evaluating new products with different backfill materials for selecting optimum geocell

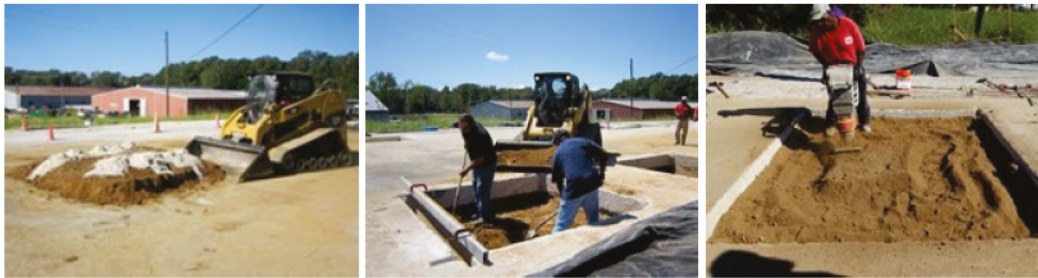
**Figure 1.4. Chemically stabilized soil backfill method.**

The chemically stabilized soil backfill method (Figure 1.4) utilizes the locally available soil mixed with an additive, typically cement, lime, fly ash, or polymers. The soil stabilization additive(s) are used to modify the soil properties and improve strength and stiffness. Other additives include sodium silicate and polyurethane-based products. According to UFC 3-250-11, a minimum 7-day unconfined compressive strength (UCS) of 500 psi is required for a rigid pavement base course. Normally, with chemically stabilized soils, additives are placed in bulk with a truck with spreader bar or from bags. The additives are typically mixed in the soil using a rotary mixer and then compacted. However, the equipment used for traditional soil stabilization operations (i.e. highway applications) is not available or feasible for RADR scenarios. In 2017, laboratory tests were conducted to evaluate viable chemical stabilization alternatives for use in crater repairs (Johnson et al. 2018). With limited equipment available, an alternative method for mixing and compacting was fielded and proven as a reduced-logistics technology.

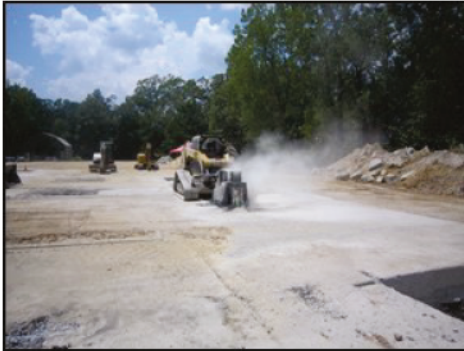
Figure 3.4. Cutting, breaking, and excavation process.

(a) Cutting PCC with wheel saw.

Each simulated crater was initially prepared by cutting the PCC surface with a 60-in. wheel saw attachment (Caterpillar SW60) on the Caterpillar compact track loader (CTL 279C), which was representative of cutting around upheaval for a crater repair. Once the repair was cut to size (approximately 8.5-ft square), the PCC was broken into smaller pieces with amoil-tipped hydraulic breaker (Bobcat HB1180) on a mini excavator (Bobcat E45 T4). Large debris and material underneath the PCC surface were then removed with the bucket attachment on the mini excavator. Each crater was excavated to a minimum depth of 34 in. to ensure that a uniform natural foundation (subgrade) was reached at the bottom of the crater repair. Dynamic cone penetrometer (DCP) (ASTM D6951 2018) data were collected on the subgrade and correlated to CBR strength values (Table 3.2). Photographs of this process are shown in Figure 3.4.

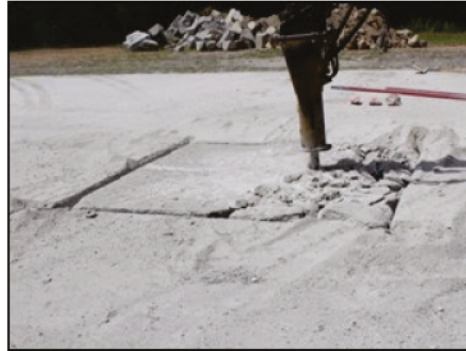
(b) Breaking PCC.

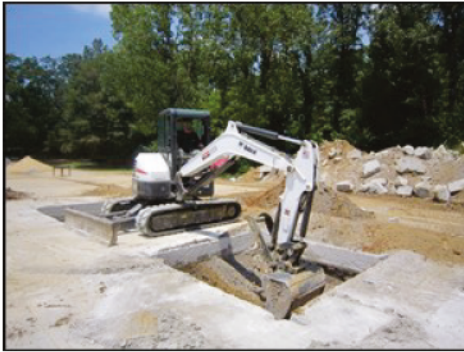
(c) Excavating to proper depth.

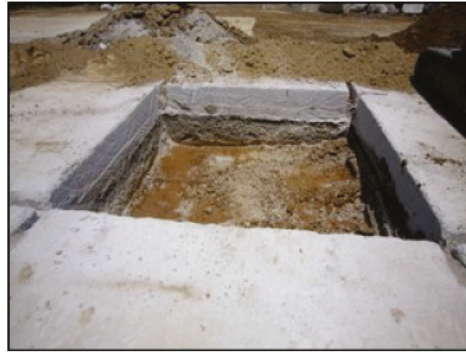
(d) Bottom of crater excavation.

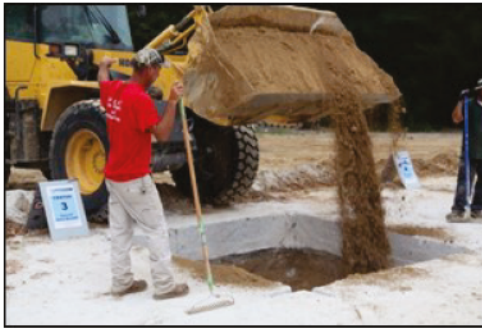
Figure 3.5. Subgrade construction.

(a) Placing CL-ML lift into crater.

A silty clay (CL-ML) material was added in each simulated crater to provide a consistent and stable subgrade throughout the experiment. Each compacted CL-ML layer was at least 11-in. thick and was finished to a depth of 23 in. below the surface. The material was placed in approximately 3- to 4-in.-thick compacted lifts (5- to 6-in.-thick loose) to produce a uniform, constructed subgrade. Compaction of each lift was carried out by applying two coverages with a rammer, commonly called a jumping jack (Multiquip Mikasa MTX70 HD Rammer) compactor. A coverage consisted of starting compaction in one corner of the repair and working towards the center of the repair in a circular motion, and then returning in a circular motion towards the corner where compaction began. Photographs of subgrade construction are shown in Figure 3.5.

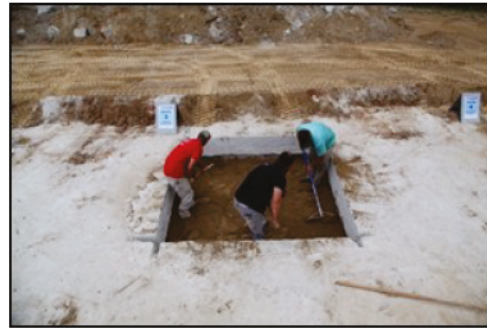
(b) Leveling CL-ML lift.

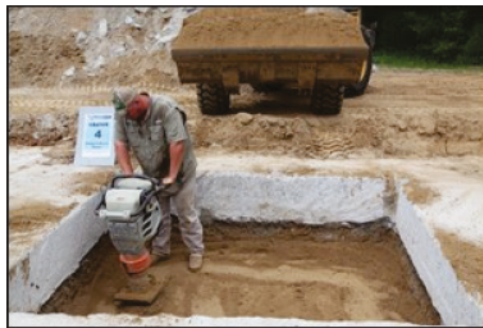
(c) Compacting CL-ML lift with jumping jack.

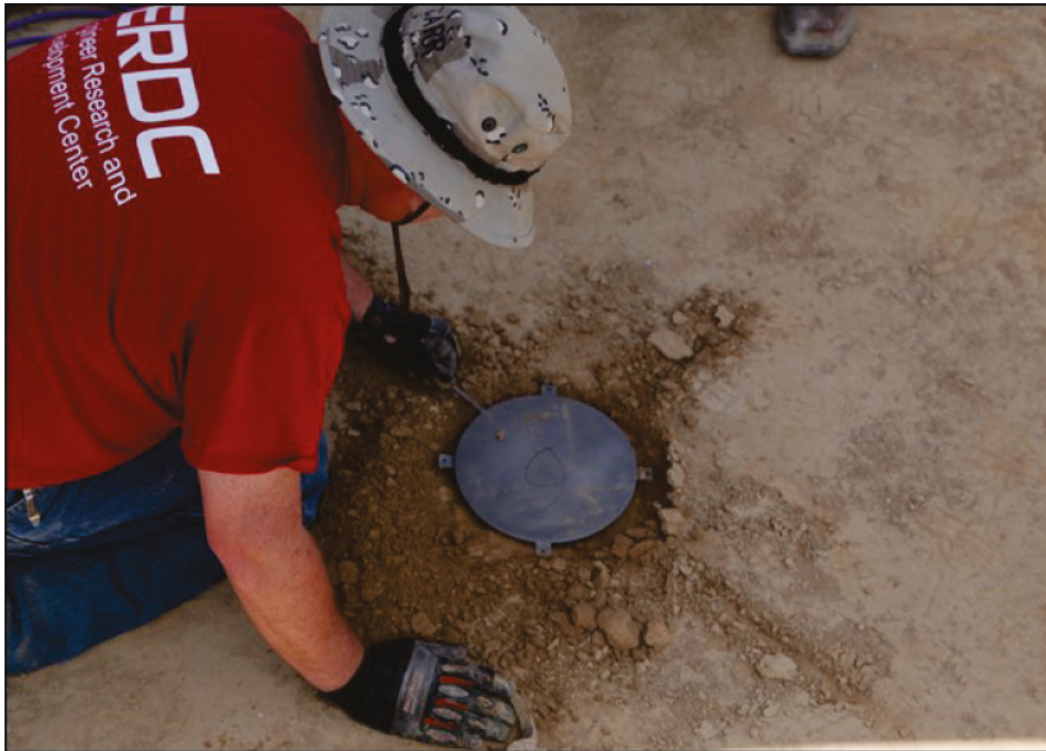
Figure 3.7. EPC being installed at the center of a repair over the constructed subgrade.

One earth pressure cell (EPC) was installed on the surface of the constructed subgrade in each repair to measure the magnitude and changes in pressure below the backfill material during traffic. The EPCs were installed at the center of each crater, as shown in Figure 3.7, and were connected to a data acquisition box that was placed nearby to the craters. During each test sequence, data were continuously recorded while simulated traffic was being applied to the repairs.

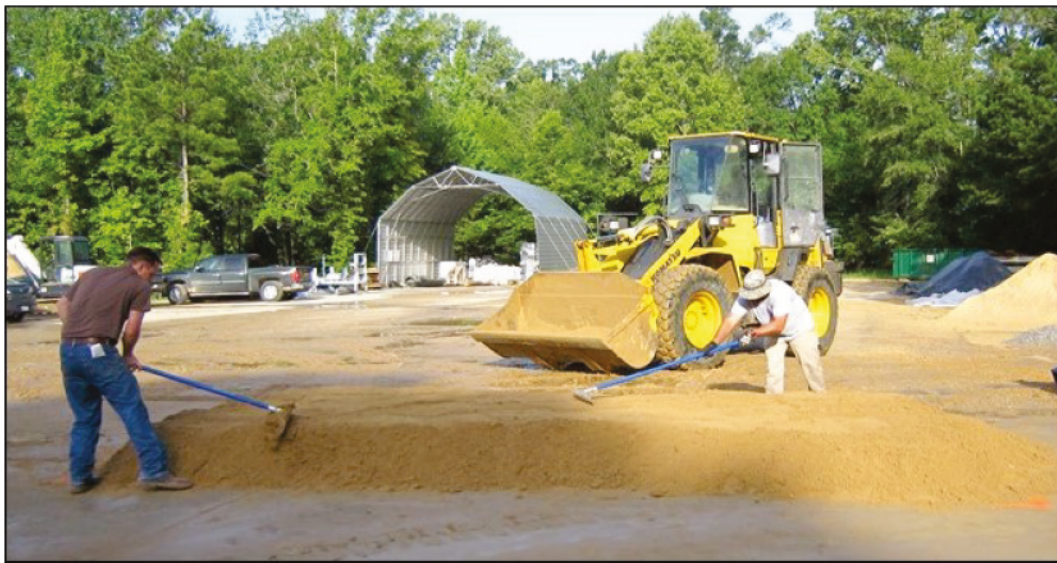
**Figure 3.8. Placement of soil in 21-ft by 10-ft area.**

The mixing process required a team of three (3) people. To ensure the correct amount of soil was mixed, the soil was carefully laid out in a 21-ft by 10-ft blend area, at a height of 1 ft with the front-end loader (Figure 3.8). The SM was at a moisture content of approximately 8.2%, which was slightly above the optimum moisture content of 7.9% (Appendix C). According to ETL 12-7 (AFCEC 2012), it is recommended to use 1% more moisture content than the optimum moisture content. However, based on

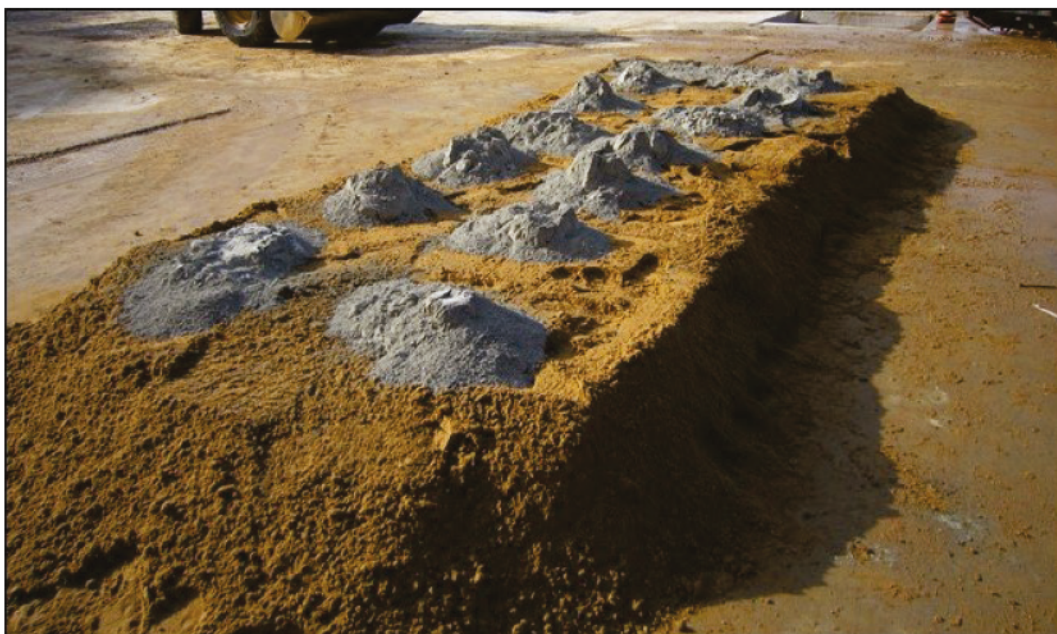
**Figure 3.9. Addition of PLC.**

previous laboratory testing, 5% PLC at an 8% moisture content was recommended for field testing (Johnson et al. 2018). To achieve the 5% PLC, 3.34 lb of PLC was added per cubic foot of loose soil. A total of 700 lb of PLC was added to the soil for this testing. The PLC was packaged in 50-lb buckets, and half of the total PLC, seven buckets, were incorporated at a time, as shown in Figure 3.9.

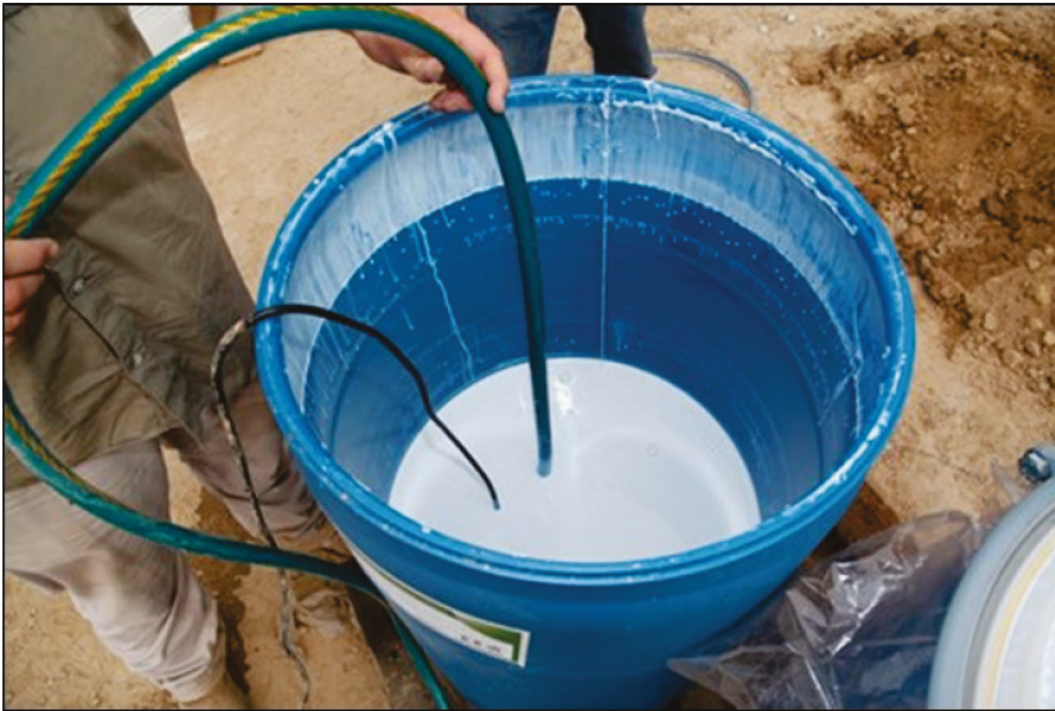
Figure 3.11. Submersible utility pump in 55-gal drum of polymer.

To blend the soil with the Soil-Sement® polymer emulsion, a 1/6-hp submersible utility pump was placed into the polymer drum, and a hose was used to distribute the product (Figure 3.11). The polymer was added at a rate of 3% by weight of soil -- approximately 0.225 gal of polymer per cubic foot of loose soil. The SM soil moisture content was approximately 7.5%, which was just under the optimum moisture content of 7.9%. It was important to make sure that the soil is at or below optimum because the polymer emulsion would add moisture to the mixture. To mix the polymer emulsion, the loose soil was laid out similar to the cement-mixing method in a 21-ft-long by 10-ft-wide area at a height of 1 ft. For this test, a total of 47 gal of Soil-Sement® polymer emulsion was used. Initially, approximately 27 gal was sprayed using the submersible utility pump and hose (Figure 3.12). The CTL with tiller attachment mixed the soil, and the

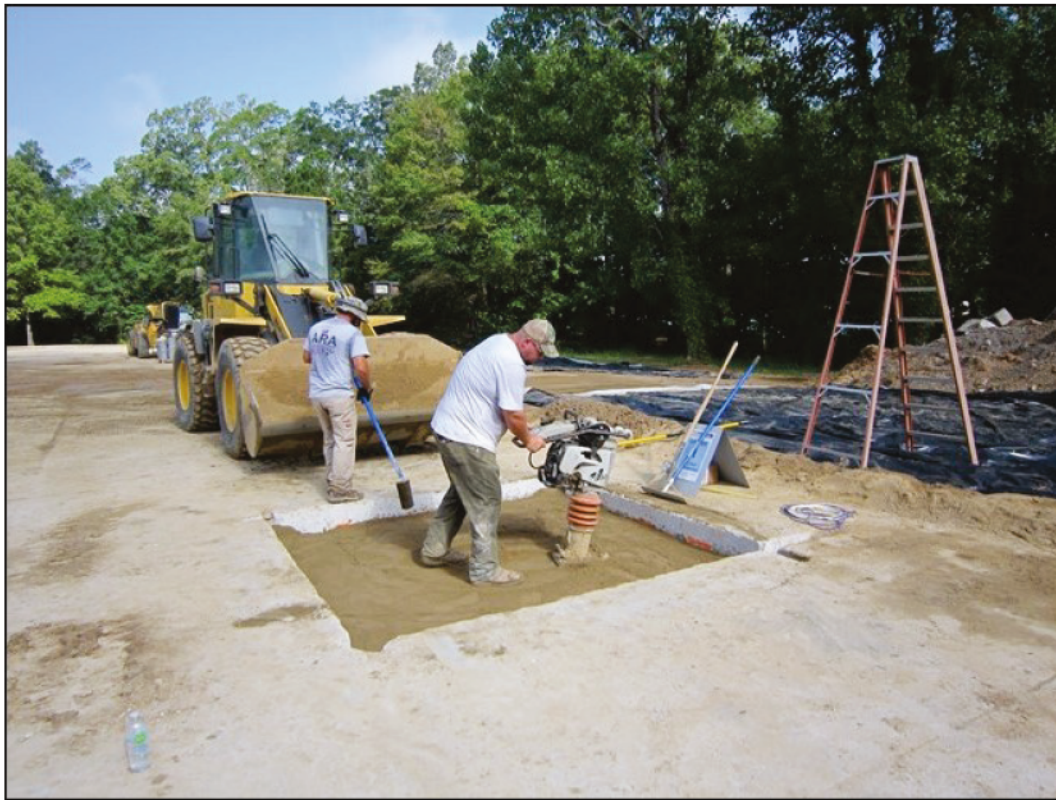
Figure 3.13. Compacting soil.

For both PLC and polymer mixed soil, the backfill placement process was executed by placing the mixed soil in four 4-in.-thick compacted lifts to obtain a total compacted thickness of 16 in. The mixed soil was placed by a team of three (3) people using a front-end loader and shovels. For each lift, the stabilized soil was placed into the crater above the desired level to account for compaction and was compacted with two coverages of a jumping jack (Multiquip Mikasa MTX70 HD rammer) (Figure 3.13). A coverage is defined as starting compaction in one corner, working in a spiral pattern towards the center, and spiraling back around to the starting point. The final top surface was compacted with a plate compactor (Northern Industrial JPC-80) for two additional coverages to ensure a flat surface was achieved (Figure 3.14). The plate compactor was not a required step but, since this was a controlled test, more attention was focused on the final surface of the backfill to ensure thickness consistency between repairs.

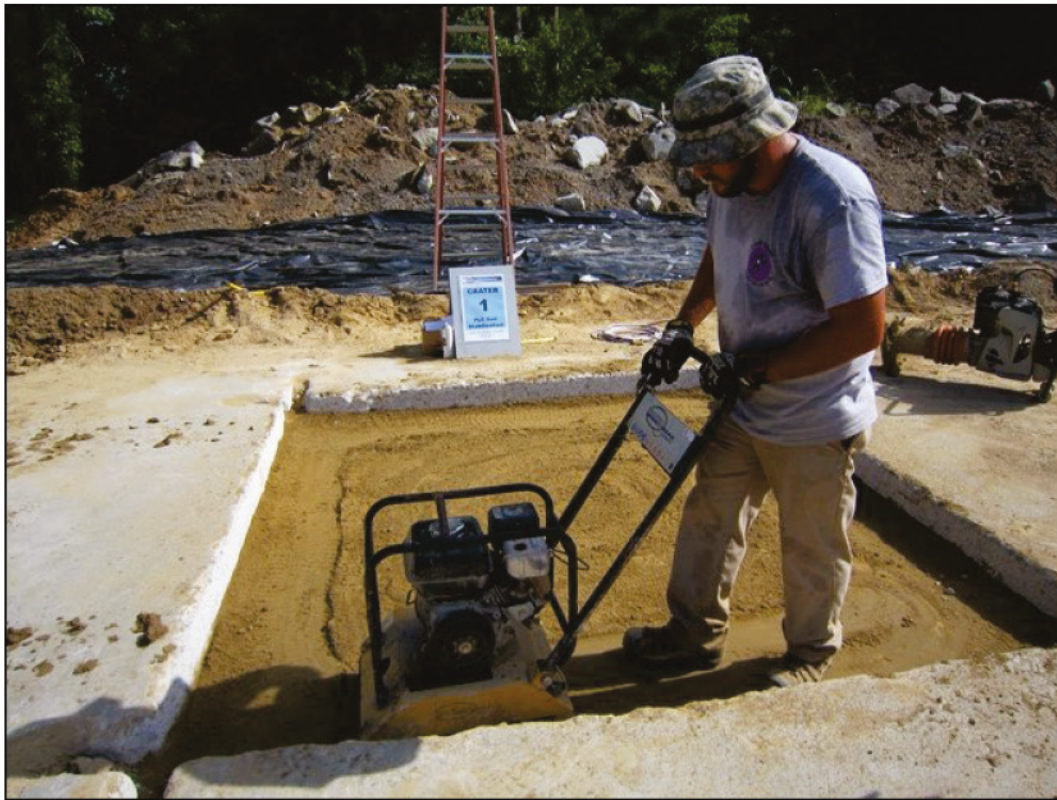
Figure 3.14. Final surface preparation with plate compactor.

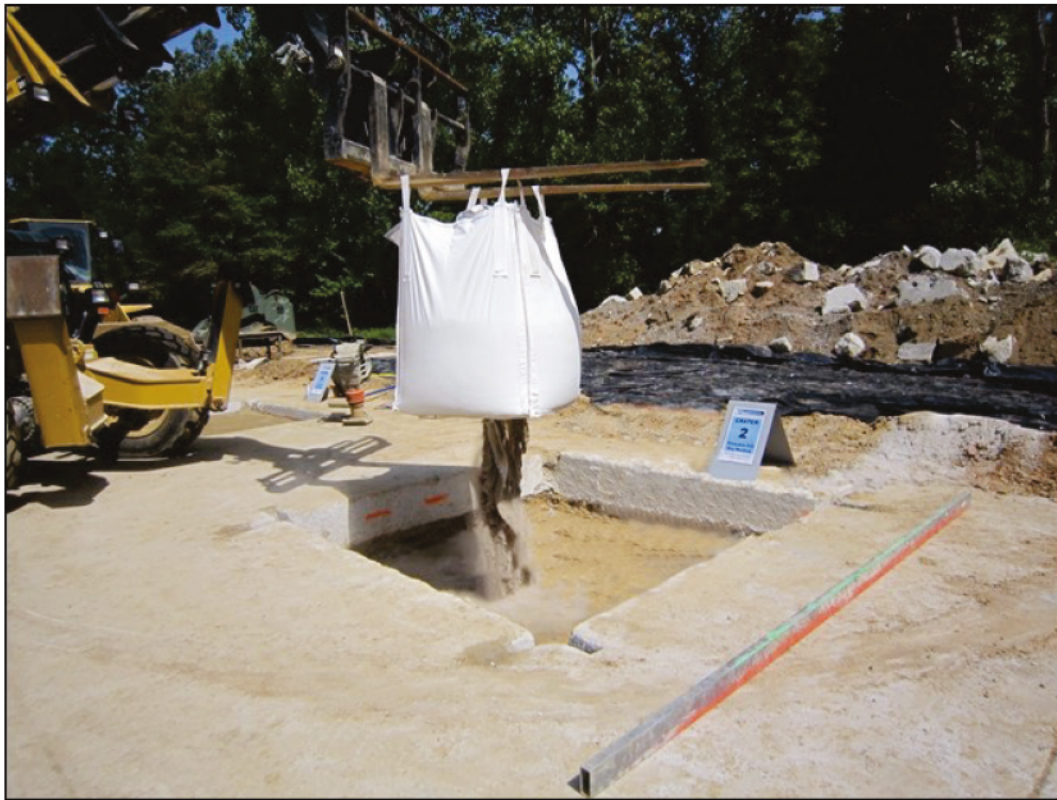
Figure 3.15. Rapid-setting flowable fill dry placement method.

Approximately 3.5 super sacks of dry material were used to complete 16 in. of rapid-setting flowable fill backfill in the 8.5-ft  $\times$  8.5-ft repairs. The material was placed in 6-in. lifts. Each lift consisted of placing one super sack of dry material in the excavated repair, and then applying approximately 40 to 50 gal of water to the surface. The water was allowed to percolate through the dry material by gravity before placing the next lift. Figure 3.15 shows flowable fill being placed inside Repair 2 using the dry placement method. Figure 3.16 shows the process of adding water to the rapid-setting flowable fill. The finished rapid-setting flowable fill surface is shown in Figure 3.17. Equipment required for rapid-setting flowable fill placement included one telehandler for transporting the super sacks of rapid-setting flowable fill from the staging area to the excavated hole, a water truck with a water flow meter, and assorted hand tools such as rakes and shovels to distribute the dry material in the repair.

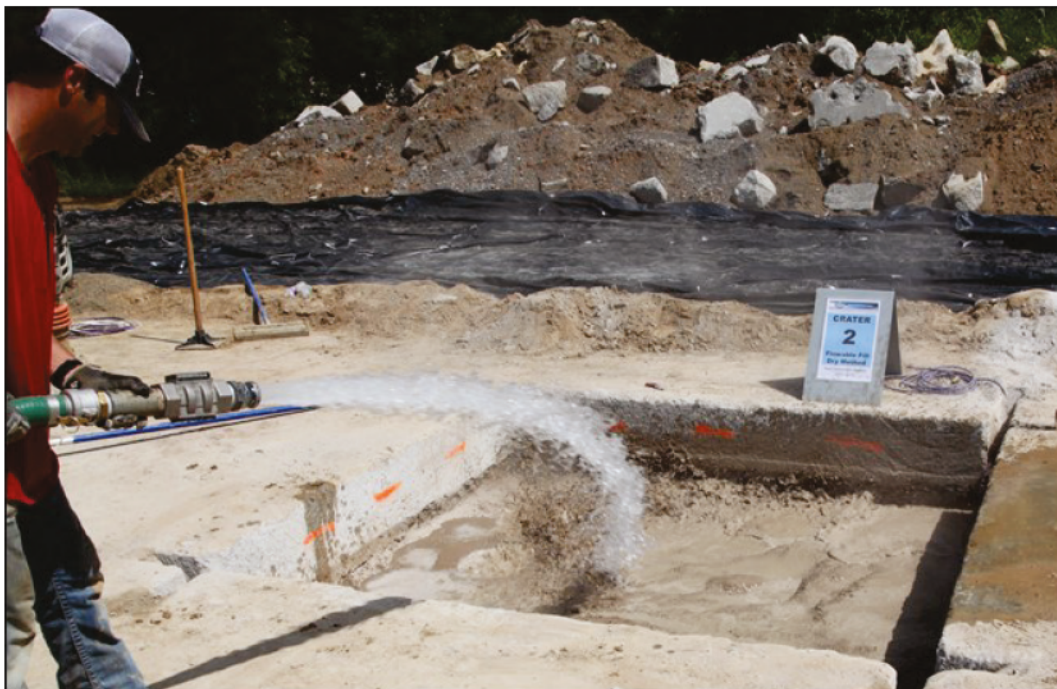
Figure 3.16. Adding water to rapid-setting flowable fill during dry placement method.

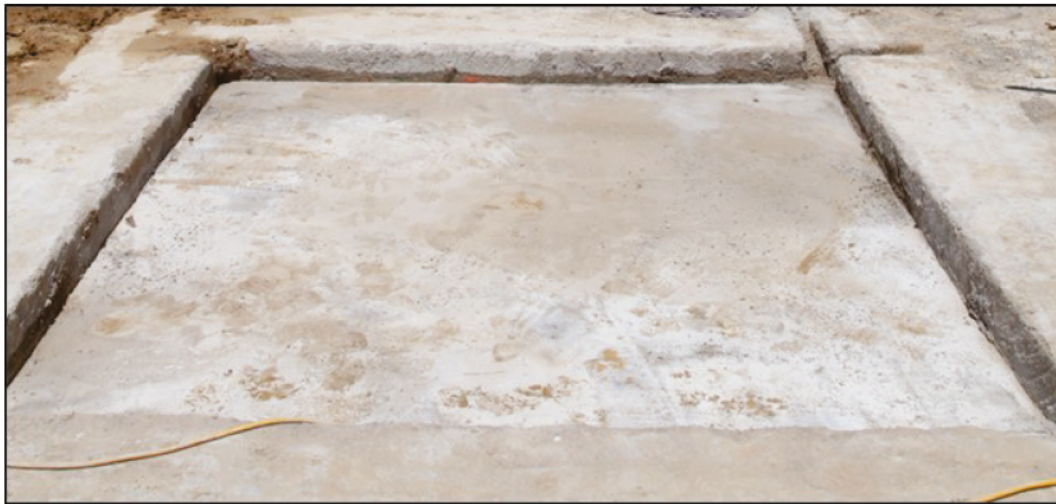
Figure 3.17. Finished rapid-setting flowable fill surface.

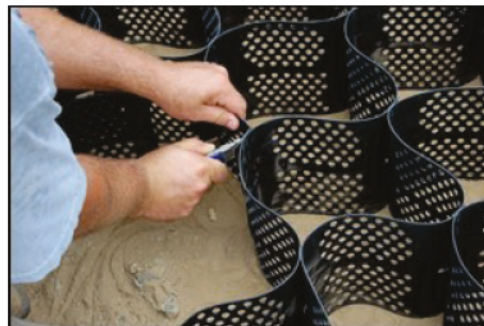
(b) Cutting geocell section with utility knife.

Once the constructed subgrade was compacted for Repairs 3 and 7, the horizontal dimensions of the crater were measured so that the geocell sections and geotextile could be cut to size (Figure 3.18). Tools for cutting the geocell sections and geotextile to the appropriate size included utility knives, a measuring tape, rebar, and hammers.

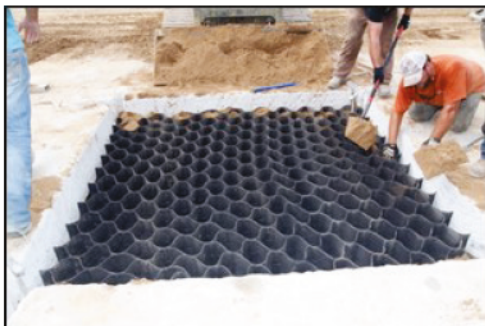
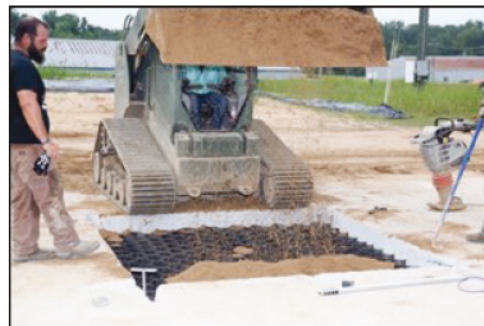
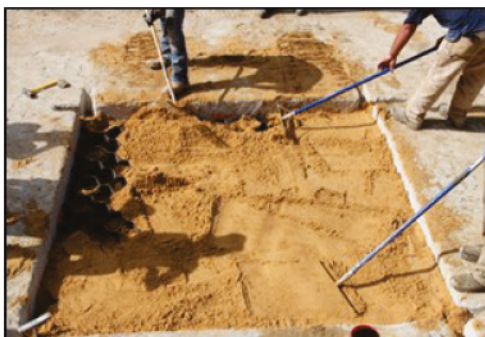
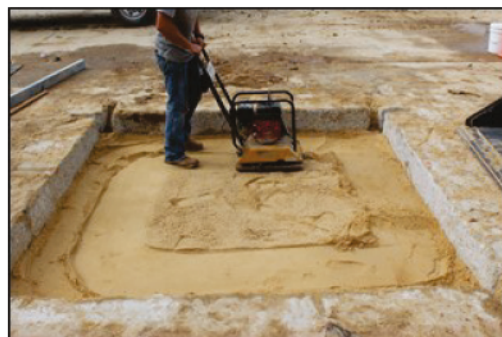
**Figure 3.19. Geocell-reinforced backfill placement.**

(a) Fabric placed over the constructed subgrade.

(b) Geocell section placed in crater

(c) Placing SM along edges (Repair 7).

(d) Backfilling geocells with SM (Repair 7).

(e) Spreading SP evenly with rakes (Repair 3).

(f) Compacting SP with plate compactor (Repair 3).

5. The surface of the first layer of geocells was then lined with the non-woven, 6-oz, needle-punched polypropylene geotextile.
6. The second layer of geocells was expanded perpendicular to the center-line and held in place, as described in Step 2.
7. The second layer of geocells was backfilled and compacted, and excess material was removed, as described in Steps 3 and 4.

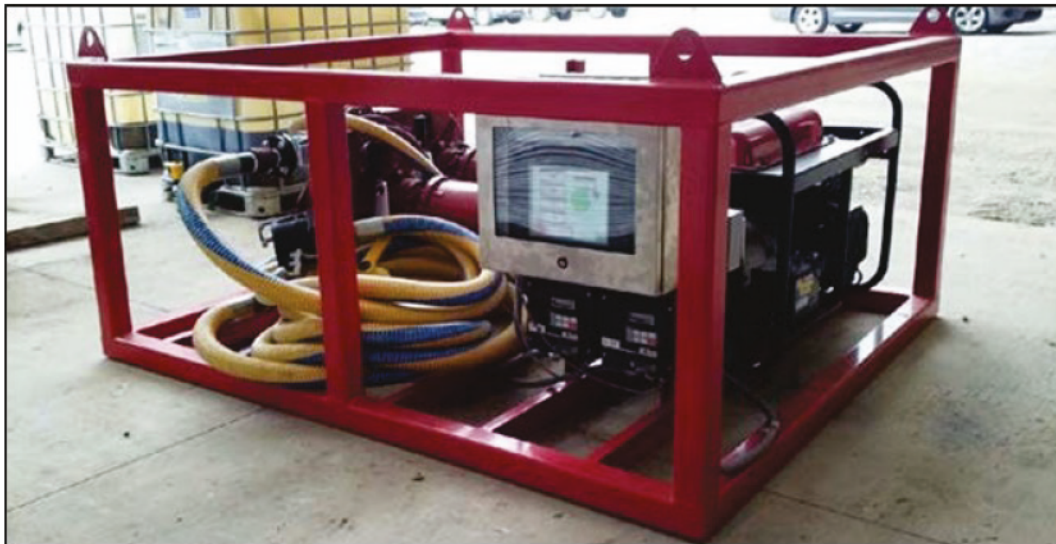
Figure 3.20. CRADR 1-L prototype foam dispensing system.

1. The excavated repair dimensions were measured and entered into the automated foam distribution system through the touch screen control

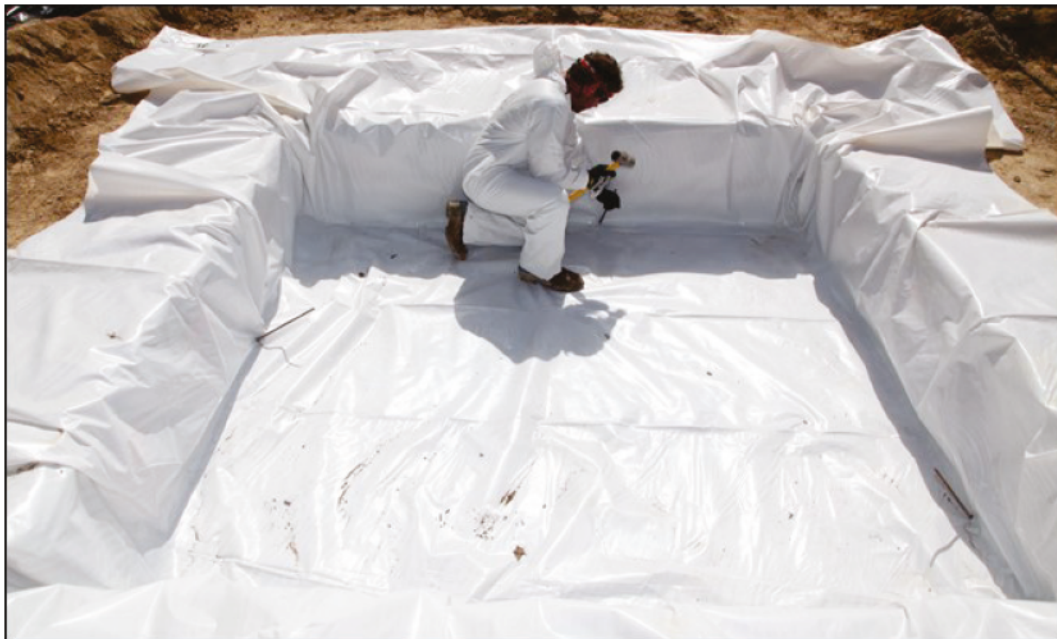
**Figure 3.21. Polyethylene liner applied to Repair 4.**

- panel. The required measurements, in inches, were the total width, length, and depth of the repair, as well as the desired cap thickness.
2. The bottom of the excavation was lined with 10-mil polyethylene plastic sheeting, making sure that the liner was in contact with the excavation walls and corners. Rebar was installed to hold the liner in place (Figure 3.21).

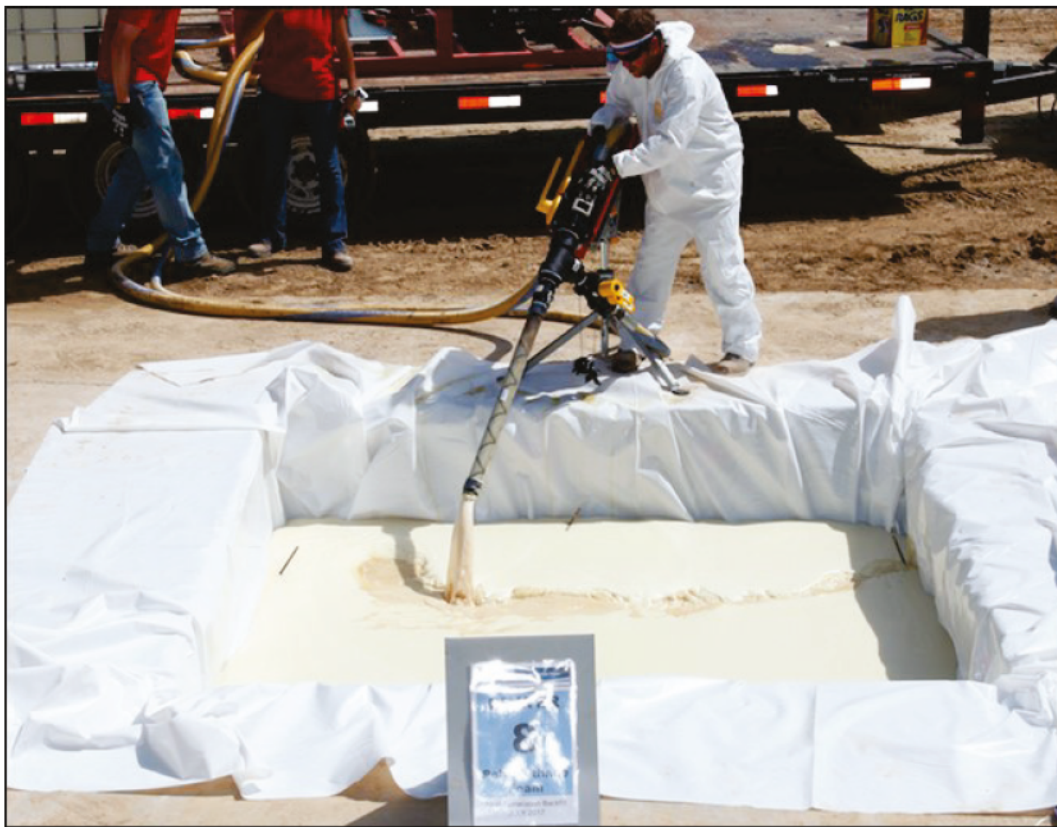
Figure 3.22. Foam placement.

3. The foam dispenser (Figure 3.22) was operated by following the procedures indicated in the user's manual. All of the fluid lines and the mixing head were connected in advance to save time during the repair process. Crater dimensions varied slightly between Repair 4 and Repair 8, thus requiring different foam pour times for each crater (Figure 3.23 and Figure 3.24). The liquid polyurethane foam mix was dispensed in approximately 4 to 6 min. Once the liquid foam placement was completed, the mixing head was disconnected from the fluid lines and placed in a bucket for draining.

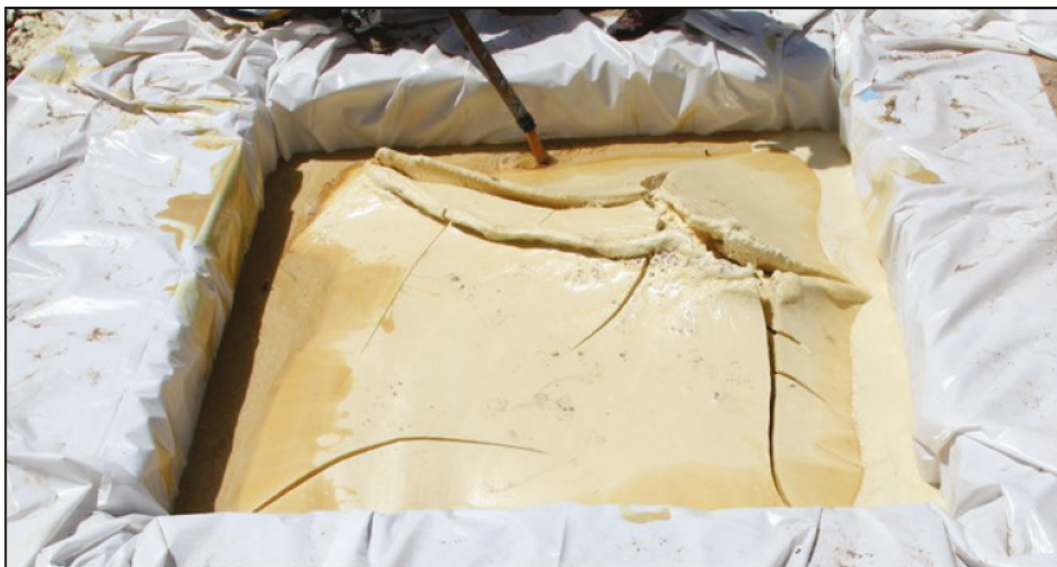
Figure 3.23. Placing additional foam in Repair 4 to achieve the desired backfill thickness.

- a. On Repair 4, the dispensed foam liquid was not enough to produce a 16-in.-thick layer. Therefore, an additional layer of foam was poured on top. Since the foam surface on the first layer was uneven, the liquid foam was deposited in the low areas creating more of an uneven overall surface. The second layer foam was soft to the touch and did not bond very well to the first layer. No cutting was required on Repair 4.

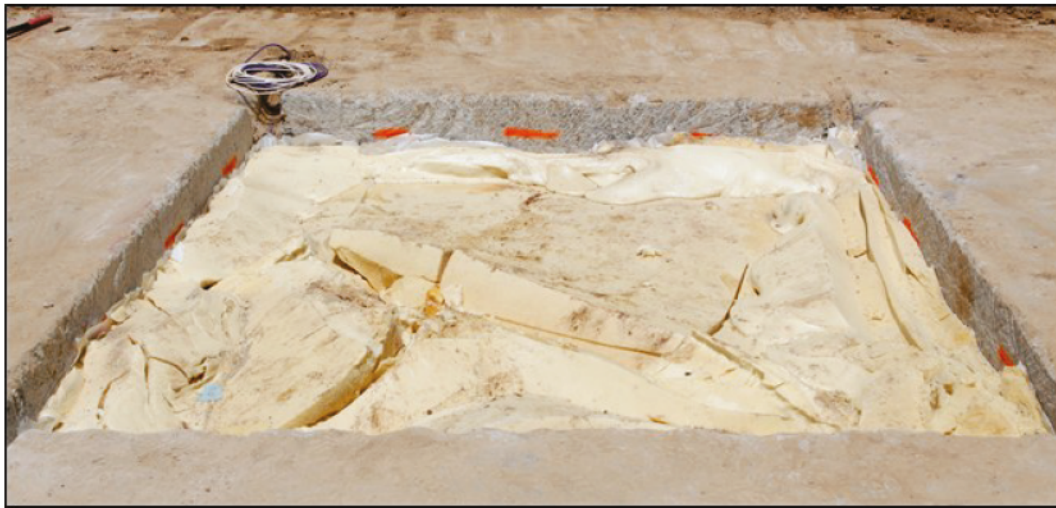
Figure 3.24. Final foam backfill surface of Repair 4.

- c. The target backfill thickness was 16 in. However, since the expanded foam backfill surfaces were uneven, the backfill thicknesses varied throughout the repairs. The average foam layer thicknesses were 14 in. and 15 in. in Repair 4 and Repair 8, respectively.

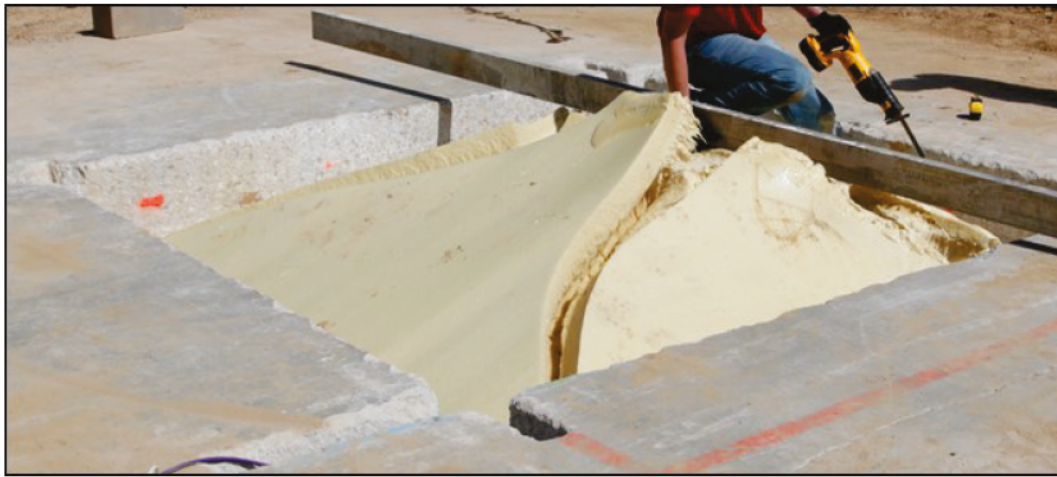
Figure 3.25. Expanded foam backfill surface of Repair 8.

4. The foam was allowed to expand and cure for about 10 min. At that point, the excess liner was cut and removed. When the foam expanded in each excavated repair, an uneven and cracked domed surface was formed (Figure 3.25). Therefore, the foam surface was inspected to identify areas that required leveling or cutting so that a smooth and level surface was provided for the required 7-in. cap thickness. These domed areas were cut with a reciprocating saw, and the excess material was discarded.

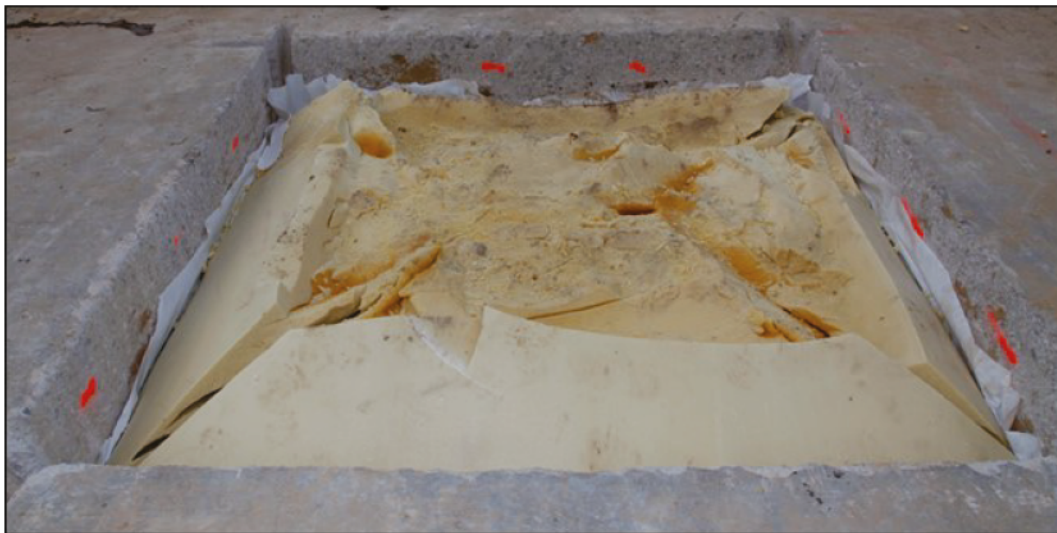
Figure 3.26. Final foam backfill surface of Repair 8 (after cutting).

- b. On Repair 8, the foam was dispensed in a single pour. However, the expanded foam surface was very uneven and cracked. Cutting was required to meet the thickness requirement (Figure 3.26).

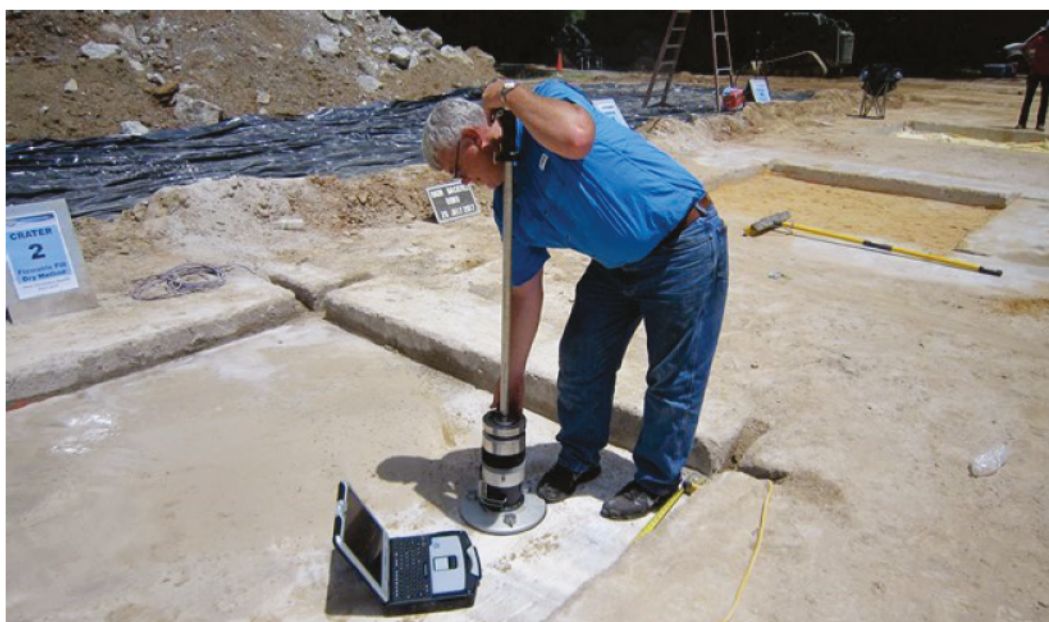
Figure 3.27. Dynatest LWD Model 3031.

Results from both devices indicated that cementitious-type backfills, the rapid-setting flowable fill and cement-stabilized backfills, were the stiffest. The Zorn LWD showed that both of the rapid-setting flowable fill repairs (2 and 6) were the strongest, with similar modulus values of 402 and 403 MPa and small deflection values of 0.080 and 0.076 mm. The Dynatest LWD showed that the stabilized cement and flowable fill have small deflection values of 0.074 mm or less, and modulus values greater than 758 MPa. The remaining backfill repairs with the polymer-stabilizer and the geocells had much lower values than the rapid-setting flowable fill and cement-stabilized backfills. The polymer-stabilized backfill showed approximately double the modulus values than the geocell backfill, but the polymer backfill was much less stiff than the cementitious-type backfill. The polymer backfill required more curing time, and for water to evaporate and increase strength in the polymer-stabilized backfill.

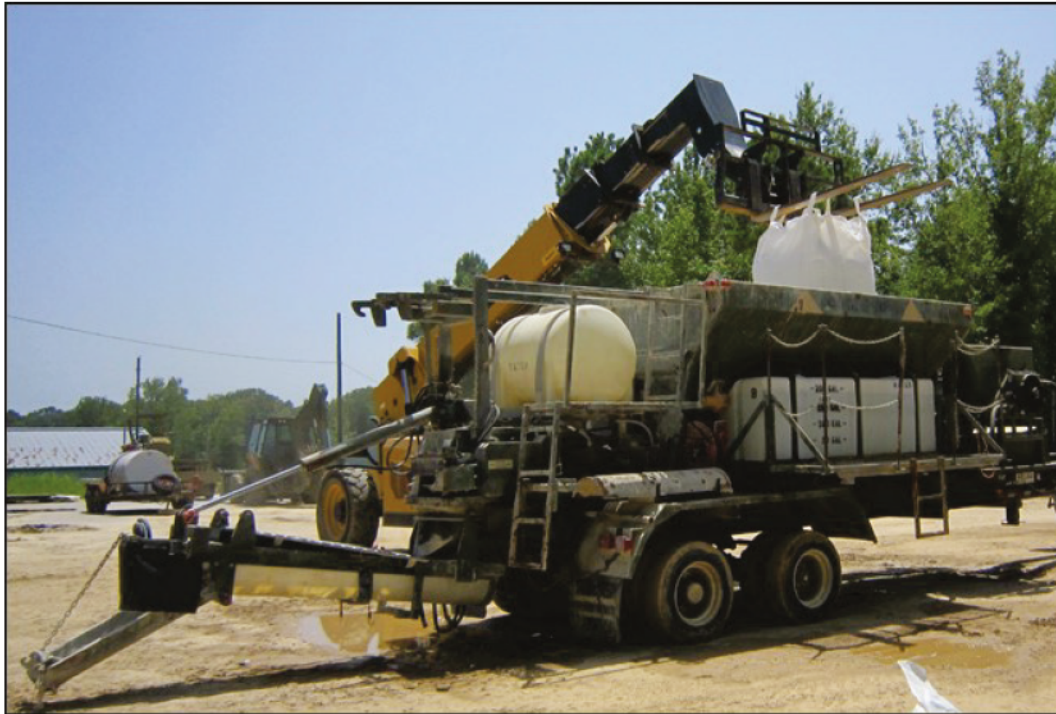
**Figure 3.29. Volumetric mixer.**

The rapid-setting concrete cap was placed by a team of seven (7) people including a mixer operator, a forklift operator, two screed operators, and three hand-tool workers. The volumetric mixer (Figure 3.29) was filled with approximately six super sacks of Rapid Set Concrete Mix® prior to the starting the pour. However, a forklift was required to consistently

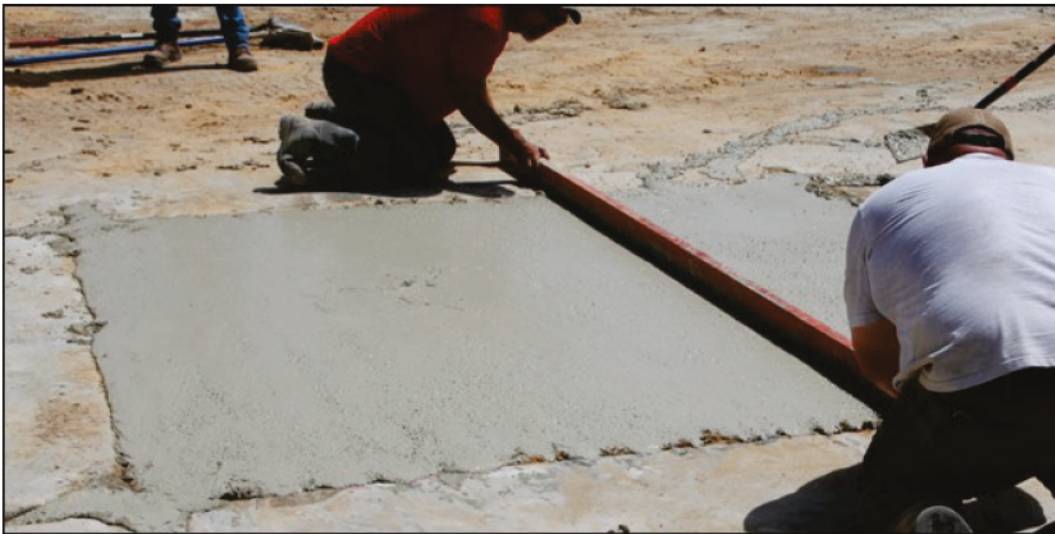
Figure 3.30. Rapid-setting concrete cap screeding with straight-edge bar.

feed the mixer with Rapid Set Concrete Mix® material to keep enough material weight on the dry material belt to get a consistent mix. The mix was poured into each crater until reaching the surface level. Concrete rakes were used to distribute the mix throughout the crater. The screeding process was performed by hand using a straight-edge bar (Figure 3.30). Concrete hand-finishing was performed after screeding by using aluminum or magnesium trowels. Once all repairs in a test sequence were capped, the mixer was pressure-washed to remove residual material. No intermediate wash was required between crater repairs. Figures 3.31 through 3.38 show the finished rapid-setting concrete surfaces for all eight repairs before traffic was applied.

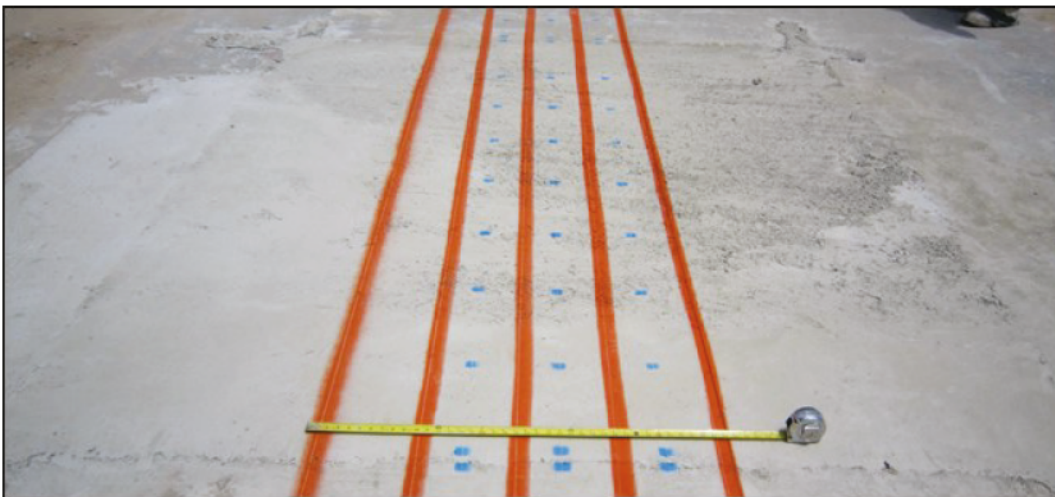
Figure 3.37. Finished rapid-setting concrete cap on Repair 7.

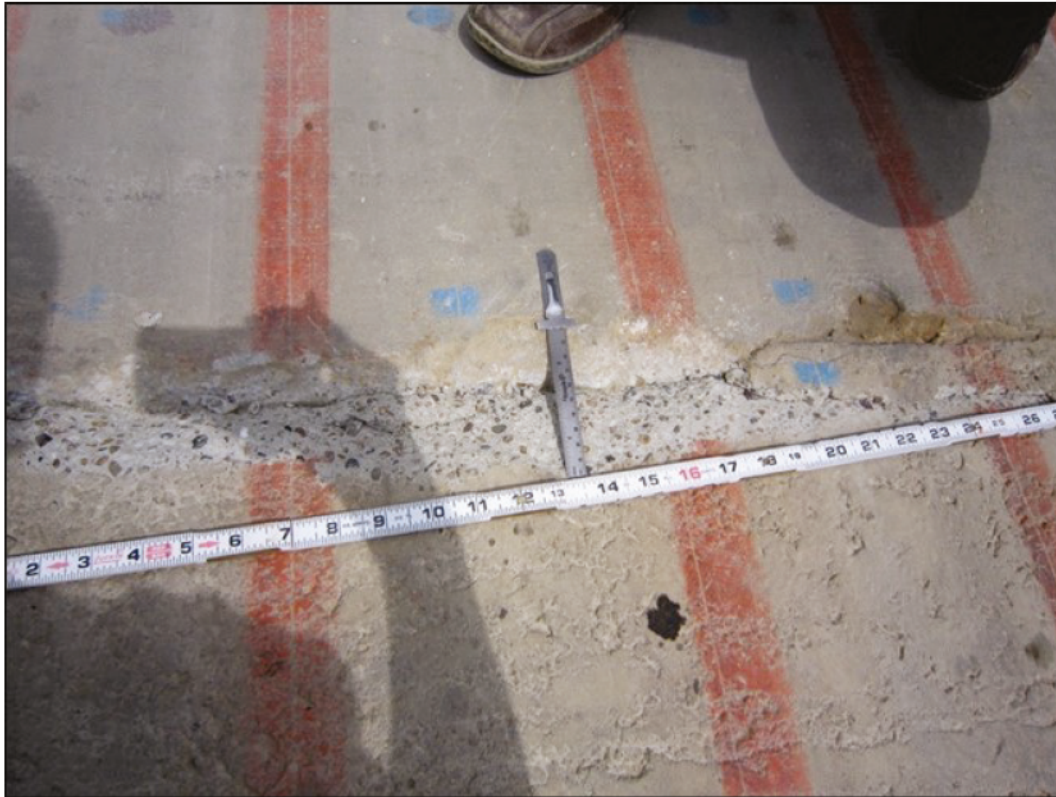
**Figure 3.40. Measuring a spill on repair edge.**

the crack/failure progression. Spalling was measured for length, width, and depth (Figure 3.40). Loose, spalled material was also measured, and the average size of particles was recorded.
