## **Rapid Airfield Damage Recovery Next Generation Backfill Technologies Comparison Experiment**

Technology Comparison Experiment

Mariely Mejias-Santiago, Lyan Garcia, and Lulu Edwards

February 2021

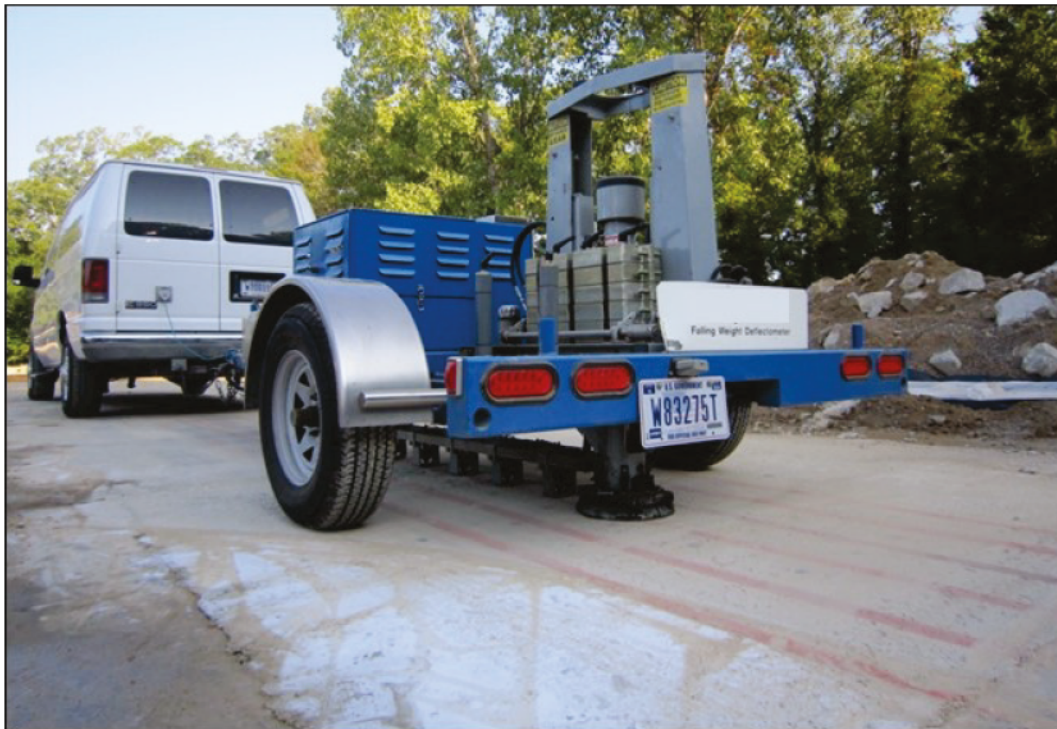
Figure 3.42. FWD testing on the surface of a repair.

A Falling Weight Deflectometer (FWD) was employed in the center of each repair and on a control slab within the test site in order to monitor changes in stiffness of Repairs 1-7 (Figure 3.42). FWD data were not collected on the foam-backfilled repairs 4 and 8. The control slab was not trafficked. FWD data were collected prior to trafficking, after 112 passes, and then at 200- to 500-pass intervals until failure, or when 3,600 passes were completed.

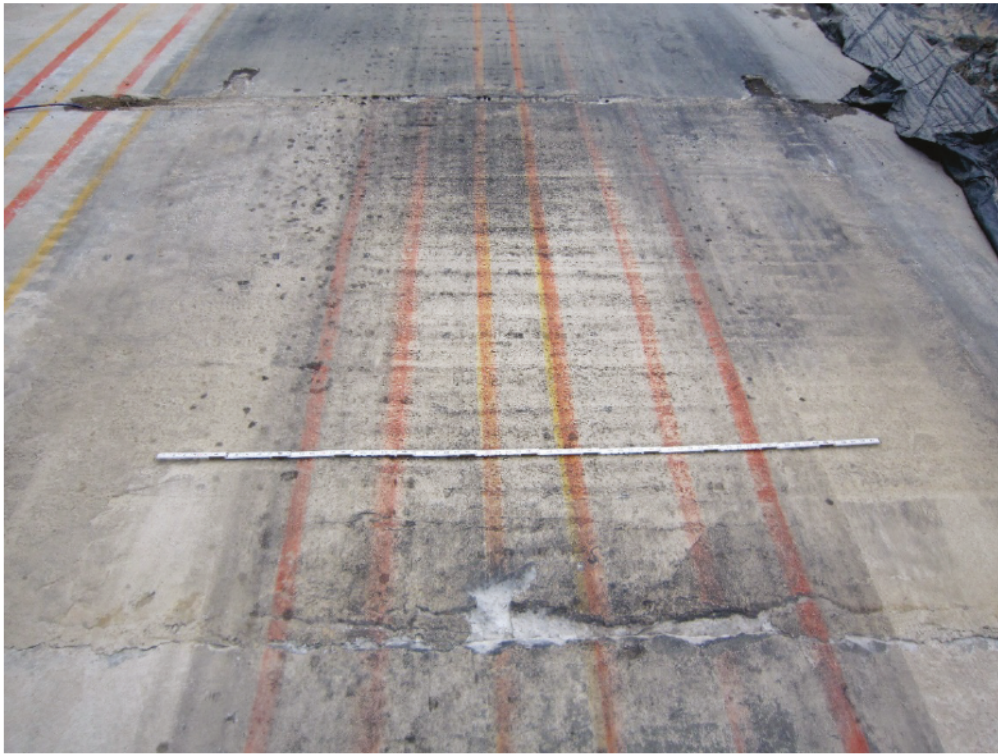
Figure 4.3. Post-traffic photographs of Repair 1 after 3,600 passes.

The main mode of failure was high-severity spalling along the transverse joints (perpendicular to the direction of traffic). Minor distresses, such as shrinkage cracking after curing, were noted prior to traffic for many of the repairs but did not appear to contribute to their failures. Figures 4.3 through 4.10 show post-traffic photos for each repair. Figure 4.11 shows shrinkage cracking on Repair 4 prior to trafficking (marked with orange paint stick).

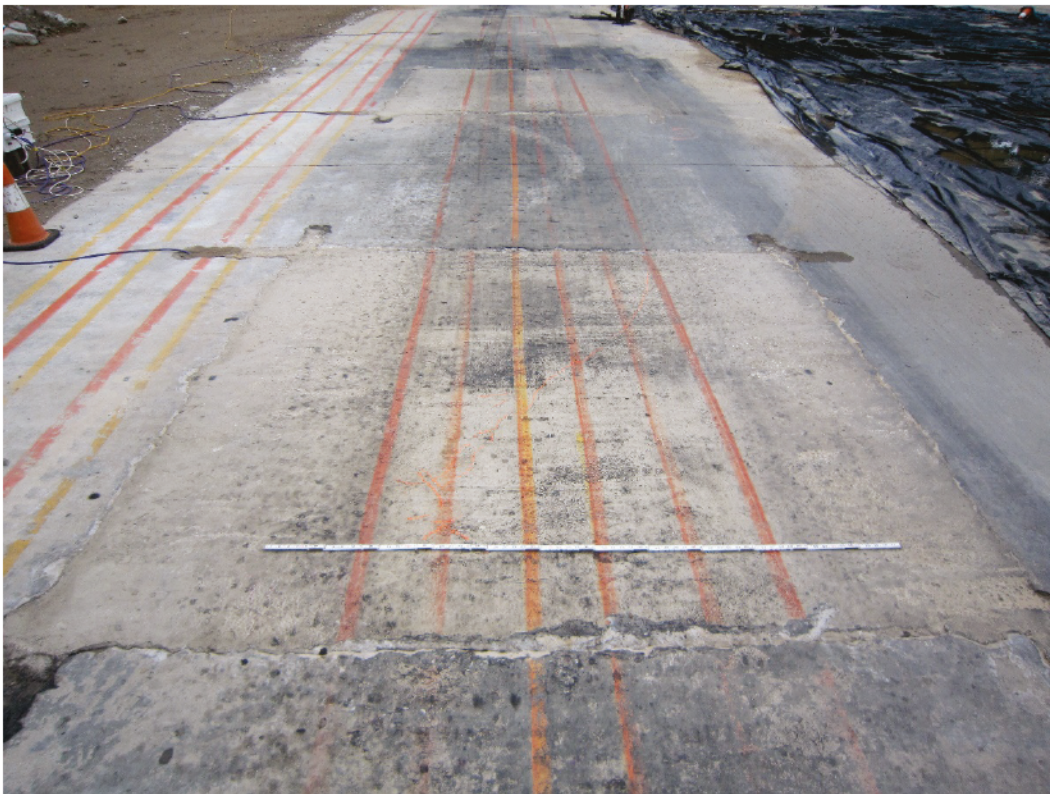
Figure 4.4. Post-traffic photographs of Repair 2 after 3,600 passes.

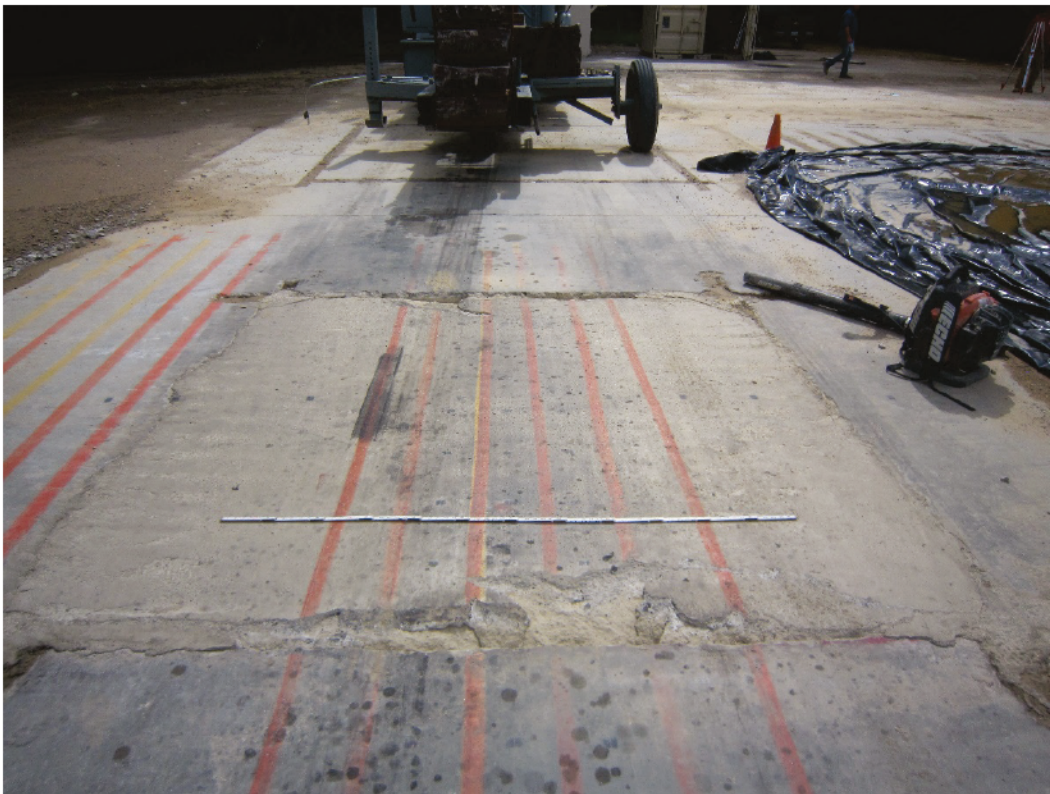
Figure 4.6. Post-traffic photographs of Repair 4 after 830 passes.

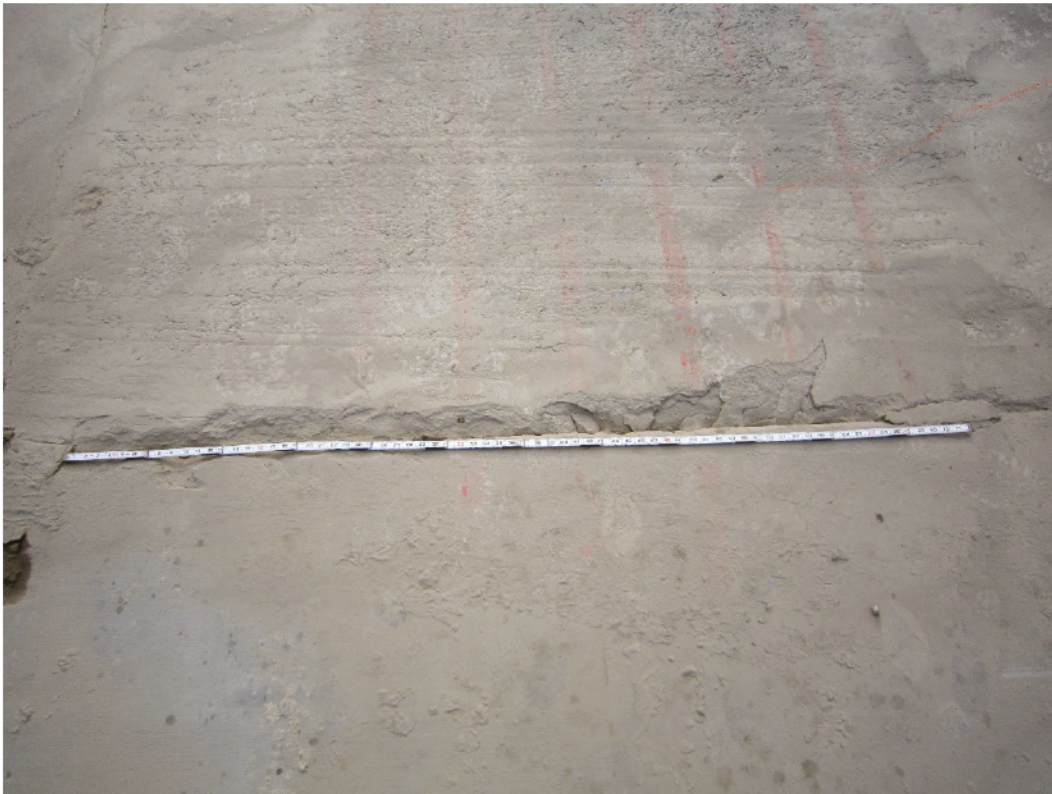
Figure 4.7. Post-traffic photographs of Repair 5 after 1,520 passes.

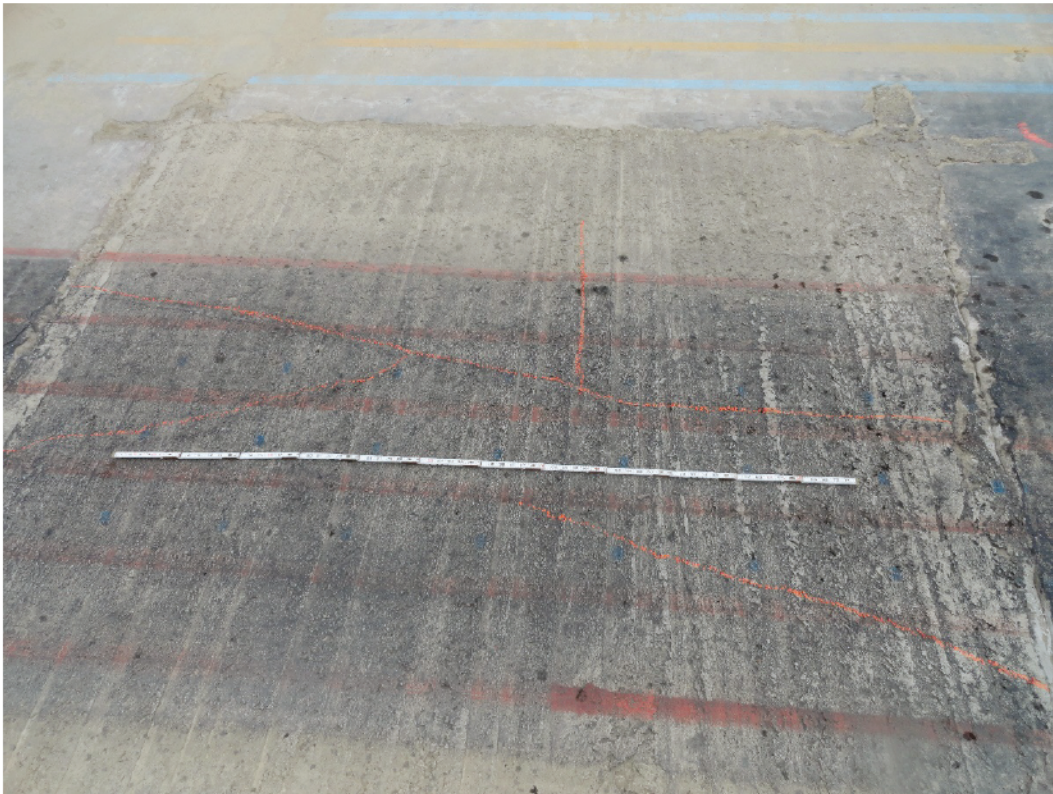
Figure 4.8. Post-traffic photographs of Repair 6 after 3,600 passes.

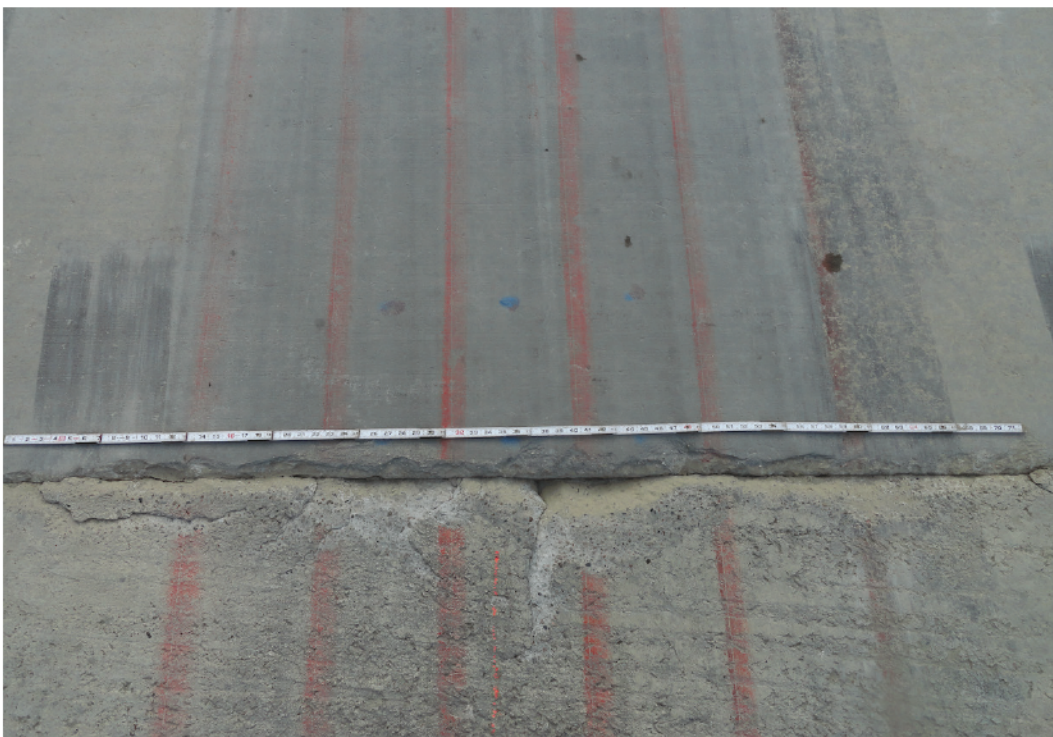
Figure 4.9. Post-traffic photographs of Repair 7 after 1,792 passes.

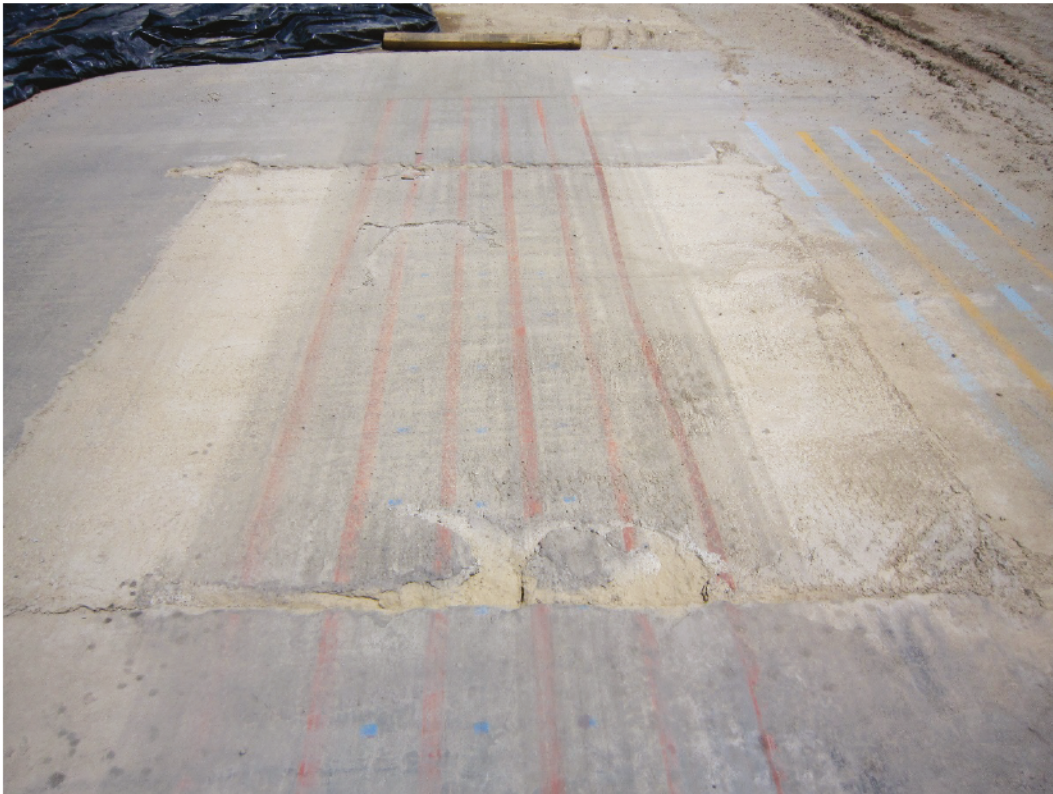
Figure 4.10. Post-traffic photographs of Repair 8 after 1,520 passes.

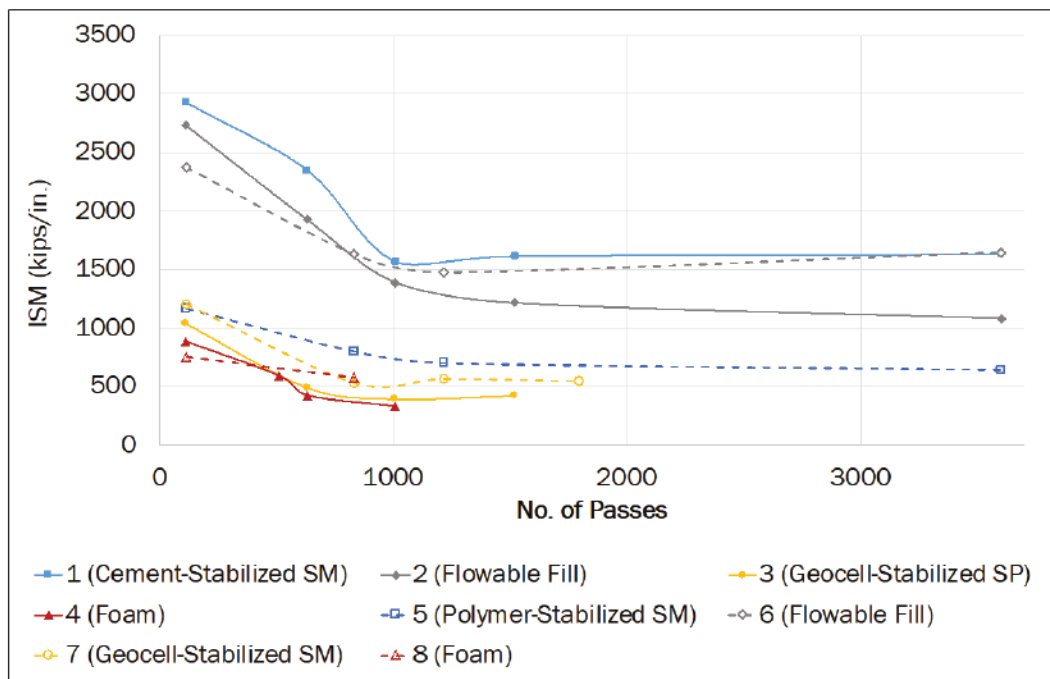
Figure 4.12. FWD results.

After that point, the ISM values stabilized, and no significant change was observed. Repairs with cement-stabilized soil and flowable fill backfills had similar trends and were the stiffest compared to the rest of the repairs. This was expected, considering the cementitious nature of the flowable fill and cement-stabilized materials. The polymer emulsion-stabilized SM showed a slightly higher stiffness than the geocell-reinforced repairs. However, it showed a much lower stiffness than the PLC-stabilized repair. For the geocell-reinforced repairs, Repair 7, which was backfilled with SM soil, was stiffer than Repair 3, which was backfilled with a uniform SP soil.
