NRL Report No. R-1694
Test of Model 500D Radio Telephone Equipment (50 watt)
Manufactured by - Jefferson-Travis Co., New York City

NRL Report No. R-1694
BuShips Prob. T5-37C

Test of Model 500D Radio Telephone Equipment (50 watt)

NAVAL RESEARCH LABORATORY
ANACOSTIA STATION
WASHINGTON, D. C.

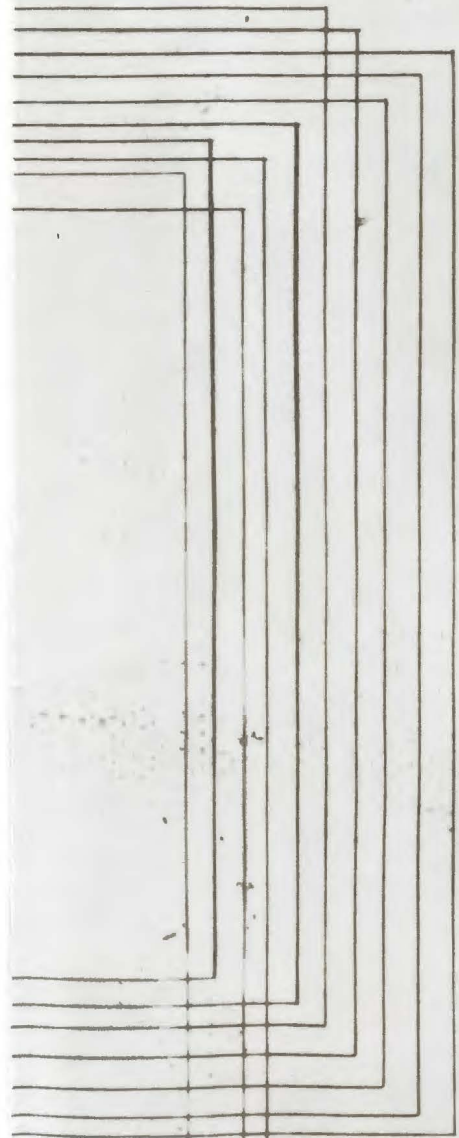
- 20 gauge Black
- Black
- White
- White
- Red
- Red
- Blue
- Blue
- Purple
- Orange
- Brown
- Yellow
- Yellow
- Yellow
- Gray
- Green
- Black-Red
- Red-Black
- Red-Black
- Red-Black
- Black White
- Stranded Black
- Red
- Heavy Yellow
- Red
- Green
- Shielded
