**NAVAL
POSTGRADUATE
SCHOOL**

JOINT APPLIED PROJECT REPORT

**A PROCESS TO DIGITALLY MAP HELICOPTER MAIN
ROTOR BLADES IN SUPPORT OF CONDITION BASED
ACQUISITION AND SUSTAINMENT ACTIVITY**

September 2021

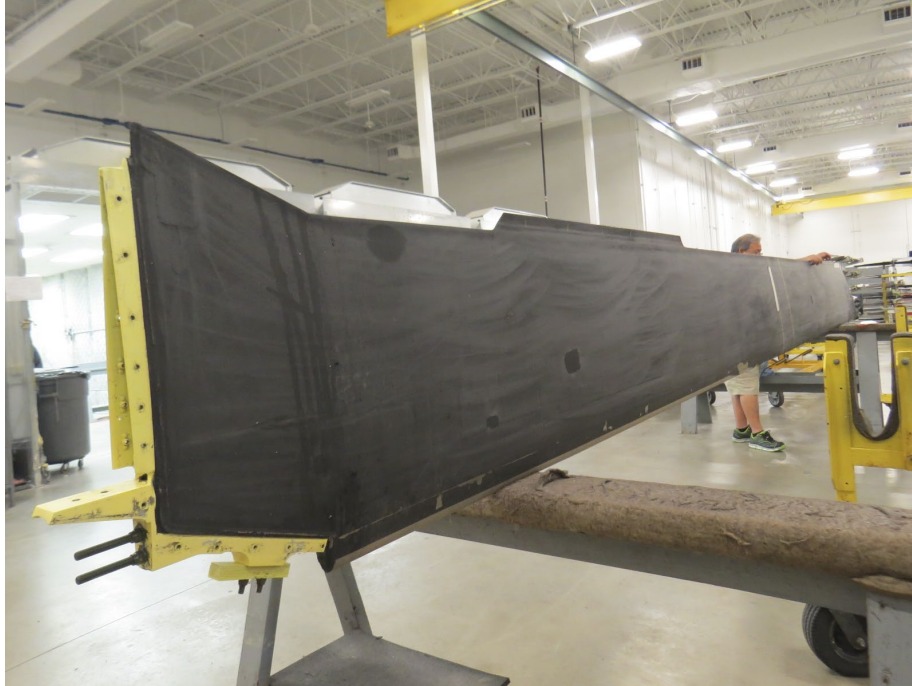
Figure 2. Black Hawk MRB. Source: RIMFIRE (2018).

a Black Hawk rotor blade. This document will articulate the benefits of digitally mapping MRBs throughout the component life cycle and the associated inspection technologies that could support digital mapping. The following are the research questions:

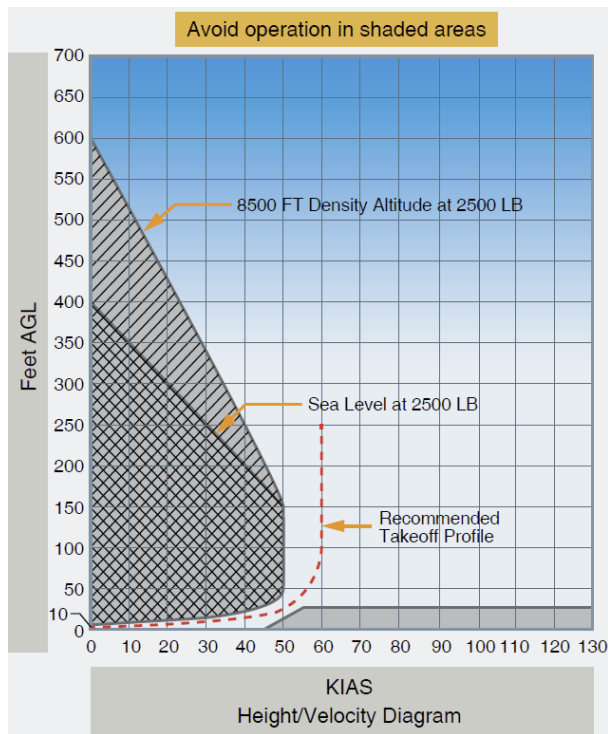
Figure 3. Sample Height/Velocity Diagram. Source: Flight Literacy, <https://flightliteracy.com/helicopter-performance-charts-part-one/>, n.d.).

Helicopters operate routinely within the avoid area of the performance chart. Varieties of missions require such operation; routine observance of transient controlled flight occurs during takeoff, landing, and hovering events. Optimal MRB design with reliable and uncompromised material integrity help ensure adequately driven rotor systems perform safely through their intended flight regimes.

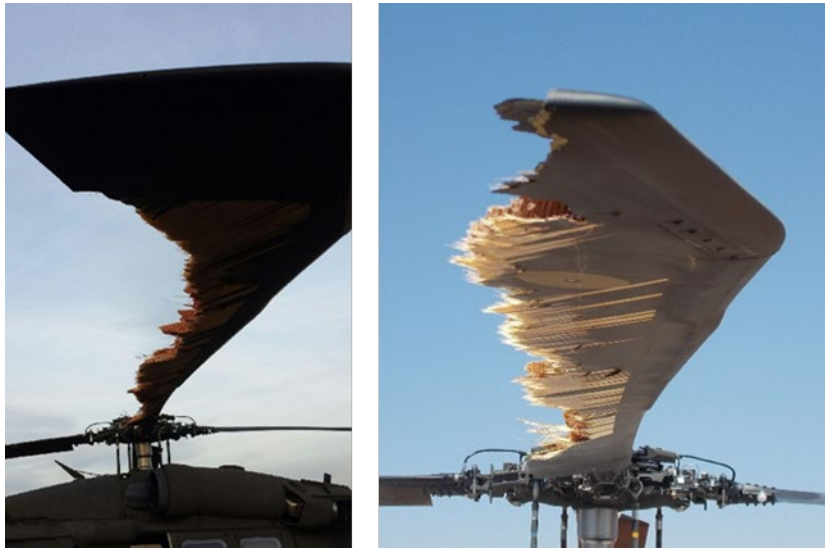
Figure 4. Undetected Material Faults. Images courtesy of U.S. Army Program Executive Office - Aviation (2014, 2012).

introduce expanded inspection methods and inspection frequencies to mitigate known concerns. The released messages have not resolved all identified concerns, and the fleet continues to struggle with sufficient nondestructive inspection methods capable of detecting conditions known to undermine component integrity. Undetected material faults may ultimately compromise component integrity as evidenced in Figure 4.

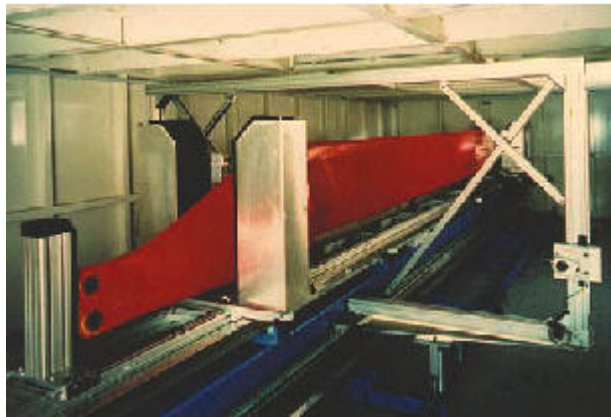
Figure 12. Shearography Applied to a Rotor Blade Inside a Vacuum Chamber. Source: Krupka (2003)

platform on one end while the opposite side of the MRB is coupled to a torque motor that would provide the stressing required by shearography. Understanding the MRB stress limits would need to be taken into careful consideration to ensure no damage to the rotor blade. Cameras could be placed in multiple locations to provide a 360° view of the MRB while subjected to light waves. An article written in 2003 by R. Krupka, T. Waltz, and A. Ettemeyer regarding the *Industrial Applications of Shearography for Inspection of Aircraft Components* validates shearography as an improved non-destructive test (NDT) for aircraft components, specifically helicopter rotor blades. This article provides examples of shearography being applied as inspection methods for rotor blades as seen in Figure 12. Figure 12 shows an inspection of a helicopter rotor blade inside a vacuum chamber that is using shearography to detect any deformations and/or delamination (Krupka, 2003). In this particular example, the vacuum chamber is applying the stress required to conduct a non-destructive shearography test.

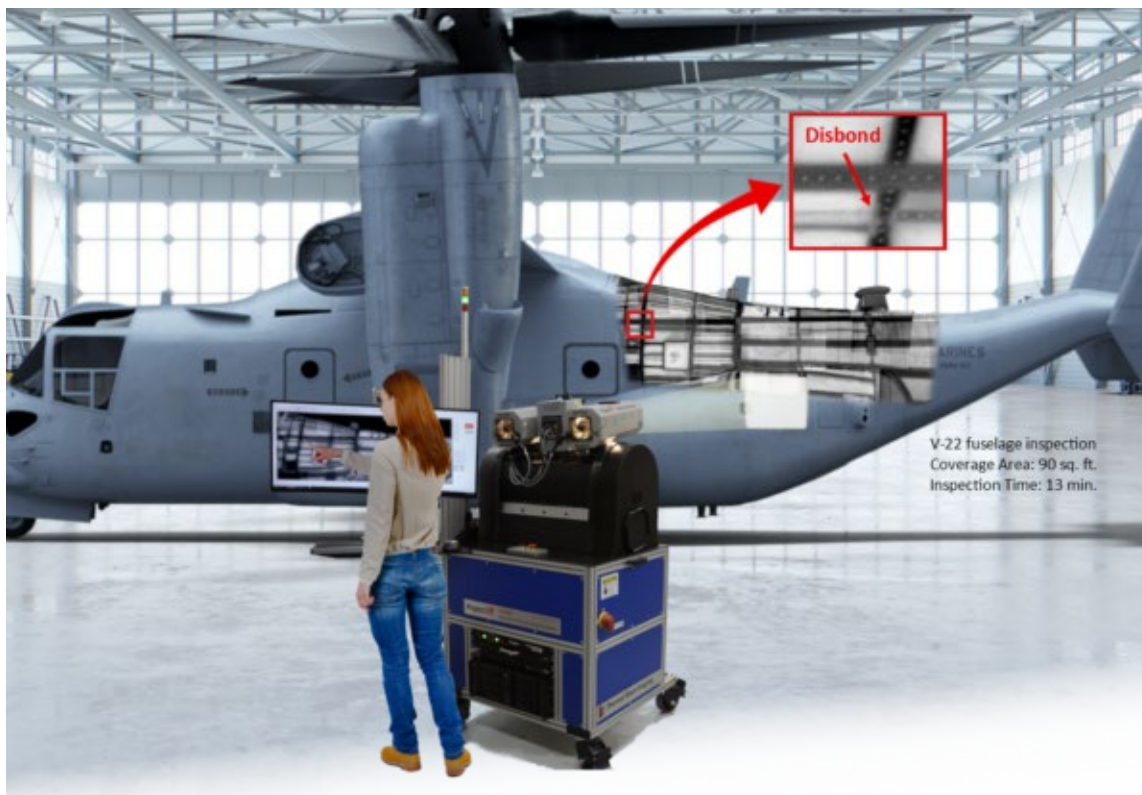
Figure 15. Large Area Inspection Concept as presented on the TWI website.
Source: TWI, <https://www.thermalwave.com/technology/>.

With improvements in instrumentation that can be used to conduct thermography scans, a leading industry organization Thermal Wave Imaging (TWI) is pushing the limits for how thermography is used in the defense industry. Like shearography, thermography is also a NDT that can be used to detect anomalies or defects of composite materials. As depicted in Figure 15, TWI is pushing to advance inspection techniques in the field even with new and emerging weapon systems such as the future vertical lift platforms. Although Figure 15 shows an inspection on the body of an aircraft, according to TWI the technology is best fit to inspect composite images for impact damage, delaminations, water ingress, foreign object debris detection, thickness measurement, porosity, and disbonds (TWI, n.d.). Similar to the honeycomb structure of a rotor blade, TWI shows an example on their website, Figure 16, of how thermography can assist in detecting trapped water internal to a honeycomb structure.

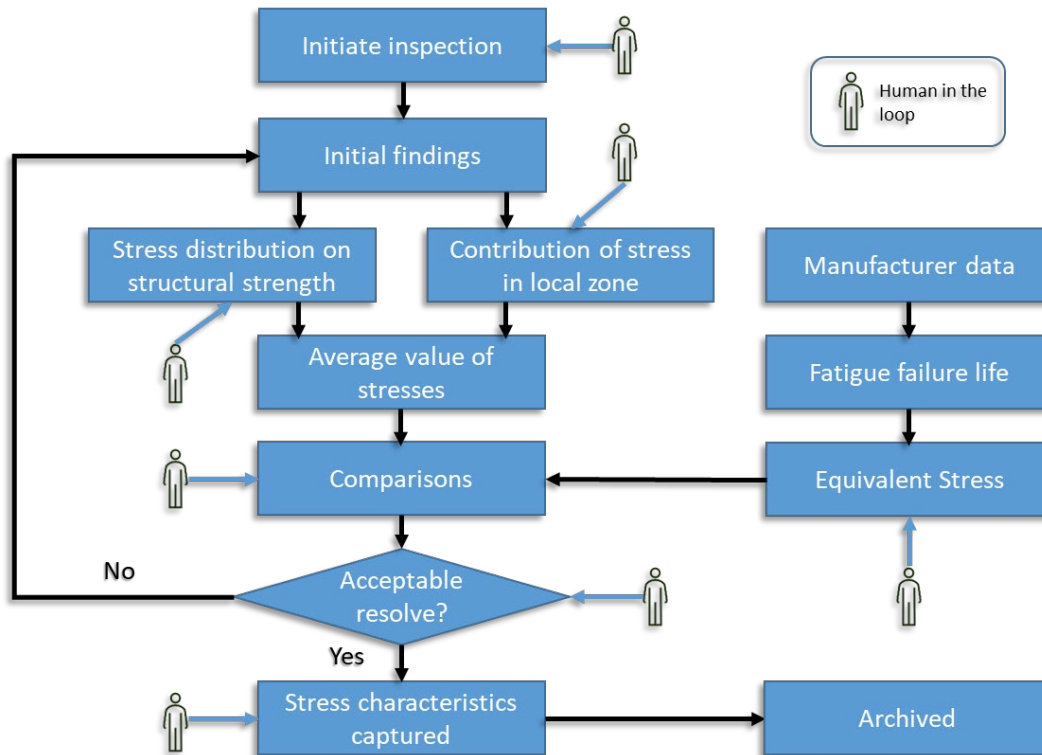
Figure 17. Current process of identifying characteristic stress of the component. Adapted from *A Modified Stress Field Intensity Approach for Fatigue Life Prediction of Components* (2020, p. 4).

Figure 17 furthermore illustrates where a person is required to examine a component consisting of composite material. As mentioned before, the complexity of identifying flaws or defects on a modern MRB is very challenging and subject to human error due to its composite nature. At this point in time, the Army does not possess a computer system that can assist in the comparison process; let alone a means of correlating the data since past findings are manually scanned and archived into a resting database. During all inspections the data collected and repairs initiated end up being logged into a RIMFIRE report. An extraction from a RIMFIRE report can be seen in Figure 18. This current process mapping is plagued with inconsistent information and data that is not easily accessed for analyzing present maintainability concerns and predicting future component failures. As can be seen in the RIMFIRE report extract, it would be extremely difficult to correlate incidents and repairs over time via sorting through PDF documentation.

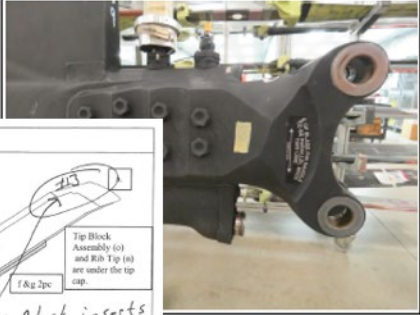
Part Name: Cuff ASSY

Conditions: N/A			
Severity: N/A			
Comment: Mandatory Photo			
Sequence Number: AX18MHR362ANJ31-1038			
DMWR 1-1615-281 10 FEBRUARY 2012 Note: All applicable safety and Maintenance messages will be complied during Recap.
