LASER WINDOW SURFACE FINISHING AND
COATING TECHNOLOGY

Morris Braunstein

Hughes Research Laboratories

August 1974

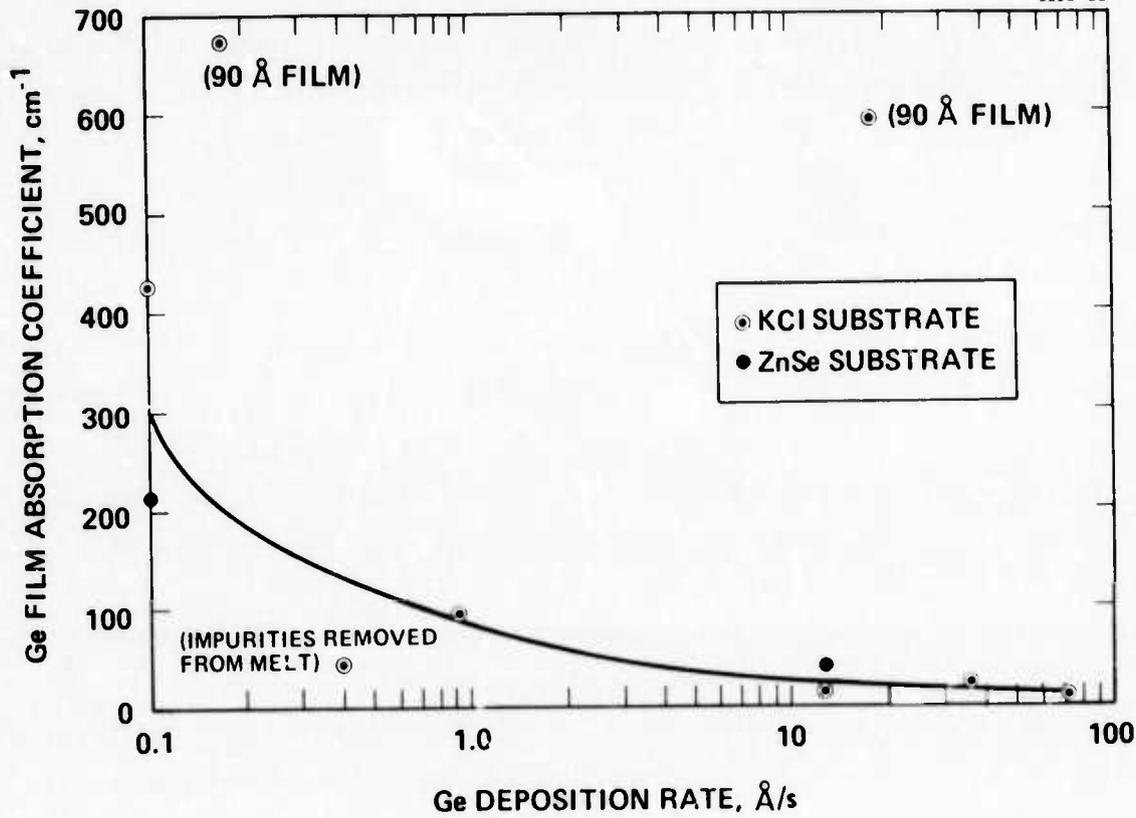
Fig. 1. $10.6 \mu\text{m}$ absorption versus deposition rate for UHV germanium films.

Figure 1 summarizes the germanium film absorption versus deposition rate results. The points which fall on the dashed curve are for films of more than a few hundred angstroms in thickness. These points clearly show the inverse dependence of 10.6 μm absorption on deposition rate. Other deposition parameters, such as substrate temperature and system pressure during deposition, were found not to affect the absorption results within the ranges studied (pressure: 1.5×10^{-7} - 2.5×10^{-9} Torr; temperature 27 to 150°C). The two points which are labeled "90 Å film" in Fig. 1 are indicative of an excess absorption in thin layers which is probably concentrated at the film-substrate interface. This high apparent absorption coefficient in thin layers is a result of assuming a uniform absorption coefficient throughout the layer and thereby neglecting the possibility of any surface effects. For the thicker layers the error introduced is small since the surface absorption is a small percentage of the total absorption. It

The work on germanium film preparation which was reported in preliminary form in Semiannual Technical Report 1 is completed. The inverse dependence of 10.6 μm absorption on film deposition rate observed in our initial work is now confirmed. Correlations are found between the deposition rate, the impurity content, and physical structure of the films which appears to explain the variation in the 10.6 μm absorption data. Germanium film absorption continues to be limited to a β of $\approx 10 \text{ cm}^{-1}$ for the best films produced. High deposition rates minimize the impurity content in the films and leads to amorphous film structure; both are required for low optical absorption at 10.6 μm . A reduction of the KCl substrate temperatures from 150°C to 30°C markedly reduces the K and O levels in the germanium films on KCl.

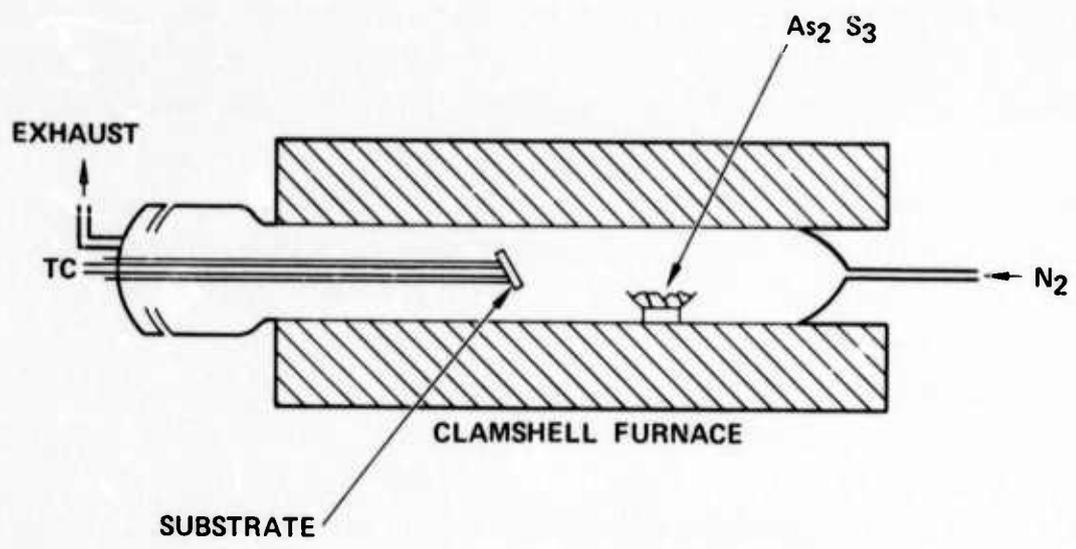
Fig. 2. PVD apparatus.

Early in this period a number of runs were made using an open-tube PVD system (see Fig. 2) in which As_2S_3 was heated in a stream of hot dry nitrogen. Experiments were performed using glass (vitreous silica) substrates as well as cleaved and cut and polished KCl surfaces. The series of experiments indicated that a freshly etched

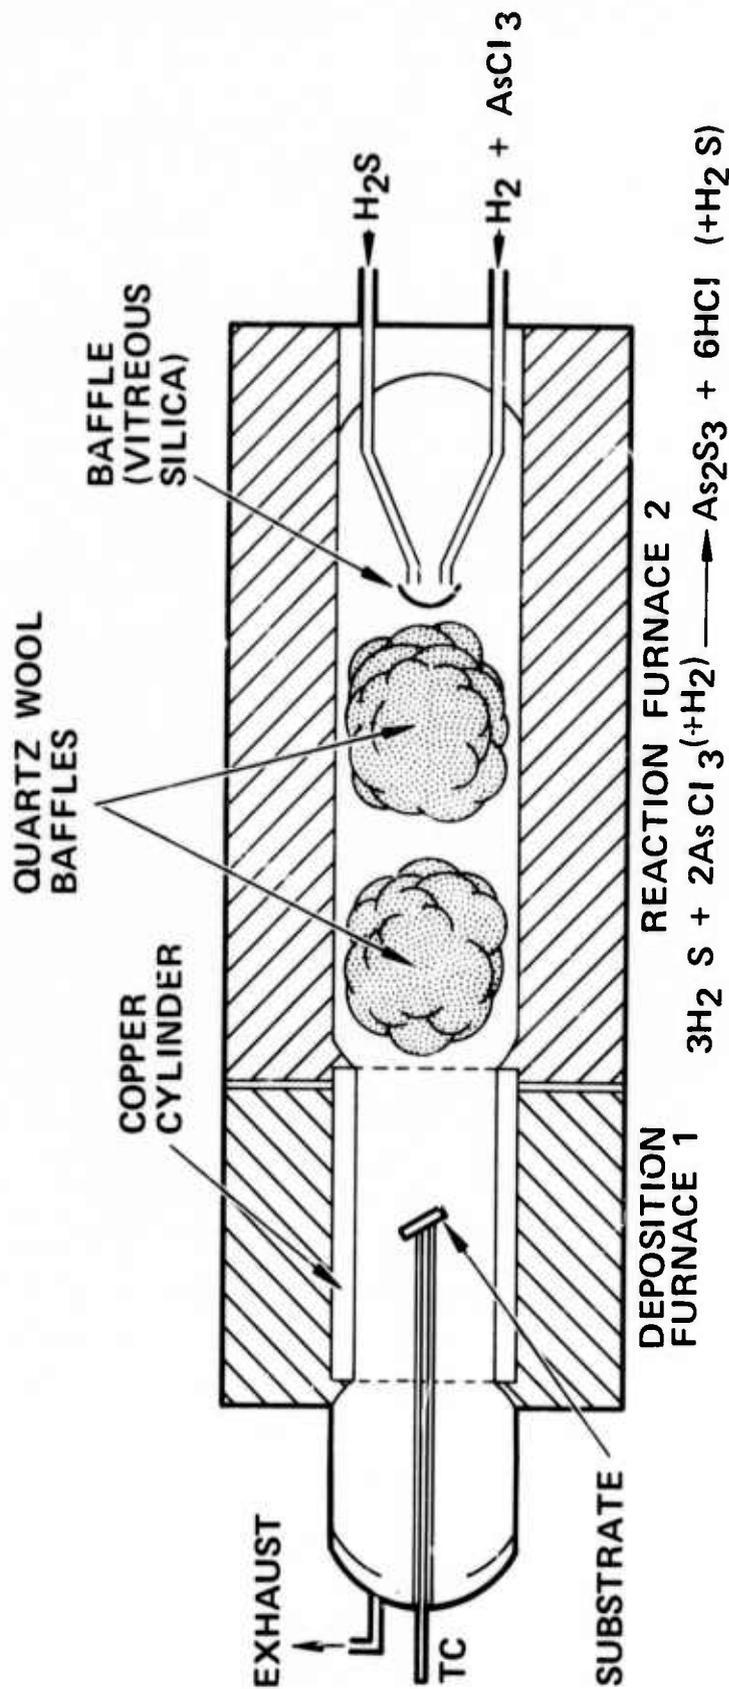
Fig. 3. CVD apparatus.

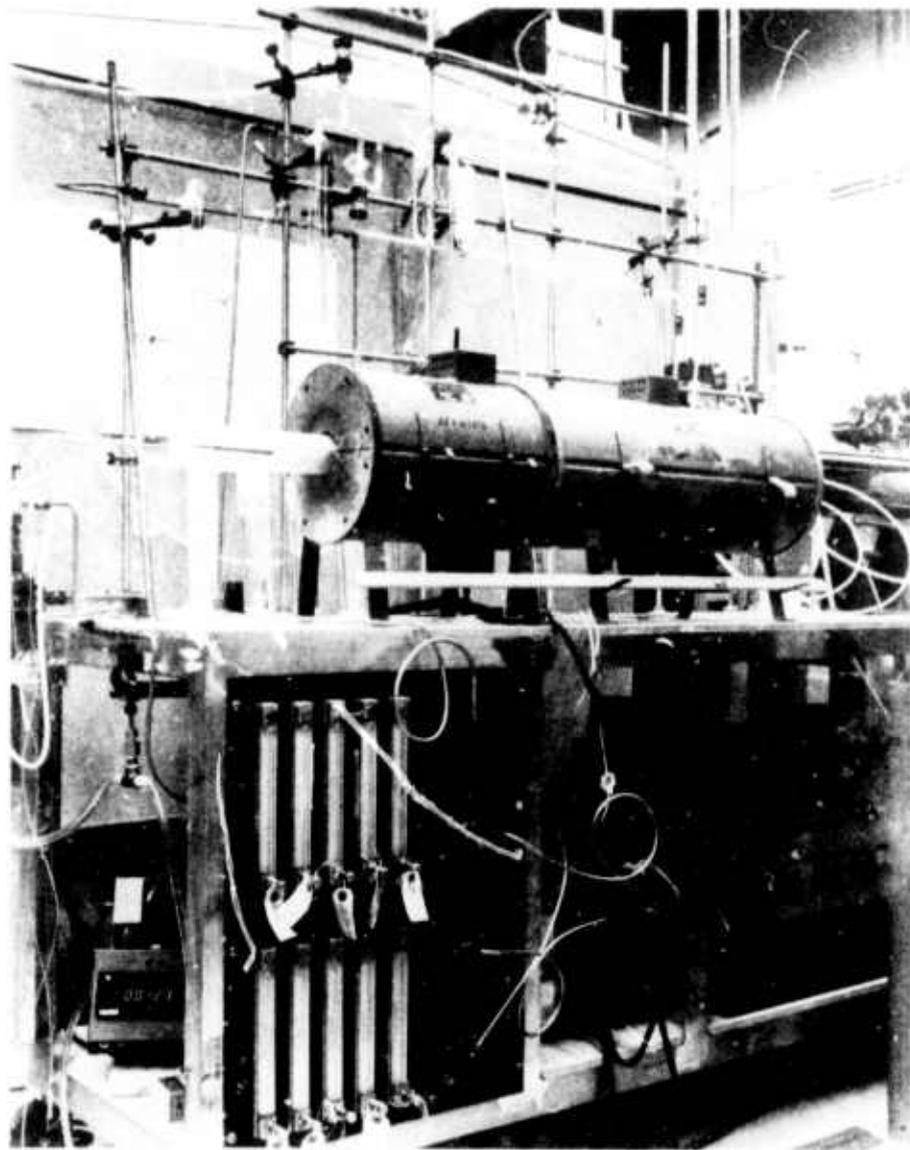
Fig. 4. Chemical vapor deposition of As_2S_3 .

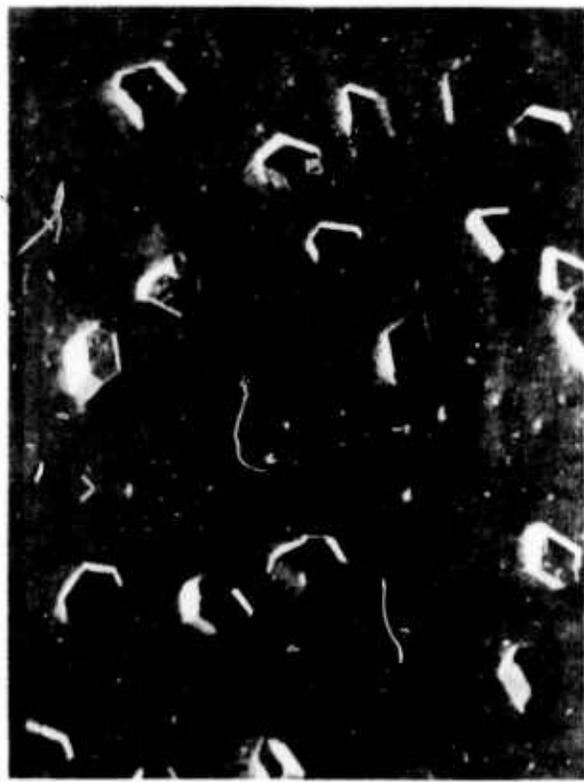
350X

Fig. 5(a). Microprobe SEM photograph

The major problems encountered so far have been the growth of crystals of dimorphite (As_4S_3) nucleating within the amorphous As_2S_3 matrix (see Fig. 5(a) and (b)), the crystals appear to grow larger at the expense of surrounding smaller crystals with increased time.

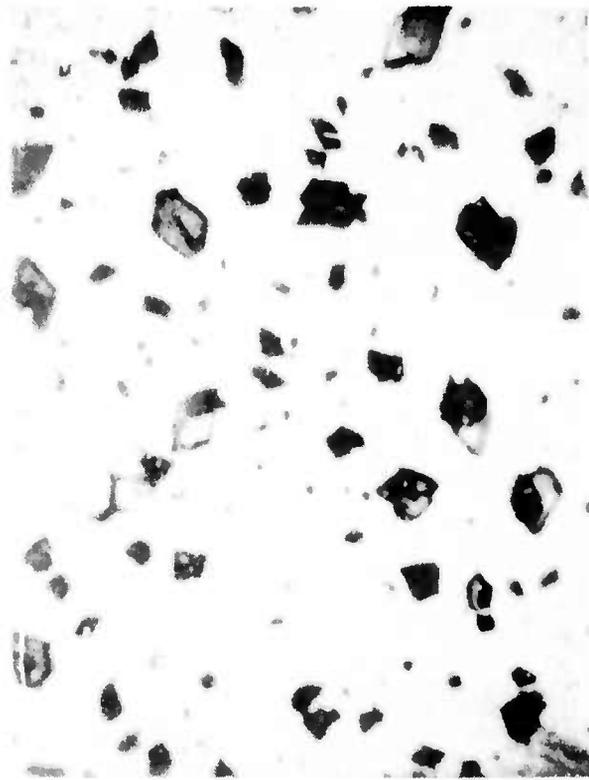
320X

Fig. 5(b). Photomicrograph.

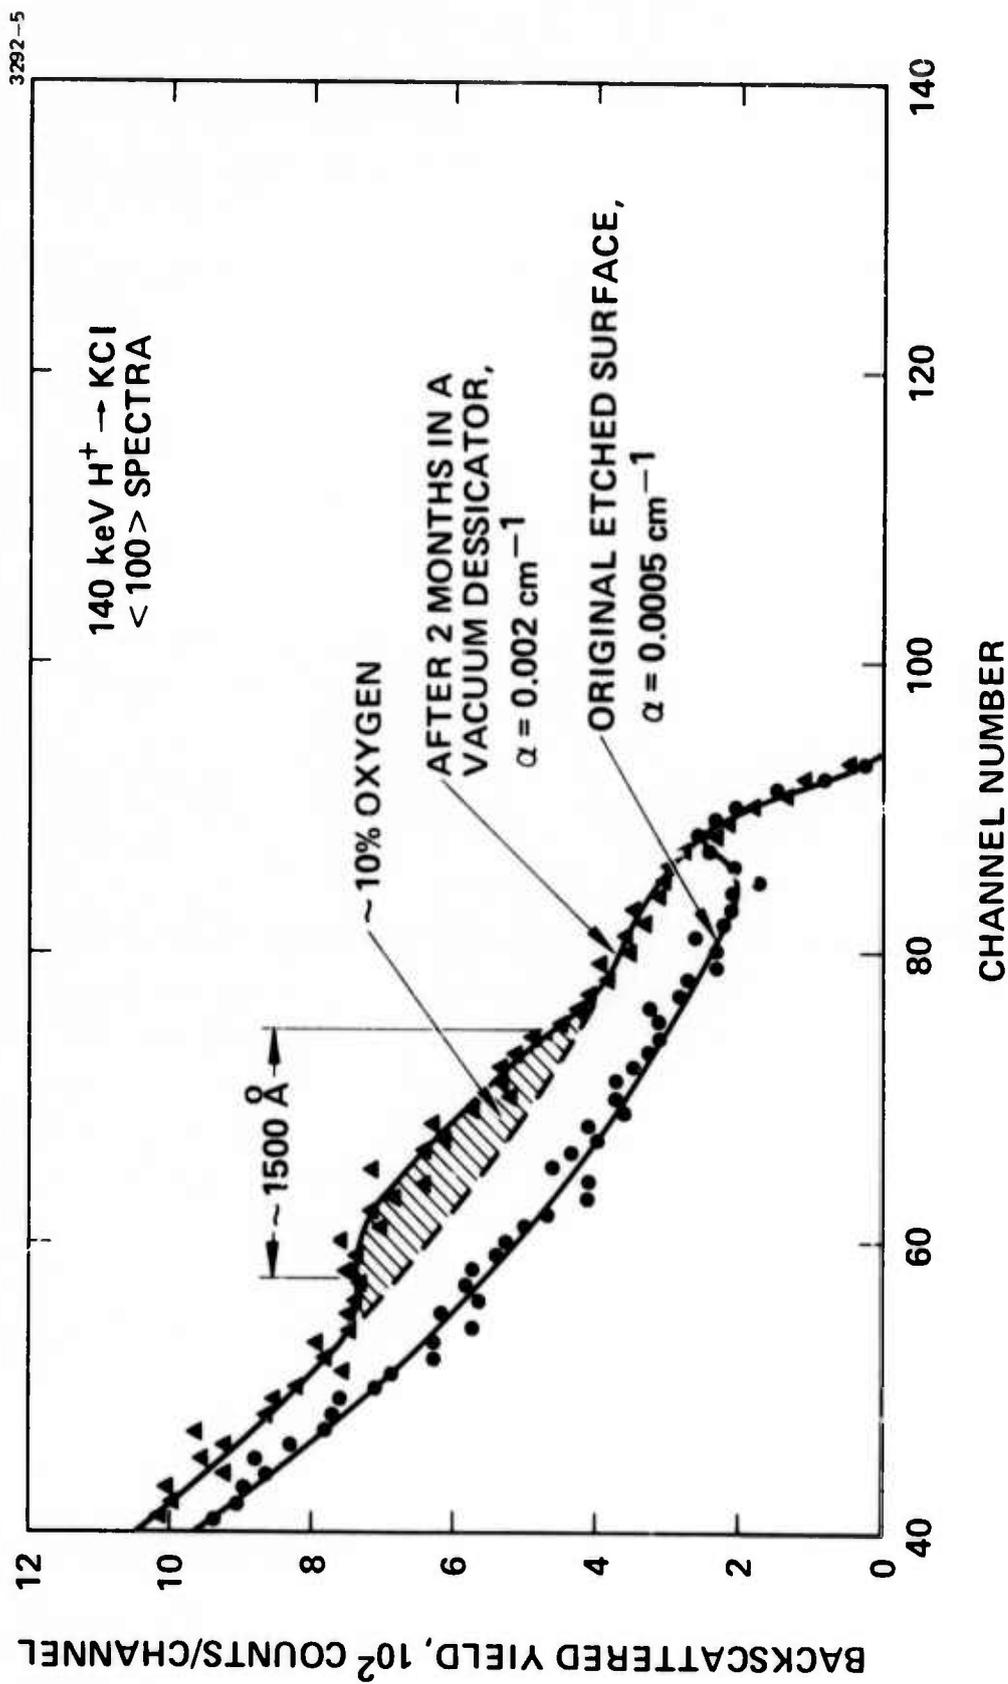
Fig. 6. Backscattered energy spectra of 140 keV protons incident along the 100 channel of KCl after HCl etching and after 2 months' storage in a vacuum desiccator.

The small peak at the surface (channel 90) of Fig. 6 on the original etched surface is probably caused by a thin oxide layer. The $\langle 100 \rangle$ yield just behind this peak is about 5% of the random or

nonchanneled yield, a result typical of a good single crystal surface region. However, the $\langle 100 \rangle$ spectrum after two months' storage in a vacuum desiccator, which is also shown in Fig. 6, indicates an approximately 50% increase in yield near the surface and a broad peak starting at channel 75. This peak is consistent with the incorporation of about 10% oxygen in a 1500 Å surface layer. The presence of the oxygen apparently causes the increased yield from K and/or Cl atoms near the surface by a distortion of the original lattice. It is also of interest to note that the 10.6 μm absorption coefficient increased from 0.0005 cm^{-1} soon after etching to 0.002 cm^{-1} after two months' storage. Thus there seems to be a definite correlation of increased absorption with chemical and physical degradation of the surface region. Although additional work is needed to better define the reaction rate of KCl surfaces with environmental conditions, the present results suggest that protective coatings of KCl are essential to long-term surface stability even in a relatively H_2O -free environment, i. e., a vacuum desiccator.

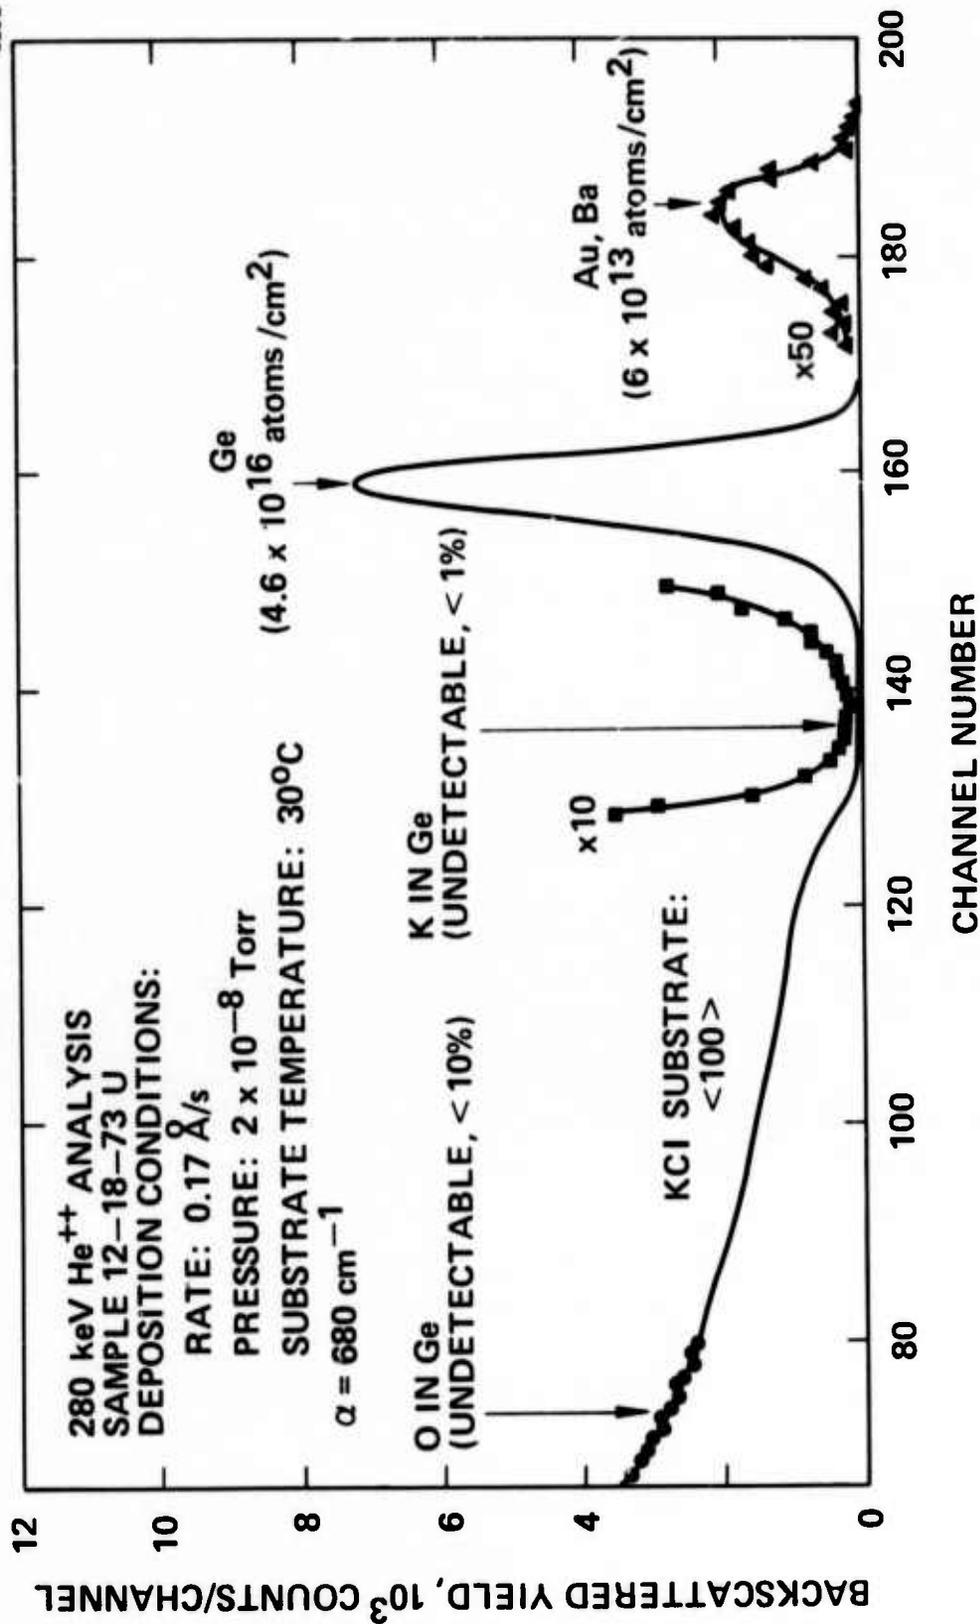
Fig. 7. Backscattered energy spectrum of 280 keV He⁺⁺ incident on a thin germanium film evaporated onto KCl in UHV.

A backscattered energy spectrum using 280 keV He^{++} analysis of this recent germanium film is shown in Fig. 7. The amounts of K and O in the film are less than the measurement sensitivities, $\sim 1\%$ and $\sim 10\%$, respectively. These results should be contrasted with the 4% K and 20% O observed earlier in the low rate film deposited at 150°C.

However, the heavy impurity peak at channel 185 of Fig. 7 is comparable in amount to the 0.07% observed earlier, and consequently, is unaffected by substrate temperature. Electron microprobe analysis of the surface of the germanium material used for the depositions revealed that trace amounts of gold and barium were located in a small area (100 mil radius) near the tip of the germanium which was locally heated by electron beam bombardment during the depositions.

Thus the heavy element peak of Fig. 7 is attributed to gold and barium. It is postulated that the gold may have been present in the bulk of the germanium and diffused to the tip during e-beam bombardment. To check this point the contaminated tip was lapped away, and another low-rate (0.4 Å/s) germanium film was deposited on KCl. After lapping, microprobe measurements of the germanium source material indicated that the gold and barium had been removed.

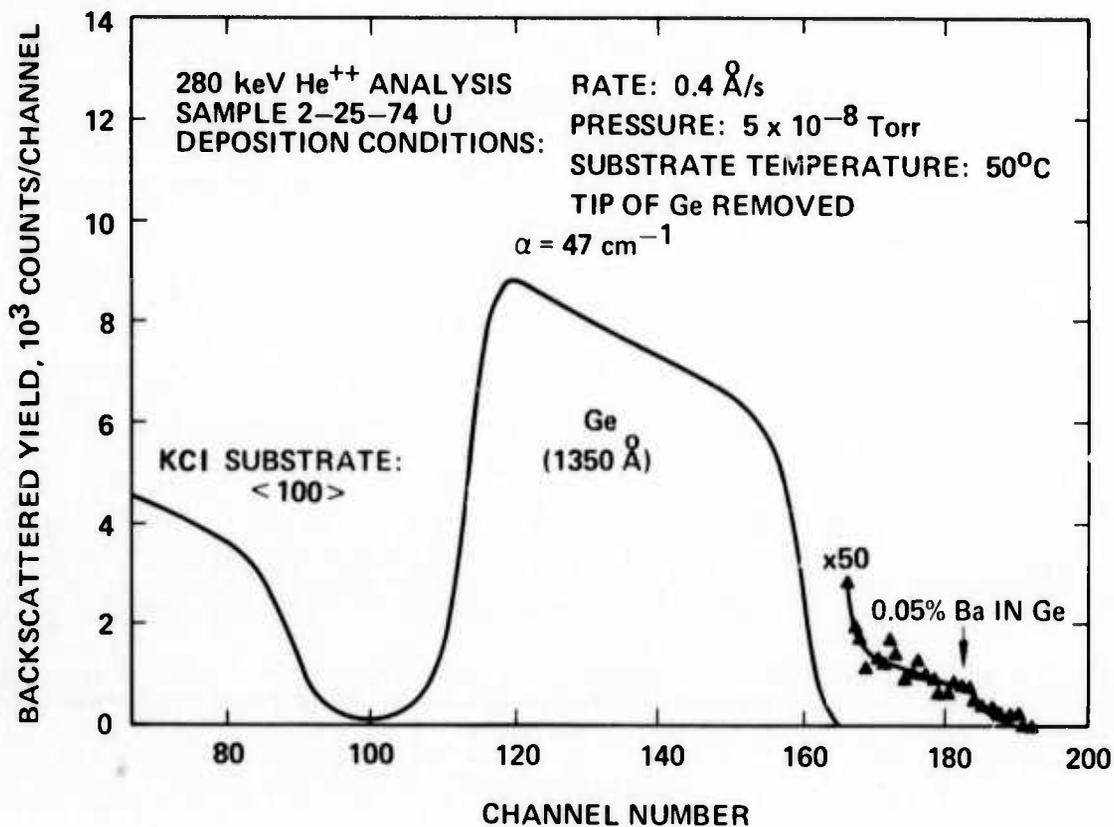
Fig. 8. Backscattered energy spectrum of 280 keV He⁺⁺ incident on a 1350 Å germanium film evaporated onto KCl in UHV after removal of the tip of the germanium source material.

A backscattered energy spectrum from this film is shown in Fig. 8. Since the germanium film is much thicker (1350 Å) than that of Fig. 7, the heavy impurity peak is broadened. Nevertheless, the level of the backscattered yield from the heavy impurity near the surface at channel 182 of Fig. 8 is reduced to about 0.5 of the previous level. Microprobe analysis of the tip of the germanium source material after evaporation of the film of Fig. 8 revealed that a trace of barium was again present, but that there was no re-introduction of gold. It seems reasonable to attribute the remaining heavy element concentration (0.05%) in the germanium film of Fig. 8 to barium. Since BaF₂ films were originally deposited in our UHV system, the re-introduction of barium onto the tip of germanium source material and in the deposited film apparently is caused by residual barium contamination of our vacuum chamber. This result points out the difficulty of avoiding cross contamination of different film material deposited in the same system.

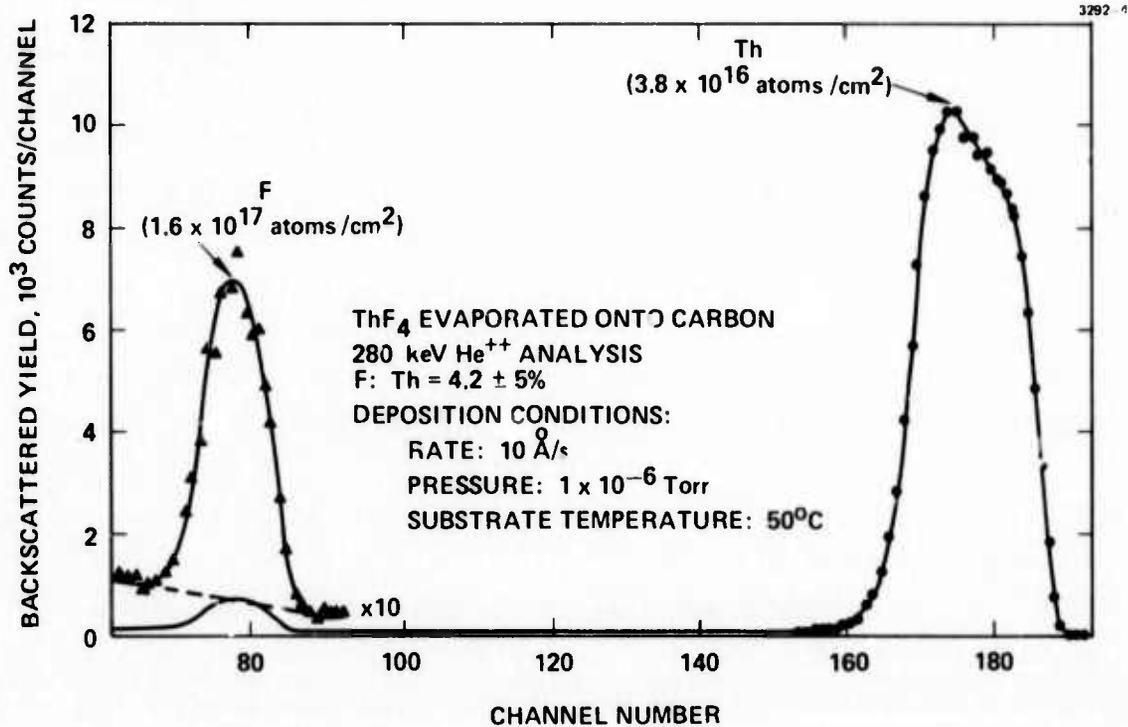
Fig. 9. Backscattered energy spectrum of 280 keV He⁺⁺ incident on a ThF₄ film evaporated onto a carbon substrate.

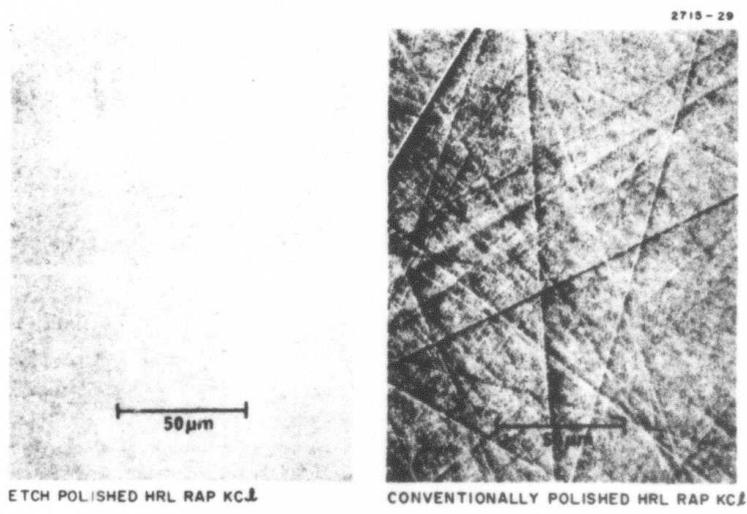
Fig. 2.

Optical micrographs of a conventionally polished and etch-polished KCl window are shown in Figure 2. In contrast to the scratches and digs observed in the conventionally polished window, the etch-polished surface shows no discernible features at this magnification. This smoothness is confirmed by SEM photographs at 18,000X (Figure 3).

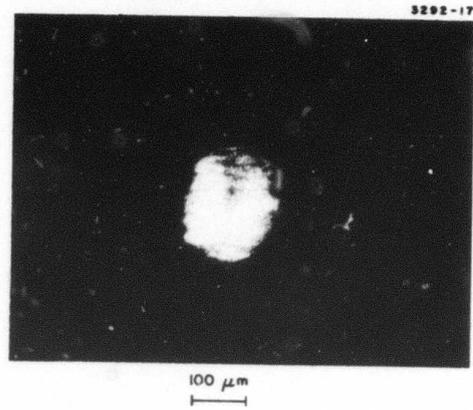
Fig. 4

The character of the exit surface damage morphology for polished KCl is illustrated in Figure 4. The central portion of the damage site has been melted and is surrounded by a ring with a relatively smooth topography as compared to the undamaged portion of the surface. Radiating from this "cleaned" area are shallow cleavage planes. This type of shallow damage is observed only on poor surfaces and at relatively low damage thresholds in KCl.

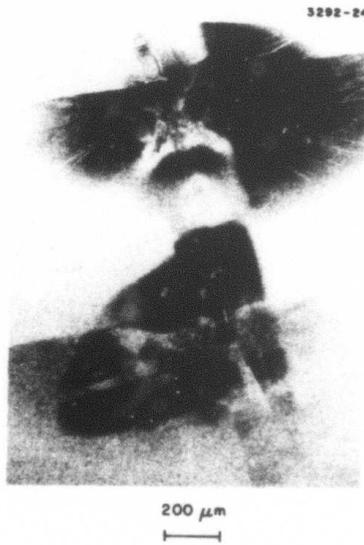
Fig. 5

Exit surface damage morphology for etched HRL RAP KCl differs markedly from that for polished surfaces (Figure 5). The damage sites are several millimeters in diameter and are composed of radiating cleavage planes. This type of behavior — minor damage at low thresholds for "dirty" surfaces, catastrophic damage at high thresholds for "clean" surfaces — had been noted by Giuliano [8] in measurements on ion-polished sapphire at 0.69 μm. The cleavage planes of exit surface damage sites in etched polycrystalline HRL RAP KCl (Figure 6) are distorted, compared to those in etched single crystal material, and seem to indicate the presence of grain boundaries. Inclusion damage, both bulk and surface, is readily distinguishable by damage morphology. A typical inclusion damage site (Optovac KCl, bulk damage) is illustrated in Figure 7. The damage region extended for a length of 400 μm along the beam path with many inclusion damage sites observable.

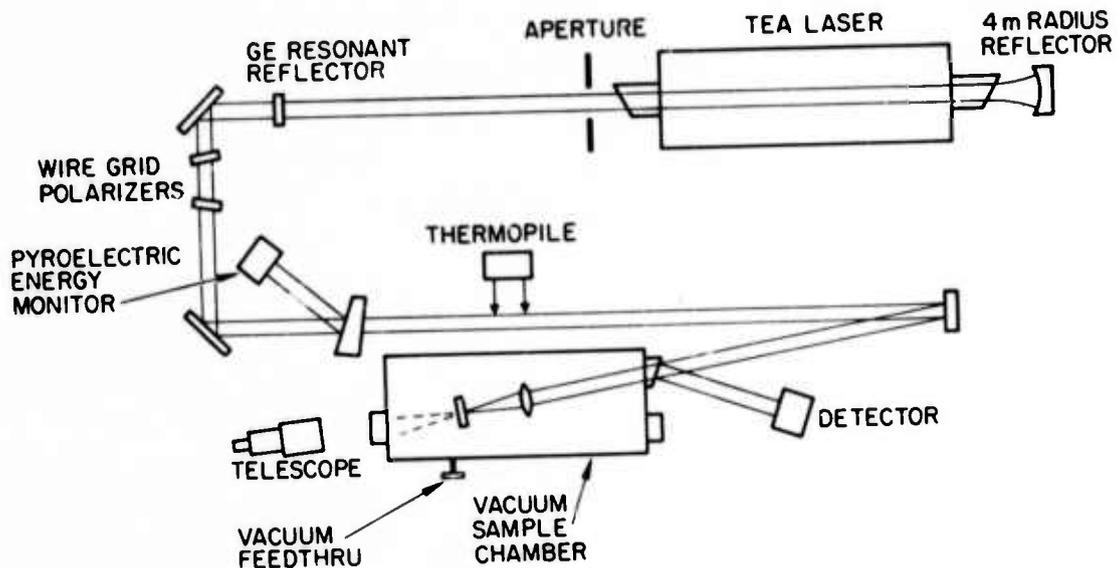
Fig. 1

- Fig. 1. Schematic of laser, optical train, and sample chamber.
- Fig. 2. Pulse temporal profile. (a) Germanium photon drag detector plus 500 MHz oscilloscope. (b) Expanded to 10 nsec/division. (c) Definition of equivalent pulse (pyroelectric detector).
- Fig. 3. Beam spatial profile and spot size.
- Fig. 4. Zinc selenide cross section.
- Fig. 5. Computed electric field in $\lambda/4$ ZnSe on KCl.
- Fig. 6. Electric field distribution on a $\text{Mo}/(\text{ThF}_4/\text{ZnSe})^2$ reflector.

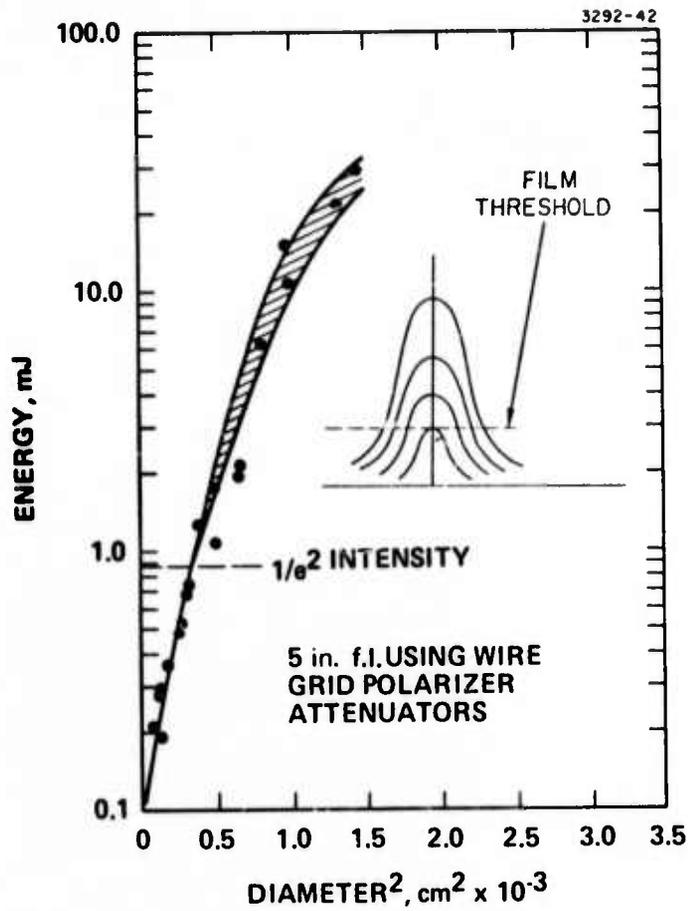
Fig. 3.

Spot size for a given lens is measured by varying the energy focused on a heat-sensitive plastic film (3 M, Type 557) in a series of burn spots, and plotting the log of energy versus spot size squared (Figure 3). A pulse of gaussian profile yields a straight line whose slope is a measure of the spot size. Measurements of spot size using the 12.5 cm germanium lens used for the majority of the tests indicate an essentially diffraction-limited spot size to beyond the $1/e^2$ intensity points. Measurements of spot size at the focus of the 6.2 cm lens give a diameter of between 0.059 mm and 0.073 mm (Figure 3). The uncertainty in measurement for this lens is due in part to the difficulty of measuring the low energies used in this calibration. Energy densities quoted for this lens are calculated for the on-axis peak intensity of a 0.073 mm spot. If a diffraction-limited waist is assumed, energy and power densities would be 50% higher for this lens at the beam waist.
