NONDESTRUCTIVE DETECTION OF STRUCTURAL  
DAMAGE UNIQUELY ASSOCIATED WITH  
FATIGUE

Rockwell International Corporation

**AFML-TR-74-131**

**JULY 1974**

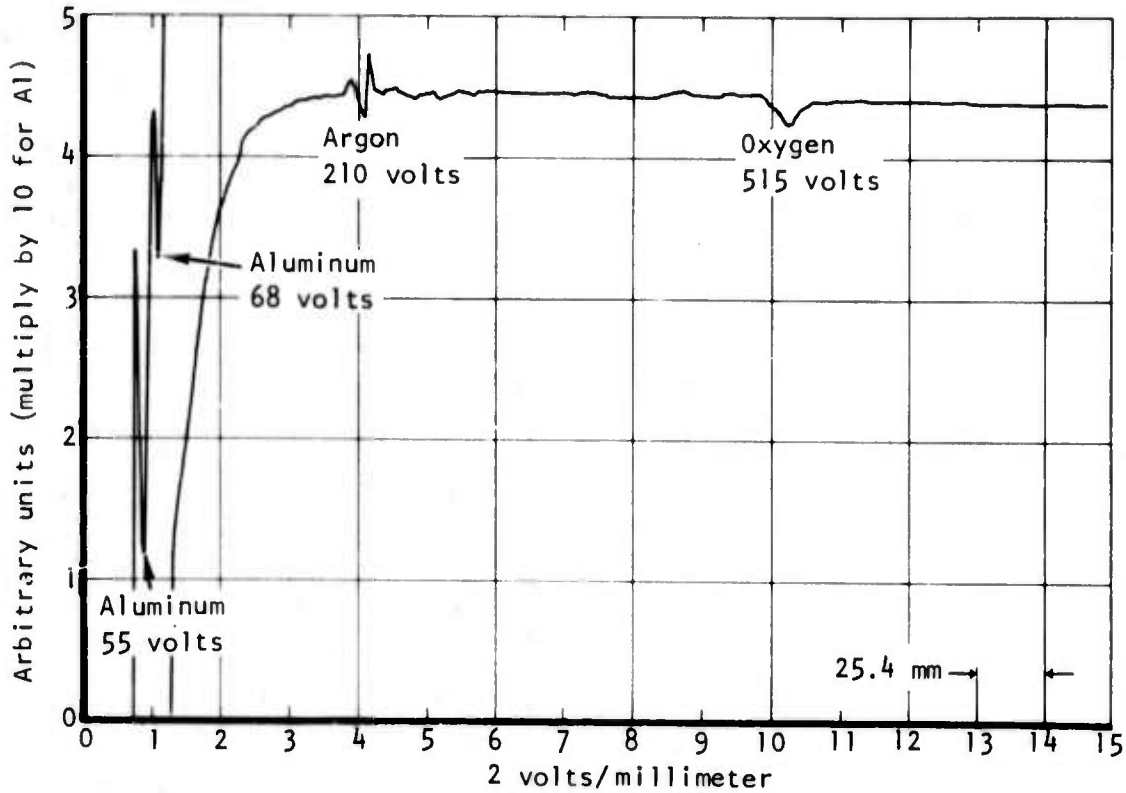
Figure 15. Auger spectrum after argon bombardment of 1100 aluminum to reduce the surface oxide thickness from 60 to 35 angstroms.

This paragraph contains the results of experiments made to determine the effect of aluminum oxide thickness on the exoelectron emission. An Auger spectral analysis was made on each specimen prior to the ellipsometric measurements to determine the chemical composition and determine how it varied as a function of the oxide thickness. Figure 13 shows an Auger spectrum of an 1100-0 specimen before fatigue, with an oxide thickness of approximately 60 angstroms. The ordinate is measured in arbitrary units, and the scale for the abscissa is 2 volts per millimeter. The voltage represents the measure of the Auger electrons emitted in the analysis. The aluminum oxide peaked at approximately 55 volts. The oxygen peak is shown at 515 volts. It should be noted that the arbitrary scale on the ordinate is multiplied by 10 for aluminum; i.e., the aluminum magnitude is diminished by a factor of 10 relative to the oxygen peak in this particular plot. After fatigue, a similar Auger spectrum plot is shown in Figure 14. It is seen that no essential differences occur in the Auger spectrum before or after fatigue. Figure 15 shows an Auger spectrum

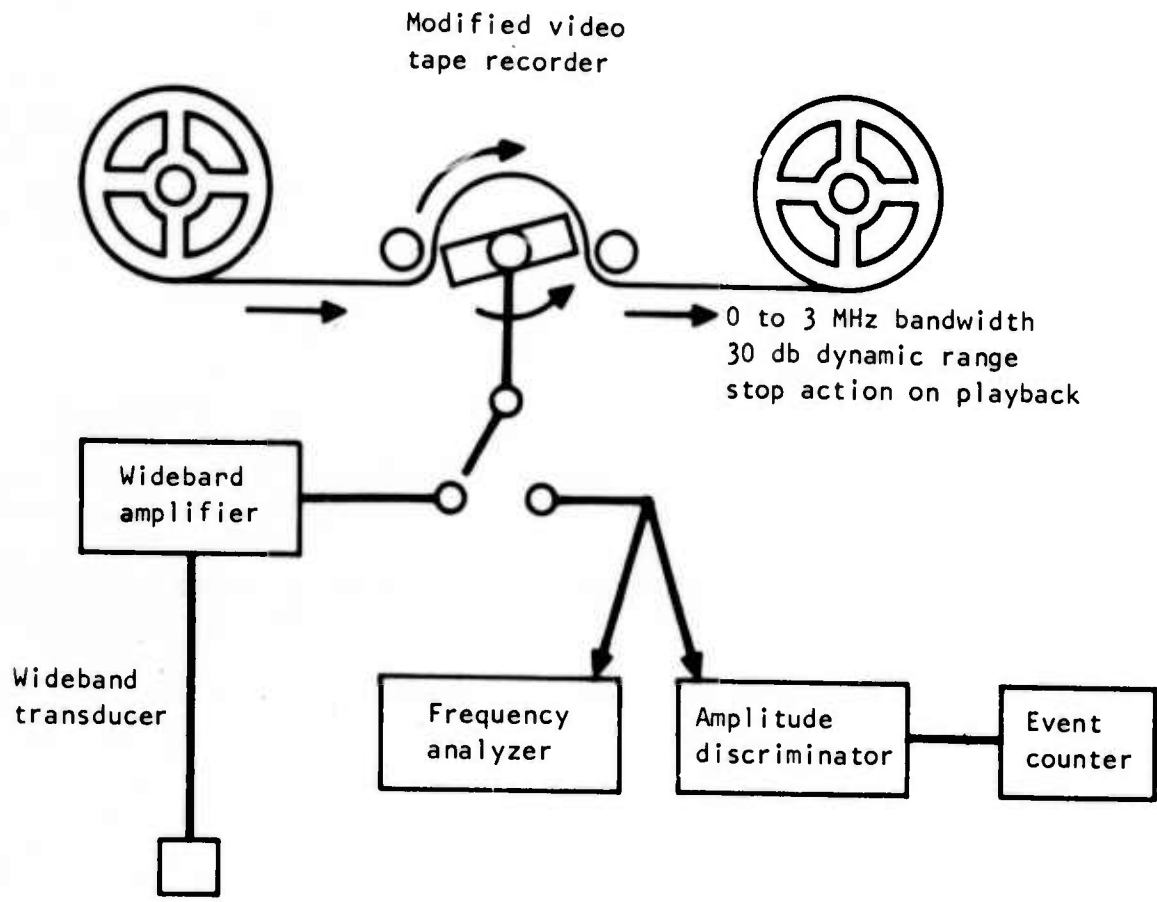
Figure 58. Block diagram of video tape recorder system for acoustic emission analysis.

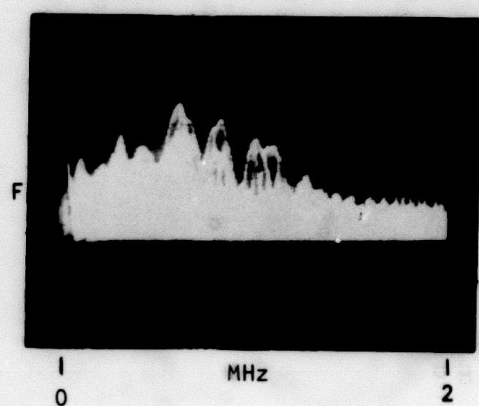
Figure 61. Typical acoustic emission data.
