LASER WINDOW SURFACE FINISHING AND COATING TECHNOLOGY

HUGHES RESEARCH LABORATORIES

PREPARED FOR  
AIR FORCE CAMBRIDGE RESEARCH LABORATORIES  
DEFENSE ADVANCED RESEARCH PROJECTS AGENCY

JANUARY 1975

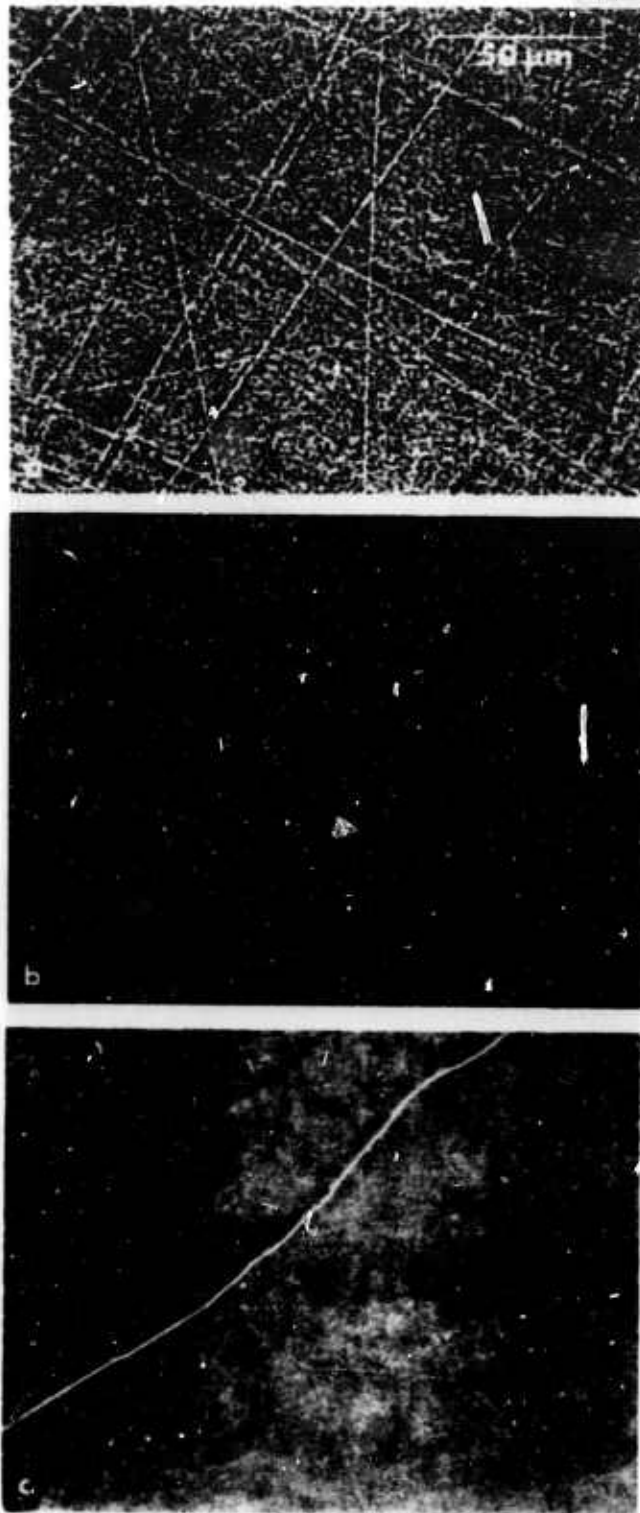
Fig. 2.  
Optical micrographs of KCl under oblique  
lighting conditions (500 $\times$ ).

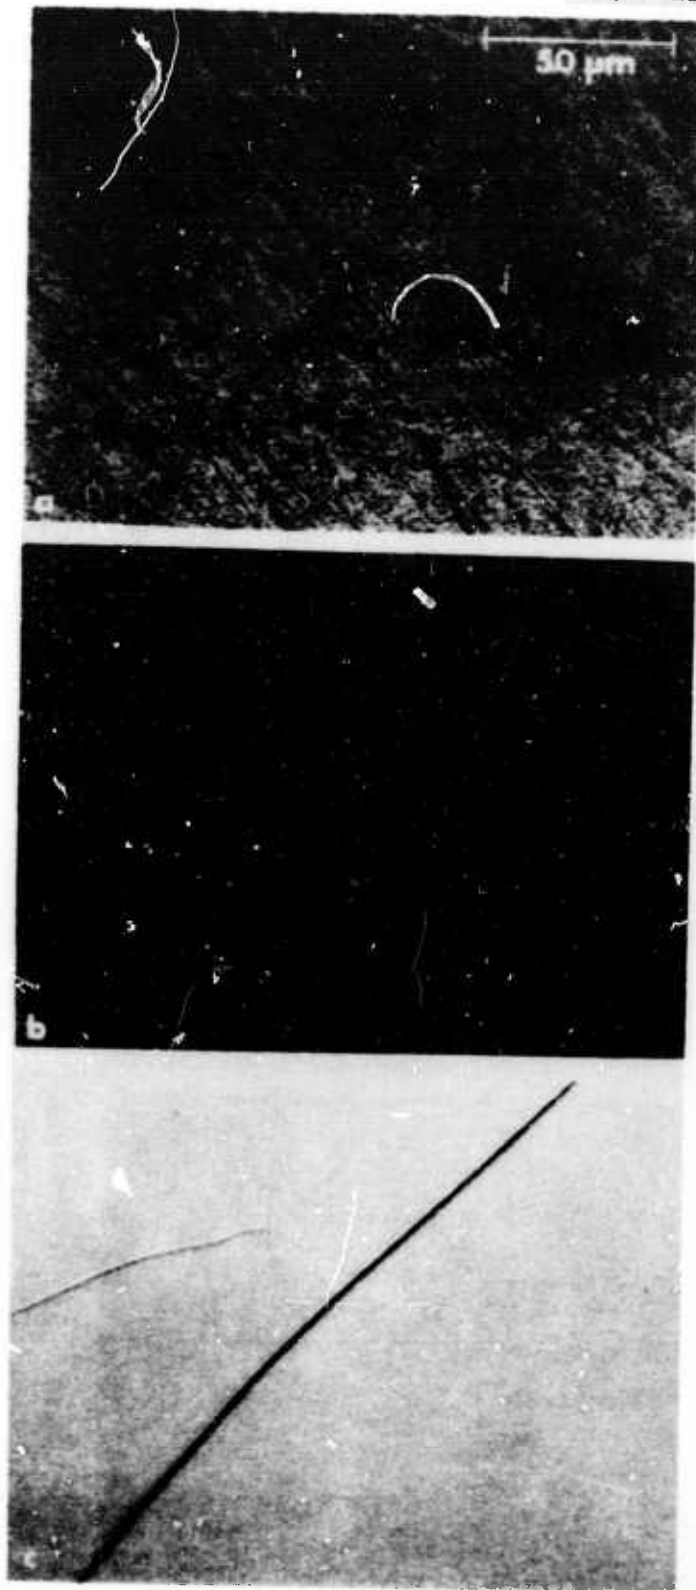
Fig. 3.  
Optical micrographs of KCl under phase  
contrast illumination (500x).

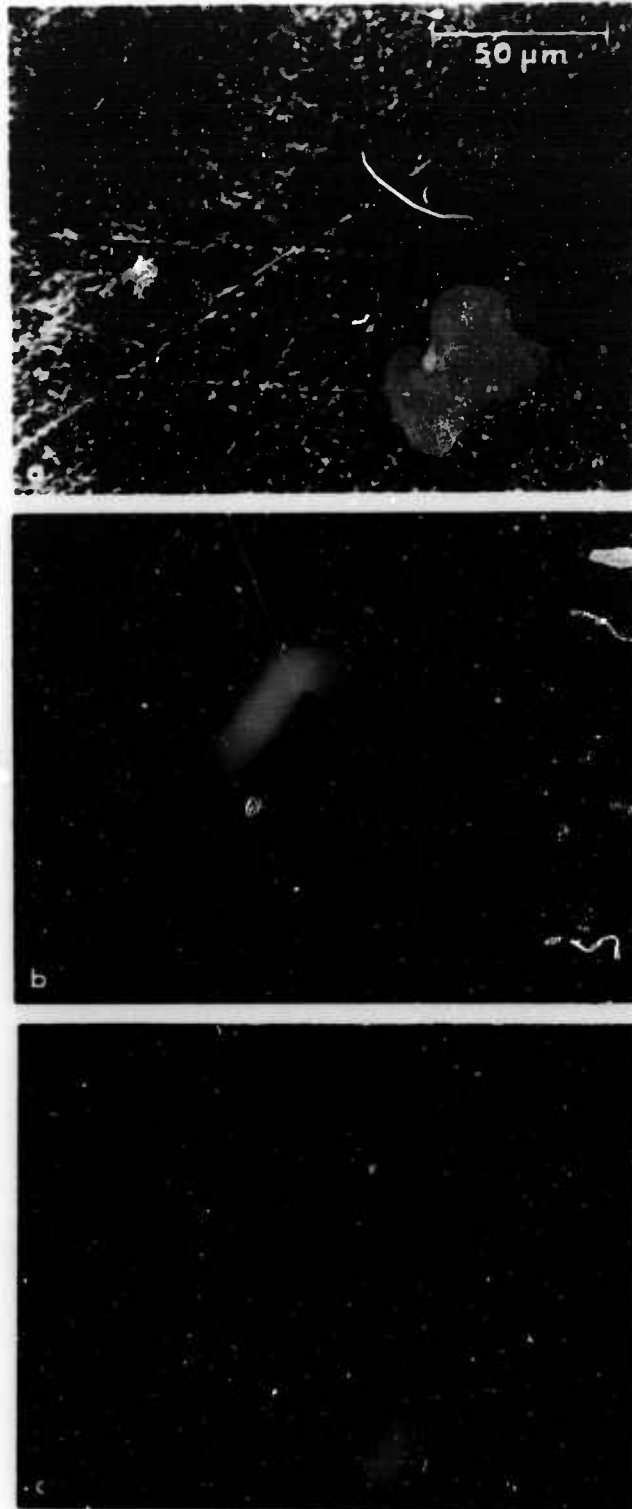
Fig. 4.  
Optical micrographs of KCl under phase  
contrast illumination (325x).

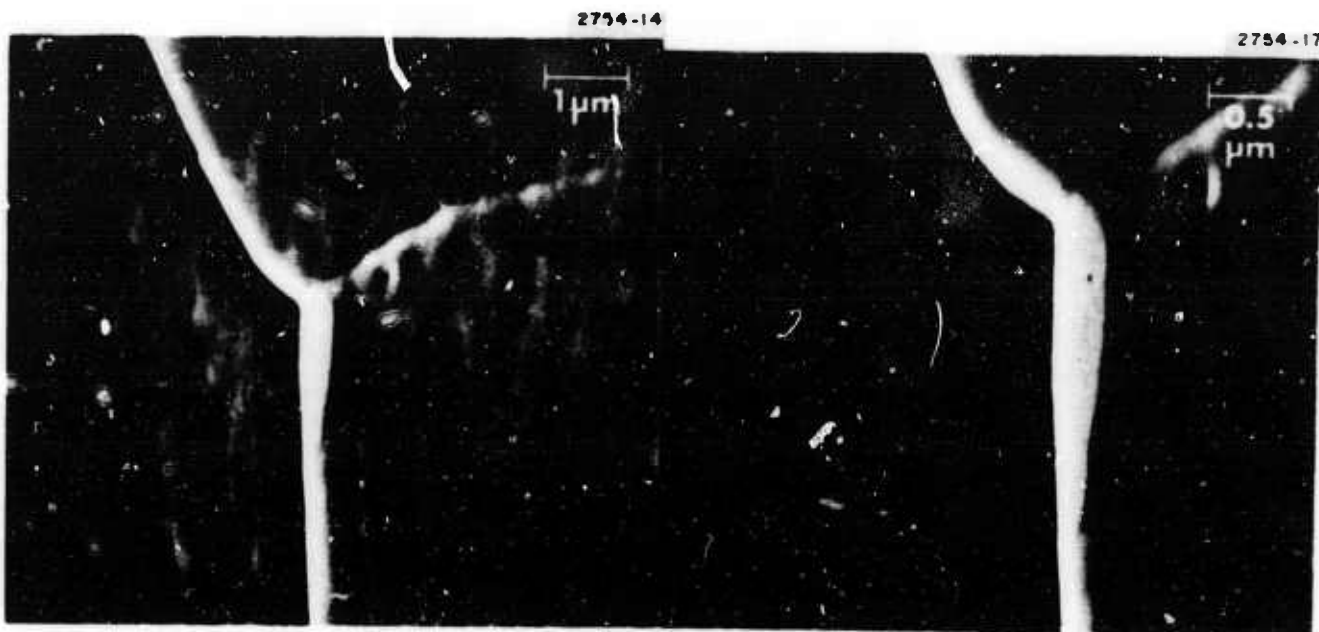
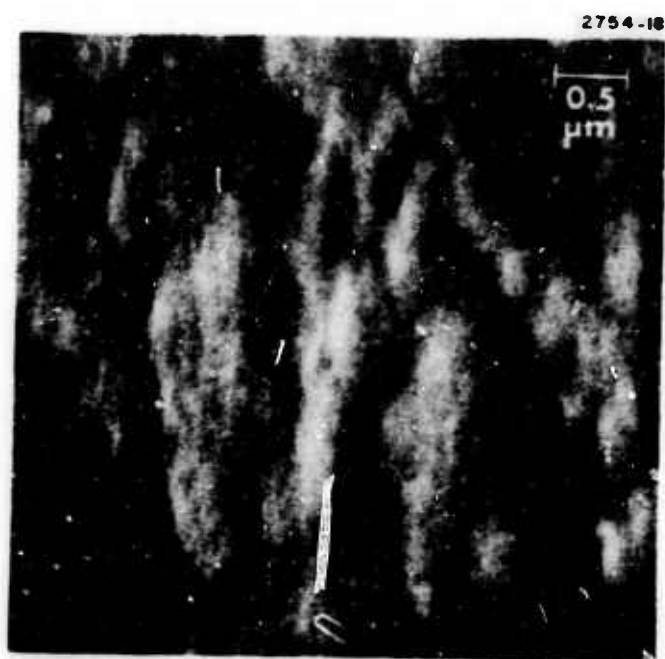
BEAM  $\approx 70^\circ$  TO SURFACE

Fig. 6. SEM photographs of KCl surface at a beam voltage of 20 kV.

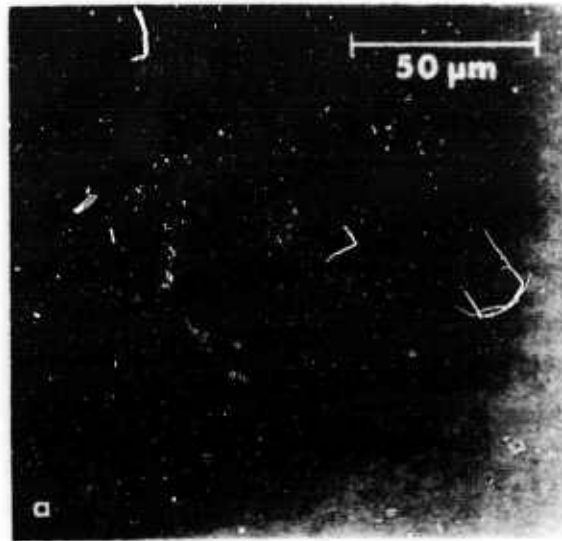
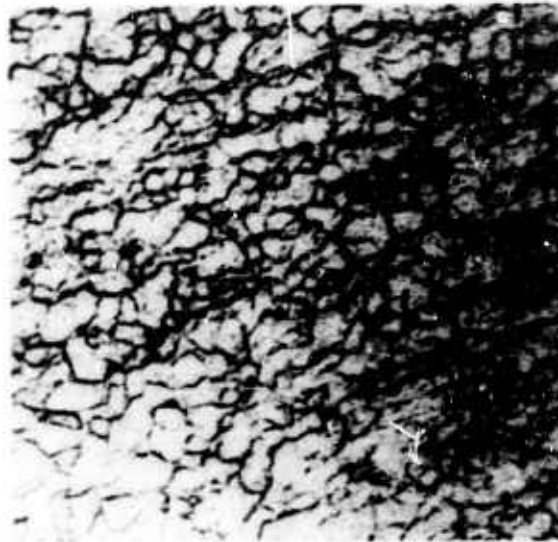
Fig. 7.  
Optical micrographs of press-forged  
KCl after 1 min HCl etch.

Figure 7(a) and 7(b) show some results obtained for HCl etching of two press-forged KCl samples. One had been forged some time prior to the experiments (2-20-73) and the second shown in view (b) was forged just prior to etching (10-31-73). These results indicate that the recrystallization induced by forging of undoped halides (to provide increased strength to the material) under the circumstances of the forging conditions used here did not result in a stable crystal structure. Upon aging, the sample produced earlier had reverted to a predominately larger grained single crystal structure. The forging conditions used for the two samples which were pressed from starting blanks 1 in. thick were

The final pressure for the above two samples was 4000 psi; sample 2-20-73 when first forged evidenced a grain size of  $1 \mu\text{m}$  to  $10 \mu\text{m}$  after forging. Measurements made on the same piece 10-19-73 showed very large grains (several mm) with some small areas of 1 to  $10 \mu\text{m}$  crystallites. Sample 10-31-73, when measured after HCl

surface etching of the forging, indicated material with 1 to 10  $\mu\text{m}$  grain size over the entire surface as shown in Fig. 7(b). Both samples were HCl etched for 1 min.

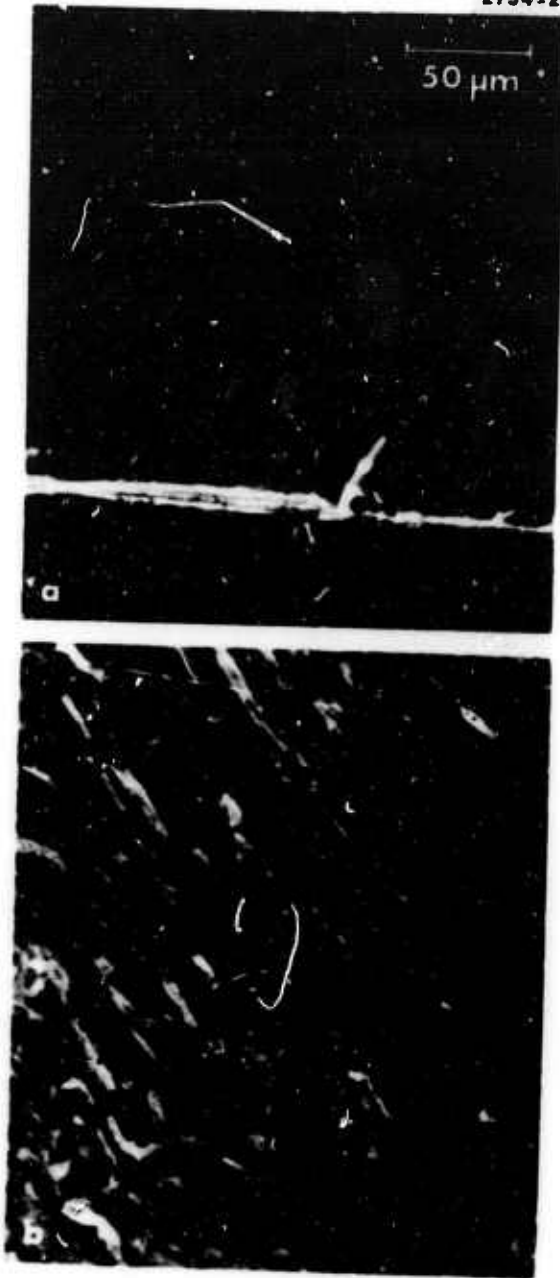
**Fig. 8.**  
Photomicrographs of ZnSe sur-  
faces after removal of polished  
surface layer (325x).

Optical examination of surfaces of ZnSe, finished in the above manner, under bright-field illumination reveals some scratches plus surface digs, resulting from surface pullout caused by the mechanical finishing operations. Further examination of the surface using transmitted light with phase contrast optical equipment reveals a multitude of scratches. We interpret these to be subsurface scratches, since they are not visible using brightfield or darkfield illumination. In addition to these subsurface scratches, one can see a faintly-revealed twinned-grain structure. Phase contrast examination reveals differences in refractive index, so scratches and twinned structure are visible as a result of index changes caused by strain or rearrangement of crystalline structure.

- a. The mechanically polished ZnSe surface layer is softer than the underlying crystalline substrate.
- b. The surface layer is caused by smearing of the surface during lapping in the near-final polishing stages, since scratches are positioned within the layer and result from the finer abrasives.
- c. We have estimated that the surface layer is thin, about 5000 Å, and amorphous, since no structure is seen in the layer itself.

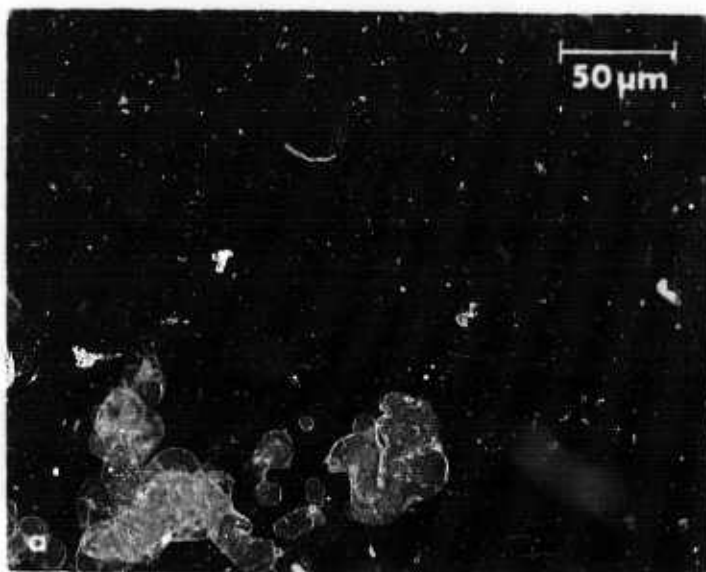
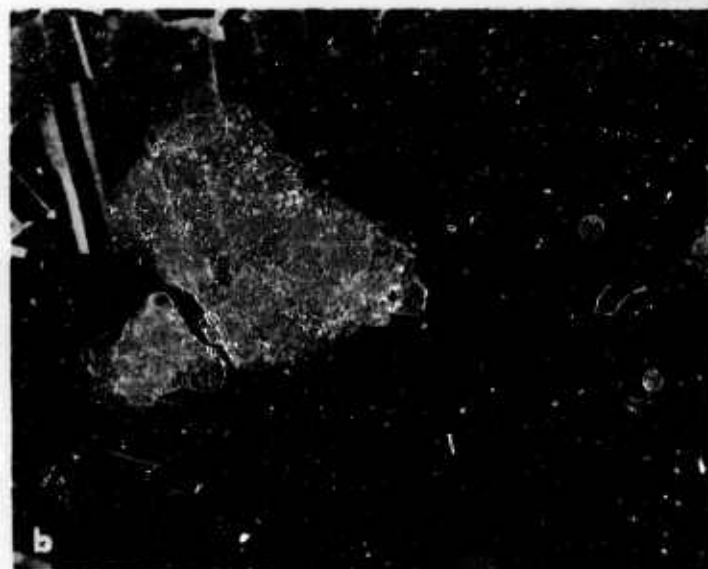
Mechanical polish

Mechanical/chemical  
polish

Fig. 9. Photomicrographs of ZnSe surfaces after mechanical polishing and after final etch polishing (325x).

Figure 9(a) shows a 325x photograph of a mechanically polished ZnSe surface using steps (1) and (2) outlined above. Figure 9(b) shows a 325x photograph of the same ZnSe surface after final etch polishing. The crystalline grain structure of the ZnSe can be clearly observed. (The ZnSe used in our work was CVD material produced by Raytheon Corporation.) Using the complete step-wise procedure outlined above we have been able to reproducibly produce polished ZnSe windows that have less than  $0.002 \text{ cm}^{-1}$  optical absorption at  $10.6 \mu\text{m}$ . Using windows polished this way, antireflection coatings can be applied to the window surfaces that meet program goals for an AFML sponsored program reported by M. Braunstein, et al., in the Proceedings, Third Conference on High Power Infrared Laser Window Materials. (Program goal was to produce coated windows that had less than 0.1% reflectance and absorptance at  $10.6 \mu\text{m}$ .)

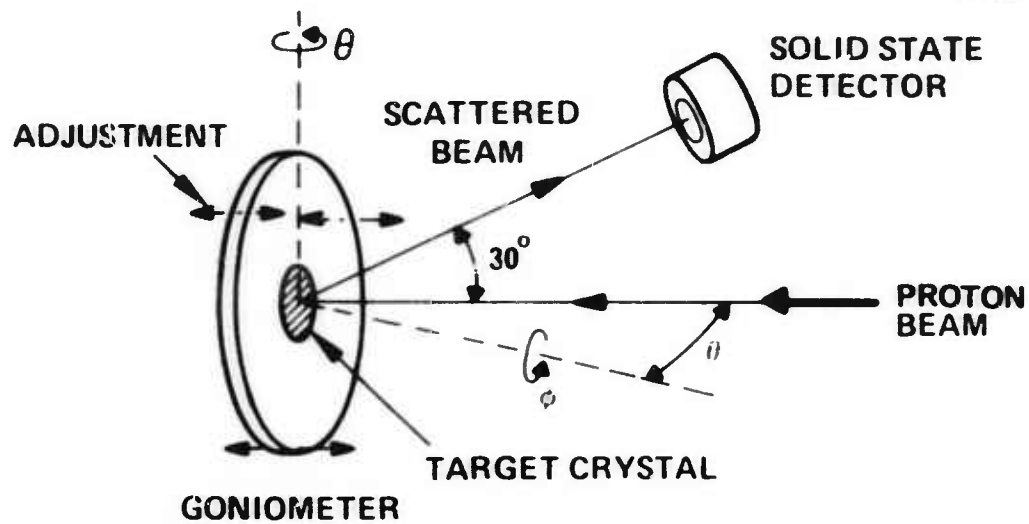
Fig. 10. Schematic of ion backscattering target chamber.

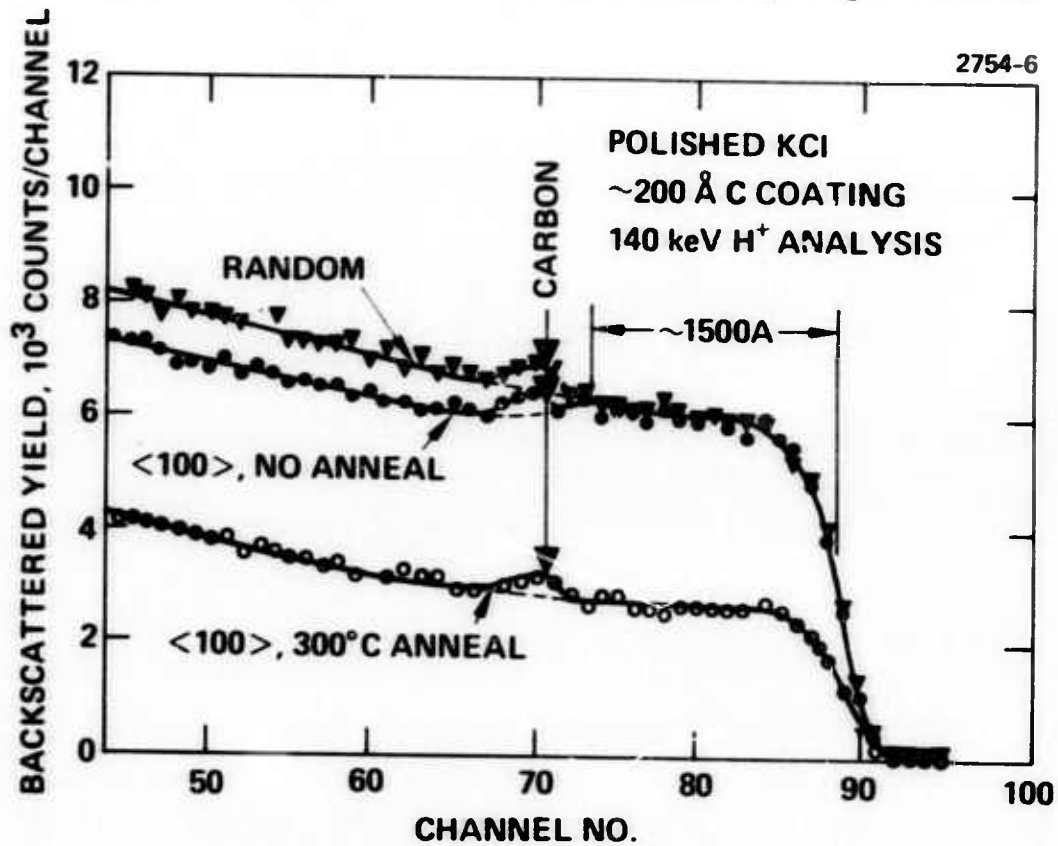
ANALYSIS ION:  $H^+$  AT 140 keV  
POLISH: LINDE B - METHANOL ON FLANNEL  
ANNEAL: 30 min AT  $10^{-6}$  Torr

Fig. 11. 140 keV  $H^+$  channeling analysis of polished KCl before and after 300°C anneal.

The samples used for this work were single crystal platelets of KCl (Optovac) which were cleaved along  $\{100\}$  planes and then polished with either Linde A or Linde B abrasive on flannel using methanol. Backscattered energy spectra of 140 keV  $H^+$  incident in random and  $\langle 100 \rangle$  directions before and after 30 min anneal at  $300^\circ\text{C}$  on a Linde B polished sample are shown in Fig. 11. In this case, a 200 Å carbon layer was deposited on the specimen to prevent beam charging. Before anneal the coincidence of the  $\langle 100 \rangle$  and random yields from the surface to a depth of about 1500 Å indicates that an amorphous layer was formed to this depth by the mechanical polishing. At deeper depths (smaller channel numbers), the  $\langle 100 \rangle$  yield is less than the random yield as a result of ion channeling in at least partially crystalline material. However, long range disorder or strain is suggested since, even though the beam is significantly dechanneled in traversing the amorphous layer, the  $\langle 100 \rangle$  yield does not decrease as much as expected if the substrata were perfectly crystalline below the amorphous layer. The small peaks near channel 70 are caused by the carbon coating. A  $\langle 100 \rangle$  backscattered energy spectrum taken after the anneal sequence is also shown in Fig. 11. As can be seen, the  $\langle 100 \rangle$  yield is about one-half of the random yield, indicating about 50% recrystallization of the amorphous layer and thus comparable ion channeling. Clearly, either longer times or higher anneal temperatures are required to effect complete recrystallization. Nevertheless, the data of Fig. 11 indicate that significant reduction in polishing damage occurs after relatively mild thermal treatment.

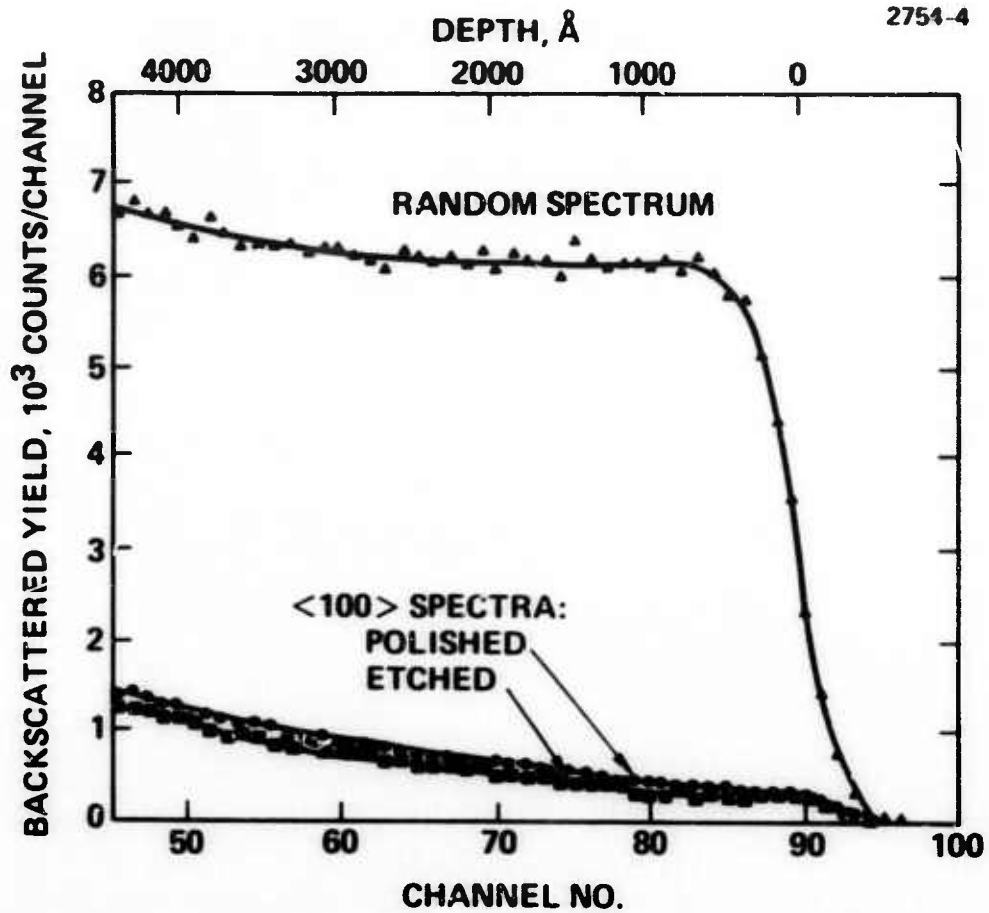
ANALYSIS ION:  $H^+$  AT 140 keV

Fig. 12. 140 keV  $H^+$  channeling analysis of polished and etched KCl.

Backscattered energy spectra of 140 keV  $H^+$  from both a Linde A polished sample and a sample etched for 30 sec in HCl are shown in Fig. 12. In these cases electron flooding prevented beam charging. As can be seen in Fig. 12, the  $\langle 100 \rangle$  backscattered yield of the etched sample near its surface is about 1/20 of the random yield. Such a ratio is consistent with good crystalline qualities. The small peak at the surface (channel 90) is probably caused by a thin surface oxide. Although the  $\langle 100 \rangle$  yield of the polished sample is somewhat greater than that of the etched sample, indicating some lattice disorder or strain, it is remarkable that no amorphous layer is observed as was seen on the Linde B polished sample of Fig. 11. In fact, greater than 90% of the beam remains channeled in the surface region.

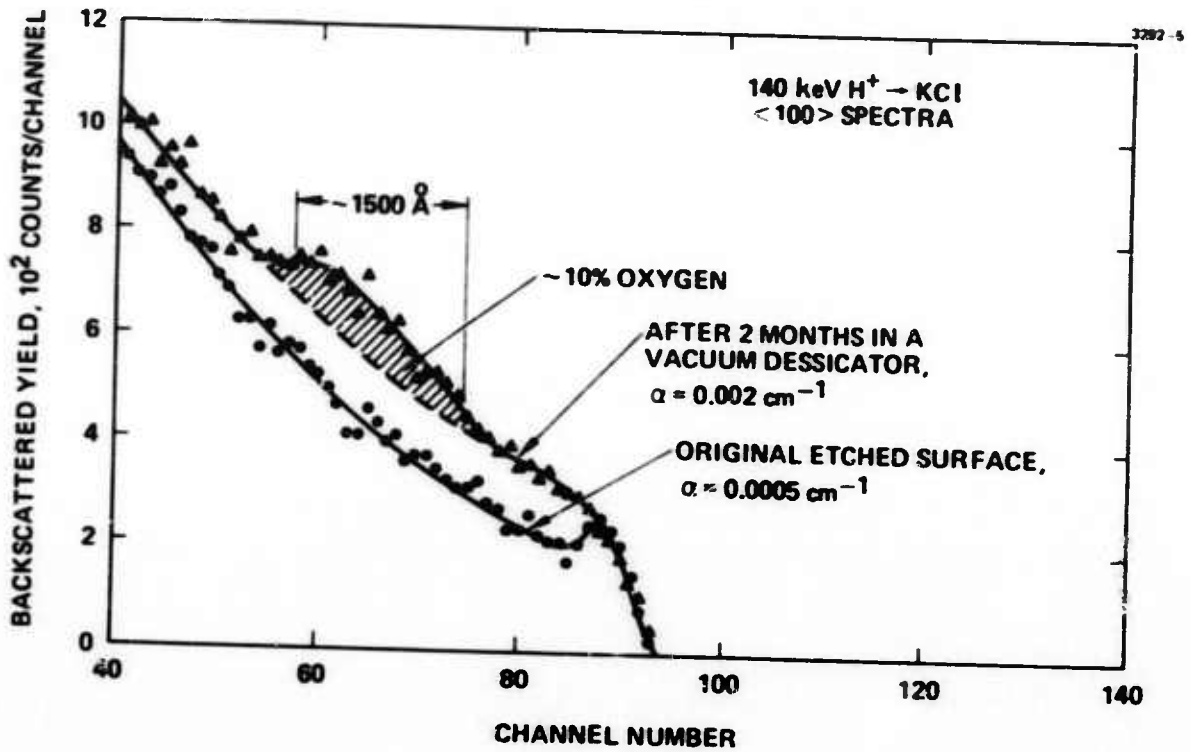
Fig. 13. Backscattered energy spectra of 140 keV protons incident along the 100 channel of KCl after HCl etching and after two months' storage in a vacuum desiccator.

The small peak at the surface (channel 90) of Fig. 13 on the original etched surface is probably caused by a thin oxide layer. The  $\langle 100 \rangle$  yield just behind this peak is about 5% of the random or non-channeled yield, a result typical of a good single crystal surface region. However, the  $\langle 100 \rangle$  spectrum after two months' storage in a vacuum desiccator, which is also shown in Fig. 13 indicates an approximately 50% increase in yield near the surface and a broad peak starting at channel 75. This peak is consistent with the incorporation of about 10% oxygen in a 1500 Å surface layer. The presence of the oxygen apparently causes the increased yield from K and/or Cl atoms near the surface by a distortion of the original lattice. It is also of interest to note that the apparent 10.6 μm absorption coefficient increased from 0.0005 cm<sup>-1</sup> soon after etching to 0.002 cm<sup>-1</sup> after two months' storage. Thus there seems to be a definite correlation of increased absorption with chemical and physical degradation of the surface region. Although additional work is needed to better define the reaction rate of KCl surfaces with environmental conditions, the present results suggest that protective coatings of KCl are essential to long-term surface stability even in a relatively H<sub>2</sub>O-free environment, i. e., a vacuum desiccator.

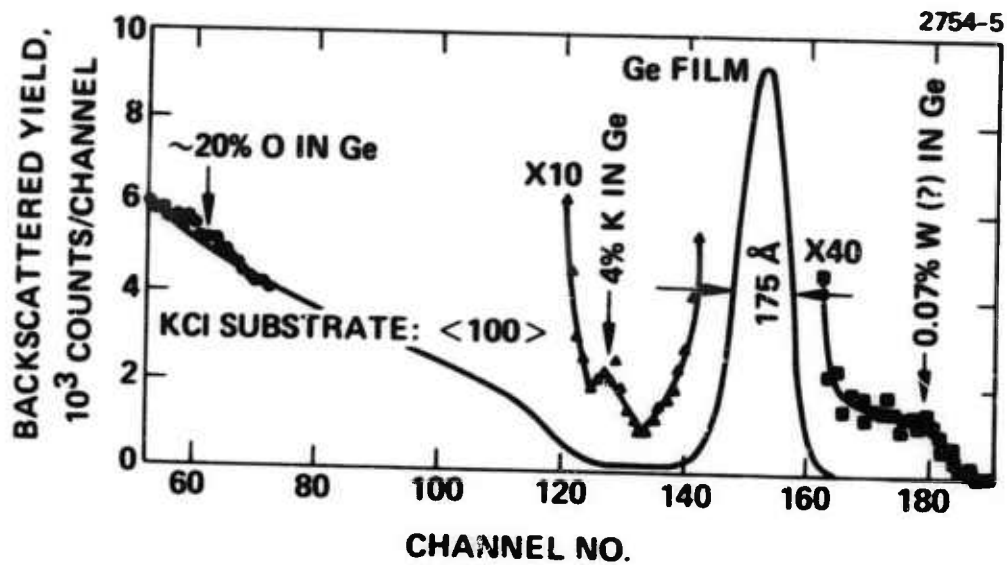
ANALYSIS ION:  $\text{He}^{++}$  AT 280 keV

Fig. 14. Backscattered energy spectrum of  $280 \text{ keV He}^{++}$  incident on a  $175 \text{ \AA}$  UHV deposited Ge film on KCl.

Rutherford backscattering analysis has been used in some preliminary experiments to compare the properties of Ge films on KCl produced in ultrahigh vacuum (UHV) and by ion beam sputtering. Figures 14 and 15 show the results of a comparison of UHV-prepared thin Ge films deposited on KCl at a low rate and a somewhat higher rate, 0.6 Å/sec and 27 Å/sec, respectively. A 2700 Å film deposited at the low rate has a 10.6 μm absorption coefficient of 94 cm<sup>-1</sup> and the more rapidly deposited film with a thickness of 8800 Å has a lower absorption of 24 cm<sup>-1</sup>. The backscattered energy spectra also reveal, when compared, that there is some evidence for presence of heavy metal impurity oxygen and potassium. The concentration of these impurities is somewhat lower in the data shown in Fig. 15 for the

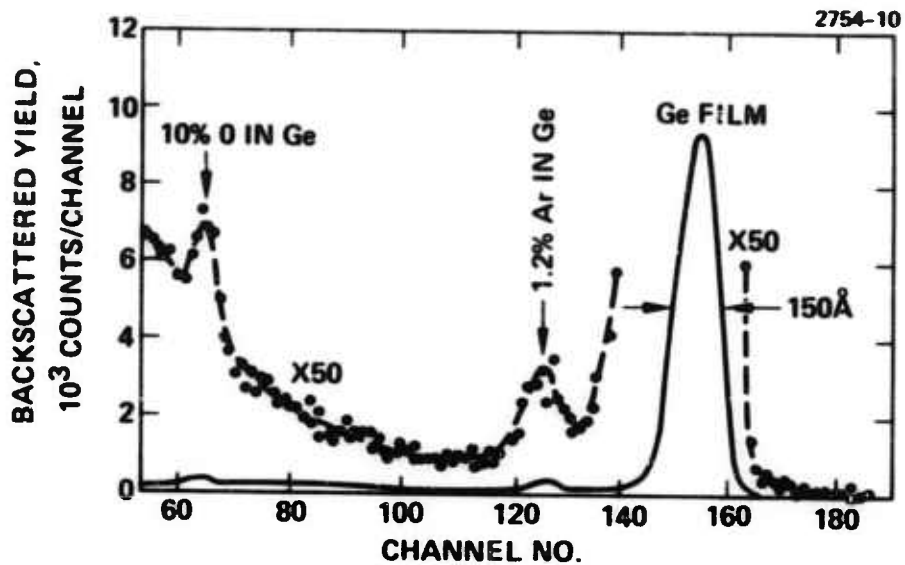
Fig. 16. Backscattered energy spectrum of 280 keV H<sup>++</sup> incident on a 150 Å Ge film sputter deposited onto a carbon substrate.

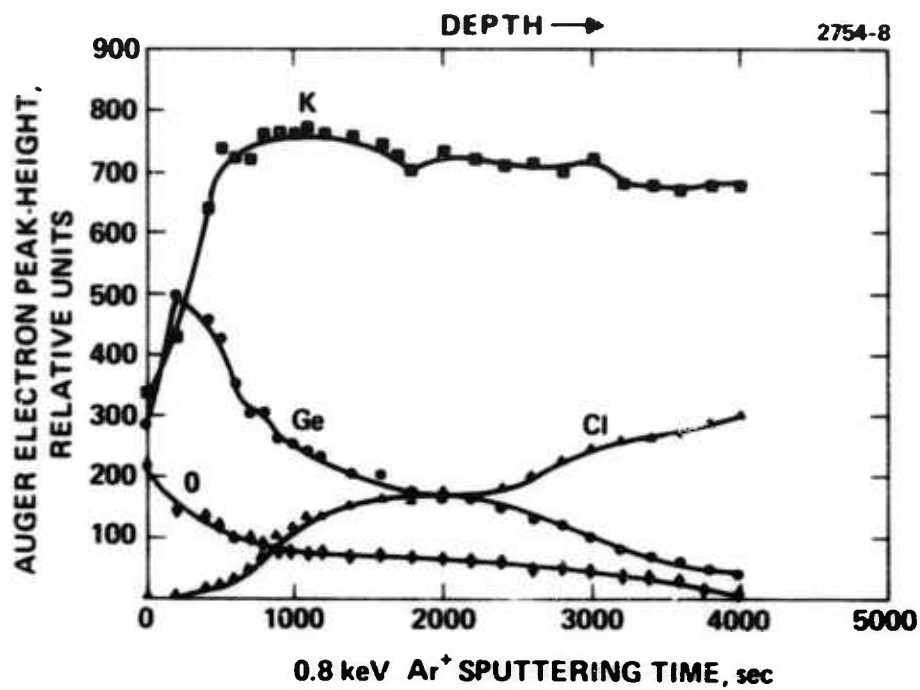
Fig. 17. Auger electron analysis of a 175 Å UHV deposited Ge film on KCl.

Auger electron analysis of the Ge film produced in UHV at the low rate of 0.6 Å/sec was performed to determine if the potassium found in the film using ion backscattering analysis would be confirmed by Auger analysis. As can be seen in Fig. 17, the Auger spectra produced by ion beam sputter profile analysis provide further evidence that the Ge film deposited on KCl has undergone diffusion of the substrate material into the film, as evidenced by the Cl and K peaks.

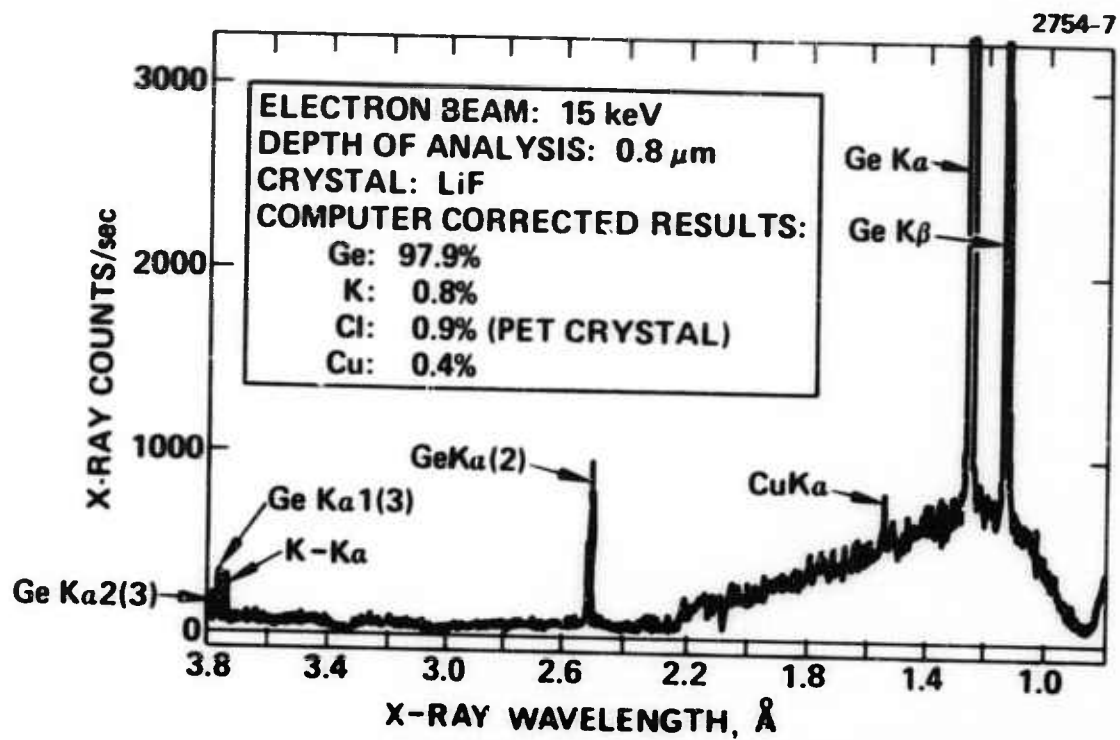
**SAMPLE: DONOVAN #1**  
**DEPOSITION CONDITIONS:**  
 RATE: 1-3  $\text{\AA}/\text{sec.}$   
 PRESSURE:  $1 \times 10^{-9}$  Torr  
 SUBSTRATE TEMP.: AMBIENT  
 ANNEAL: 100°C FOR 2 hr  
 THICKNESS; 1.24  $\mu\text{m}$   
 $\alpha = 77 \text{ cm}^{-1}$

Fig. 18. Electron microprobe analysis of a 1.25  $\mu\text{m}$  UHV deposited Ge film on KCl. Film produced at Naval Weapons Center, China Lake.

In Fig. 18 electron microprobe analysis of UHV deposited Ge on KCl is shown for a Ge film produced by T. Donovan of the Naval Weapons Center, China Lake. The 10.6 μm absorption coefficient for this film was measured at HRL to be  $77 \text{ cm}^{-1}$ . The probe analysis showed the presence of K, Cl, and Cu impurities in the film at 0.8%, 0.9%, and 0.4% levels, respectively. It should be noted that the relatively high,  $77 \text{ cm}^{-1}$  value, for the Ge film absorption occurs for a rate of deposition which is low compared with the data for our film shown in Fig. 15, which was 27 Å/sec. This trend for Ge films showing high absorption when produced at low rates is consistent for films produced in oil-pumped vacuum systems too, as will be shown by Ge film data presented later in this report.

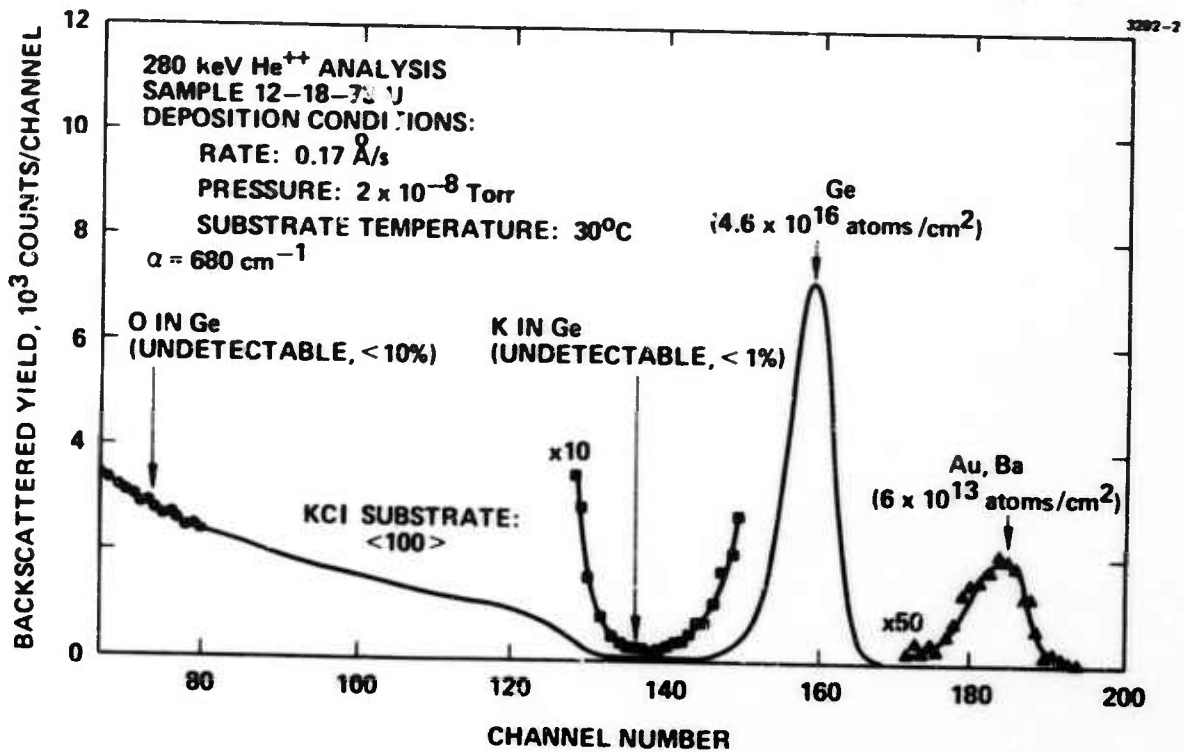
Fig. 19. Backscattered energy spectrum of 280 keV He<sup>++</sup> incident on a thin germanium film evaporated onto KCl in UHV.

A backscattered energy spectrum using 280 keV He<sup>++</sup> analysis of this germanium film is shown in Fig. 19. The amounts of K and O in the film are less than the measurement sensitivities, ~1% and ~10%, respectively. These results should be contrasted with the 4% K and 20% O observed earlier in the low rate film deposited at 150°C. Therefore, a reduction of substrate temperature to 30°C markedly reduces the K and O contents in germanium films on KCl.

However, the heavy impurity peak at channel 185 of Fig. 19 is comparable in amount to the 0.07% observed earlier, and consequently, is unaffected by substrate temperature. Electron microprobe analysis of the surface of the germanium material used for the depositions revealed that trace amounts of gold and barium were located in a small area (100 mil radius) near the tip of the germanium which was locally heated by electron beam bombardment during the depositions.

Thus the heavy element peak of Fig. 19 is attributed to gold and barium. It is postulated that the gold may have been present in the bulk of the germanium and diffused to the tip during e-beam bombardment. To check this point the contaminated tip was lapped away, and another low-rate (0.4 Å/sec) germanium film was deposited on KCl. After lapping, microprobe measurements of the germanium source material indicated that the gold and barium had been removed.

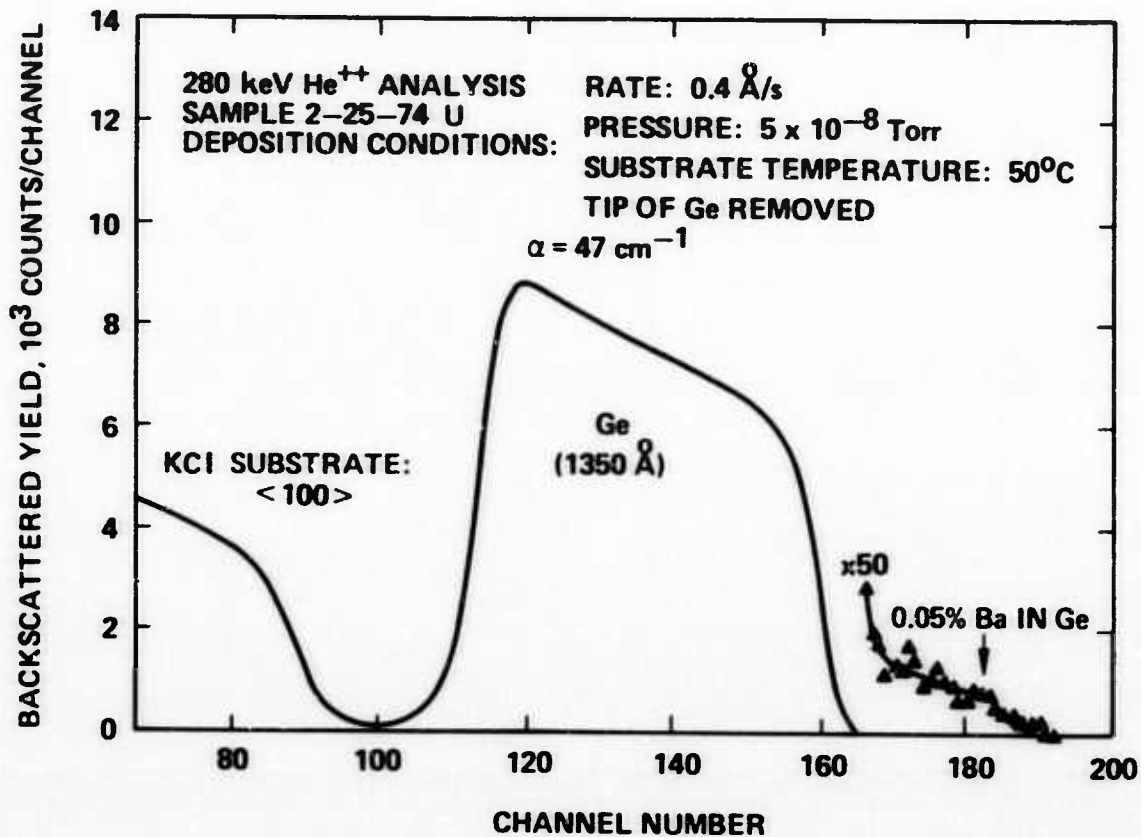
Fig. 20. Backscattered energy spectrum of 280 keV He<sup>++</sup> incident on a 1350 Å germanium film evaporated onto KCl in UHV after removal of the tip of the germanium source material.

A backscattered energy spectrum from this film is shown in Fig. 20. Since the germanium film is much thicker ( $1350 \text{ \AA}$ ) than that of Fig. 19, the heavy impurity peak is broadened. Nevertheless, the level of the backscattered yield from the heavy impurity near the surface at channel 182 of Fig. 20 is reduced to about 0.5 of the previous level. Microprobe analysis of the tip of the germanium source material after evaporation of the film of Fig. 20 revealed that a trace of barium was again present, but that there was no reintroduction of gold. It seems reasonable to attribute the remaining heavy element concentration (0.05%) in the germanium film of Fig. 20 to barium. Since  $\text{BaF}_2$  films were originally deposited in our UHV system, the reintroduction of barium onto the tip of the germanium source material and in the deposited film apparently is caused by residual barium contamination of our vacuum chamber. This result points out the difficulty of avoiding cross contamination of different film materials deposited in the same system.

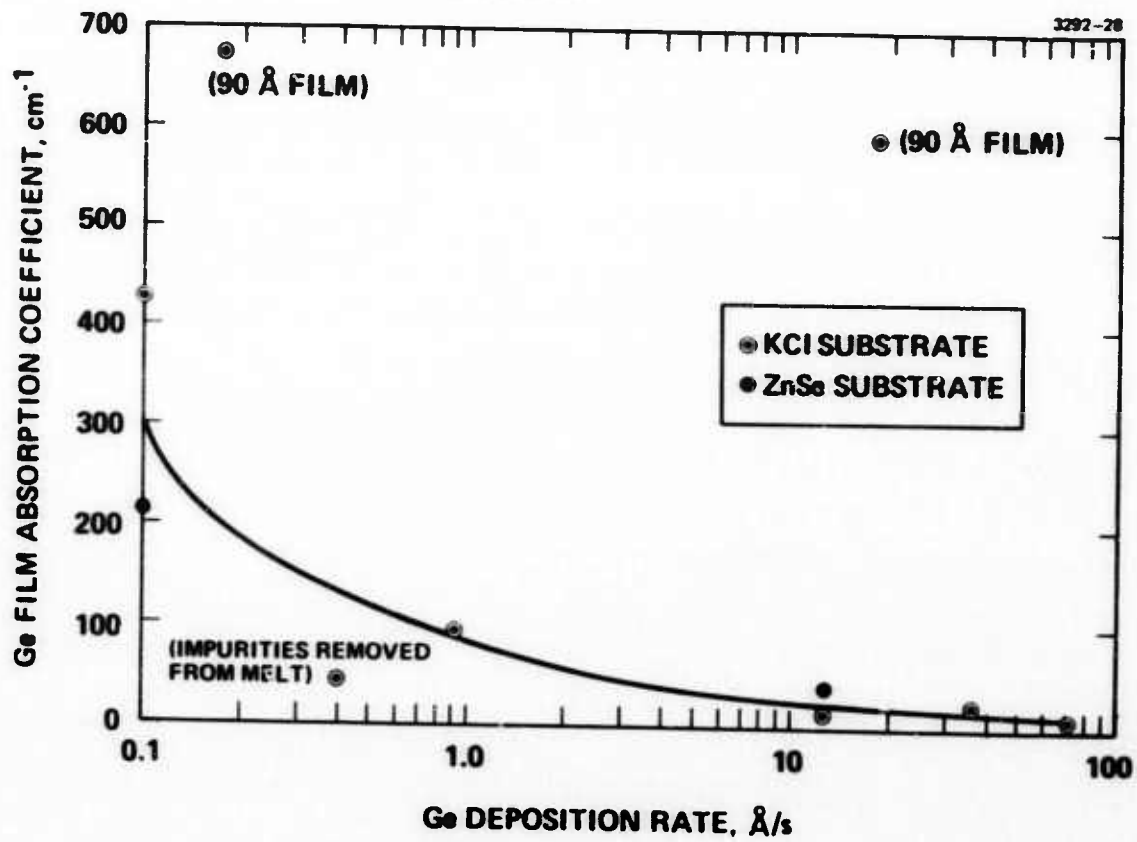
Fig. 21.  $10.6 \mu\text{m}$  absorption versus deposition rate for UHV germanium films.

Figure 21 summarizes the germanium film absorption versus deposition rate results. The points which fall on the dashed curve are for films of more than a few hundred angstroms in thickness. These points clearly show the inverse dependence of 10.6  $\mu\text{m}$  absorption on deposition rate. Other deposition parameters, such as substrate temperature and system pressure during deposition, were found not to affect the absorption results within the ranges studied (pressure:  $1.5 \times 10^{-7}$  -  $2.5 \times 10^{-9}$  Torr; temperature 27 to 150°C). The two points which are labeled "90  $\text{\AA}$  film" in Fig. 21 are indicative of an excess absorption in thin layers which is probably concentrated at the film-substrate interface. This high apparent absorption coefficient in thin layers is a result of assuming a uniform absorption coefficient throughout the layer and thereby neglecting the possibility of any surface effects. For the thicker layers the error introduced is small since the surface absorption is a small percentage of the total

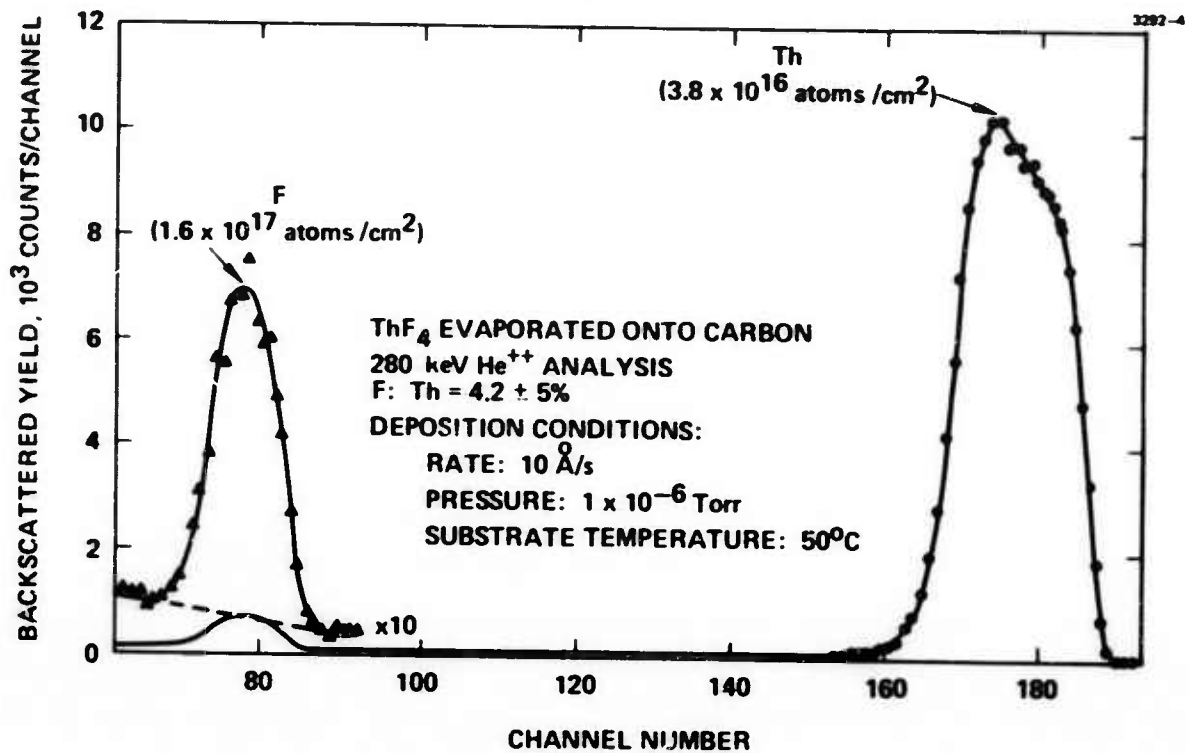
Fig. 22. Backscattered energy spectrum of 280 keV He<sup>++</sup> incident on a ThF<sub>4</sub> film evaporated onto a carbon substrate.

The compositions of several fluoride films were determined during the course of the program. We were especially interested in comparing the compositions of evaporated and sputter-deposited thorium fluoride. A backscattered energy spectrum of 280 keV He<sup>++</sup> from an evaporated thorium fluoride film on a carbon substrate is shown in Fig. 22. The amounts of thorium and fluorine in the film are

determined from the areas of the peaks corresponding to scattering from thorium and fluorine atoms, respectively, together with the known Rutherford scattering cross sections and are indicated on the figure. The ratio of the number of fluoride atoms to the number of thorium atoms is calculated to be  $4.2 \pm 5\%$ , the estimated error being caused primarily by uncertainty in the background level of the fluoride peak, the dashed line of Fig. 22. Therefore, this ratio of fluoride to thorium is in agreement with the expected composition of  $\text{ThF}_4$ . Furthermore, no impurities were detectable.

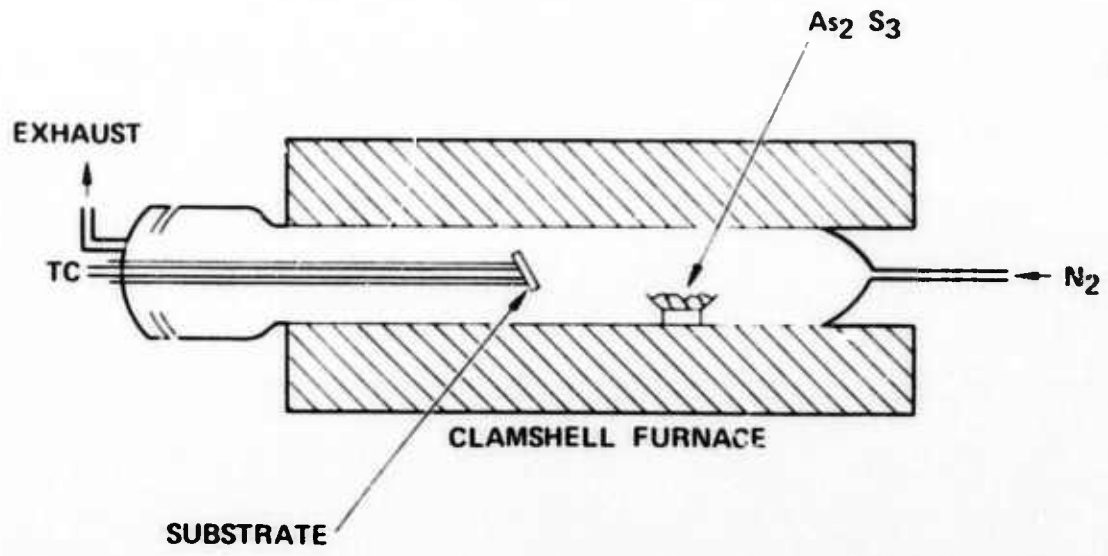
Fig. 23. PVD apparatus.

This material was used as source material in the PVD investigation. Experiments were performed using vitreous silica substrates as well as cleaved or cut and polished KCl surfaces. The series of experiments indicated that a freshly etched surface of KCl was necessary in order to get a smooth film. The result of these experiments was the deposition of films of As<sub>2</sub>S<sub>2</sub>. Because of the difficulties of composition control in this type of apparatus, construction of a CVD apparatus was begun.

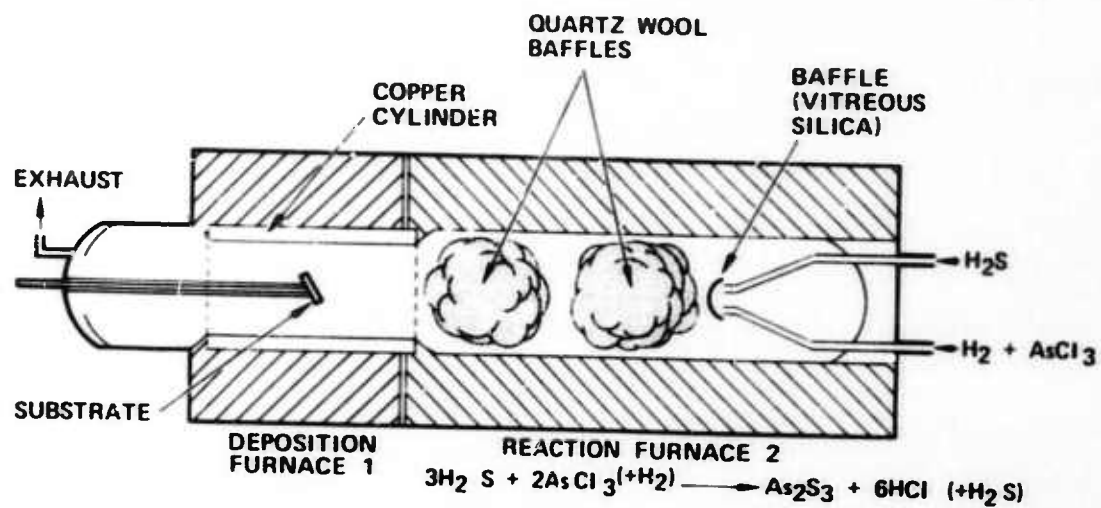
Fig. 24. CVD apparatus.

The CVD apparatus (Figs. 24 and 25) was completed early in 1974. The apparatus is designed for the reaction:

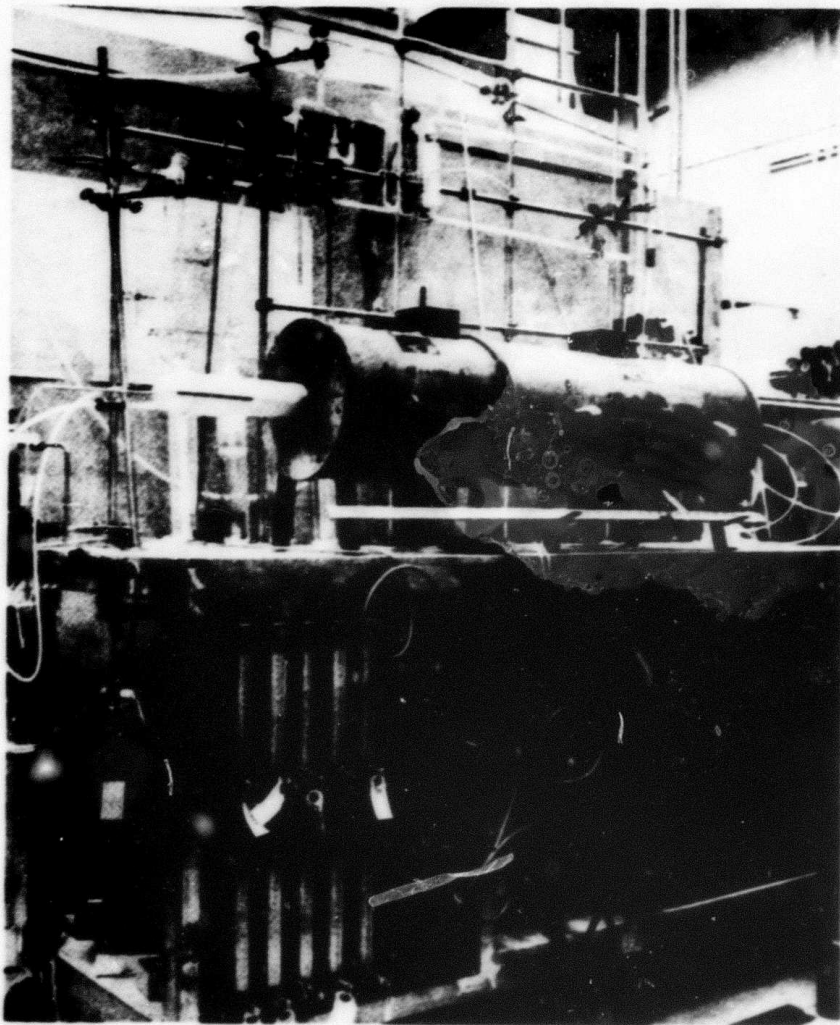
Fig. 25. Chemical vapor deposition of  $\text{As}_2\text{S}_3$ .
