LASER WINDOW SURFACE FINISHING AND COATING TECHNOLOGY

HUGHES RESEARCH LABORATORIES

PREPARED FOR  
AIR FORCE CAMBRIDGE RESEARCH LABORATORIES  
DEFENSE ADVANCED RESEARCH PROJECTS AGENCY

JANUARY 1975

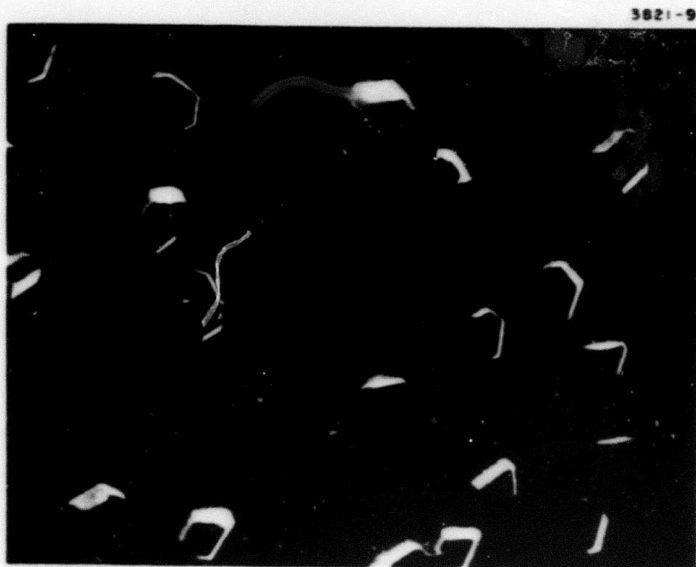
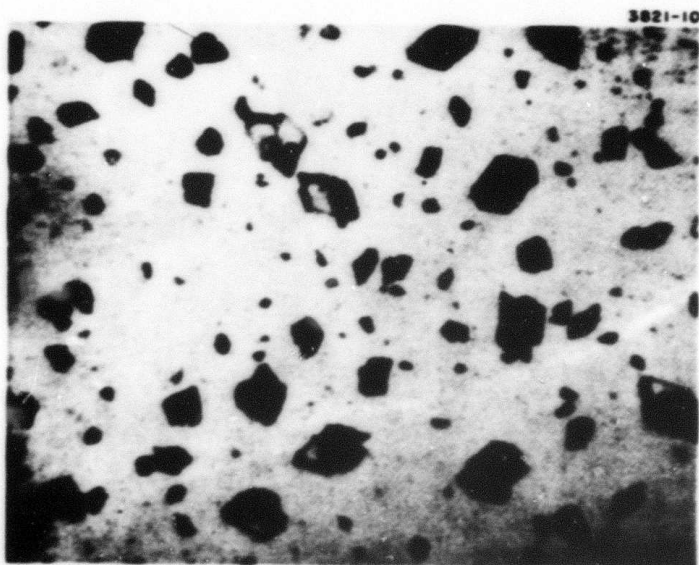
a. Microprobe SEM photograph.

b. Photomicrograph.

Fig. 26. Dimorphite crystals on  $\text{As}_2\text{S}_3$  matrix - KCL substrate.

The major problem encountered was the growth of crystals spuriously nucleating on the surface. These crystals have been observed to be surrounded by an amorphous thin film matrix whose composition has been determined to be  $\text{As}_2\text{S}_3$ . The crystals have been made to vary in composition (with variations in gas flow rates) from  $\text{As}_2\text{S}_2$  to  $\text{As}_4\text{S}_3$  (dimorphite) (See Fig. 26). Variations in substrate temperature indicated better crystal morphology at elevated temperatures (180 to 200°C) and more dendritic growth at lower temperatures (150 to 170°C); in either case the larger crystals appeared to grow at the expense of the surrounding smaller ones creating island-like appearances across the  $\text{As}_2\text{S}_3$  matrix (Fig. 27). Figure 27 also shows the tendency for crystal nucleation along surface flaws, especially scratches. An experiment designed to minimize surface nucleation by the initial deposition of an  $\text{As}_2\text{S}_3$  film by vacuum evaporation was performed on KCl substrates. Following HCl etchings, half of the surface was masked and a thin  $\text{As}_2\text{S}_3$  film was deposited. The sample then was loaded into the CVD apparatus and heated to 160°C. After four hours of deposition at optimum rates (see above) the results shown in Fig. 28 were observed. The precoated side (right side of photograph) showed a fairly uniform dendritic growth over the film with islands of larger dendrites, again appearing to grow at the expense of surrounding smaller dendrites. The uncoated side showed less uniform dendritic growth having more islands with some small dendrite regions. A thin film of  $\text{As}_2\text{S}_3$  appears to have grown as well, forming the principal matrix on the uncoated side. Reduction in substrate temperature to below 150°C (approximately 140°C) did not improve the film quality, but caused more uniform deposition of crystallites (Fig. 29) the smaller ones on the precoated side.

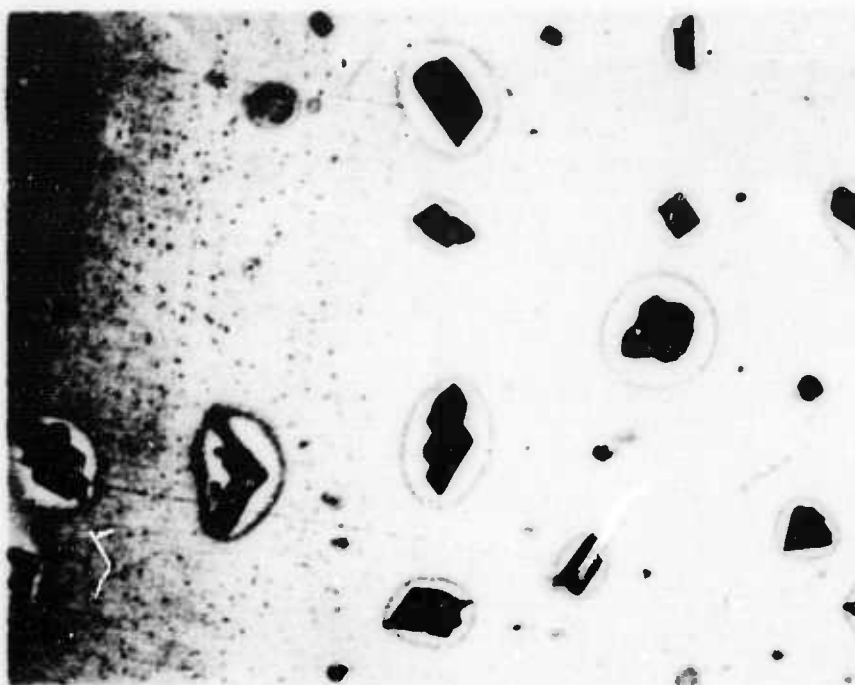
Fig. 27. Crystal "islands" on  $\text{As}_2\text{S}_3$  matrix, KCl substrate (50x).

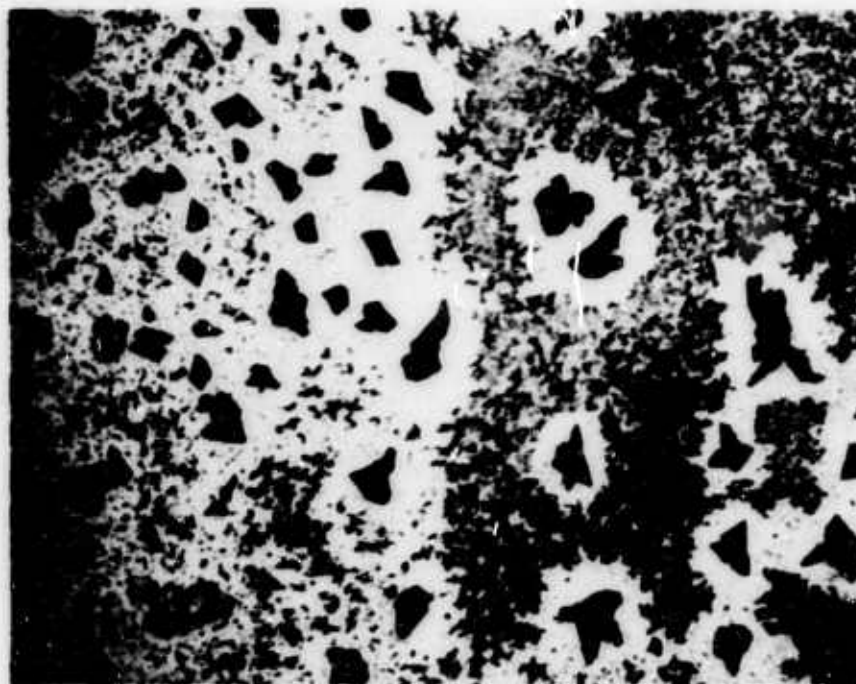
Fig. 28.  $\text{As}_2\text{S}_3$  deposit on uncoated (left) and pre-coated KCl substrate (50x).

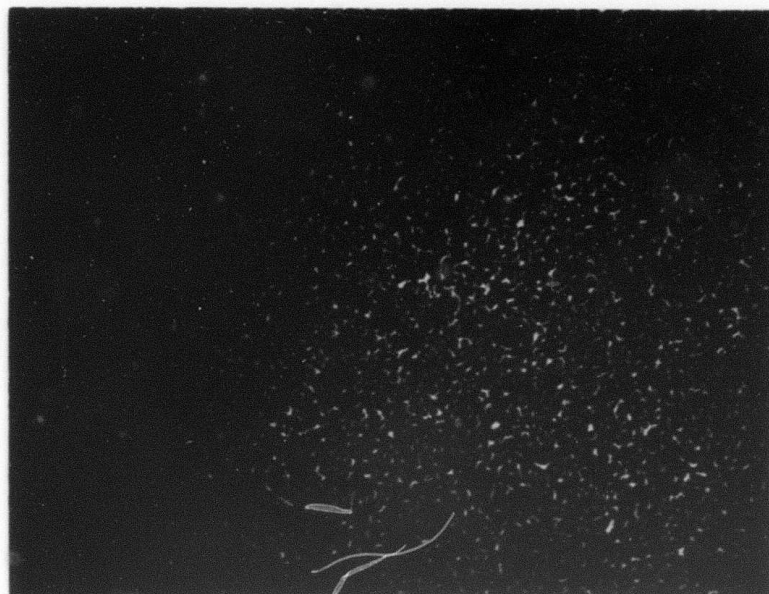
Fig. 29(a). Deposition at low temperature on previously coated KCl (50x).

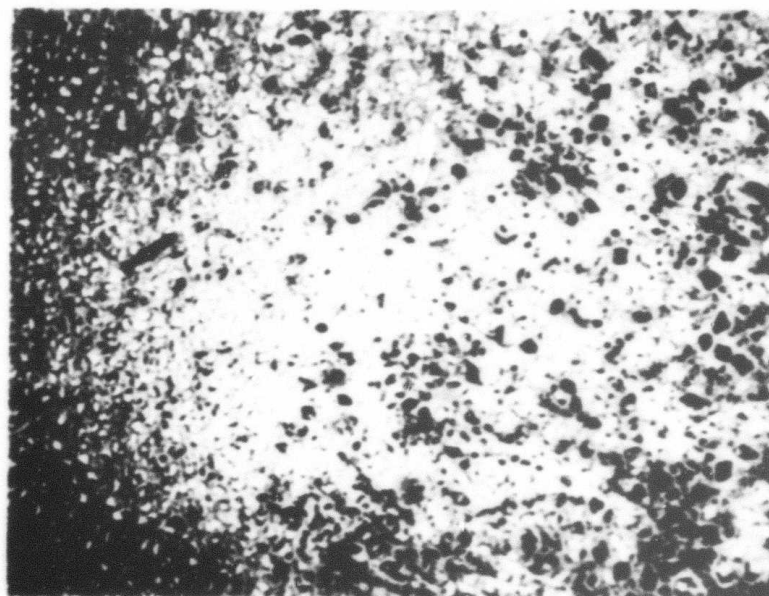
Fig. 29(b). Deposition at lower temperature on uncoated KCl (50x).

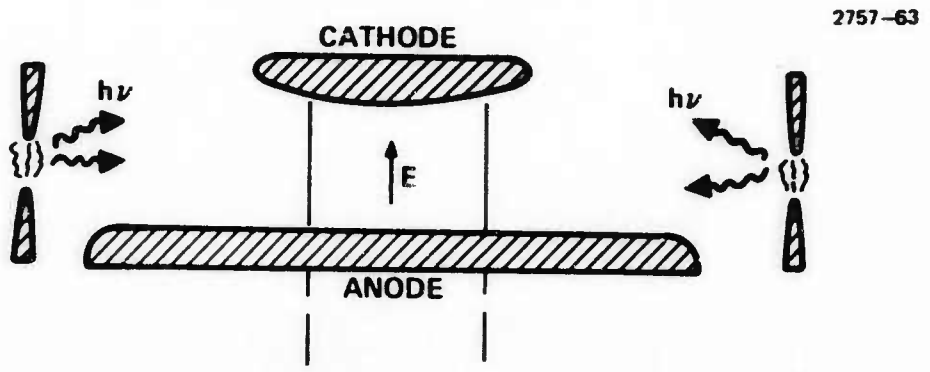
Fig. 30. Schematic of TEA laser cross section showing electrodes and preionizers.

An ultraviolet preionized  $\text{CO}_2$  TEA laser developed at HRL provided the laser for this study.<sup>6</sup> It consists of a 50 cm x 50 cm x 2.5 cm discharge between a modified Bruce profile electrode and a flat electrode, as illustrated in Fig. 30. Preionization is accomplished by a row of resistively ballasted arcs on each side of the main discharge, controlled by a separate pulse forming network. Two types of pulsing networks were used, ignitron and thyatron switched,

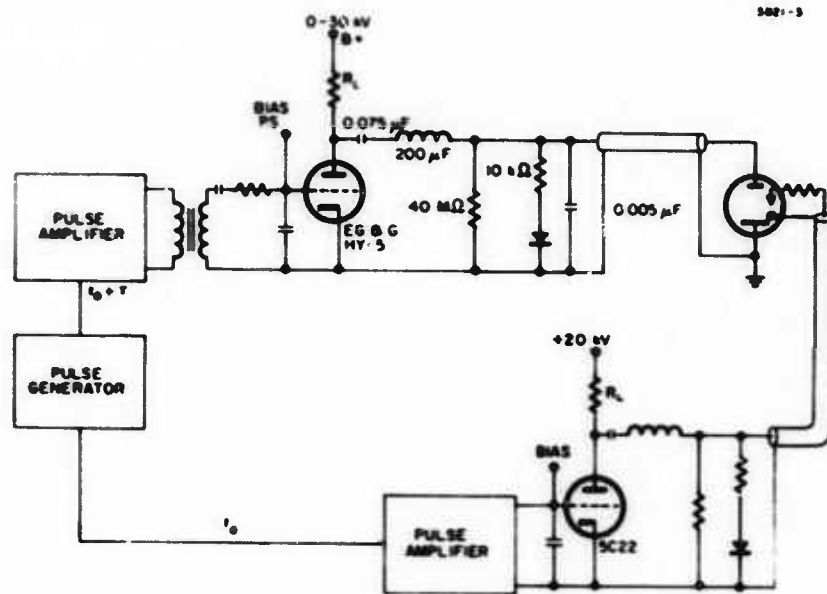
Fig. 31. Simplified schematic of double discharge electrical pulse forming network. Ignitron.

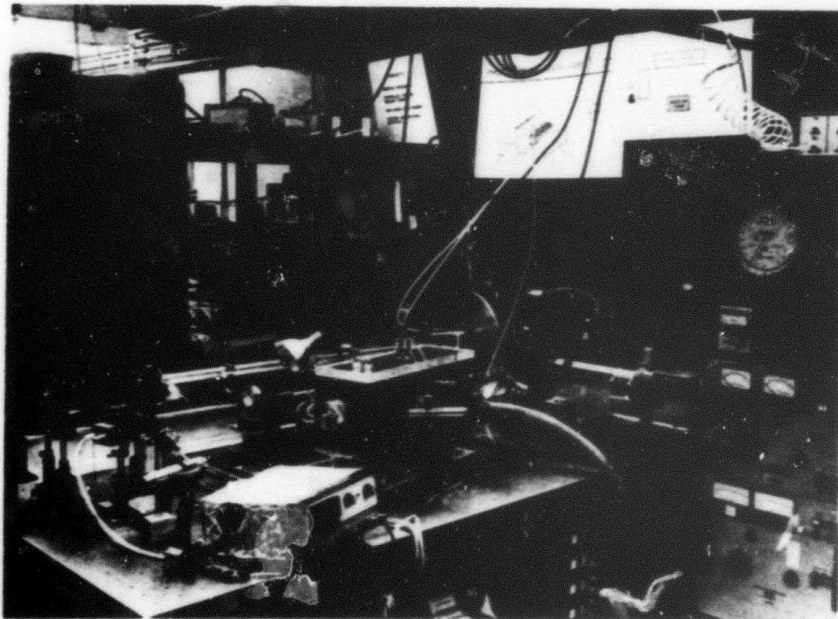
Fig. 34(b). Damage facility.

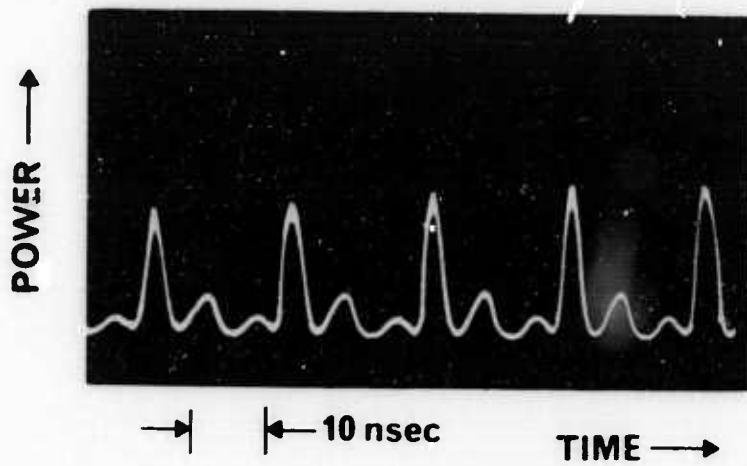
Fig. 36(a).  
Pulse shape mea-  
sured with photon  
drag detector.

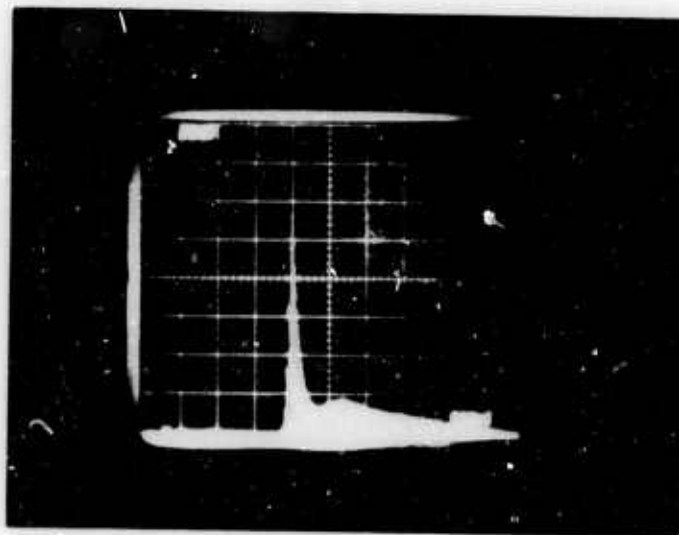
Fig. 36(b).  
0.6  $\mu$ sec equivalent  
pulse length.

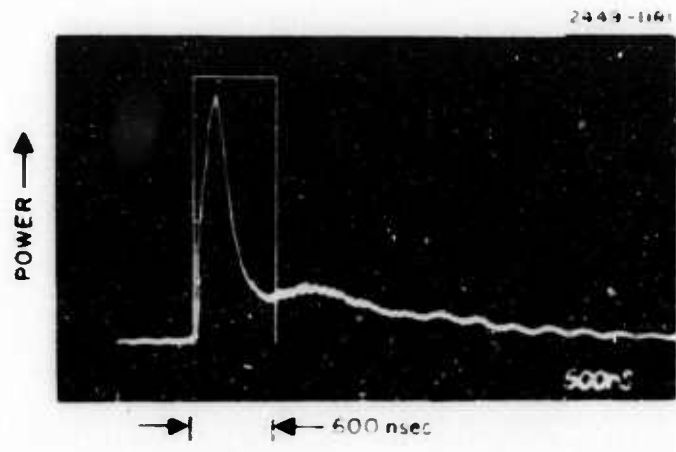
Fig. 37. Definition of equivalent pulse.

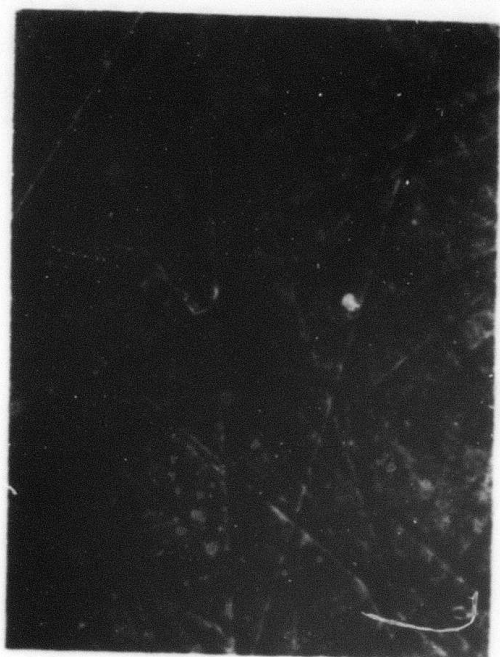
Fig. 38(a). Etch polished HRL  
RAP KCl.

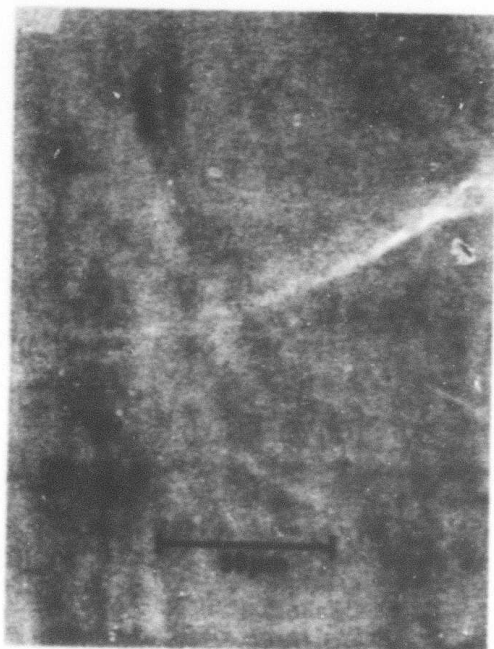
Fig. 38(b). Conventionally  
polished HRL RAP  
KCl.
