**TIEDOWN AND BENCH TESTING OF GREASE-LUBRICATED  
HELICOPTER TAIL AND INTERMEDIATE GEARBOXES**

**United Aircraft Corporation**

**Army Air Mobility Research and Development Laboratory**

**April 1975**

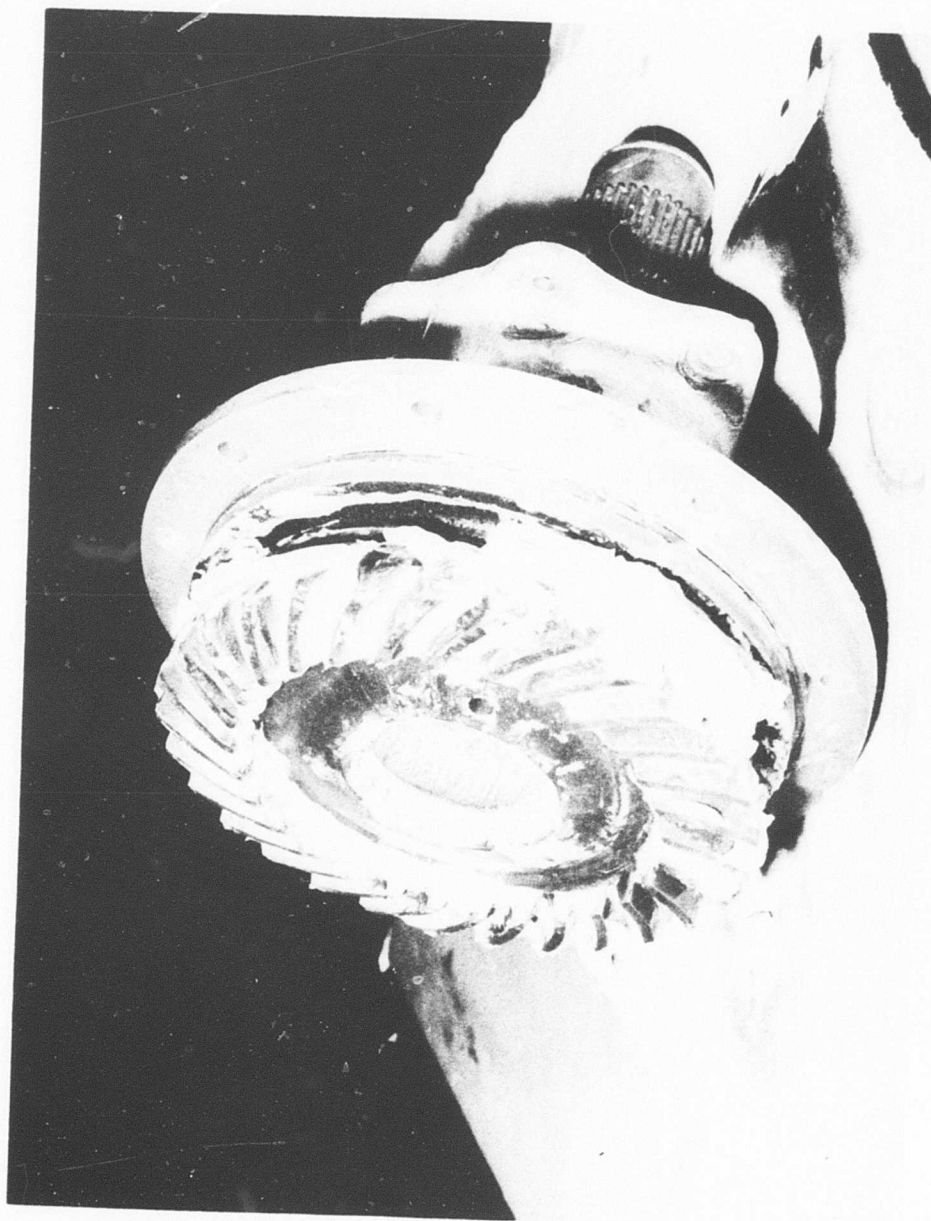
Figure 7. Intermediate Gearbox Input Section  
Following Tiedown Testing.

Following the tiedown test, the intermediate and tail gearboxes were completely disassembled. The inspection of the intermediate gearbox showed excellent condition of both gears and bearings. The tail gearbox exhibited similar results with one exception. Moderate scoring had been experienced on the tail gearbox spiral bevel gears. This scoring, while not typical of H-3 tail gearbox performance in production, is attributed to the high power levels, relative to prorated design, experienced during tiedown testing. The intermediate and tail gearbox components following tiedown testing are shown in Figures 7 through 12. The scoring evident on the tail gearbox gear teeth, while not typical in H-3 tail gearboxes, is similar in appearance to scoring which has been experienced on spiral bevel gears of other gearboxes such as the H-53 nose gearbox and the H-3 and H-54 main transmissions. As far as can be determined, scoring of this nature has in no case resulted in gear tooth fracture.

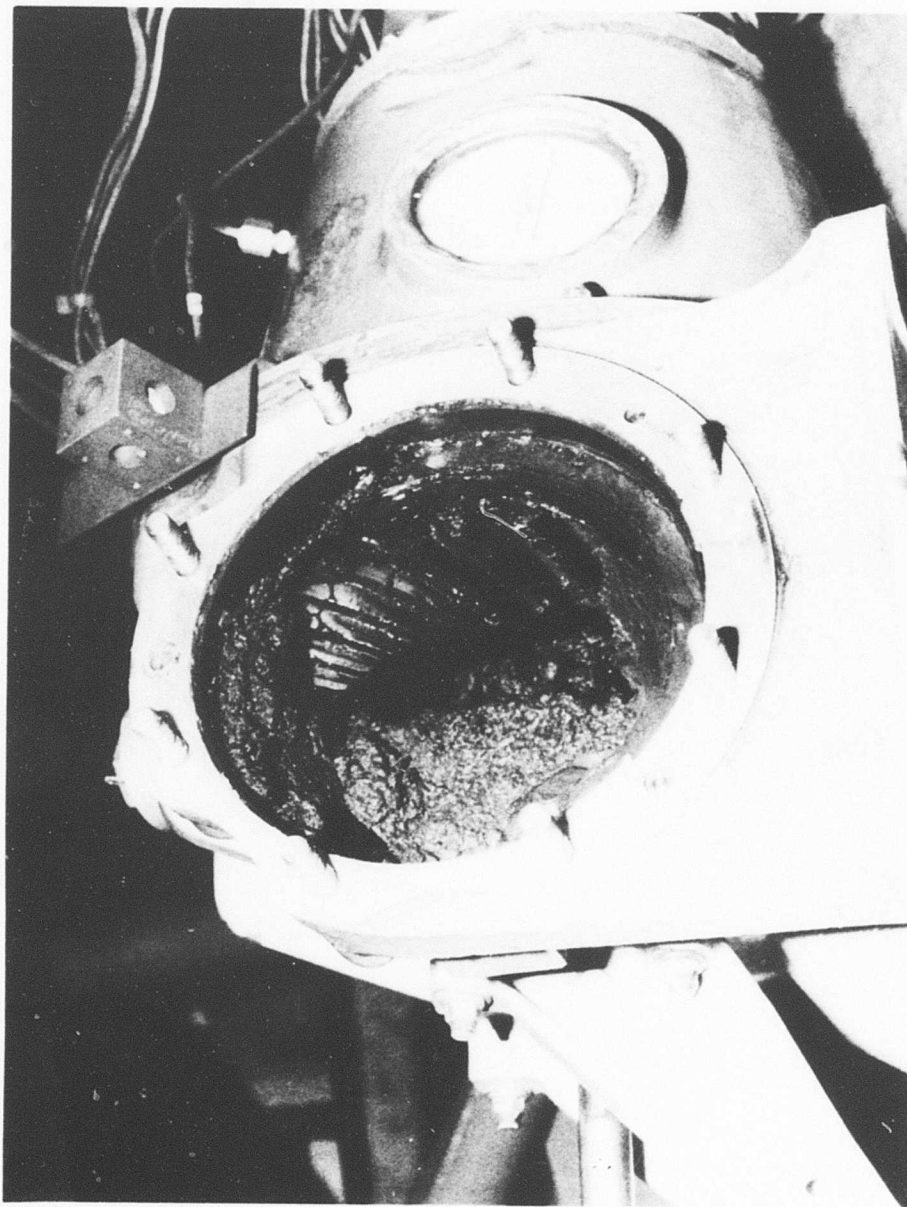
Figure 10. H-3 Tail Gearbox Following  
Tiedown Testing.
