Mechanical, Corrosion, and Fatigue Properties of 15-5 PH,  
Inconel 718, and René 41 Weldments

# NAVAL SHIP RESEARCH AND DEVELOPMENT CENTER

by  
Harvey P. Hack

May 1975

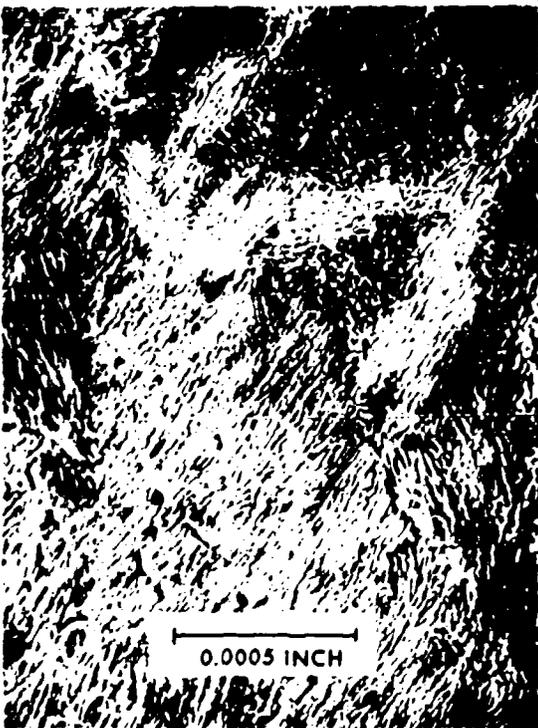
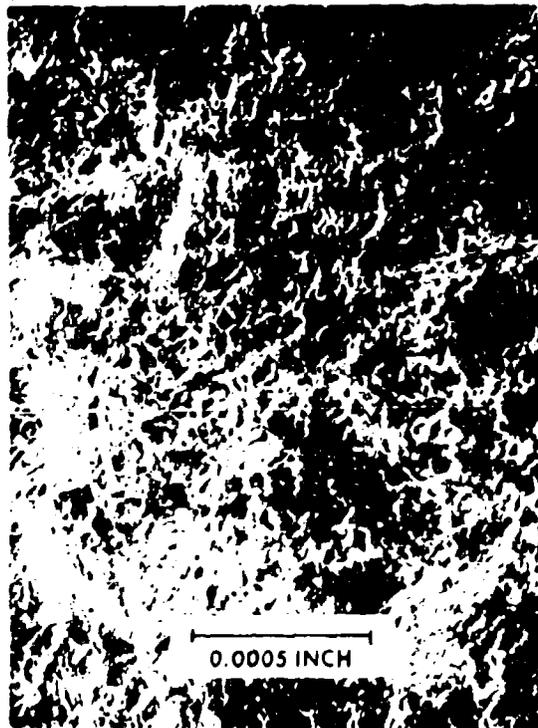
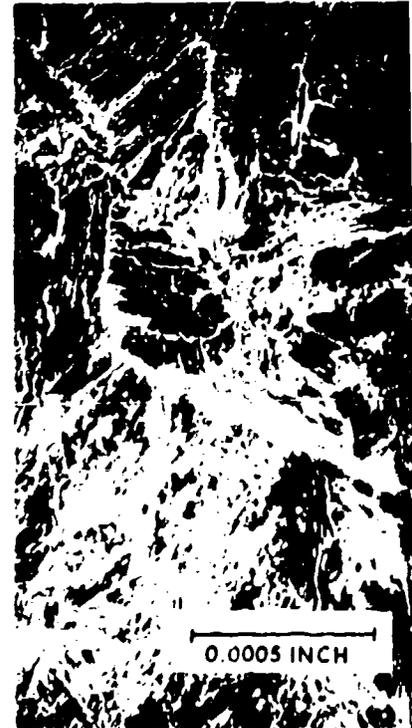
Figure 10  
Metallurgical Structure of 15-7 PH  
in the WELD HAZ (Firth's Reagent)

WELD METAL  
(FINE ACICULAR STRUCTURE)

HIGH TEMPERATURE HAZ  
(GRAIN BOUNDARIES OUTLINED)

CENTRAL HAZ  
(SMALL EQUIAXED GRAINS)

LOW-TEMPERATURE  
HAZ  
(SUSCEPTIBLE TO KNIFE  
EDGE ATTACK OF DARK  
PHASE)

BASE METAL  
(COARSE MIXED  
STRUCTURE)

Four high-magnification scanning electron photomicrographs of selected areas of the microstructure compose the lower portion of figure 10. The left-hand photo shows the fine dendritic structure existing in the weld metal. The next photo shows a fine, equiaxed structure with acicular regions existing in the middle temperature heat-affected zone, resulting from the heat of welding. Between these two areas is a region within the high-temperature, heat-affected zone where partial liquification probably has occurred, causing distinct outlining of the grain boundaries. The right-hand photo shows the coarse structure of the base metal. Next to this is a photo of the region where the dark phase corresponding to the area of knife-edge attack occurs. This structure shows that the precipitates had a preferred orientation. The prior grain boundaries are also evident. Unfortunately, further analysis of this structure is not practical due to the narrow width of the zone where it exists.
