DEVELOPMENT AND EVALUATION OF REPAIRS FOR EMP LEAKS  
IN CONDUIT SYSTEMS

Army Construction Engineering Research Laboratory  
Champaign, Illinois

TECHNICAL REPORT C-17  
April 1975

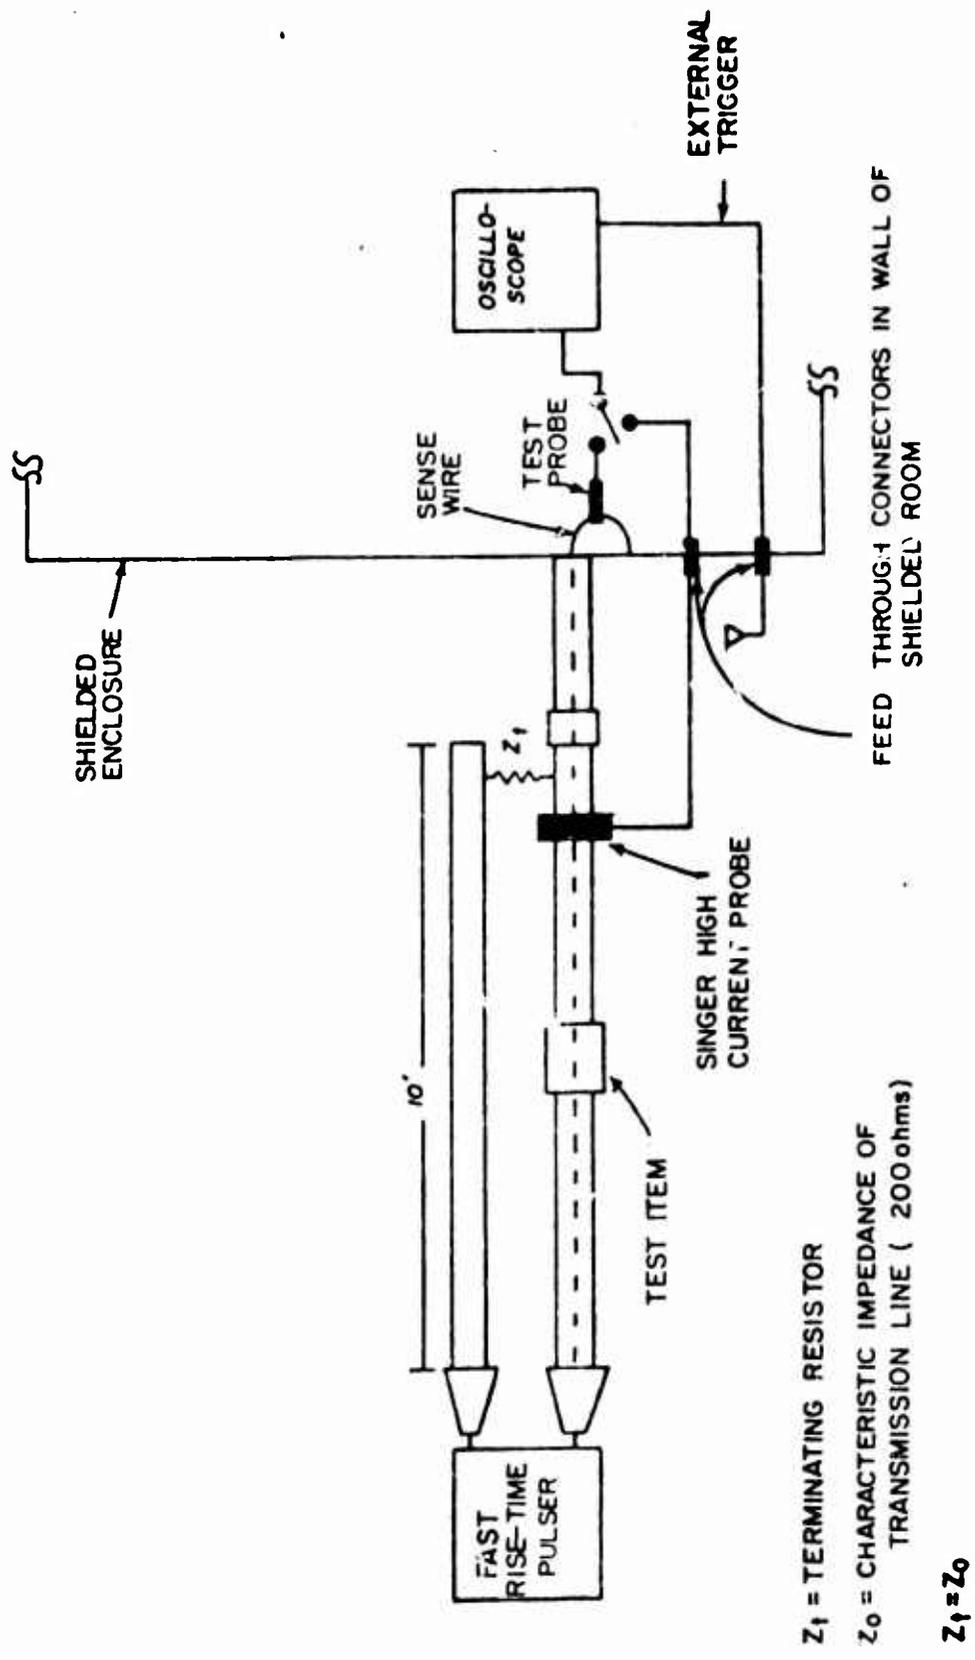
Figure 1. Block diagram of parallel conduit transmission-line test setup.

For all  $I_{SC}$  measurements described herein, a Tektronix P-6021 current-probe type 134 amplifier and a type 454, 7623, or 7904 oscilloscope were used. This setup had a low-frequency response to 10 Hz and provided a nondistorted record of the diffusion and leakage current. Figure 1 shows a schematic of the test setup.

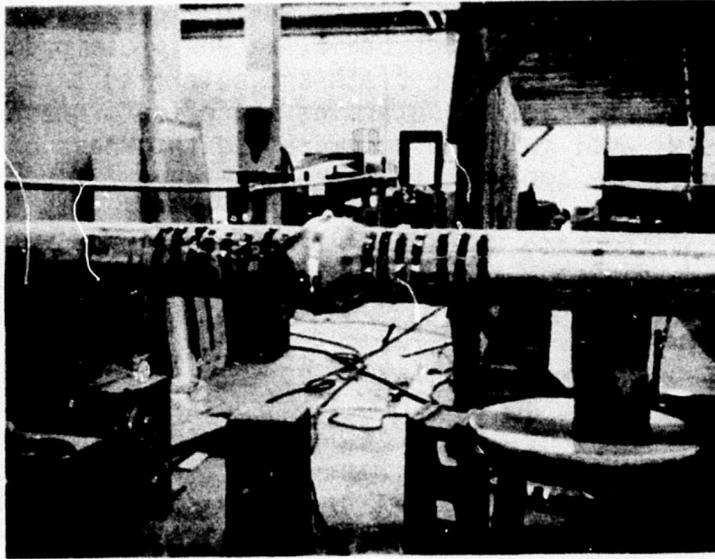
Figure 3. UNF union wrapped with hardware cloth.

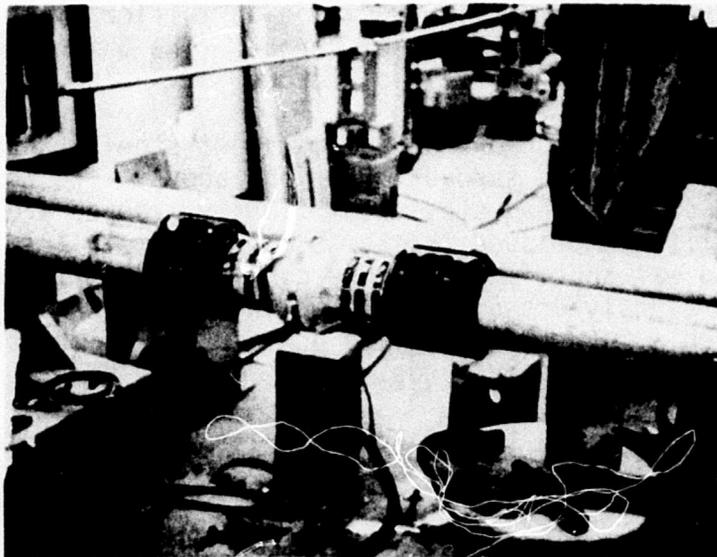
Figure 4. UNF union wrapped with hardware cloth and clamped with Skinner pipe clamps.

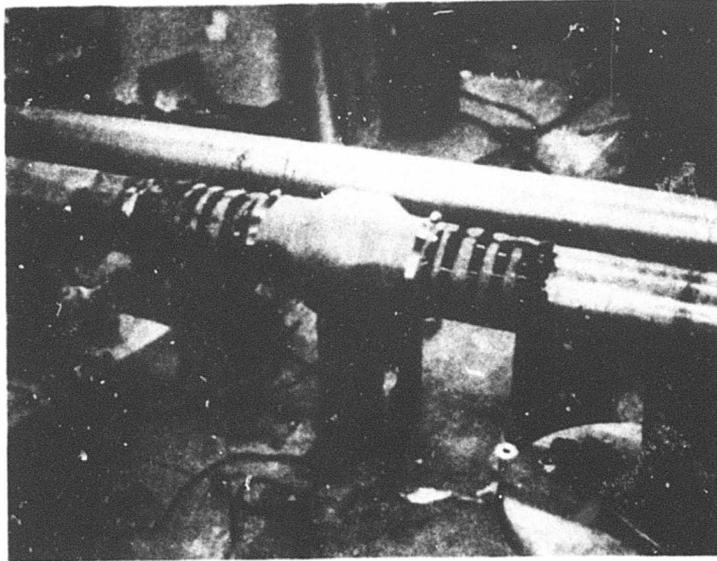
Figure 5. UNF union wrapped with hardware cloth and shielding tape.

inch hardware cloth, wrapped with three additional layers of shielding tape,\* was also tested (Figure 5). As shown in Figure 6, tests were also conducted with a tinned copper braid, securely clamped with screw type hose clamps over the hardware cloth and shielding tape shroud. An additional test was performed to determine the effectiveness of wrapping the union with steel wool (with an uncompressed thickness of approximately 1 1/2 in.) before applying the shroud (Figure 7).

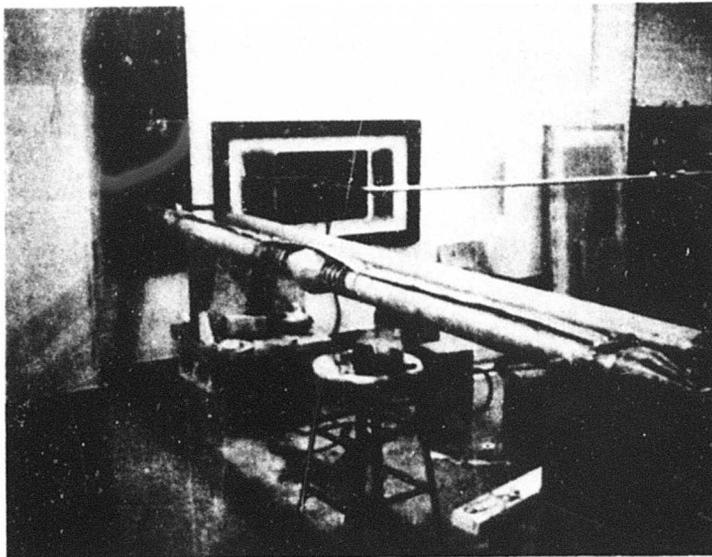
Figure 6. UNF union wrapped with hardware cloth and shielding tape, plus tinned copper braid.

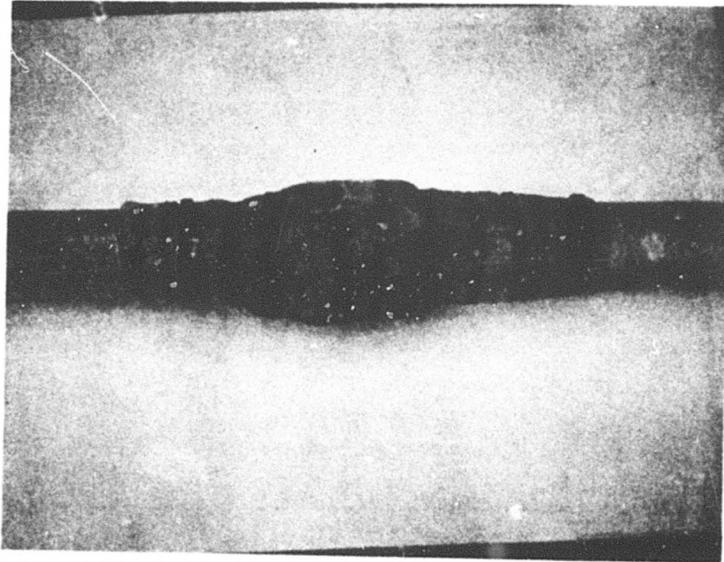
Figure 7. UNF union wrapped with steel wool and one layer of hardware cloth.

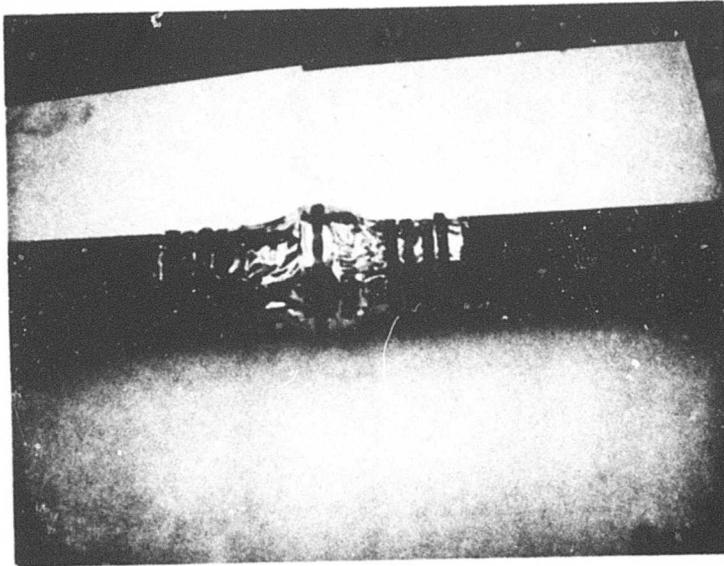
Figure 9. UNF union with Conetics foil shroud.

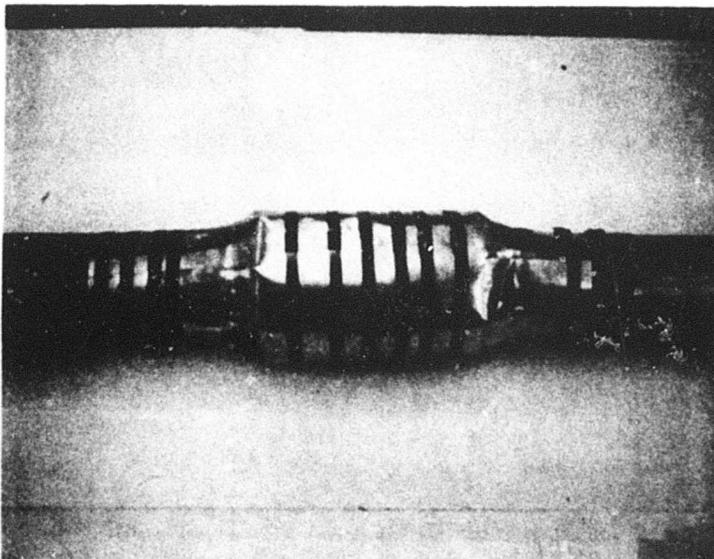
Figure 10. UNF union with 26-gauge sheet steel shroud.

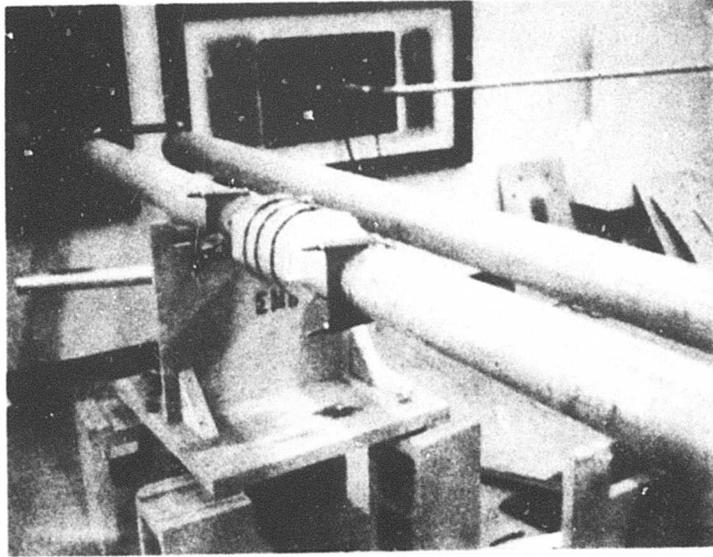
Figure 11. UNF union with 26-gauge sheet steel shroud clamped with muffler clamps.

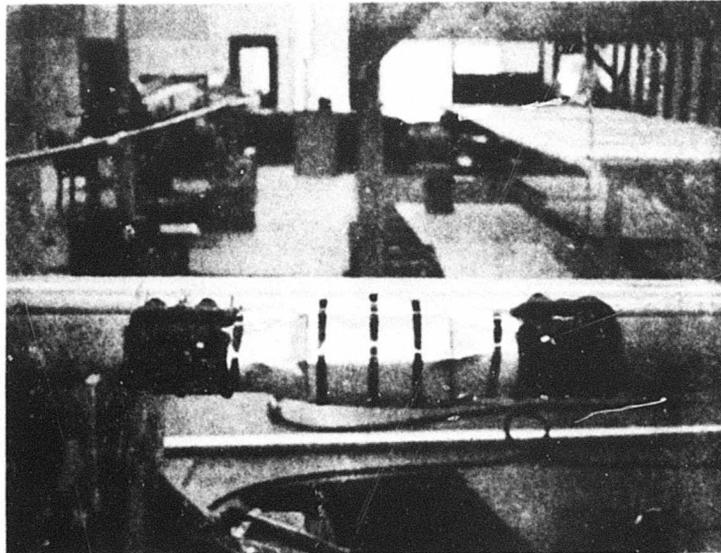
Figure 12. UNF union with 26-gauge sheet steel shroud clamped with Skinner pipe clamps.

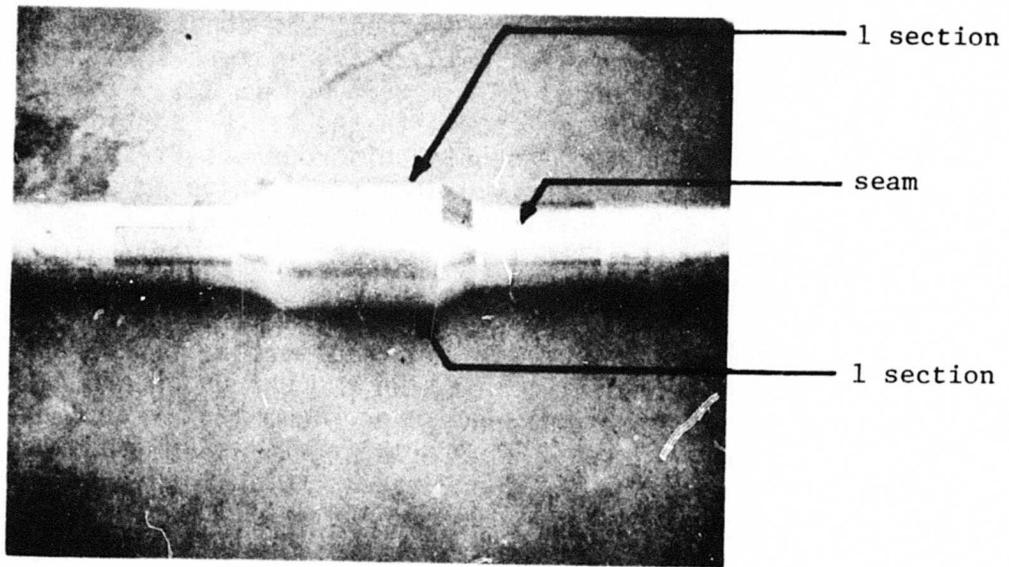
Figure 13. UNF union with Bishop shroud (as received from manufacturer--not clamped).

26-gauge galvanized sheet steel. For ease of installation, this shroud (hereafter referred to as the Bishop shroud) was constructed in two separate overlapping pieces, each being slightly more than one-half of the circumference of the shroud (Figures 13 and 13[a]). The unit was sized for a snug fit on the conduit--with the center portion large enough to fit over the union. The Bishop shroud was first tested while held in place with several tightly drawn, steel shipping bands. It was also tested with one 5-in. muffler clamp on each end--with each tightened to approximately 30 ft-lb of torque, and with steel shipping bands on the middle section only (Figure 14).

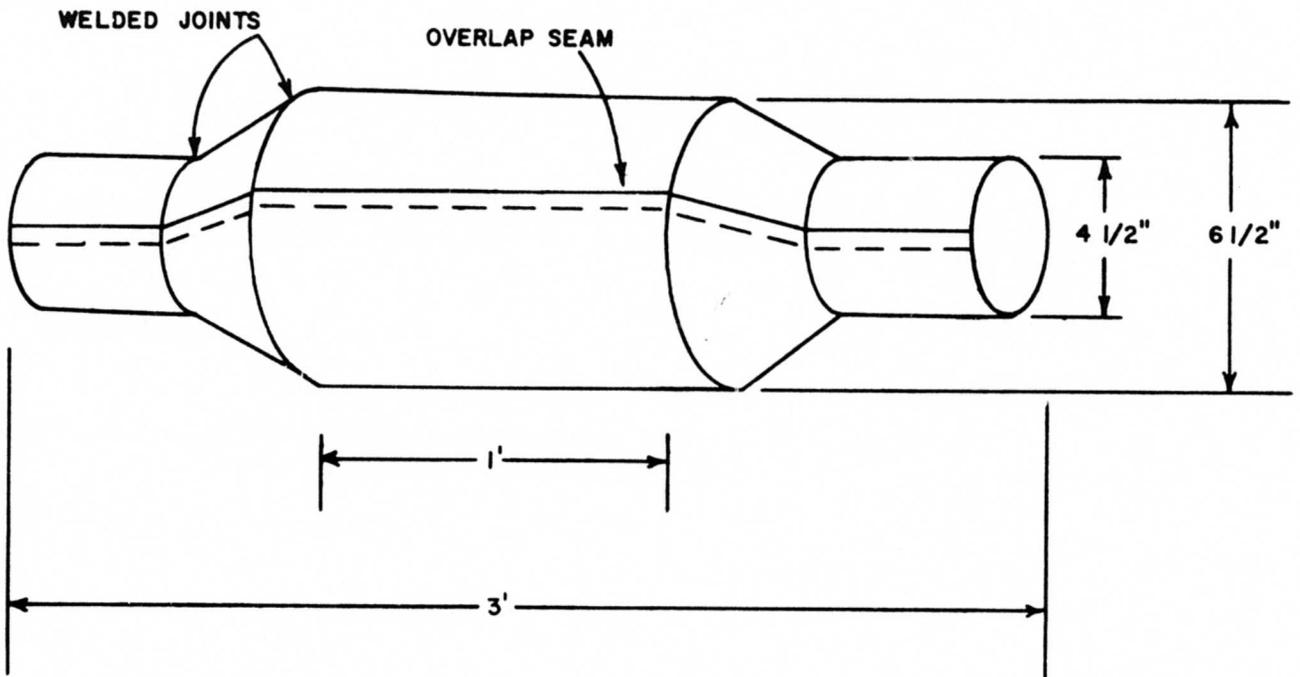
Figure 13a. Bishop shroud UNF union fix.

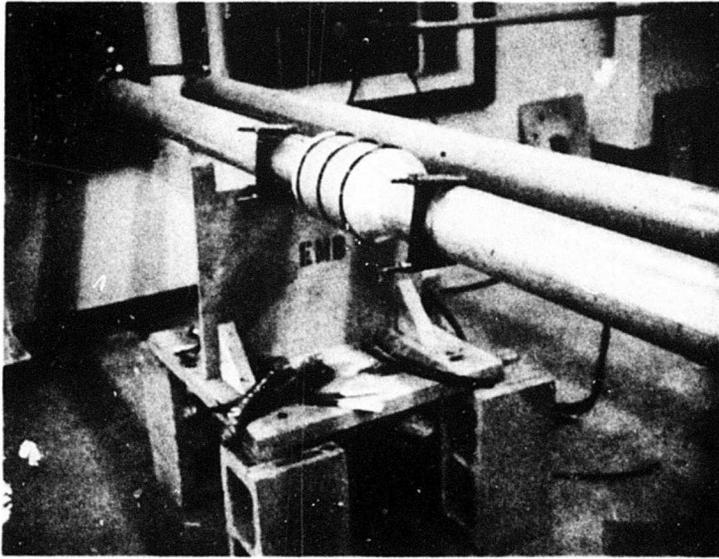
Figure 14. UNF union with Bishop shroud clamped with two muffer clamps.

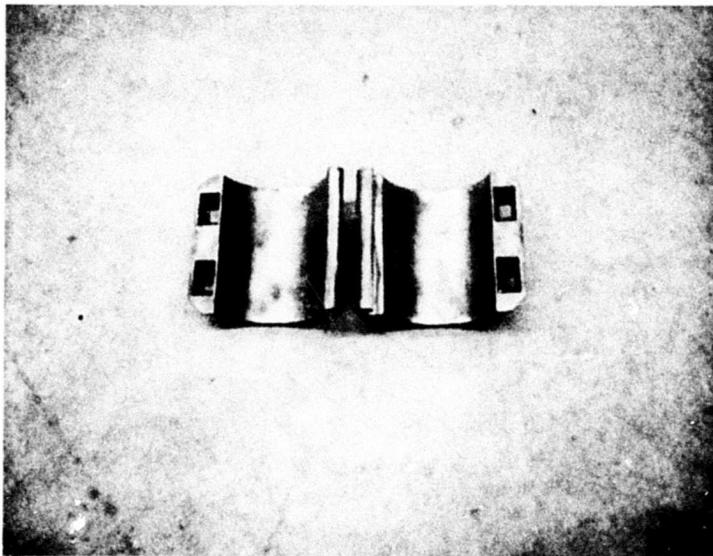
Figure 15. Skinner emergency pipe clamp--open.

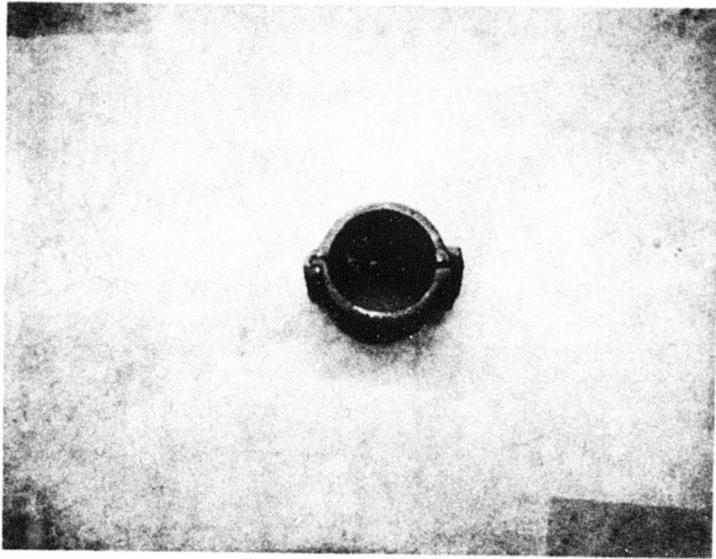
Figure 16. Skinner emergency pipe clamp--closed (but without bolts).

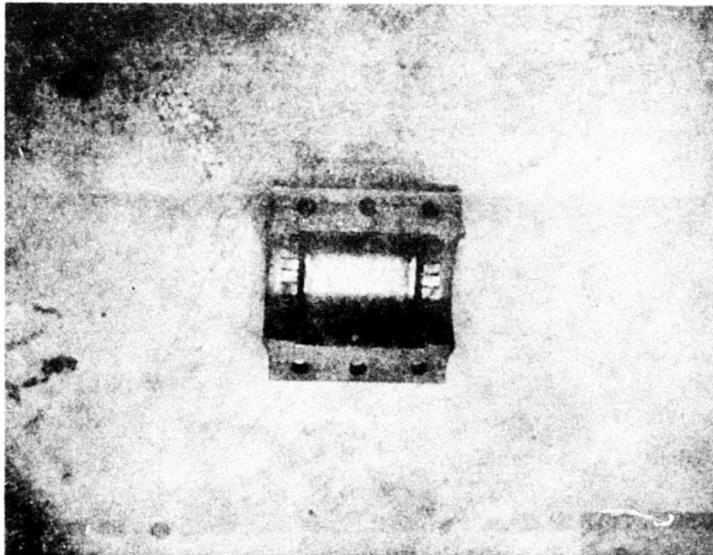
Figure 17. One of two similar halves of a PLIDCO pipe clamp.

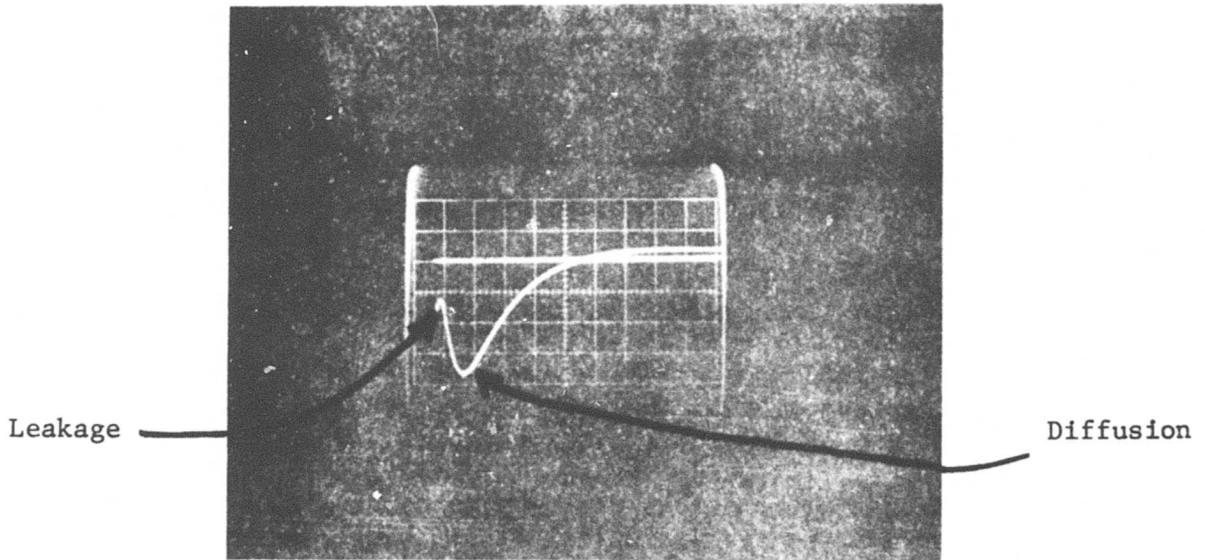
Figure 20. Wave form of  $I_{SC}$  during test of 26-gauge sheet steel shroud clamped with two muffler clamps ( $I = 1 \text{ mA/div}$ ;  $t = 200 \text{ } \mu\text{sec/div}$ ).

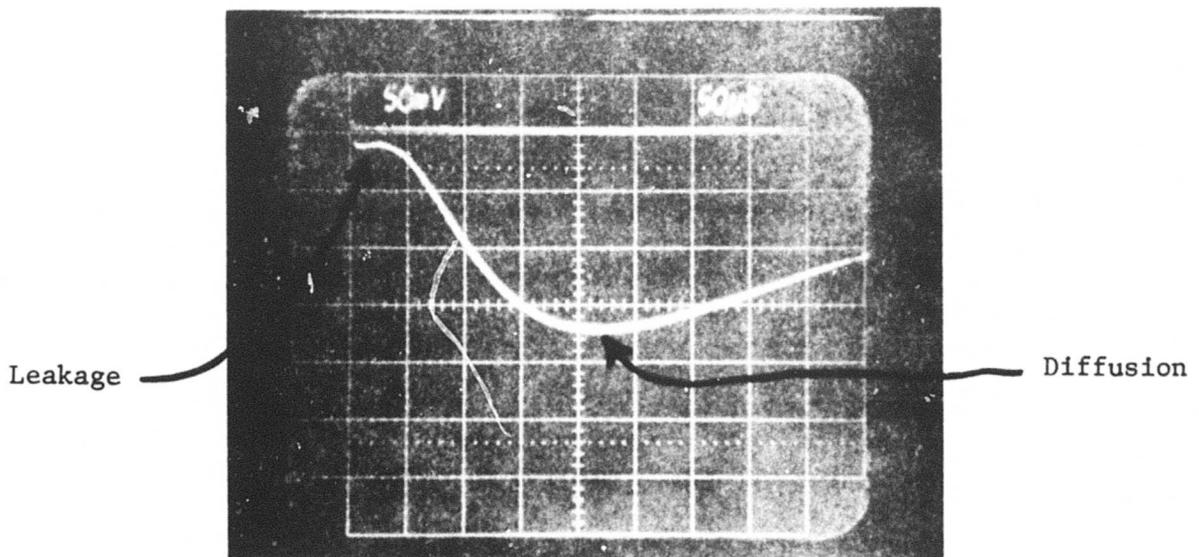
Figure 21. Wave form of  $I_{SC}$  during test of Bishop shroud with steel shipping bands ( $I = 1 \text{ mA/div}$ ;  $t = 50 \text{ } \mu\text{sec/div}$ ).

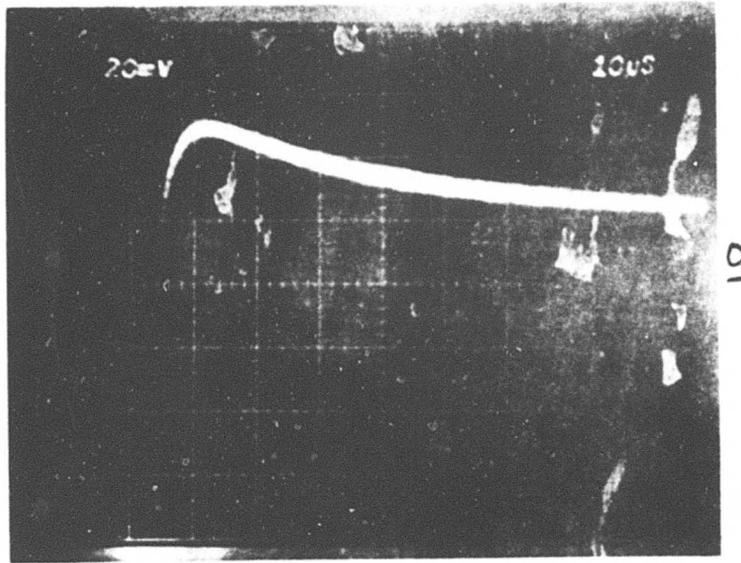
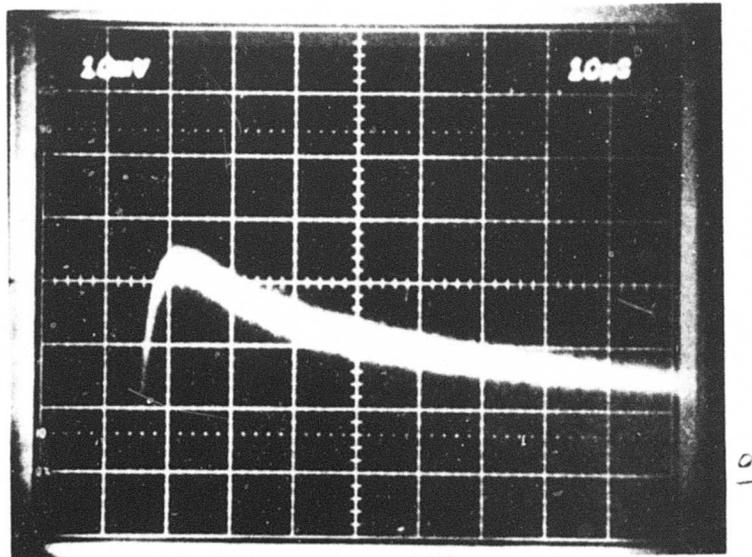
Figure 22. Wave form of  $I_{sc}$  during test of Skinner pipe clamp with sleeve of two layers of sheet steel ( $I = 0.4$  mA/div;  $t = 10 \mu\text{sec/div}$ ).

Figure 23. Wave form of  $I_{sc}$  during test of PLIDCO pipe clamp with sleeve of two layers of sheet steel ( $I = 0.2$  mA/div;  $t = 10 \mu\text{sec/div}$ ).

*Pipe Clamps.* Table 2 gives the peak value of the short-circuit current ( $I_{SC}$ ) flowing in the sense wire for each of the pipe-clamp variations. Figures 22 and 23 are typical photographs of this  $I_{SC}$  wave form. It should be noted that, unlike the shroud fixes, the major component of  $I_{SC}$  for all the pipe clamps is leakage current. This is as expected since the actual conducting material (the walls of the pipe clamp) is relatively thick. The primary source of the leakage current appears to be the gap between the mating surfaces of the two halves of the pipe clamp, the effect of which was greatly reduced by the various liners tested.

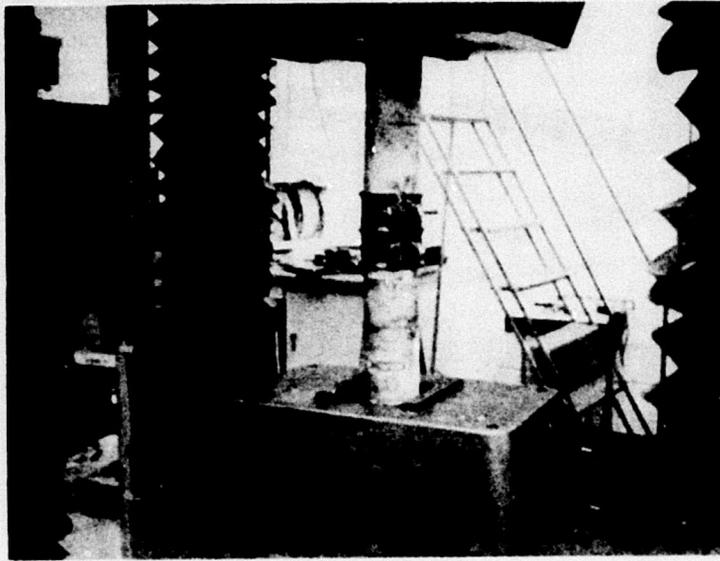
Figure 24. Universal test machine used for tension tests.

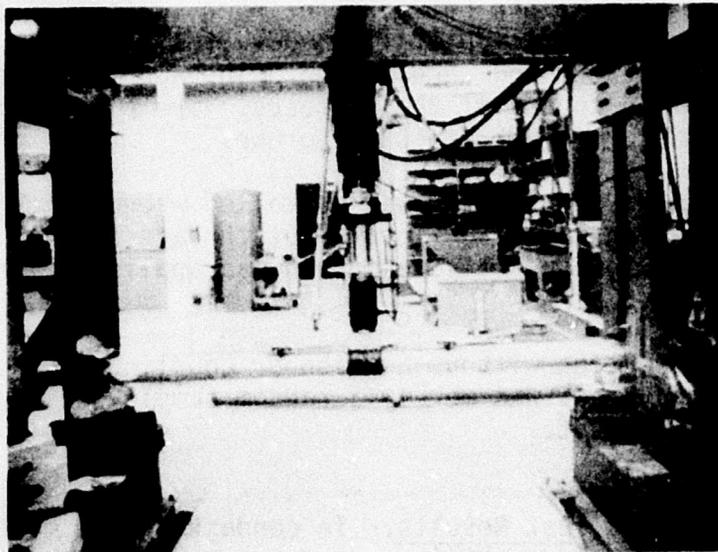
Figure 25. Universal test machine used for lateral-stress tests.

Samples subjected to the lateral-stress test were individually installed in a universal test machine (Figures 25 and 26) and subjected to an increasing lateral force (bending force), perpendicular to the cylindrical axis of the conduit sample, until some part of the test sample failed, or, if the sample deflected sufficiently without failing, until the test machine reached the end of its stroke. The load was applied simultaneously on both sides of the test union approximately 15 in. from the center of the union. The amount of force applied to each sample was recorded as a function of machine stroke (i.e., test item deflection).

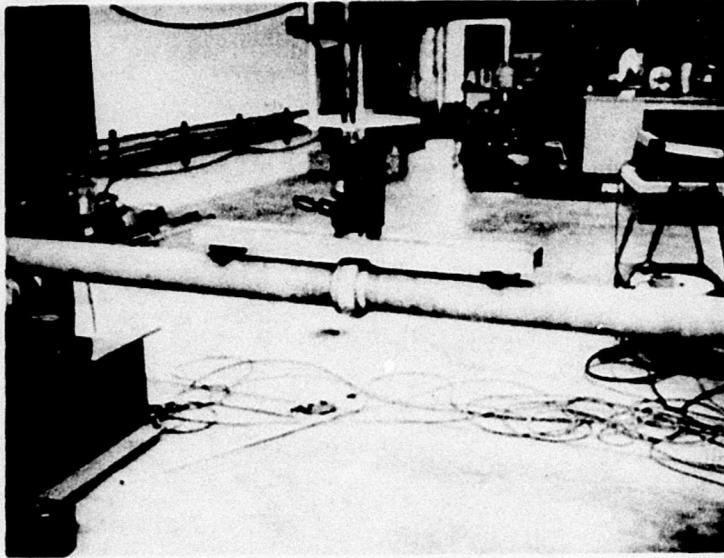
Figure 26. Lateral stress being applied to UNF union test sample.

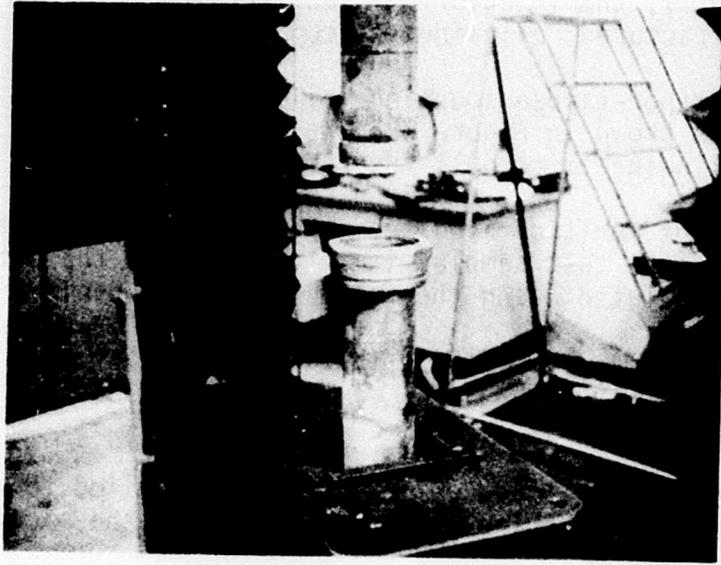
Figure 27. UNF union sample after tension test.

The UNF union failed when 55,060 lb of tension was applied. As shown in Figure 27, the interior-beveled, retainer-ring portion of the union casting fractured, allowing the conduit to pull free of the union.

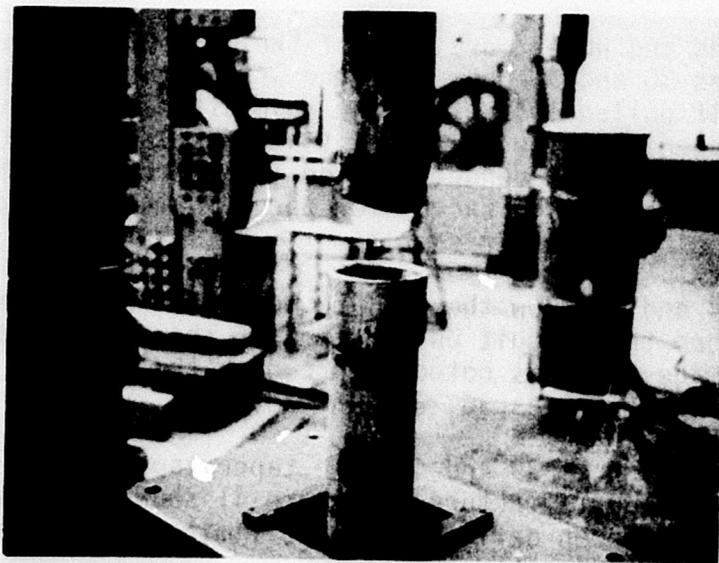
Figure 28. Taper-tapped coupling sample after tension test.

The 4-in. taper-tapped coupling failed when 74,290 lb of tension was applied. As shown in Figure 28, the conduit fractured along one of the threads, allowing it to pull free of the coupling.

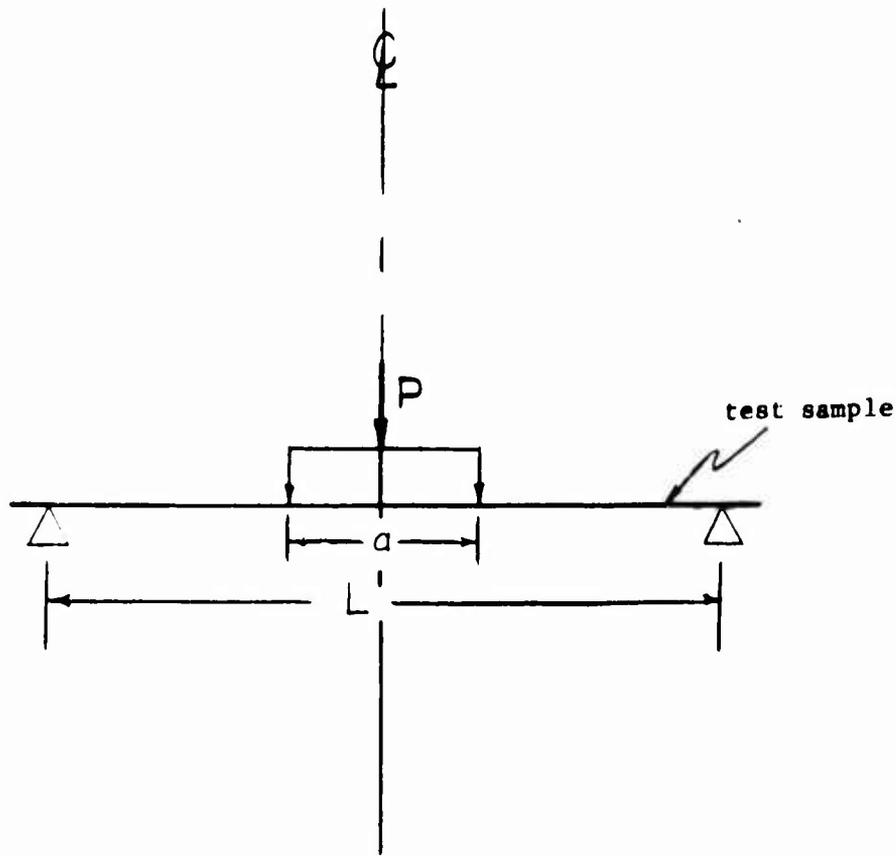
Figure 29. Test parameters for lateral-stress test.

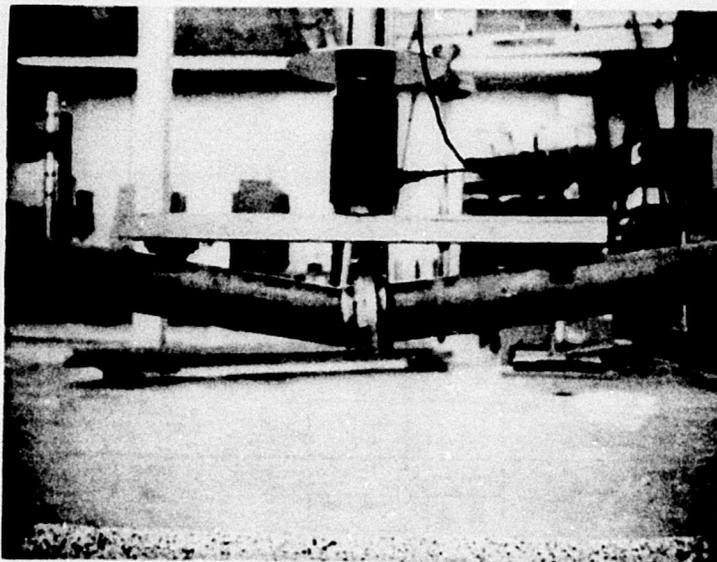
Figure 30. Side view of UNF union wrench-tight sample after lateral-stress test.

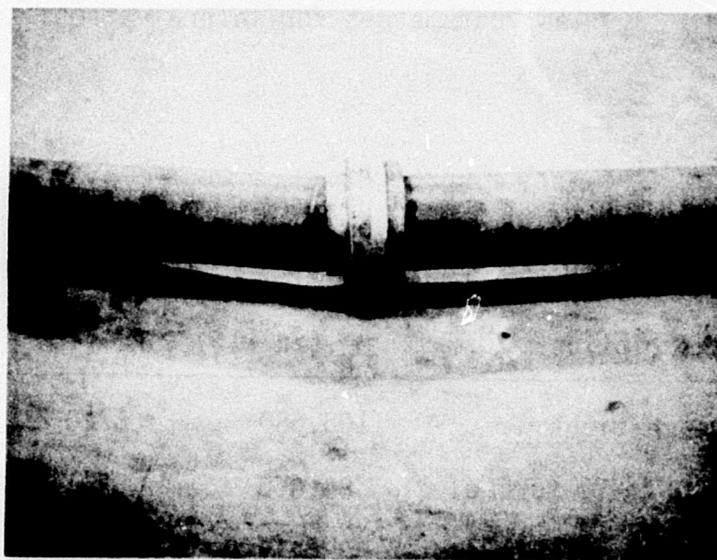
Figure 31. Bottom view of UNF union wrench-tight sample after lateral-stress test.

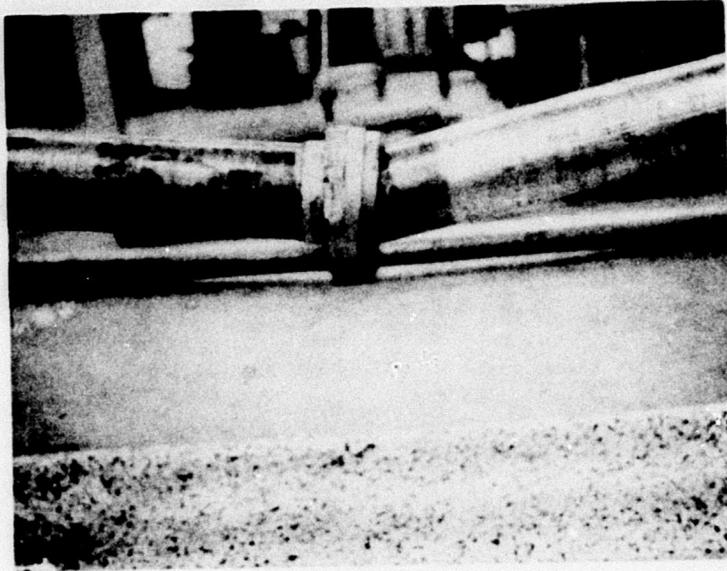
Figure 32. Side view of UNF union 1200 ft-lb sample after lateral-stress test.

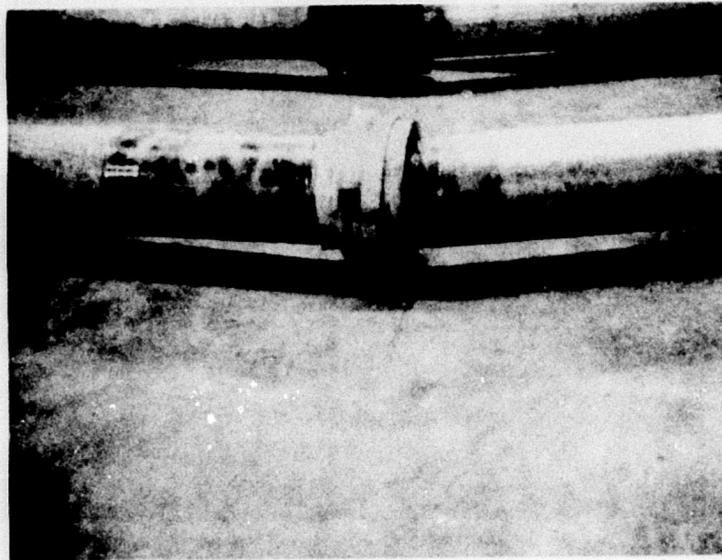
Figure 33. Bottom view of UNF union 1200 ft-lb sample after lateral-stress test.

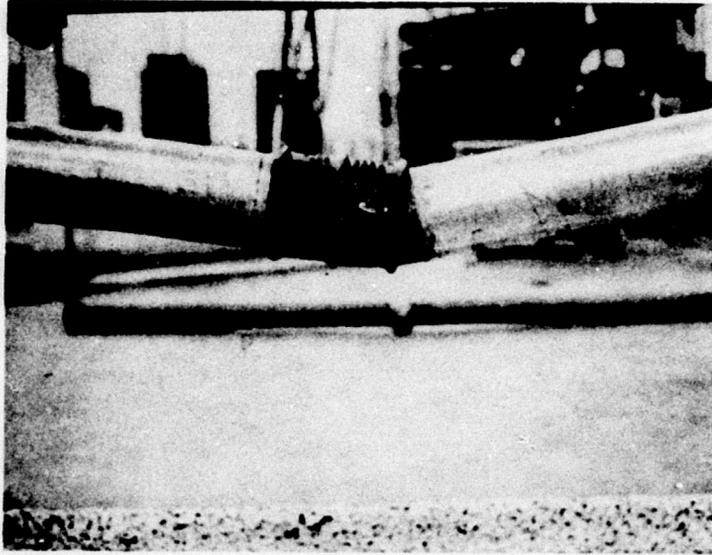
Figure 34. Side view of Skinner pipe clamp with sheet steel sleeve sample after lateral-stress test.

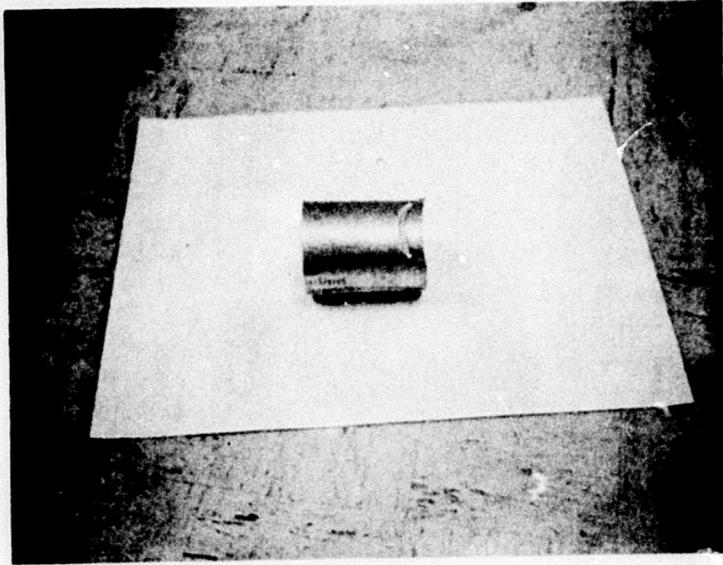
Figure 36. Sheet steel sleeve from Skinner pipe-clamp sample after lateral-stress test.

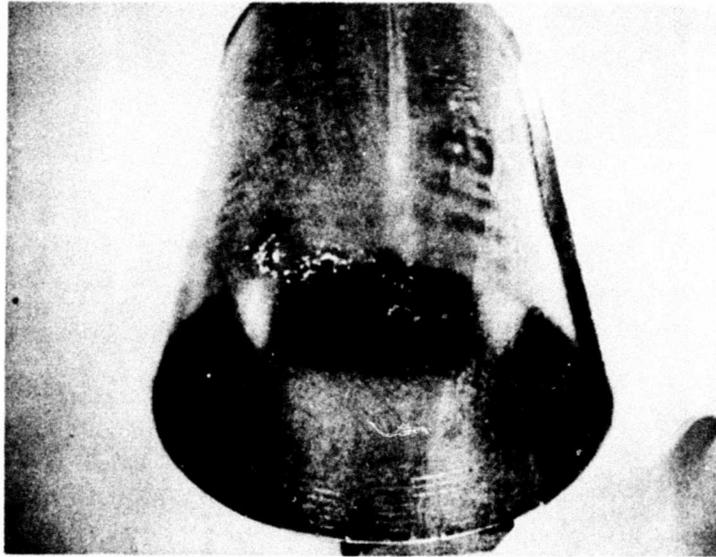
Figure 38. End of sheet metal sleeve from Skinner pipe-clamp sample in which conduit remained secure during lateral-stress test--showing scoring by conduit threads.

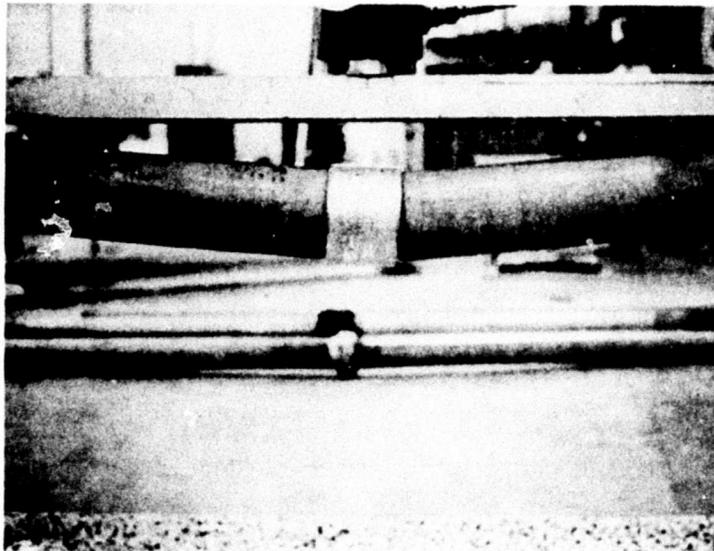
Figure 39. Side view of taper-tapped coupling sample after lateral-stress test.

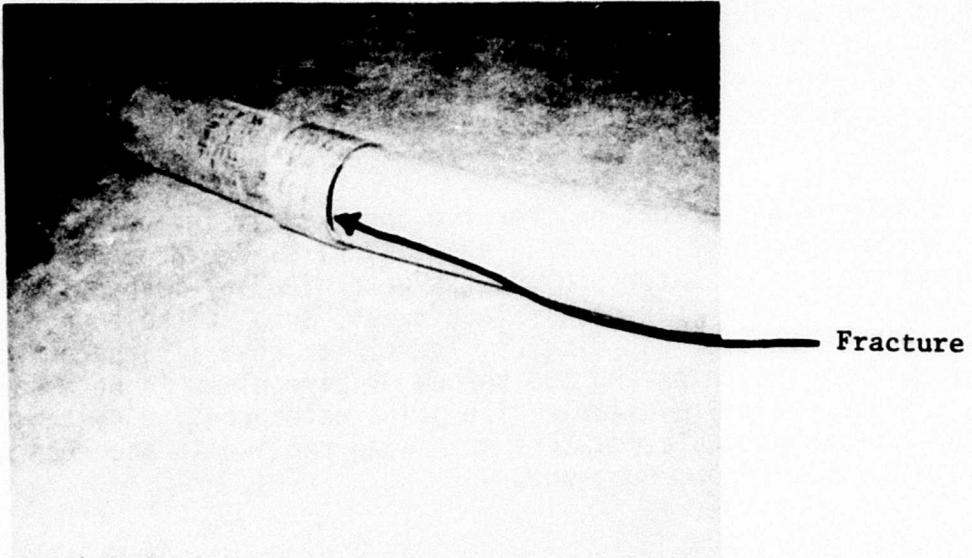
Figure 40. Bottom view of taper-tapped coupling sample after lateral-stress test--showing conduit wall fracture.

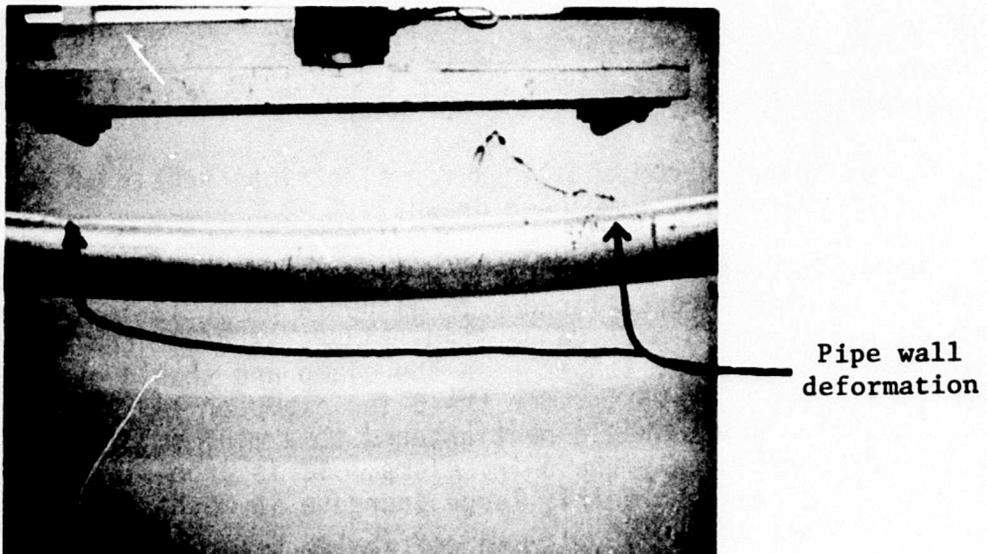
Figure 41. Side view of continuous conduit sample after lateral-stress test--showing conduit wall deformation.

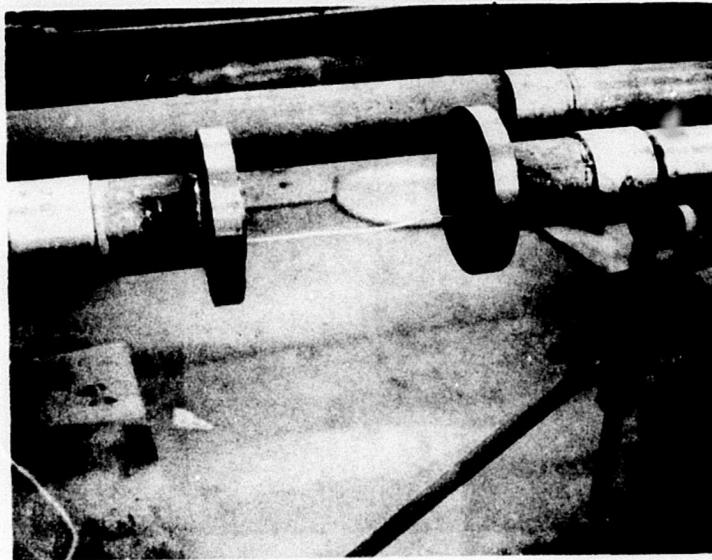
Figure 42. Test setup showing cable-gripper box ends installed in 4-in. conduit.

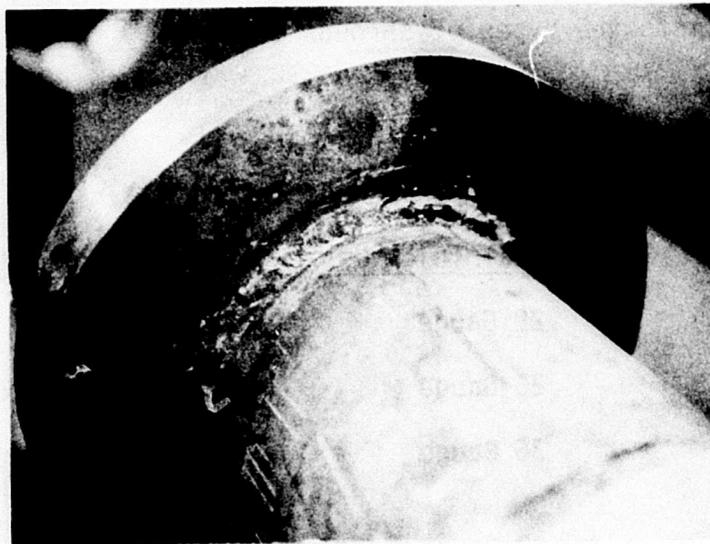
Figure 43. Cable-gripper box disc welded to 4-in. conduit.

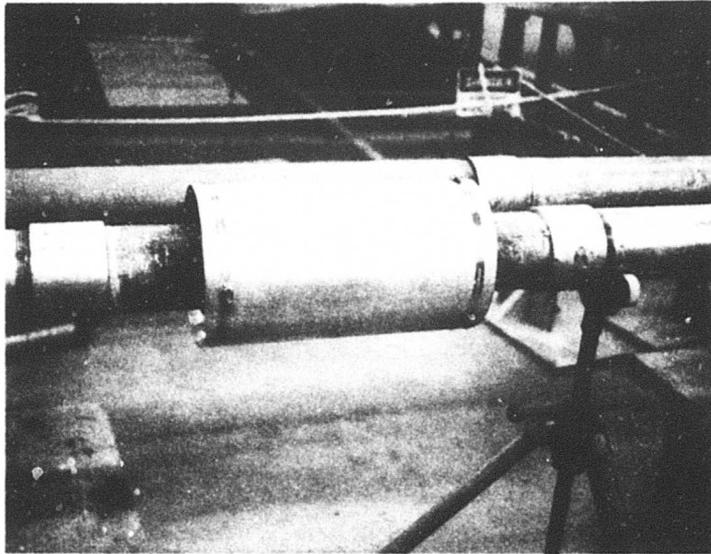
Figure 45. Cable-gripper box with shroud and stainless-steel hose clamps.

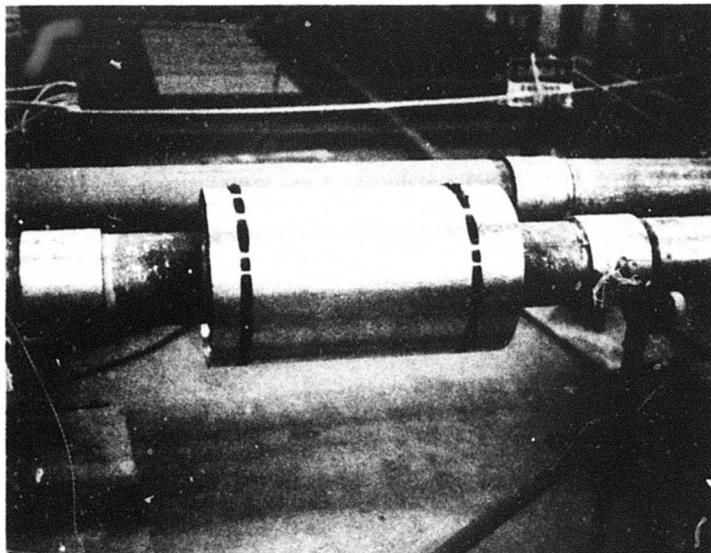
Figure 46. Cable-gripper box with shroud and metal shipping bands.

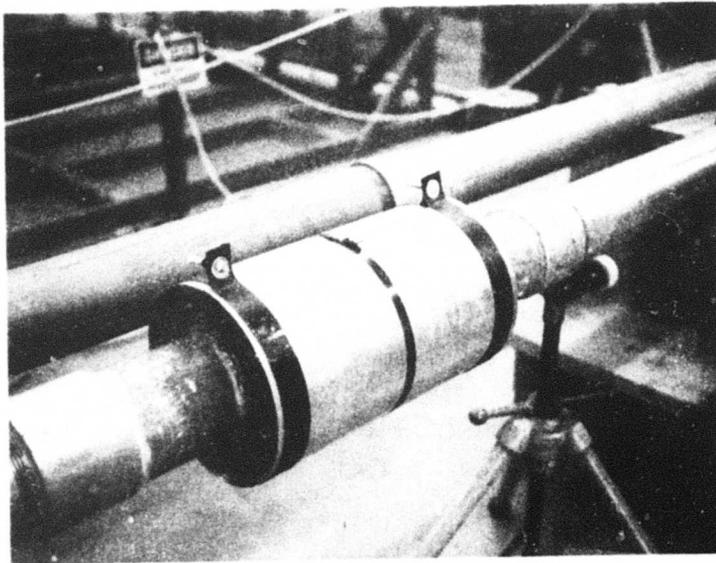
Figure 47. Cable-gripper box with shroud and locally manufactured clamps and one metal shipping band.

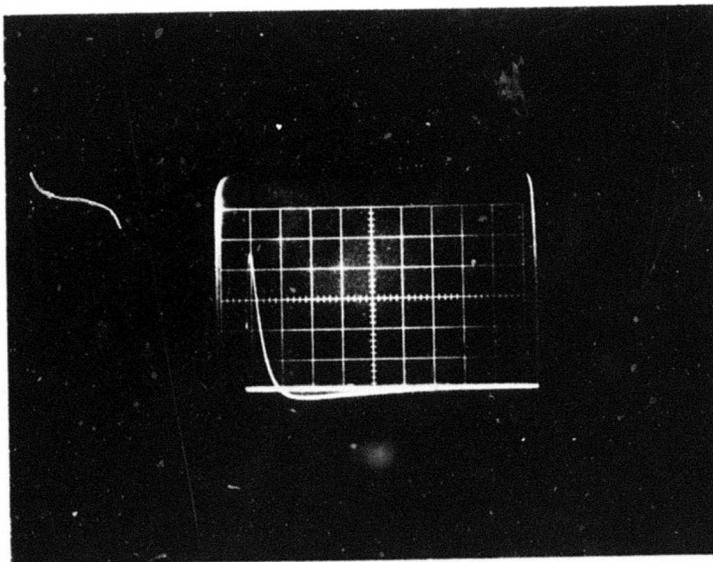
Figure 48. Single-layer shroud, 26 gauge ( $I_{SC}$ , 2 mA/div, 0.5  $\mu$ sec/div).

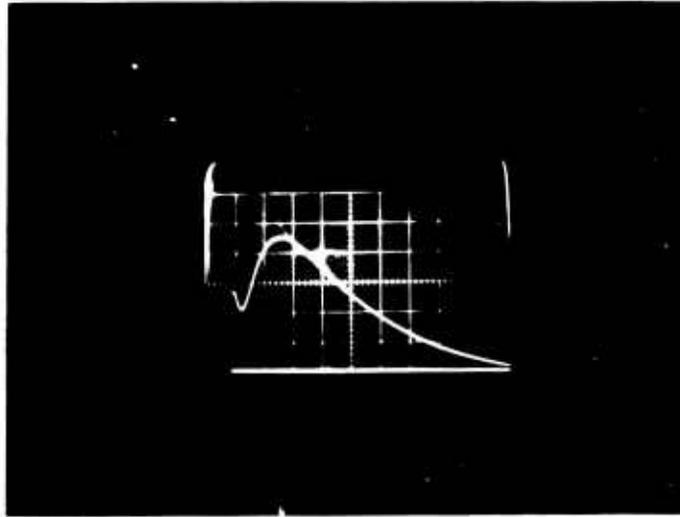
Figure 49. Single-layer shroud, 26 gauge ( $I_{SC}$ , 2 mA/div, 50  $\mu$ sec/div).

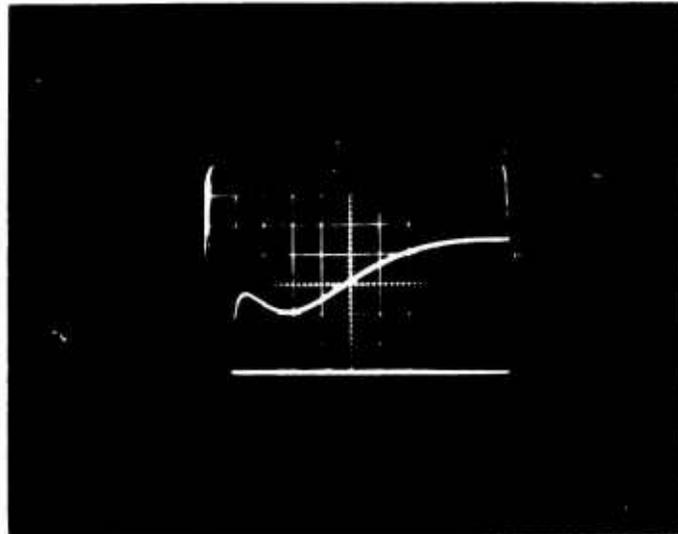
Figure 50. Single-layer shroud, 26 gauge ( $I_{SC}$ , 2 mA/div, 10  $\mu$ sec/div).

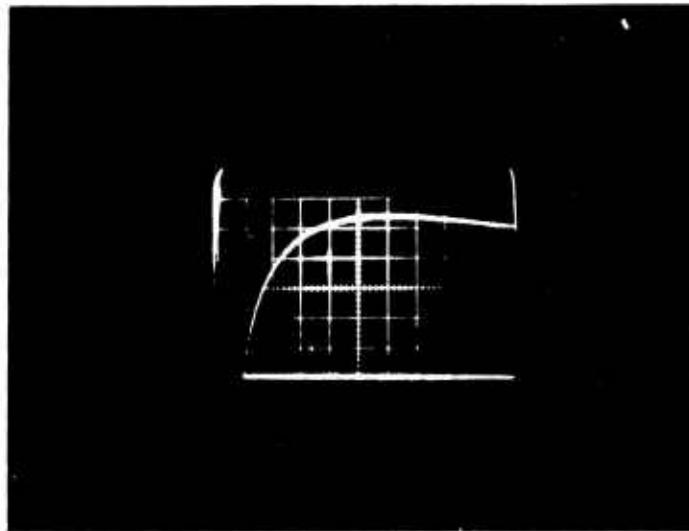
Figure 51. Single-layer shroud, 26 gauge ( $I_{SC}$ , 2 mA/div, 1  $\mu$ sec/div).
