DEVELOPMENT AND EVALUATION OF REPAIRS FOR EMP LEAKS  
IN CONDUIT SYSTEMS

Army Construction Engineering Research Laboratory  
Champaign, Illinois

TECHNICAL REPORT C-17  
April 1975

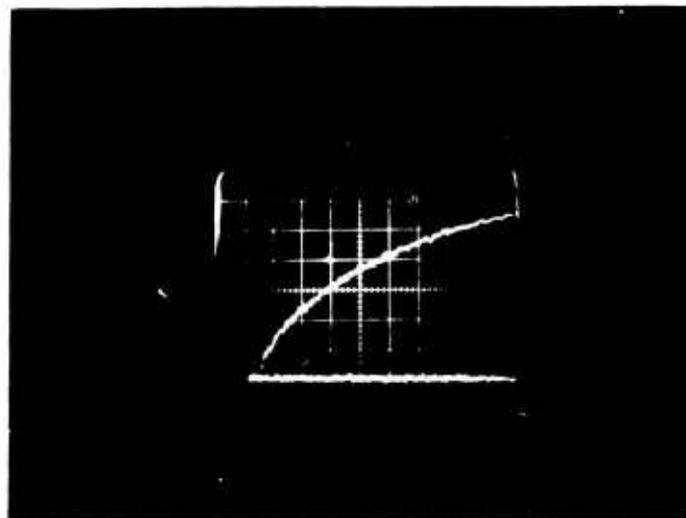
Figure 52. Single-layer shroud, 26 gauge ( $I_{SC}$ , 0.8 mA/div, 0.2  $\mu$ sec/div).

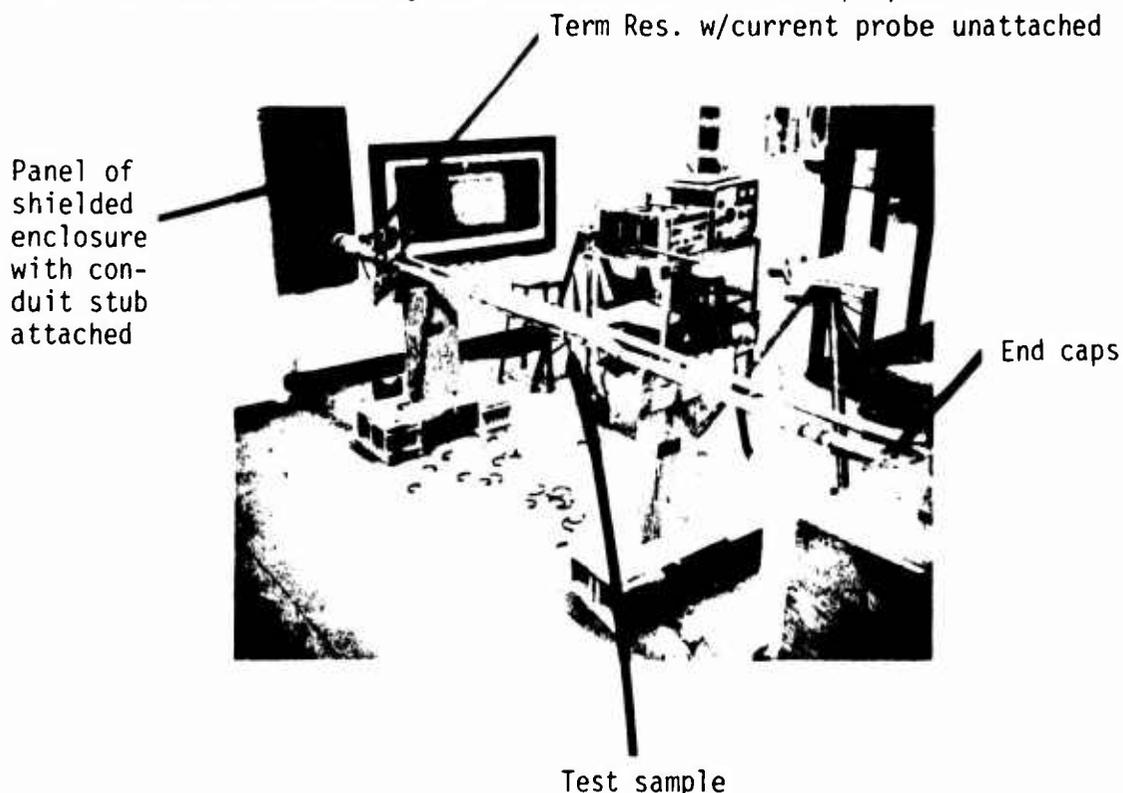
Figure 54. Parallel conduit transmission-line test assembly.

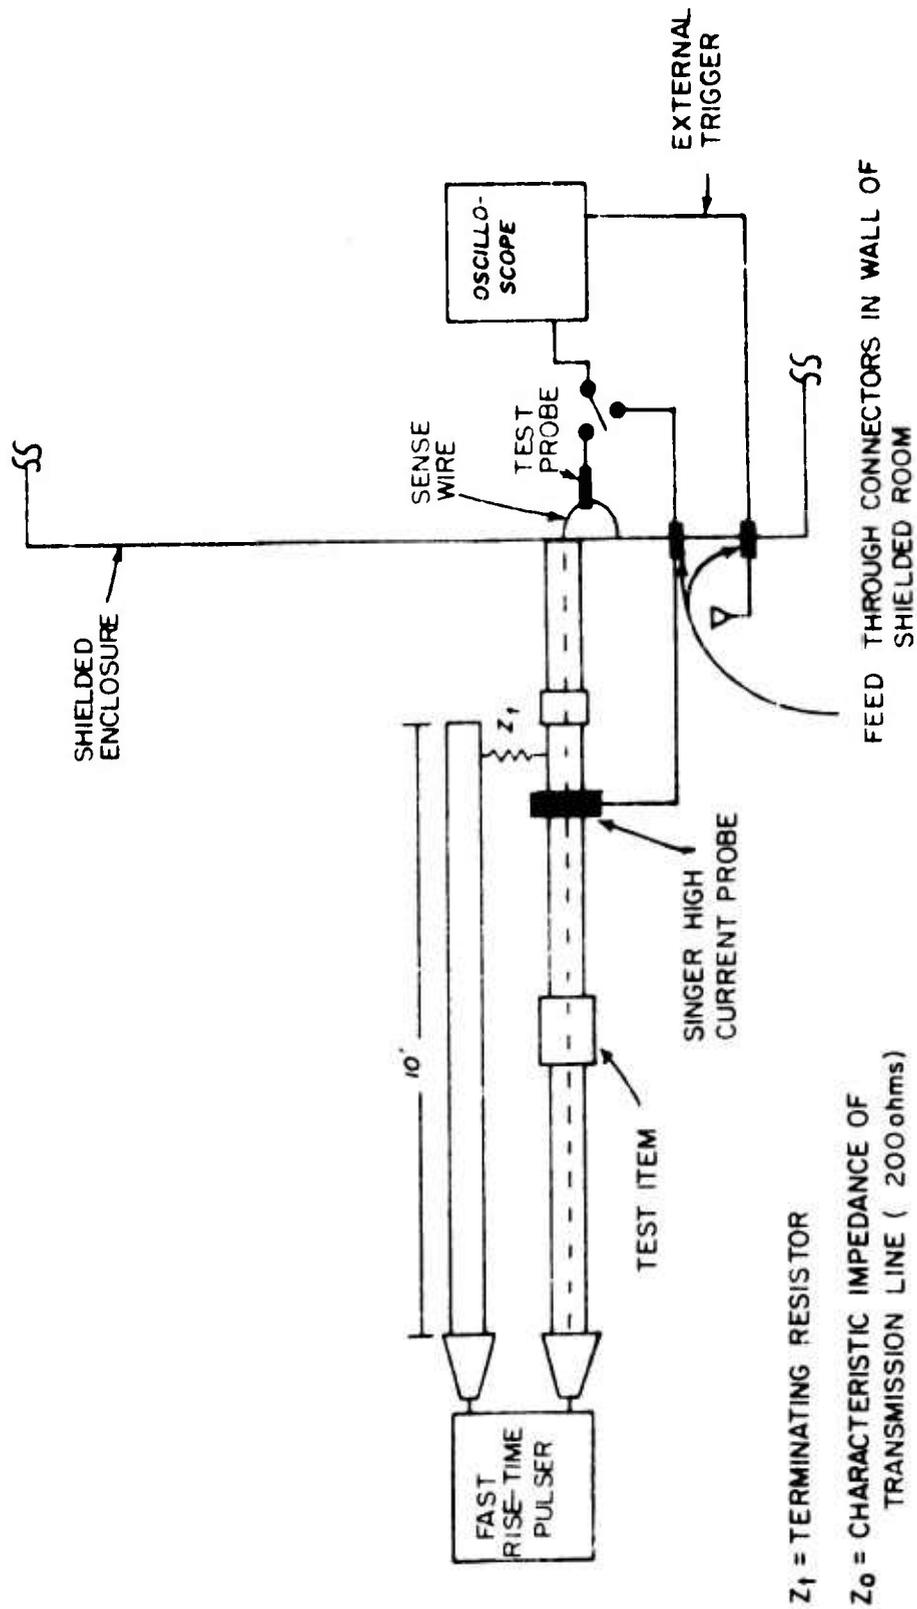
Figure 55. Block diagram of parallel conduit transmission-line test setup.

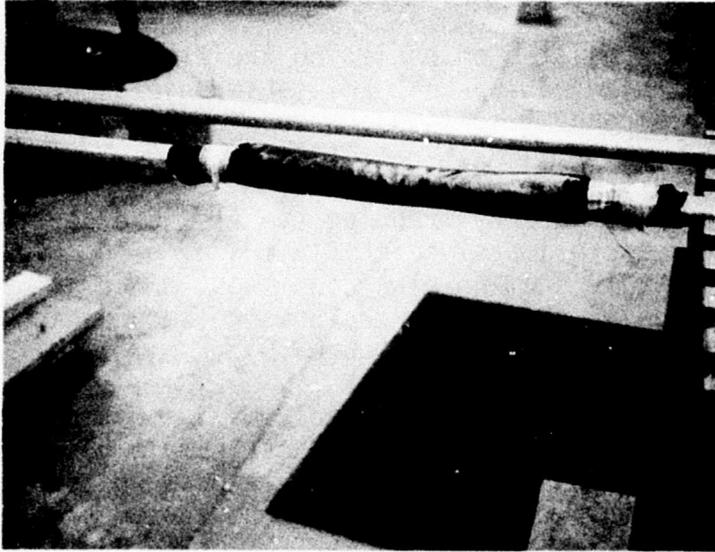
Figure 58. Test sample with conduit section covered with ZIP-EX-2 cable shielding (test sample 3).

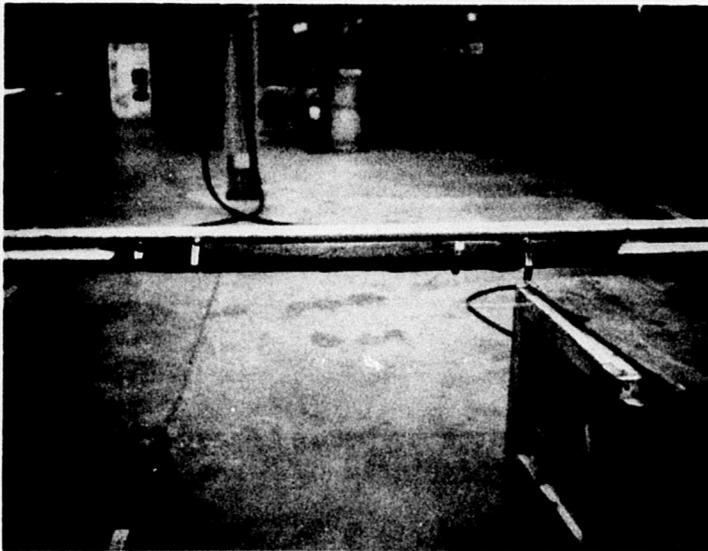
Figure 59. Test sample with conduit section wrapped with Monel wire mesh (test sample 4).

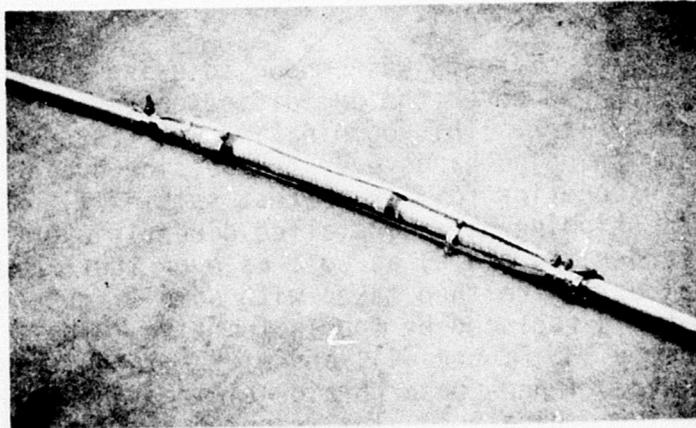
Figure 61. Test sample with conduit section wrapped with Monel wire mesh and nylon-reinforced tape over which three tinned copper braid straps have been clamped (test sample 8).

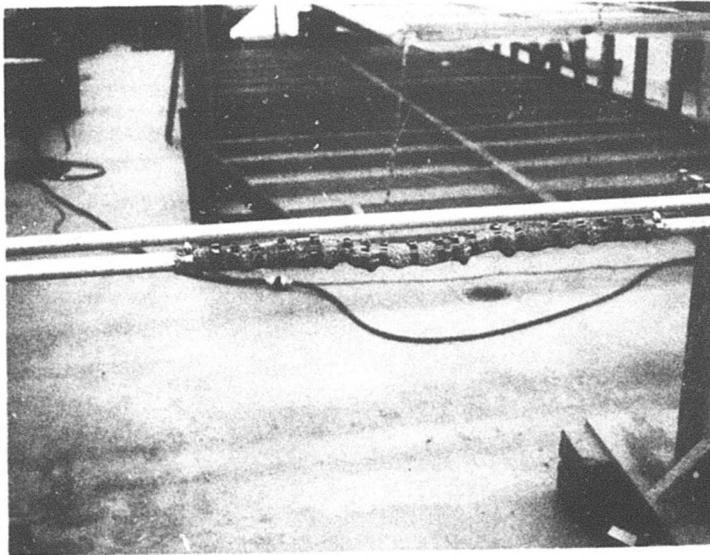
Figure 62. Test sample with conduit section covered by split galvanized steel braid sleeve (test sample 9).

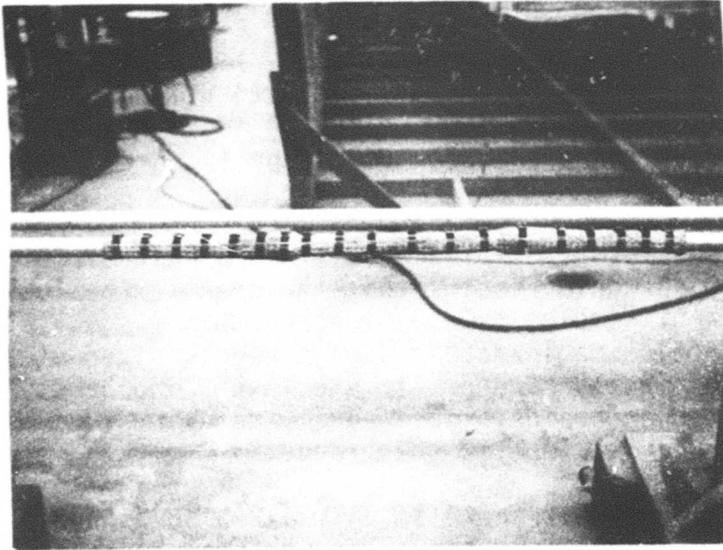
Figure 63. Test sample with conduit section covered by galvanized steel braid sleeve--not split (test sample 10).

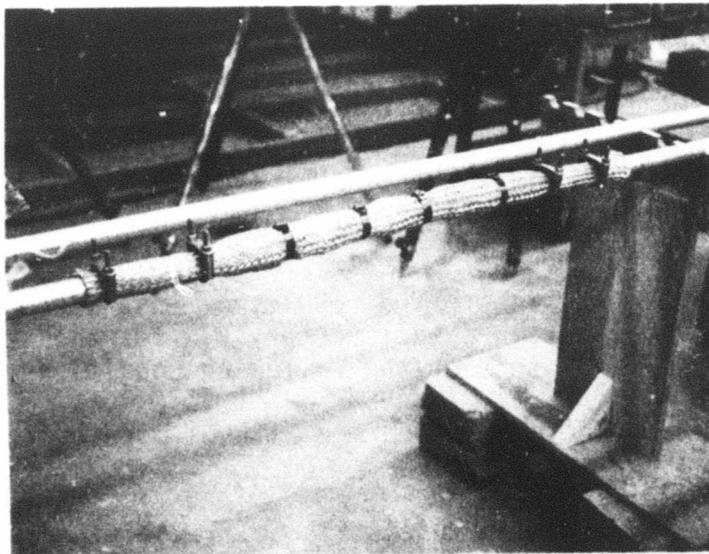
Figure 64. Test sample with conduit section covered by Conetics foil and a galvanized steel braid sleeve (not split) held in place with steel shipping bands and muffler clamps (test sample 13).

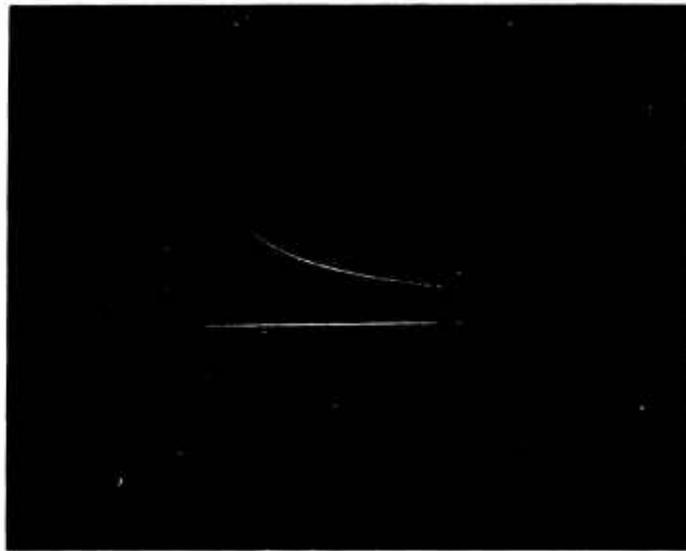
Figure 65.  $I_{sc}$  wave form--flexible conduit section without any additional shielding, test sample 1 ( $I = 2 \text{ A/div}$ ,  $\tau = 5 \text{ } \mu\text{sec/div}$ ).

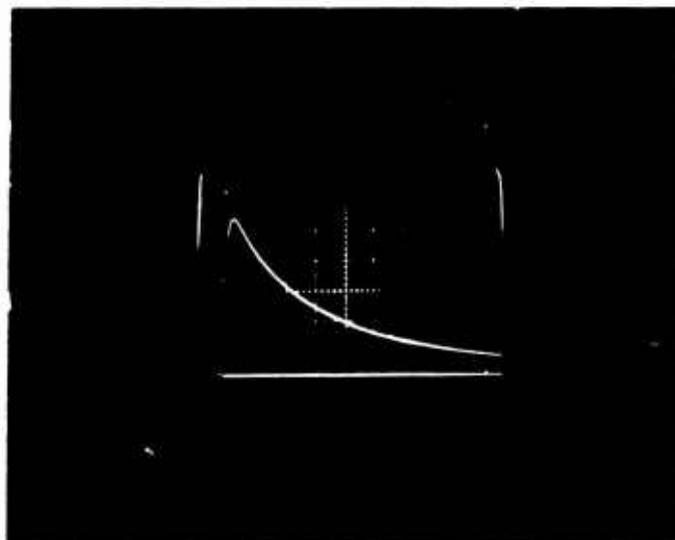
Figure 66.  $I_{sc}$  wave form--flexible conduit section wrapped with Monel wire mesh held with hose clamps and tape, test sample 8 ( $i = 500 \text{ mA/div}$ ;  $t = 20 \text{ } \mu\text{sec/div}$ ).

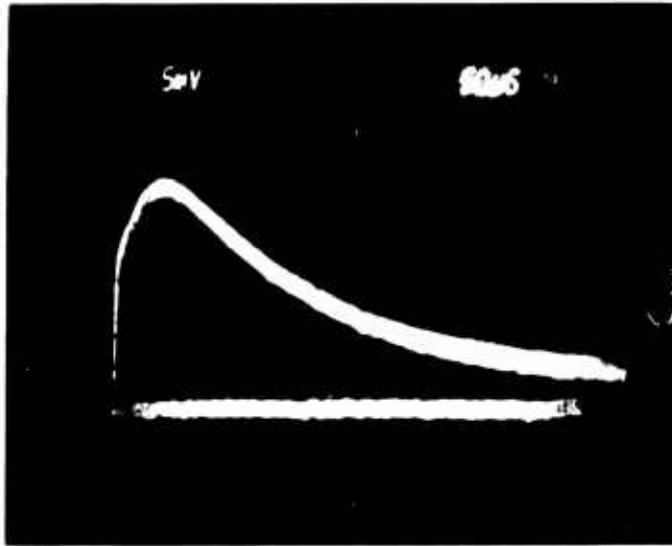
Figure 67.  $I_{sc}$  wave form--flexible conduit section covered with split galvanized steel braid sleeve, test sample 9 ( $i = 20 \text{ mA/div}$ ;  $t = 50 \text{ } \mu\text{sec/div}$ ).

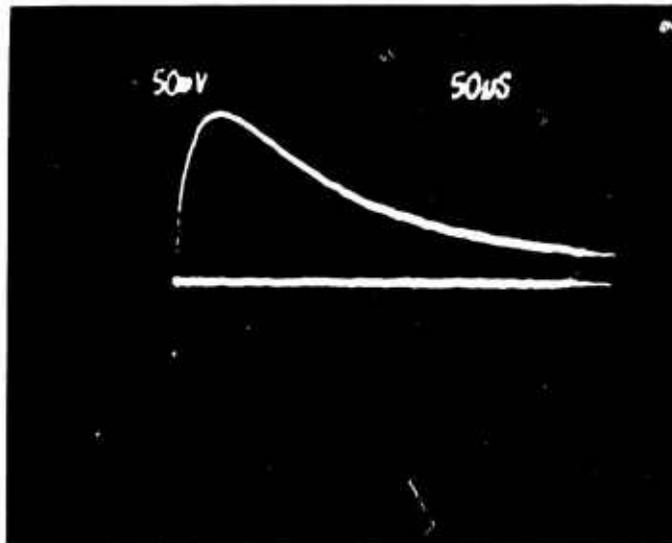
Figure 68.  $I_{sc}$  waveform--flexible conduit section covered with galvanized steel braid sleeve (not split), test sample 10 ( $i = 20 \text{ mA/div}$ ;  $t = 50 \text{ } \mu\text{sec/div}$ ).

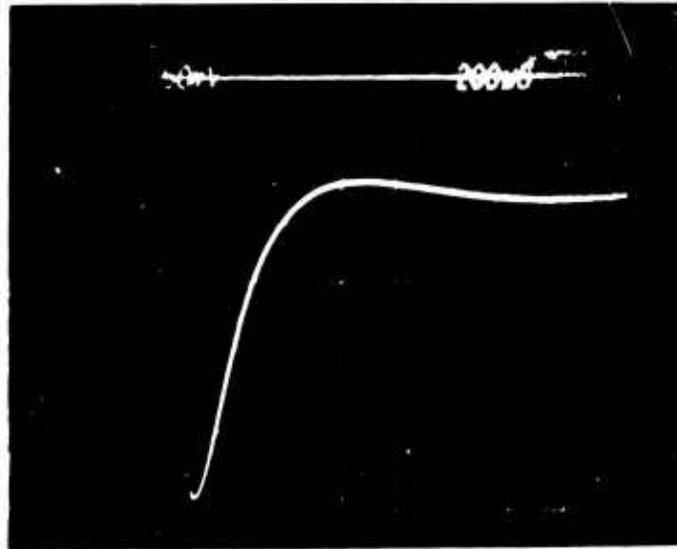
Figure 69.  $I_{sc}$  wave form--flexible conduit section wrapped with Conetics foil and braid sleeve, with bands on sleeve only, test sample 11 ( $i = 5 \text{ mA/div}$ ;  $t = 200 \text{ } \mu\text{sec/div}$ ).

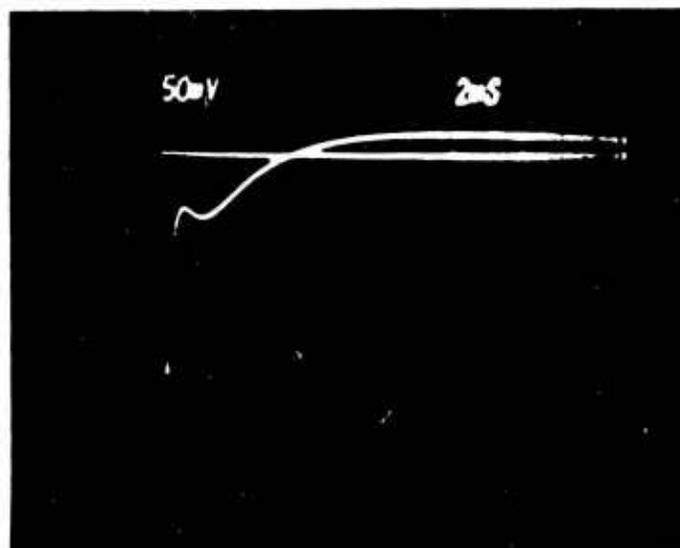
Figure 70.  $I_{sc}$  wave form--flexible conduit section wrapped with Conetics foil and braid sleeve, with bands on sleeve only, test sample 11 ( $i = 10 \text{ mA/div}$ ;  $t = 2 \text{ } \mu\text{sec/div}$ ).

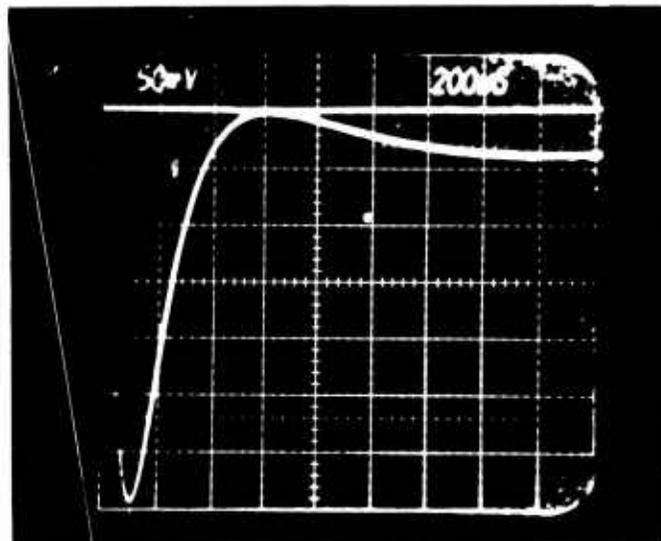
Figure 71. I<sub>sc</sub> wave form--flexible conduit section with Conetics foil and braid sleeve (bands on both), tinned copper braid strap in parallel, test sample 14 ( $i = 2 \text{ mA/div}$ ;  $t = 200 \text{ } \mu\text{sec/div}$ ).
