AFRPL-TR-75-5

PRELIMINARY FLIGHT RATING TESTS OF THE HAST PROPULSION SYSTEM

JANUARY 1975

FINAL REPORT FOR PERIOD JUNE 1972 TO DECEMBER 1973

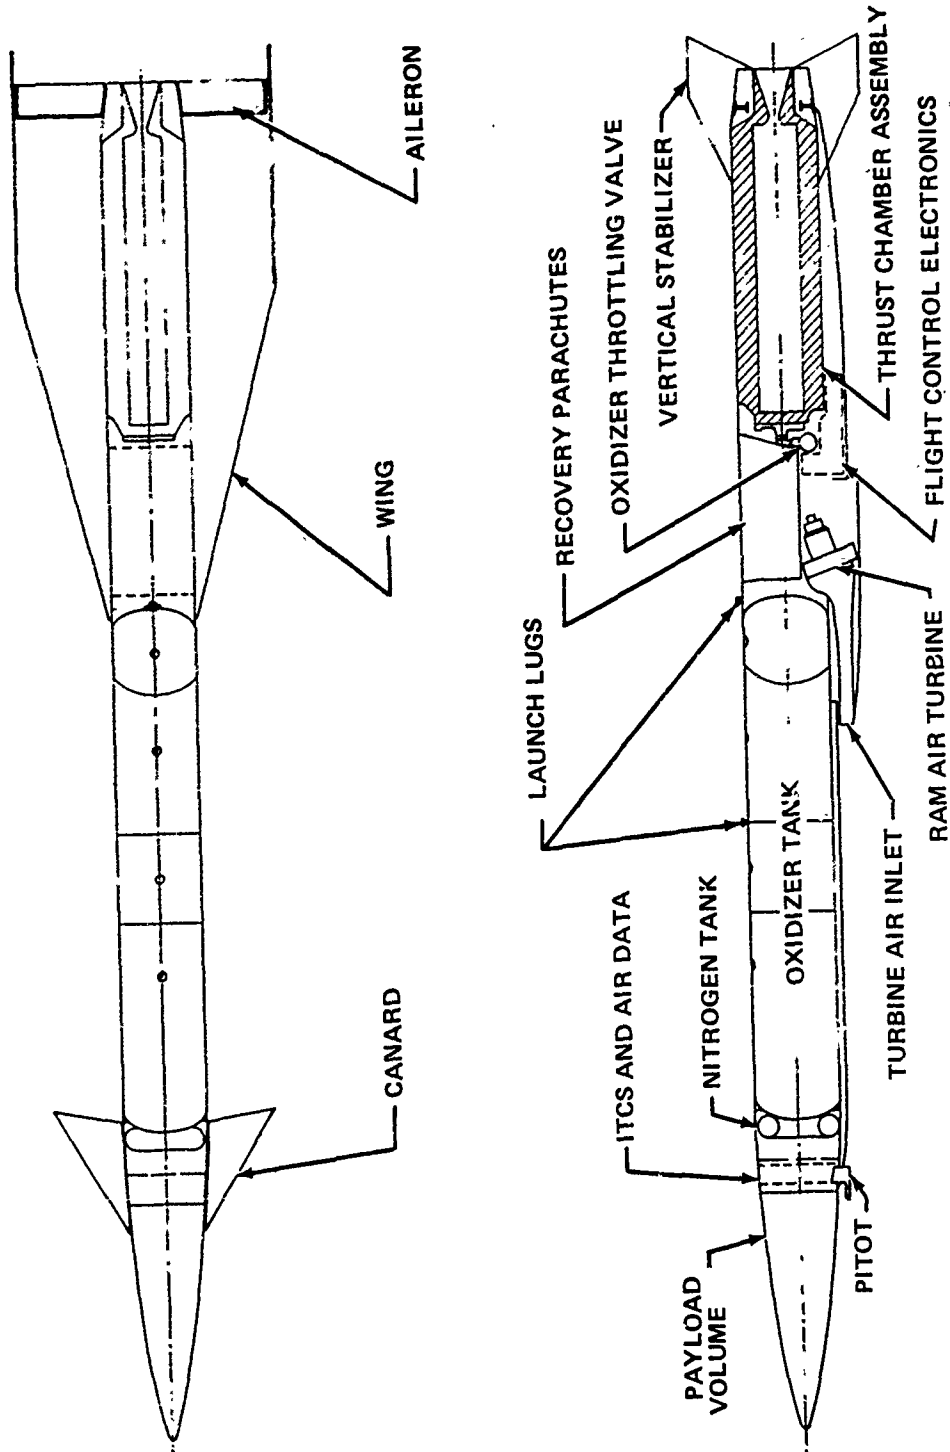
Figure 1. HAST Inboard Profile

The oxidizer tank is a rolled and welded structure of 17-7 PH stainless steel. The tank volume is 9,465 cubic inches, with a maximum IRFNA loading of 496 pounds. The tank is divided into four compartments so as to control the location of the vehicle center of gravity as oxidizer is consumed. The forward three compartments are connected by transfer ports at the bottom of the bulkheads. Provisions are made to retain propellant in the aft compartment during vehicle maneuvers and to insure propellant flow through the outlet port.

Propellant retention is accomplished by a surface tension screen in the forward bulkhead of the aft compartment. Sufficient pressure differential is available to allow propellant to flow into the aft compartment,

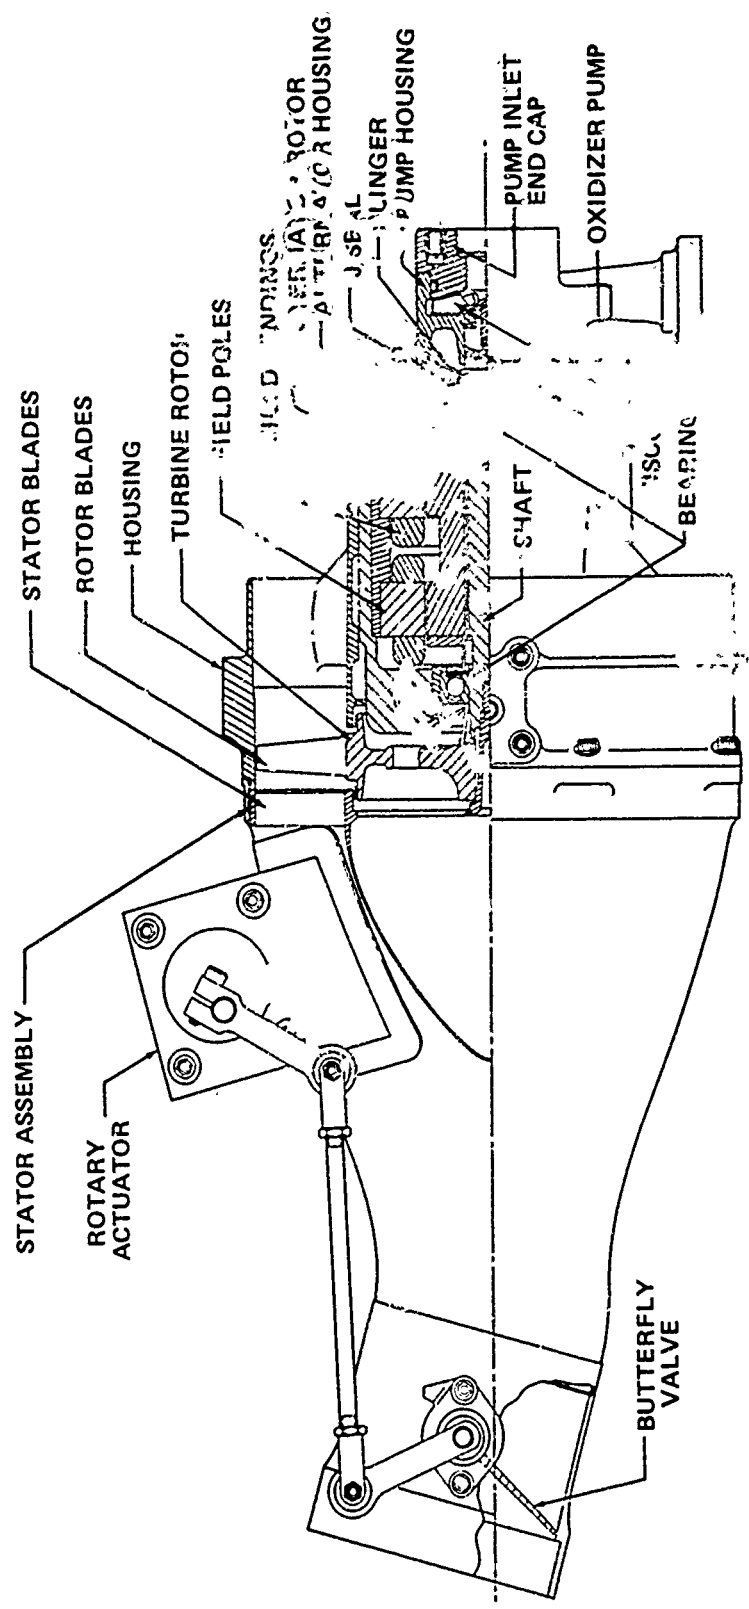
Figure 6. Ducted Power Unit

The functions of the Ducted Power Unit (DPU) are to pump the oxidizer to the pressure required by the thrust chamber and to provide electrical power for the vehicle. The unit contains a ram air turbine, an alternator, and a centrifugal oxidizer pump, all mounted in that order on a common shaft which rotates at a nominal speed of 32,000 rpm. The DPU is illustrated in Figures 6 and 7. The turbine is driven by air admitted through a normal shock inlet underneath the vehicle, with air flow throttled by a butterfly valve in the inlet duct. Position of this butterfly is controlled by an electronic speed control circuit and electric actuator. The oxidizer pump impeller is a radial vane type and is unshrouded. The pump produces a pressure rise of 685 psia at an IRFNA flowrate of 3.6 lb/sec at 70°F with a minimum suction pressure of 30 psia. The alternator was required to produce 47 amperes maximum at 28 volt DC.

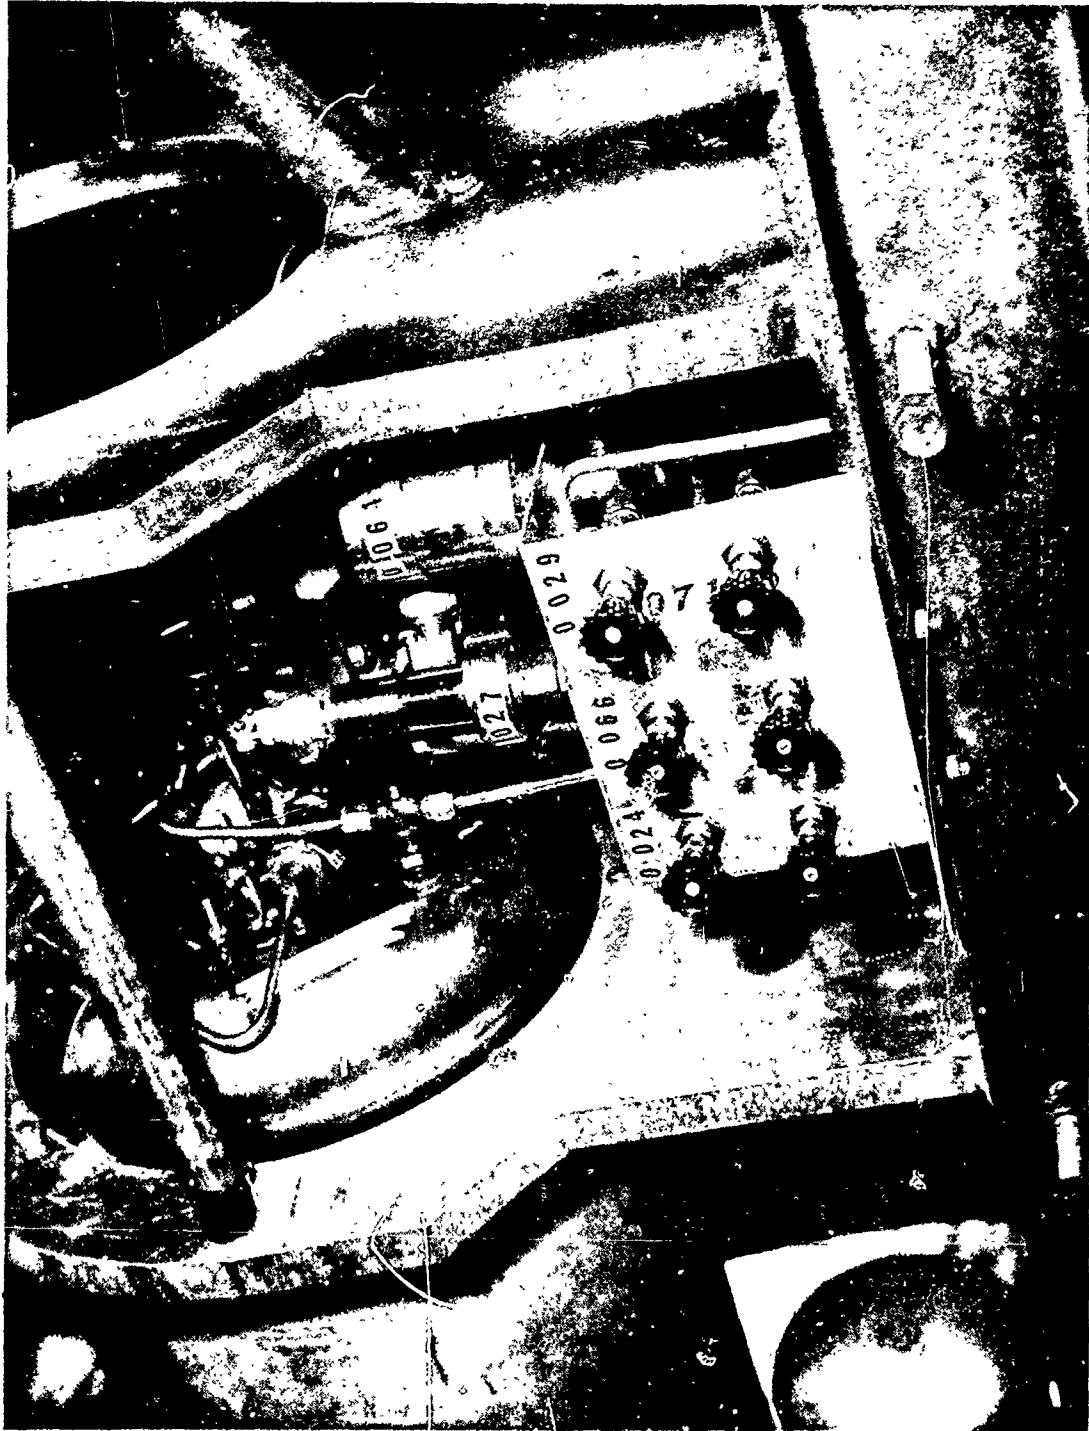
Figure 8. Test Installation of HAST Pressurization System

Gaseous nitrogen for pressurizing the oxidizer tank is stored in a toroidal tank made of 17-7 PH steel. The tank volume is 317 cu in, containing 3.3 lb of nitrogen at 3500 psia. Two stages of pressure regulation are used to reduce this pressure to the desired tank pressure of approximately 50 psia. The first stage is a spring reference, piston actuated, gage pressure regulator. The outlet pressure regulator band is specified to be 340 to 280 psig over a gas flow range of 1 to 10 SCFM. The second stage regulator is contained within the multifunction valve (MFV) and is supplied directly from the first stage regulator (see Figure 2). This regulator is the same type as the first stage. The required outlet pressure is 68 to 53 psig over a gas flow range of 1 to 8 SCFM. The nitrogen tank and regulators are shown in Figure 8.

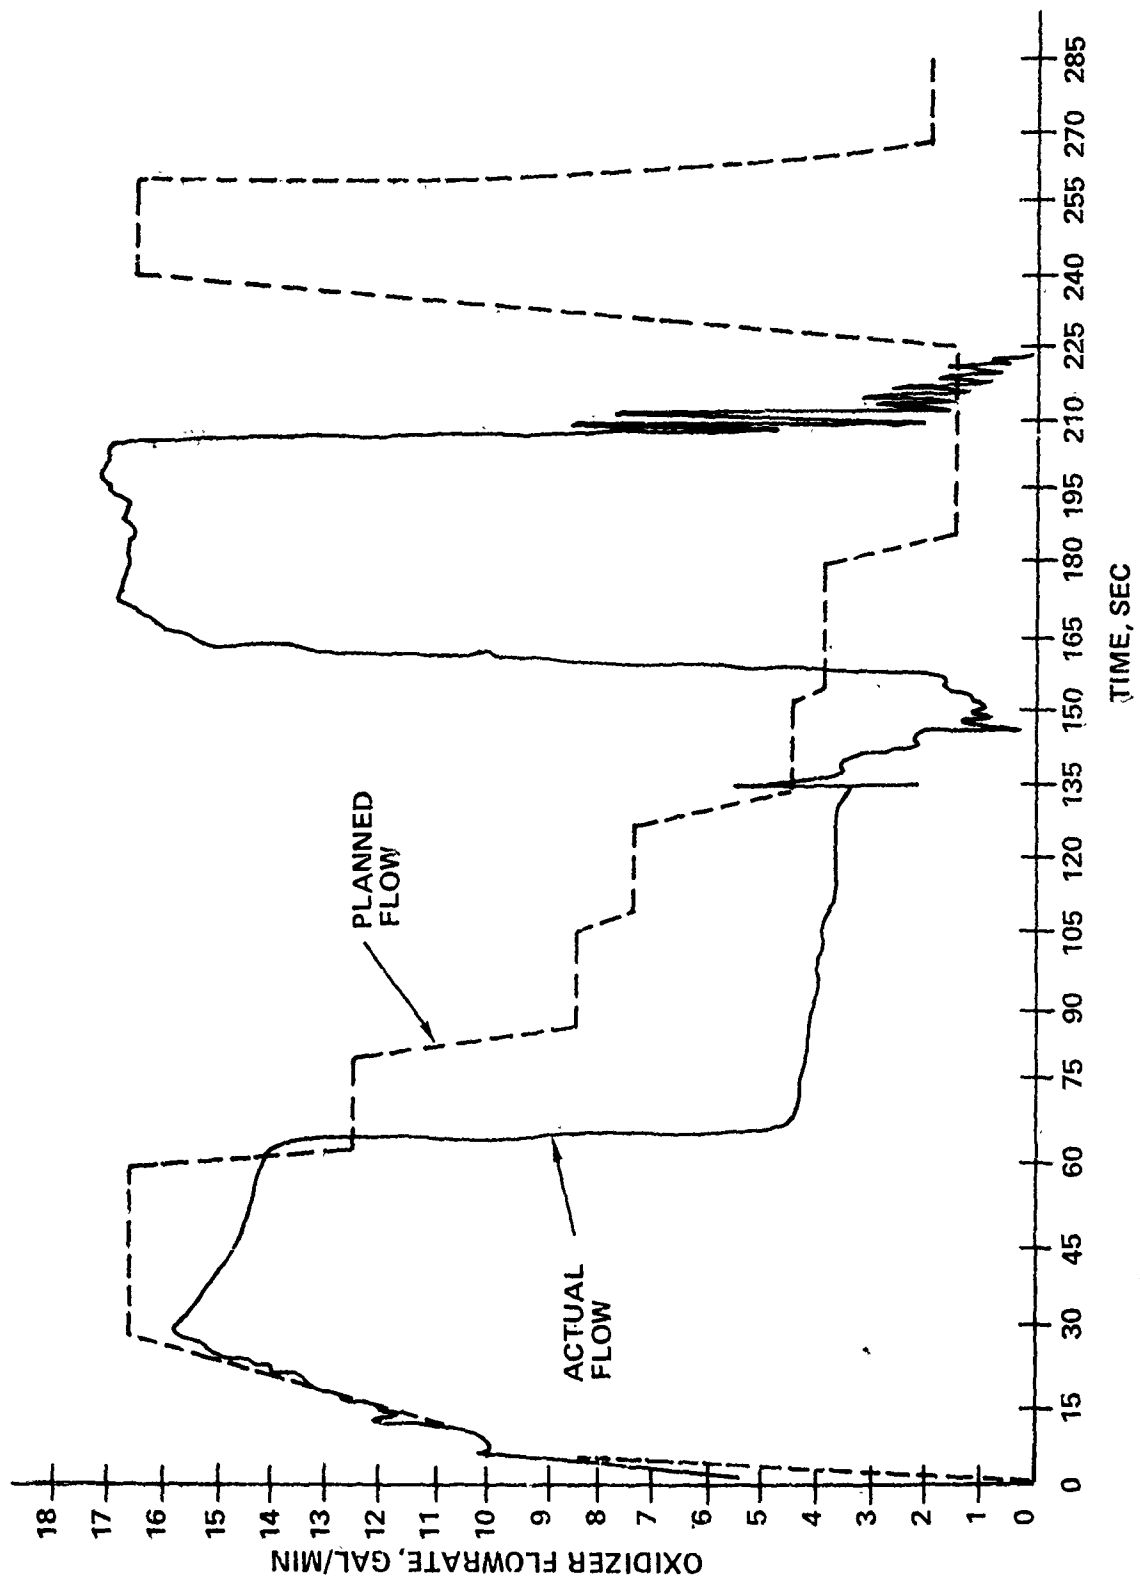
Figure 18. Planned and Actual Flow Profiles for OMA 1

Because of a tape drive malfunction, the digital data from this test could not be processed by the computer. The only data was that recorded on the strip charts and oscillograph. However, the pressure transducers at the pump suction and pump discharge were inadvertently isolated from the pressure source, and this critical data was not available in any form. This lack of data prevented a more thorough failure analysis for this test.

The postulated failure mode is considered likely because this had previously been considered a potential problem with the initial siphon design and a number of siphons had been modified to insure adequate clearance. However, this particular siphon had not been modified. The siphons used for the rest of the OMA tests and the first two PFRT tests were of the modified configuration and clearance between the inlet and tank bottom was verified before each test. No further siphon problems occurred on the OMA tests.

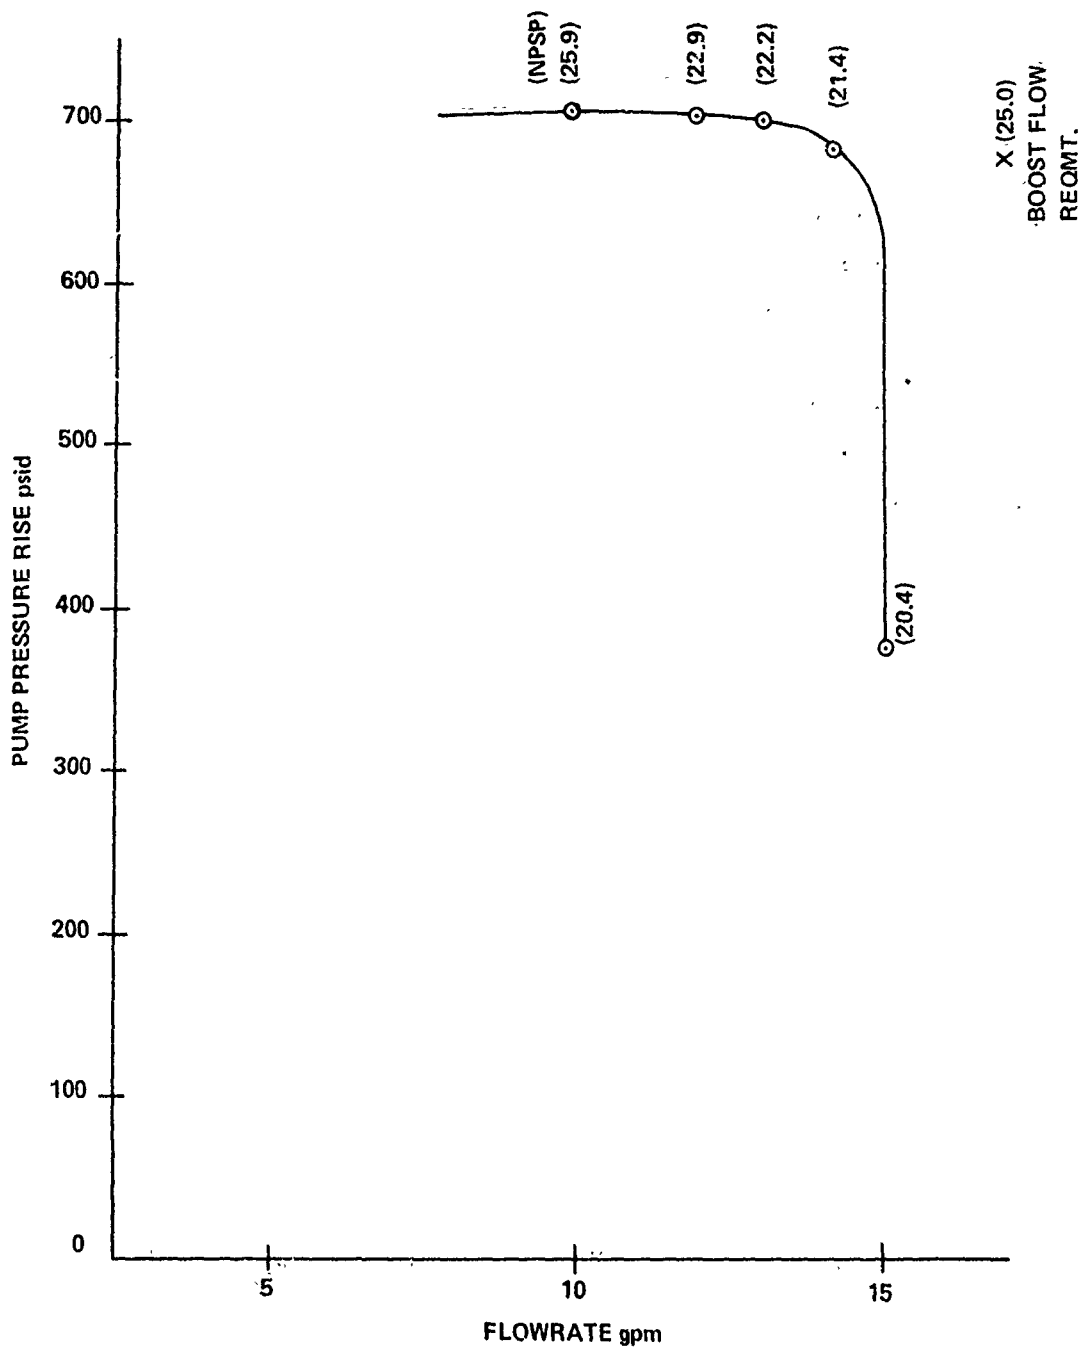
Figure 19. Pump Pressure Rise for OMA 2

Again, a malfunction of the data acquisition system prevented the recording of data essential to a failure analysis. The data in Figure 19 were taken from strip chart records of critical parameters. The available data was not adequate to determine if the low pump suction pressure was due to a malfunction of the pressure regulator in the MFV or a flow restriction in the system.

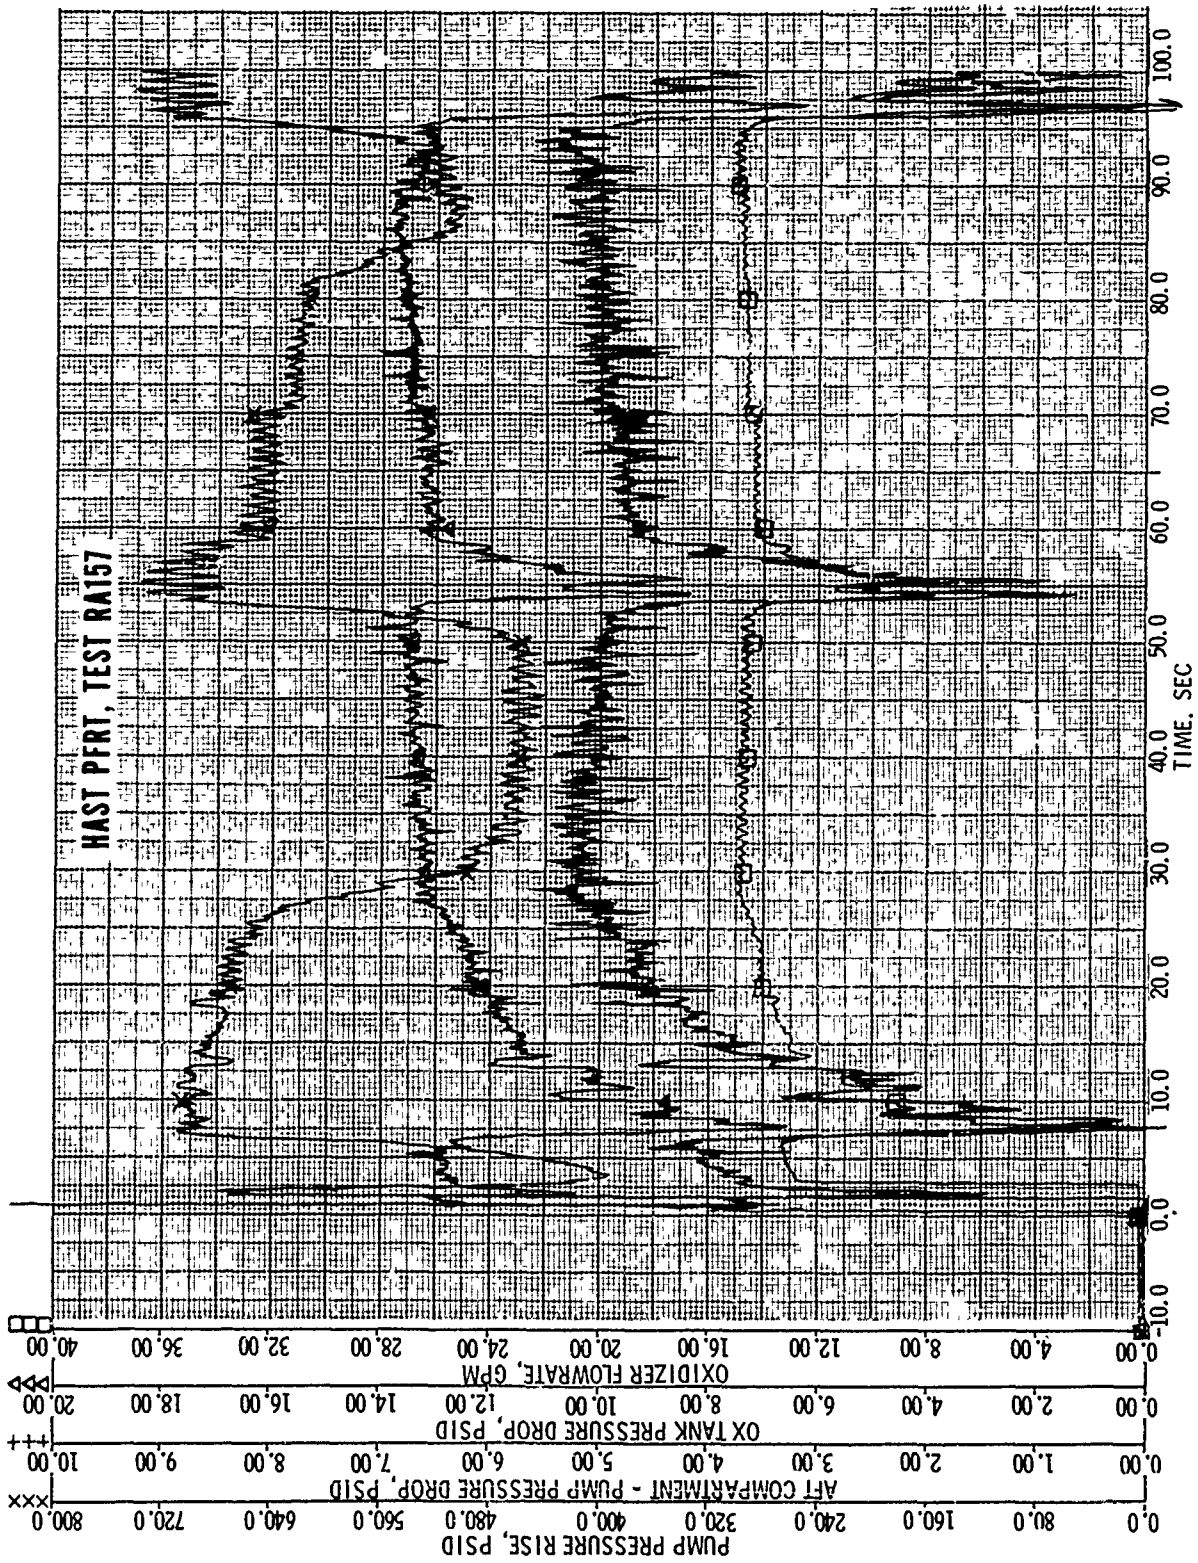
Figure 21. System Pressure Drops and Pump Performance for OMA 3

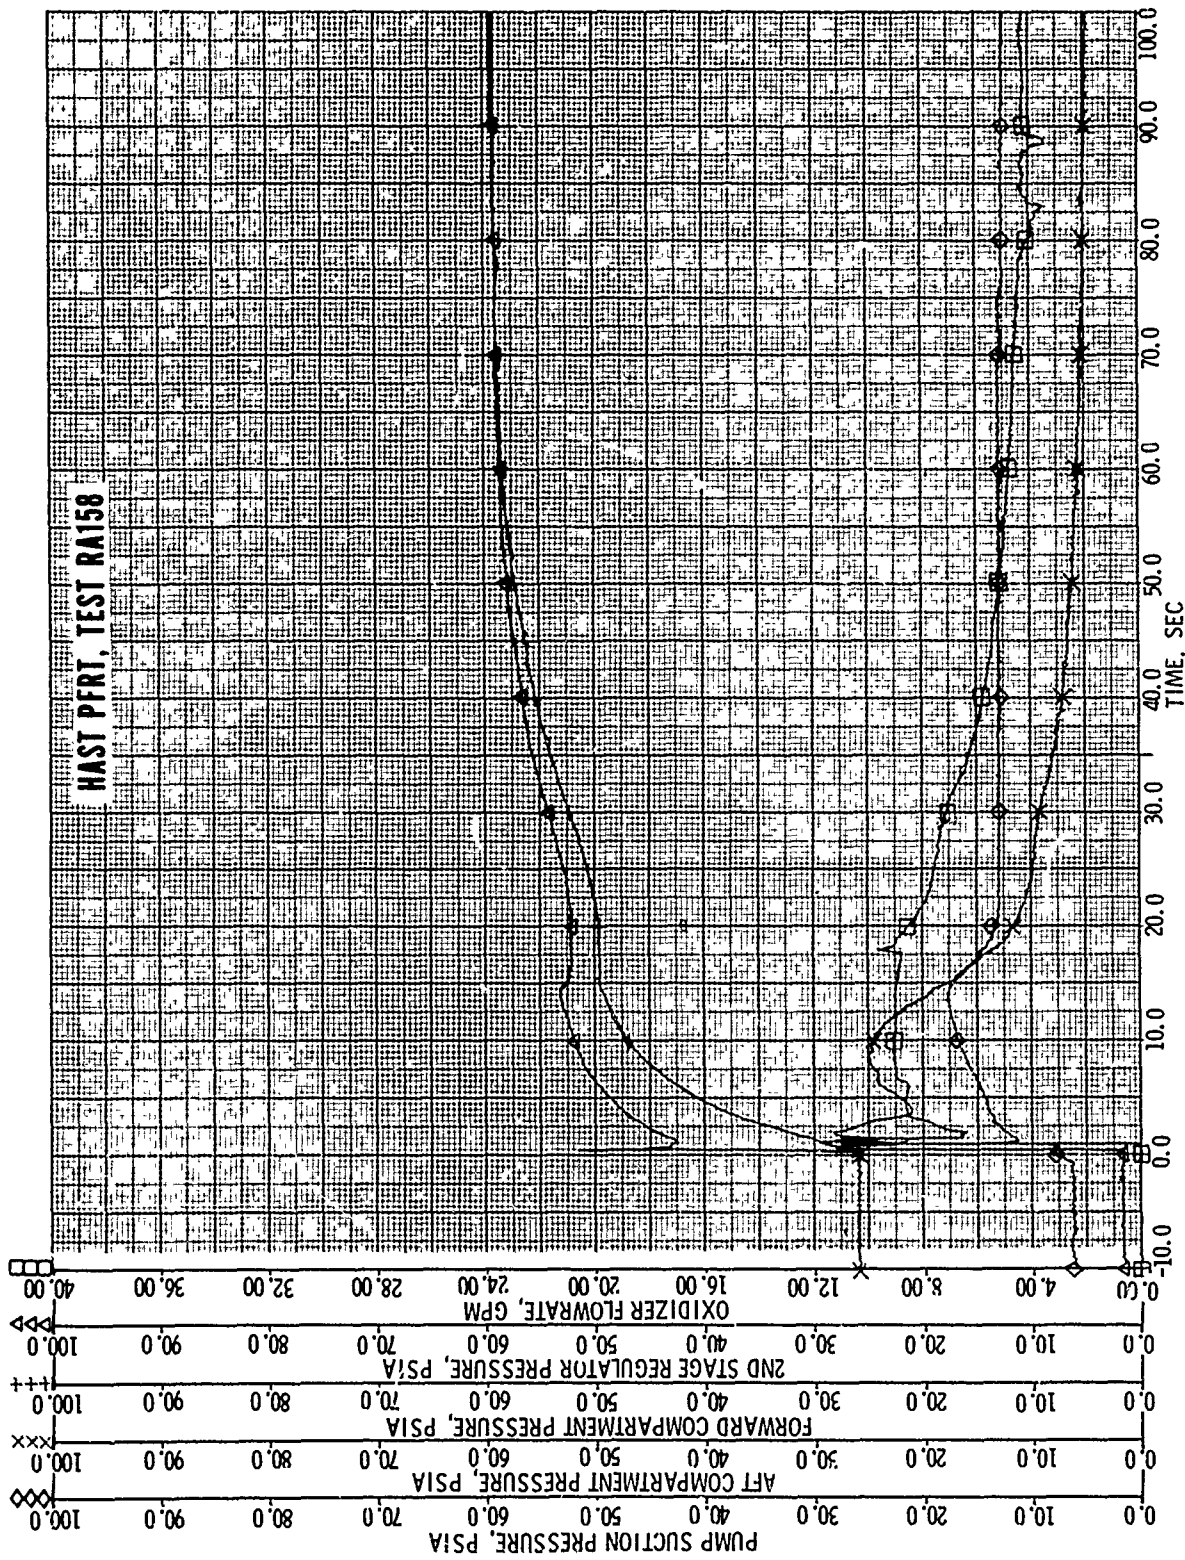
Figure 22. Pressure Parameters for OMA 4

The pertinent data from this test is provided in Figures 22 and 23. The start appeared normal, and as shown in Figure 22, the oxidizer flowrate immediately came up to 8.5 gpm. However as the throttle valve was opened further, the flowrate did not increase, even when the valve was full open. Just after 17 seconds, the flowrate began to decay and finally reached a value of 4.2 gpm. Also, as shown in Figure 23, at 17 seconds the pump pressure rise dropped rapidly, indicating severe pump cavitation. The pump suction pressure was low from the beginning of the test and at this point dropped below 15 psia. The cause of the low suction pressure is evident from examination of the tension screen pressure drop in Figure 23. During the initial 20 seconds when the maximum flow was being obtained, this pressure drop had increased to 38 psid. Even with the much lower flows during the rest of the test, this pressure drop continued to increase and had reached nearly 50 psid at 100 seconds.

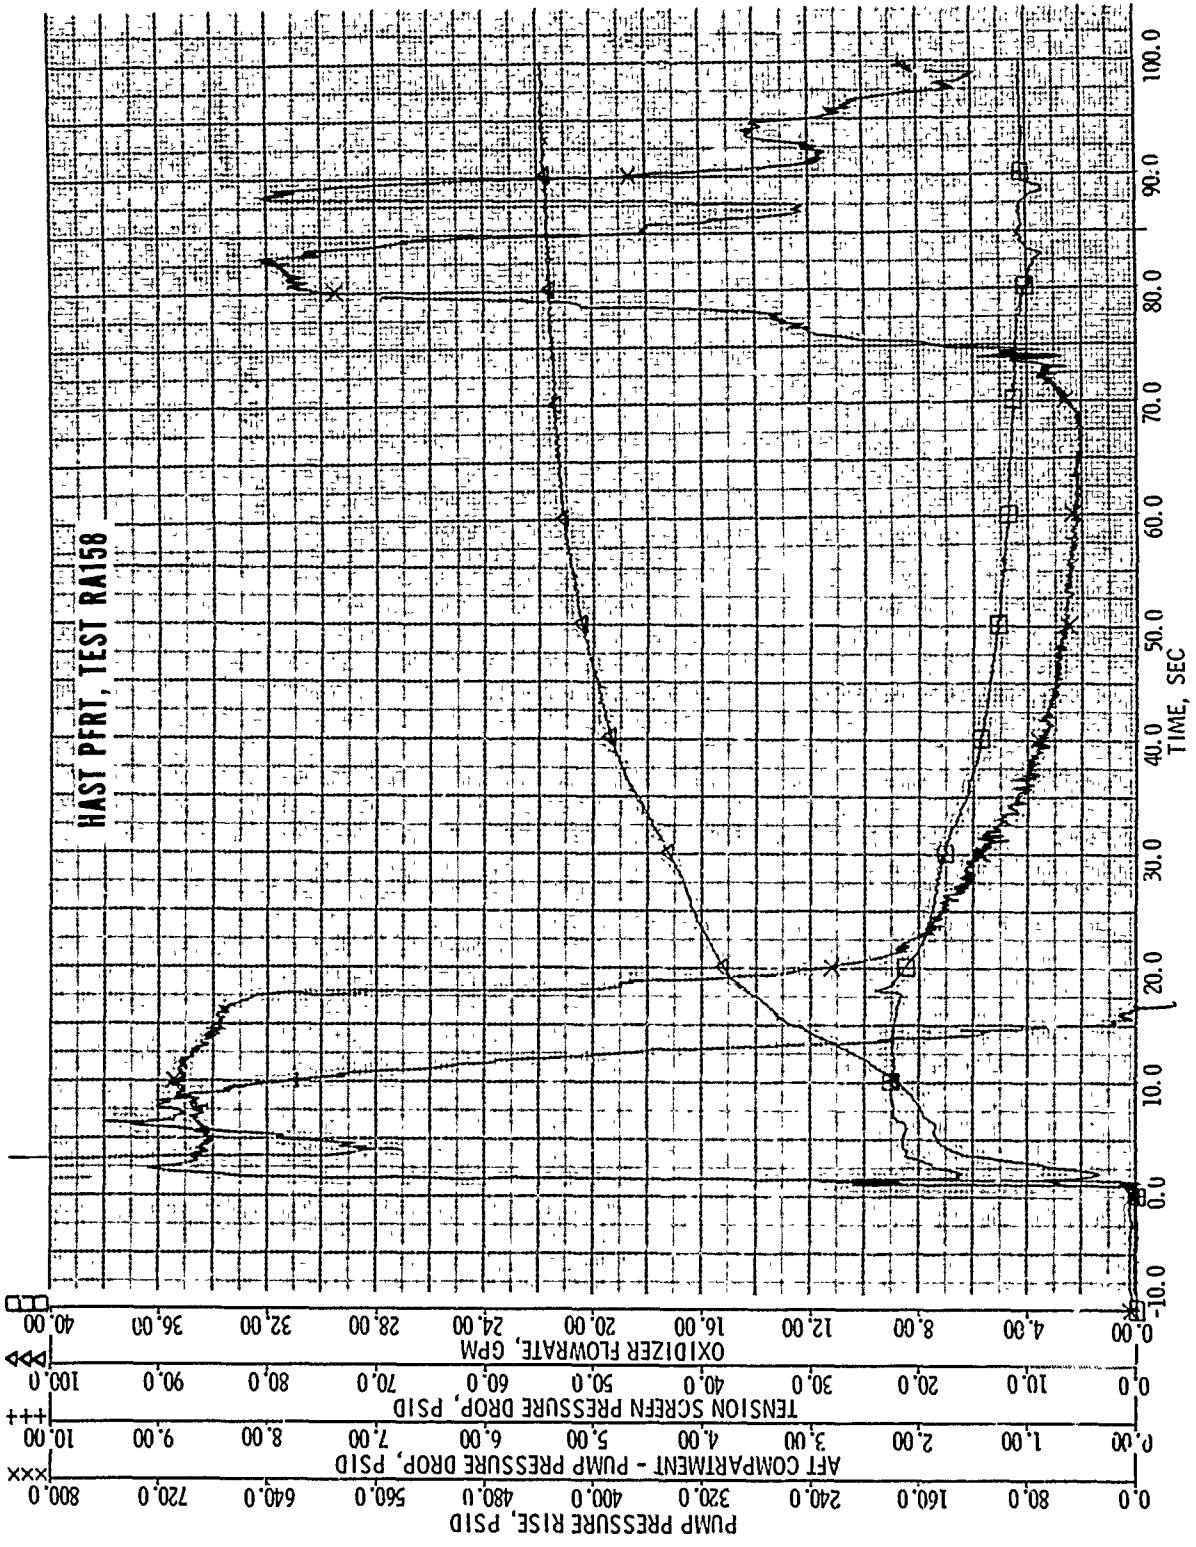
Figure 23. System Pressure Drops and Pump Performance for OMA 4

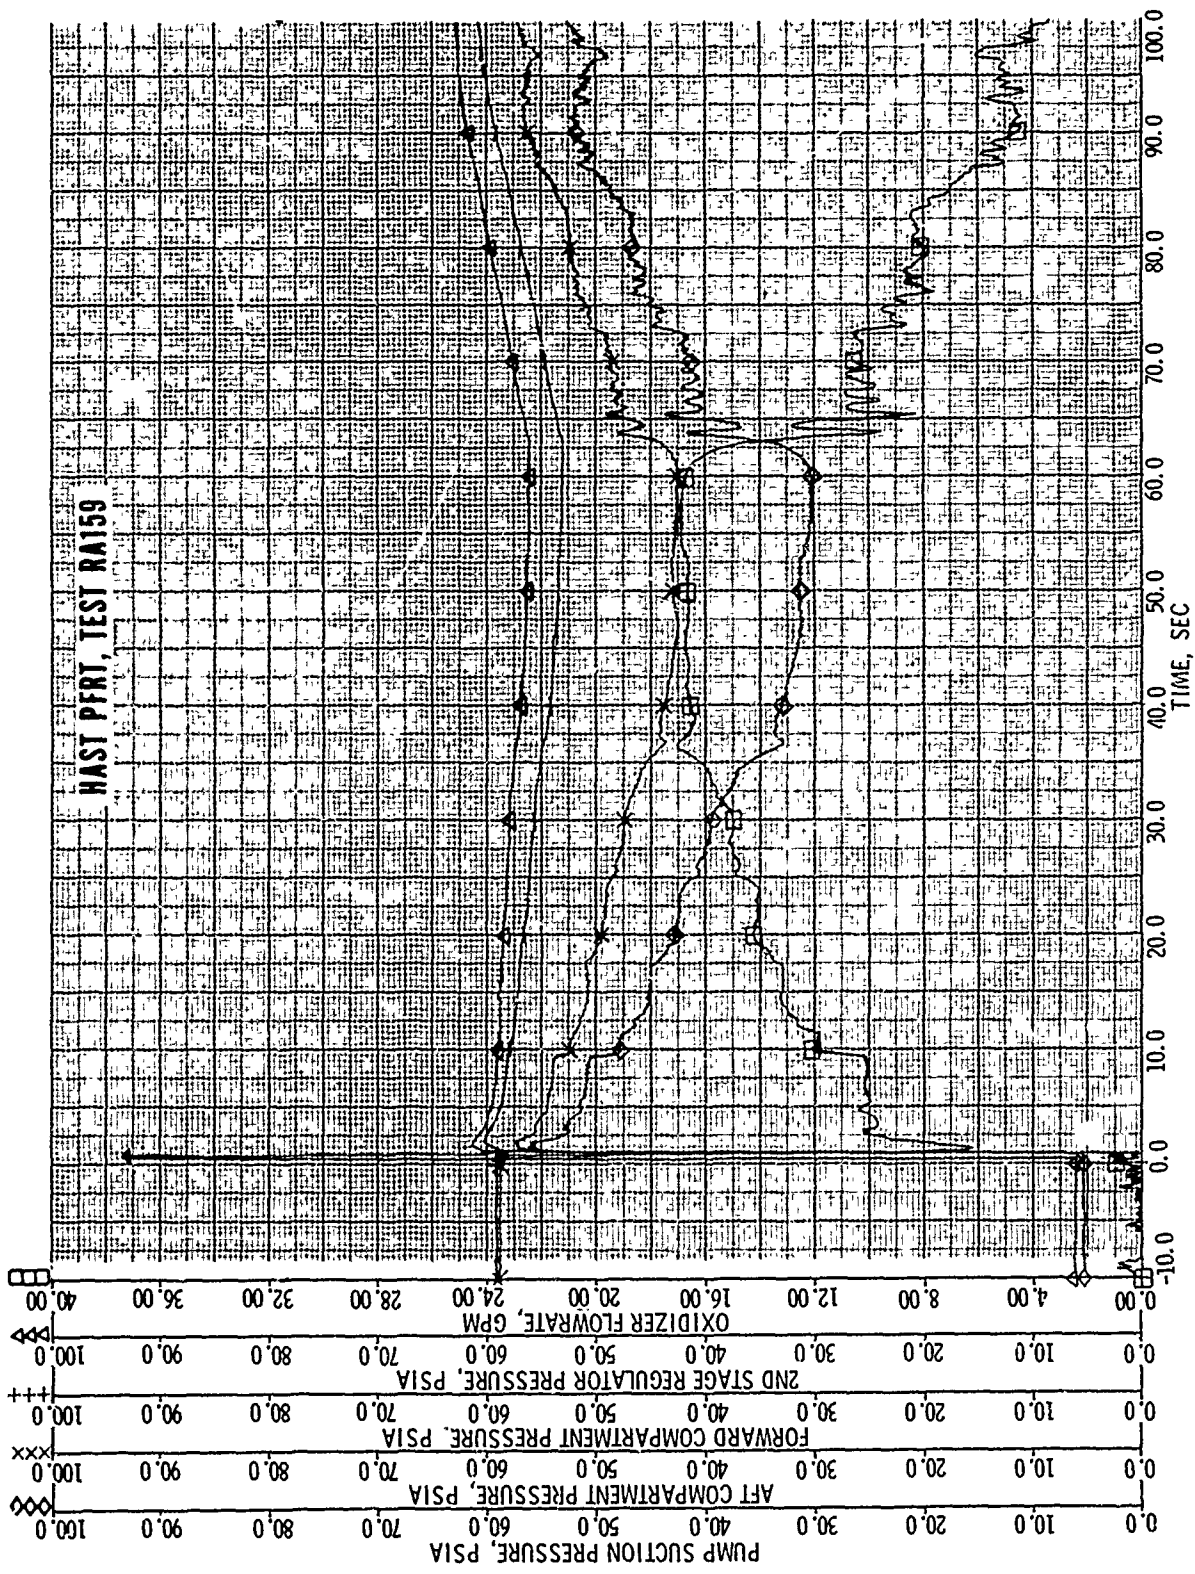
Figure 25. Pressure Parameters for OMA 5

The pressure from the second stage regulator was initially 60 psia, dropping to a minimum regulated pressure of about 56 psia at about 60 seconds into the run. This characteristic is normal for the second stage regulator. The first stage regulator, not shown on the pressure plots, regulated low, ranging between 231 and 245 psig. The minimum specified regulation pressure is 275 psig and bench tests of the regulator consistently ran above 300 psig. Since the second stage pressure regulation was normal this low first stage pressure did not influence the test.

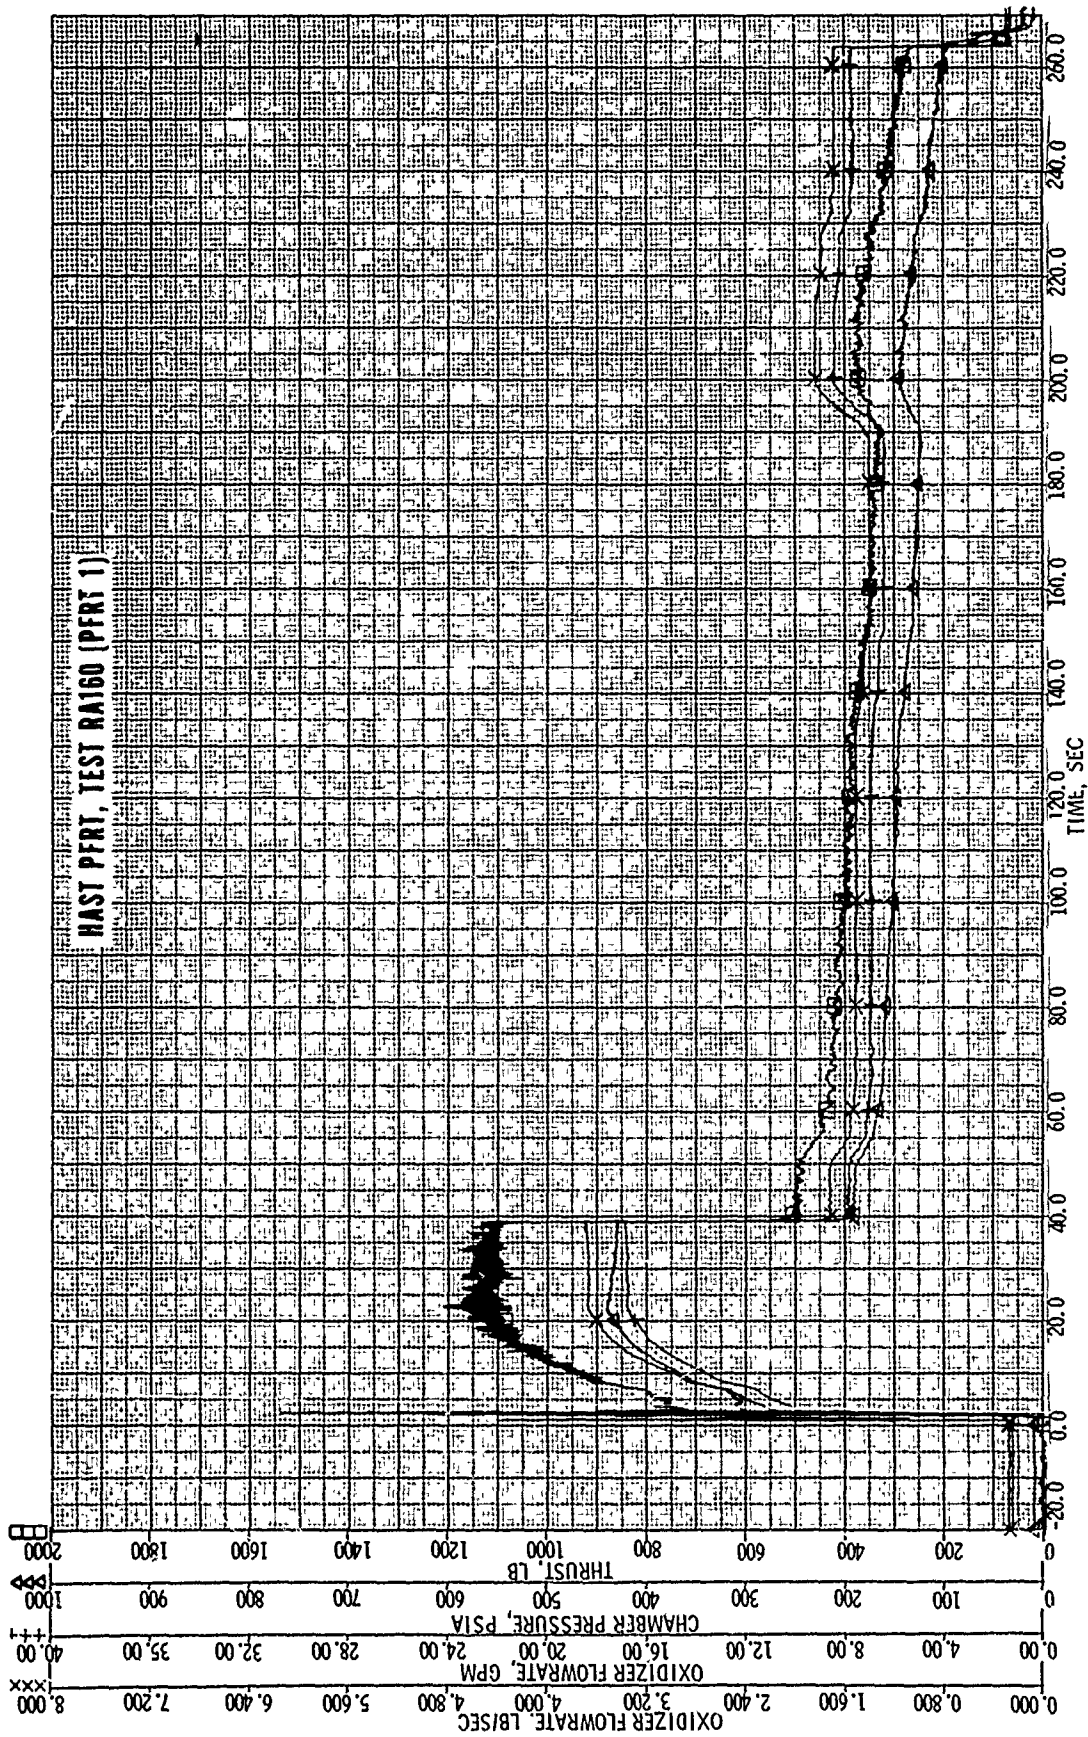
Figure 27. Thrust Chamber Parameters for PFRT 1

The error in controlled thrust was reflected in a lower oxidizer flowrate than would otherwise have been required. This in turn reduced the operating O/F ratio of the hybrid motor and reduced the specific impulse. The net result was that the measured total impulse and burn time for this simulated mission was not necessarily representative of an actual flight. The degree of error can be inferred when data analysis is completed by UTC and total impulse is calculated from measured chamber pressure.

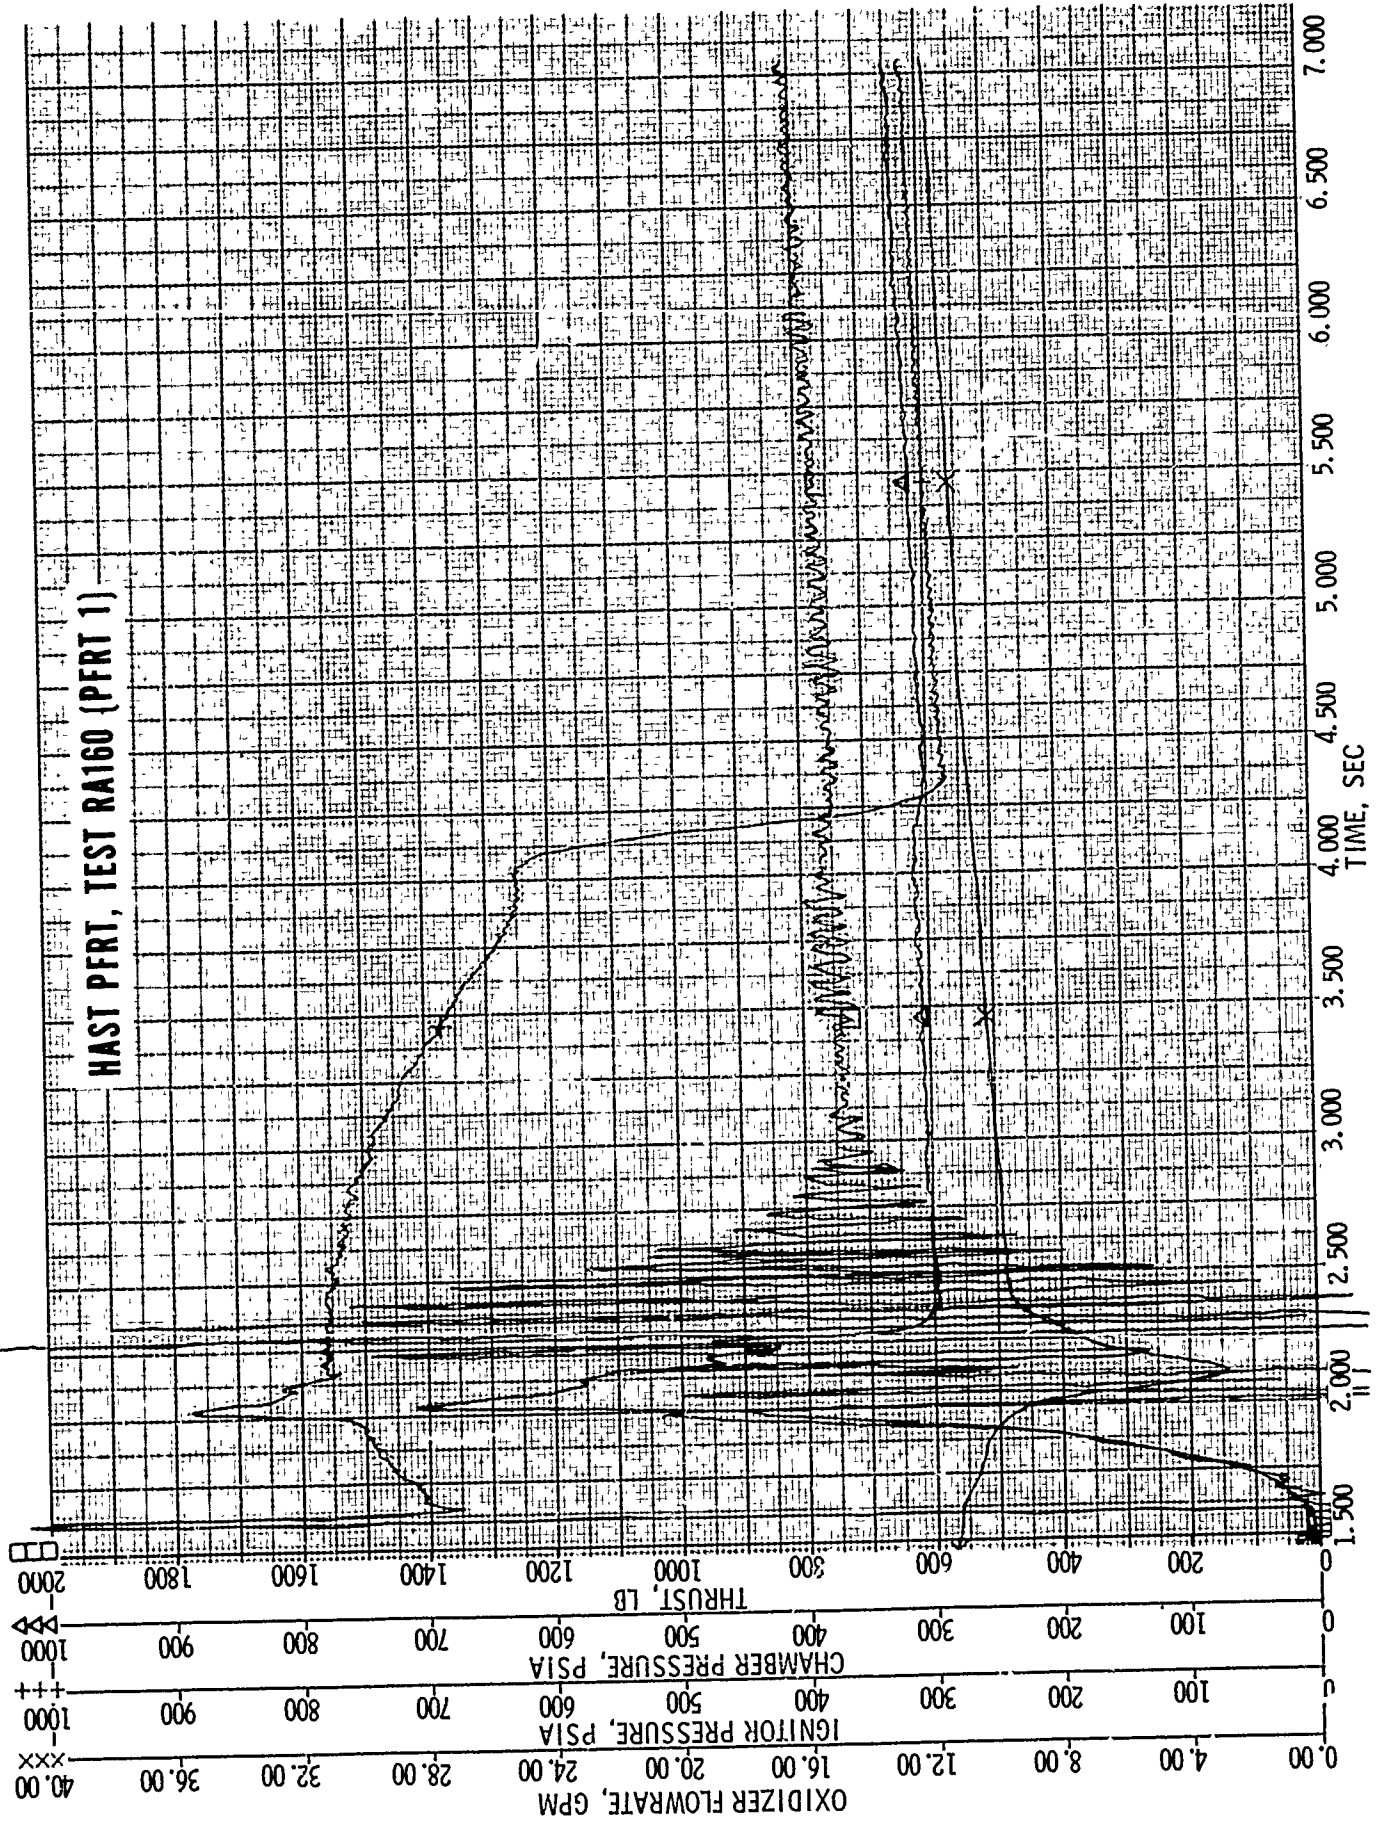
Figure 33. Ignition Transient for PFRT 1

The DLS did not properly sequence the propulsion system starting operations. In the normal sequence, the nitrogen start command occurs at +0.5 sec (time referenced to launch command at 0.0 sec), the oxidizer start command is at +0.9 sec, the igniter is fired at +1.7 sec, and the OTV is opened at +2.2 sec. On this test, the first three commands occurred at the correct time, but the OTV was opened at the same time as the oxidizer start valve. The presence of oxidizer in the thrust chamber when the igniter fired resulted in a hard start, with a spike in chamber pressure to over 700 psia. The start transient is shown in Figure 33. No damage to the thrust chamber resulted from this overpressure, and the rest of the test proceeded normally.

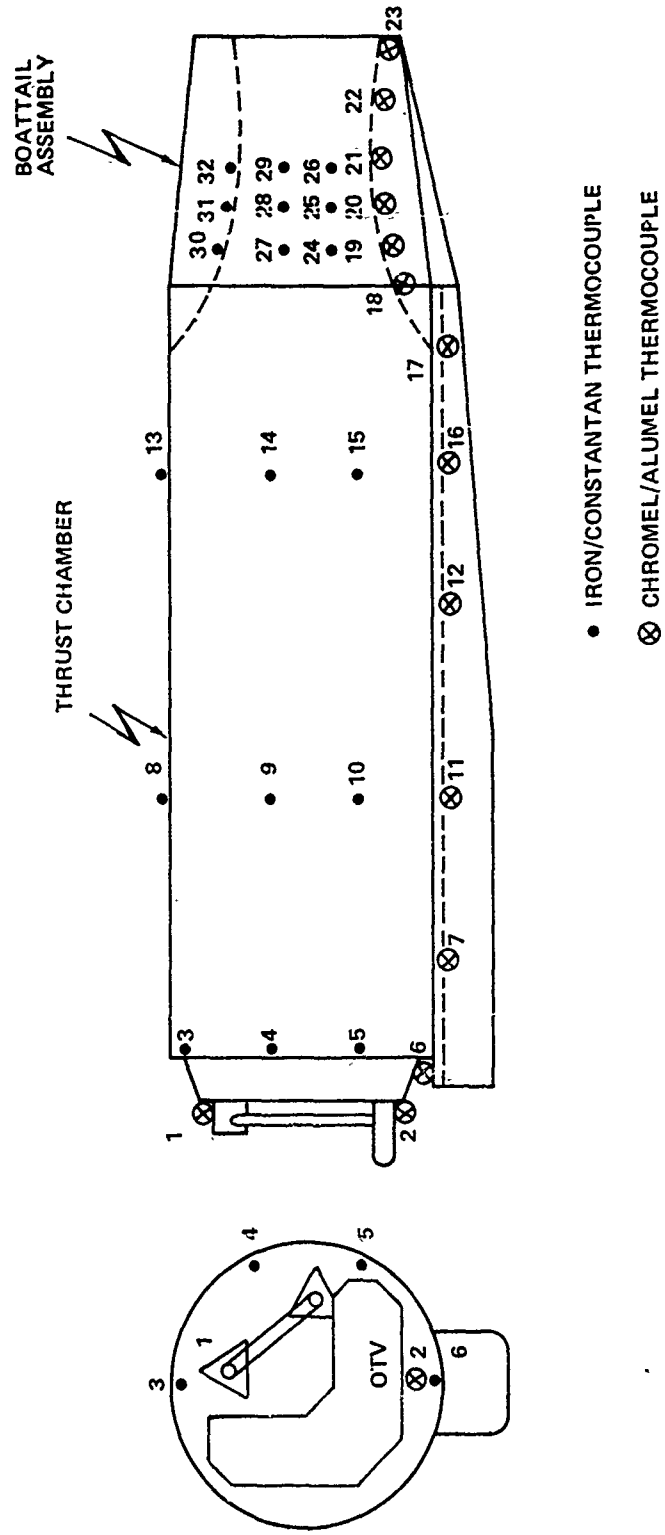
Figure 35. Thermocouple Locations on CTA for PFRT 2 and 3

In addition to being a test of the propulsion system at the design baseline mission, another objective of this test was to measure temperatures at various locations on the CTA during operation and during heat soak after shutdown. The missile boattail assembly was installed around the CTA nozzle, as shown in Figure 34. This assembly contains the aileron actuator motor and drive mechanism, the recovery system battery, and the destruct mechanism. An aluminum foil/asbestos insulation around the nozzle housing protects these components from thermal radiation. Temperatures were measured on the outside of this insulation to permit calculation of the radiation heating of adjacent components. Thermocouples were attached to the insulation by epoxy cements, at the locations shown in Figure 35. Temperature sensors, which indicated the maximum temperature by color change of temperature sensitive material, were placed on the components themselves.

Since the CTA temperature measurements made during PFRT 2 were not representative of an actual mission, thermocouples and temperature indicators were installed in the same locations for this test, and the boattail assembly was installed. Maximum temperature on the CTA case was 1063°F, reached during the heat soak 120 secs after shutdown. The temperature indicators showed that the recovery battery had exceeded 200°F, and the aileron actuator had reached temperatures between 340°F and 390°F.
