AFRPL-TR-75-5

PRELIMINARY FLIGHT RATING TESTS OF THE HAST PROPULSION SYSTEM

JANUARY 1975

FINAL REPORT FOR PERIOD JUNE 1972 TO DECEMBER 1973

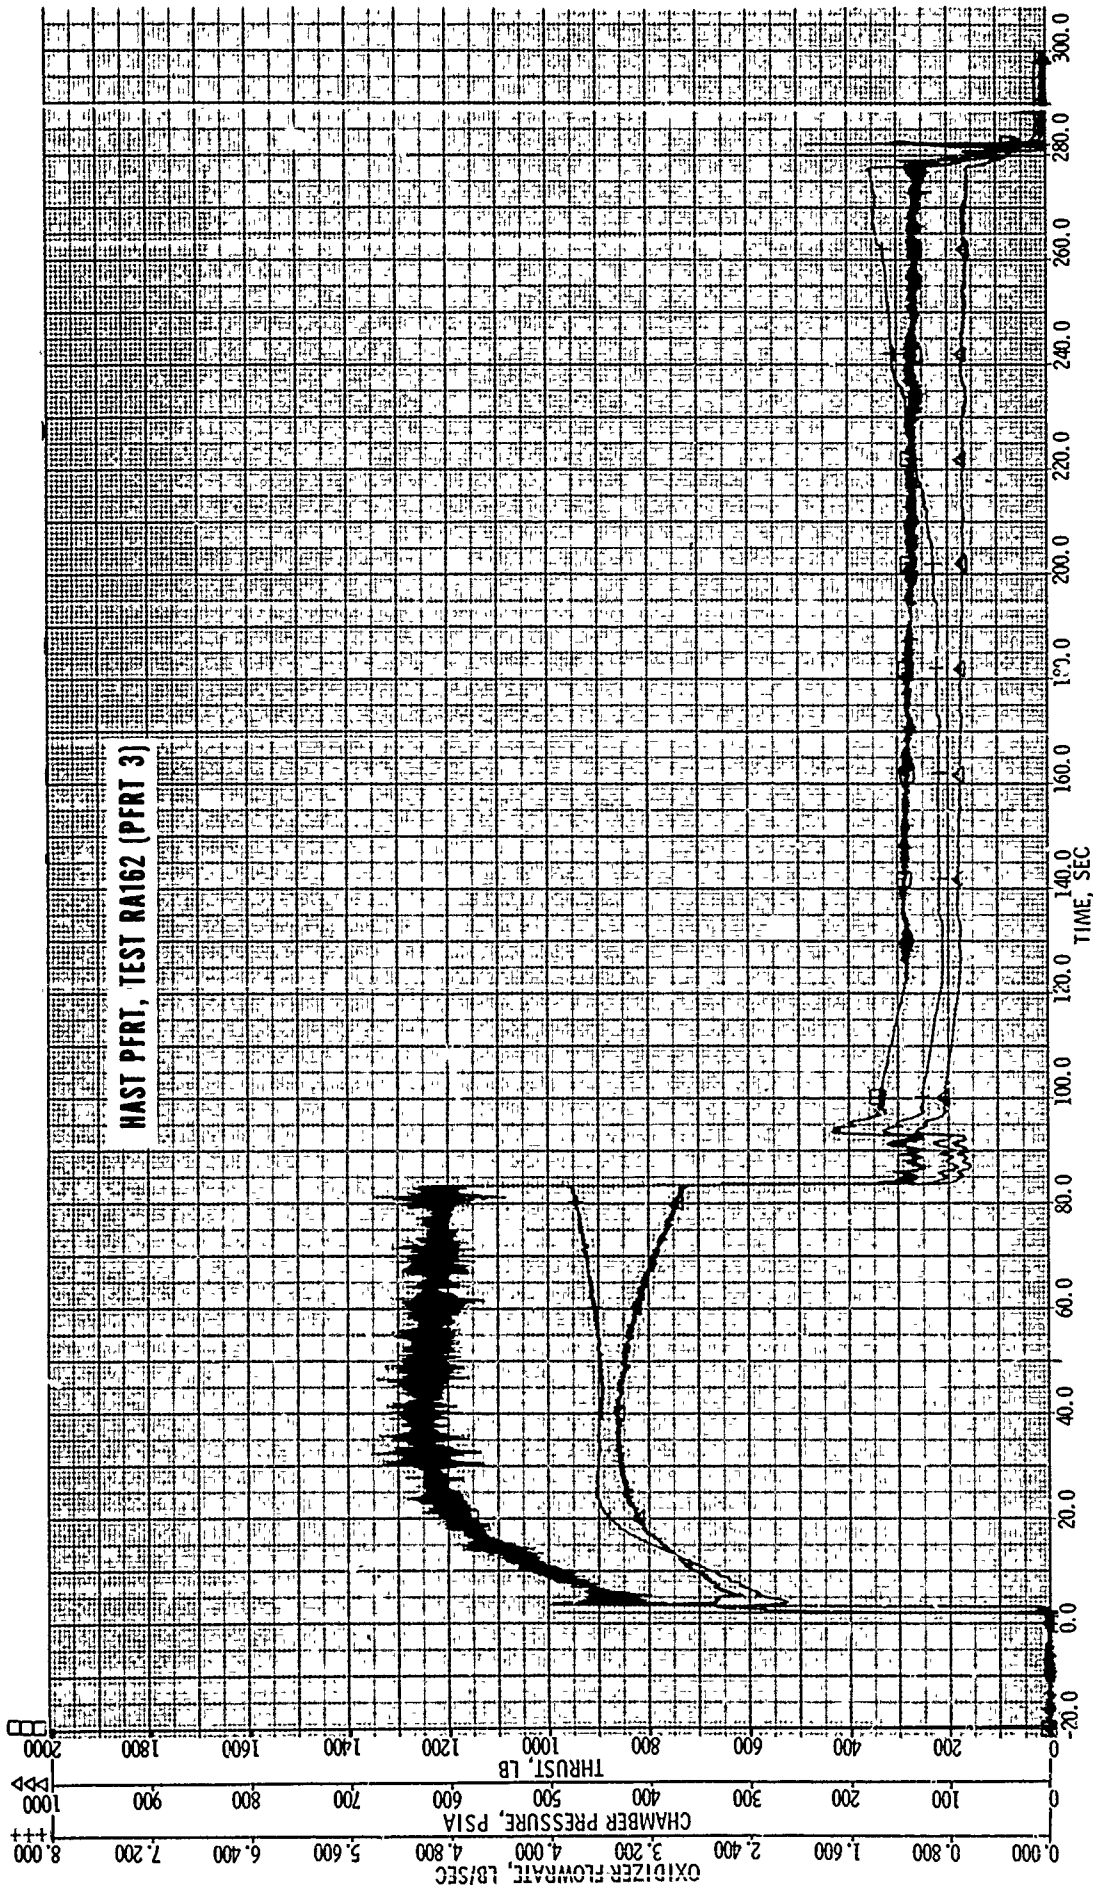
Figure 42. Thrust Chamber Parameters for PFRT 3

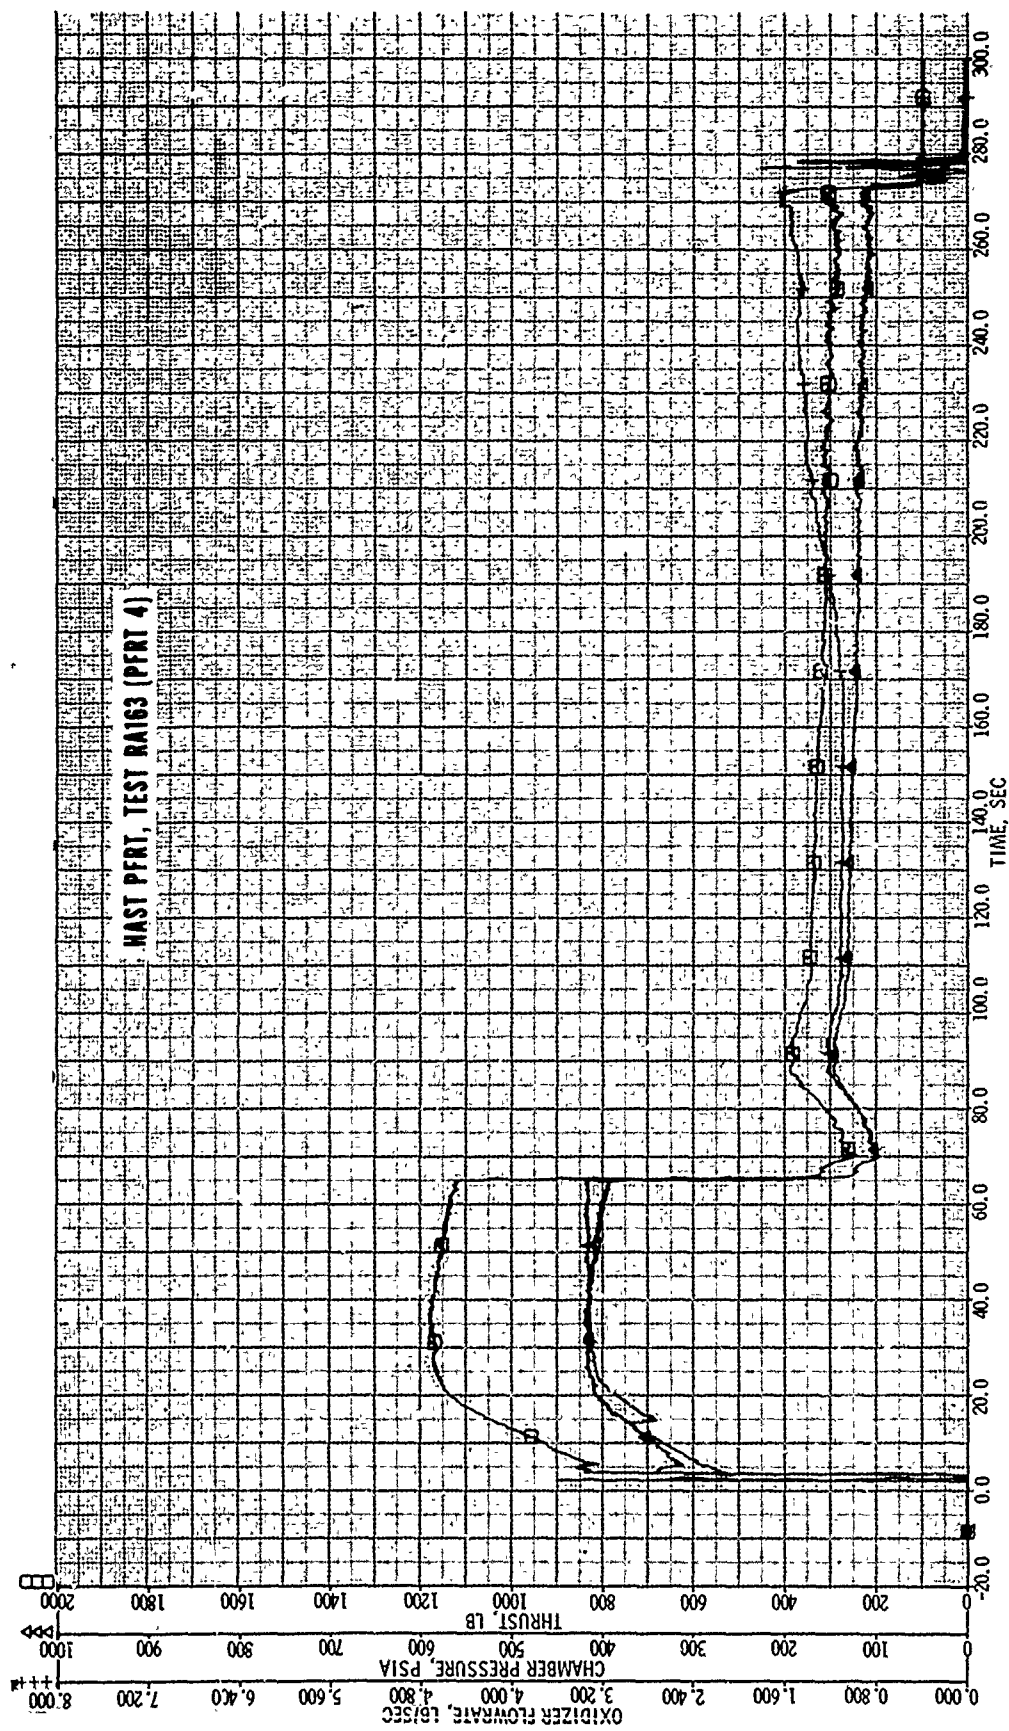
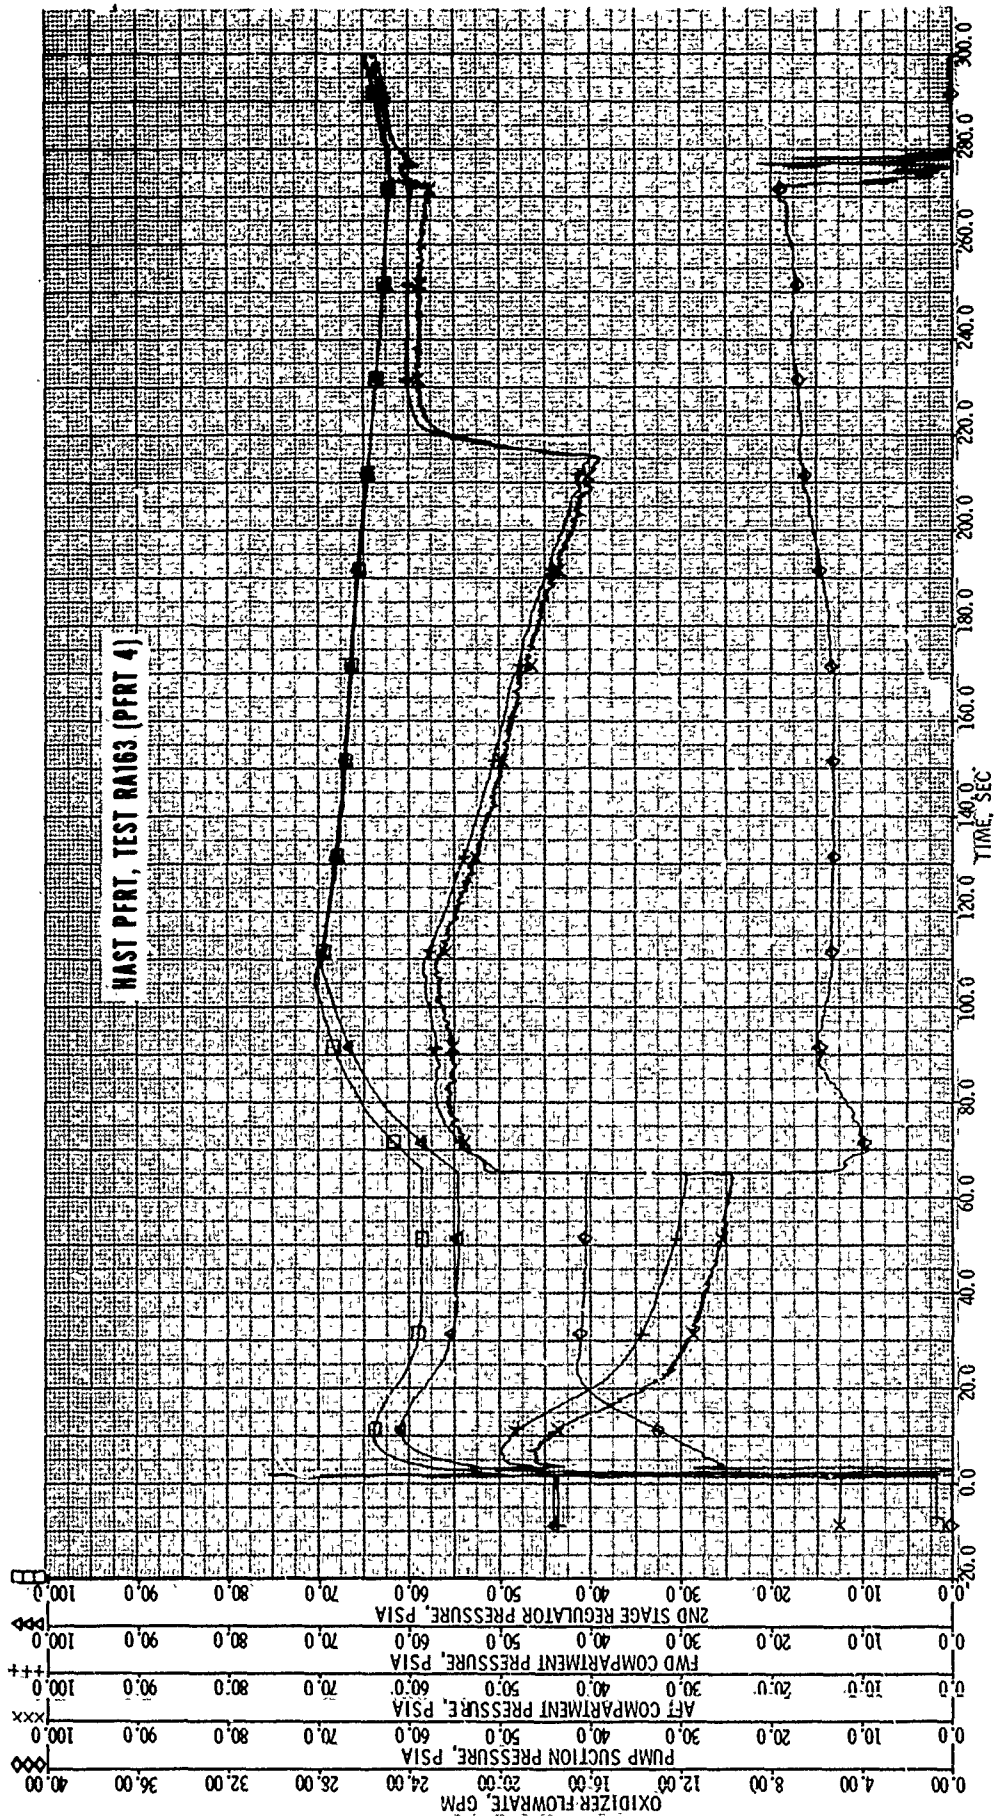
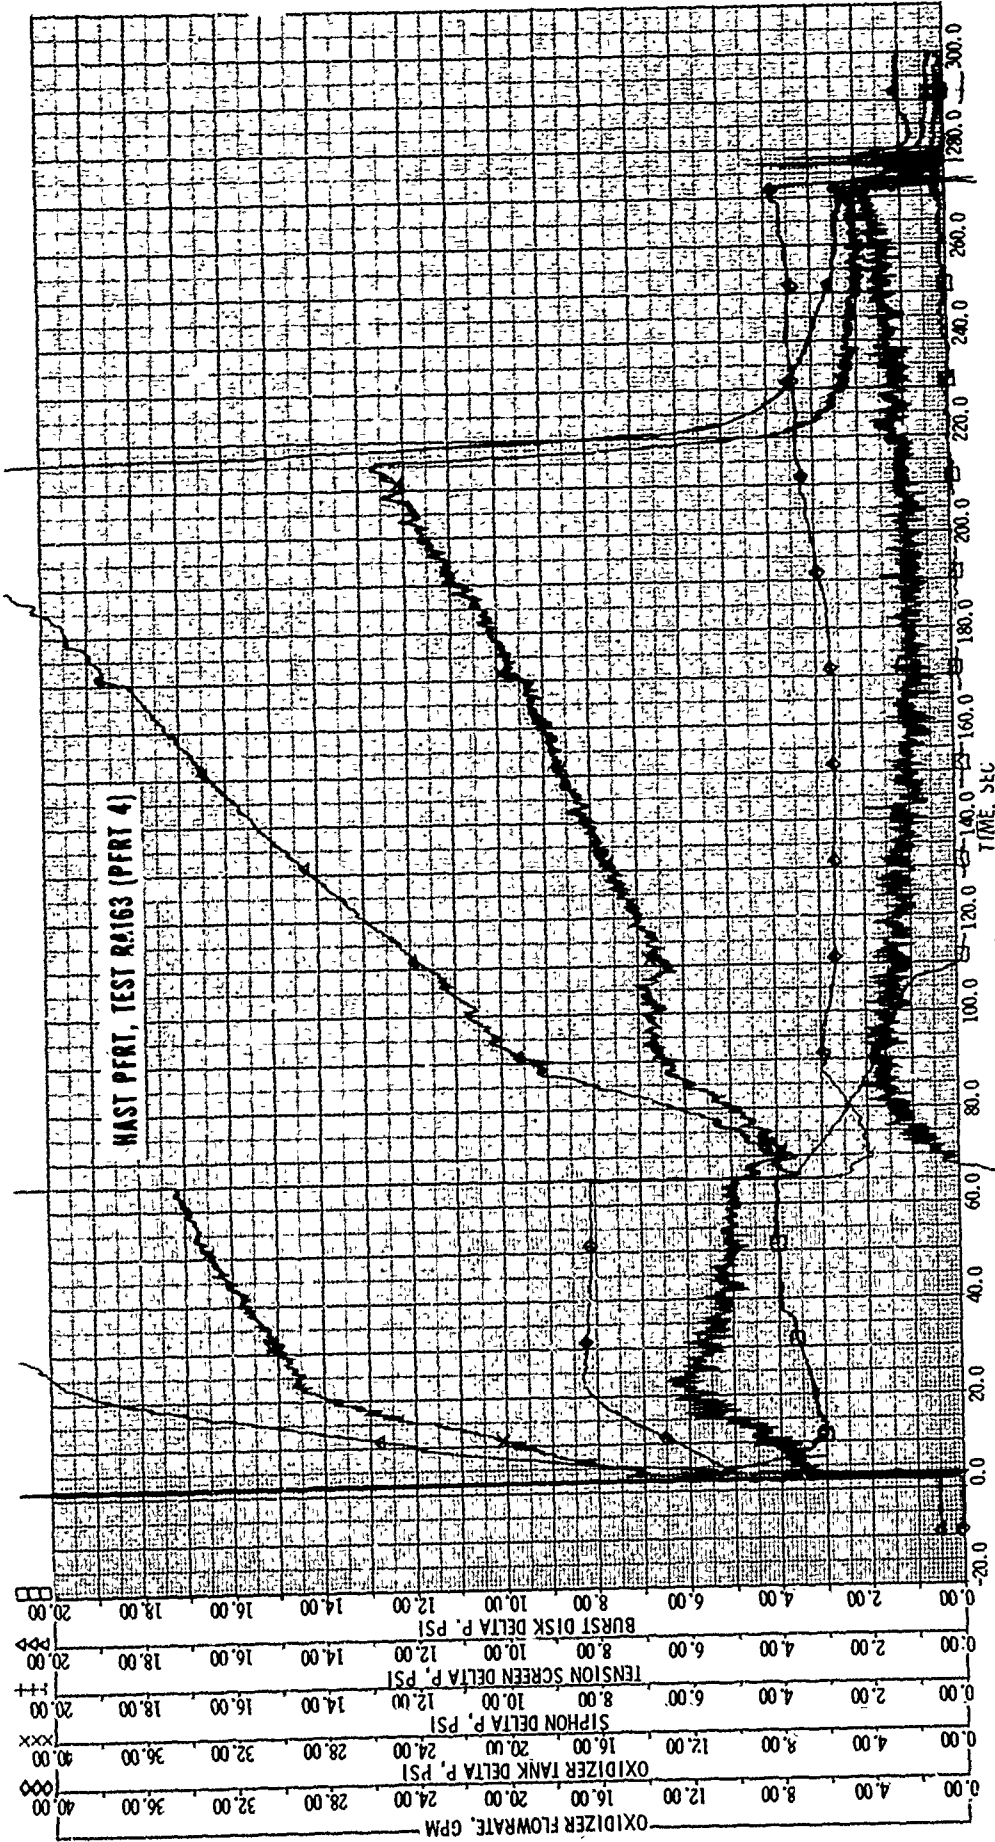
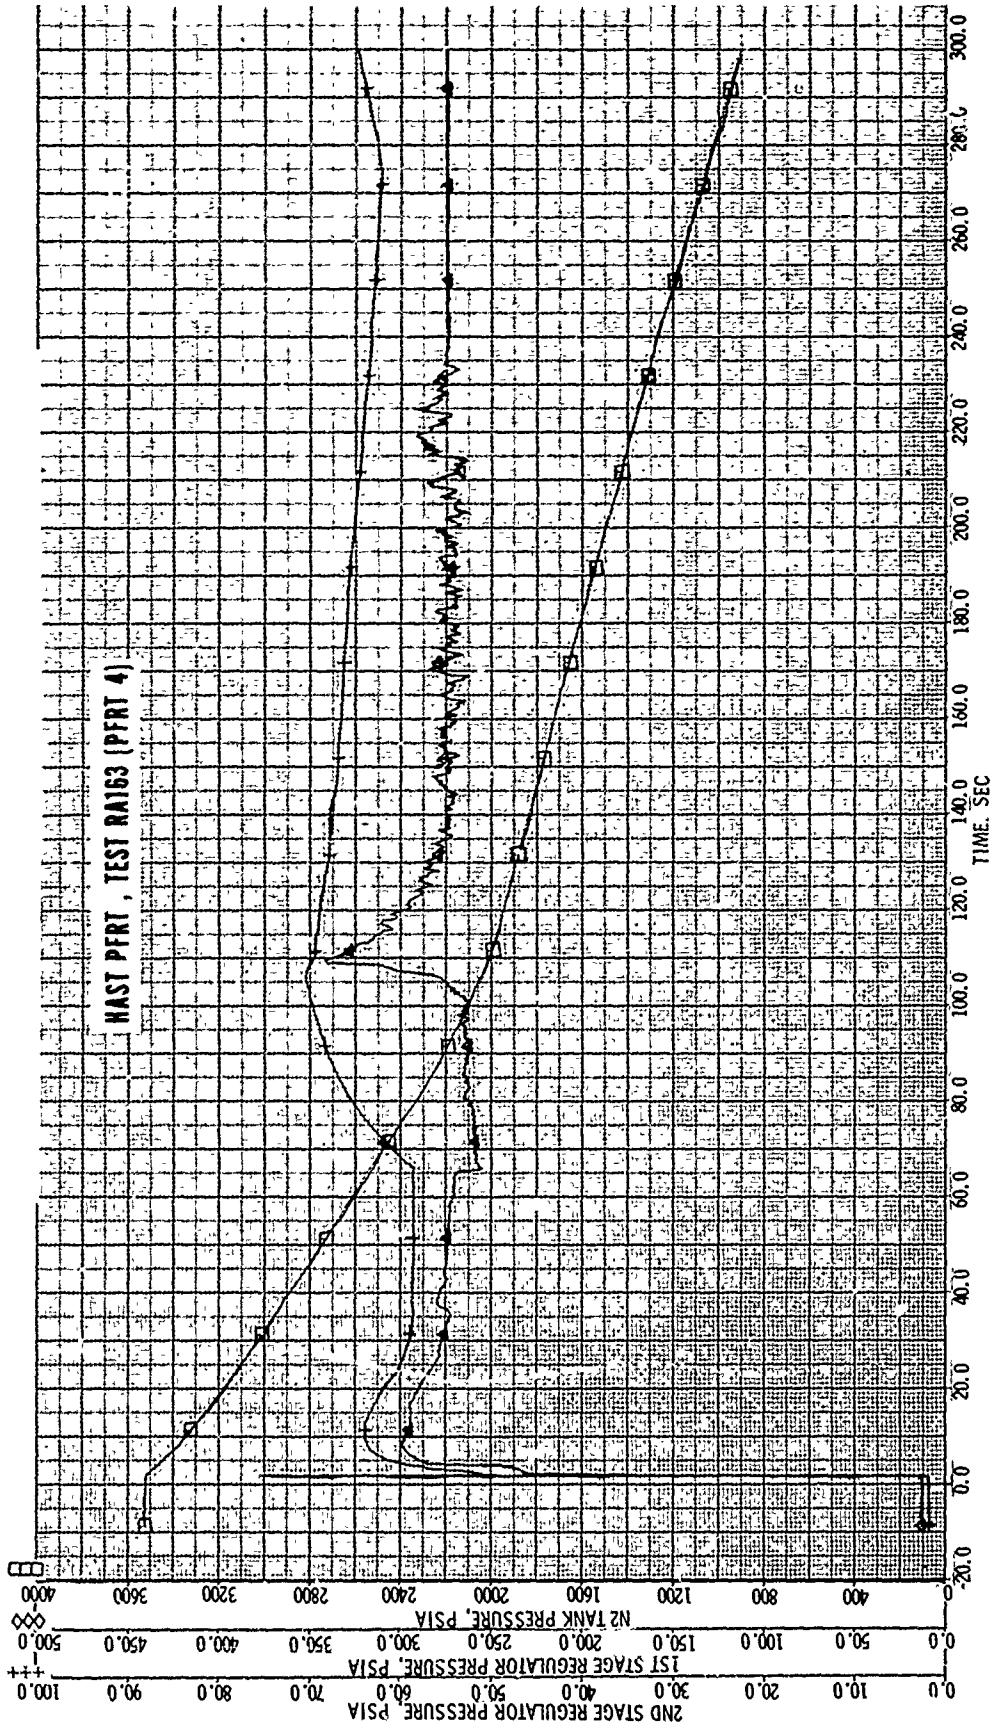
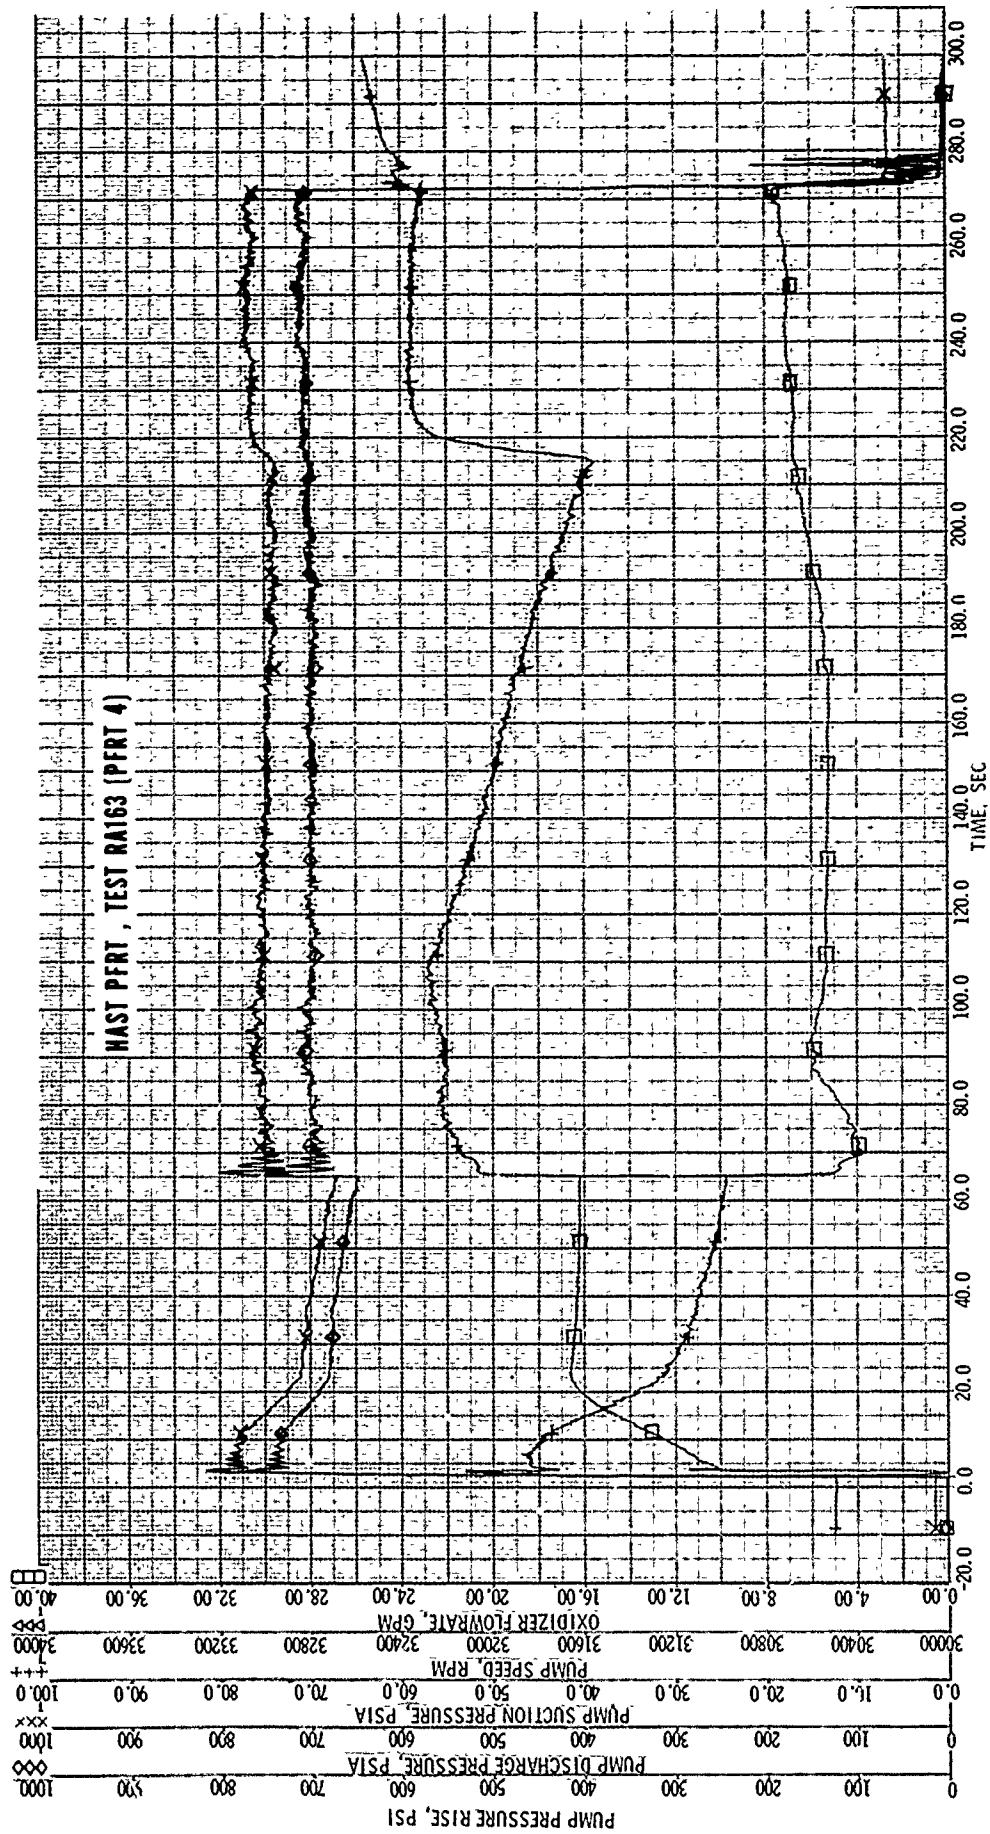
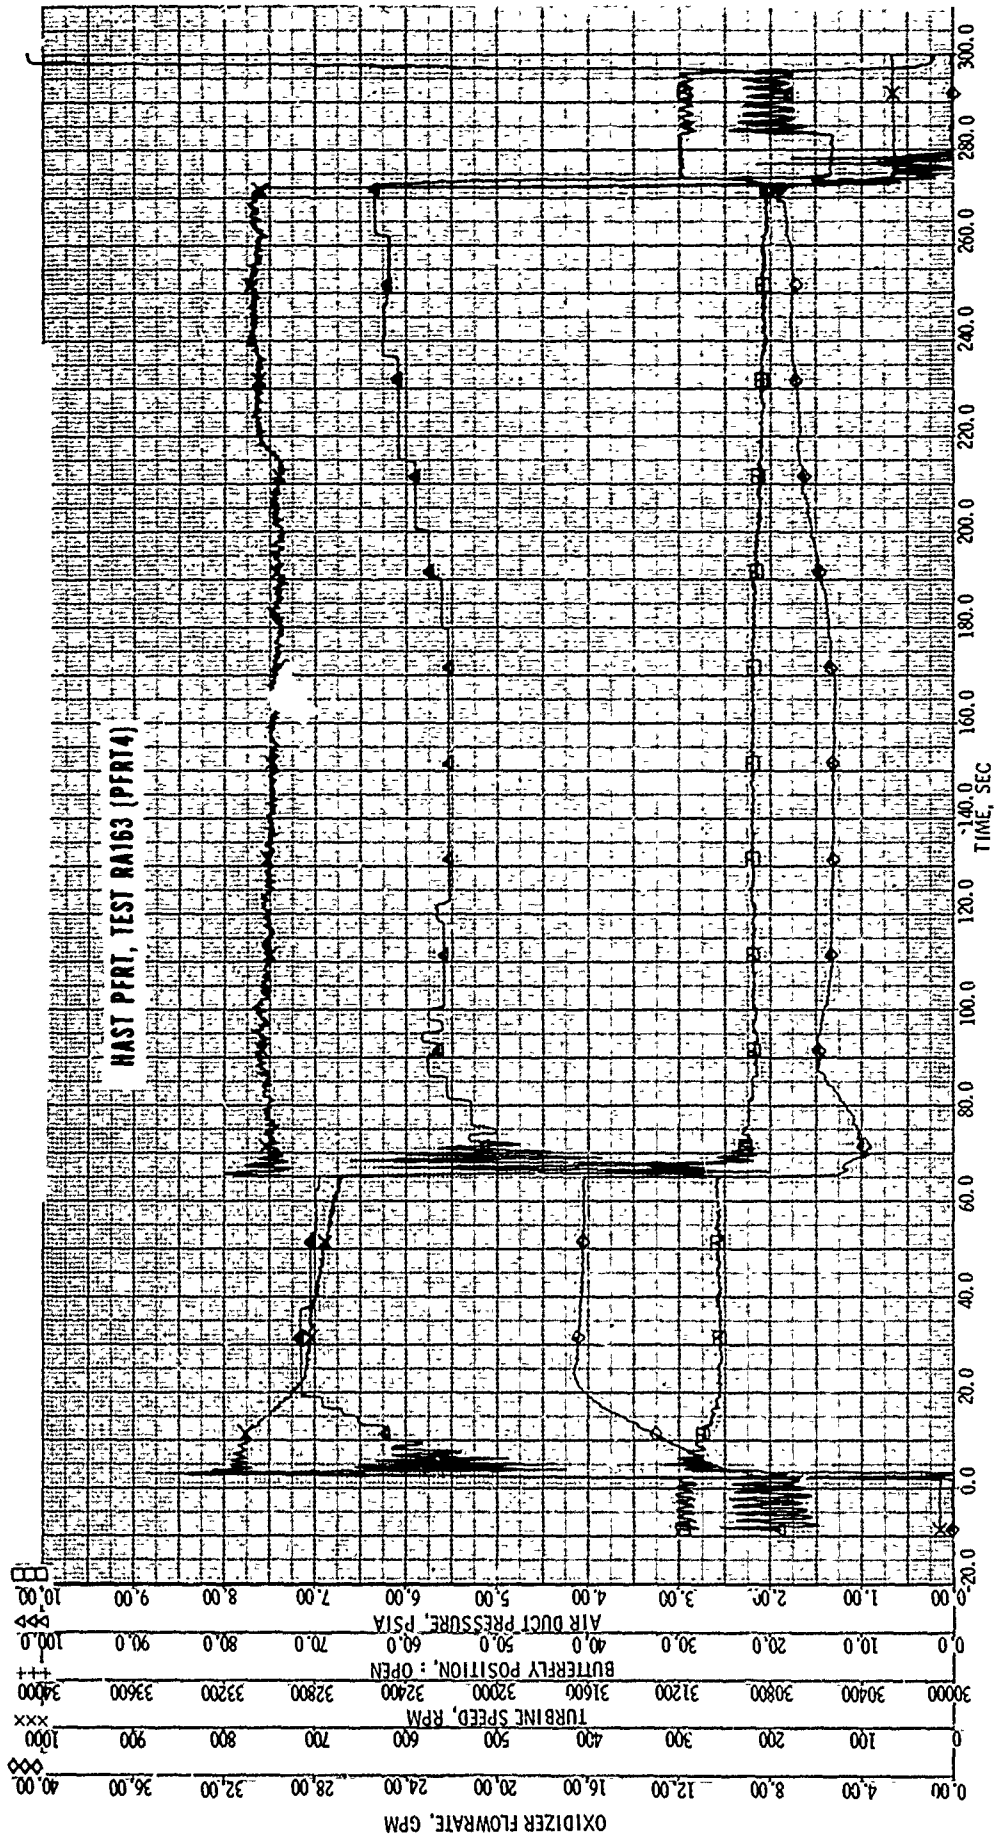
Figure 49. Thrust Chamber Parameters for PFRT 4

Figure 50: OMA Parameters for PFRT 4

Figure 51. Pressure Drops in OMA for PFRT 4

Figure 52. Pressurization Parameters for PFRT 4

Figure 53. Pump Performance for PFRT 4

Figure 54. Ram Air Turbine Parameters for PFRT 4

The duty cycle for this test simulated the Mach 2.5 at 60,000 ft flight test mission. The actual boost duration was 65 sec and the sustain duration was 209 sec. The data are presented in Figures 49 through 54.

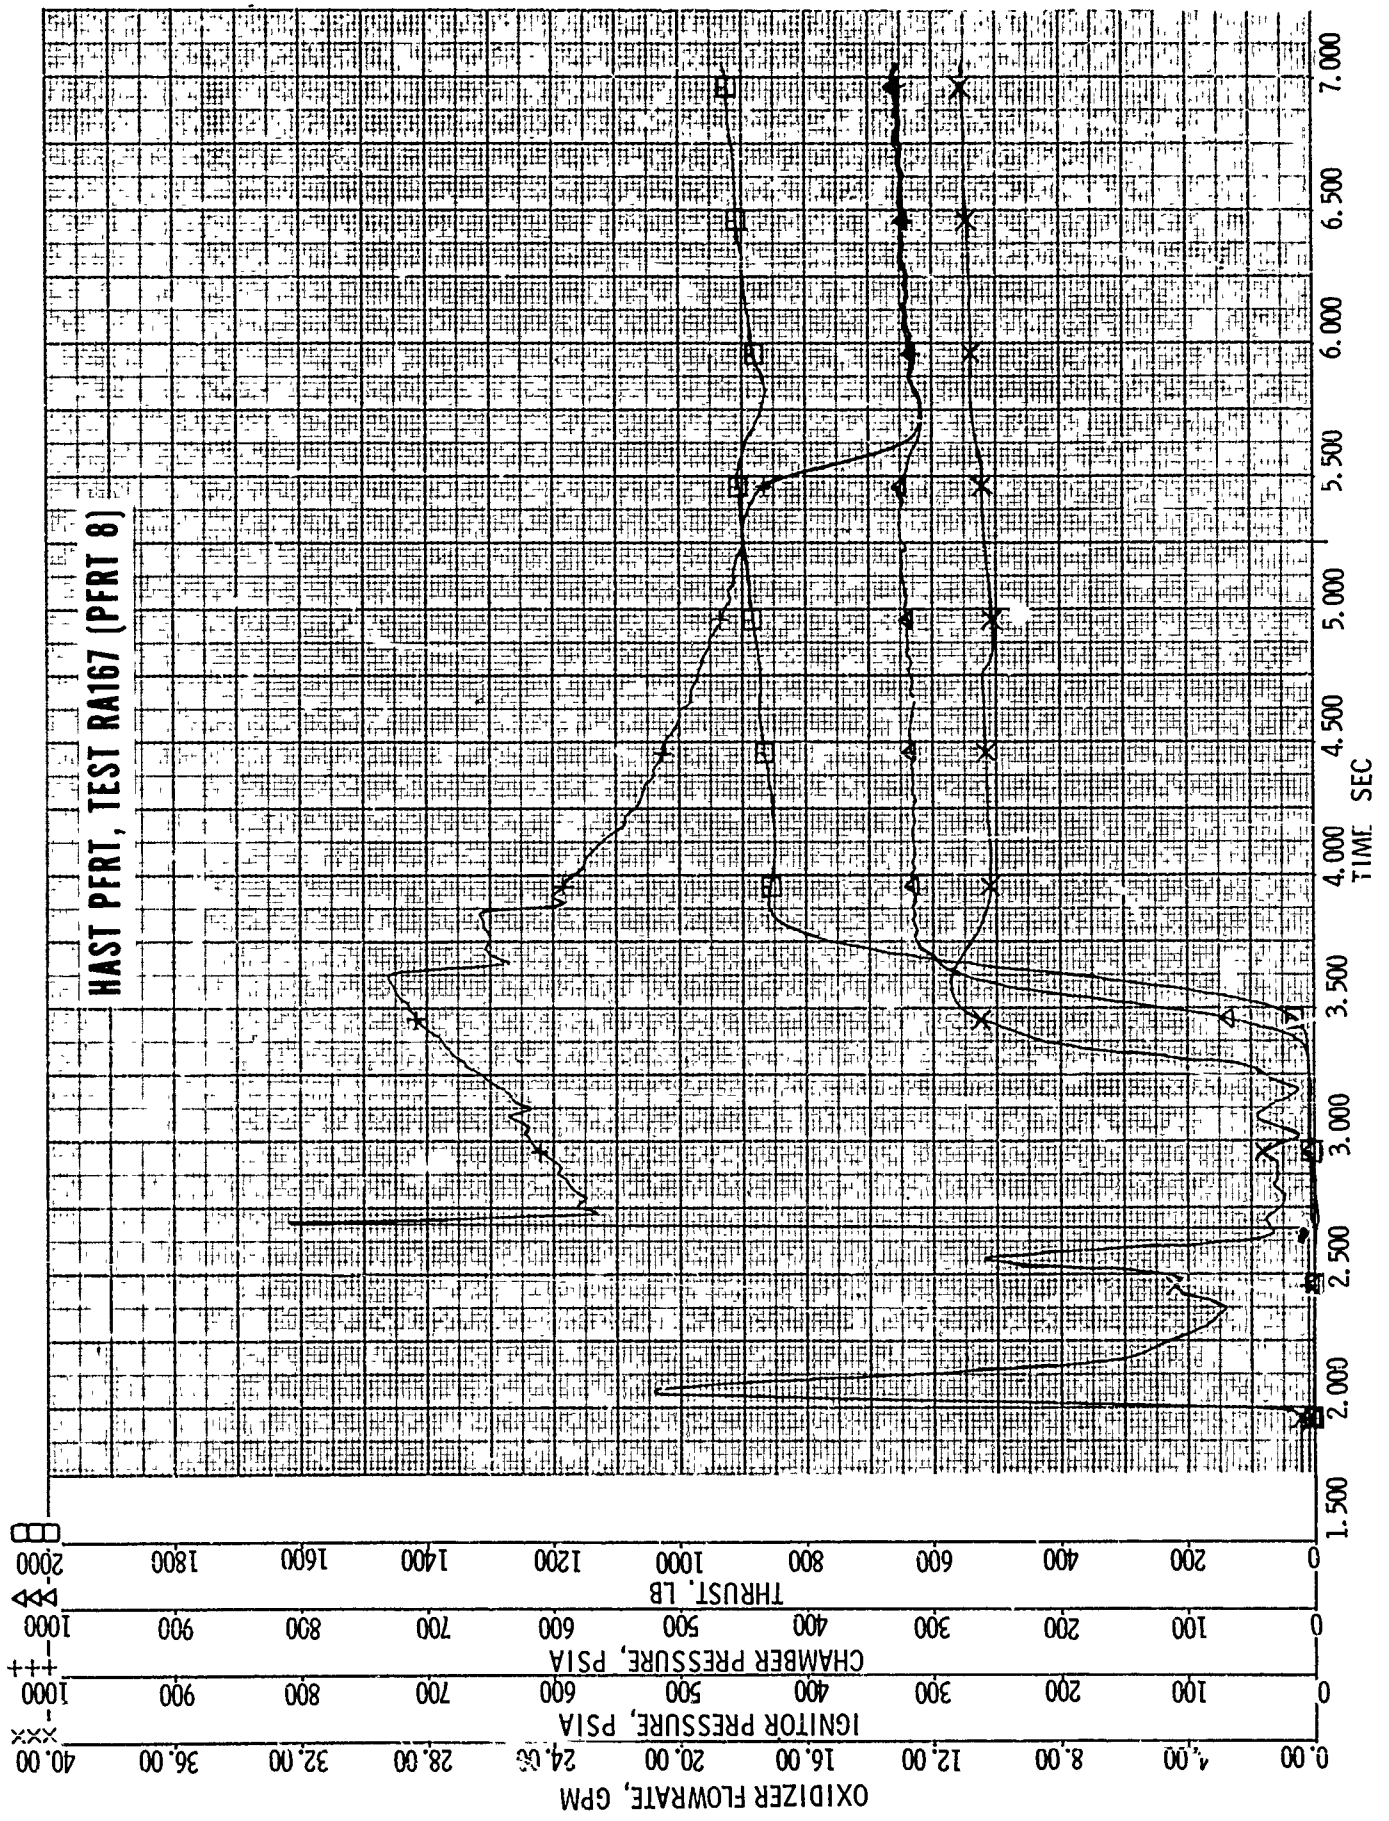
Figure 80. Start Transient for PFRT 8

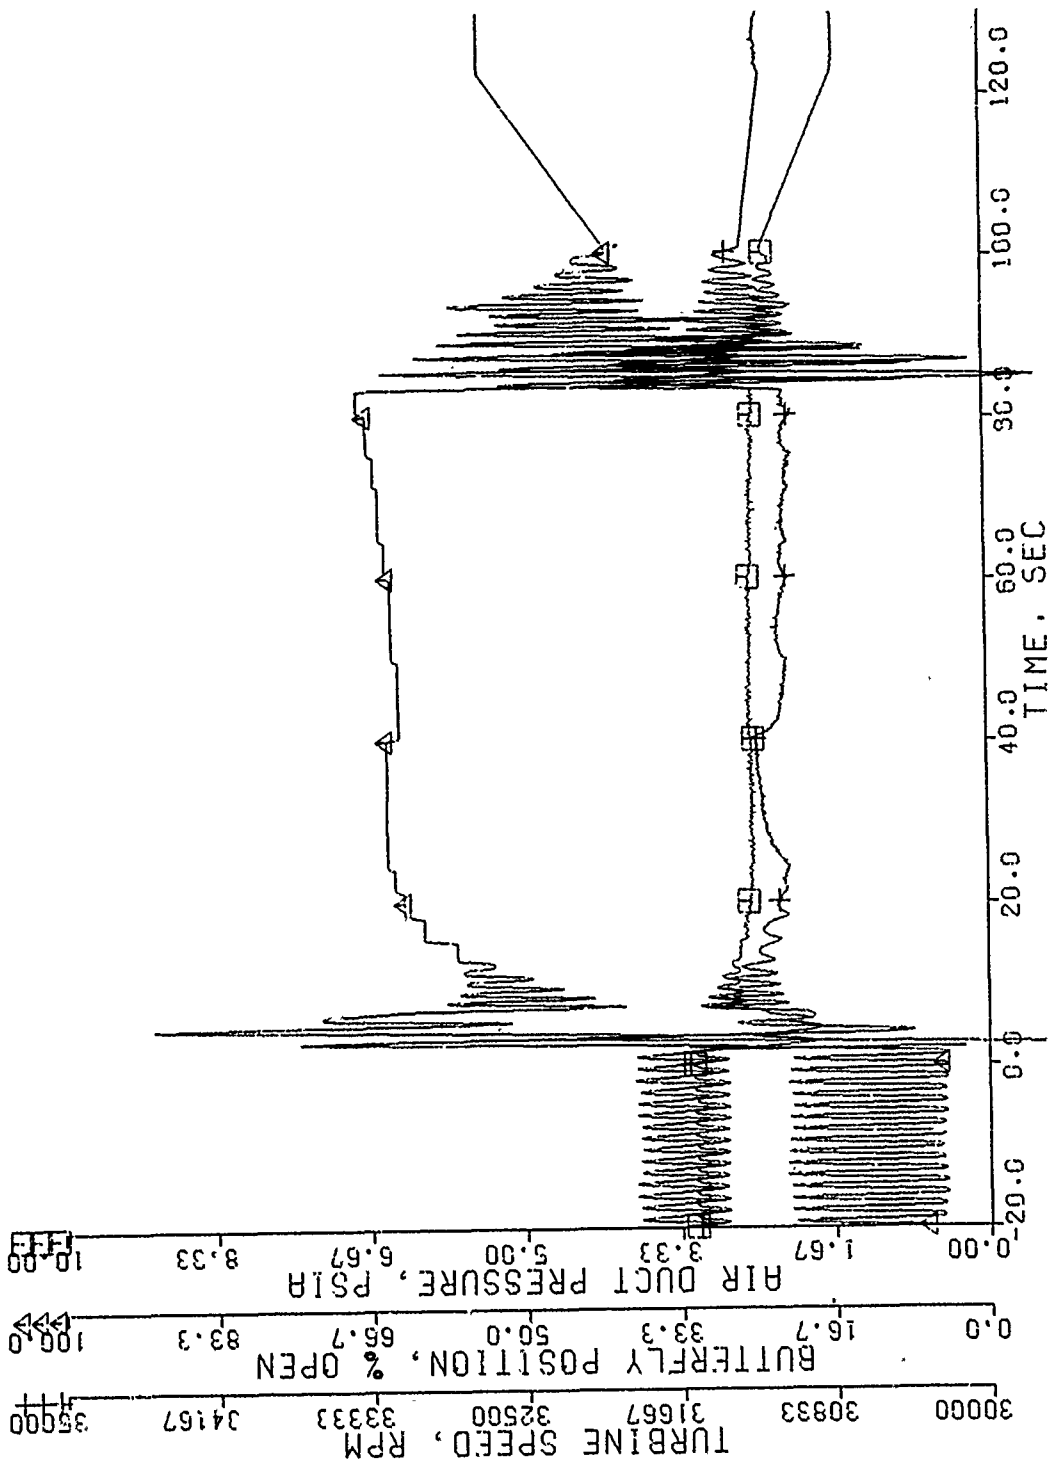
Figure 91. DPU Speed Control with Original Controller

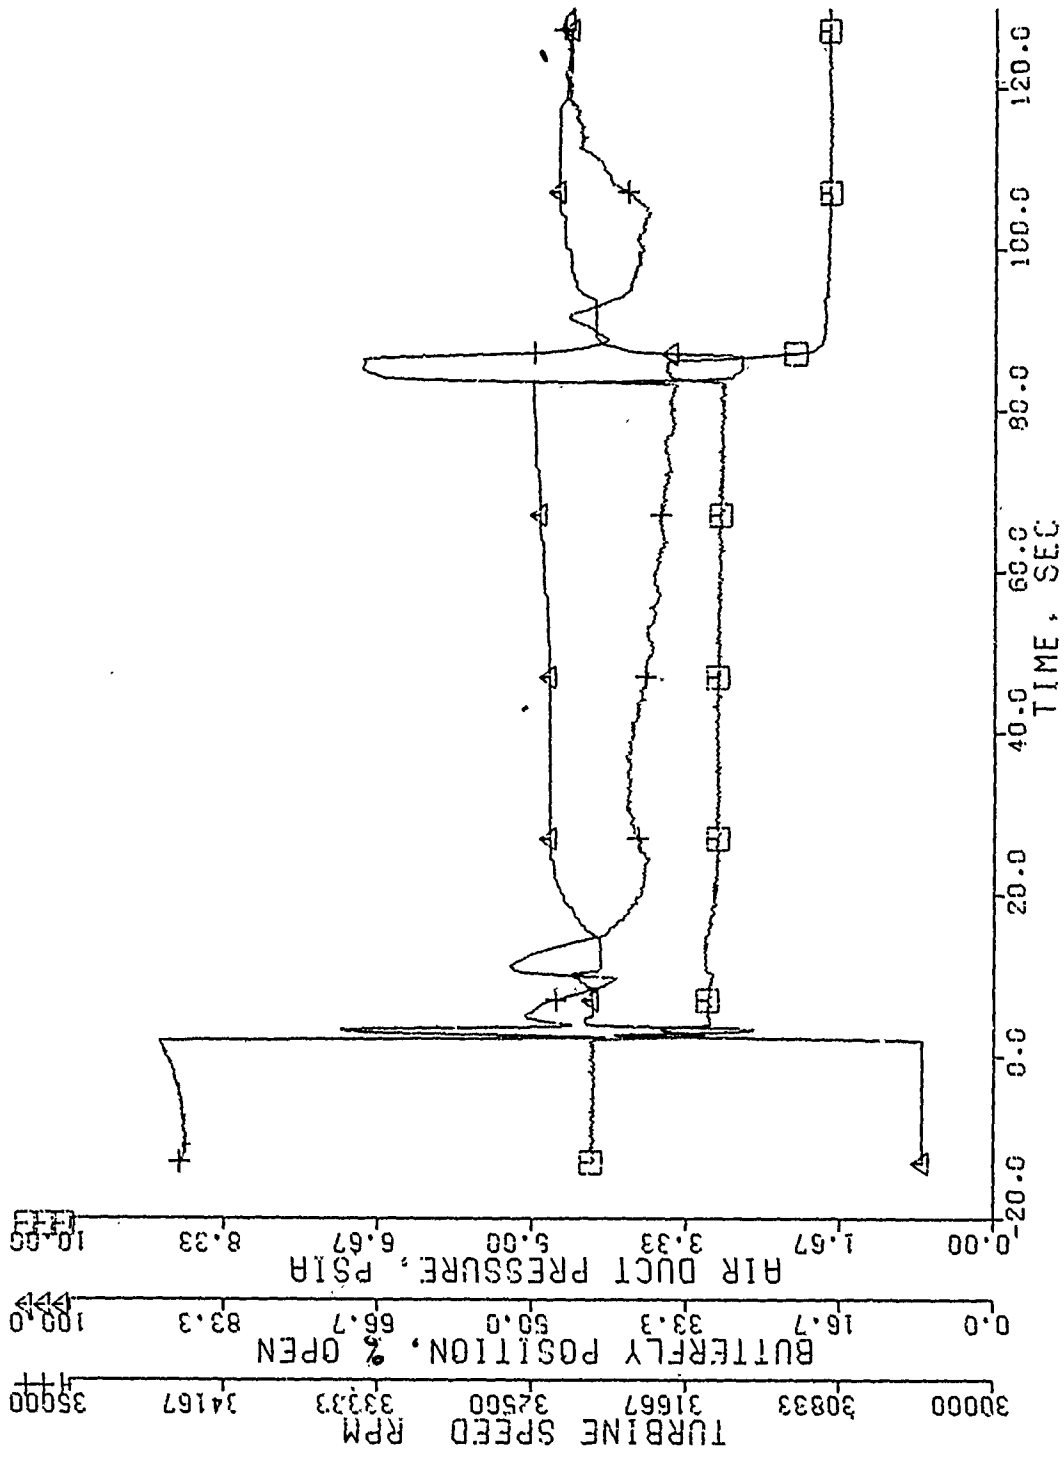
Figure 92. DPU Speed Control with Reduced Gain Controlled

An altitude checkout of the modified speed controller was conducted prior to its use on PFRT 8. With and without electrical load, the inlet duct pressure was varied so as to drive the butterfly from nearly closed to full open. No oscillations were observed over the complete range of positions. Turbine speed varied within the error expected. The speed tended to increase as the butterfly went further closed with increasing duct pressure.

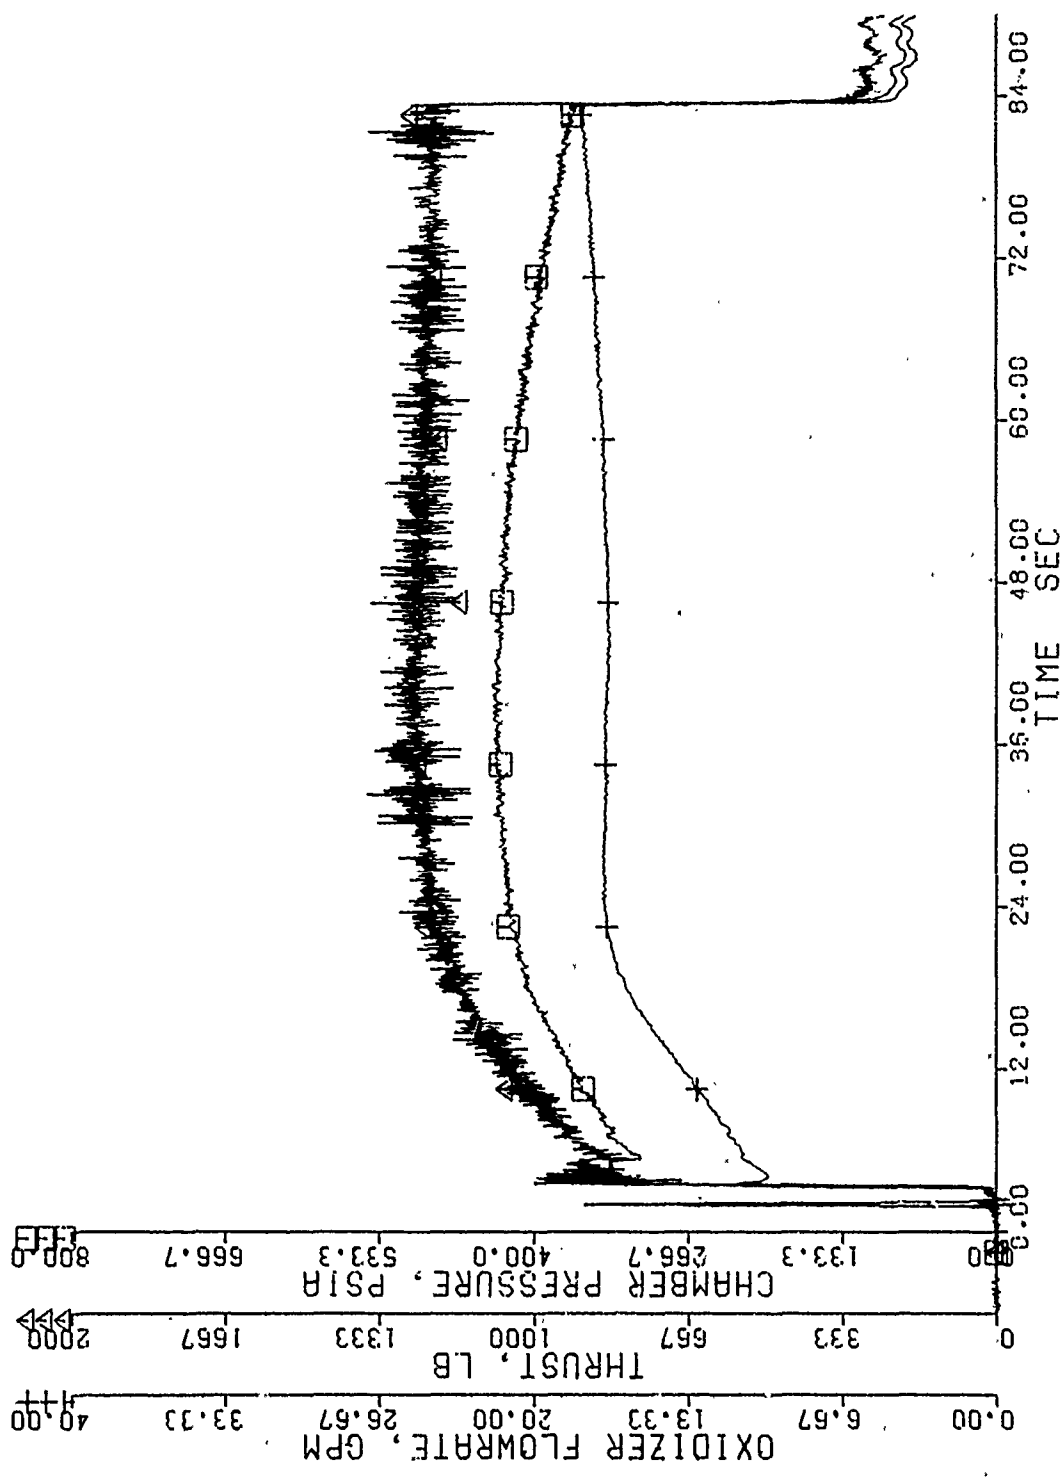
Figure 94. Effect of Nozzle Throat Erosion During Boost

The effect of throat erosion on chamber pressure, oxidizer flowrate, and thrust is illustrated in Figures 94 and 95. It may be noted that little erosion, as indicated by a loss in chamber pressure and increase in oxidizer flowrate, occurs until approximately 50 seconds. These effects of erosion are more pronounced toward the end of the long boost mission.
