FEASIBILITY STUDY OF CYCLIC PRESSURE TESTING
THICK-WALLED CYLINDERS

REPORT NO. NT-026
JANUARY 1975

PHASE I

FINAL REPORT

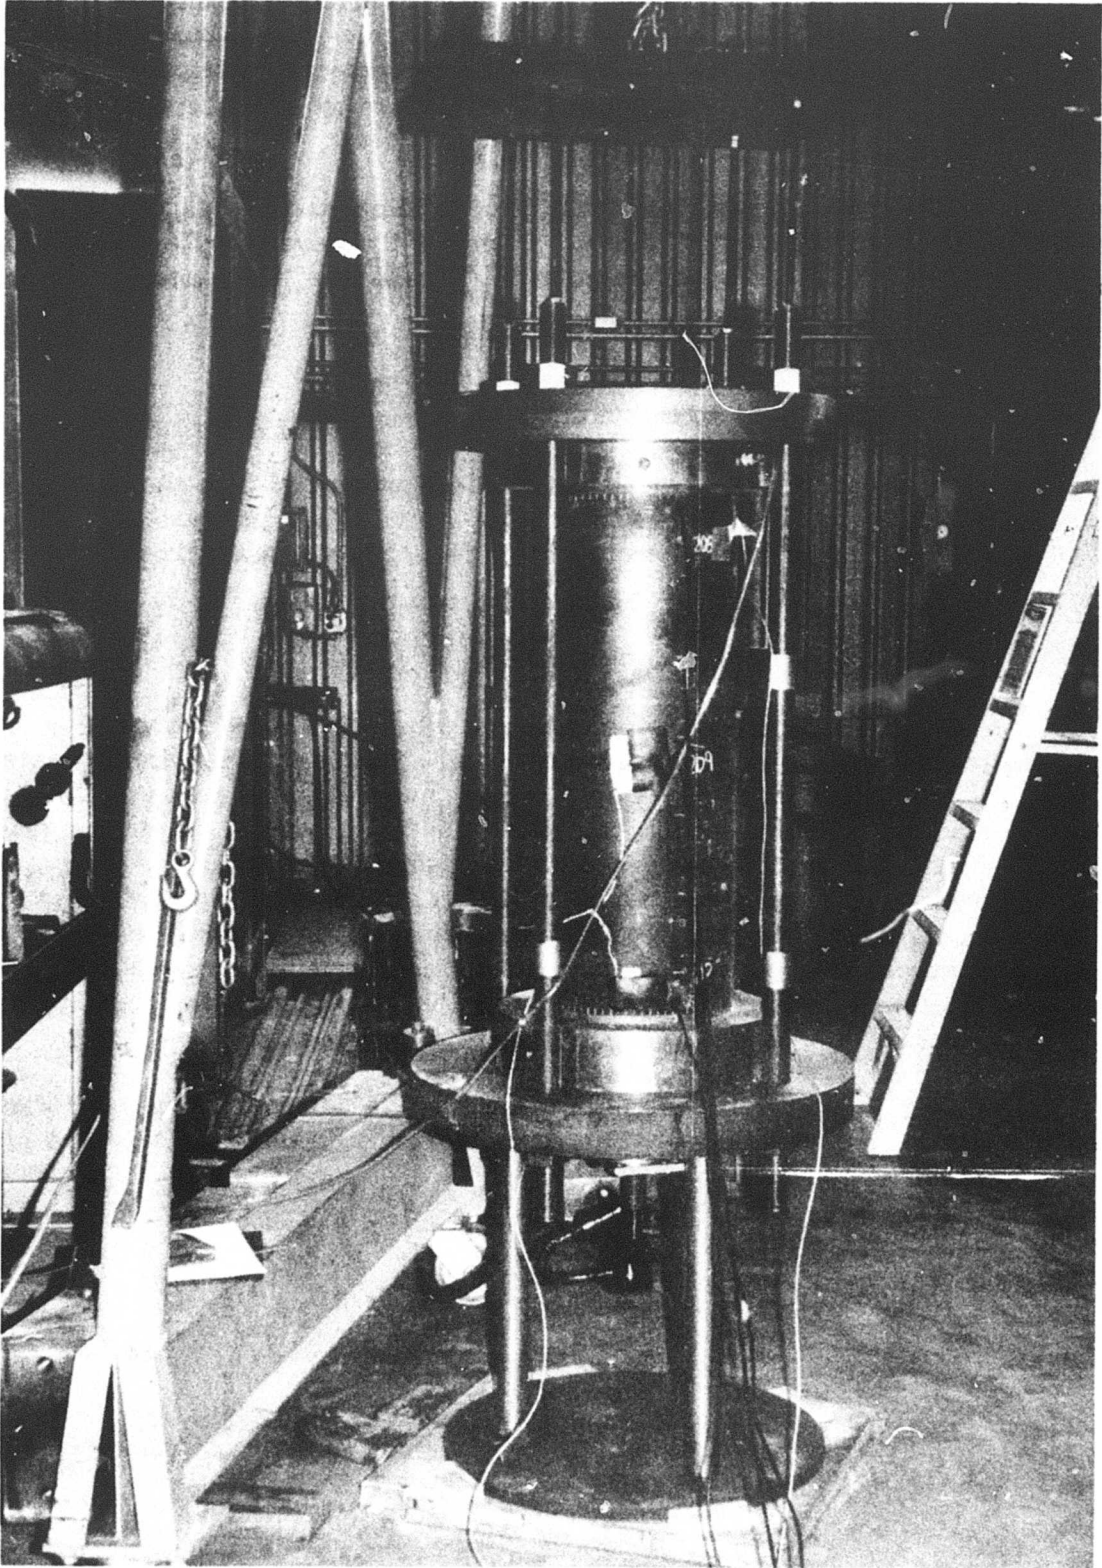
FIGURE 2

A restraining fixture was designed and fabricated by Soniform which could hold the test assembly as used in the first trials, Figure 2. The gases generated during the spark discharge required bleeding after each shot so a gas bleed in the upper portion of the assembly controlled the firing switch. While the gases were bled from the section, the capacitor bank would charge but the firing circuit was interrupted. As the gaseous mixture cleared the section, a continuous stream of water would be emitted through the hose, actuating the switch to complete the firing circuit. In this manner, cycle times of four per minute were obtained. The longest, continuous number of cycles obtained in this manner was over 600 cycles. The total number of pressure cycles obtained exceeded 4,500.

ELECTROHYDRAULIC TEST ASSEMBLY

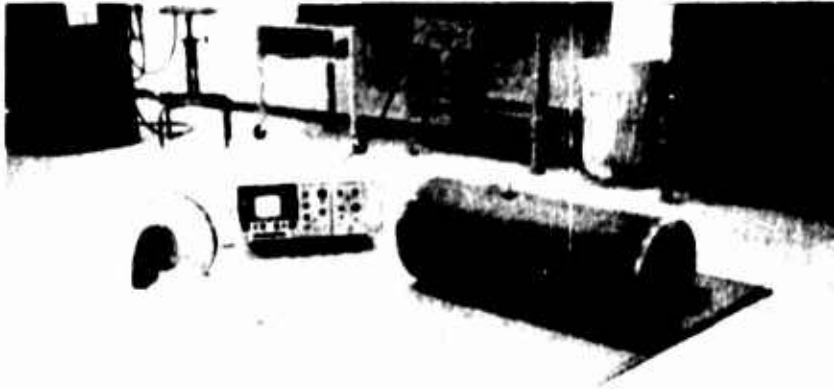
FIGURE 14

1. Set-up the instrument and allow to stabilize for $\frac{1}{2}$ hour.
2. Perform a thorough calibration.
3. Place the transducer holder on the gun barrel, Figure 14.

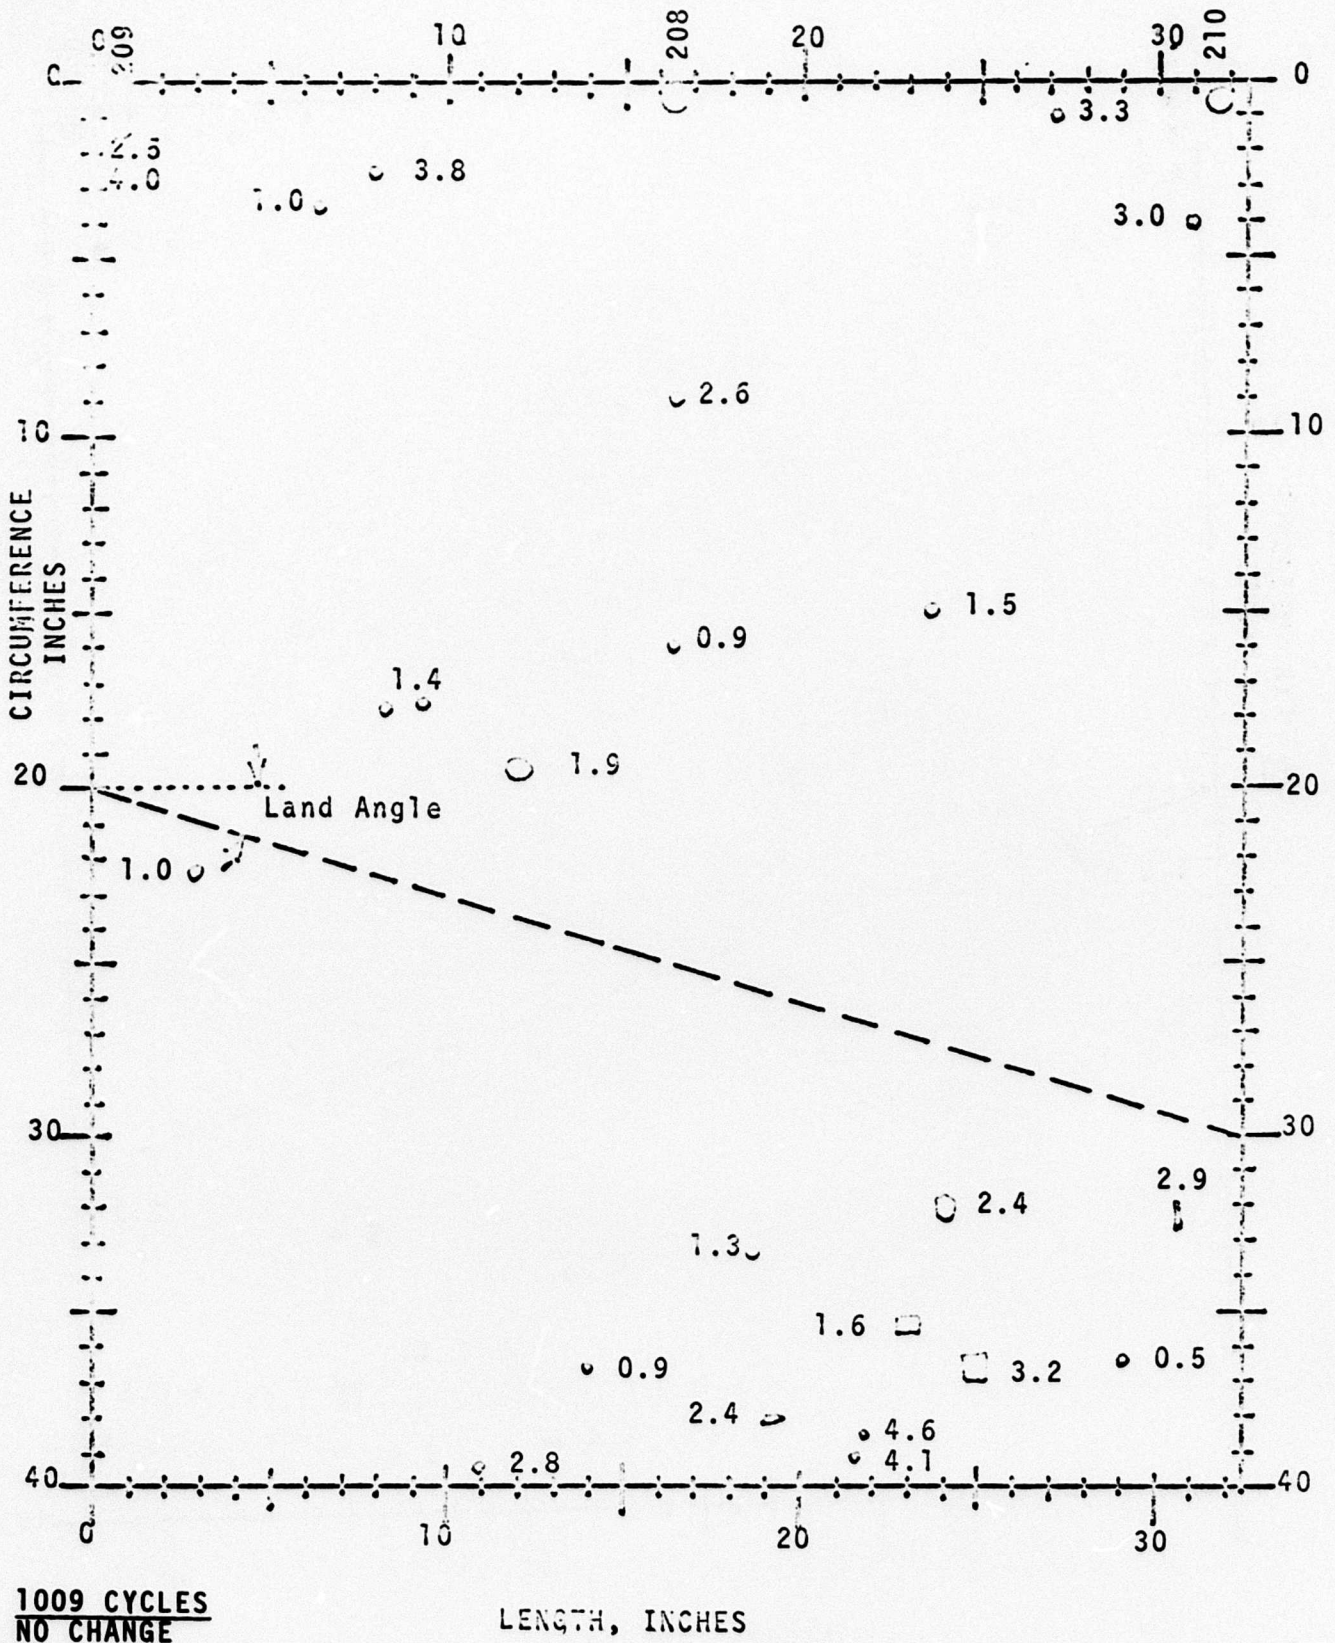
FIGURE 16

A thorough inspection scan was performed over the gun barrel in its test-rig mounting at Sonoform, Inc., San Diego, California. The bore was empty of water. All of the original indications were reconfirmed and no changes or new indications were observed, Figure 16.

INSPECTION AFTER 1009 CYCLES

Numbers are divisions
at .02 x 10 time scale
