construction
engineering
research
laboratory

TECHNICAL REPORT C-19
June 1975

EMP SHIELDING PROPERTIES OF CONDUIT
SYSTEMS AND RELATED HARDWARE

by
D. J. Lovrenz
P. H. Nielsen
R. G. McCormack

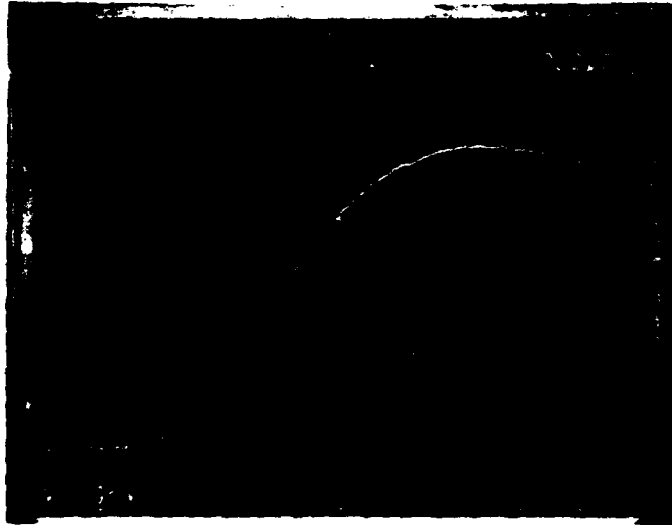
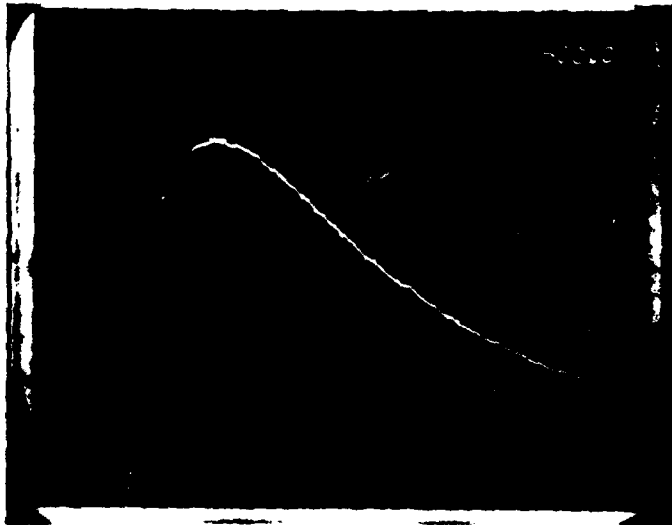
(a) Vertical: 1000 x 50 mV/div
Horizontal: 200 usec/div

(b) Vertical: 1000 x 50 mV/div
Horizontal: 500 μ sec/div

Figure 11. Diffusion signal for 1-in. galvanized steel conduit showing sense wire voltage.

Conclusions. From the results presented in the previous section, the function for $v_I^n(t)$ and the value of M can be obtained by normalizing the data given in Figures 11 and 12. The values for $v_I^n(t)$ can be obtained for 1-in. and 2-in. galvanized-steel conduit. These functions agree with the analytical value for $v_I^n(t)$. From values given in Table 1 the value for M can be found. Using Eq 1-12, the sense-wire diffusion current for any conduit-current sense-wire connection and conduit length can be found. This provides a base-line signal for the conduit system and should give a meaningful basis for use in evaluating the seriousness of the leakage signals described in the next two chapters.

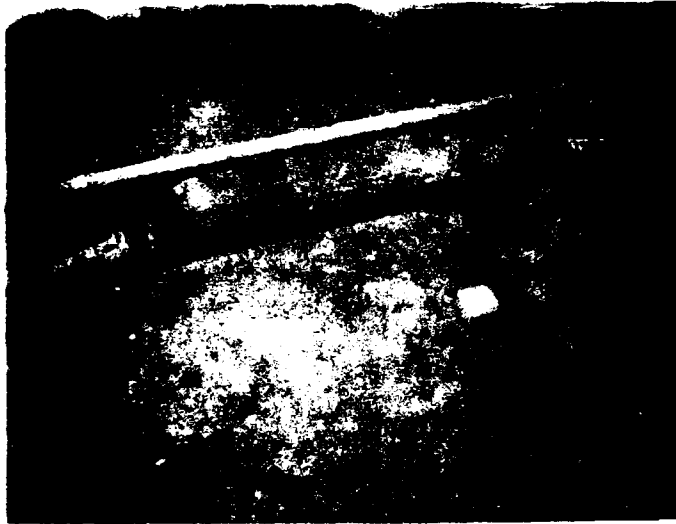
Figure 25. A 1 1/2-in. flexible conduit sample with a standard steel flexible bellows and two layers of galvanized steel braid.

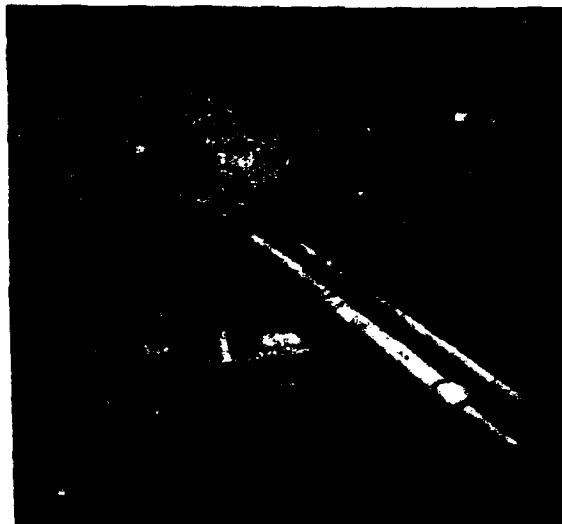
Figure 38. Rusted 2-in. conduit sample as installed in parallel conduit transmission line (showing reducer).

The 2-in. conduit samples received were 4 ft long with a factory-galvanized thread on one end and the rusted field-cut thread on the other end. The couplings received were plastic (vinyl) covered and intended for use with the vinyl-coated conduit used at the site. In the preparation of samples at CERL, the vinyl sleeves were cut away from the couplings at each edge in order to simplify sample assembly. Samples were assembled for testing in a parallel conduit transmission line (using 1-in. conduit). The completed test sample included two of the 4-ft long field-rusted samples with the rusted field-cut threads mated with the field-rusted coupling. The factory-galvanized ends of the conduit samples were thoroughly cleaned and mated with a female 2 in. to 1 in. reducer. One-in. conduits, 1 ft in length, were then threaded onto each reducer, thus making up a test sample about 10 ft long that was installed in the 1-in. conduit-test setup (Figure 38).

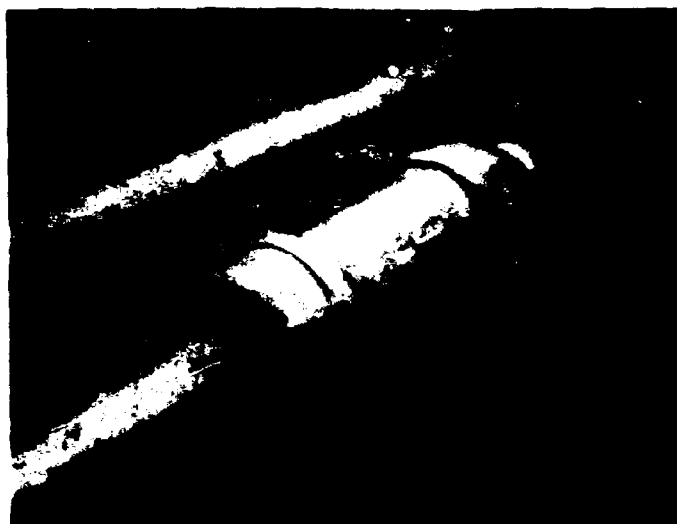
Lock nut
(other
lock nut
on inside
of end
cap)

End cap
with hole
drilled to
accept
conduit

Figure 40. Close-up of lock-nut test assembly.

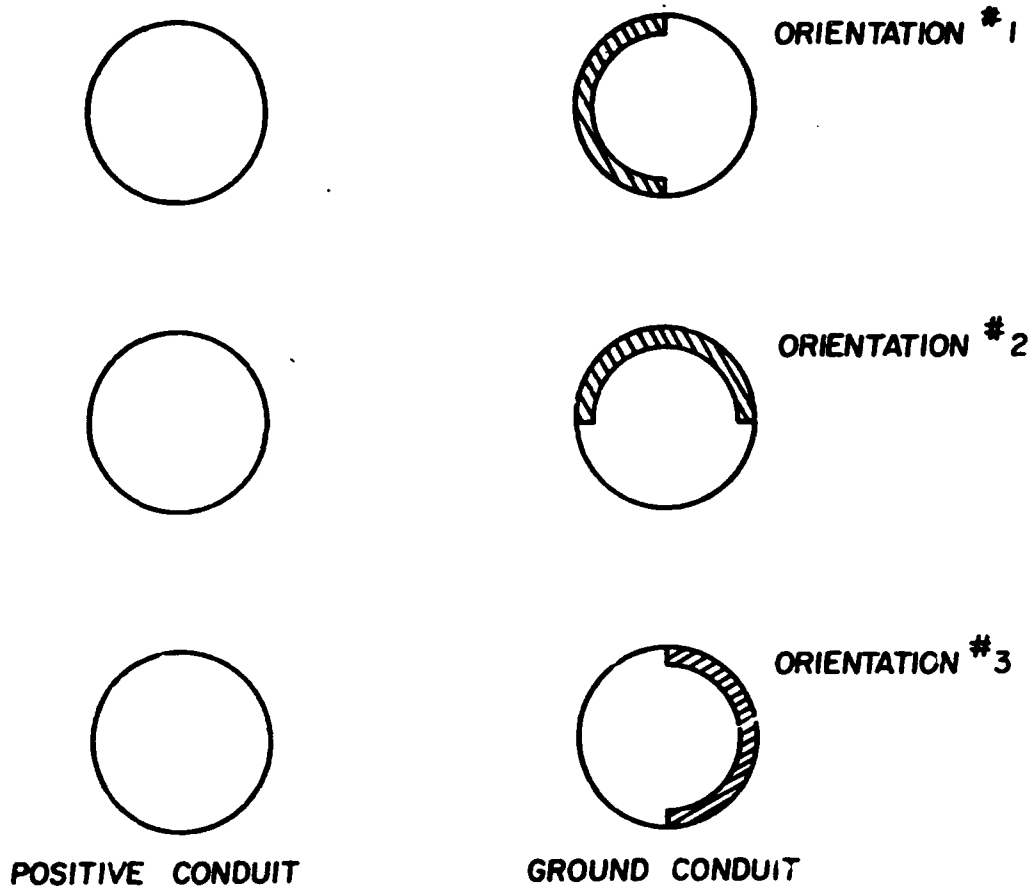
NOTE :   SLOT (shaded area) IS IN Y-Z PLANE

Figure 43. Cut-away end view of transmission line showing orientation of slot for transverse-slotted conduit tests.

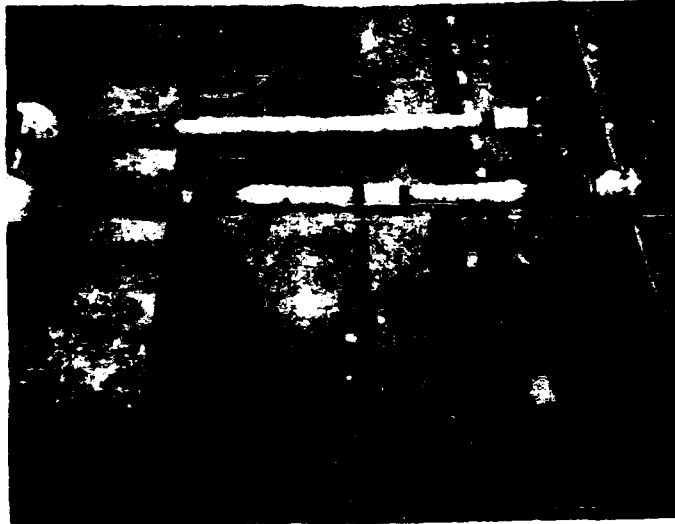
Test
coupling

Figure 44. Three-ft long sample as installed.

Effects of Conduit Length on I_{SC} . These tests were conducted to investigate the effect of conduit length on the resulting I_{SC} wave form for the common-mode configuration. In preparing this test sample, a 1-ft section was cut from the center of sample three of the rusted 1-in. conduits discussed in the section on Rusted-Conduit Repeatability. This sample provided a relatively large I_{SC} signal as originally tested. The 1-ft assembly was threaded on both ends and couplings were wrench-tightened to these threads. Various lengths of conduit (up to 1 in.) could be added to this sample to make a test conduit of any desired length without disturbing the rusted coupling. The assembled sample was inserted into a transmission line setup for testing. Figures 44 and 45

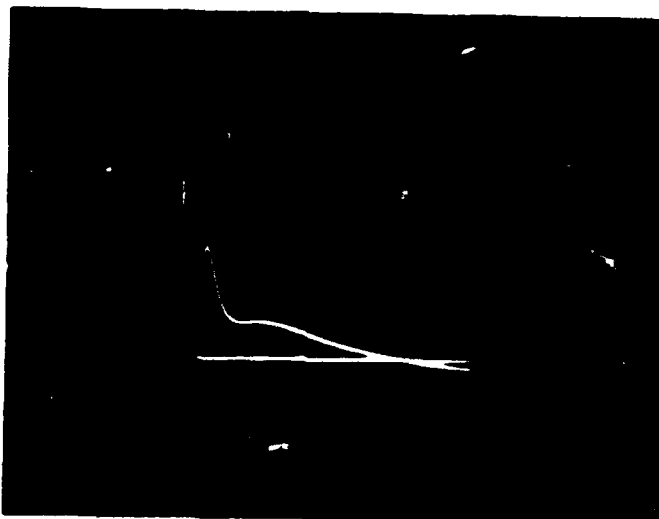
Figure 51. I_{sc} wave form--1 1/2-in. special design flexible conduit
($i = 10 \text{ mA/div}$; $t = 0.5 \text{ msec/div}$).
