AIRFIELD PAVEMENT CONSTRUCTION  
SLIPFORM PAVING METHOD

MISCELLANEOUS PAPER S-75-16

# AIRFIELD PAVEMENT CONSTRUCTION: SLIPFORM PAVING METHOD

Soils and Pavements Laboratory  
U. S. Army Engineer Waterways Experiment Station  
P. O. Box 631, Vicksburg, Miss. 39180

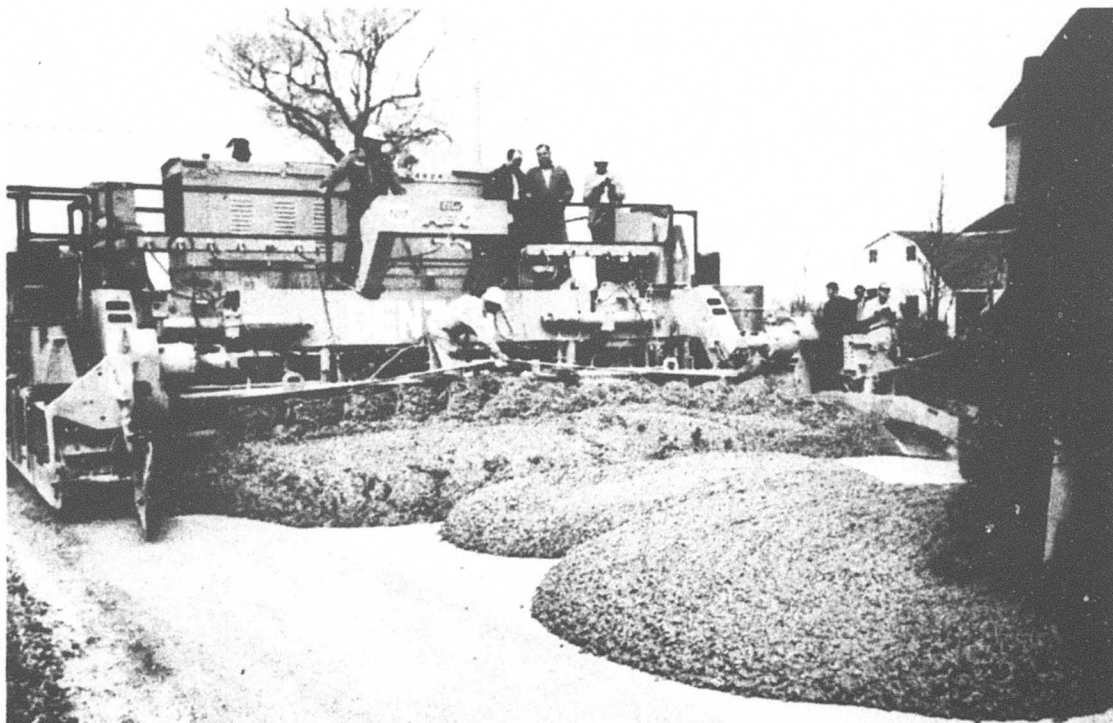
*Photo 3. Example of Rex slipform paver*

18. Rex slipform pavers (Photo 3) form the concrete to the desired cross section with a process which is similar in some respects to both the Guntert and Zimmerman and CMI machines. The cross section is formed by (a) striking off the concrete to roughly the desired cross section; (b) consolidating the concrete and conditioning the surface with internal vibrators and surface tampers; (c) confining the fluid concrete with a relatively large forming plate and the side forms until it reverts back to a nonfluid state. Final surface finish is applied with a pan float or oscillating belts. Figure 3 illustrates the basic mechanisms for forming the pavement cross section. The success of this process will depend on the ability of the equipment to condition the concrete so that it can be shaped by the large conforming plate.

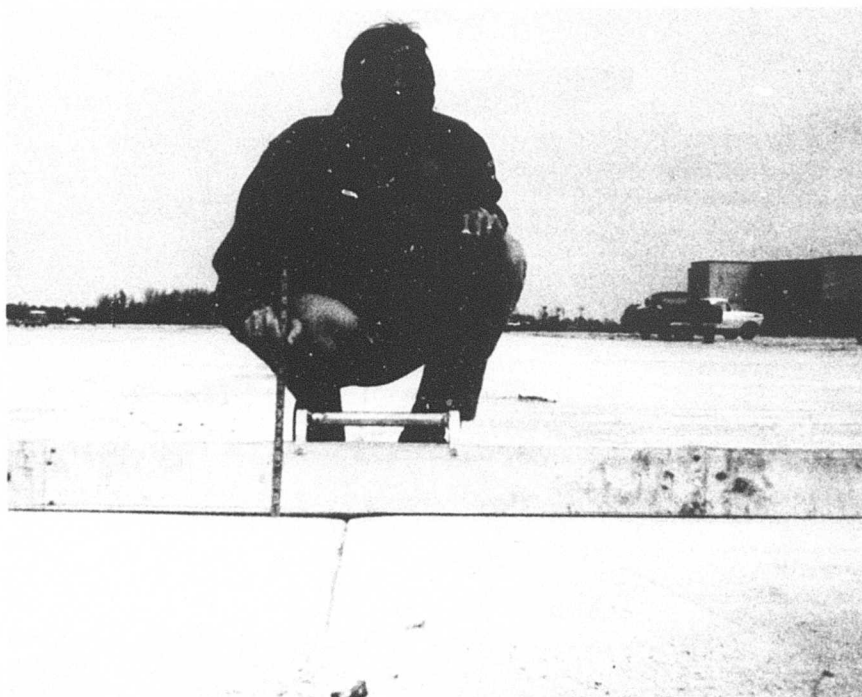
*Photo 14. Placement of straightedge across longitudinal construction joint*

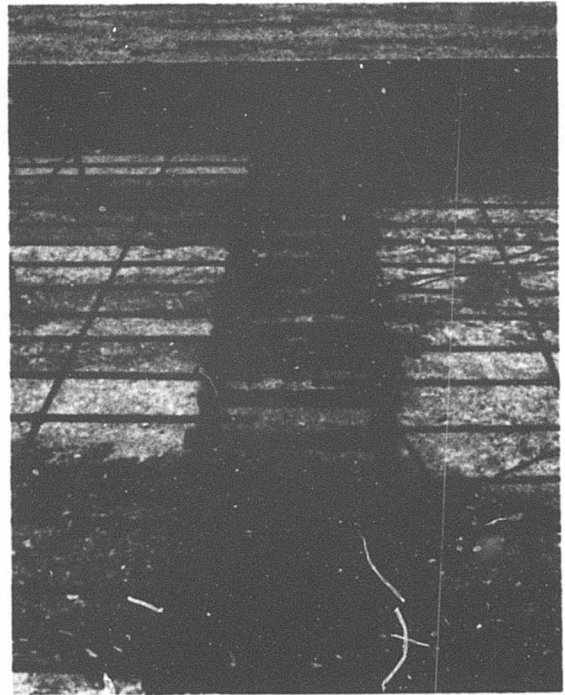
*Photo 18. Reinforcing steel and dowel assembly preset and ready for concrete placement*

66. Photo 18 shows transverse and longitudinal reinforcing bars and dowel assemblies preset on chairs and ready for concrete placement. This procedure is usually used only for thin pavements (defined by CE specifications, Reference 8, as 12 in. or less in thickness). It may be difficult to place concrete through the reinforcement to the bottom of the slab, especially when large quantities of steel are used, and to properly consolidate the concrete in the bottom of the slab.

75. The installation of dowels in transverse contraction joints presents no unique problems. The dowels are mounted on a frame (see Photo 18) and attached to the underlying material. The dowels will be positioned near slab middepth so that the forming mechanism and vibrators can pass over the dowel assembly. The three most important factors to be considered when installing dowels in transverse joints are: (a) the dowels must be aligned properly; (b) the dowel assembly must be sufficiently rigid to prevent movement of the dowels when concrete is placed; and (c) the frame must be securely staked to the underlying material to prevent movement when the concrete is placed.

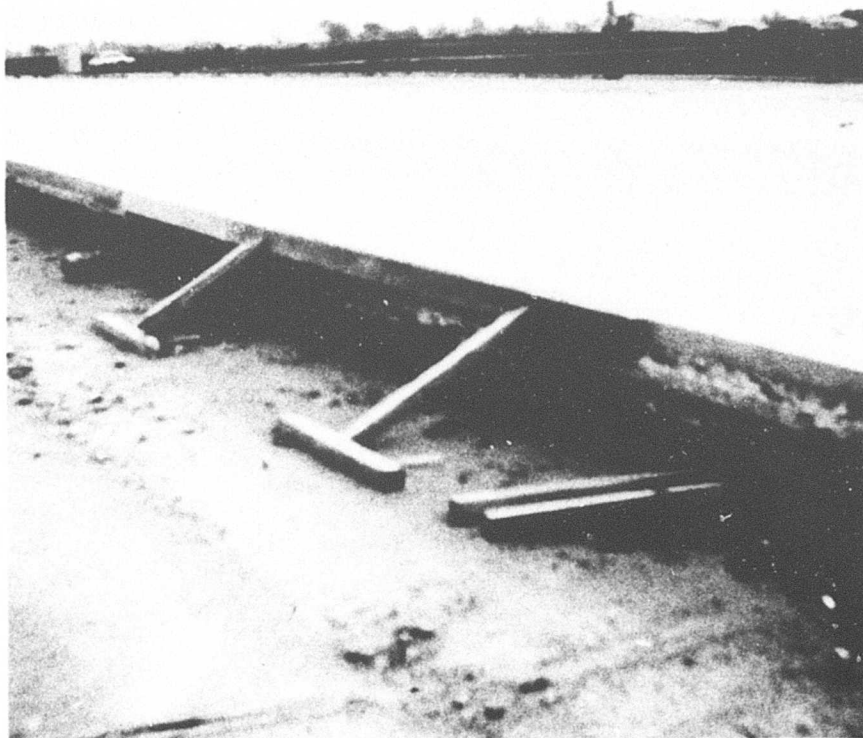
*Photo 24. Example of method for providing lateral support to edge of pavement*

83. When edges slump excessively in a localized area or when localized sloughing of keys or keyway lips occurs, it is common practice to provide lateral support (Photo 24) and to repair the edge manually. Another method repairs keys and keyways using epoxy grout after the concrete has hardened. Neither method is recommended for widespread use and, if edge stability problems persist, adjustments should be made to the mix or to the paver.
