RADC-TR-75-134
Final Technical Report
May 1975

THERMOMECHANICAL TESTING TECHNIQUES FOR MICROCIRCUITS

Motorola, Inc.

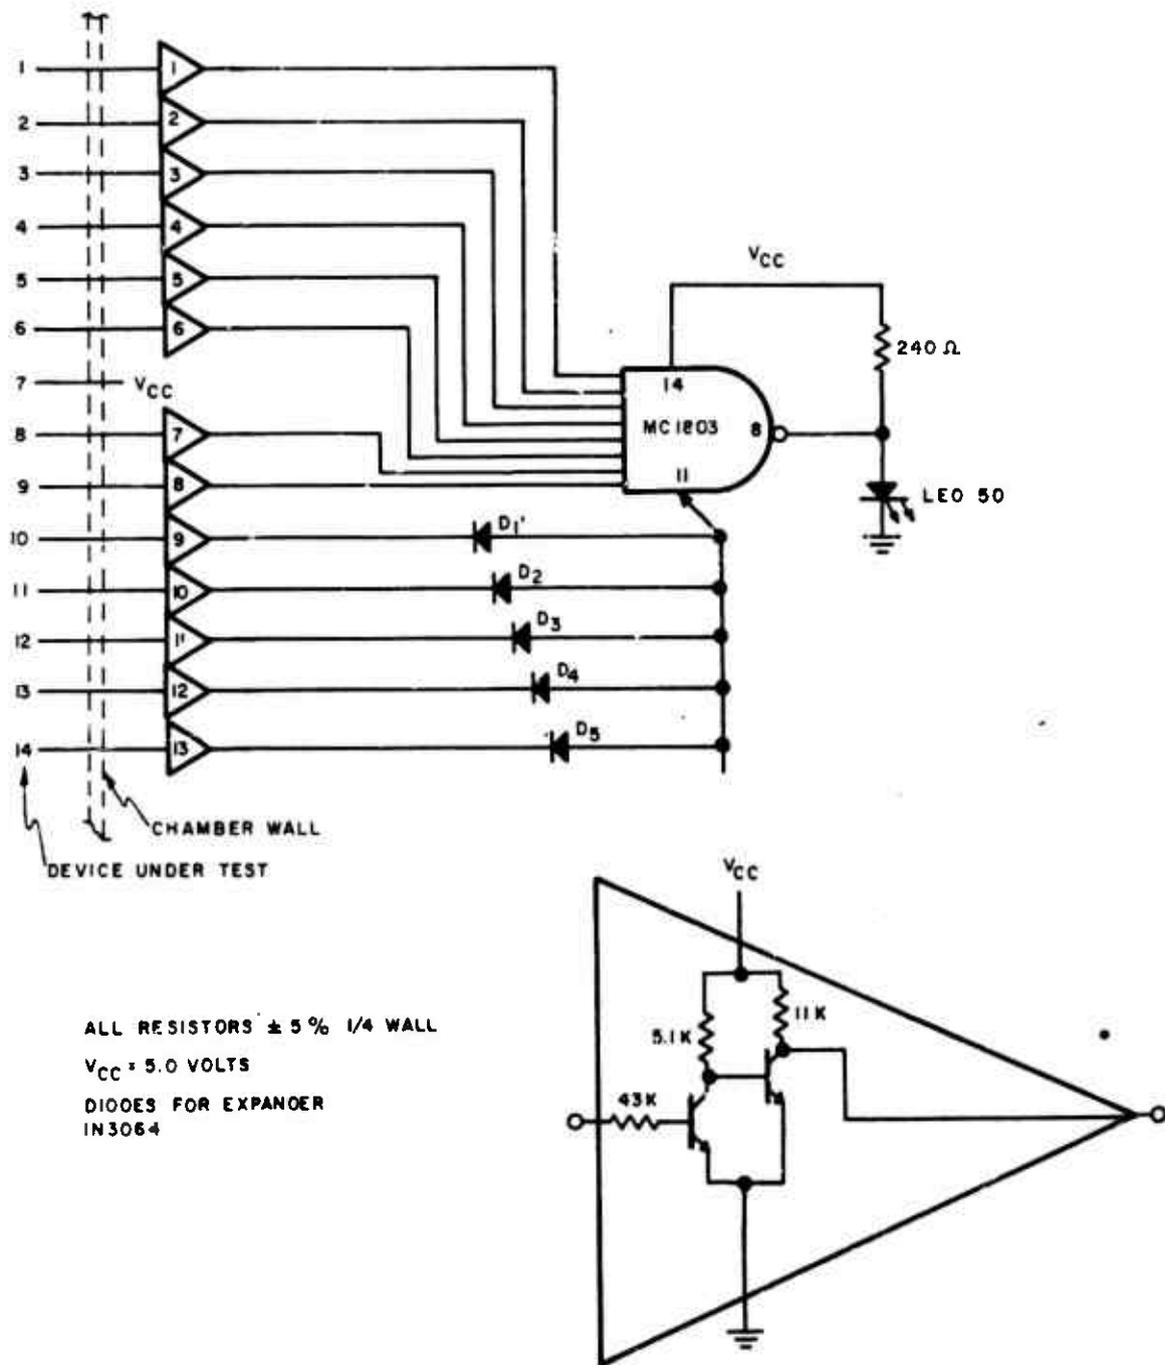
Figure 4-8. Thermal Intermittant Test Circuit Schematic

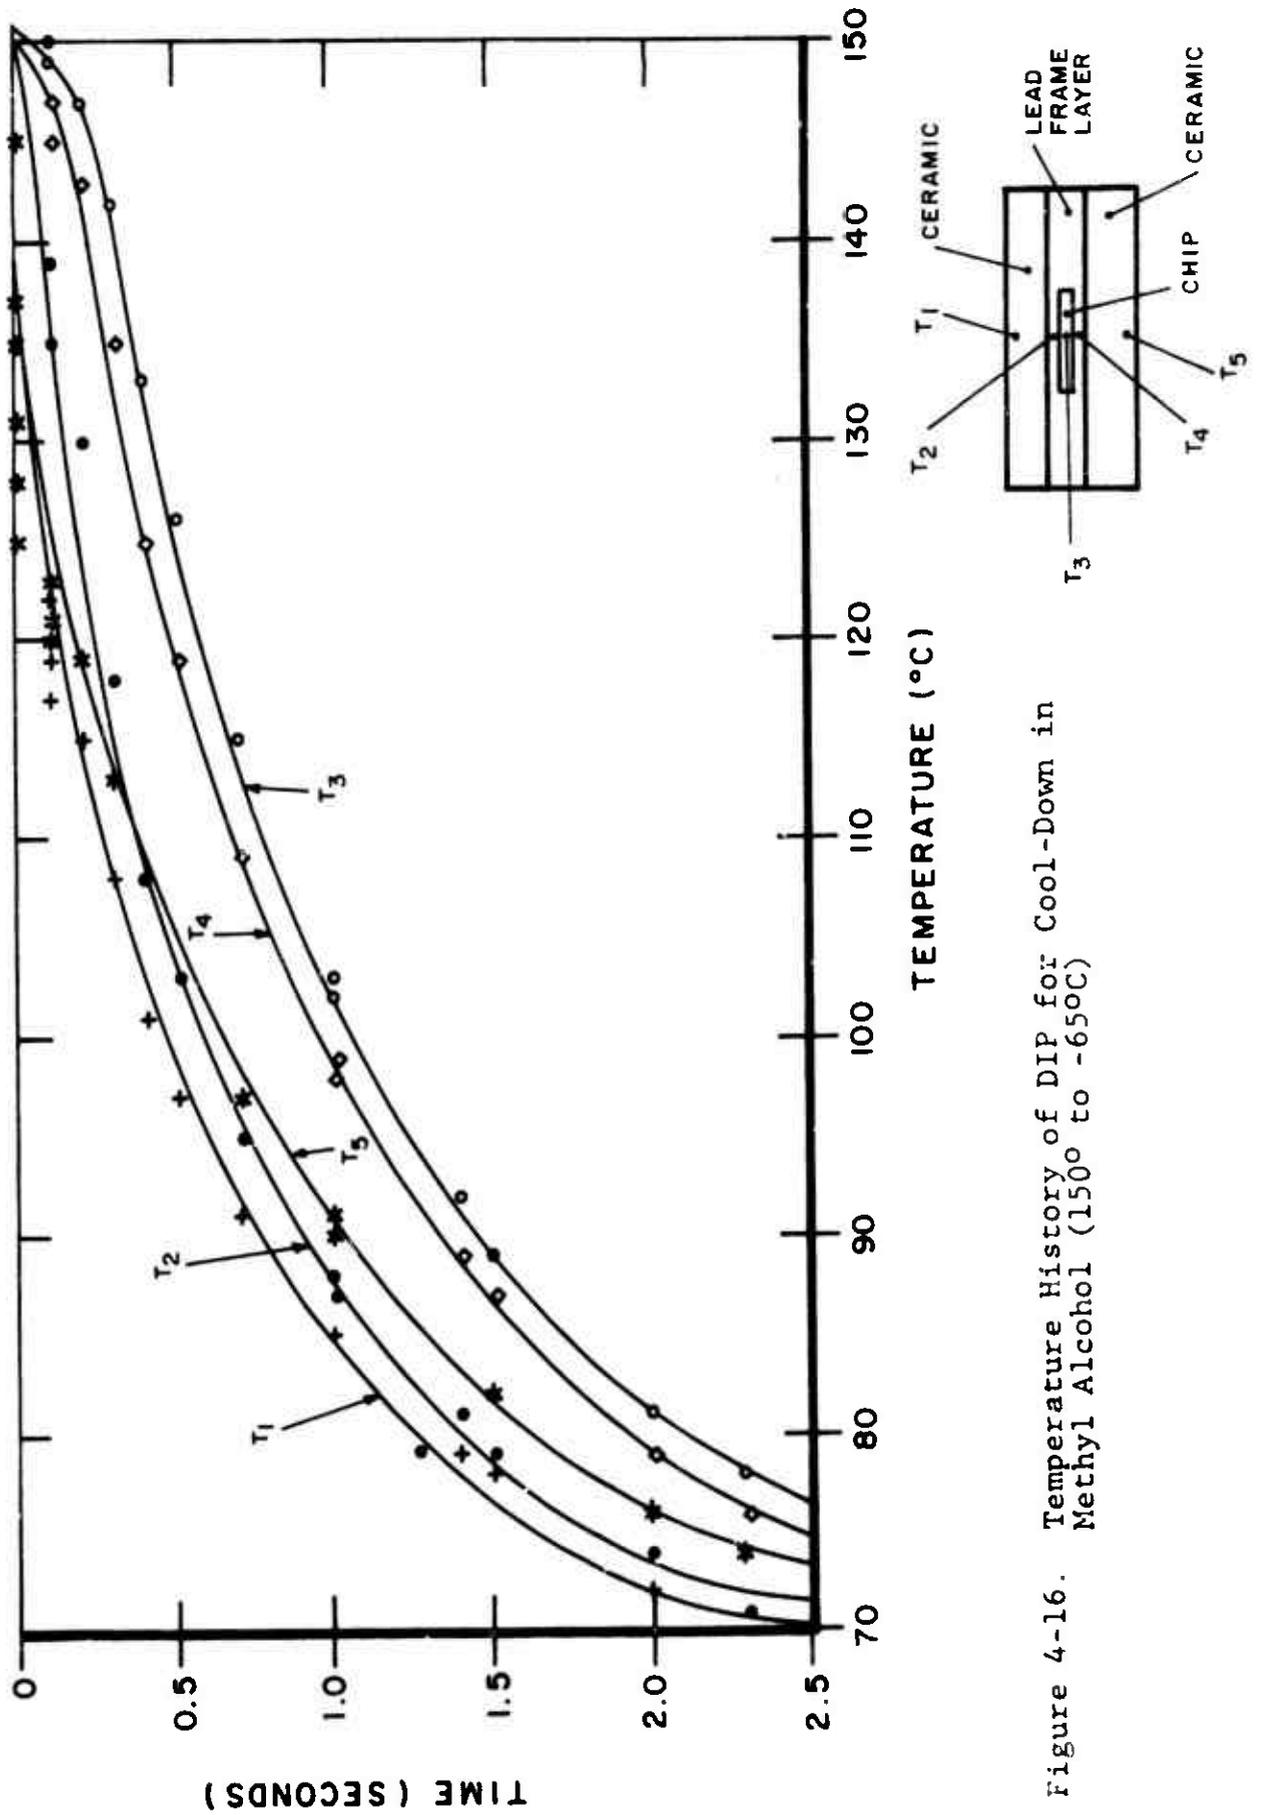
Figure 4-16. Temperature History of DIP for Cool-Down in Methyl Alcohol (150° to -65°C)

Both the cool-down and warm-up transient temperature response data was supplied as input data for the computer stress analysis of the package. However, prior to discussing the stress analysis, it is appropriate to make some additional comments concerning the thermal analysis. First, it was very difficult to obtain thermophysical properties of the Type 1 glass. The manufacturer indicated that the specific heat of the glass, as noted in Table IV-8 was $0.03 \text{ BTU/lb-}^{\circ}\text{F}$. This value is highly suspect

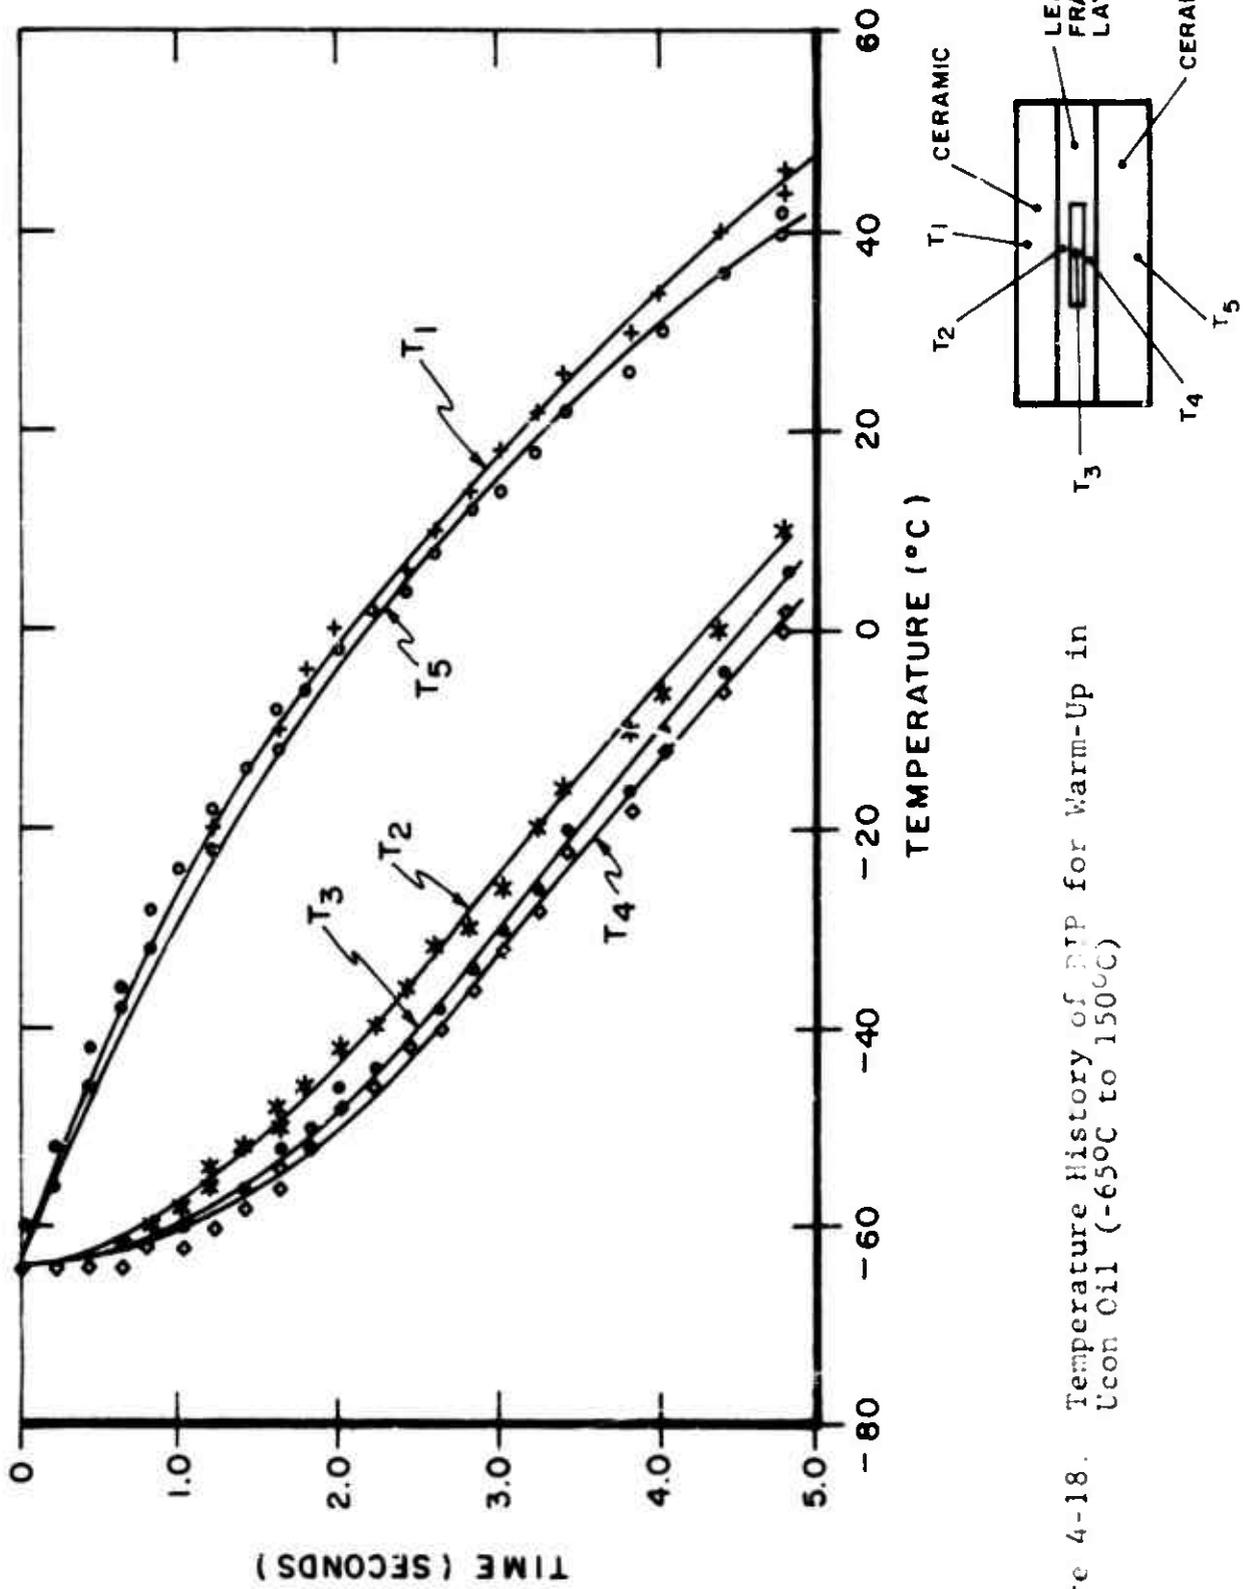
Figure 4-18. Temperature History of PIP for Warm-Up in Ucon Oil (-65°C to 150°C)

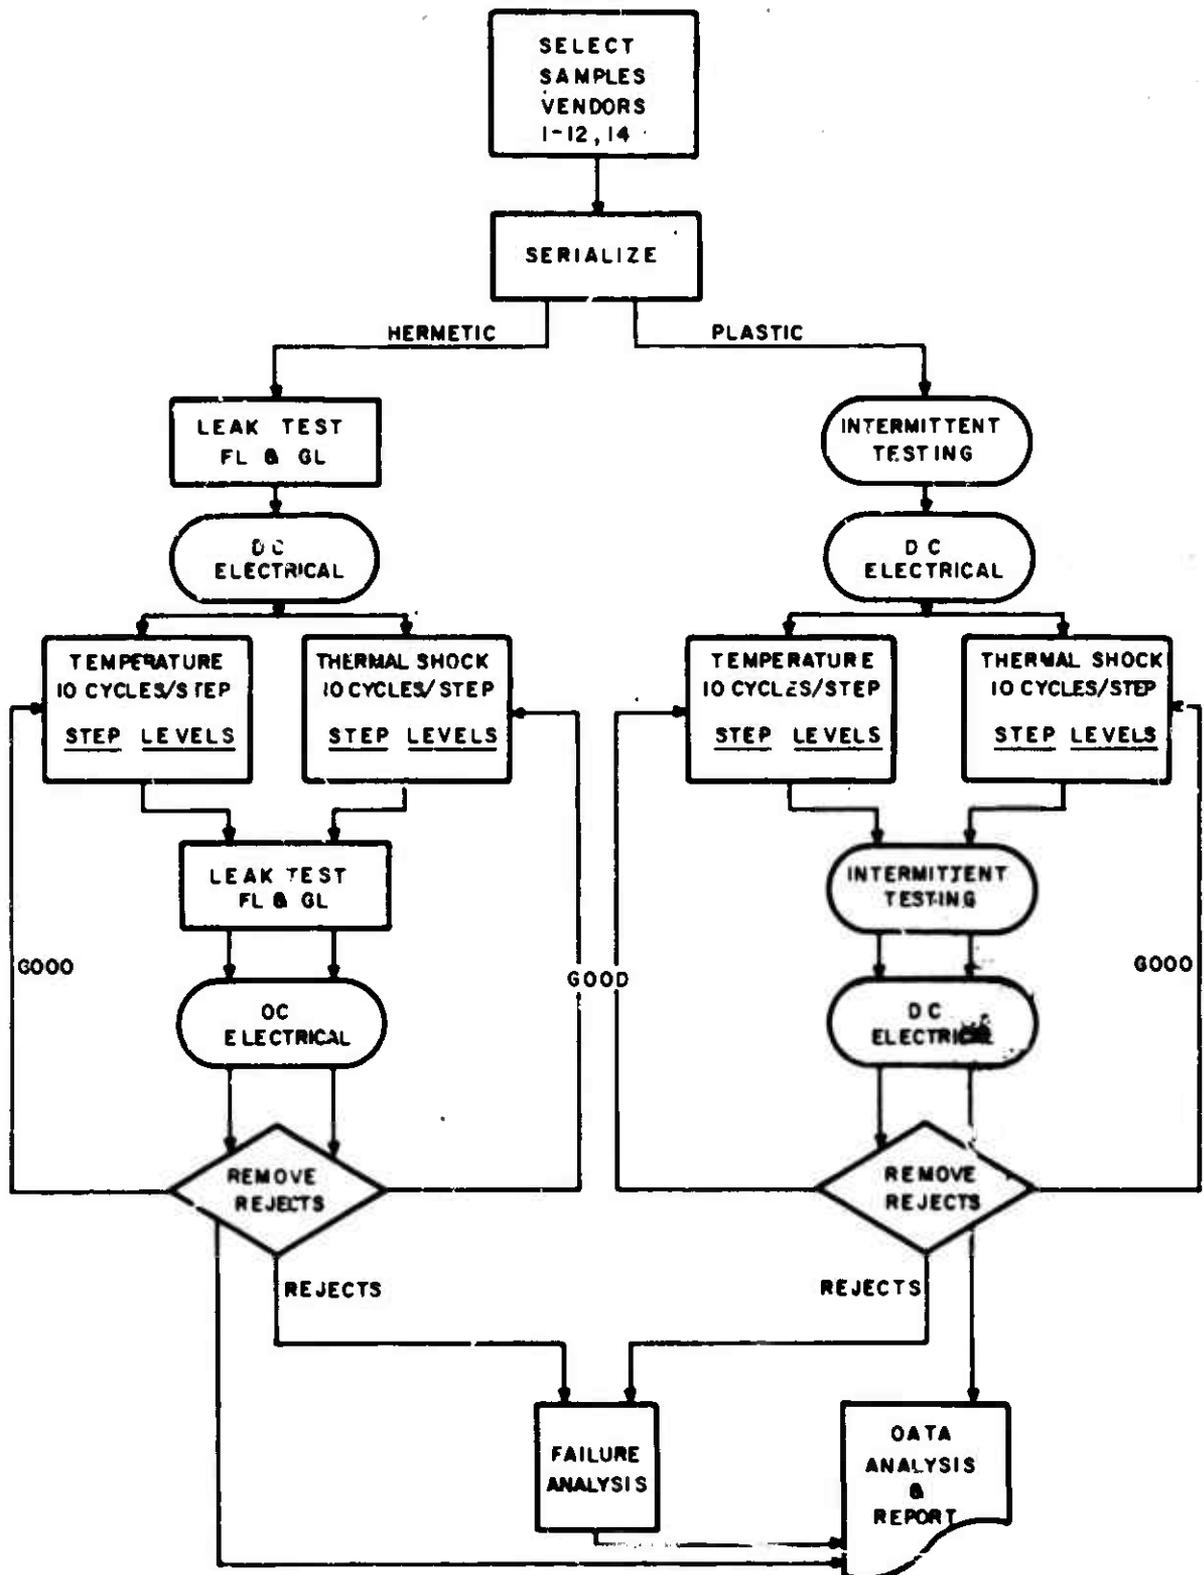
Figure 4-26. Thermal Cycling Step Stress Test Plan

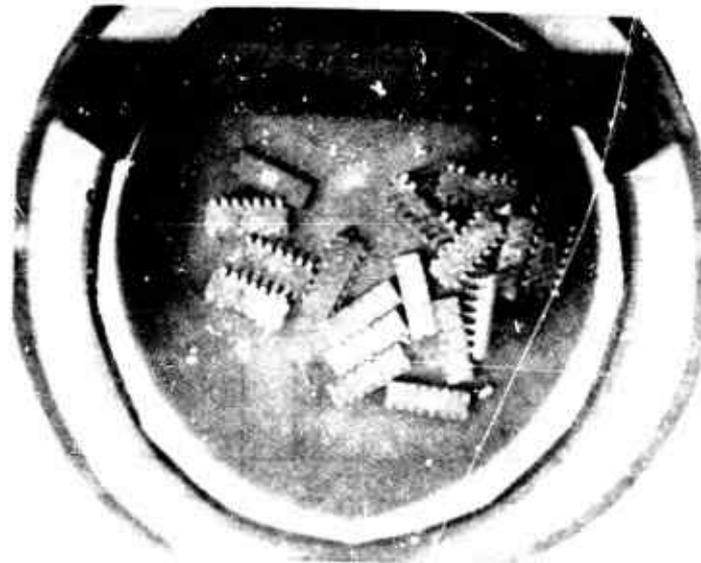
Figure 4-30. Vendor 9 Devices After 10 Cycles
Thermal Shock Method 1010D
(-65°C to 200°C)

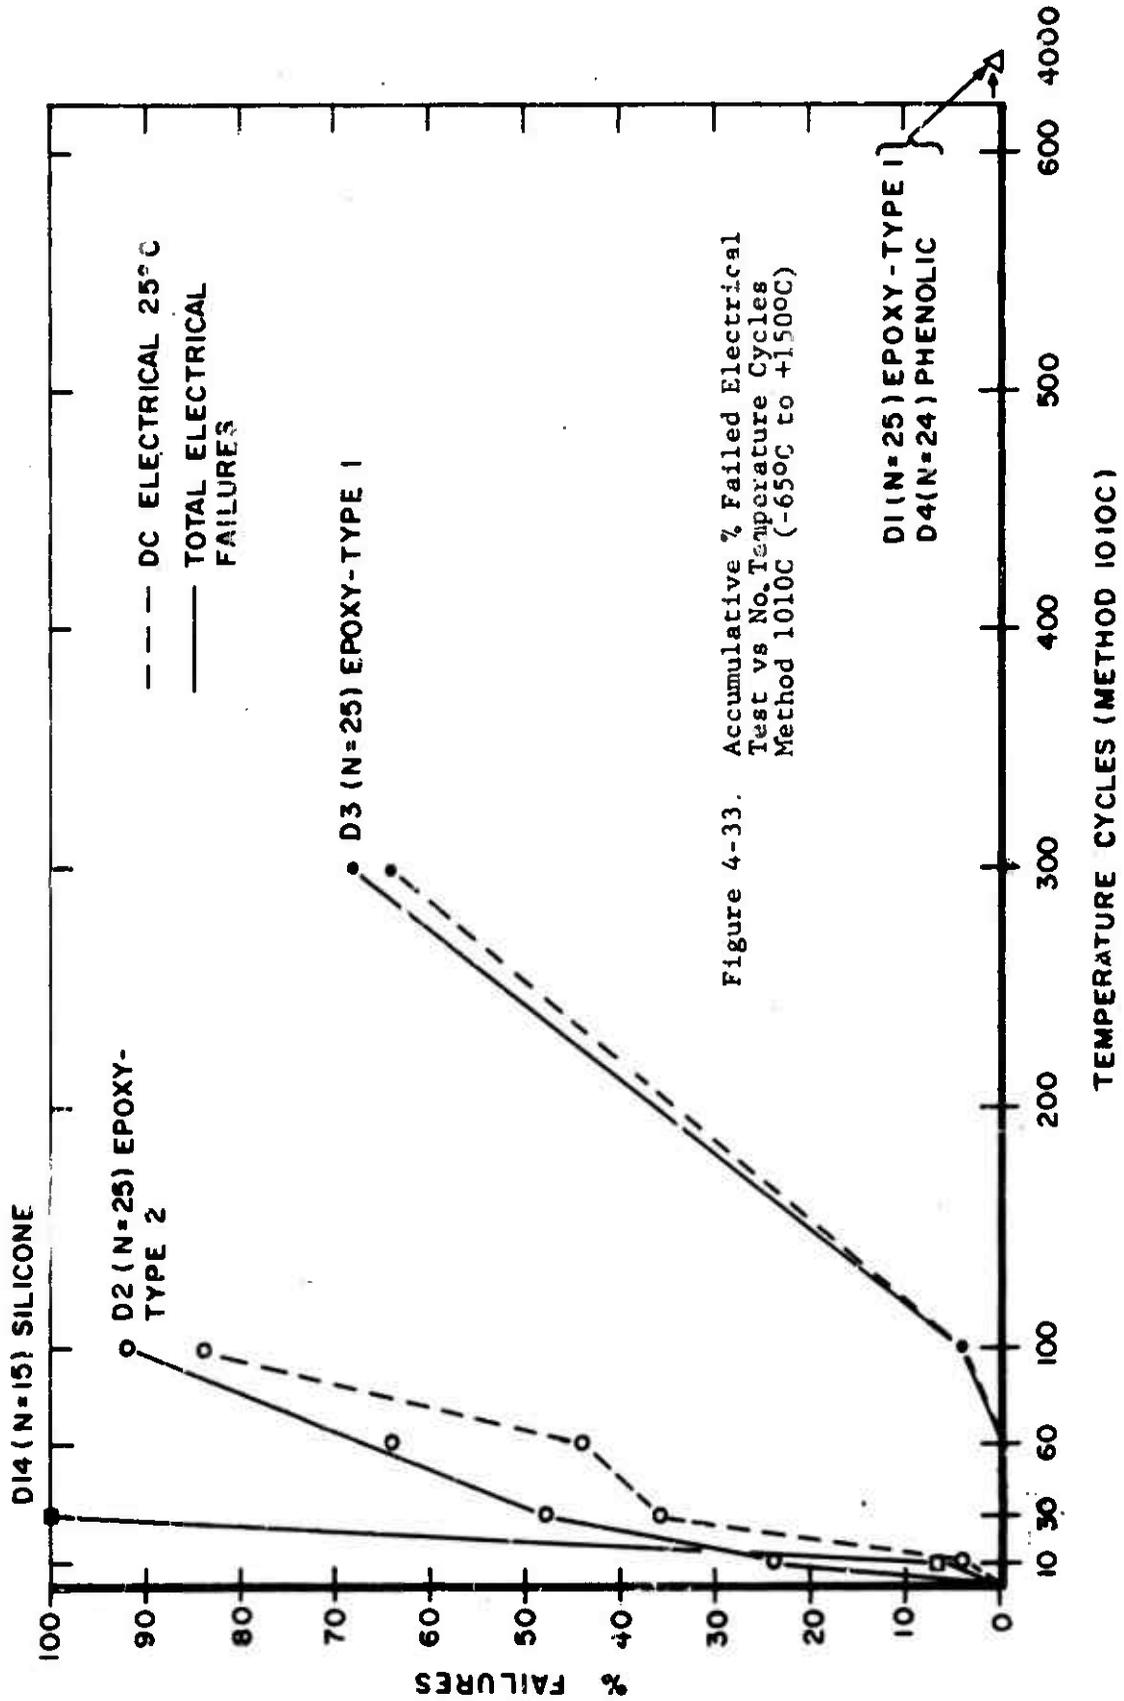
Figure 4-33. Accumulative % Failed Electrical Test vs No. Temperature Cycles Method 1010C (-65°C to +150°C)

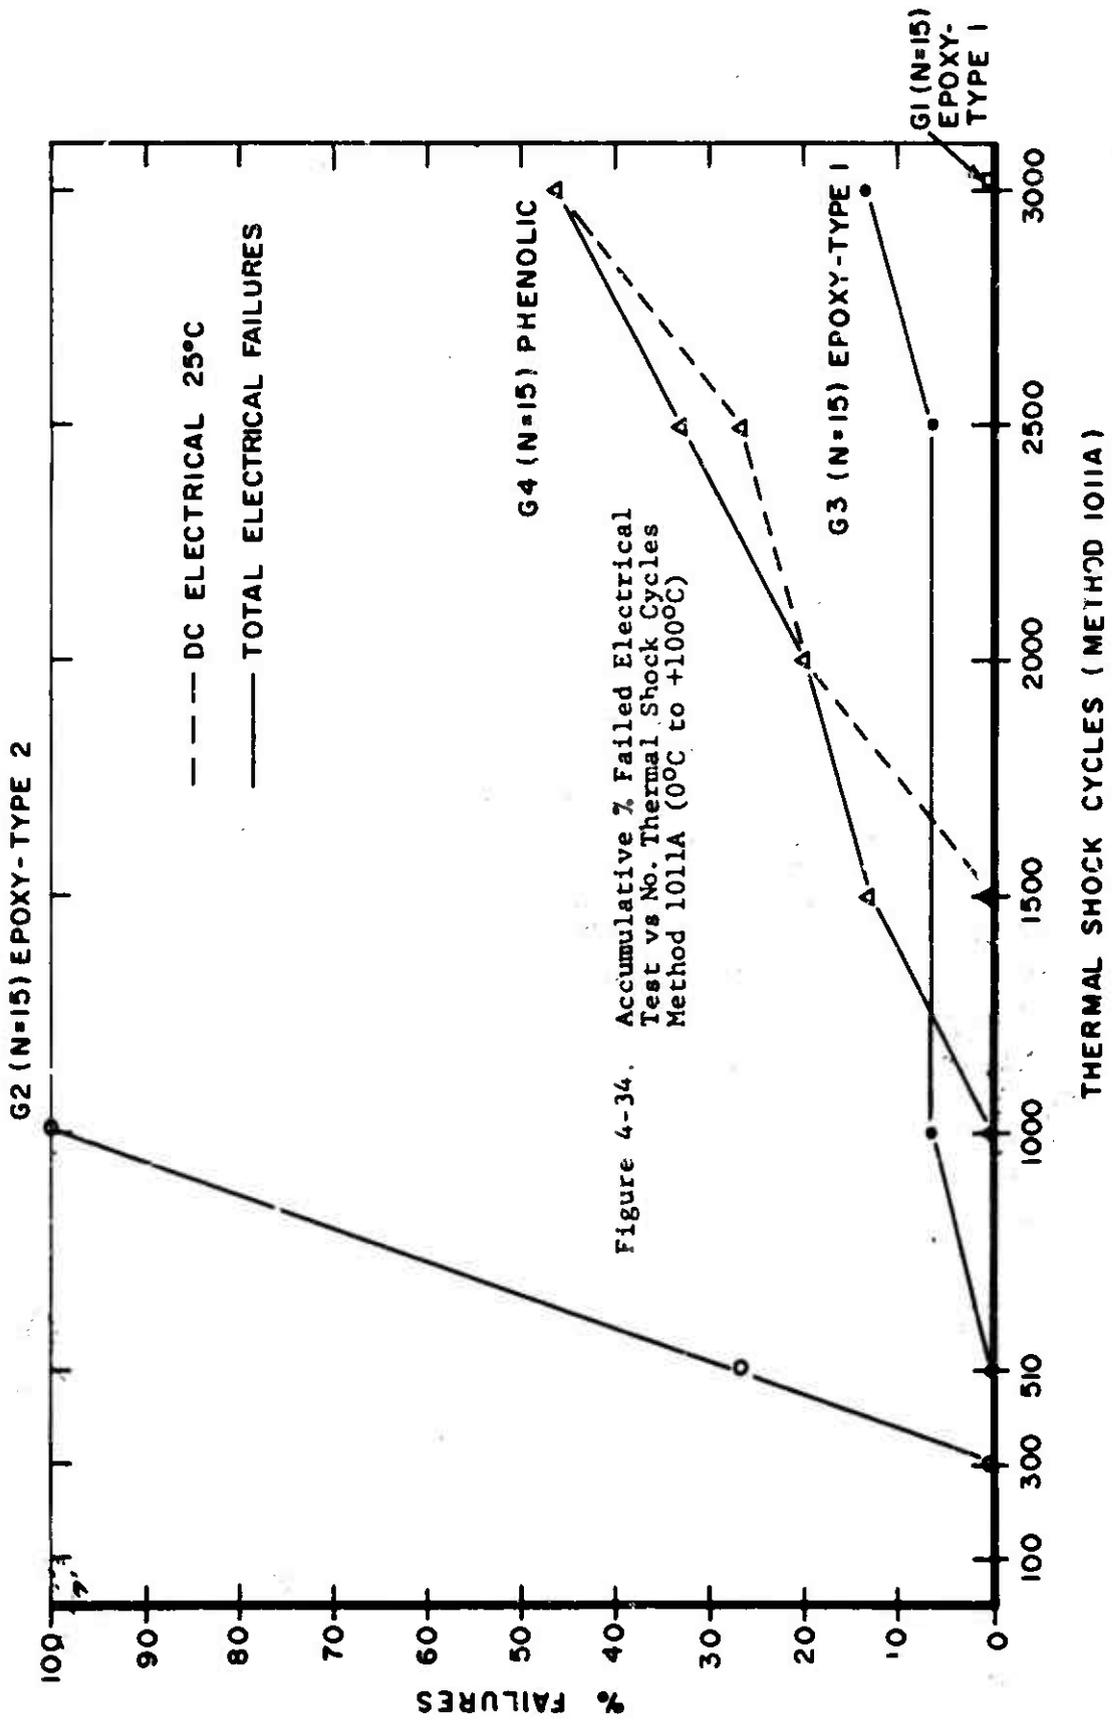
Figure 4-34. Accumulative % Failed Electrical Test vs No. Thermal Shock Cycles Method 1011A (0°C to +100°C)

The results of repeated thermal shock cycling per Method 1011 Level A and Level C are shown in Figures 4-34 and 4-35. A comparison of these Figures shows that as the stress level increased from Test Condition A to Test Condition C, the failures were apparently accelerated in Vendor 2 and Vendor 3 devices at the higher stress level. Vendor 4 devices, however, showed greater susceptibility to Test Condition A Thermal Shock than to Test Condition C. The reasons for this are related to the historic susceptibility of the phenolic package to moisture (water is used

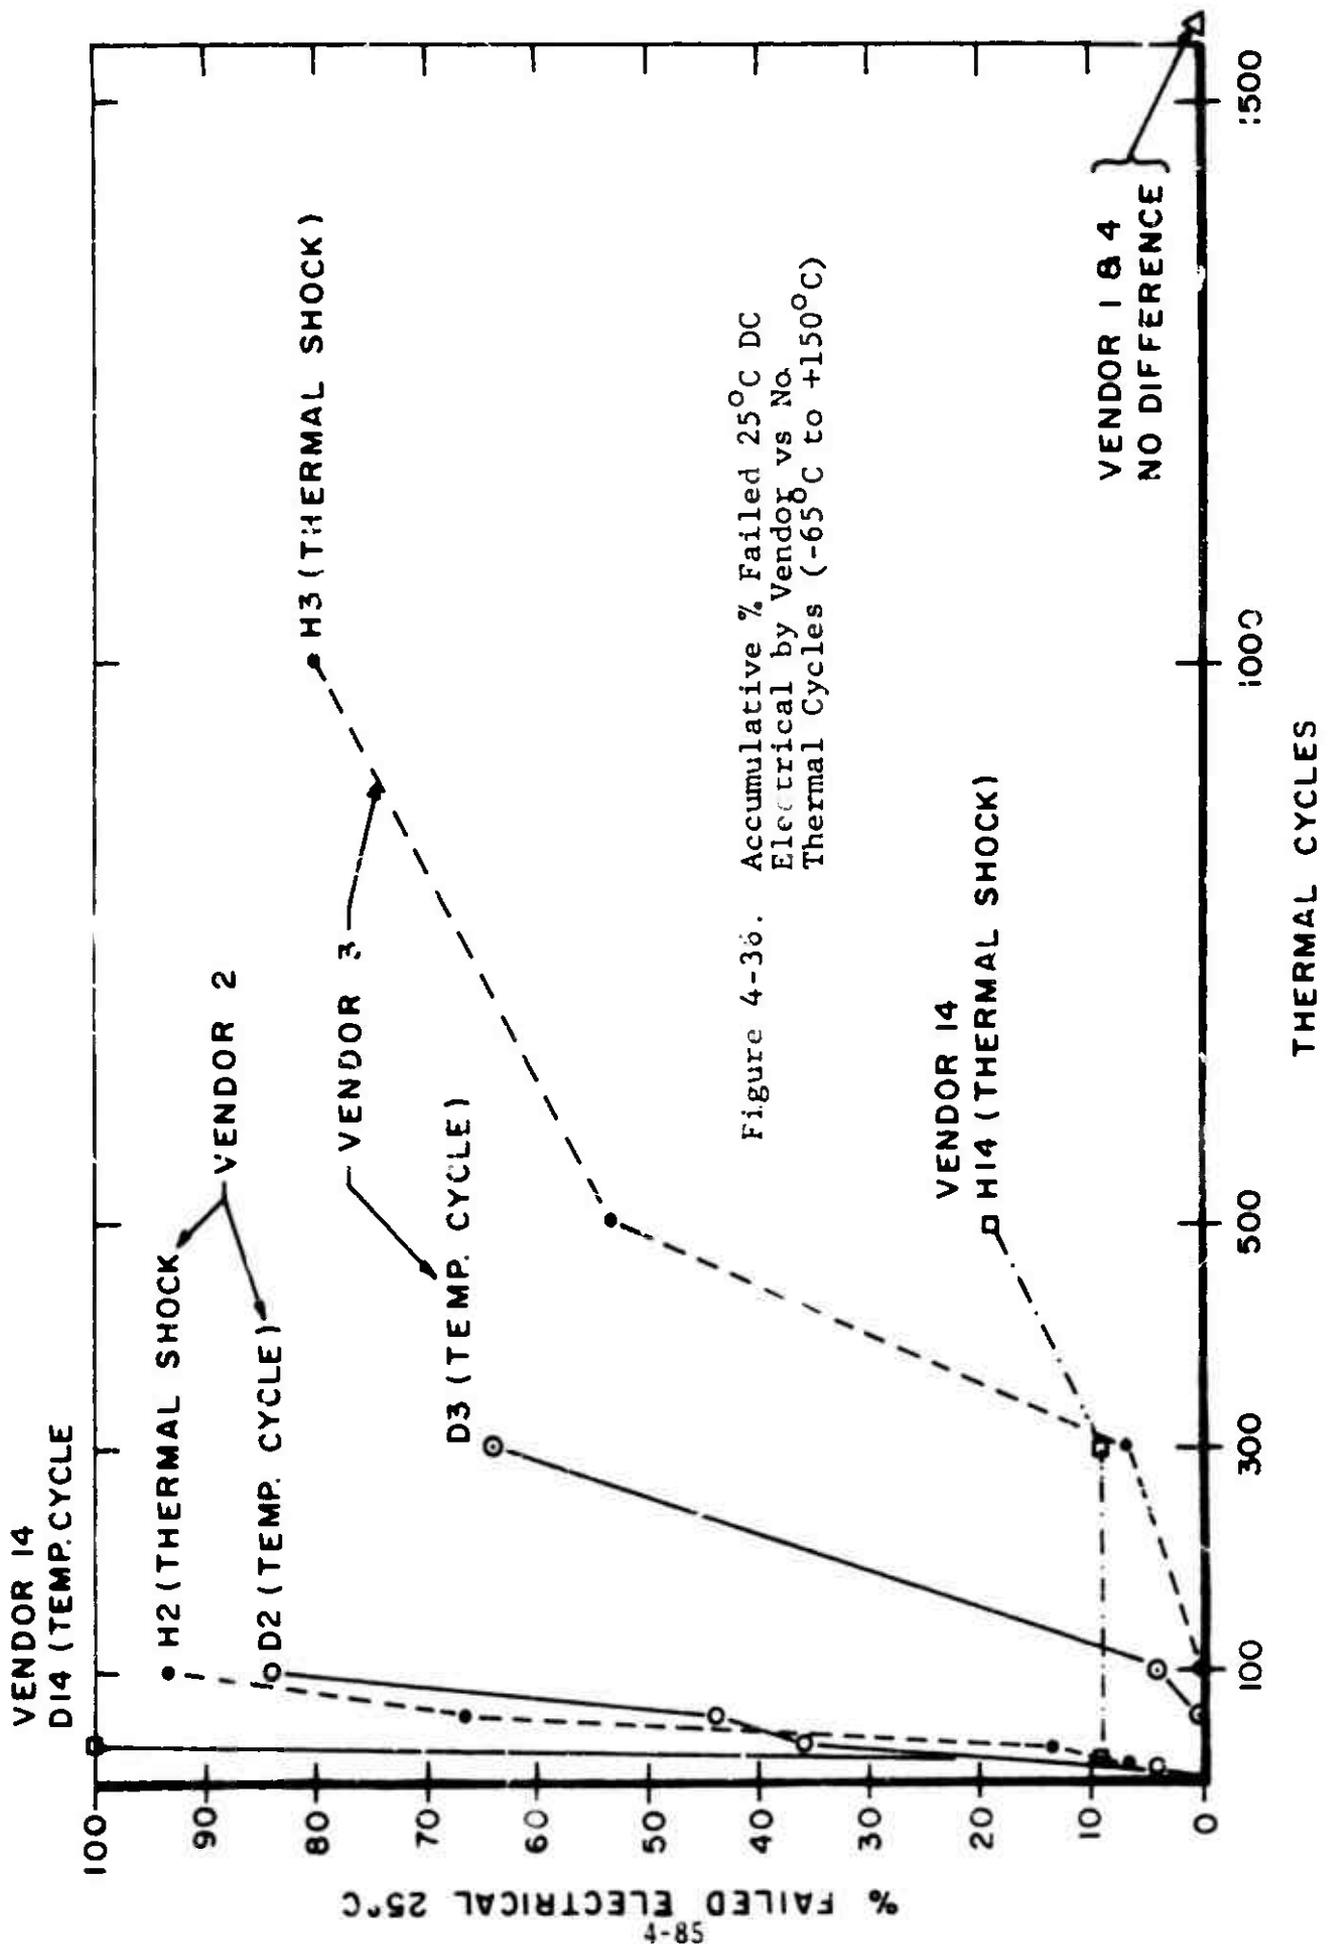
Figure 4-36. Accumulative % Failed 25°C DC Electrical by Vendor vs No. Thermal Cycles (-65°C to +150°C)

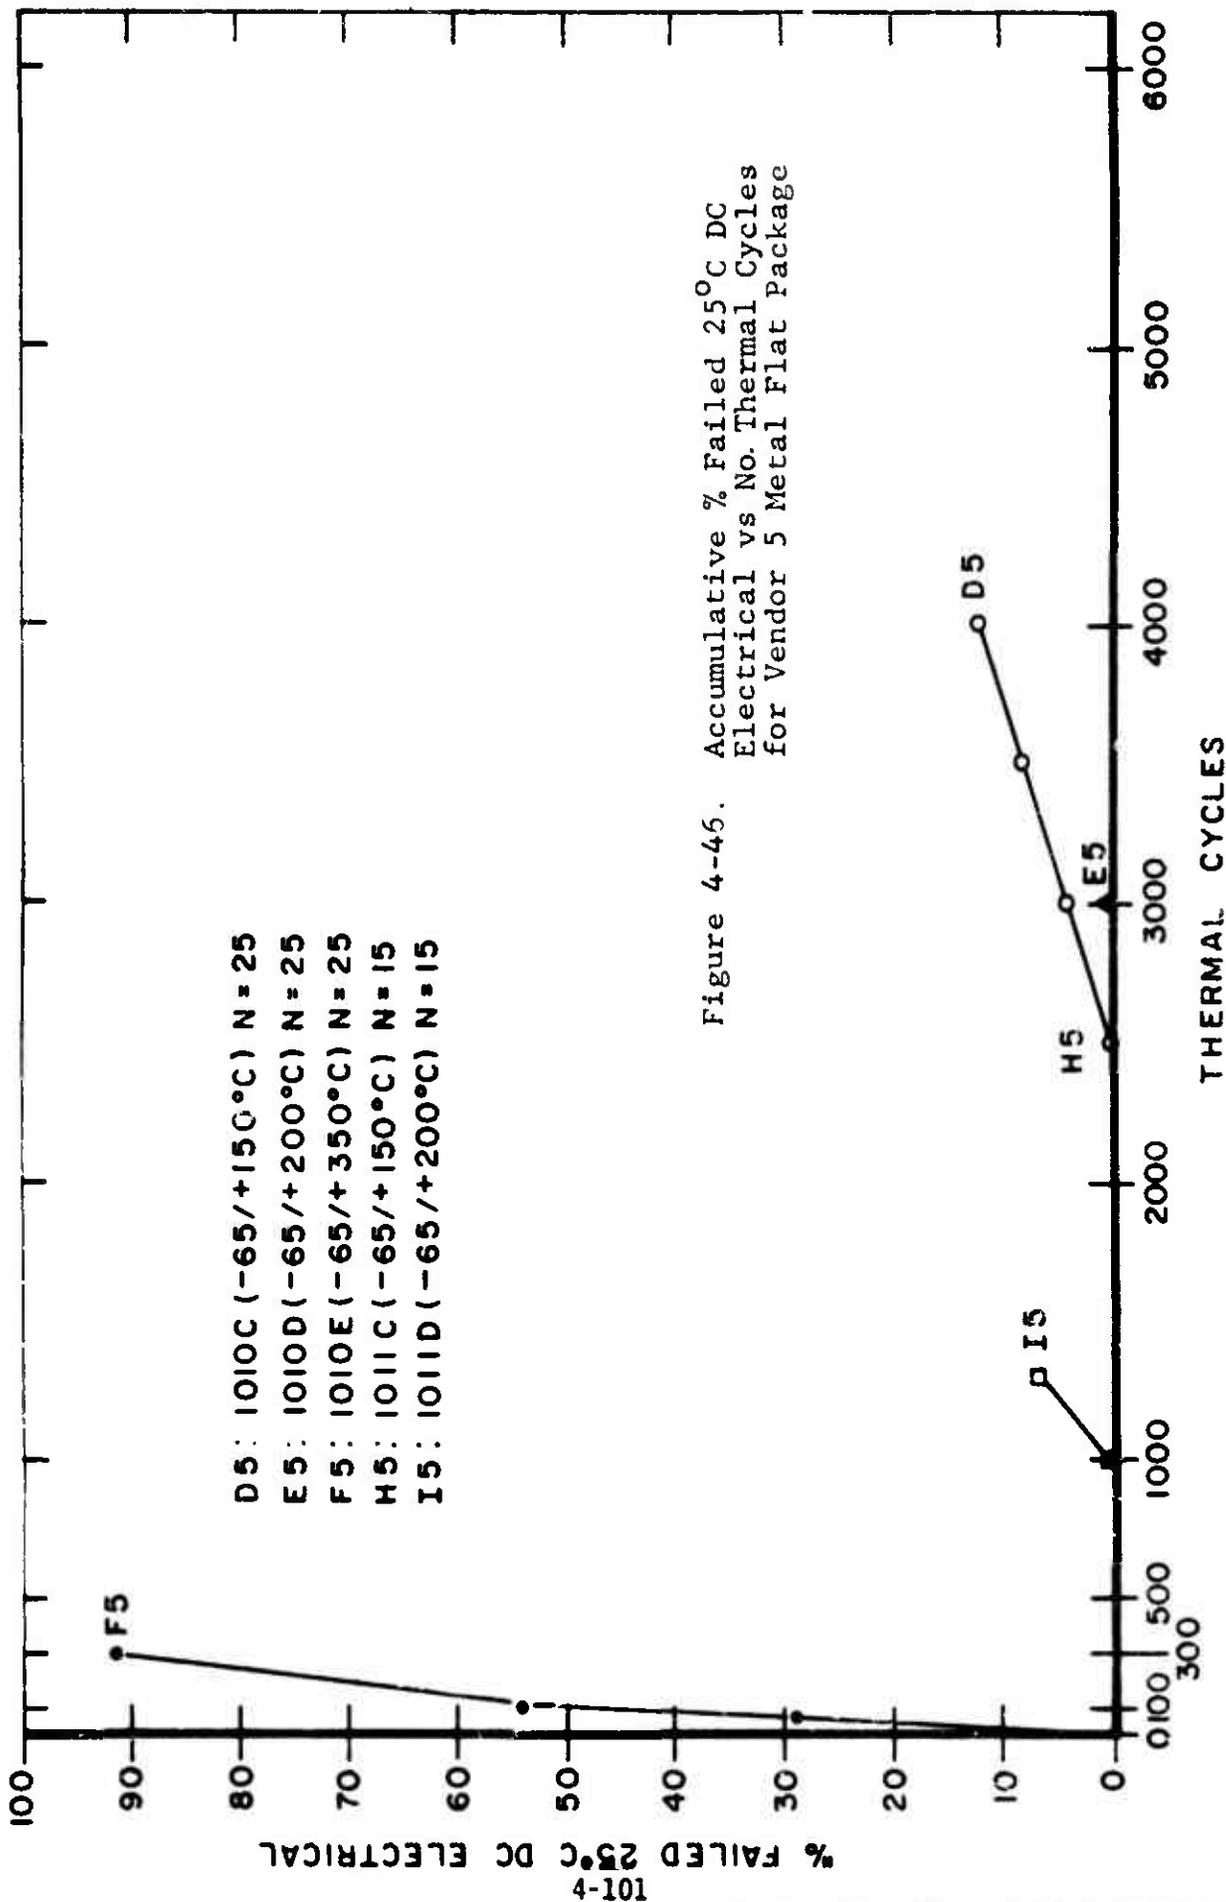
Figure 4-46. Accumulative % Failed 25°C DC Electrical vs No. Thermal Cycles for Vendor 5 Metal Flat Package

The electrical test results are given in Figures 4-46, 4-47 and 4-48 for Vendors 5, 6 and 7, respectively.

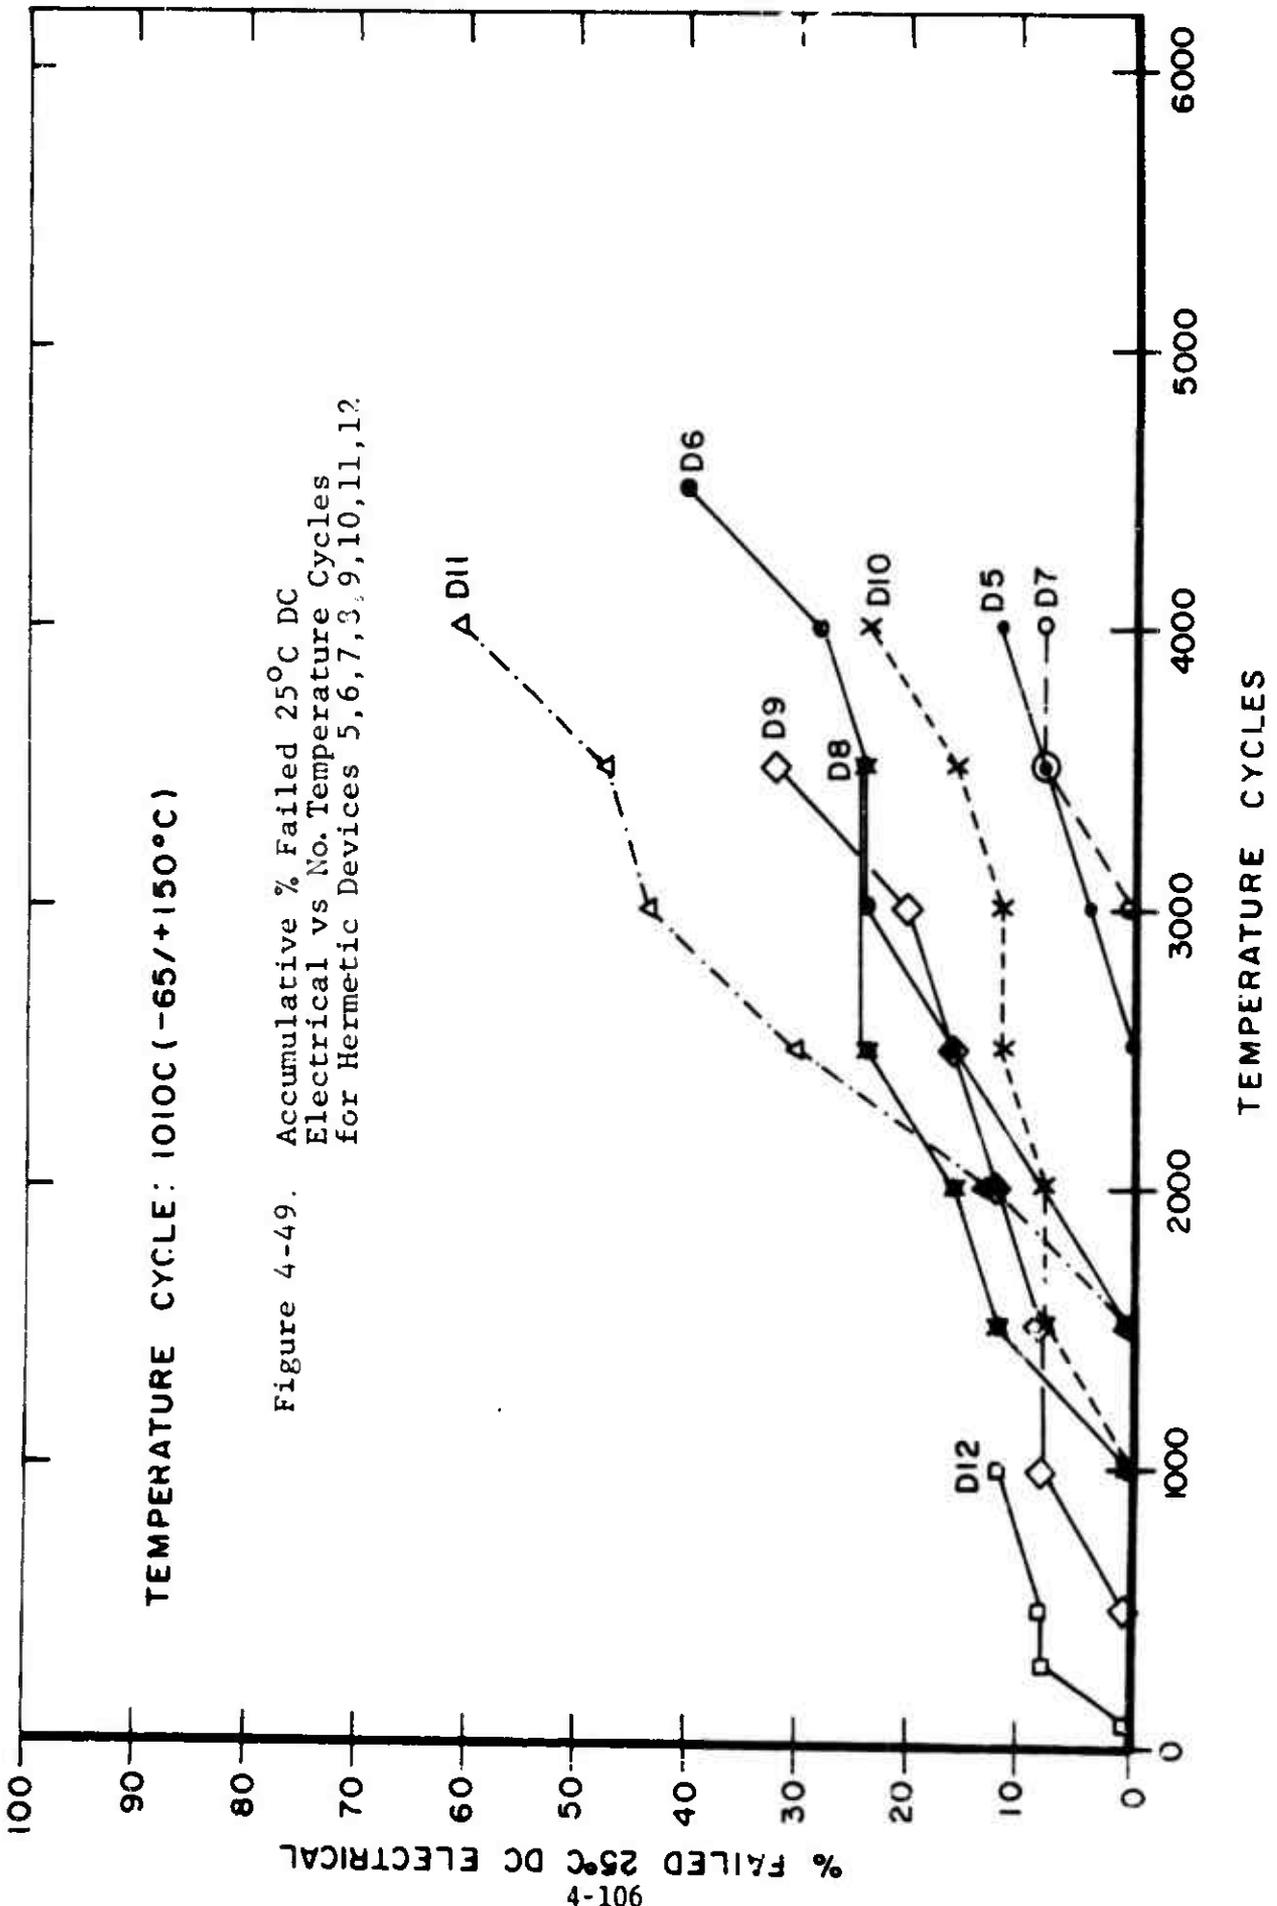
Figure 4-49. Accumulative % Failed 25°C DC Electrical vs No. Temperature Cycles for Hermetic Devices 5,6,7,8,9,10,11,12

In addition, long term cycling induces mechanical fatigue failure at the heel of the bonds in ceramic devices, giving rise to a wearout characteristic which is approximately linear with respect to the number of cycles.

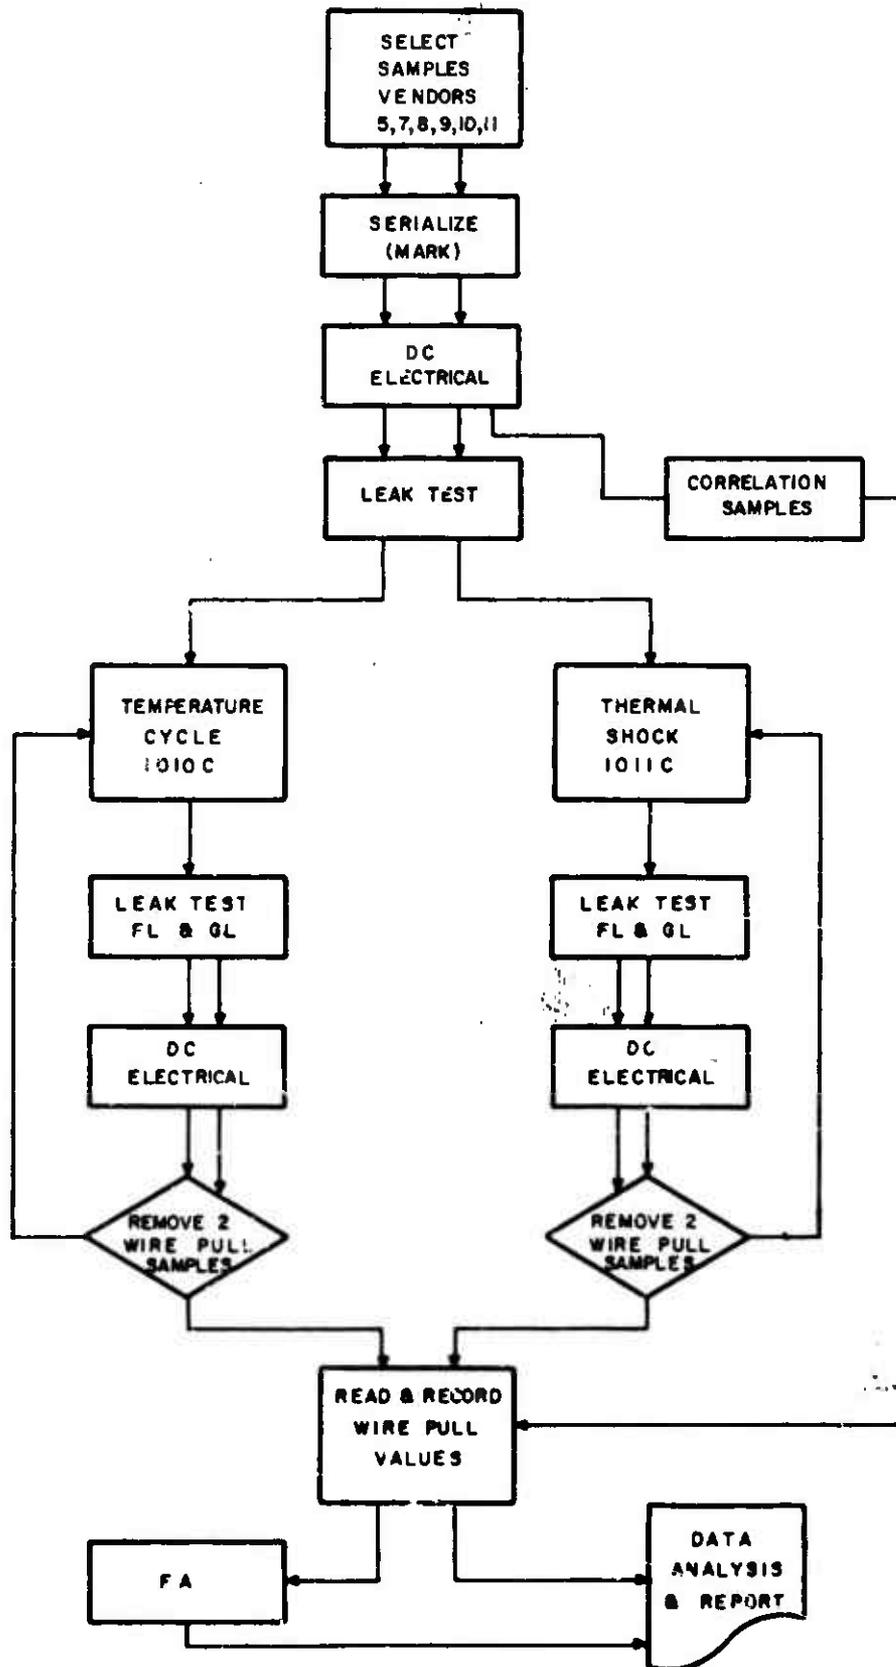
Figure 4-52. Basic Wire Pull Degradation Test Plan

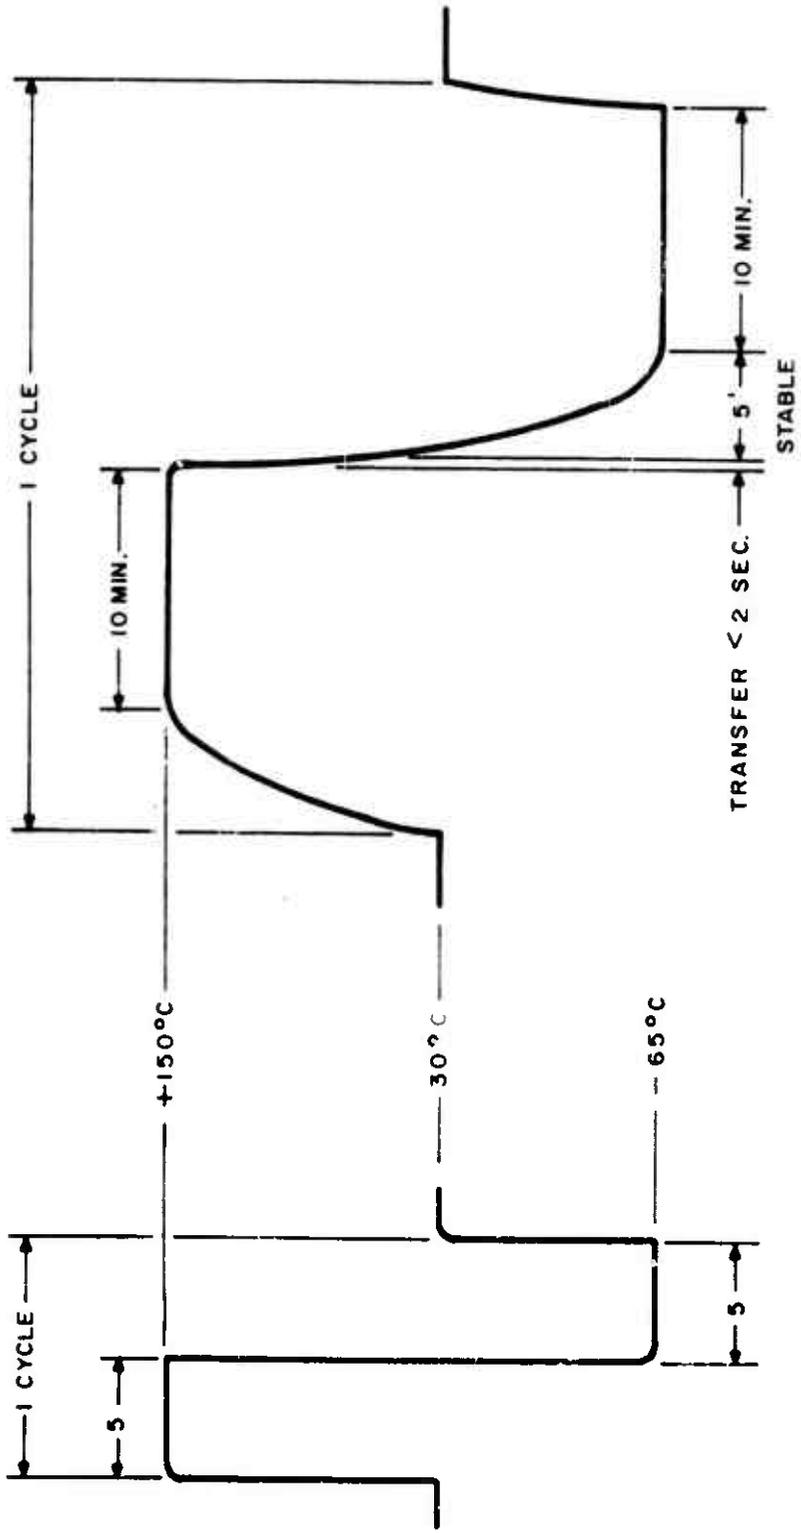
Figure 4-53 Comparison of Thermal Shock with Temperature Cycling
