RADC-TR-75-134
Final Technical Report
May 1975

THERMOMECHANICAL TESTING TECHNIQUES FOR MICROCIRCUITS

Motorola, Inc.

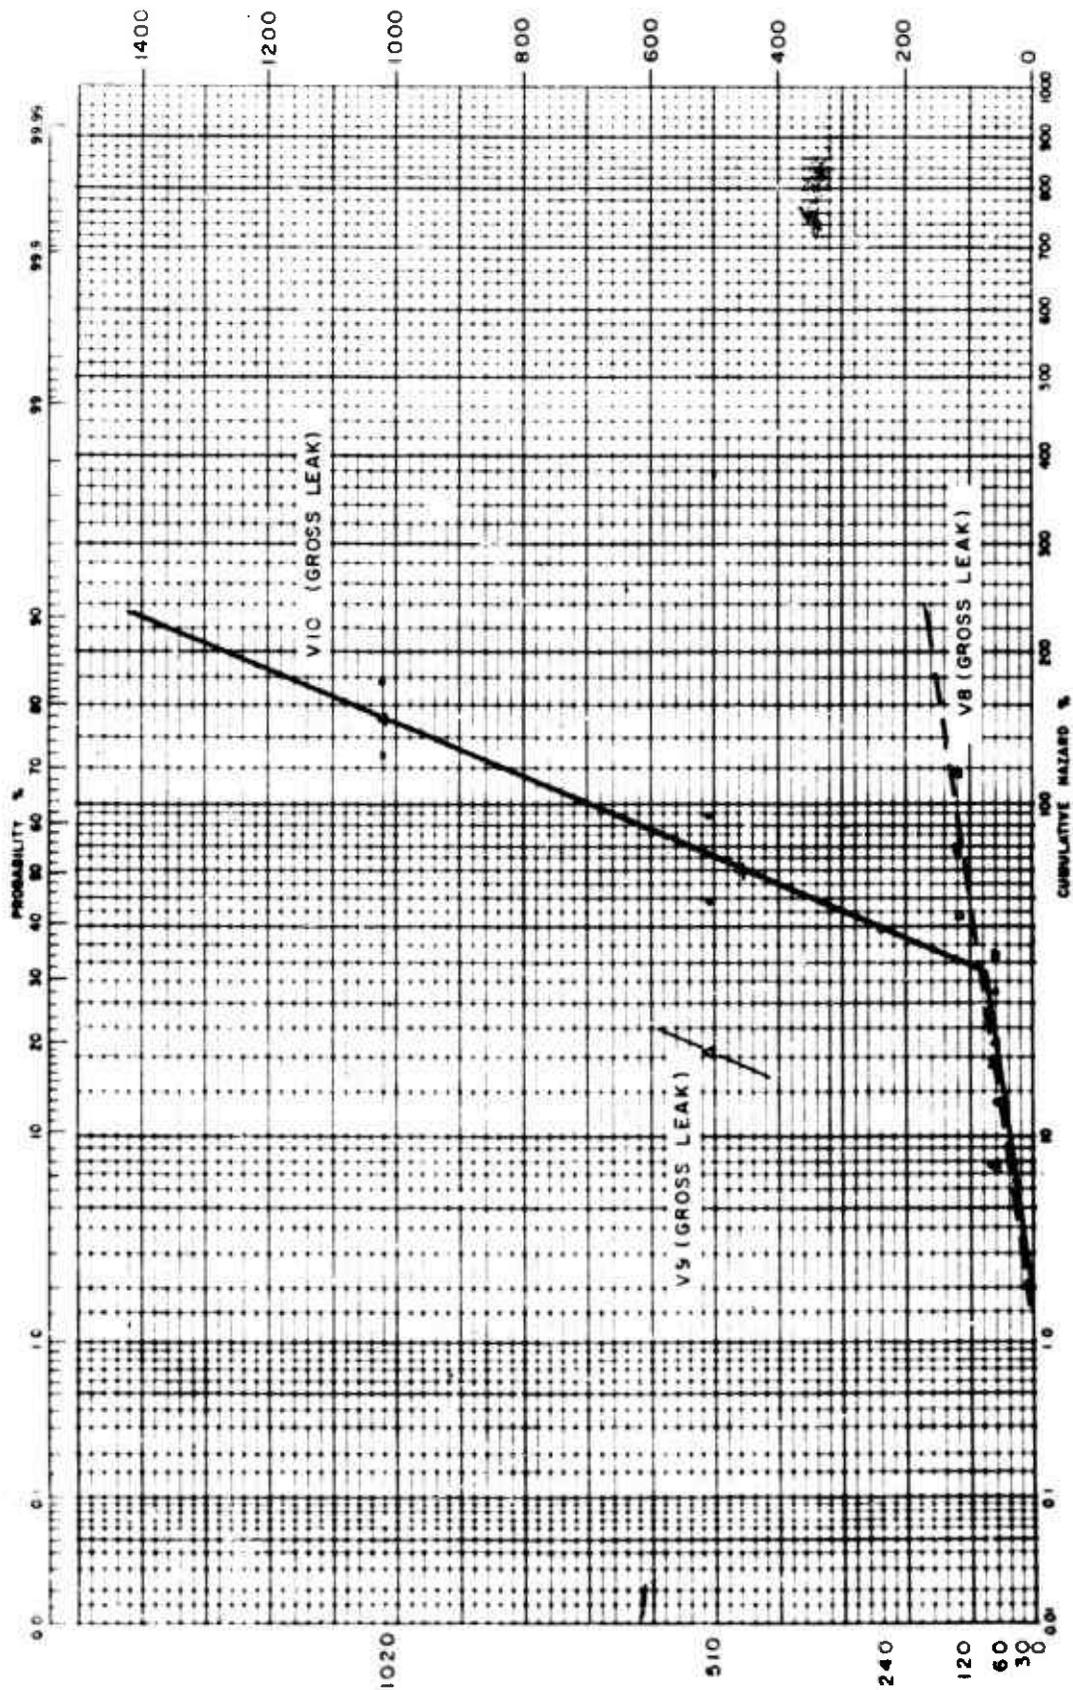
Figure 4-54. Distribution of Gross Leak Failures - Thermal Shock (1011C, -65°/+150°C)

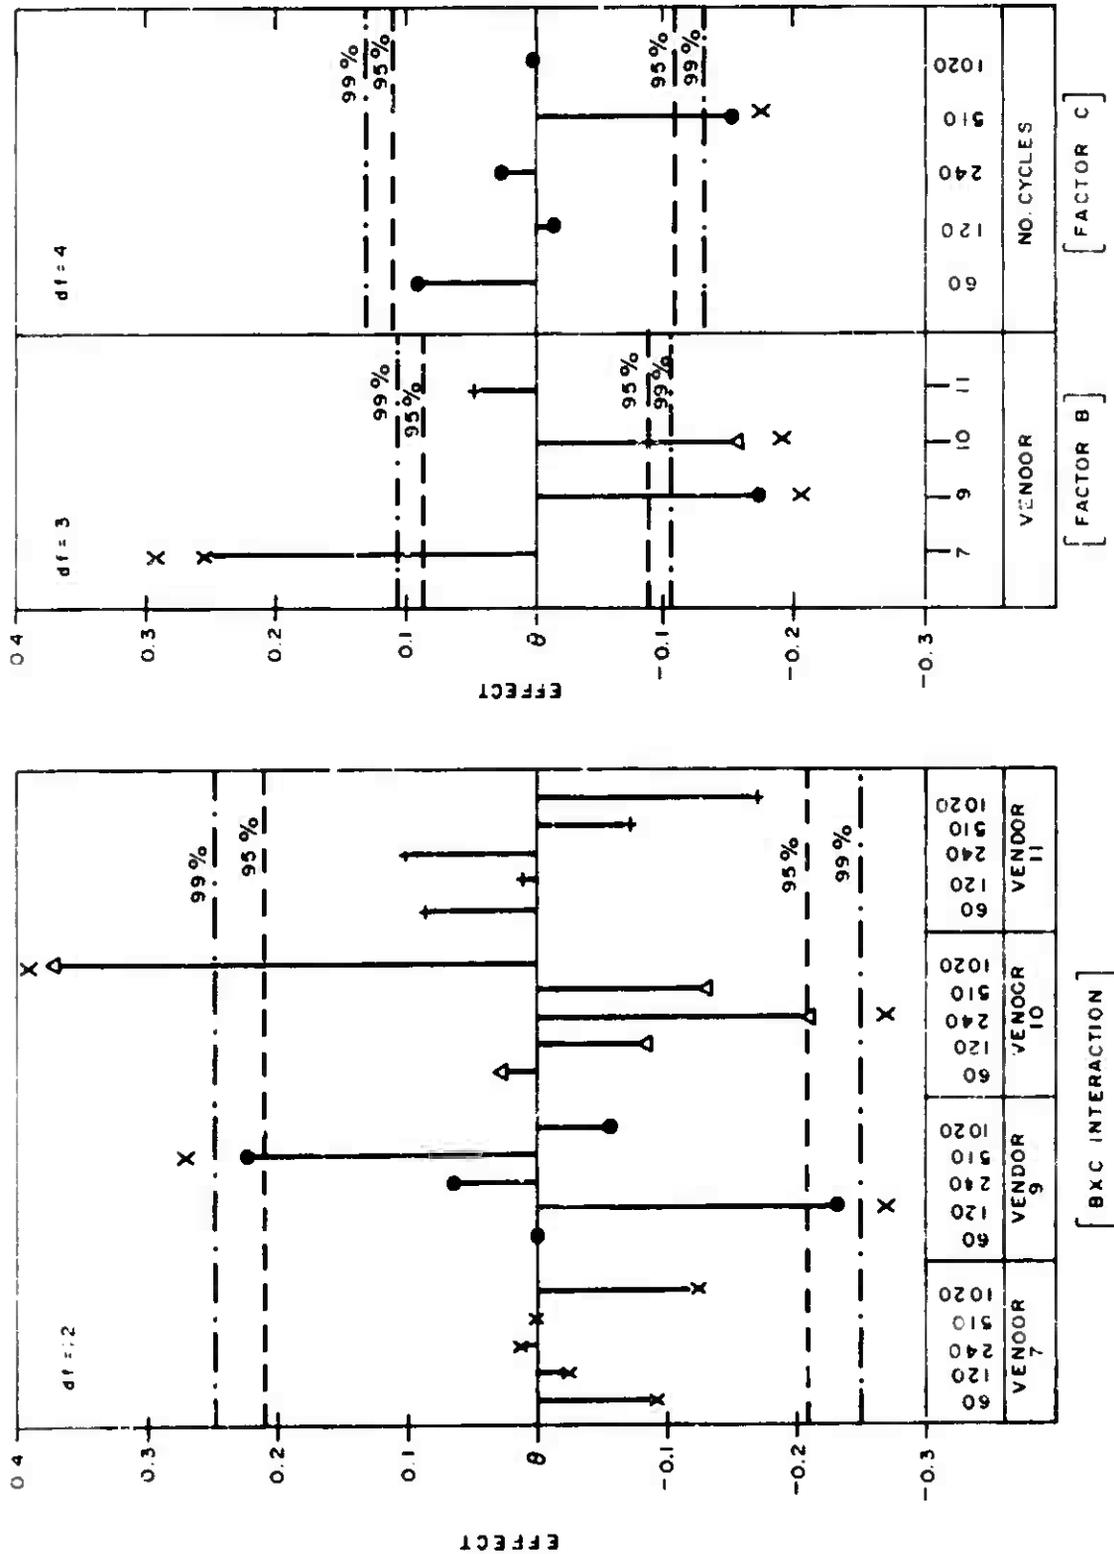
Figure 4-55. Analysis of Means - Wire Pull Strength

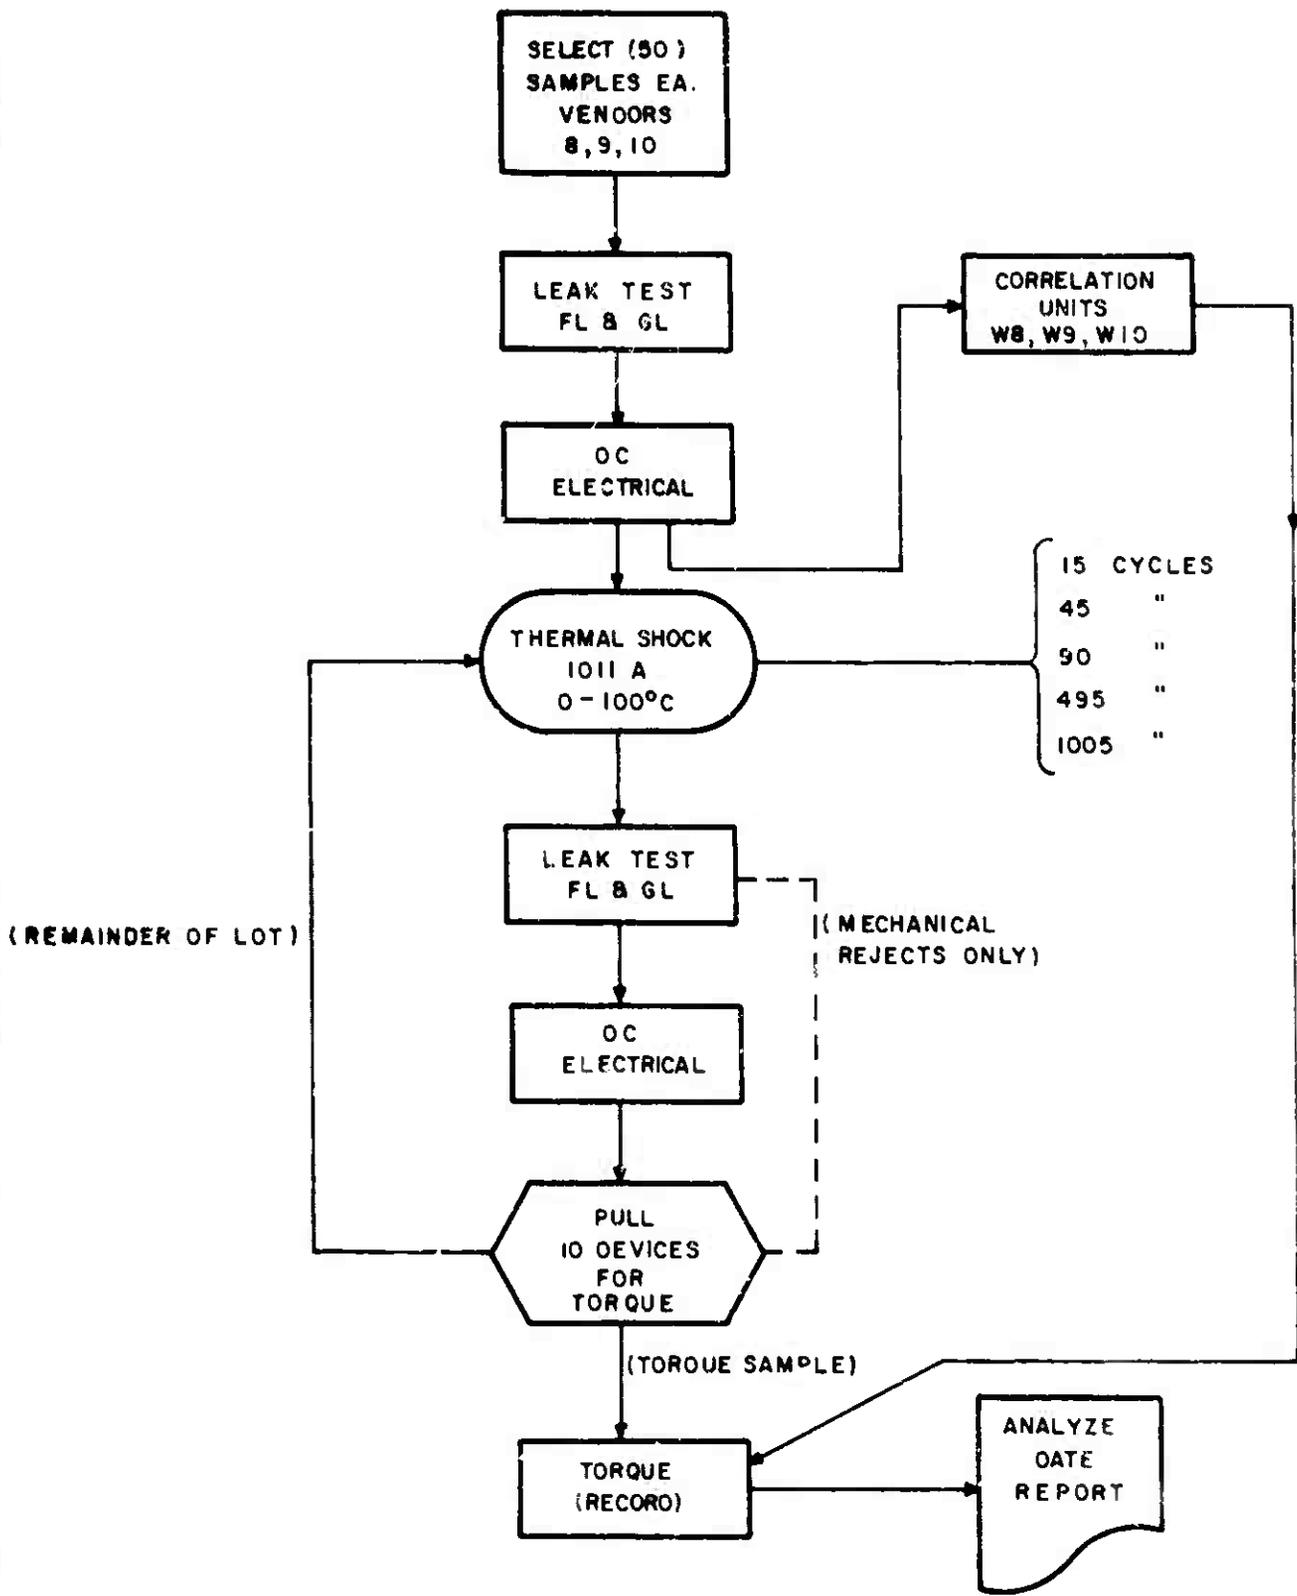
Figure 4-74. Torque Evaluation Test Plan

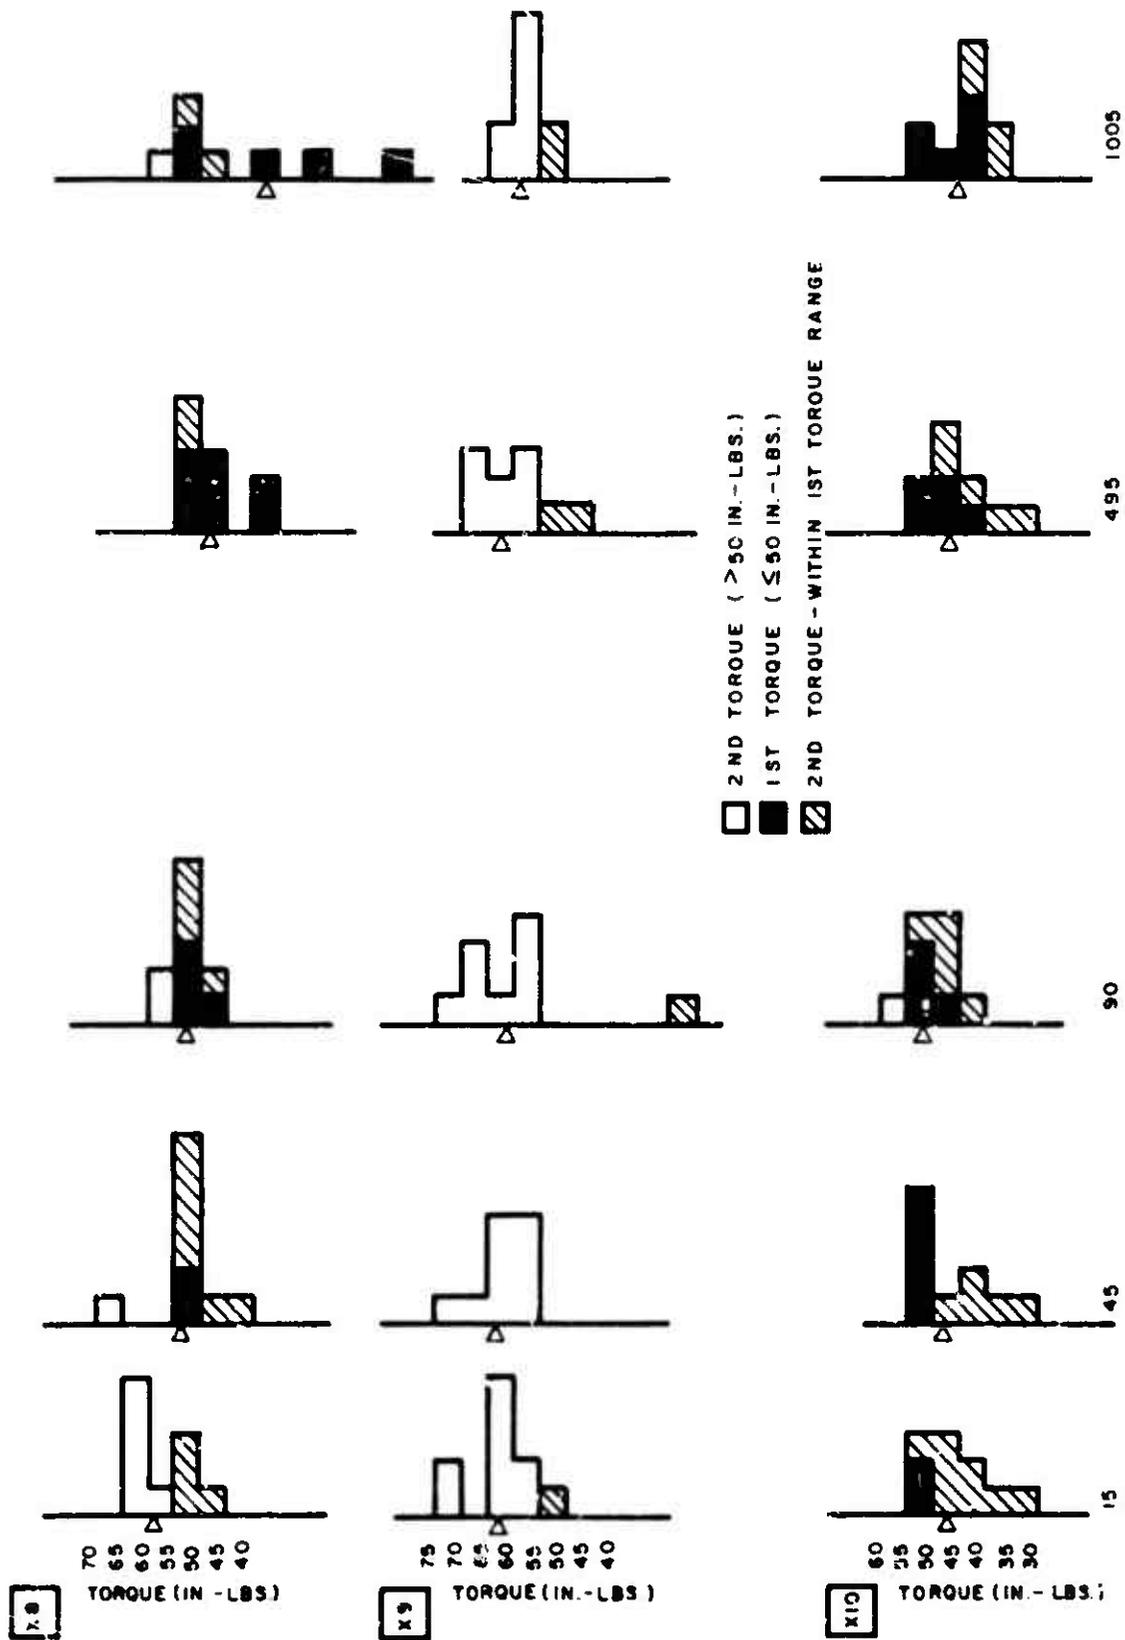
Figure 4-77. Torque Histograms vs No. Thermal Shock Cycles - Vendors 8, 9, and 10

Histograms of the torque values from samples X 8, X9, and X 10 are plotted in Figure 4-77. This figure shows that Vendor 9 had the most consistent torque distributions except for one maverick (below 3 sigma limit) reading after 90 cycles. Most of the torque values were above 50 inch - lbs and only a few readings taken with the larger torque wrench were less than 50 inch - lbs. This indicates the first 50 inch - lb torque application.

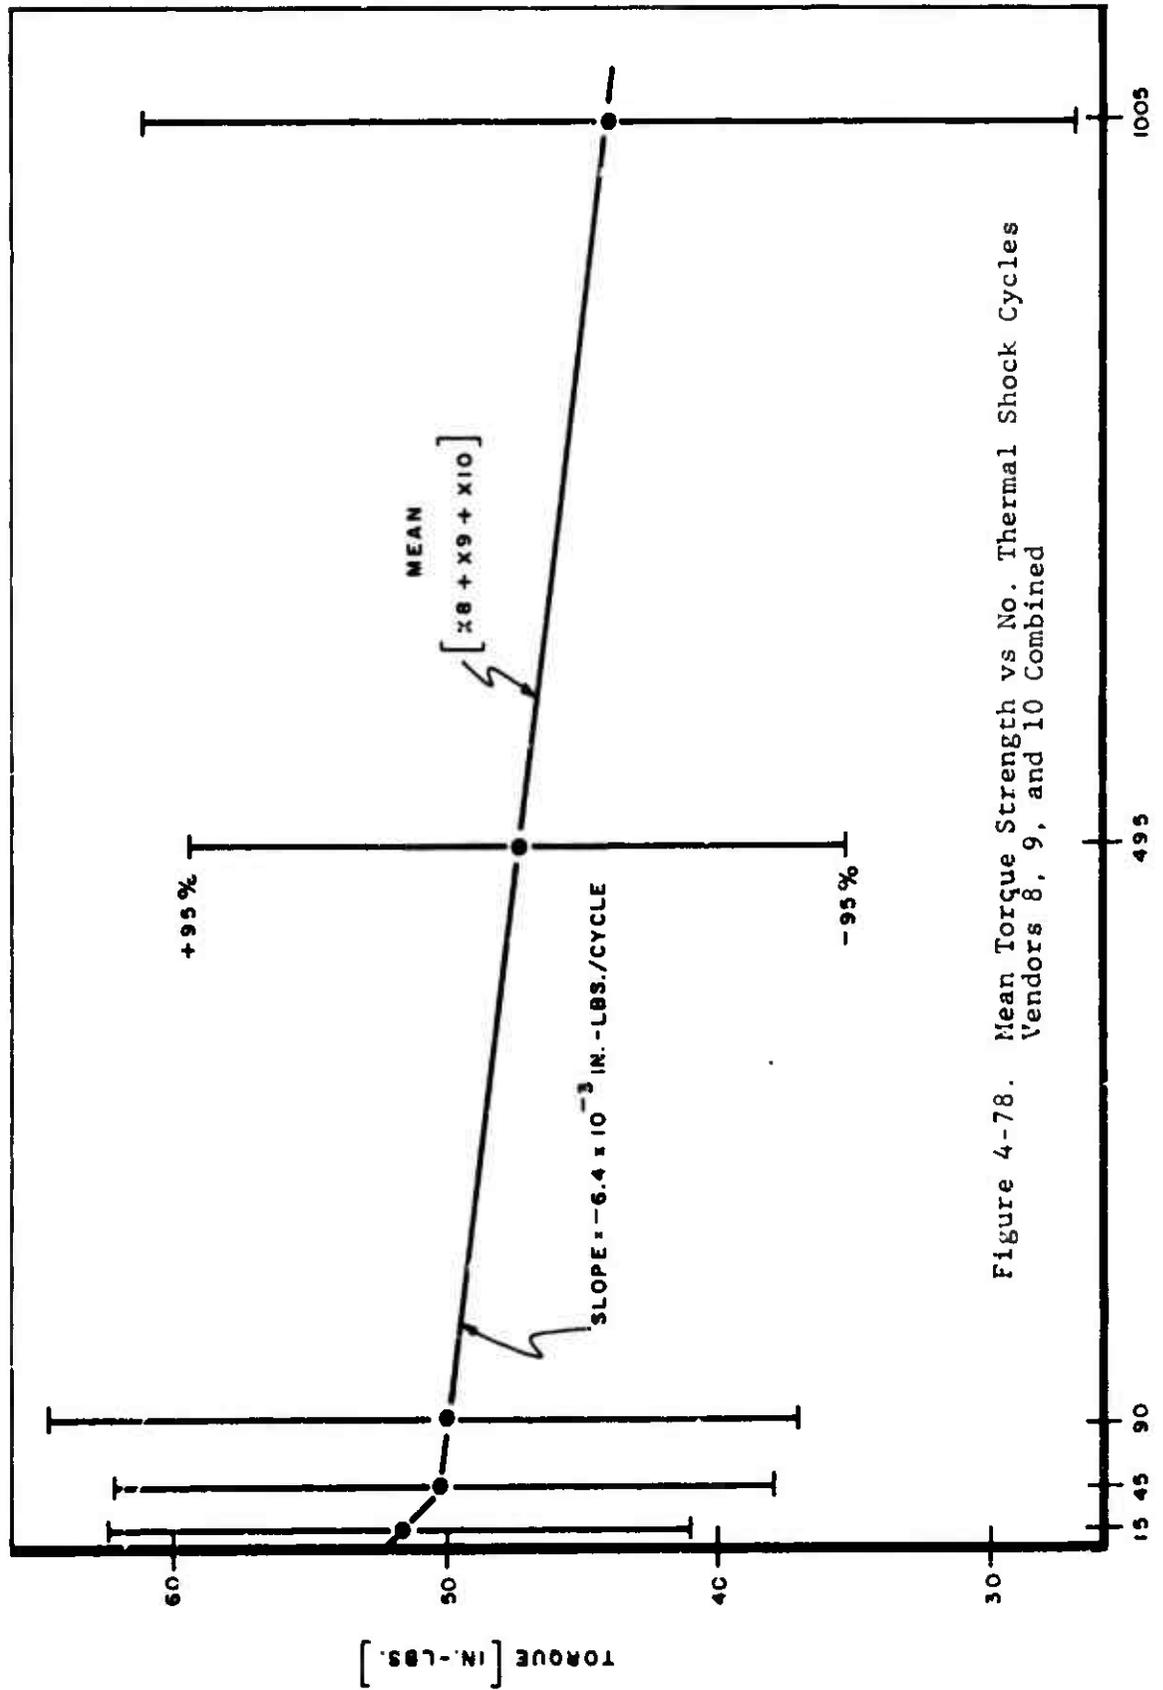
Figure 4-78. Mean Torque Strength vs No. Thermal Shock Cycles Vendors 8, 9, and 10 Combined

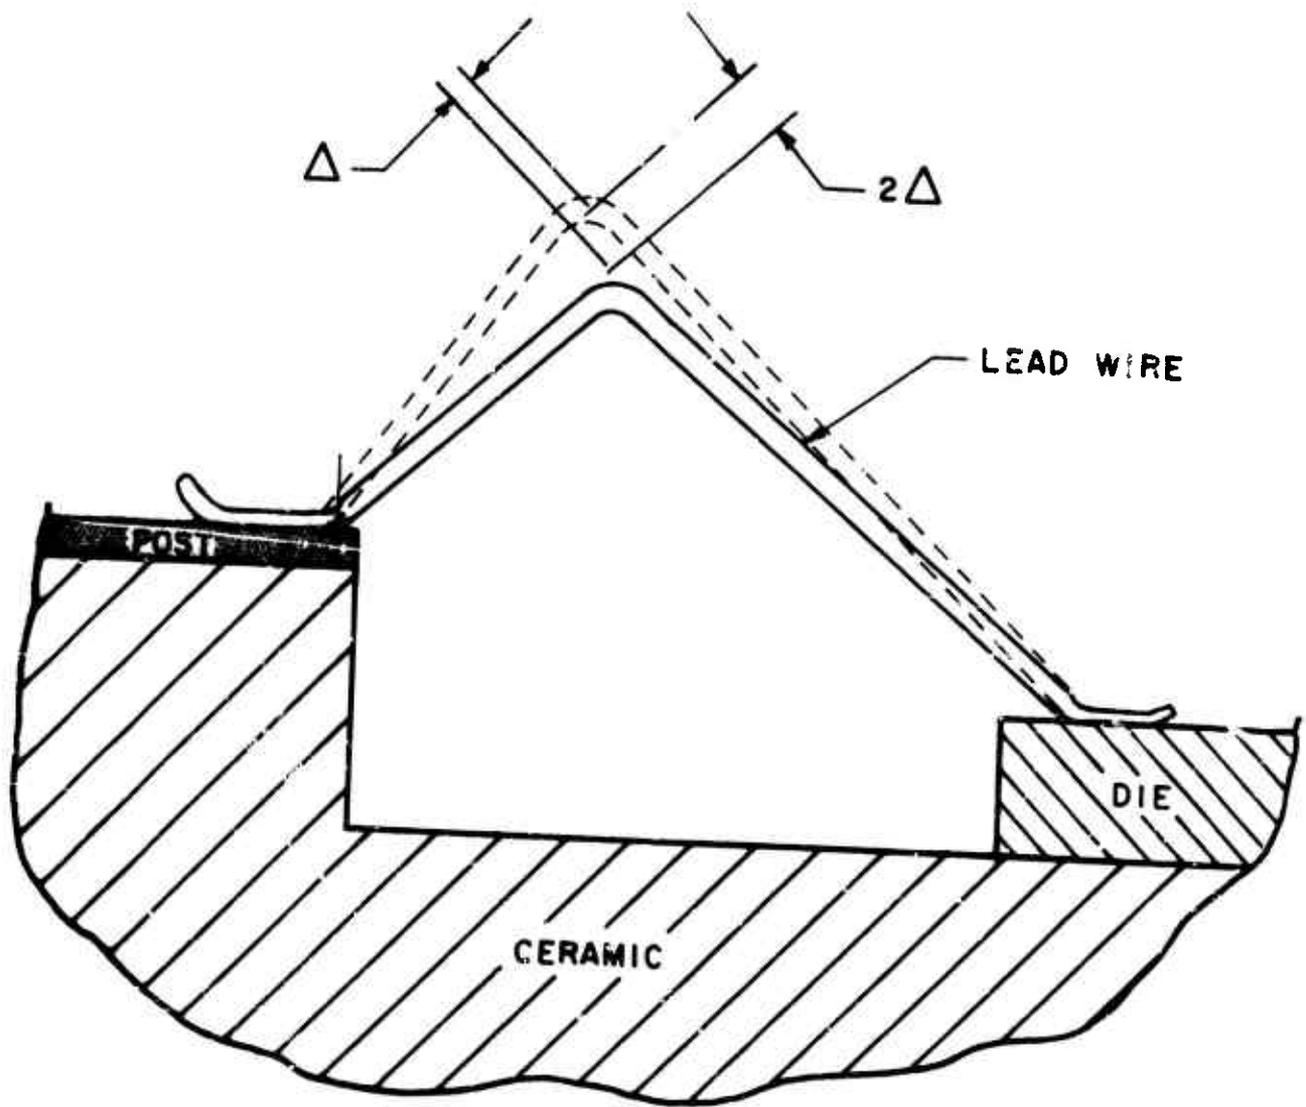
Figure 5-1. Illustration of Wireflex

Wireflex failures are more likely to occur at the heel of the first bond. This would be the post bond heel when using post-to-pad bonding as shown in Figure 5-1, and the pad bond heel when using pad-to-post bonding. When using post-to-pad bonding, the first bond is placed on the post. The bonding tool tip is

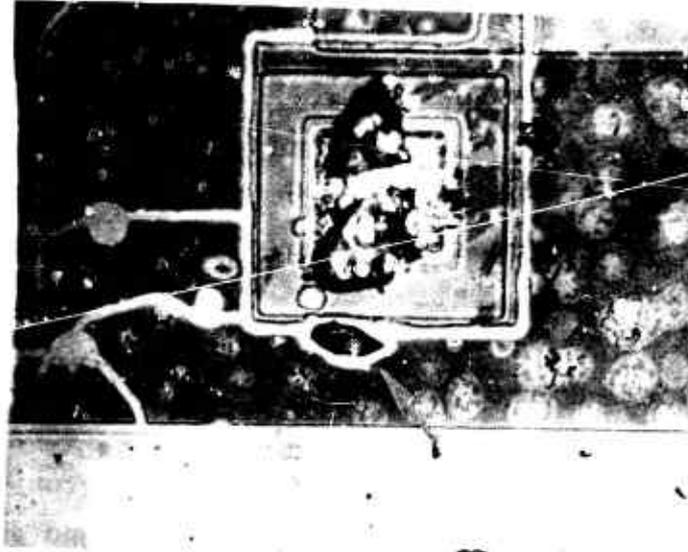
Figure 5-13. Oxide Defect - Damage by U/S Bonder
(Lot D6, 4500 Cycles of 1010C)

Oxide defects most often occur as the result of imperfect wafer masking and etching. The result is a region of oxide insulation which is thinner than normal. Expansion and contraction caused by thermal cycling will cause these thin oxide regions to develop cracks. If metal is over the oxide defect, it can work its way down the crack, eventually causing a short between the metal and underlying structure. Figures 5-12 and 5-13 show examples of oxide defects.

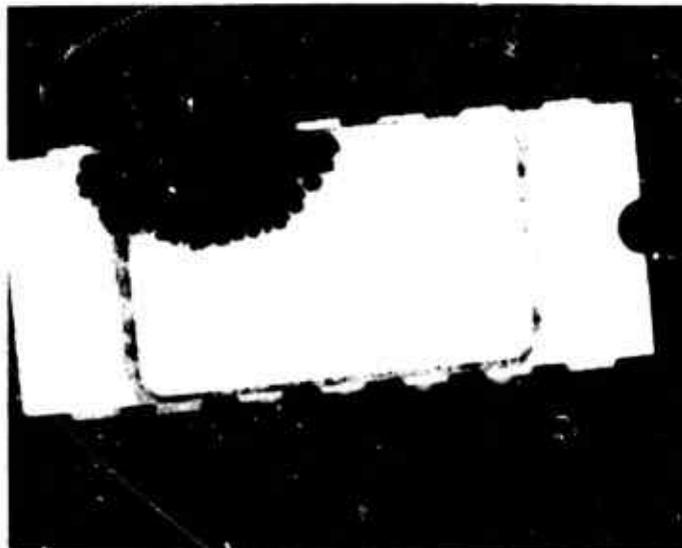
Figure 5-14. Gross Leak (Red Dye) at Cap Seal
(Lot All, Sidebrazed, 10 Cycles of 1010E)

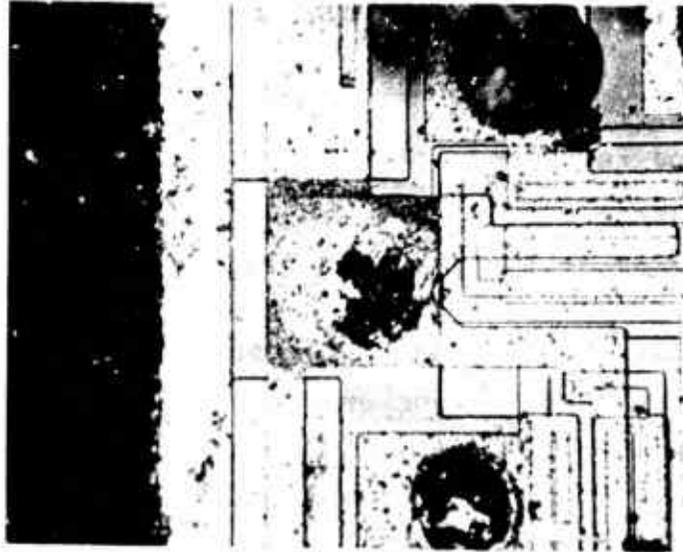
Figure 5-15. Intermetallic Open - Bond to Pad
(Lot B2, 10 Cycles of 1011C)

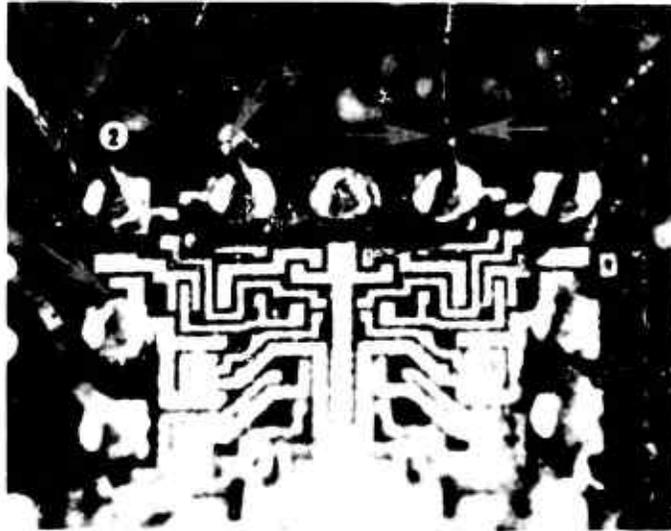
Figure 5-18. Grain Boundry Fracture
(Lot P3, 30 Cycles of 1010D)

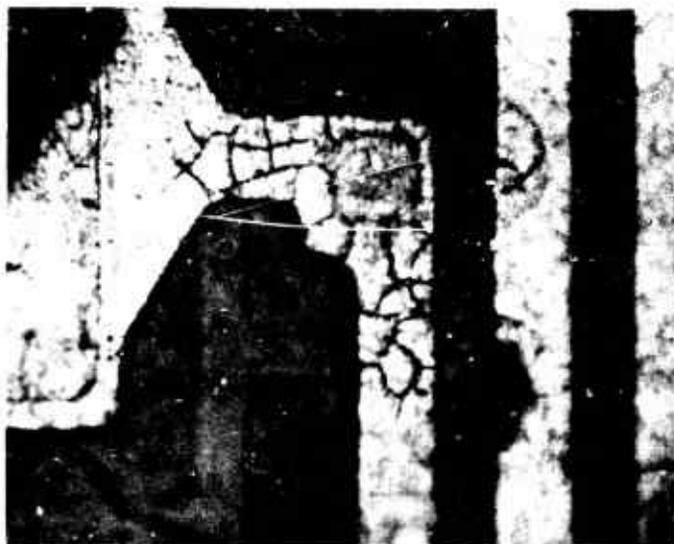
Figure 5-24. Corrosion
(Lot G4, 3005 Cycles of 1011A)

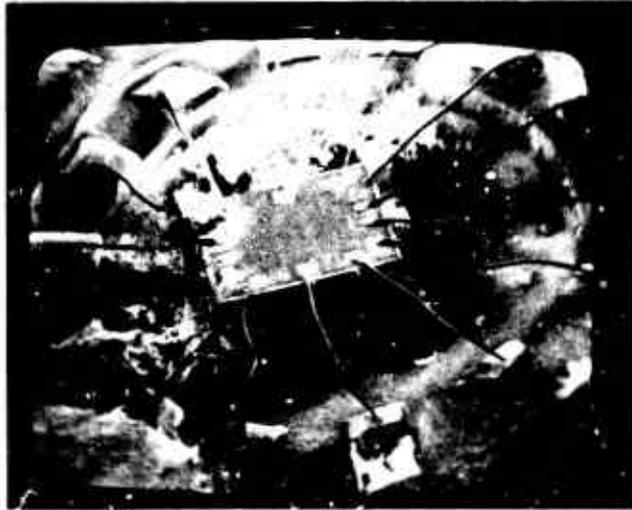
Figure 5-25. Floating Die
(Lot F7, Cerflat, 1500 Cycles of 1010E)
