RESEARCH AND DEVELOPMENT IN THE GLASS FIBER  
SODIUM-SULFUR BATTERY

Dow Chemical U. S. A.

Annual Technical Report

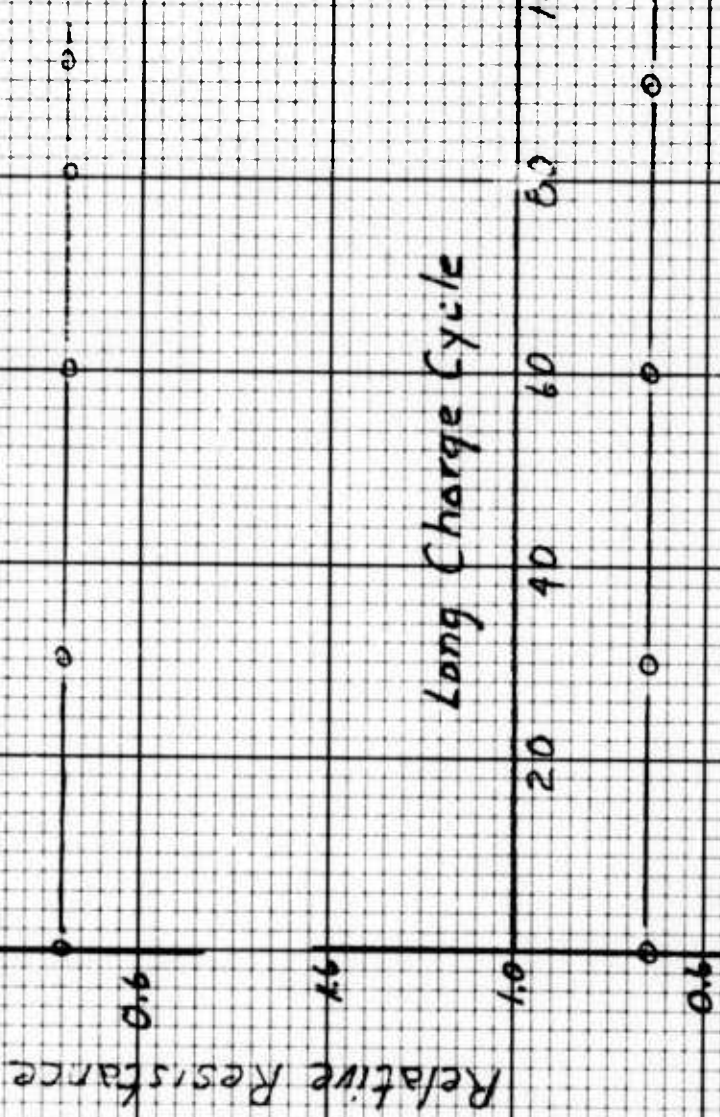
When sodium that was free of calcium was used, no resistance build-up occurred. Graph III shows typical results. In all of these experiments, current density was about three times the design rate. Calcium was removed from the sodium by heating the sodium for 1 1/2 hours at 300°C in the presence of Na<sub>2</sub>O. The metal was then cooled to 125°C and filtered through a medium frit. The Ca content dropped from 0.04% to 0.0015%.

Change of Anode Resistance

Dionode Assembly      Co-free Na (.0025%)

Long Discharge Cycle

Long Charge Cycle
