RESPONSE OF ARCHING WALLS AND DEBRIS
FROM INTERIOR WALLS CAUSED BY BLAST
LOADING

URS Research Company

DCPA Work Unit 1123G
Contract No. DAHC20-71-C-0223

Final Report

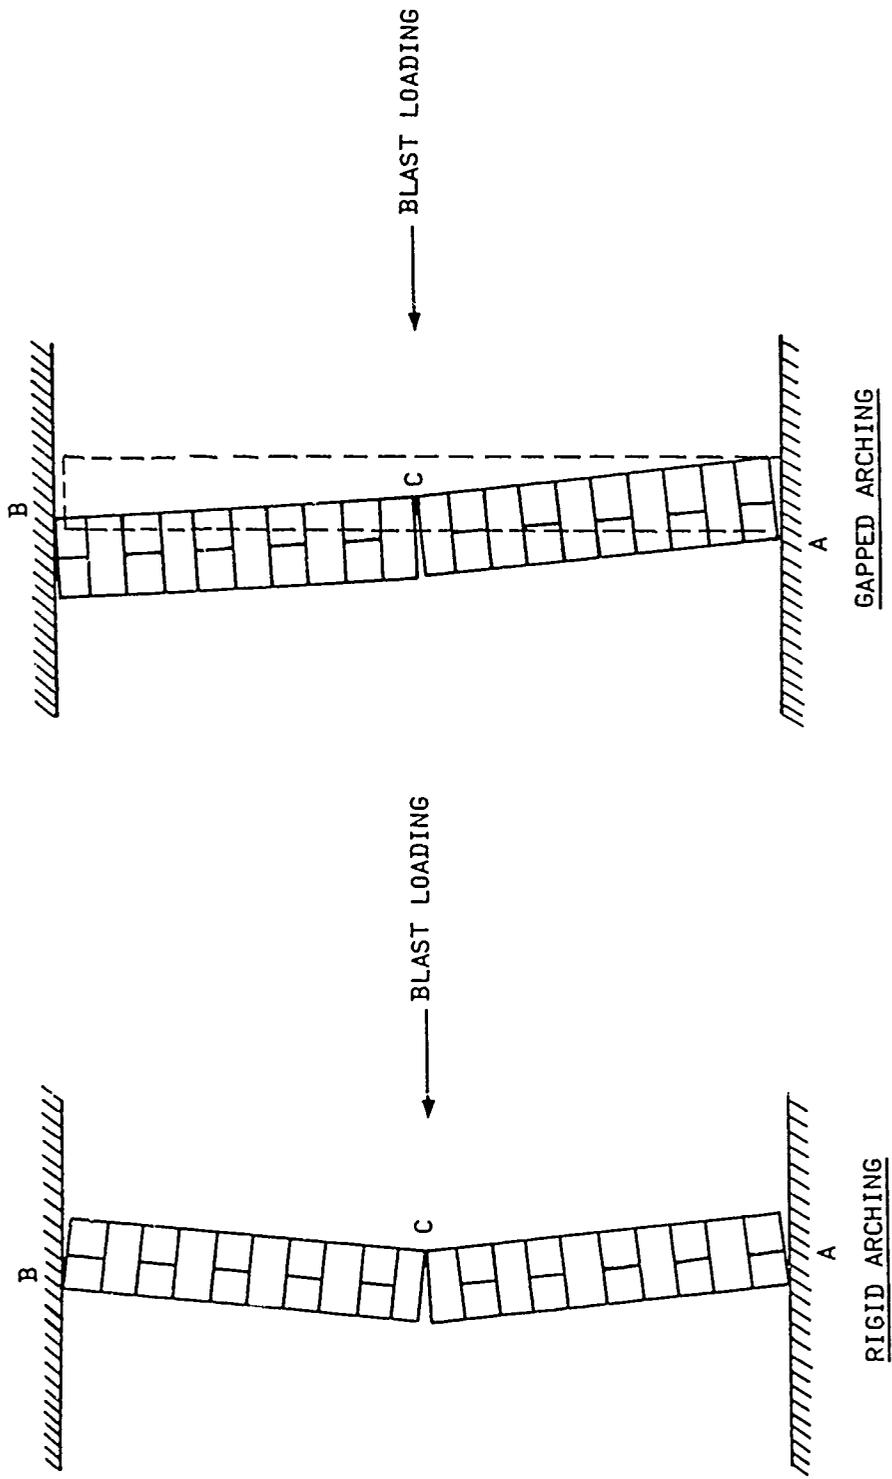
Fig. 2-1. Sketch Illustrating the Differences in Motion Between Rigid and Gapped Arching.

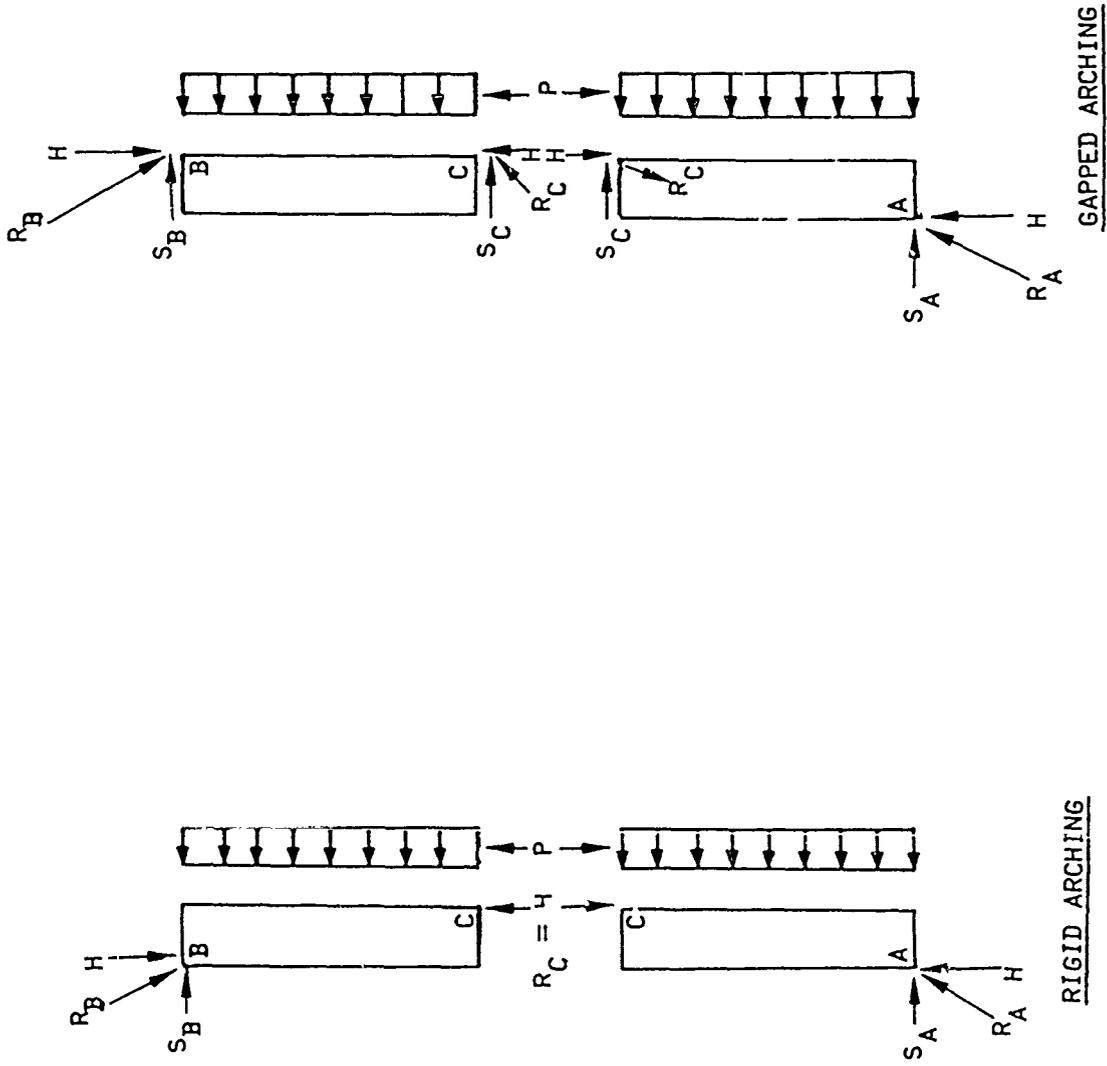
Fig. 2-2. Free Body Diagrams Showing Forces in Rigid and Gapped Arching.
 (See Table 2-1 for force values.)

Fig. 2-2 shows the directions of forces on the two parts of each wall. The general formulas for these forces per unit length of wall and the initial magnitudes of these forces for a wall with a height (h) of 96 in. and a thickness, (t) of 8 in. are given in Table 2-1 for a uniform pressure (p). Fig. 2-2 shows that in rigid arching, the resultant forces are either directed into the wall (R_A and R_B) or are parallel to the wall face (at C). In the gapped arching case, however, there are forces (R_B and R_C) directed away from the upper part of the wall, and both the force directed into the wall (R_A) and the in-plane force (H) are about twice as large as they are in the rigid arching case. Forces directed into the wall would tend to cause compressive (crushing) failures; those directed away from the wall would tend to cause tensile (spalling) failures which occur at much lower stress values. Thus, the upper part of the wall in gapped arching should fail essentially in ten-

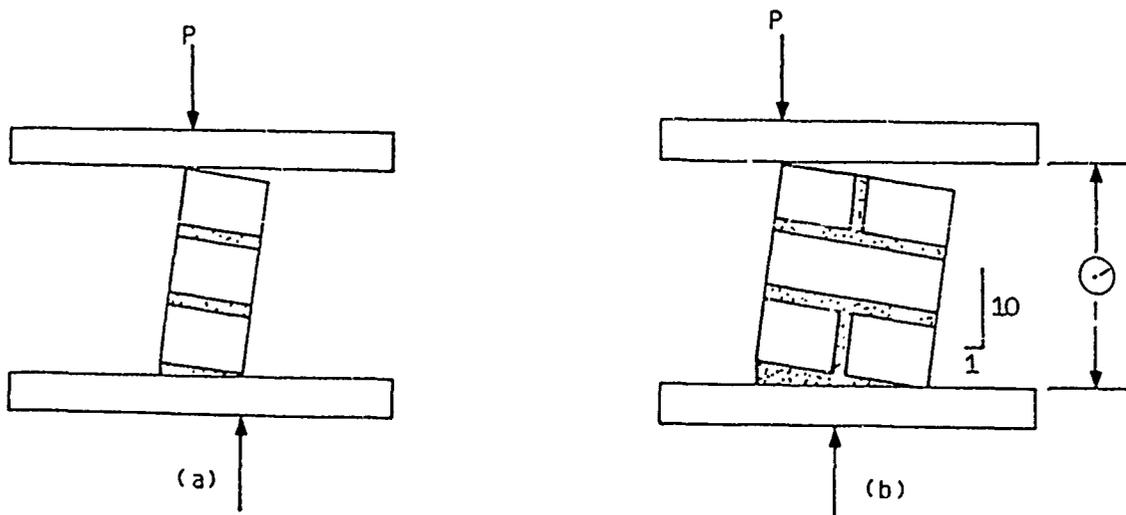
One series of tests were made using tilted brick-mortar composite specimens to determine the strength of wall composites under compressive (crushing) line loads. The basic test geometry for these static tests is sketched below.

Results from 11 tests with test setup (a) showed that failure occurred at an average total load (p) of 28,100 lbs. (Values ranged from 18,000 to 35,000 lbs. as shown in Table B-5 in Appendix B). The average line load at failure f_x for the approximately 8 in. long specimens used was 3300 lb/in. (range 2100 to 4000 lb/in.). In the test setup (b) results from 11 tests gave an average p value of 43,100 lbs. (range: 35,000 to 52,000 lb) and an average f_x value of 5100 lb/in. (range 4100 to 6000 lb/in.) again using approximately 8-in. long specimens.

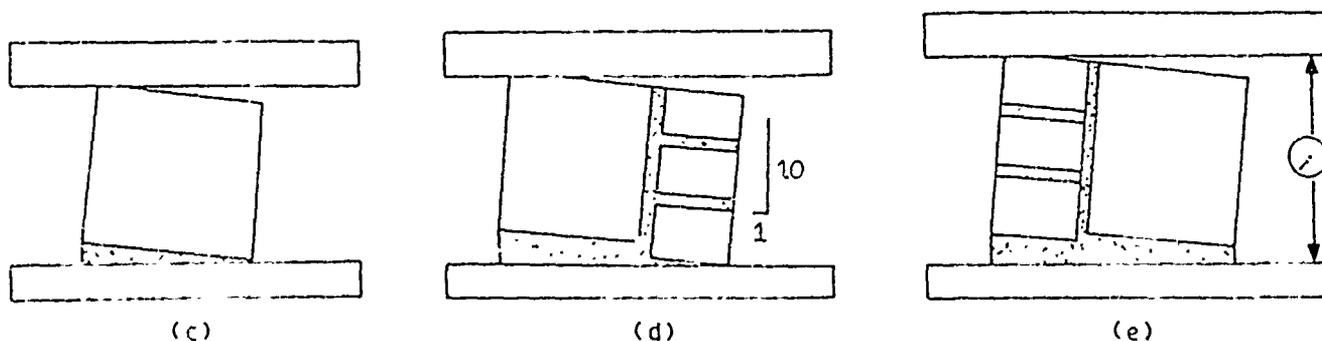
Fewer line loading tests were made with concrete block, and brick-concrete block mortar composites. Test set ups are sketched below:

Average results were as follows:

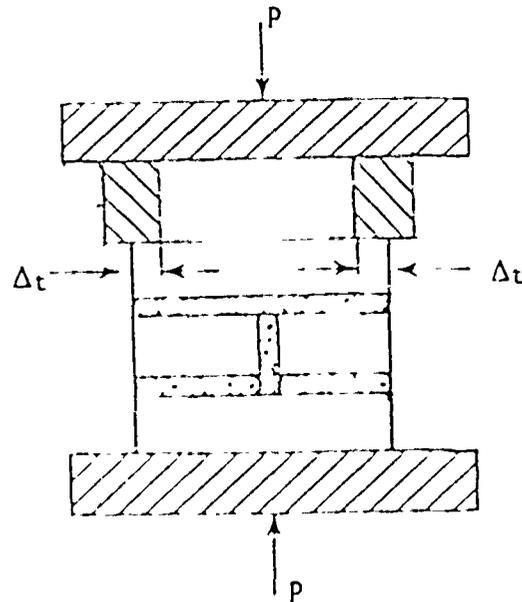
Additional tests were conducted to develop an approximation of strength under the tensile (spalling type) of line loading that could occur in the gapped arching case at points B or C in Fig. 2-1 and 2-2. That test set up is shown in the sketch below.

Two values of Δt were tested, $\frac{1}{2}$ in. and $\frac{1}{4}$ in. For the latter, spalling was clearly occurring, and on four tests, the average P was 13,390 lb. and the average f_d was 824 lb/in. As expected, these tensile line loading strengths are far below those for compressive line loading.

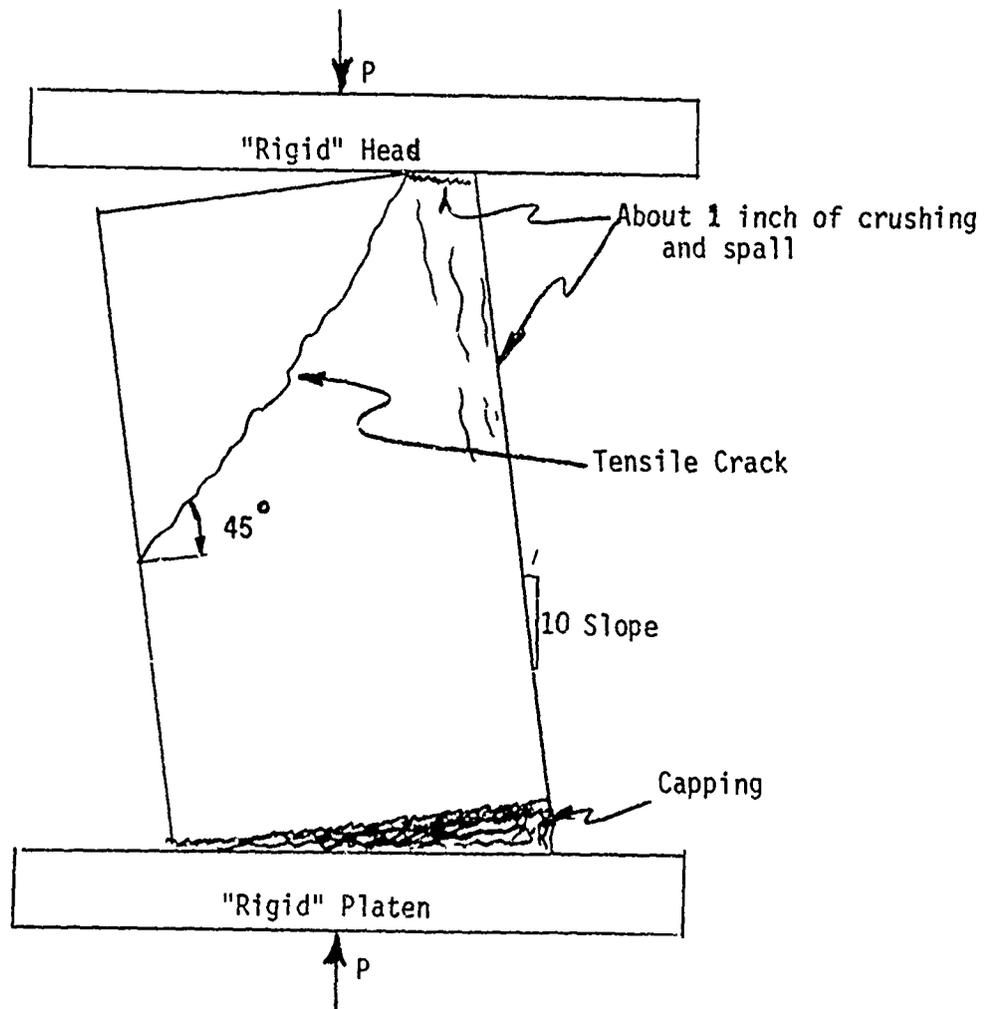
For brick test specimens consider the test set-up shown below.

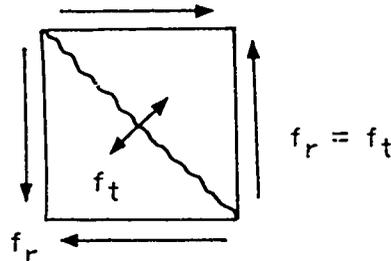
Assume the tensile crack is caused by pure shear as shown below.

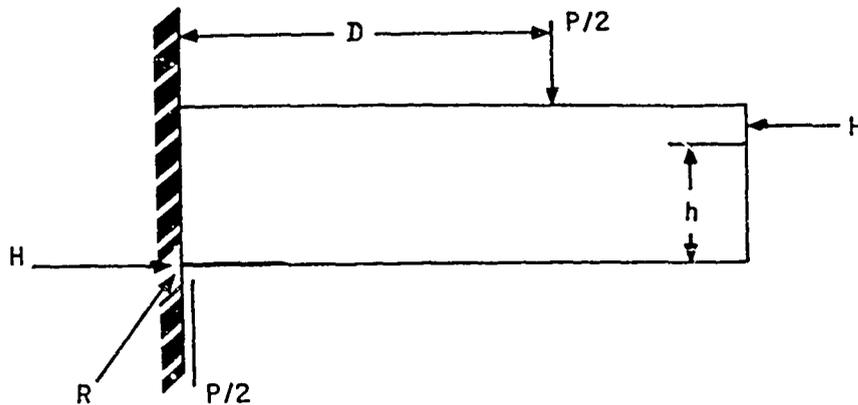
Fig. B-4). A free-body diagram of one-half the beam is sketched below.

Taking moments about the left lower corner we have

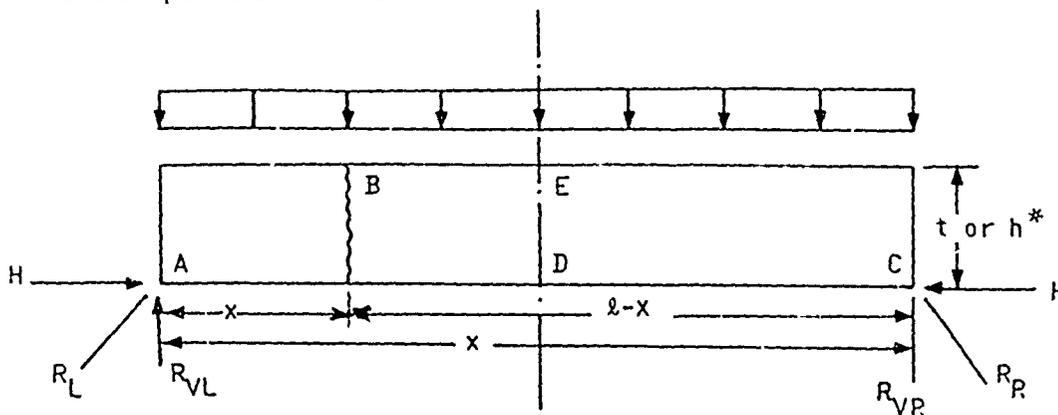
Consider the system sketched below which represents a wall of unit width whose length is " l " and whose thickness is " t ". The wall is being loaded normal to its face by a uniform load " p ", but is prevented from moving parallel to its face. In other words, it is undergoing arching with the forces at points A and C composed of forces " H " applied parallel to its face; and forces " R_{VL} " normal to its face. (" R_L " and " R_R " are the resultant forces.) The wall is cracked a distance " x " from one end at point B. Points D and E mark the wall centerline.

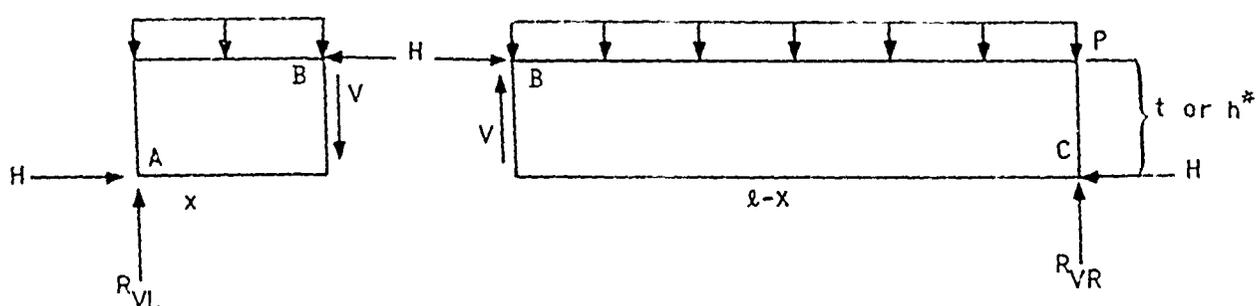
Forces on the two parts of the wall are as shown below.

* If crushing occurs at A, B, or C as a result of application of these forces, the distance, " h " between lines of application of force H at A and B on the left free body, or at points B and C on the right free body will be less than the wall thickness " t ".

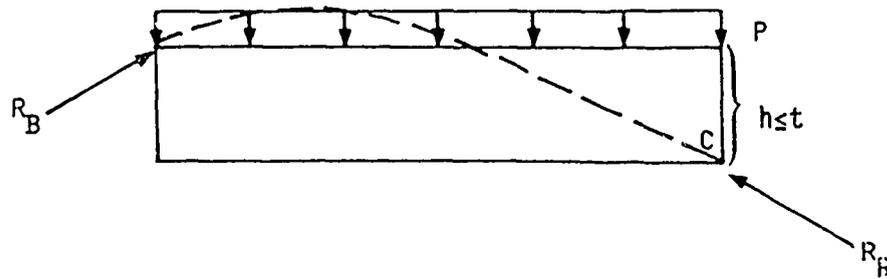
Note that $R_B = \sqrt{(H^2 + V^2)}$ is directed away from the body in a manner that would tend to encourage spalling similar to that for gapped arching. This means that this portion of the wall has thrust lines outside the body as sketched below.

This body can fail in one of two ways: in bending at the point of maximum moment; or in spalling at the point of application of R_B , that is, spalling due to application of a line load. Previous work suggests that the line load spalling will occur, because the line load capacity for this outward directed force is likely to be less than the tensile strength of the material. To determine how much less, we must first consider the bending problem and determine what the maximum tensile force is.

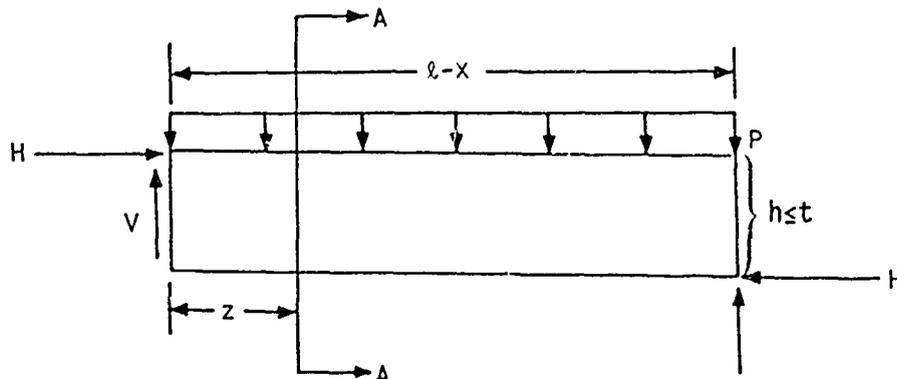
Consider the following sketch with z being an arbitrary distance from the crack.

$$H = \frac{px}{2h} (\ell - x)$$

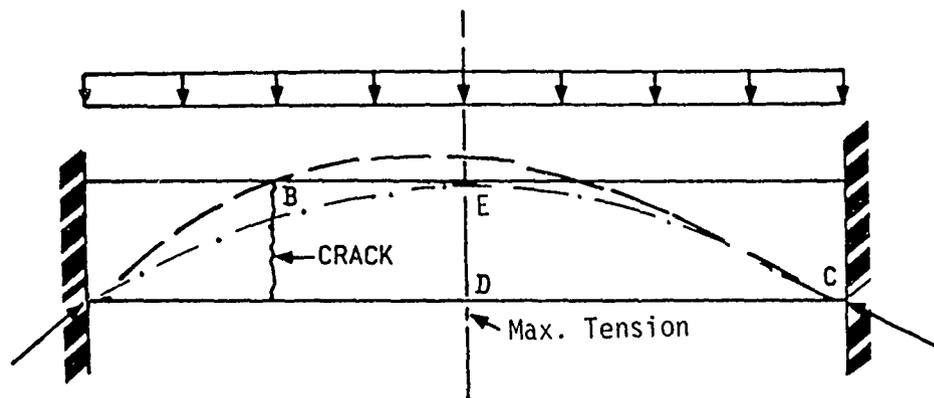
Thus, wherever the crack, the maximum stress occurs at the wall center line. A sketch of the wall, with the thrust line (shown by the dashed line) in keeping with the preceding discussion, is shown below. Note that the line is parallel to the wall face at the center line.

The actual stress at the wall center line is dependent on the location of the crack; it is least if the crack is at the center line, in which case $f_t \text{ max.} = (1/4)p(l/t)^2$, and increases to a maximum when the crack is at the edge of the wall where $(3/4)p(l/t)^2$. However, the preceding diagram suggests that as soon as the tensile strength at D is exceeded, conditions will revert to those of rigid arching in which a tensile crack occurs at the center line, and a hinge forms at E. That is, although the initial hinges are at A, B, and D, high tensile forces at the center line could cause a flexural crack to occur at D. If this happens the crack at B must close.

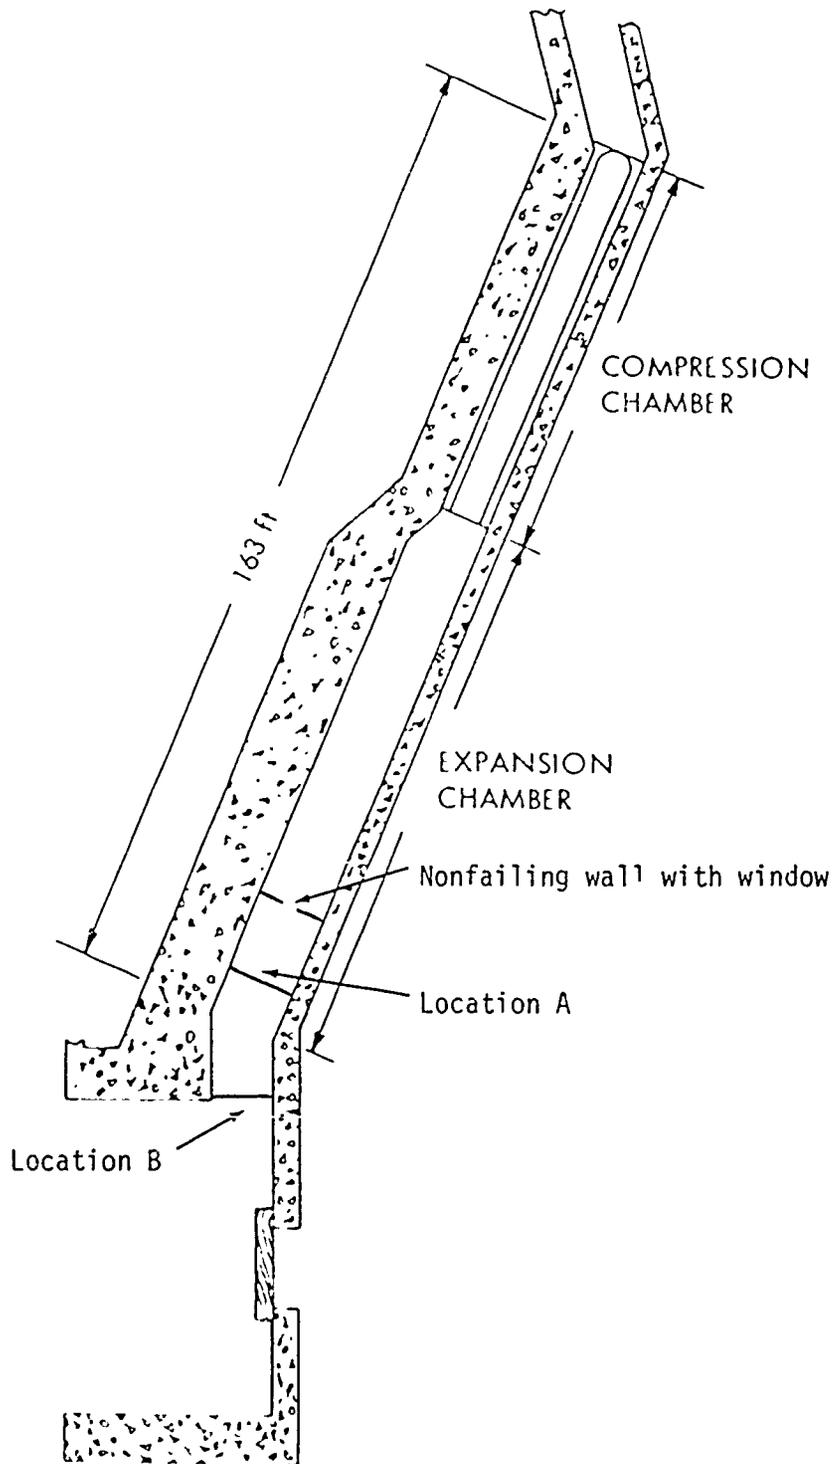
Fig. 3-1 . Plan of Shock Tunnel

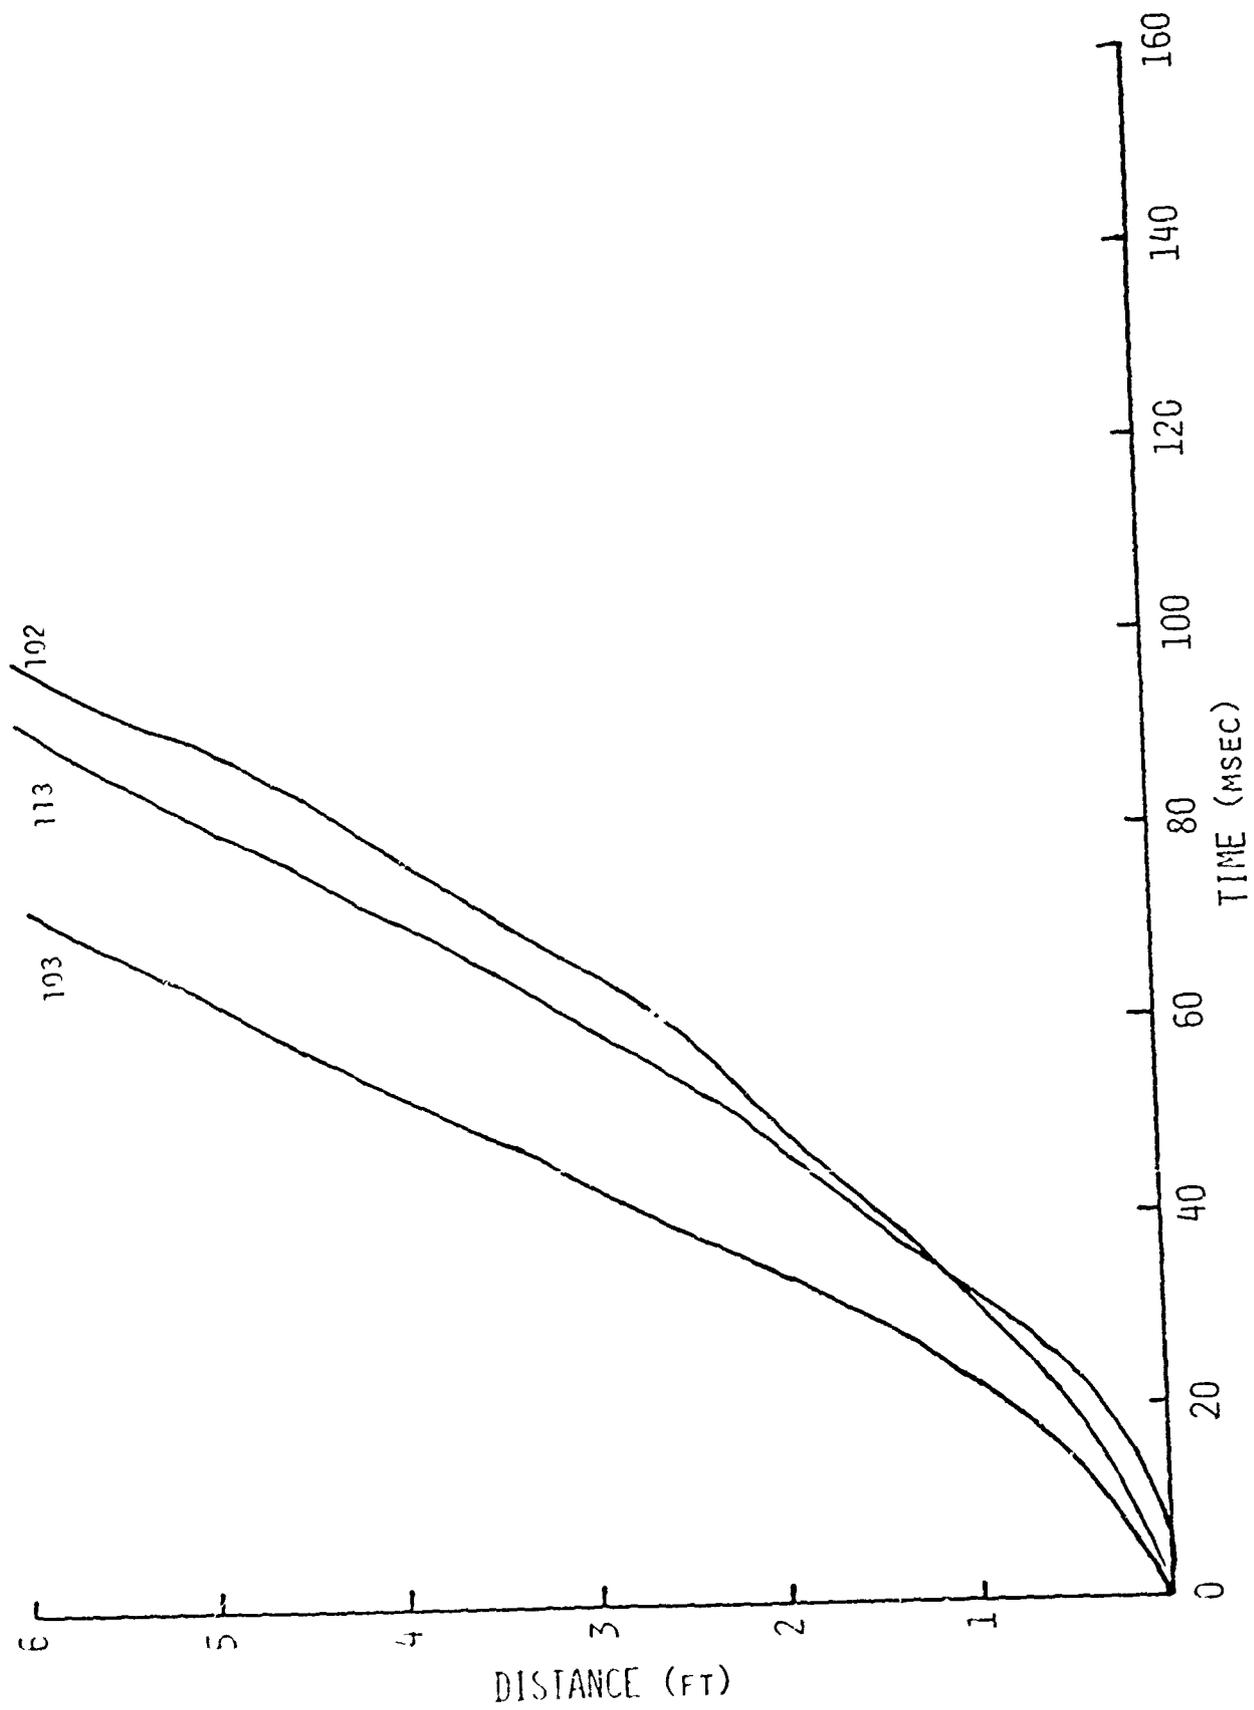
Fig. 3-7 Displacement as a function of time, Wall numbers 102, 103, and 113.

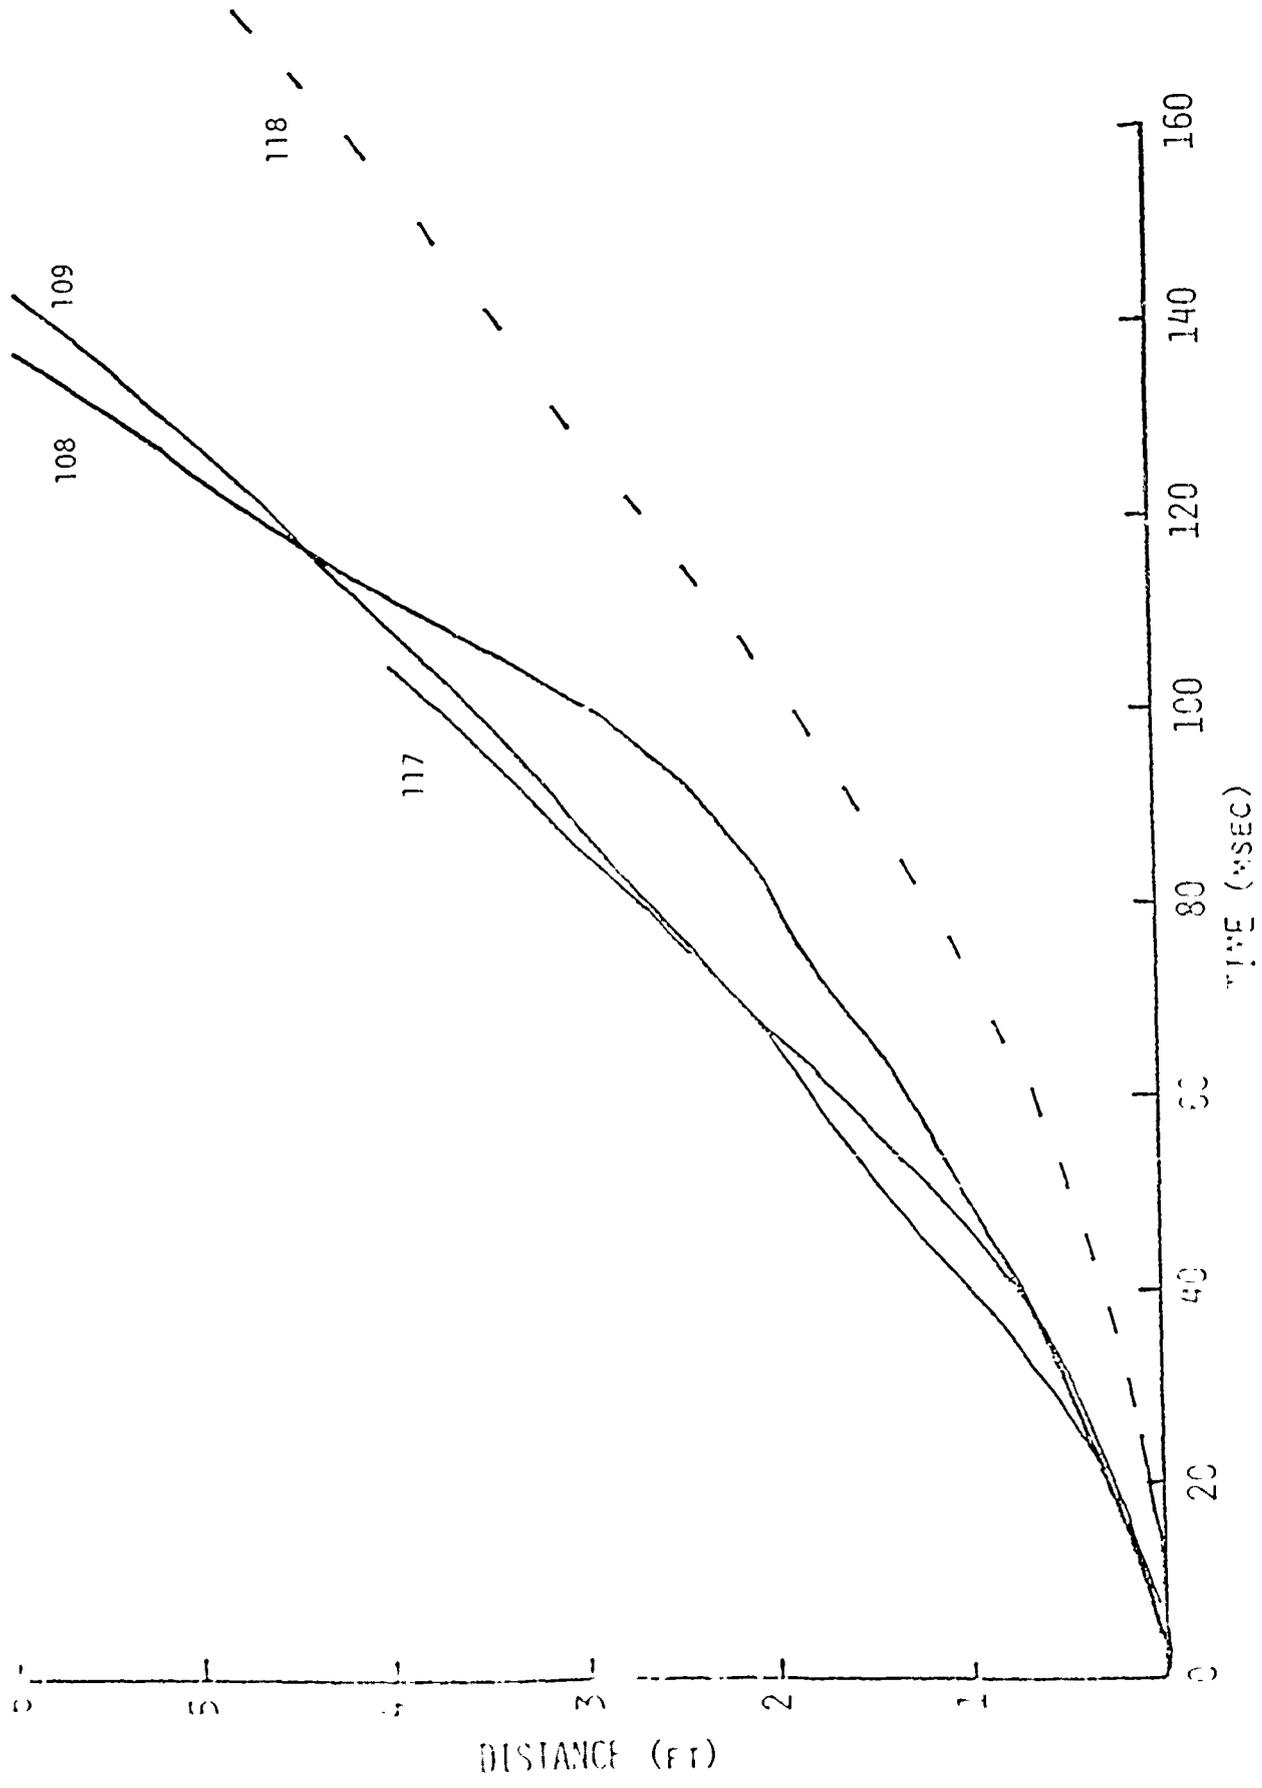
Fig. 3-14. Displacement as a function of time, Wall numbers 108, 109, 117 and 118.

The cantilever walls, 108, 109, and 117 were all tested at about the same overpressure level (3.6 to 4 psi). The failure patterns, however, were quite different between wall 108 and walls 109 and 117. Wall 108 had initial cracks between the third, fourth, and fifth rows (the wall is eleven rows high) and completely disintegrated early in the failure process. Wall 109

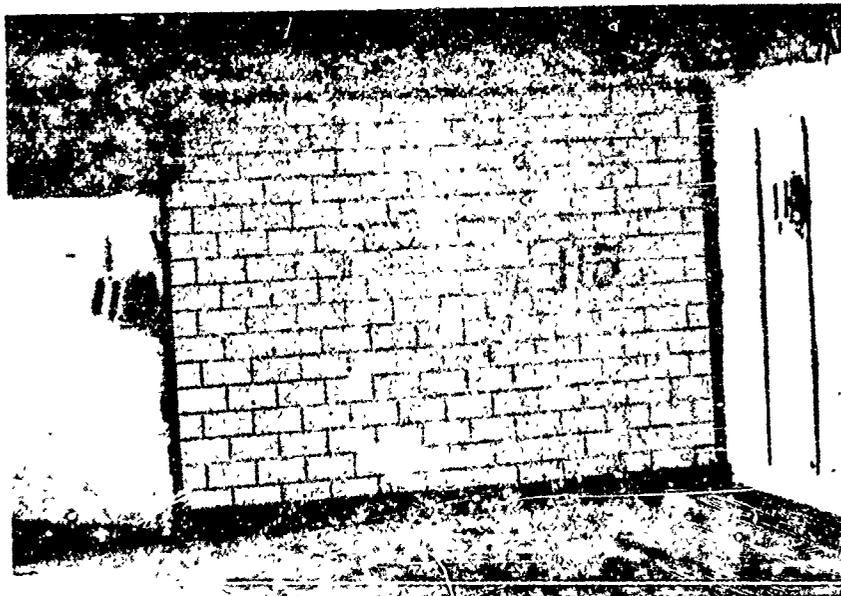
Fig. 3-15. Pretest Photograph, Wall Number 119.

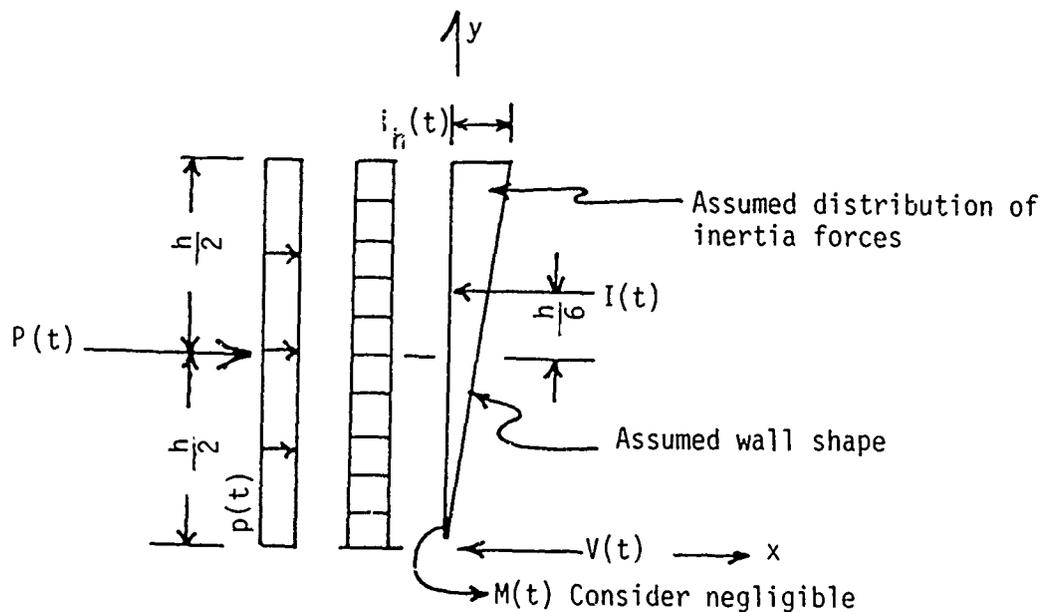
For the masonry walls, no previous experimental data were available, so an estimate was made of how break-up might occur. The assumptions made are shown in the following sketch.

Summing moments about $I(t)$ we have

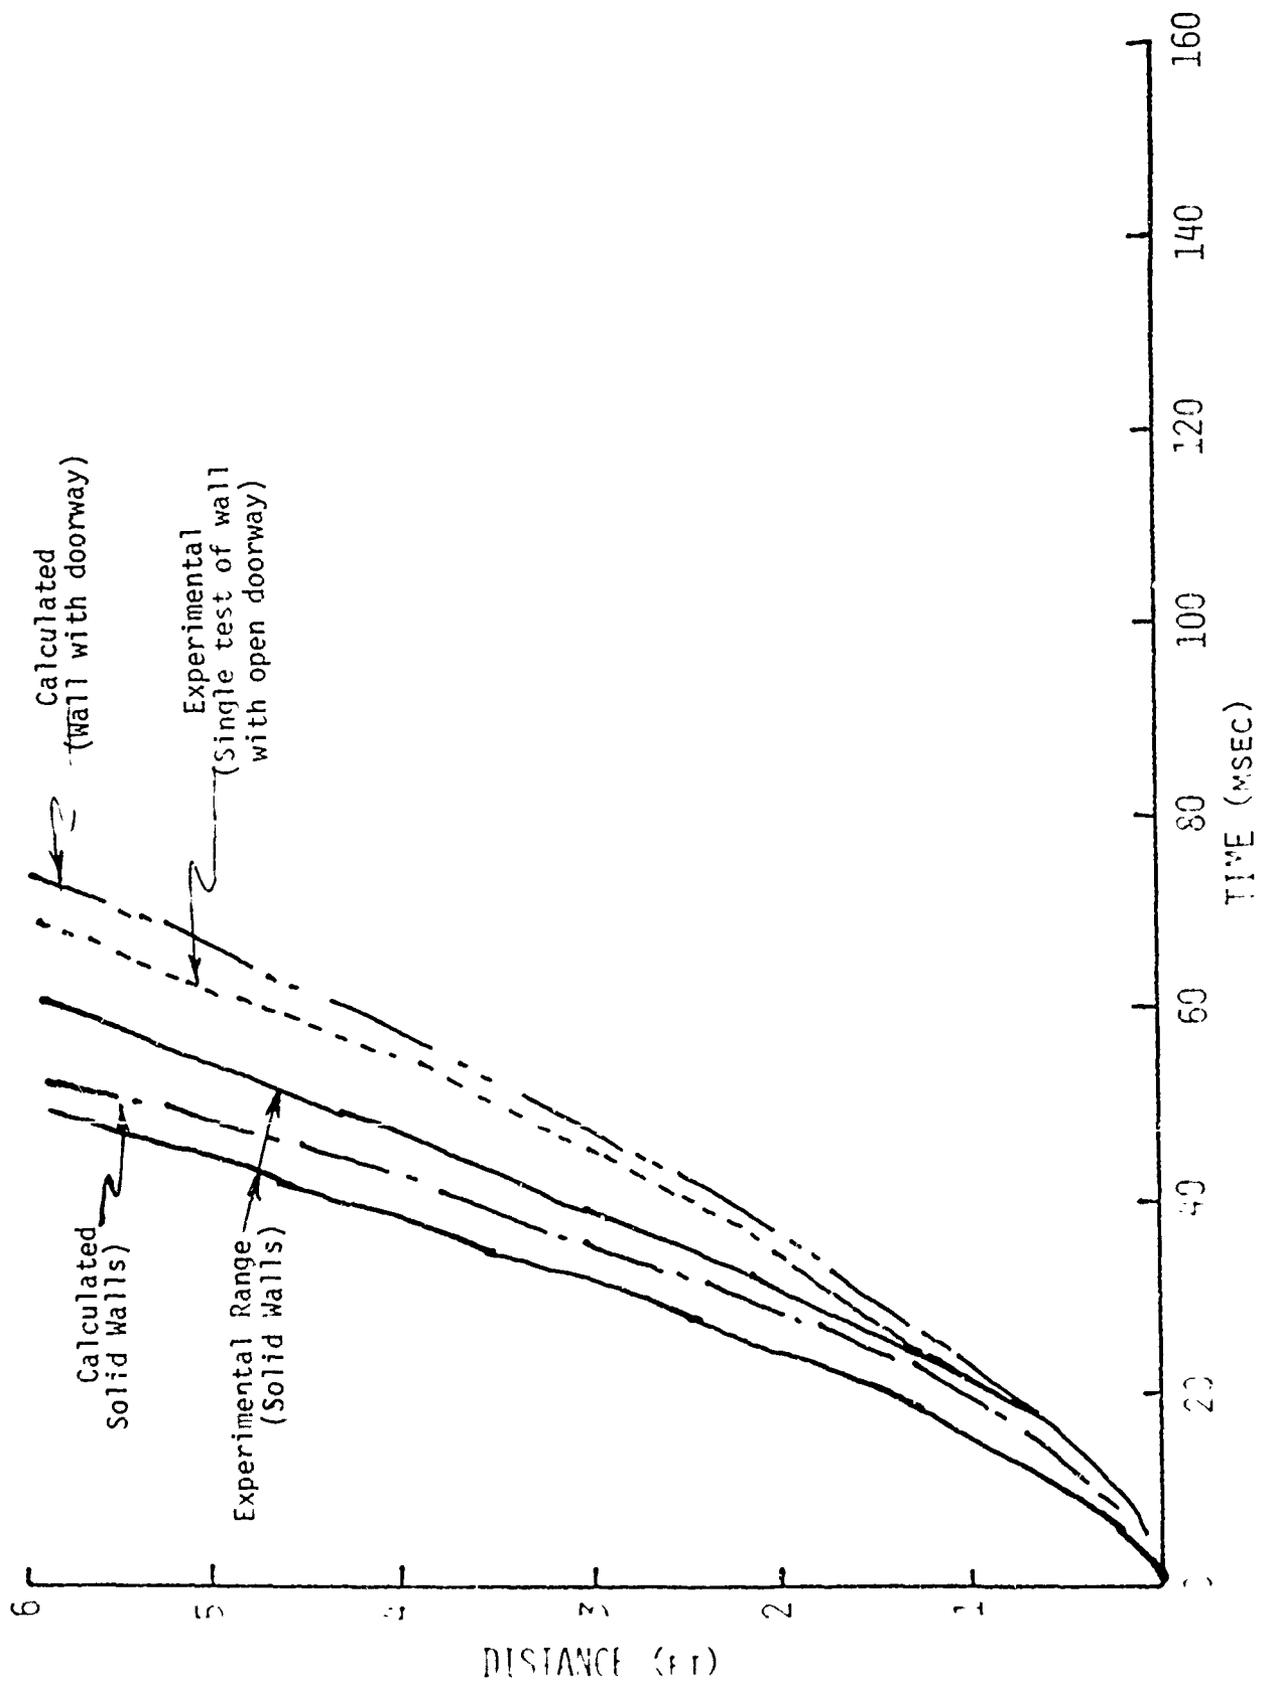
Fig. 3-19 Experimental and Calculated Displacement vs Time for Sheetrock Walls.
 Incident overpressure = 3.85 psi.

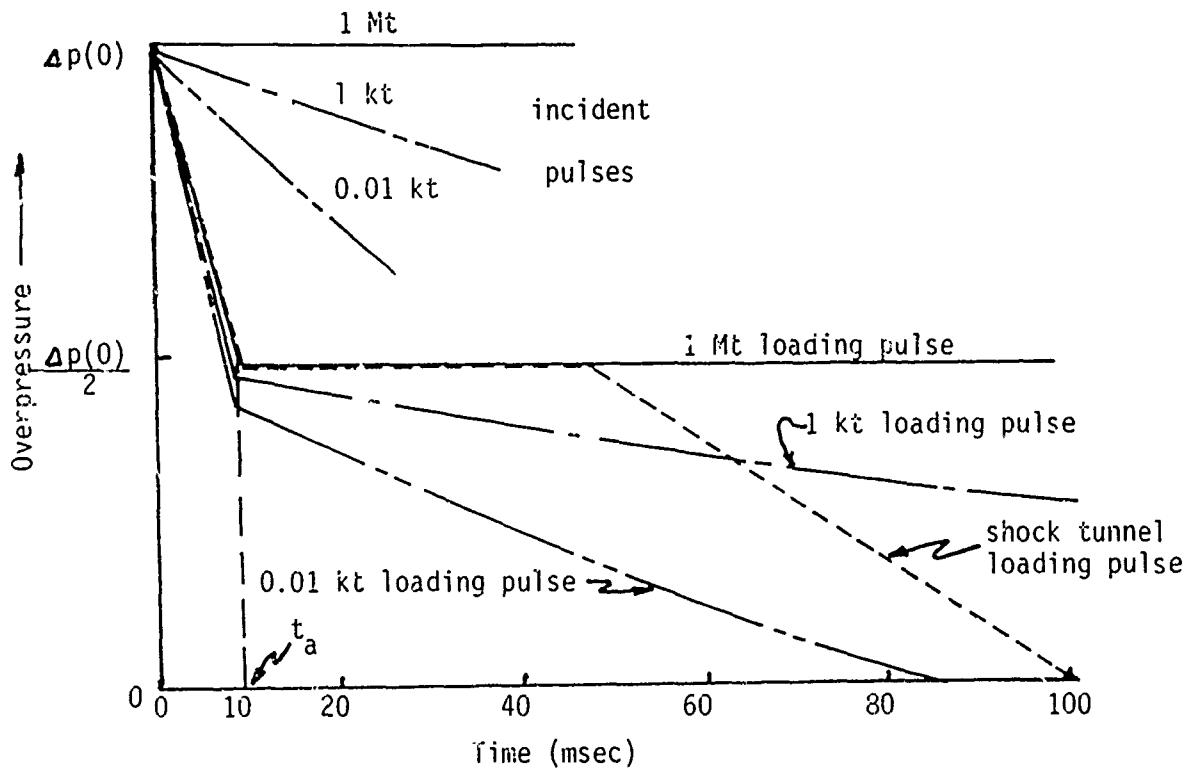
Fig. 3-23. Loading Pulses for Debris Velocity Predictions

Note that the 1 MT pulse is identical with the shock tunnel pulse up to 50 msec, but then it remains at a value of $\Delta p(0)/2$ while the shock tunnel pulse decreases to zero. This suggests that early time wall element velocities from a 1 MT blast are likely to be larger than those calculated for the shock tunnel. In contrast, the 1 kt pulse is first lower than the shock tunnel pulse, but after about 50 msec it becomes higher. This suggests that wall element velocities from 1 kt weapons will be similar to shock tunnel velocities. Finally, the 0.01 kt loading pulse lies entirely below the shock tunnel pulse, thus 0.01 kt wall element velocities should be considerably below shock tunnel velocities.

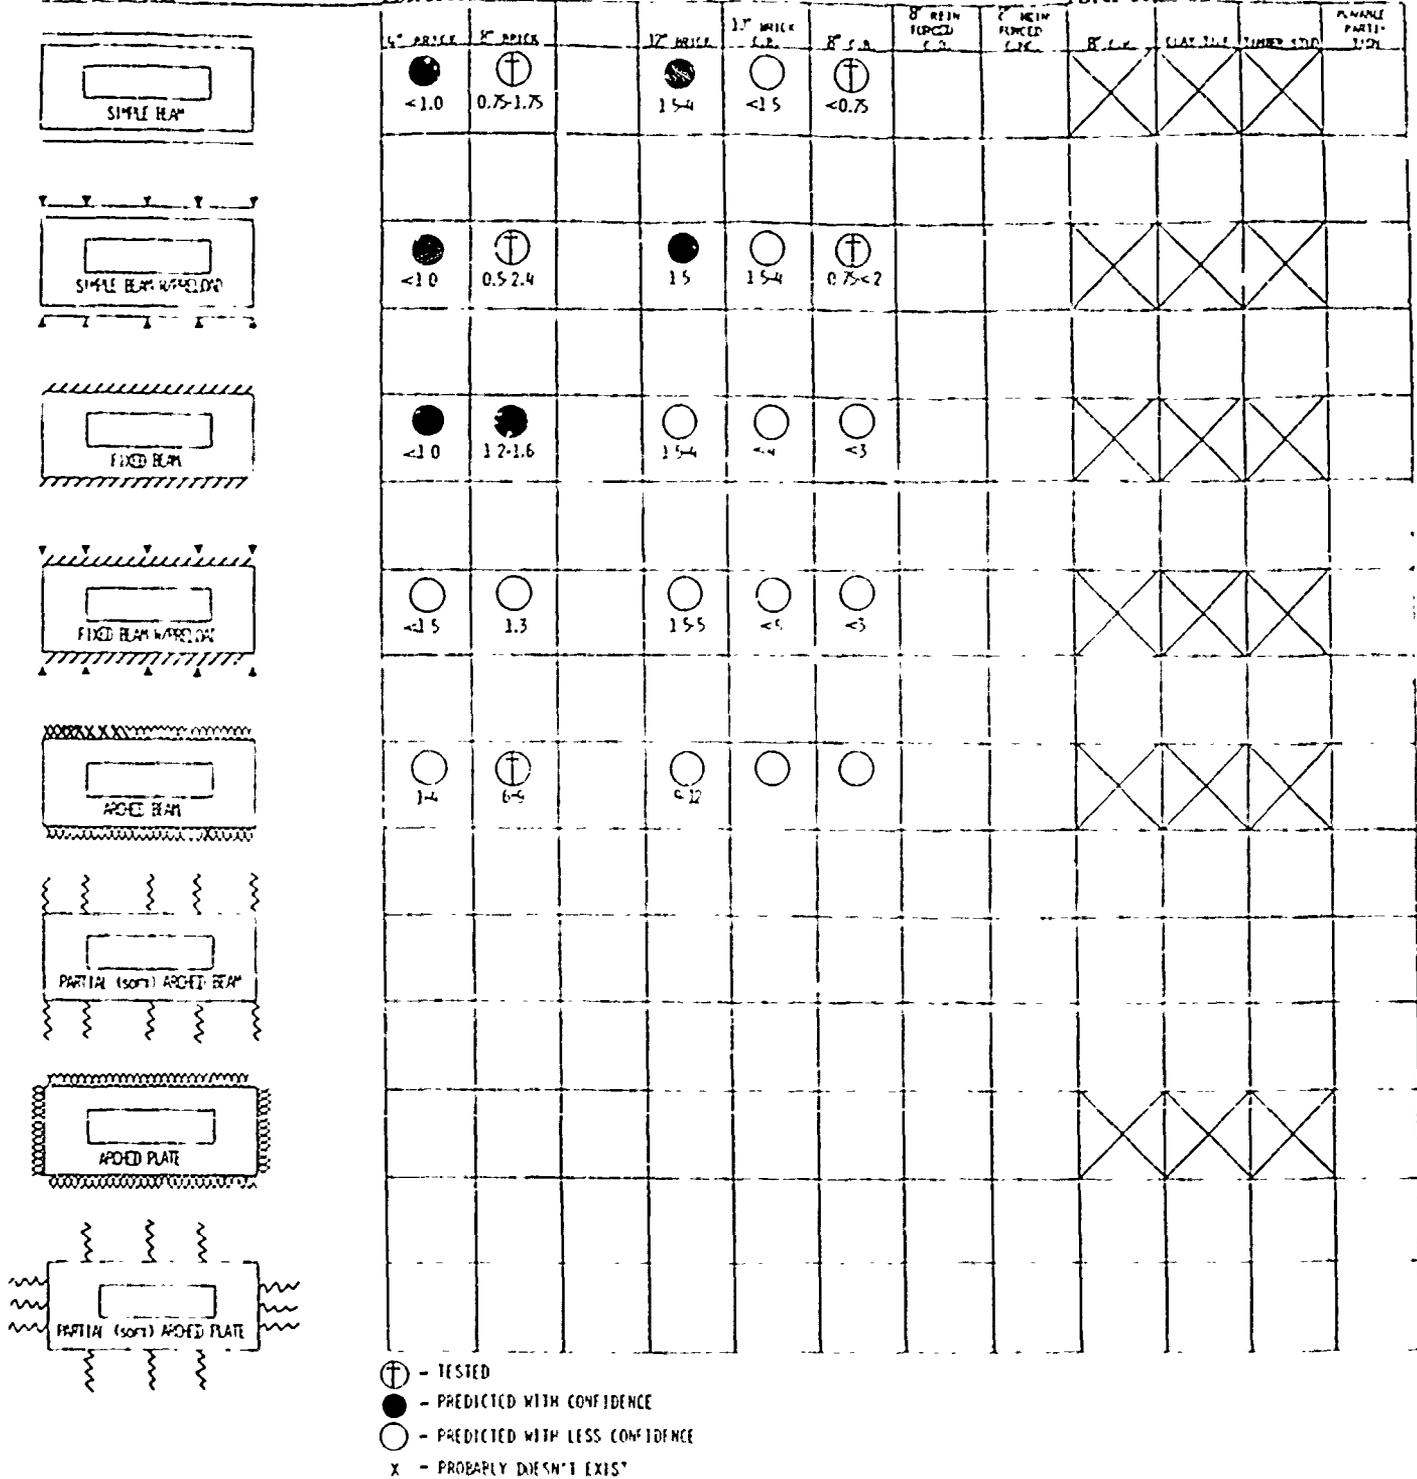
Fig. 4-2. Failure Strength Matrix - Windows. (The numbers in the matrix are incident overpressures.)

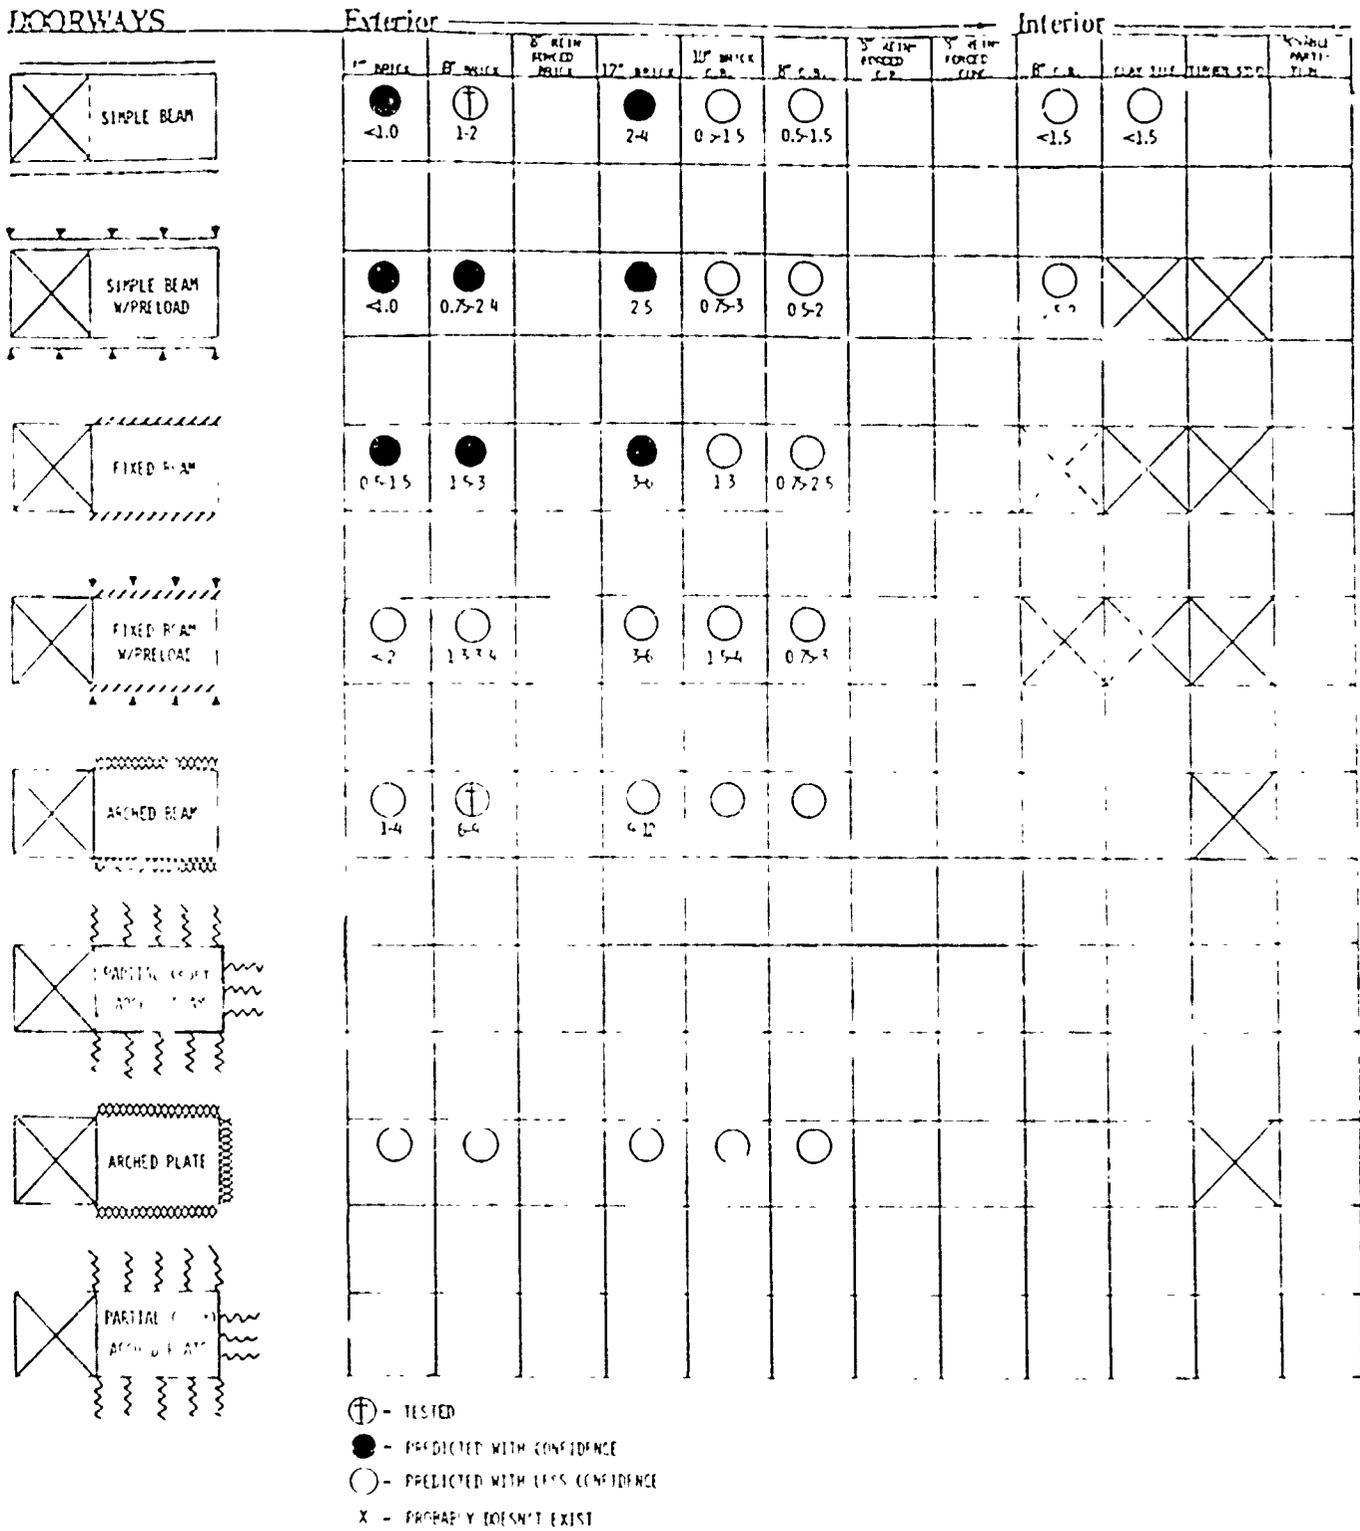
Fig. 4-3 Failure Strength Matrix - Doorways. (The numbers in the matrix are incident overpressures.)
