RESPONSE OF ARCHING WALLS AND DEBRIS
FROM INTERIOR WALLS CAUSED BY BLAST
LOADING

URS Research Company

DCPA Work Unit 1123G
Contract No. DAHC20-71-C-0223

Final Report

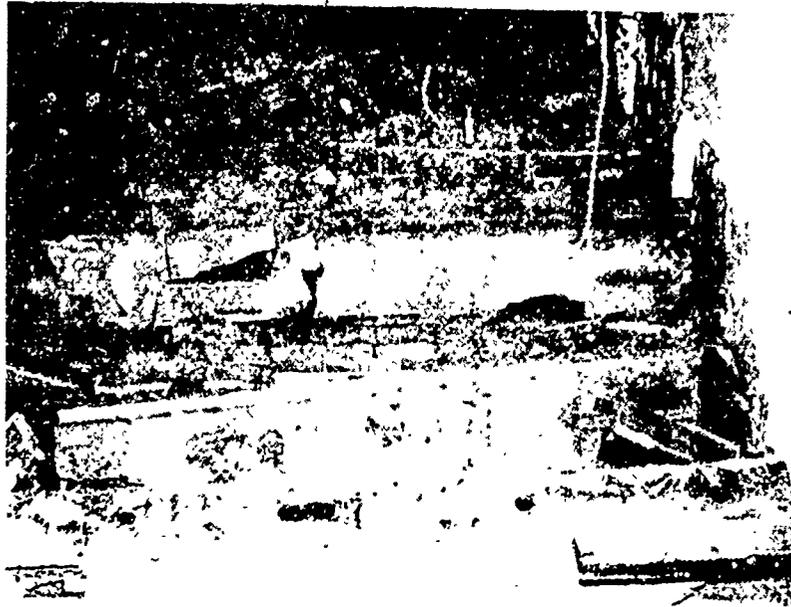
Fig. 98-1. Posttest Photographs, Wall Number 98.

One test was conducted using two strands of Primacord. The average peak incident overpressure was 1.9 psi. The three crack gauges indicated crack times of 35.5, 32, and 39.9 msec, but they are all from a single stepped crack extending from the 19th row of bricks on one side of the wall, to the 17th row on the other. As in the previous test, essentially all the debris landed within the first 30 feet. The amount and location of the debris can be seen in the posttest photographs presented in Fig. 98-1 and Fig. 98-2. Posttest inspection also indicated numerous pieces of brick upstream from the wall's initial location which had apparently been spalled off the top edge of the wall. A number of these fragments can be seen in the photographs in Fig. 98-3.

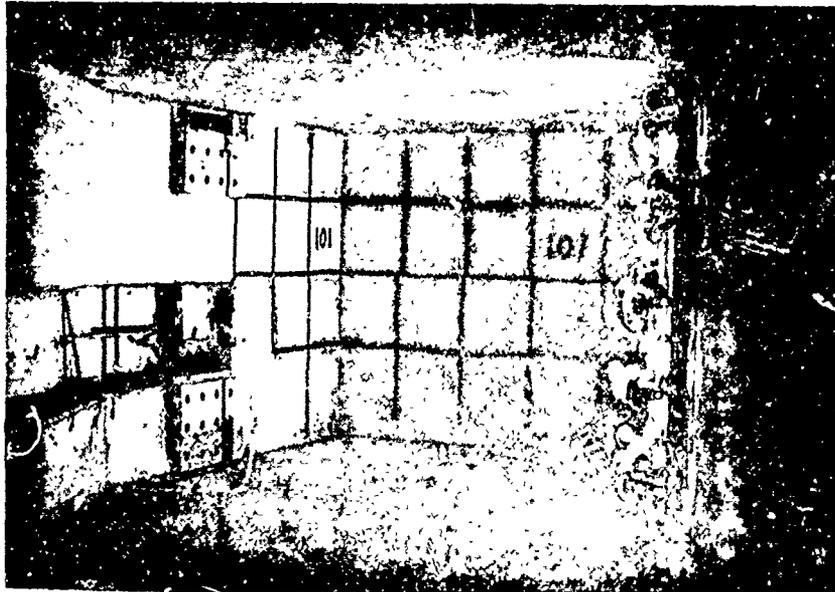
Fig. 101-1. Pre and Posttest Photographs, Wall Number 101.

This wall was tested once using four 60-ft strands of Primacord (average peak incident overpressure 3.5 psi.) Initially numerous minute cracks appeared on the downstream face of the sheetrock. The wall translated relatively intact until it hit the bend in the tunnel. The wall broke up, with the majority of the debris continuing on to the far side of the casemate., a distance of 87 ft from the original location of the wall. Pre and posttest photographs of this wall are shown in Figs. 101-1 and 101-2. A plot of displacement vs. time obtained from analysis of the motion picture records is presented in Fig. 101-3.

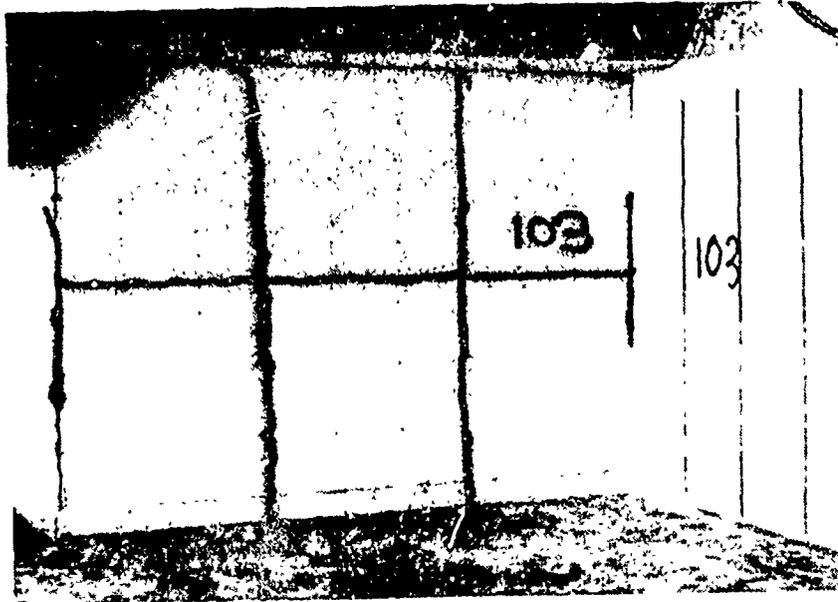
Fig. 103-1. Pre and Posttest Photographs, Wall Number 103.

This wall was subjected to one test using two 6 ft strands of Primacord (average peak incident overpressure 1.8 psi). No cracks or separation of the sheetrock from the metal studs was evident as the wall separated from the edge supports and was translated across the casemate. The edge stud from one side was pulled loose from the concrete and translated separately. The debris was essentially in one large piece as can be seen in the photographs in Figs. 103-1 and 103-2. A plot of displacement vs time is presented in Fig. 103-3.

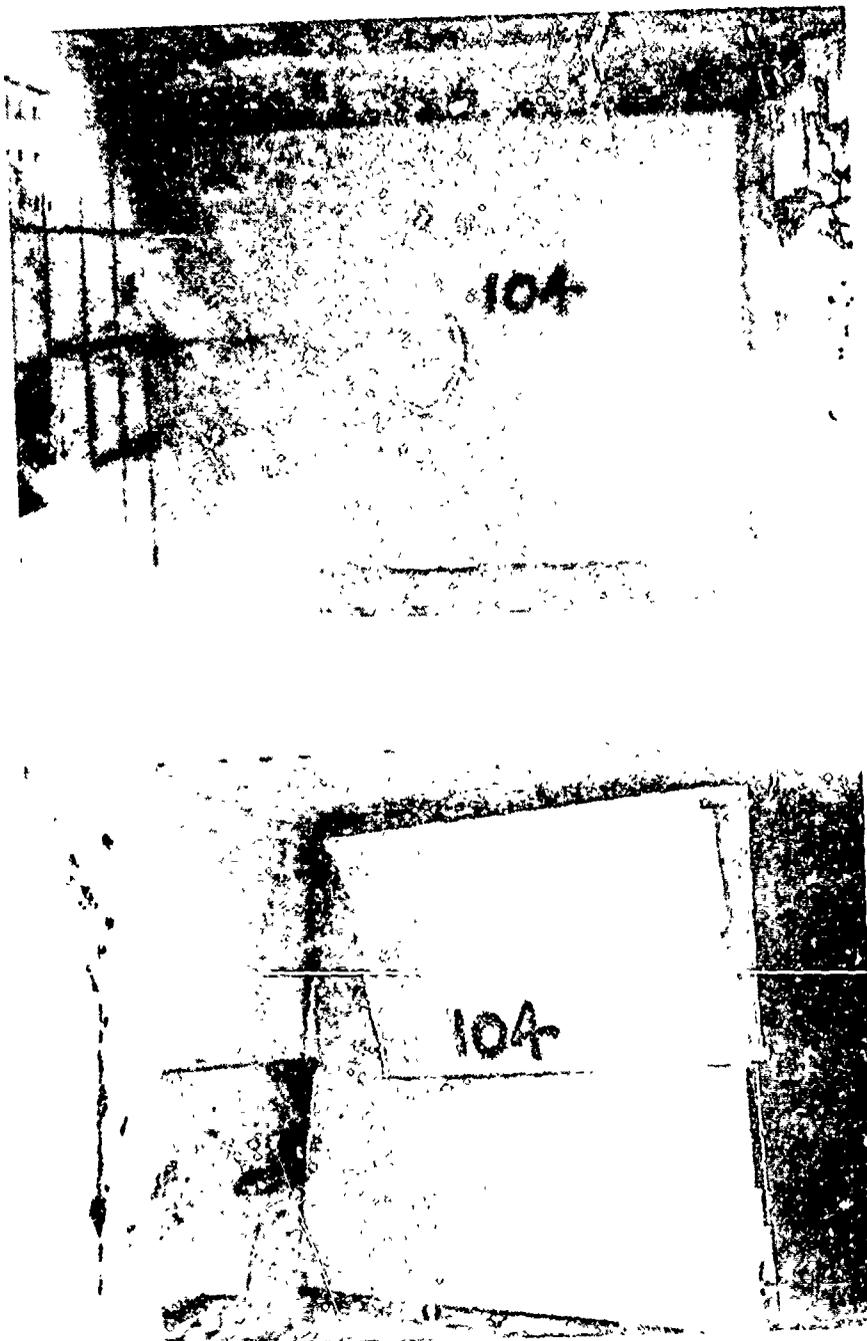
Fig. 104-1. Pre and Posttest Photographs, Wall Number 104.

One test was conducted using two strands of Primacord (average peak incident overpressure 1.8 psi). The wall remained essentially intact as it was removed from the support frame and was translated down the shock tunnel. The wall remained vertical and stopped after moving approximately 16 ft as shown in the photographs in Figs. 104-1 and 104-2. The initial blast did cause several cracks in the sheetrock panels and opened gaps between panels, as is evidenced by smoke and dust coming out of the gaps and cracks. There was only a slight amount of debris from small pieces of sheetrock torn off along the panel edges. A plot of displacement as a function of time is presented in Fig. 104-3.

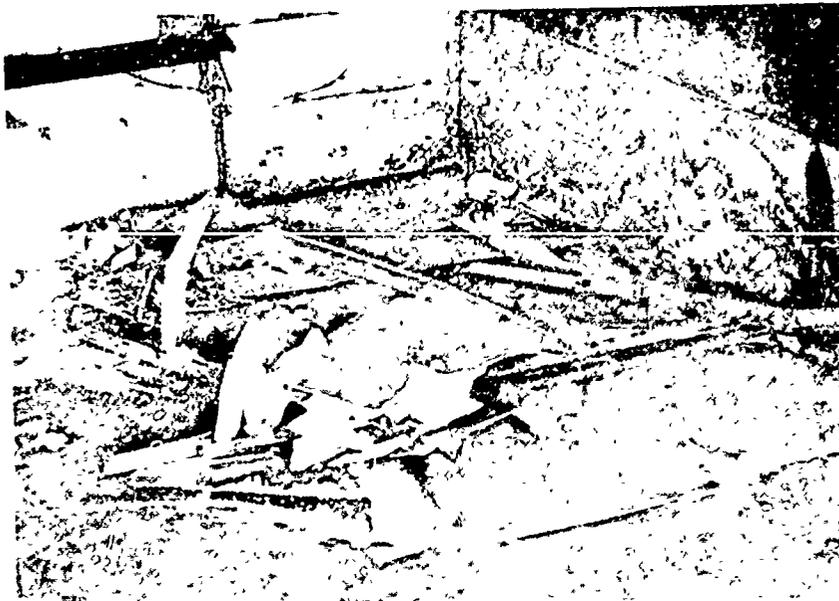
Fig. 105-1. Posttest Photographs, Wall Number 105.

One test was conducted using four 60-ft strands of Primacord (average peak incident overpressure 3.5 psi). The wall translated down the tunnel, remaining intact until it struck the bend of the tunnel; with the exception of two vertical cracks at the first and second metal studs on one side. Then, with the exception of a few pieces of sheetrock and two perimeter metal studs, the wall debris continued until impact with the far casemate wall, a distance of approximately 87 ft from the original wall location. The type, sizes, and location of the debris can be seen in the photographs in Fig. 105-1 and 105-2. A plot of displacement as a function of time is presented in Fig. 105-3.

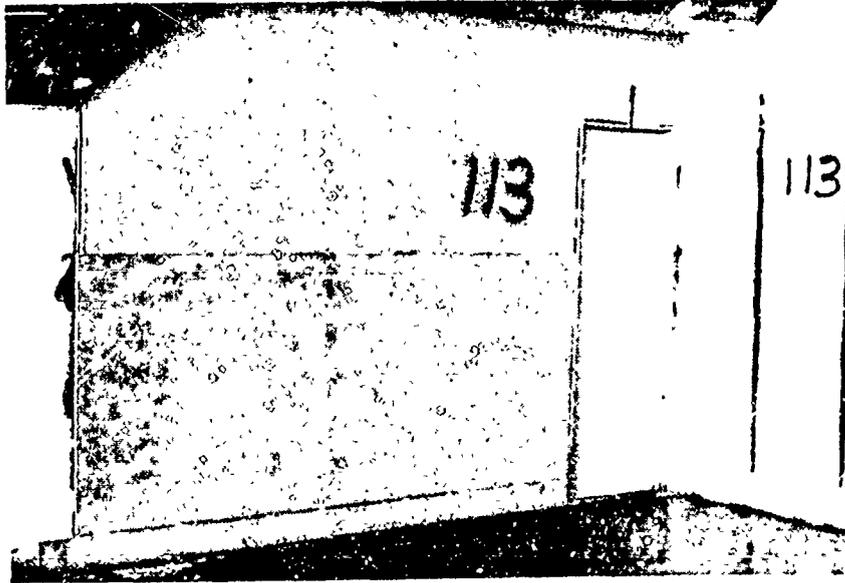
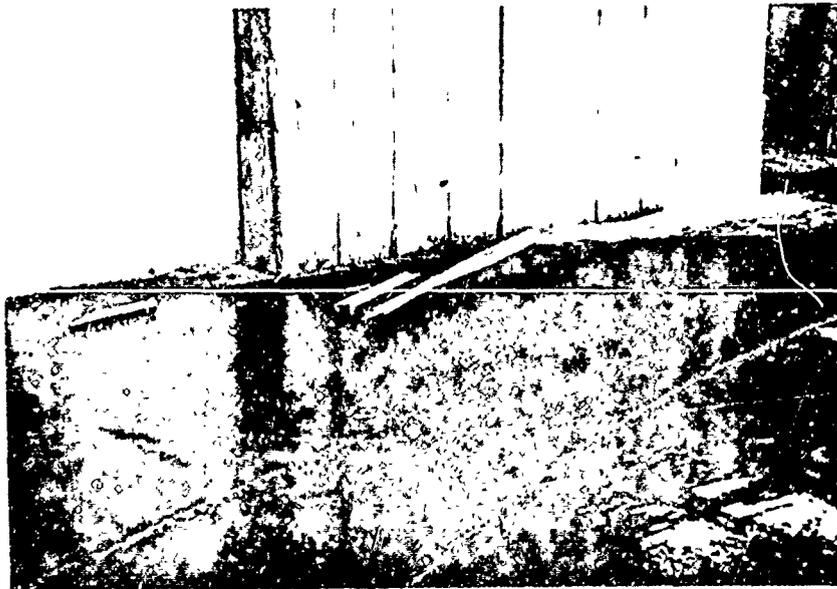
Fig. 113-1. Pre and Posttest Photographs, Wall Number 113.

This wall was tested once using two 60-ft strands of Primacord (average peak incident overpressure 1.7 psi). The door failed first and traveled ahead of the wall. With the exception of the header over the door and a metal stud at one edge, the wall remained intact until impact at the far wall. See pre- and posttest photographs, Fig. 113-1 and 113-2. A plot of displacement as a function of time is presented in Fig. 113-3.

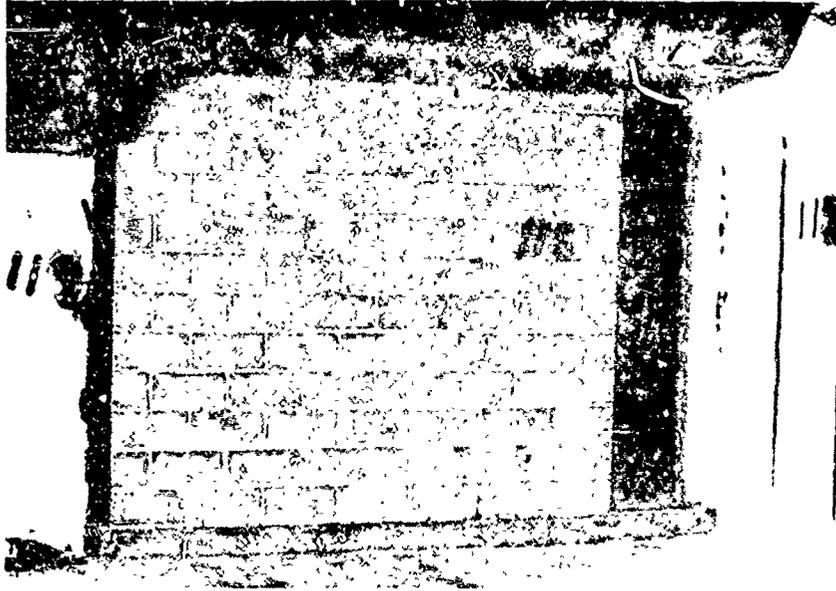
Fig. 118-1. Pre and Posttest Photographs, Wall Number 118.

This wall was tested using five 60-ft strands of Primacord (average peak incident overpressure 3.6 psi). Two initial cracks were noted between the third and fourth rows and one between the fourth and fifth rows. The film record was badly obscured by dirt and smoke flowing through the doorway opening but as nearly as could be determined the bottom third of the wall broke into small sections and fell over and hit the floor. The top two thirds remained intact and hit the floor at a distance of 25 to 30 ft. Photographs of this wall are presented in Figs. 118-1 through 118-3. A plot of displacement as a function of time is presented in Fig. 118-4.

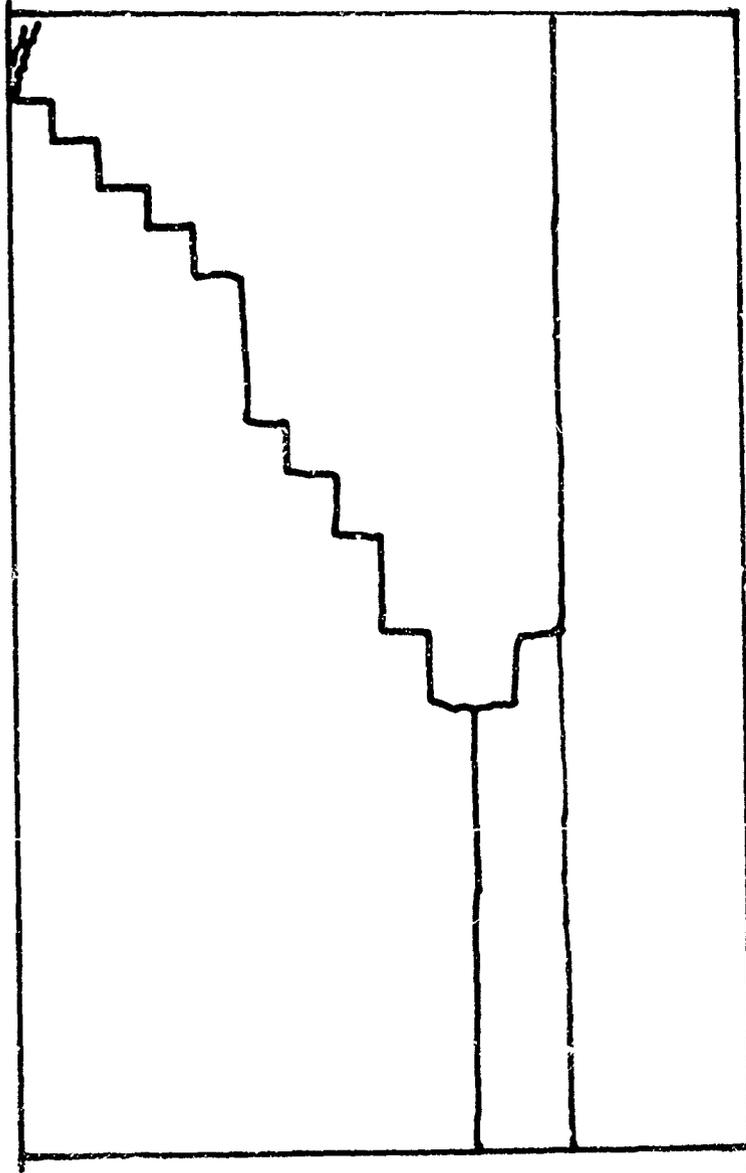
Fig. 120-1. Crack Pattern, Wall Number 120.

This wall was tested using five 60-ft strands of Primacord (average peak incident overpressure 3.9 psi). The initial crack appeared between the fourth and fifth row of blocks. The lower portion fell to the floor. The upper portion moved out and up striking the top of the tunnel. The impact broke the corner block on the one side and caused a diagonal crack as shown in Fig. 120-1, a sketch of the crack pattern. The upper portion remained airborne most of the way across the casemate. The photographs of the wall are presented in Figs. 120-1 and 120-3. A plot of displacement as a function of time is presented in Fig. 120-4.

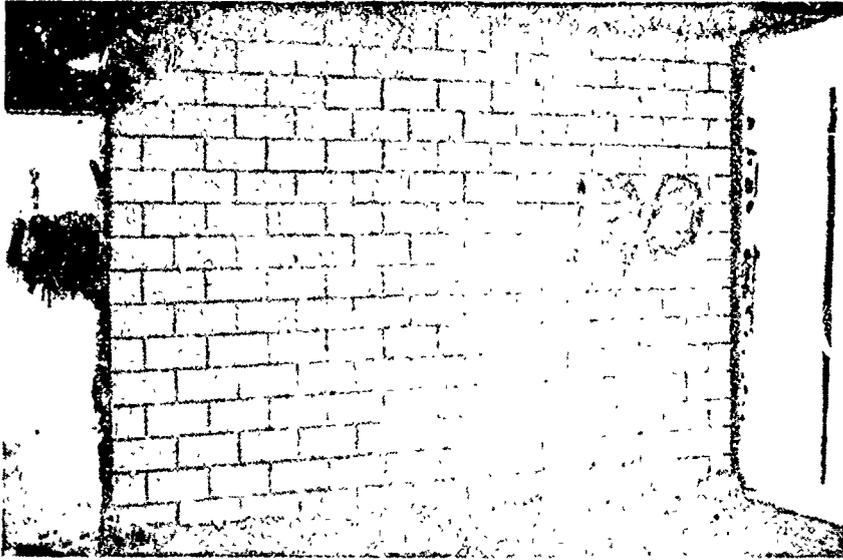
Fig. 120-2. Pre and Post Blast Photo of the same Area as Fig. 120-1.

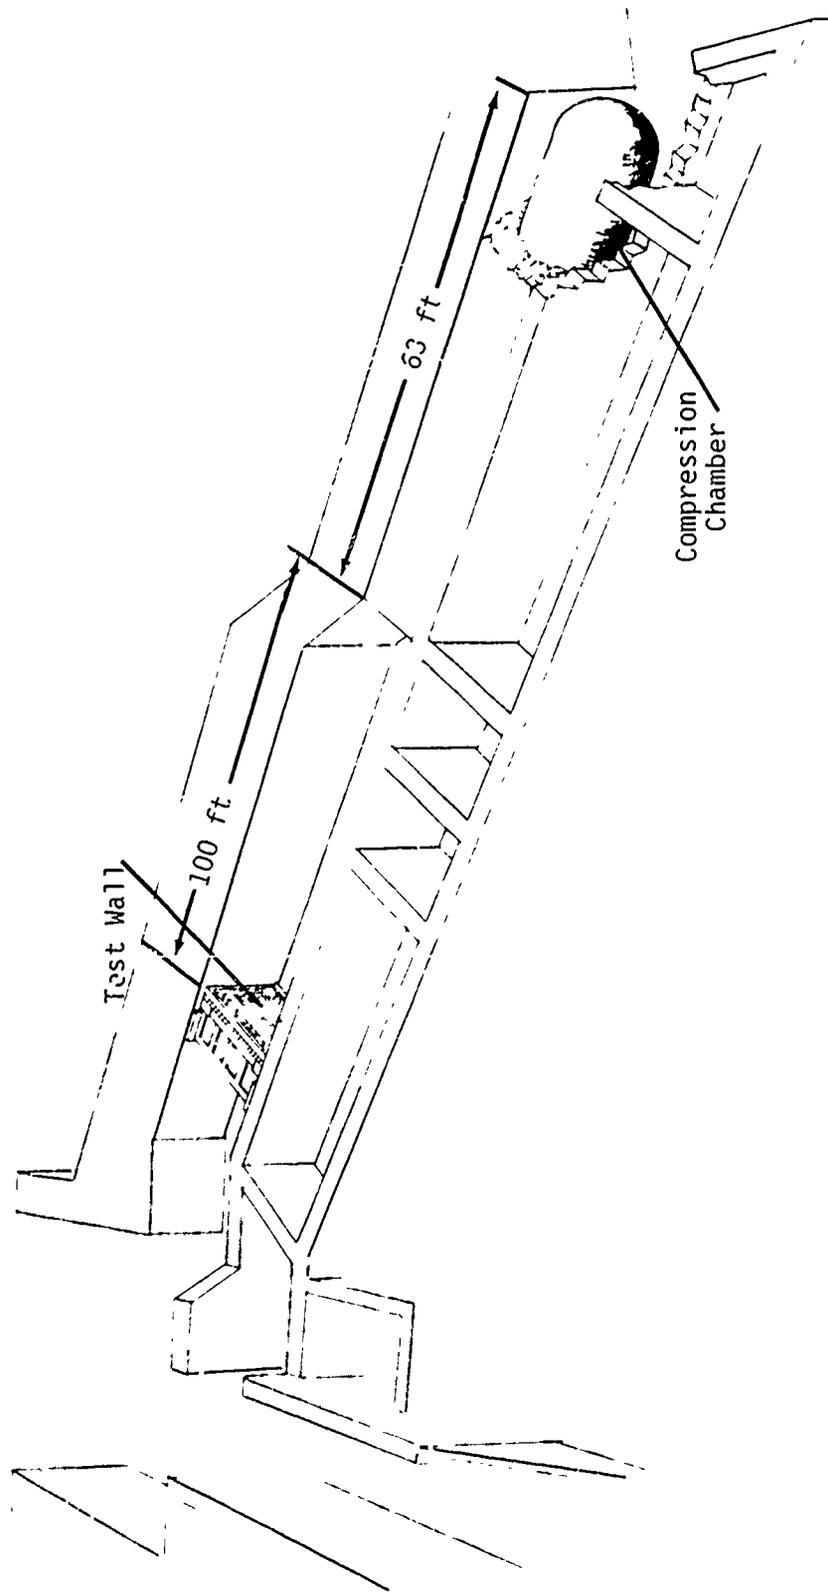
Fig. C-1. Cutaway View of Shock Tunnel Showing Wall in Place.

To understand how the multiple loading information was obtained it is necessary to consider the geometry of the shock tunnel and how it operates. The geometry of the tunnel is shown in a cutaway view in Fig. C-1.
