TECHNICAL REPORT 4869

DETERMINATION OF MINIMUM NONPROPAGATION
DISTANCE OF 105 MM M1 PROJECTILES
GROUPED 16 ON A PALLET

ROBERT KUKUVKA
PICATINNY ARSENAL

SEPTEMBER 1975

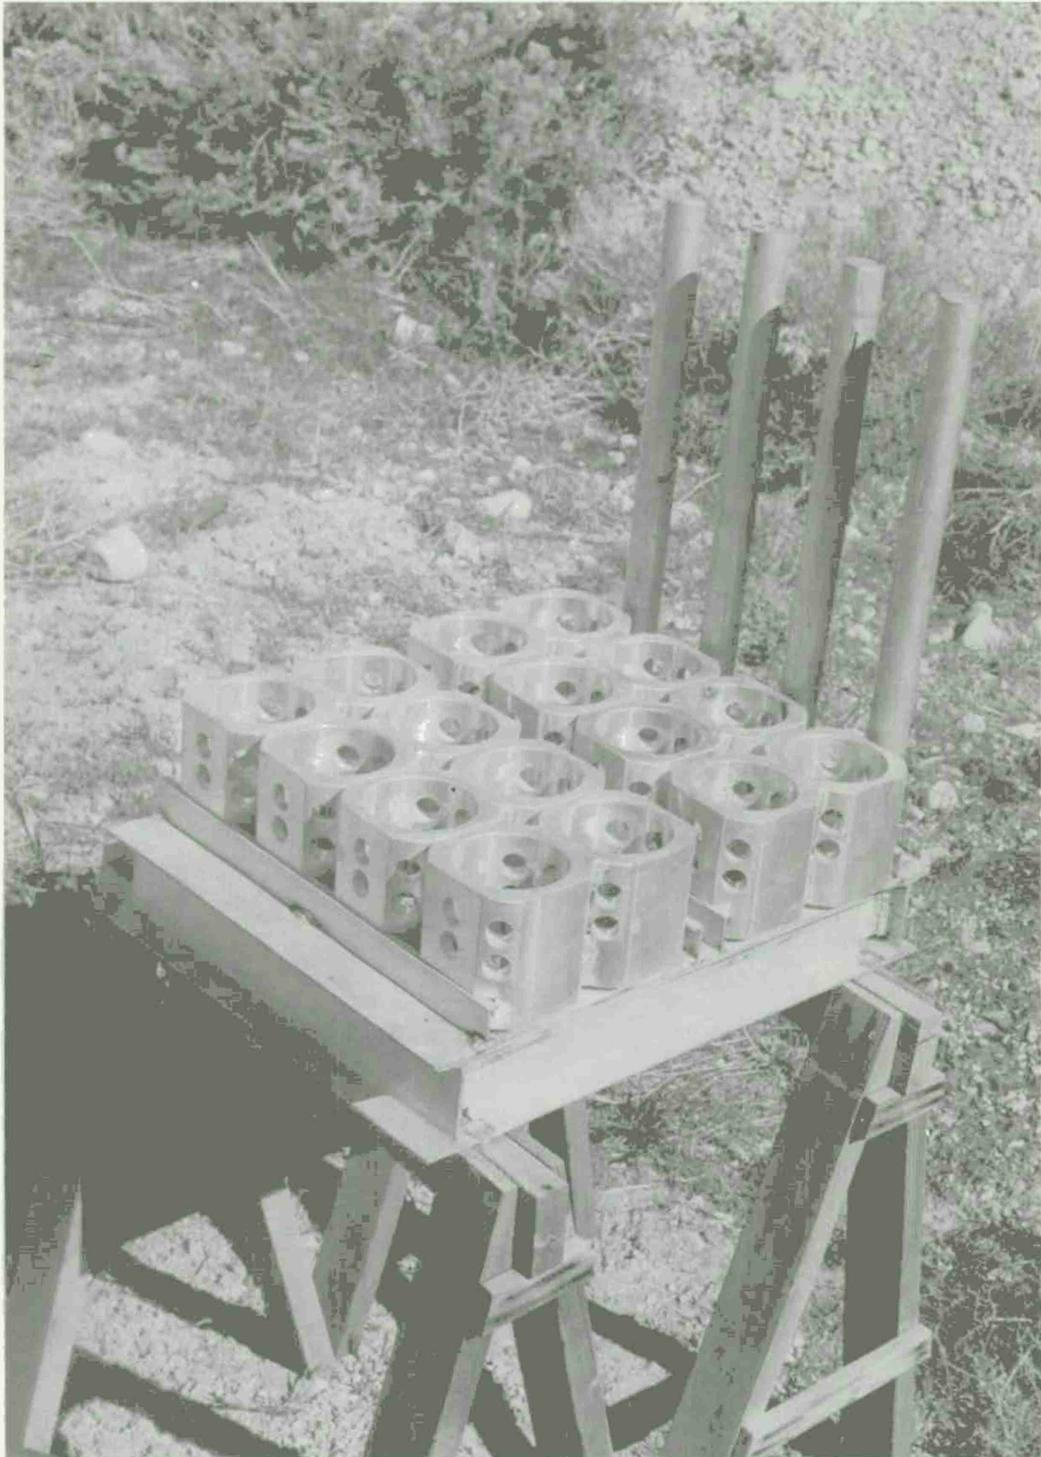
Figure 2 Test sequence I carriage with interrupter bars.

- a. 1-3/4-inch diameter aluminum blast interrupter bars attached to the donor carriage
- b. aluminum interrupter bars attached to the acceptor carriage.

The interrupter bars were of the same height (23 inches) as the plate shields tested later.

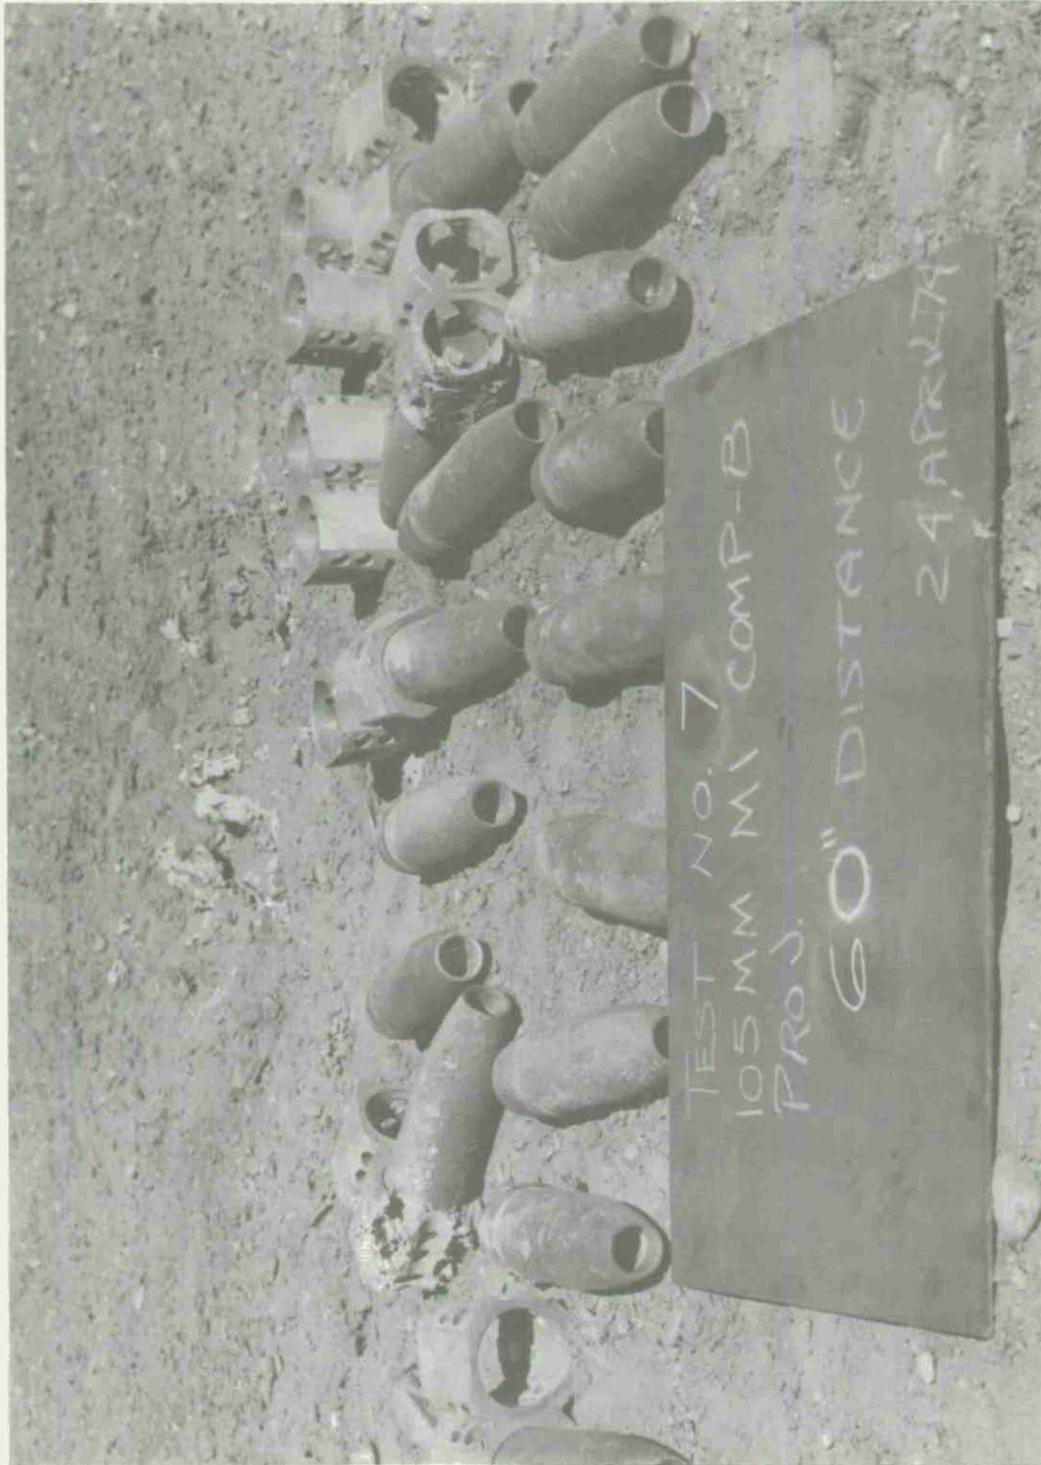
Figure 9 Typical test results - test No. 7.

High order detonation of all projectiles on the donor carriages was observed for both groups of test trials. Detonations or significant penetrations of the projectile casings were observed on the acceptor carriages for all tests but one. In some cases, acceptor projectiles were propelled as far as 300 feet from their original location. The aluminum test fixtures were reduced to shrapnel, severely contorted and in some cases, melted. In Test No. 23 where propagation was not observed, the interrupter bars were located on the donor carriage only with a spacing of 109 inches between carriages. It should be noted that though no projectiles were penetrated, three were severely attacked. Typical test results are depicted in Figures 7 through 13.

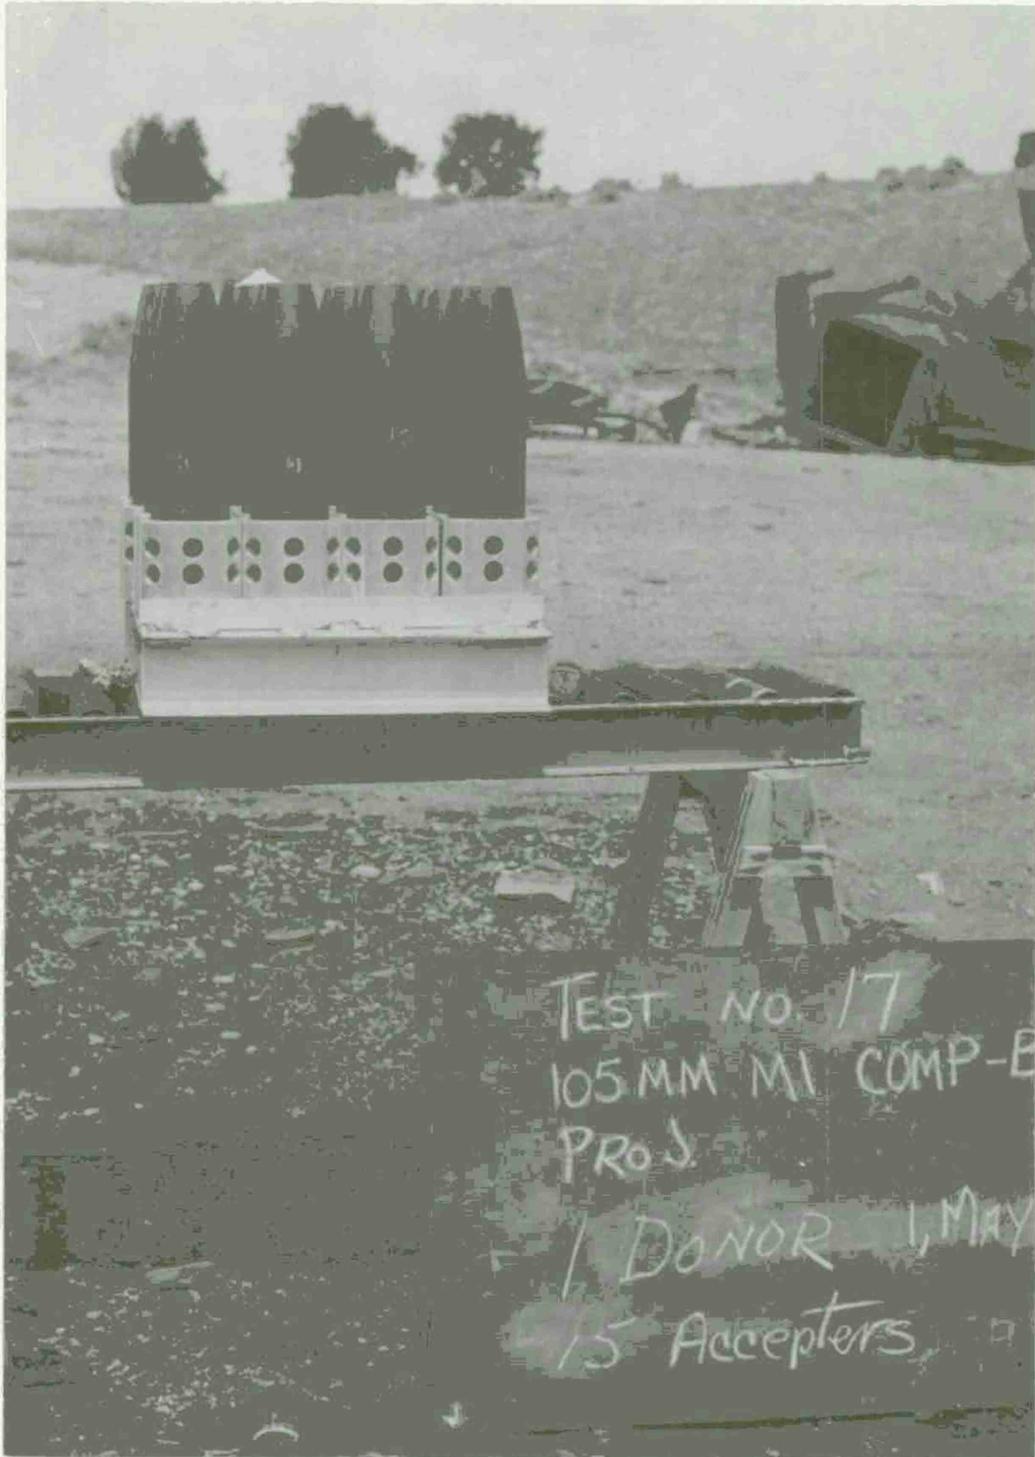
Figure 14 Test sequence II arrangement.

The physical arrangement used for this test sequence was similar to that used for Sequence I. The supplementary charges were omitted from the projectiles. One projectile on the carriage was selected as the donor and primed with approximately 1/4 pound of Composition C4 and detonated as for the previous test sequence. Figure 14 shows the test arrangement. For both of these tests, all the acceptor projectiles experienced high order detonations. Figure 15 shows the crater and debris from one of these tests.

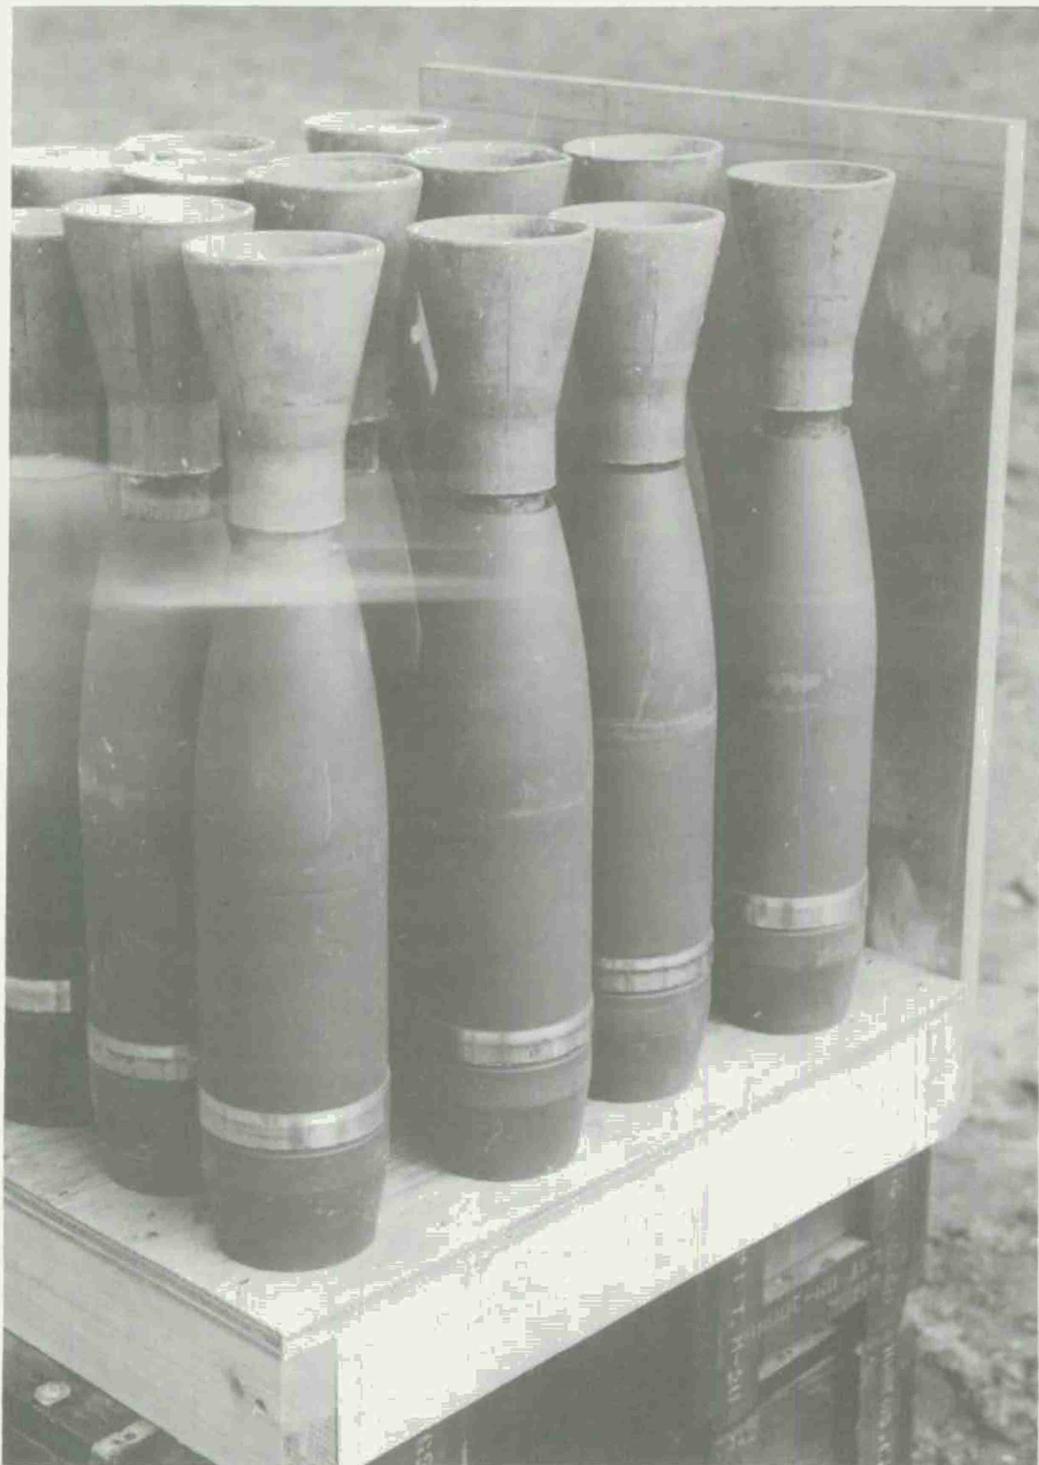
Figure 19 Typical shielded pallet.

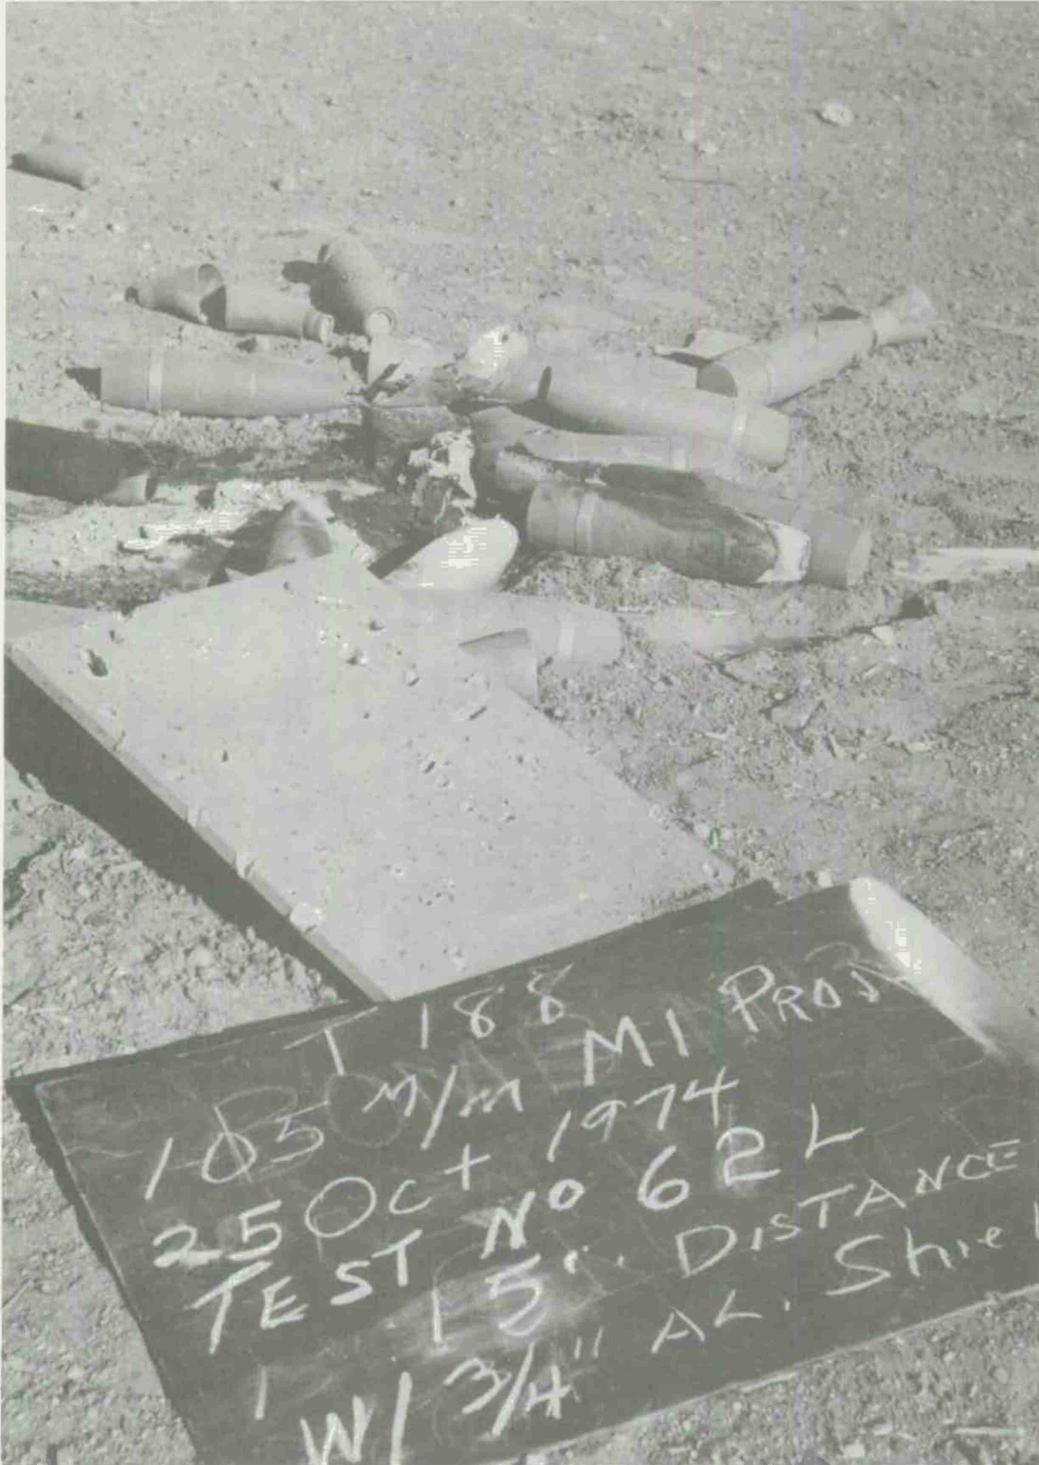
Figure 21 Typical test sequence IV results - test No. 62.

At the 5-foot distance, a high order propagation was observed on an acceptor pallet, while at the 10-foot distance, the shield was severely damaged and experienced numerous large penetrations. The shield experienced minor damage at the 15-foot distance although the projectiles were essentially blemish free. An optimistic view was taken relative to this distance and six successful tests were conducted. However, the next test produced a high order detonation. Typical test results are shown in Figures 20 and 21.

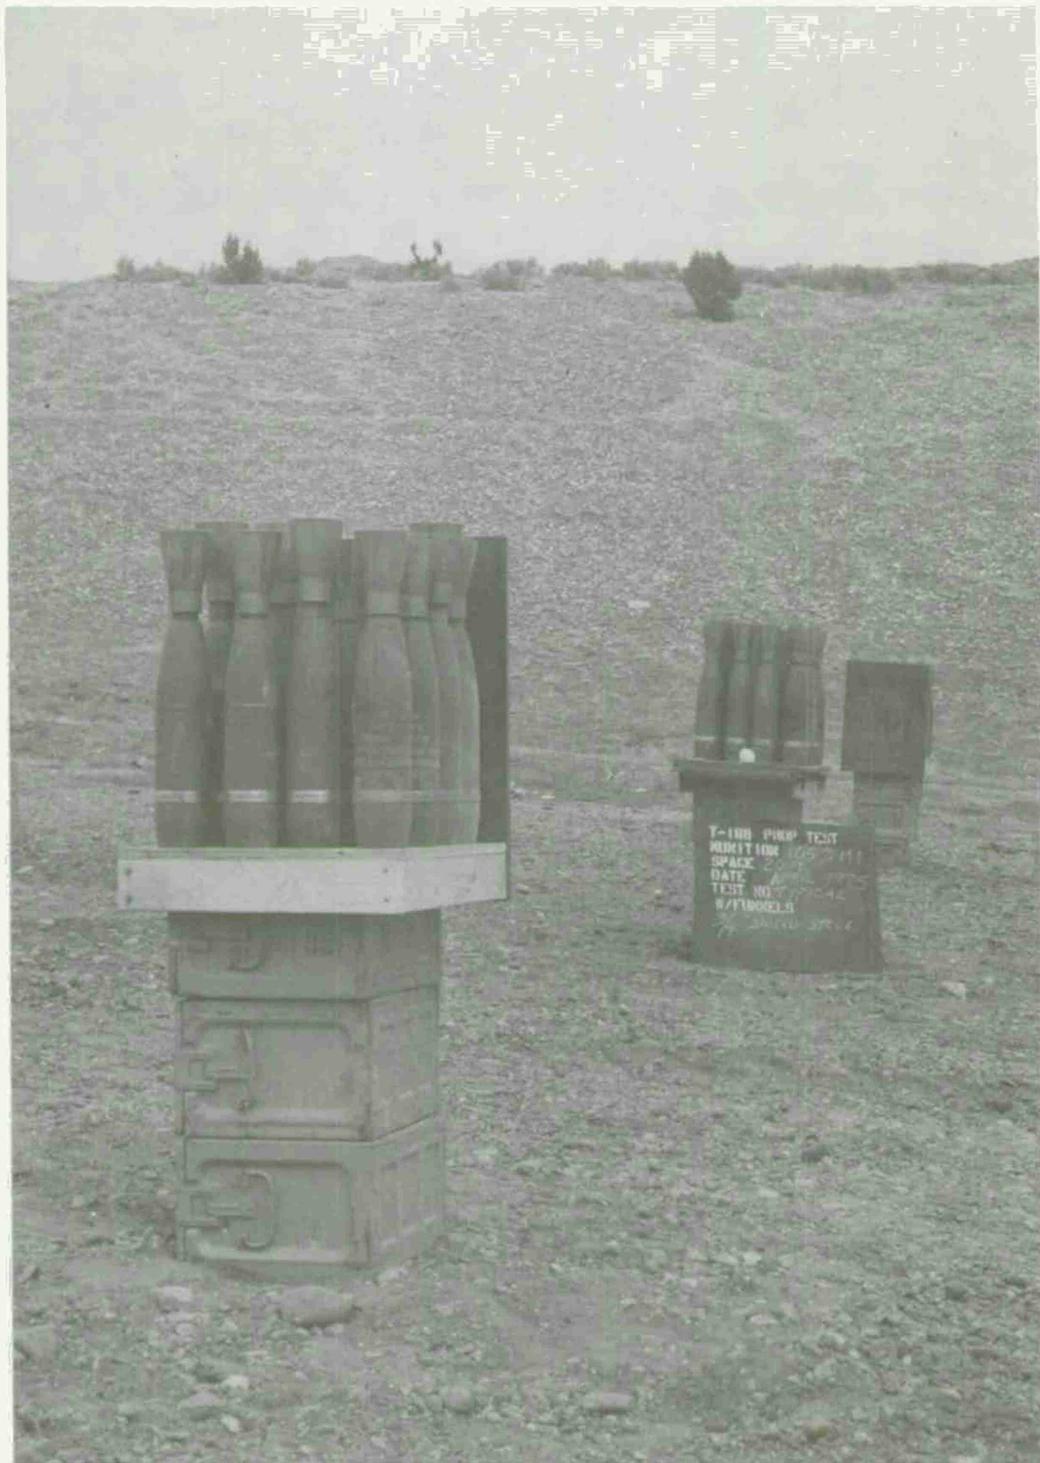
Figure 22 Test sequence V arrangement.

Four tests, identical to those of Test Sequence IV except for the use of 1020 steel in lieu of the aluminum shield, were conducted at separation distances of 5, 10 and 15 feet. A typical view of the test arrangement for all the tests of steel shields is shown in Figure 22. The shields were penetrated for the 10- and 15-foot separations and severely bent at the 5-foot distance. A large number of funnels were damaged at the 10- and 15-foot spacings while all the funnels were either burned or damaged at the 5-foot spacing. Representative photographs of the test results are shown in Figures 23 through 25.

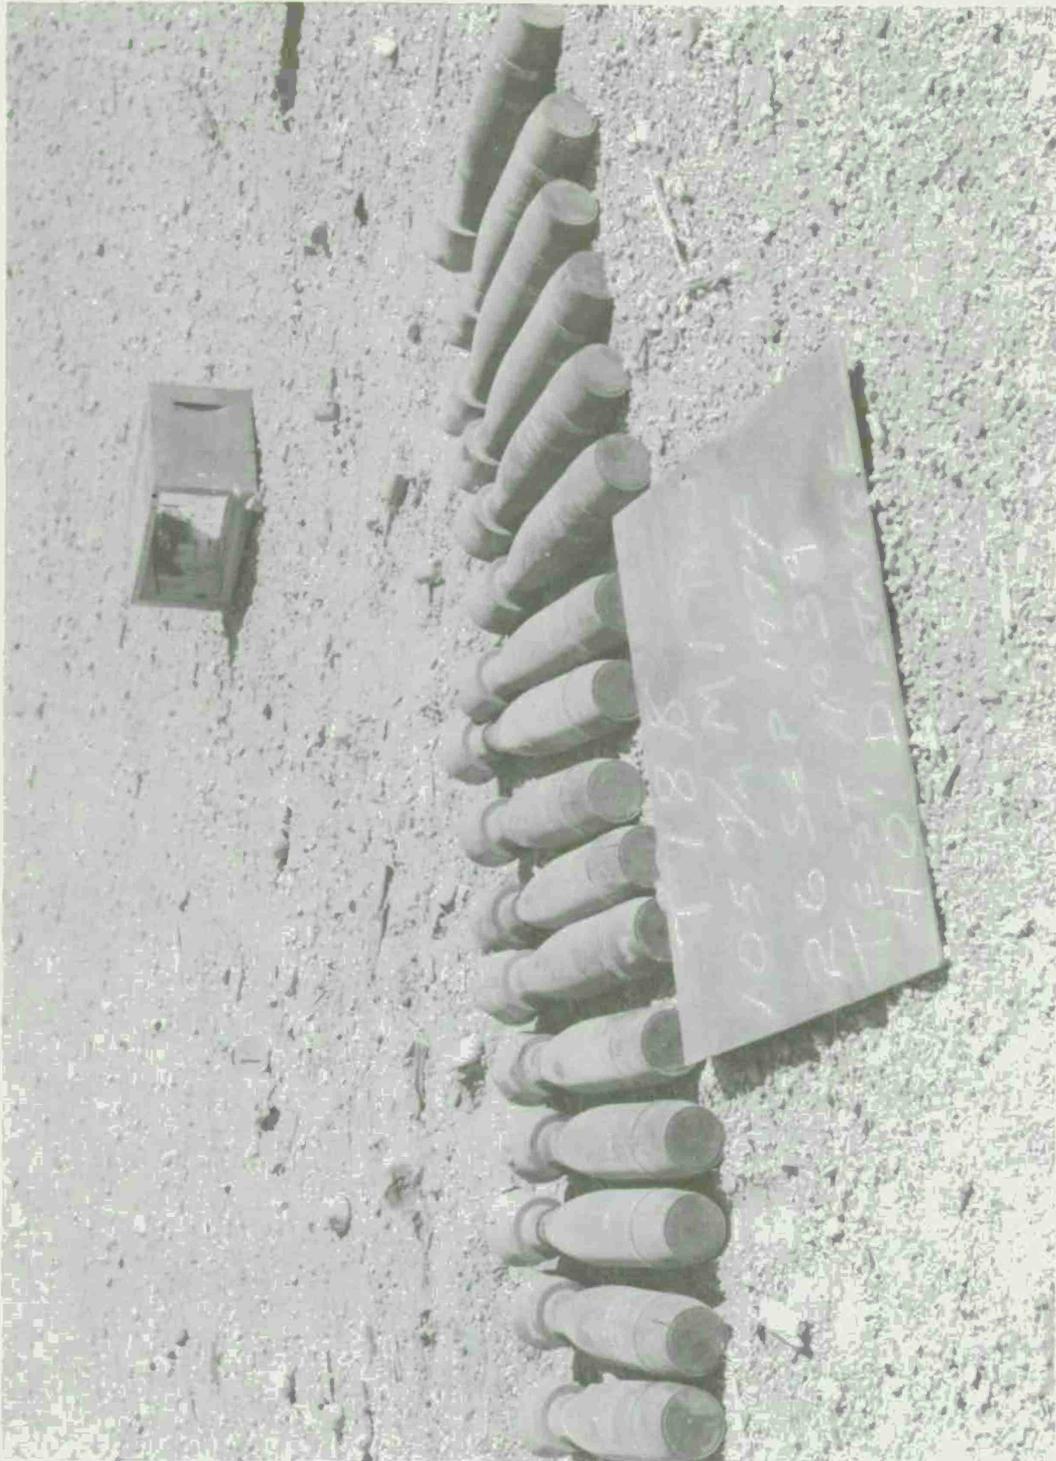
Figure 28 Typical test sequence VI results - test No. 39.

A detonation of three acceptor projectiles occurred in Test No. 97 fifteen minutes after donor initiation due to a fire which had propagated to one of them. Test No. 91 resulted in a high order detonation of an acceptor pallet. For most tests, the funnels experienced more damage than did the projectiles with holes being observed in them for most of the pallets. Representative test results are shown in Figures 26 through 28.

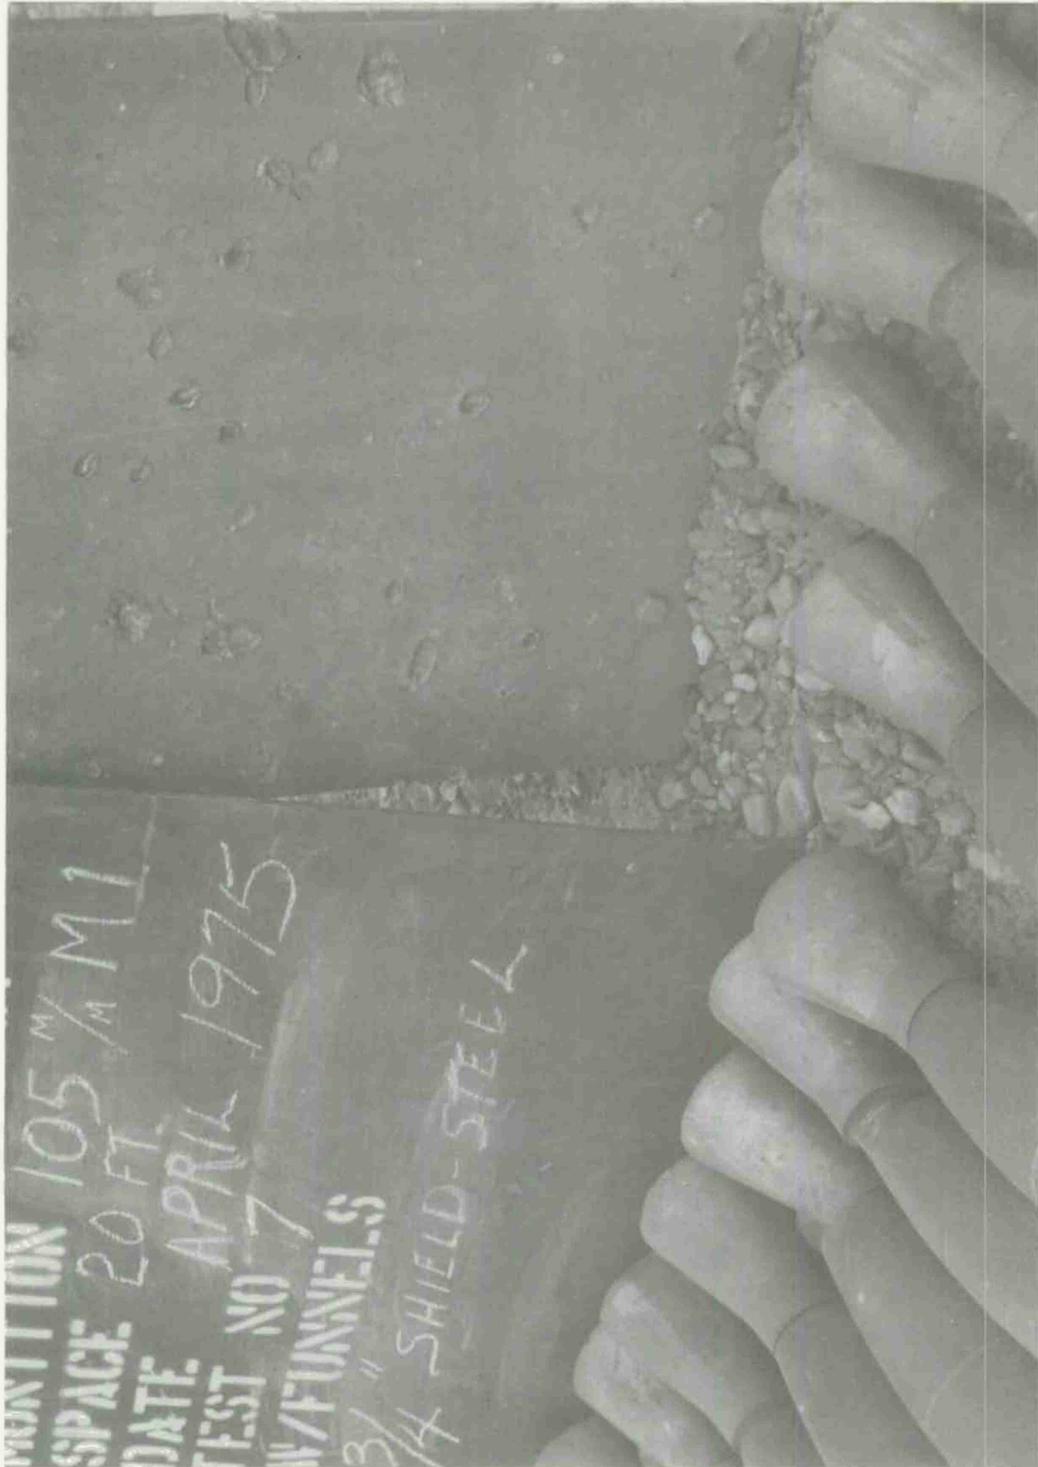
Figure 29 Typical test sequence VII results - test No. 73.

A sequence of 25 tests were conducted to confirm that propagation between pallets would not occur when the pallets were separated by a 20-foot clear distance and 3/4-inch steel plate blast shields were attached to the acceptor pallets. Funnels were used in all tests. All the tests utilized two acceptor pallets and one donor pallet so that a total of 49 pallets were tested for this sequence. Figures 29 through 31 illustrate the test results. Only one projectile was observed to have been dented. Holes were noted in six of the shields.
