# MICROSTRUCTURAL EFFECTS ON THE STRESS CORROSION CRACKING BEHAVIOR OF Ti-8Al-1Mo-1V IN METHANOLIC AND CHLORIDE SOLUTIONS

WALTER F. CZYRKLIS and MILTON LEVY  
METALS RESEARCH DIVISION

October 1975

ARMY MATERIALS AND MECHANICS RESEARCH CENTER  
Watertown, Massachusetts 02172

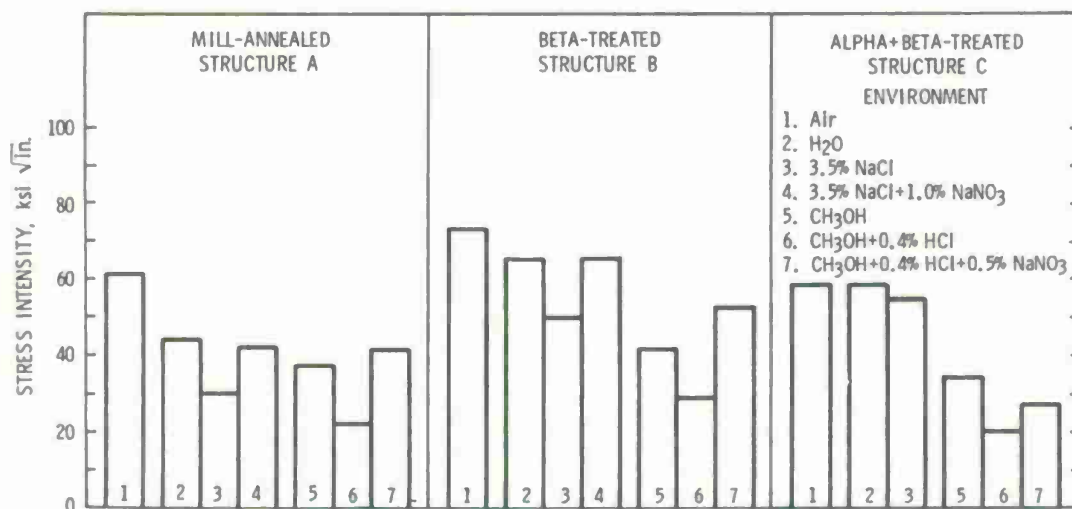
Figure 3. Comparison of SCC susceptibility of Ti-8Al-1Mo-1V.

The  $K_{ISCC}$  for the alloy in the three different heat-treated conditions was determined for each environment from a plot of stress intensity versus time to failure. The results are shown in bar graph form in Figure 3. For simplicity, the mill-annealed structure will be henceforth referred to as A; the structure resulting from treating in the beta phase field (1950 F) as B; and the structure resulting from treating in the alpha + beta field (1825 F) as C. Figure 3 shows that  $K_{ISCC}$  in distilled water is 65  $\text{ksi}\sqrt{\text{in.}}$  for structure B; 58  $\text{ksi}\sqrt{\text{in.}}$  for structure C; and 44  $\text{ksi}\sqrt{\text{in.}}$  for structure A. The air values for those structures are 73  $\text{ksi}\sqrt{\text{in.}}$ , 58  $\text{ksi}\sqrt{\text{in.}}$ , and 61  $\text{ksi}\sqrt{\text{in.}}$ . Thus, the alloy in condition C is immune to SCC in distilled water, ( $K_{ISCC}/K_{IX}$ ) = 1.0, while structure B is essentially immune ( $K_{ISCC}/K_{IX}$ ) = 0.89, and structure A shows some susceptibility ( $K_{ISCC}/K_{IX}$ ) = 0.72. The values obtained for the 3.5% sodium chloride environment show that structure C, again, is essentially immune to SCC and that structure A is, again, more susceptible to SCC than structure B. Also shown in Figure 3 is the beneficial effect of  $\text{NaNO}_3$  in mitigating SCC in the 3.5% sodium chloride solution. Note that  $K_{ISCC}$  in distilled water and inhibited salt solution is identical for structure B and within experimental error for structure A, which demonstrates the efficacy of  $\text{NaNO}_3$  in combatting the aggressiveness of the chloride ion. Since structure C was essentially immune to SCC in NaCl environment, it was not tested in the inhibited NaCl solution.

The data obtained for the alloy in the three different heat treatment conditions in methanolic solutions indicate that these structures exhibit a high and similar degree of susceptibility to SCC, with the  $\text{CH}_3\text{OH} + 0.4\% \text{HCl}$  medium being

the most aggressive environment. Structure A showed a greater susceptibility to SCC in the NaCl environment than in CH<sub>3</sub>OH, whereas structures B and C were more susceptible in CH<sub>3</sub>OH. When specimens were stress corroded in CH<sub>3</sub>OH + 0.4% HCl to which NaNO<sub>3</sub> was added, structure A showed the same marked improvement as in the inhibited NaCl solution, structure B showed somewhat less but still significant improvement, and structure C was relatively unaffected by NaNO<sub>3</sub>.

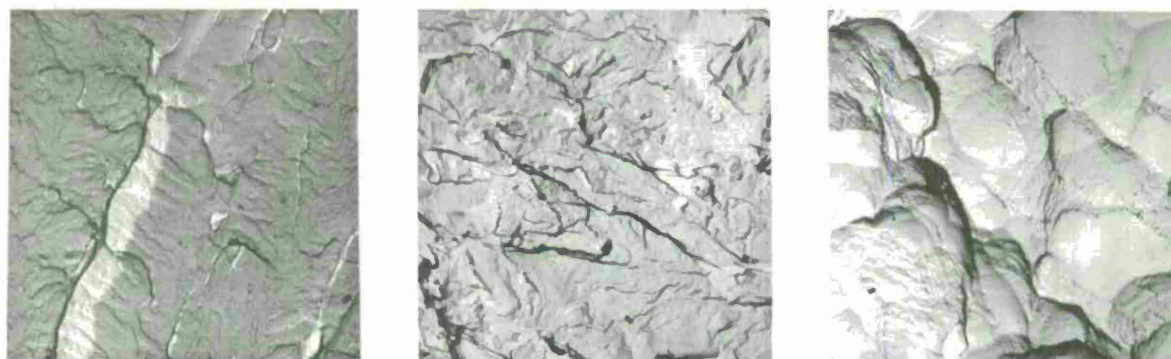
Figure 5. Water, Mag. (A) 4320X; (B) 1680X; (C) 1800X.

Figures 4 to 10 present high magnification replica fractographs for each alloy heat treatment condition showing the effect of environment on the fracture mode. The predominant mode of failure in air for the alloy in the three conditions (Figure 4) under fast fracture is transgranular dimpled rupture. Both alpha and beta phases are clearly delineated in condition C. In distilled water, Figure 5, the fracture mode in the slow crack growth (SCC) region for conditions A

and B is cleavage while condition C, which exhibited immunity to SCC in water, has the same fracture mode that was observed for failure in air, namely, ductile rupture of the alpha phase and tearing of the beta phase. The predominant mode of fracture in 3.5% NaCl environment (Figure 6) was quasi cleavage for all three conditions. Note the similarity in fracture topography for condition B in water and in NaCl. Figure 7 shows that structure A failed by a cleavage mode when exposed to 3.5% NaCl solution to which NaNO<sub>3</sub> was added, which was also the case upon exposure to distilled water. Figure 7 also shows that condition B failed by ductile rupture rather than cleavage which is reflected in the higher threshold for SCC.

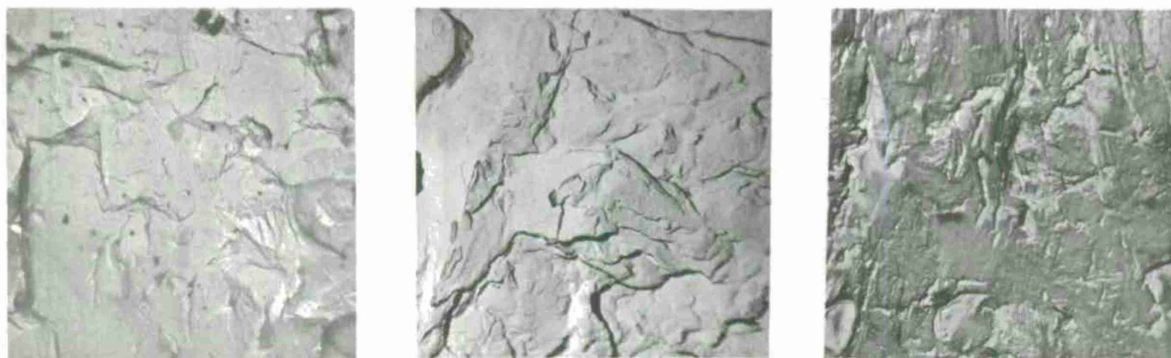
Figure 6. 3.5% NaCl, Mag. (A) 1500X; (B) 1800X; (C) 2130X.
