PROCEEDINGS OF THE TRISERVICE CORROSION OF MILITARY  
EQUIPMENT CONFERENCE (1974), HELD AT DAYTON, OHIO  
ON 29-31 OCTOBER 1974. VOLUME I. SESSIONS I THROUGH  
III

AFML-TR-75-42

**PROCEEDINGS OF THE 1974 TRISERVICE  
CORROSION OF MILITARY EQUIPMENT  
CONFERENCE, 29-31 OCTOBER 1974  
Volume I. Sessions I through III**

**TECHNICAL REPORT AFML-TR-75-42, Volume I  
FINAL REPORT FOR PERIOD 31 OCTOBER 1974 - 1 FEBRUARY 1975**

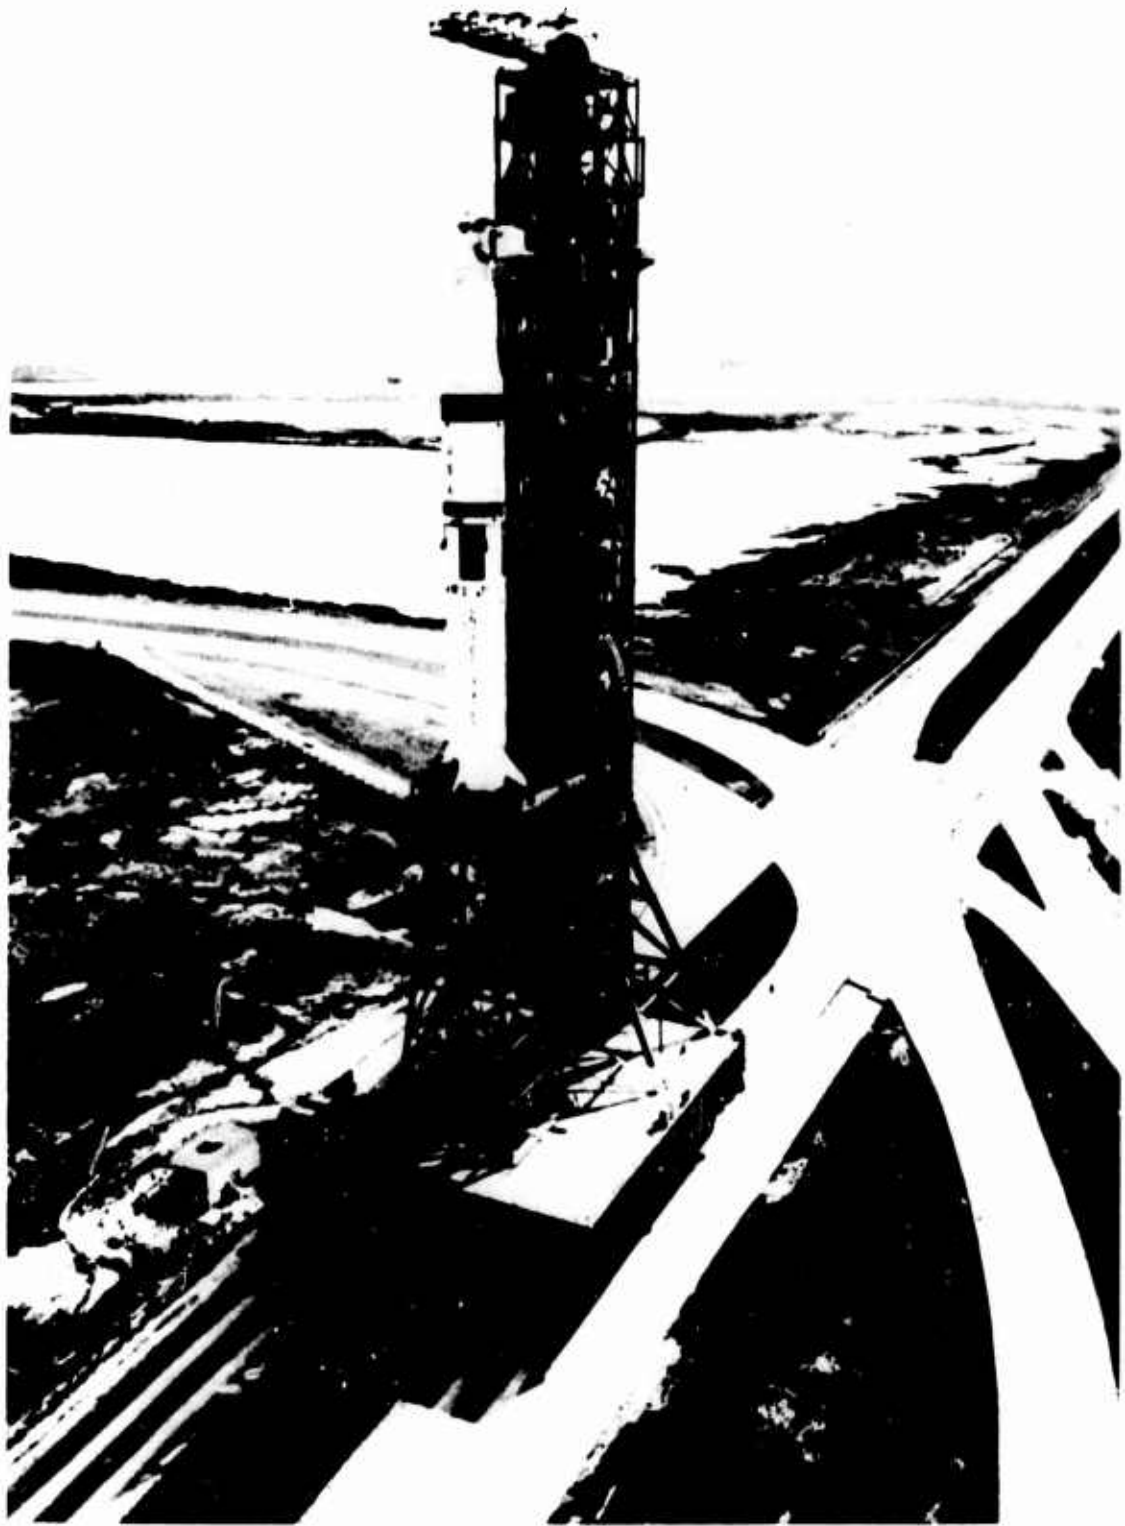
FIGURE 1 - APOLLO-SATURN LAUNCH VEHICLE AS-208

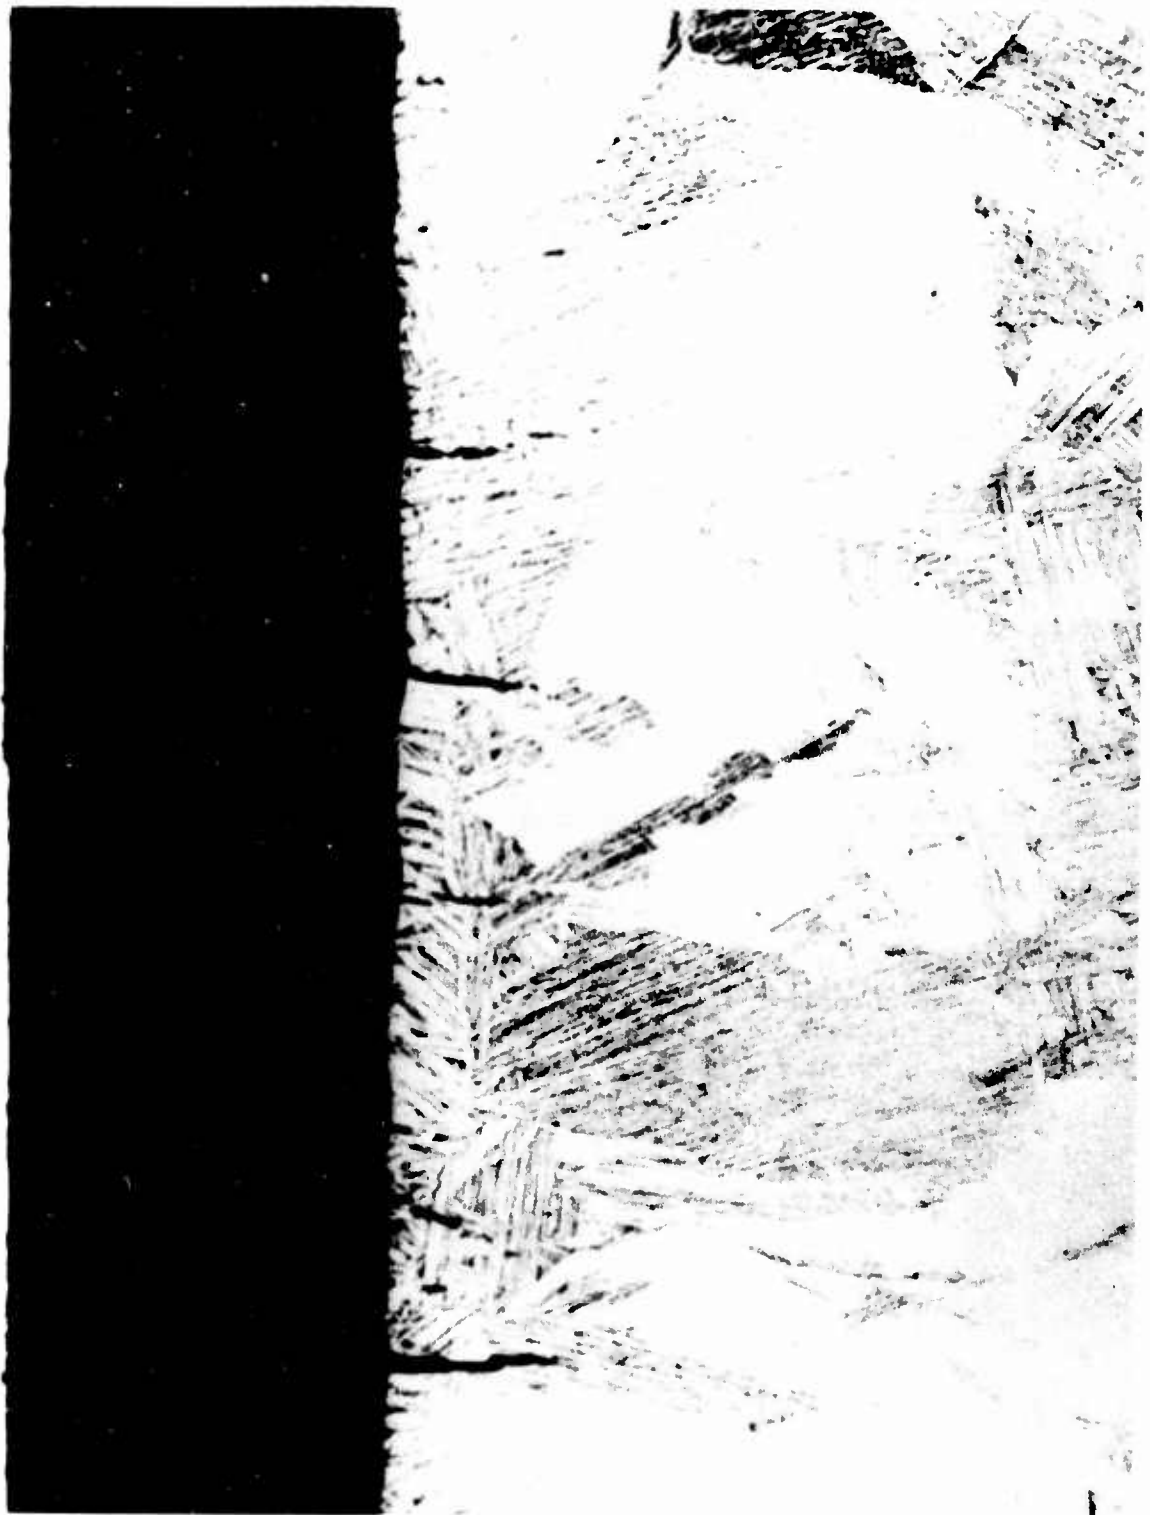
Cracks from Titanium Hydrides

15. Finding: Careful (selected) use of CP titanium for welding and structural elements required

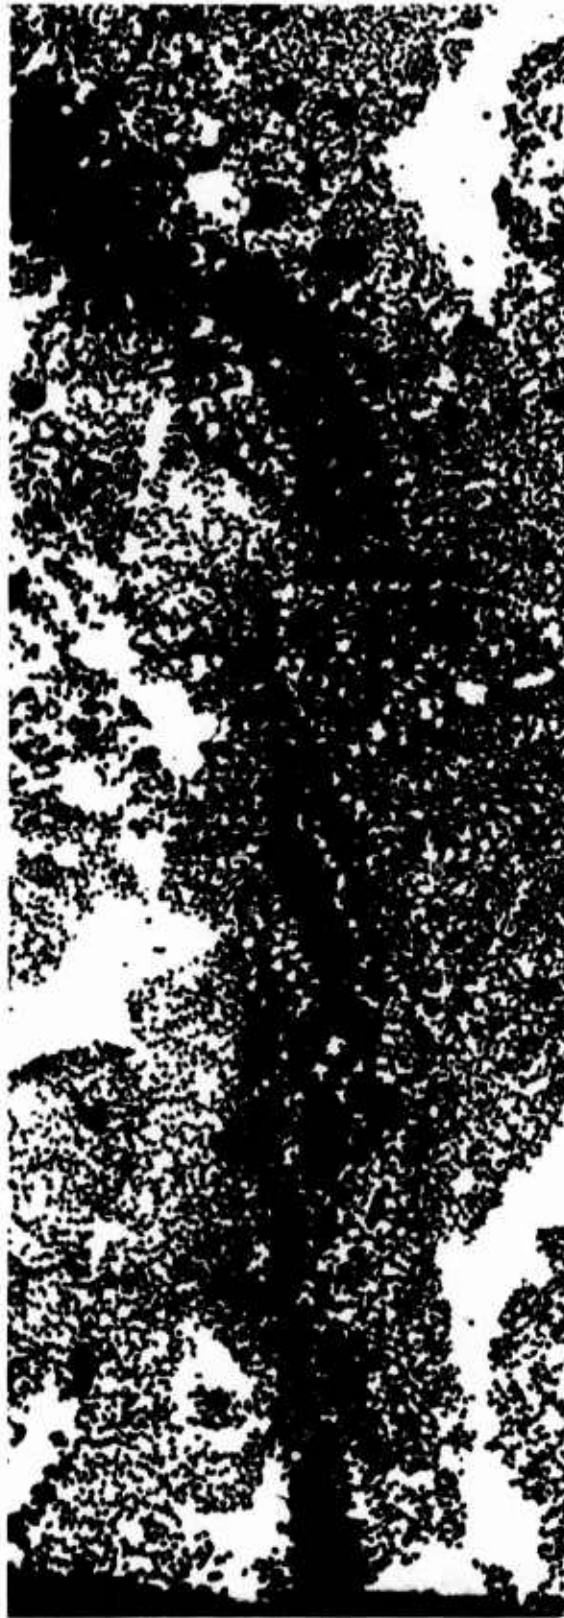
FIGURE 6. CROSS SECTION OF COMPOSITE SPECIMEN  
EXPOSED TO SODIUM CHLORIDE SOLUTION AT 323 K  
SHOWING CREVICE CORROSION IN AREAS OF  
HIGH FIBER DENSITY (150X)

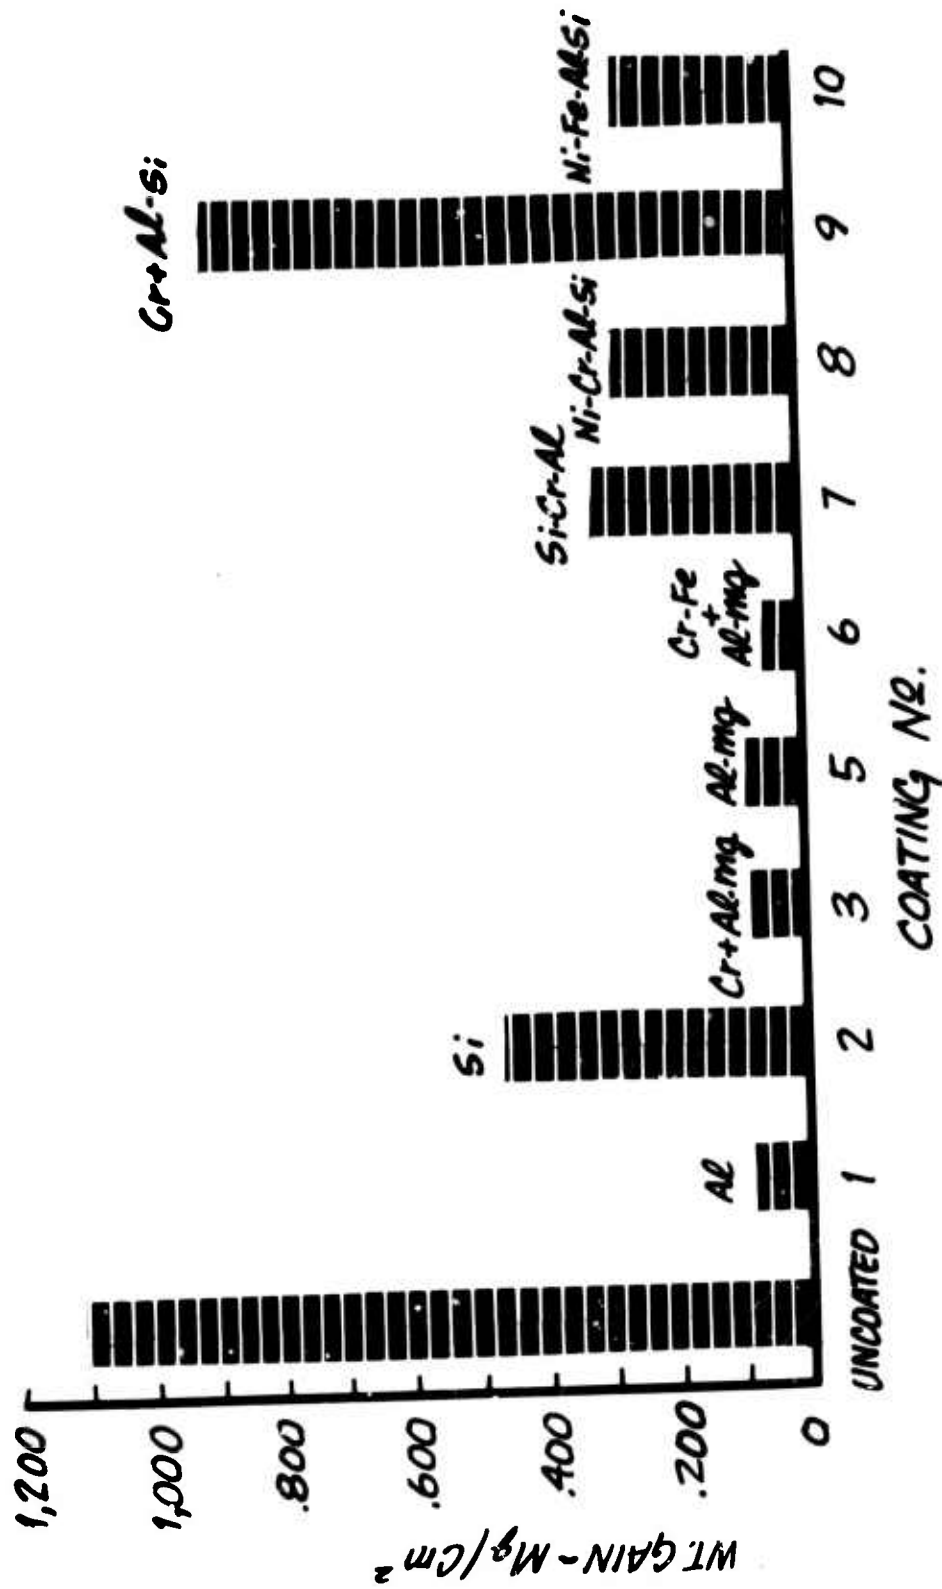
Figure 3. Cumulative Weight Gains of Uncoated and Coated Ti-6-2-4-2 Sheet After 1000 Hr/922 K (1200°F) Oxidation Exposure
