Technical Note N-1422

GROUND TRANSPORTATION FOR POLAR OPERATIONS - 16-WHEEL
LOW-GROUND-PRESSURE VEHICLE (LGPV-16)

M. W. Thomas

January 1976

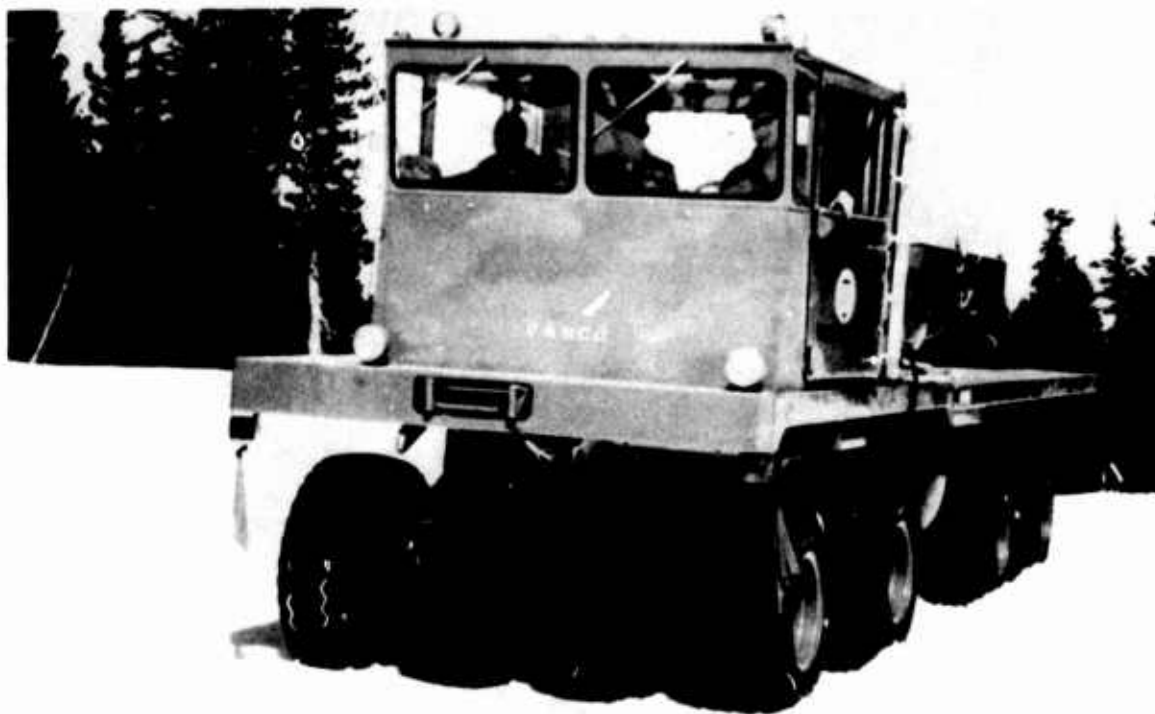
Figure 3. Operation of vehicle over undisturbed snow at Mammoth.

On the next test, the vehicle covered approximately 200 yards on a flat, level area before becoming immobile in the soft snow (Figure 3). The front wheels had penetrated 8 inches and the rear wheels 12 inches. Disturbance of the snow by the front wheels and the slightly higher axle load on the rear wheels contributed to their deeper penetration.

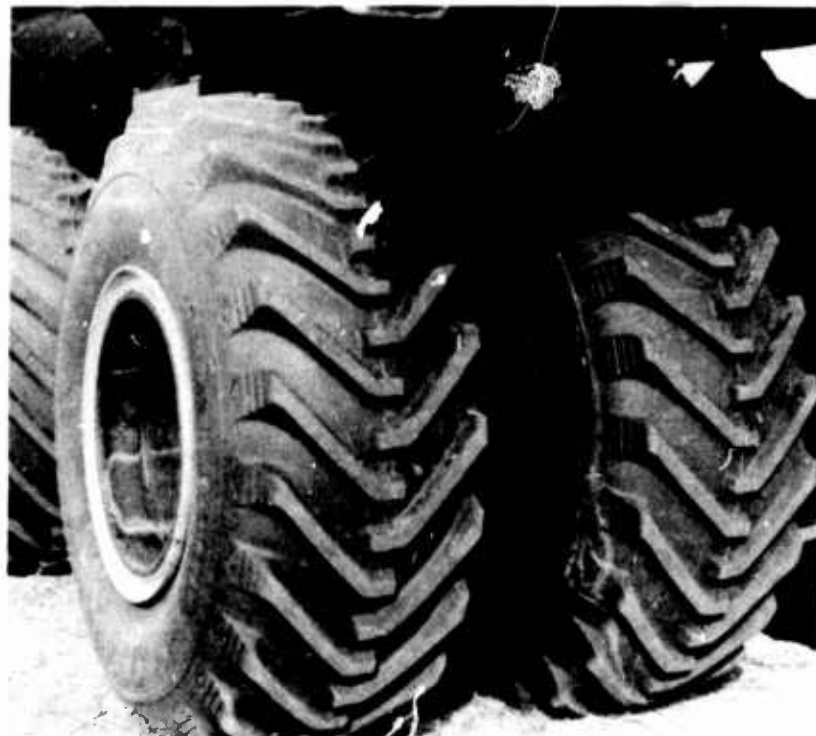
Figure 6. Goodyear 48 x 20.00 x 20 Super Terra-Grip tire, replacement tire.

After completing the Mammoth snow tests the vehicle was fitted with new tires to reduce tire ground pressure and improve vehicle traction. The largest tire the vehicle would accommodate was a 48 x 20.00 x 20, high-flotation Goodyear Super Terra-Grip. It was of 4-ply sidewall construction and would operate with a minimum inflation pressure of 4

psi. According to manufacturer's specifications, ground contact area is 280 square inches at no penetration and 590 square inches at 4-inch penetration. The new tires also required new wheels with lockbead rims to eliminate tire-rim slippage at the low inflation pressures. To use the tire also required reversing the wheel drive chains to eliminate the chain link pin ends' rubbing against the tire sidewall. Figures 5 and 6 show the difference in tread design between the original and replacement tires.

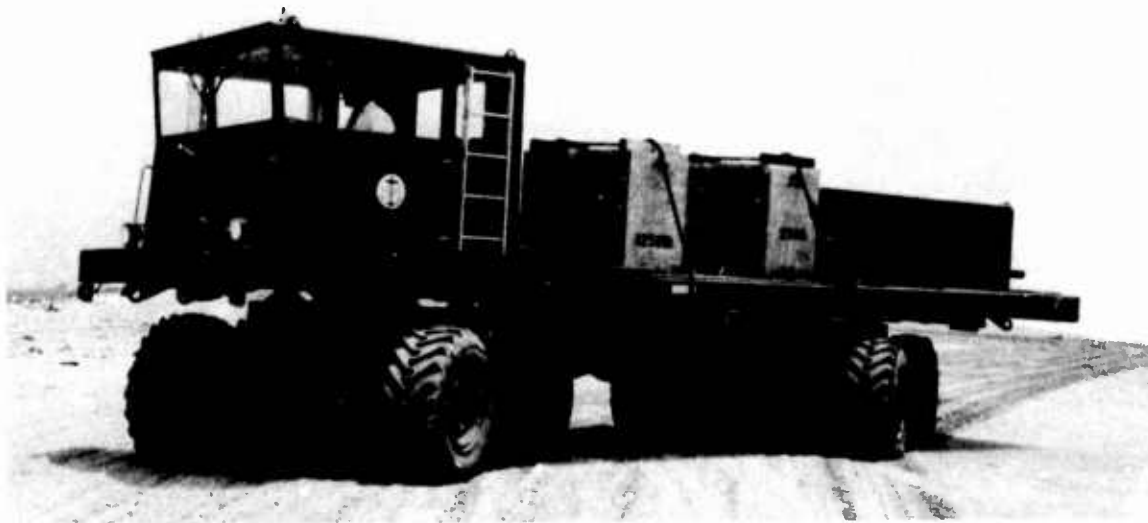
Figure 7. Operating vehicle on beach sand for Terra-Grip tire performance and frame modification tests.

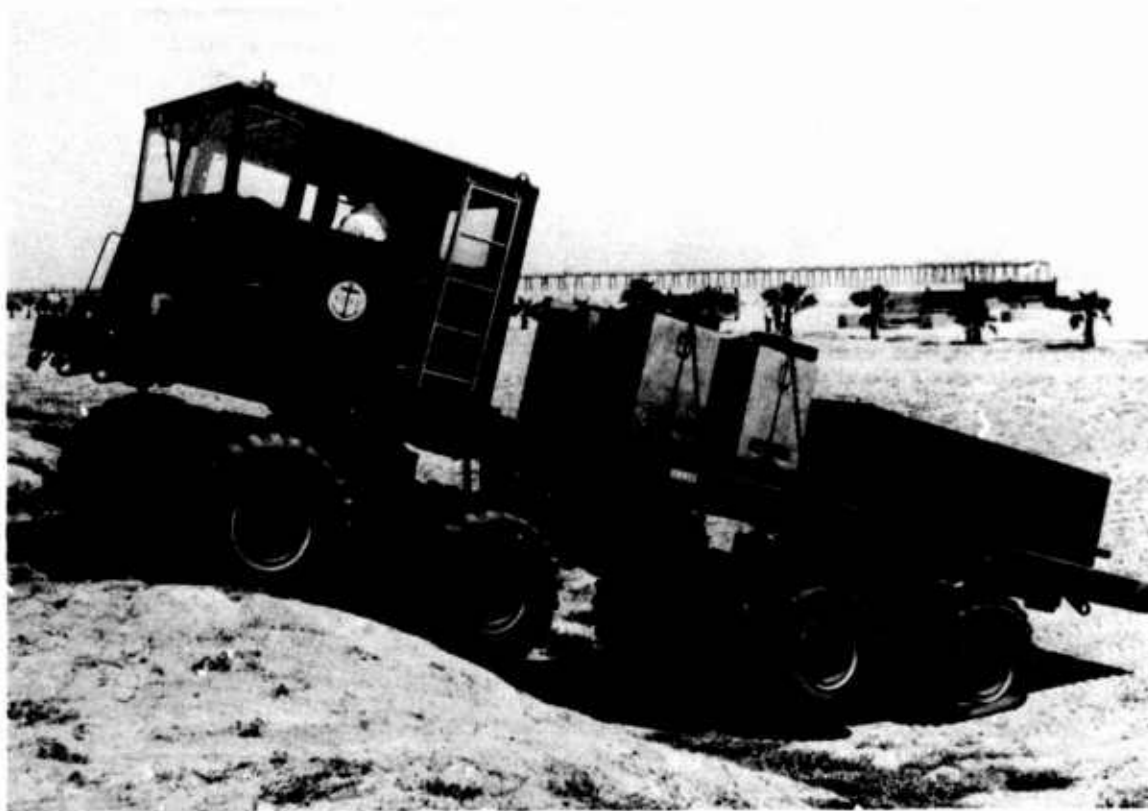
Figure 8. Operating vehicle over sand dune area to observe rough-terrain performance.

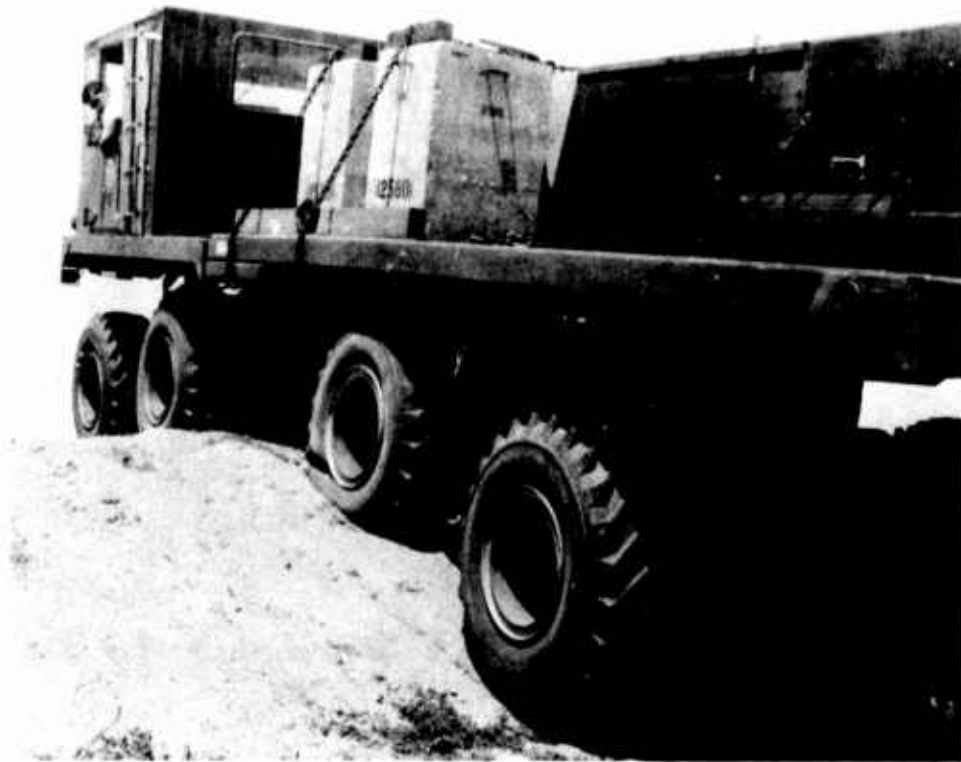
Figure 9. Sequence view of Figure 8, showing severe loading of tire as vehicle progressed over slope.

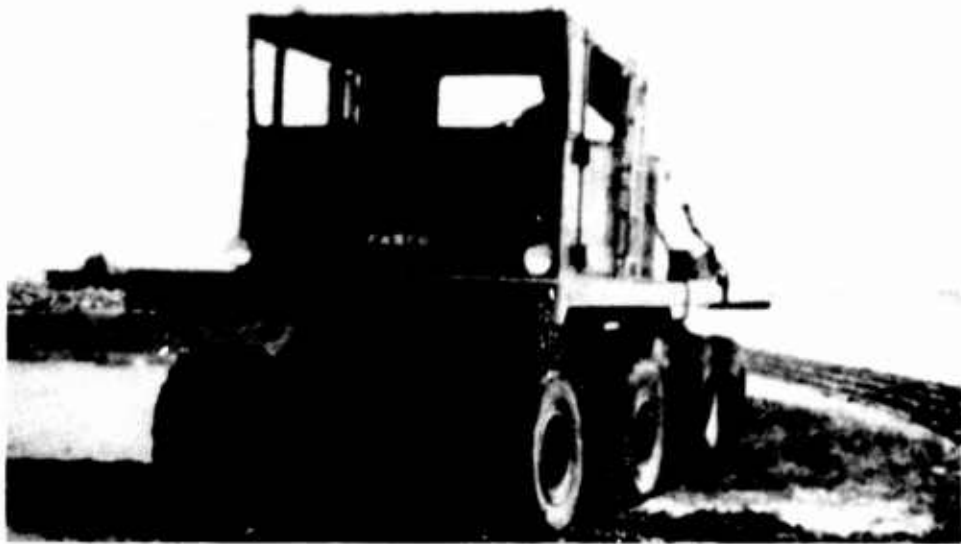
Figure 10. Vehicle making an initial pass over Point Mugu test area.

The vehicle, loaded with 10,000 pounds and tire inflation of 10 psi, had adequate flotation and traction to traverse this area on an initial pass (Figure 10) with tire penetration of 1 to 5 inches. However, on a repeat pass over the same area the tires penetrated 5 to 10 inches more into the mud until the walking-beam suspension arms dragged, completely immobilizing the vehicle (Figure 11) due to loss of traction. The vehicle successfully traversed the wet sandy beach areas with tire penetration of 1 to 2 inches. All steering modes - compound, crab, and front-only - were accomplished without difficulty during these tests.

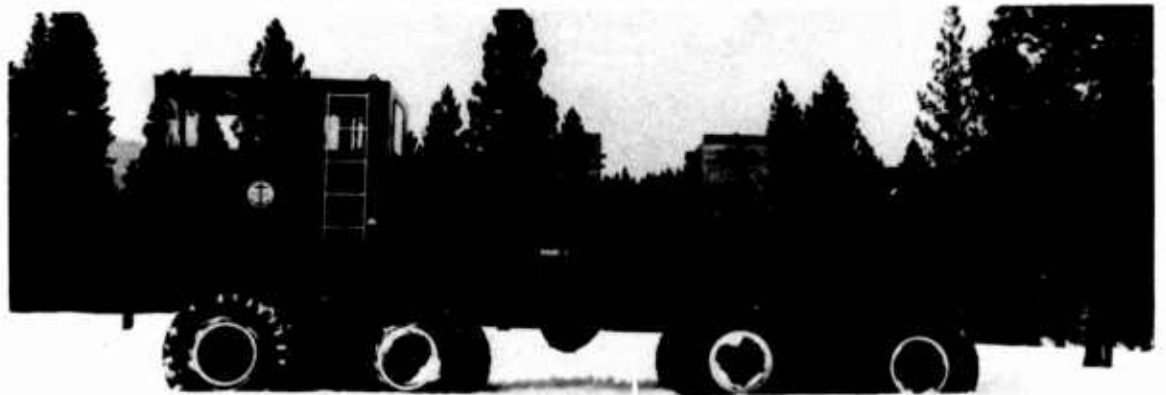
Figure 12. Vehicle operating on level terrain at Truckee test site.

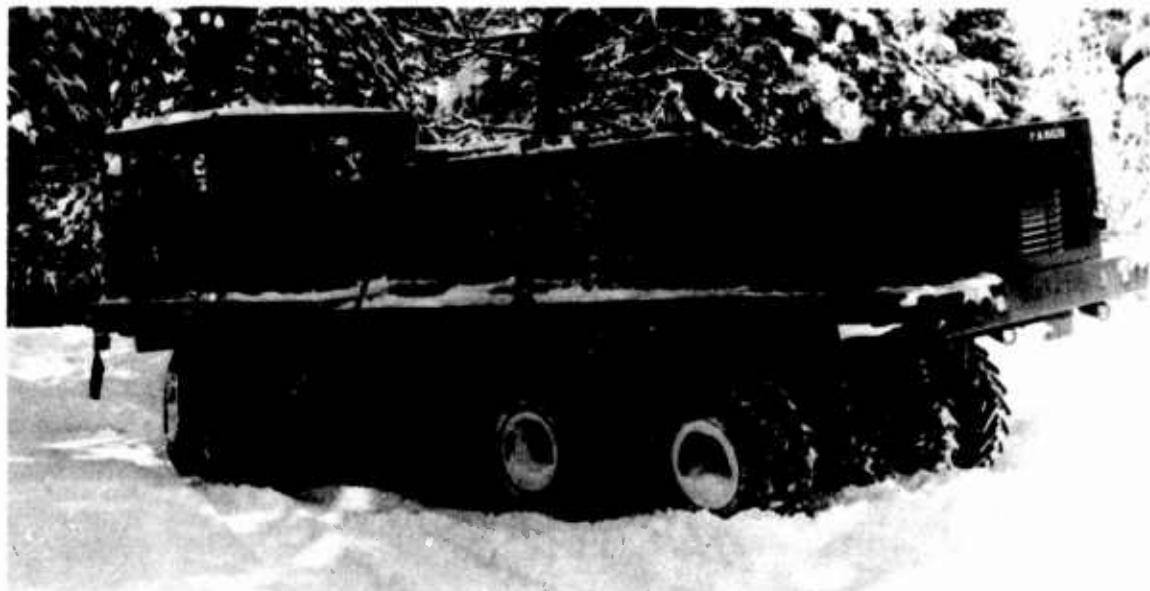
Figure 13. Vehicle operating on forest-covered hilly terrain at Truckee test site.

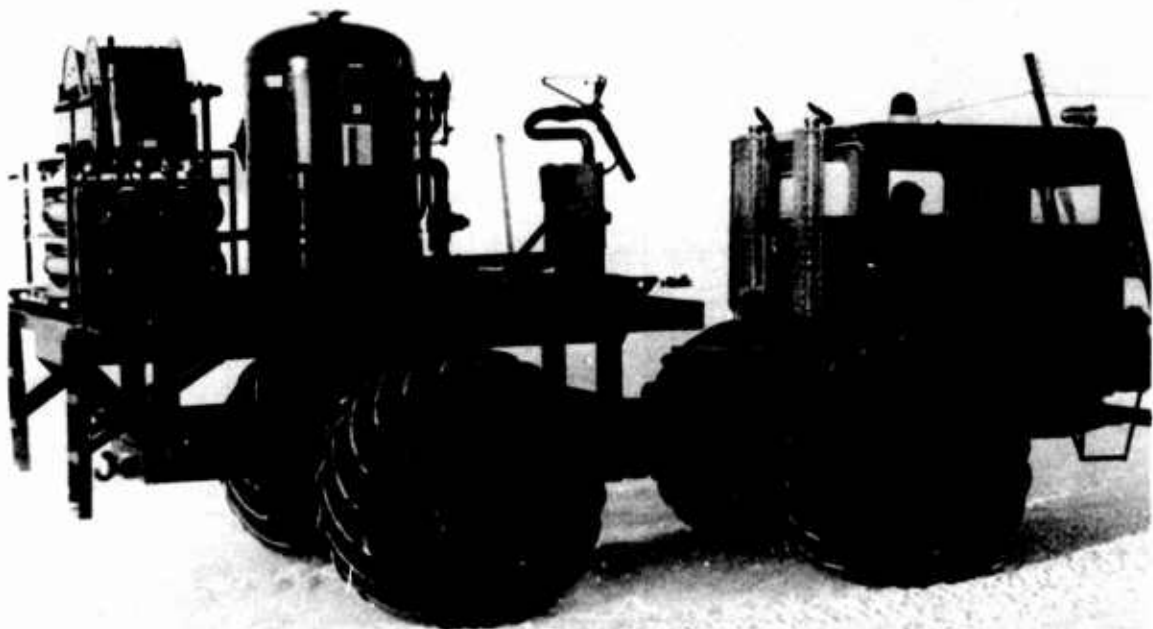
Figure 16. Nodwell Water Trotter vehicle used for aircraft crash/rescue service at McMurdo, Antarctica.

The Antarctic testing program, started in February 1974, was designed to evaluate the vehicle under various conditions of tire pressure, payload, and snow cover. To assist in evaluating the operational characteristics of the LGPV-16 vehicle, a Nodwell Model FN100TT Water Trotter cargo vehicle (empty weight 15,000 pounds) was obtained from NSFA at McMurdo to provide performance comparison.
