TECHNICAL REPORT NO. 12104

TESTING OF A DEMOUNTABLE TIRE
ROADWHEEL CONCEPT

AUGUST 1975

MOBILITY SYSTEMS LABORATORY
U.S. ARMY TANK AUTOMOTIVE COMMAND Warren, Michigan

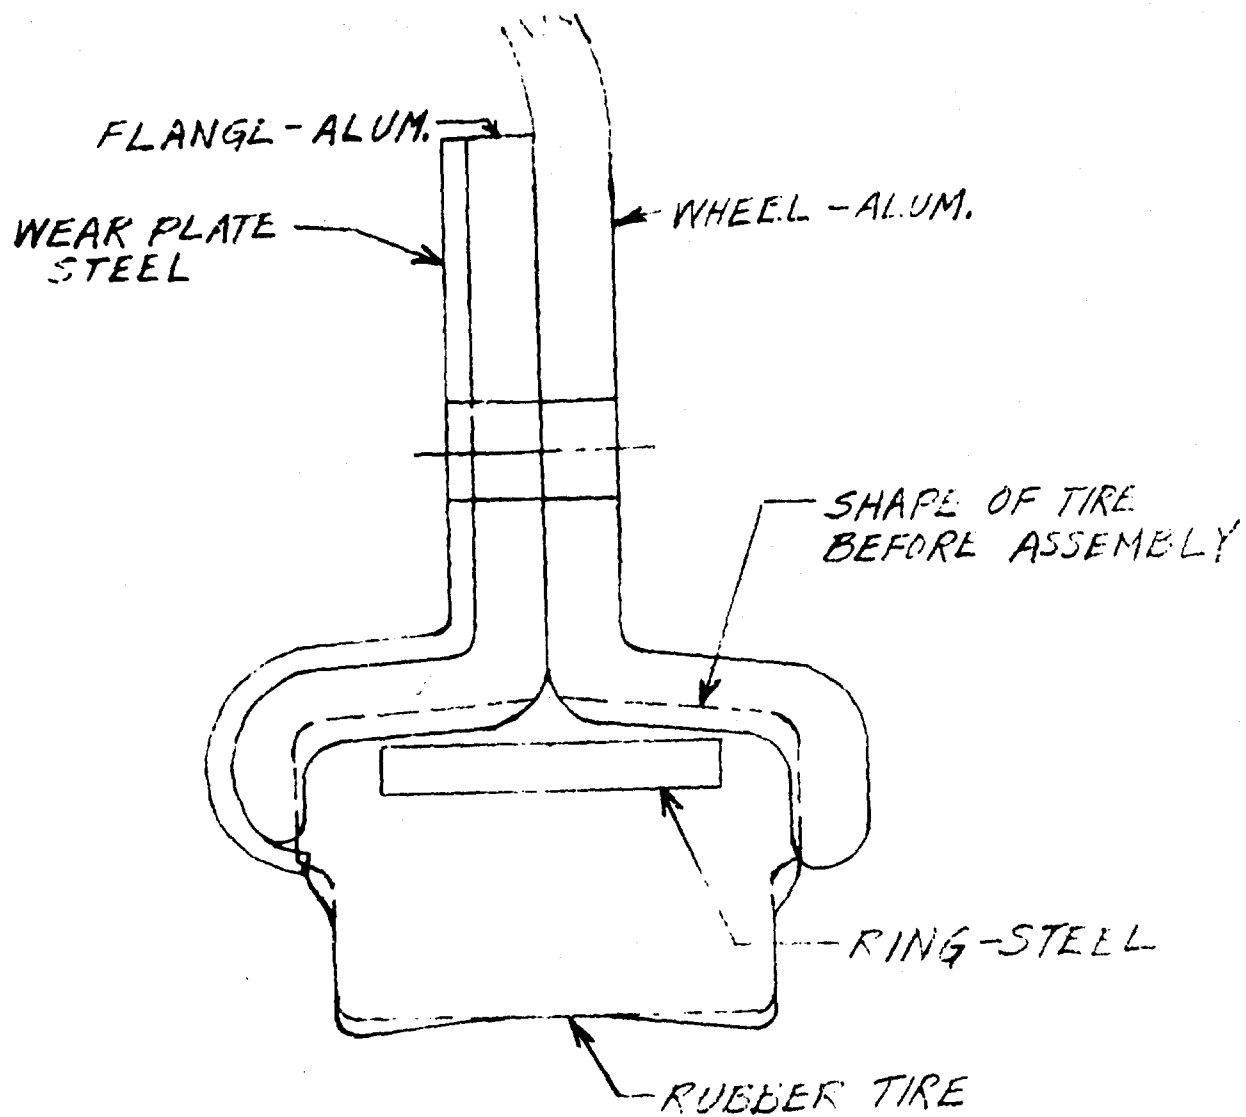
FIG. 1

CONSTRUCTION OF WHEEL. NOTE HOW RUBBER IS SQUEEZED FROM BETWEEN WHEEL AND RING DURING CLAMPING. OUTER EDGES OF TIRE ARE RAISED AS RESULT.

The wheel is formed of 3/8" thick aluminum. The rim is sloped at 5° and has an edge raised about 5/8". There is a matching flange which permits the tire to be assembled and clamped. There is a steel ring embedded in the rubber tire. While the flange is being tightened to the wheel, the excess of rubber between the wheel and the ring is compressed and forced to flow around the edge of the ring. This causes the tire to bulge upward at the edges as shown in Figure 1 and in Figure 2. The components are shown in Figure 3. The assembled wheel is shown in Figure 4, and in figure 5.

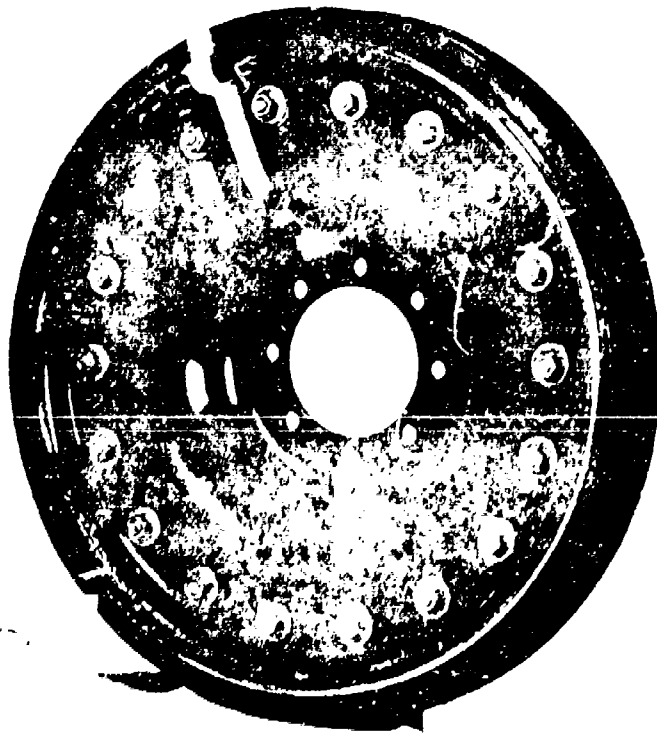
FIGURE 5 - Assembled wheel from Wheel Disc side.

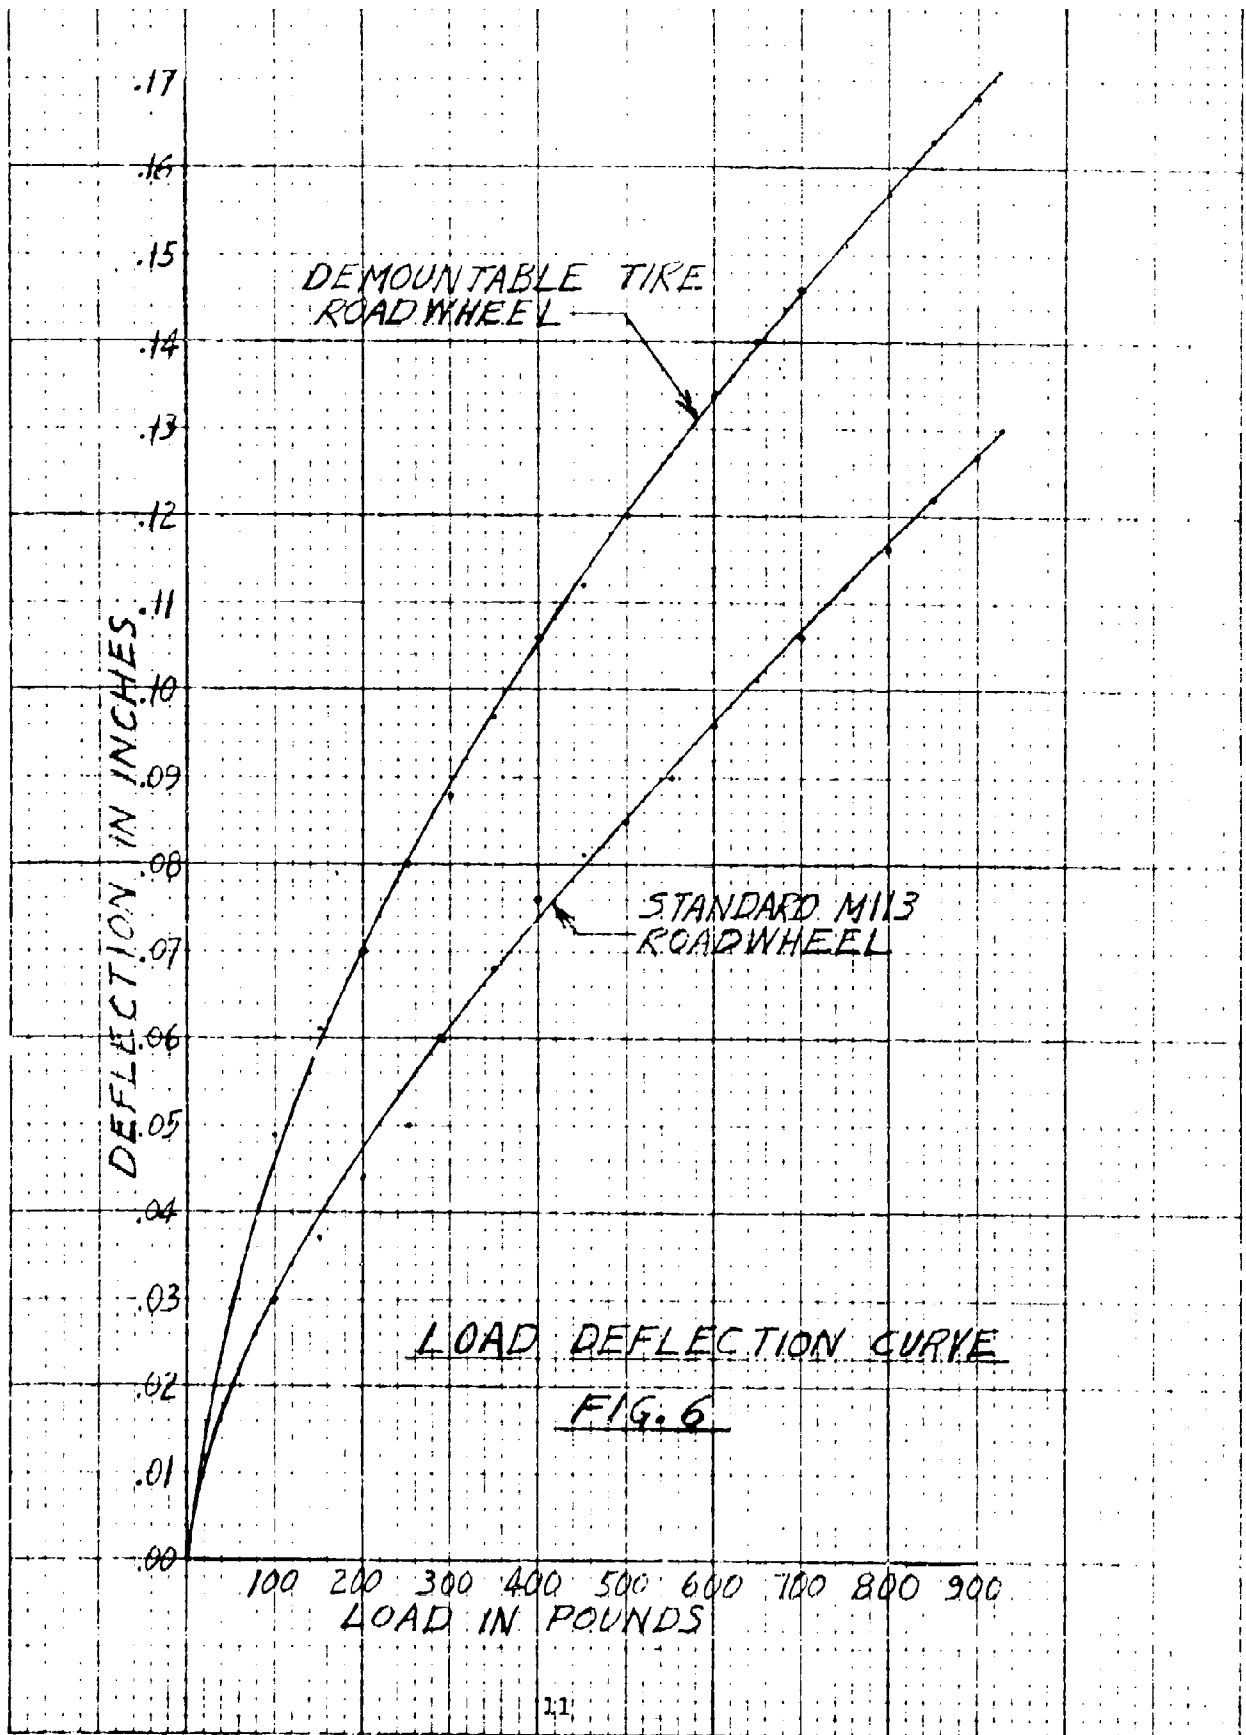
Note that the weight of this wheel is approximately 25 pounds more than the 35 pound weight of the standard M113 roadwheel. Also the durometer specification for the standard M113 wheel is 70+5 making the rubber on these test wheels somewhat softer. It should be noted that the standard specification for roadwheels in MIL-T-3100B is 70+10. A load-deflection curve is shown in Figure 6.
