Titan III
Transtage/Stage II
Separation Shock
Bench Test

REPORT DOCUMENTATION PAGE		READ INSTRUCTIONS BEFORE COMPLETING FORM	
1. REPORT NUMBER MCR-75-425-Vol-1 ✓	2. GOVT ACCESSION NO.	3. RECIPIENT'S CATALOG NUMBER

TITAN IIIC TRANSTAGE/STAGE II
SEPARATION-SHOCK BENCH TEST

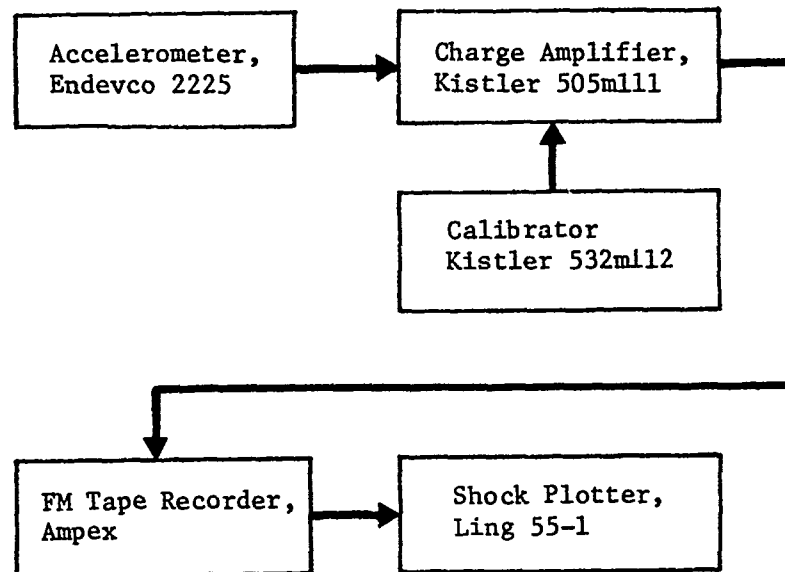
The data acquisition system for the instrumentation is shown schematically below.
