USAAMRDL-TR-76-1

ADVANCED V/STOL PROPELLER CRITICAL COMPONENTS INVESTIGATION

Hamilton Standard Division
United Technologies Corporation
Windsor Locks, Conn. 06096

Final Report for Period February 1973 - June 1975

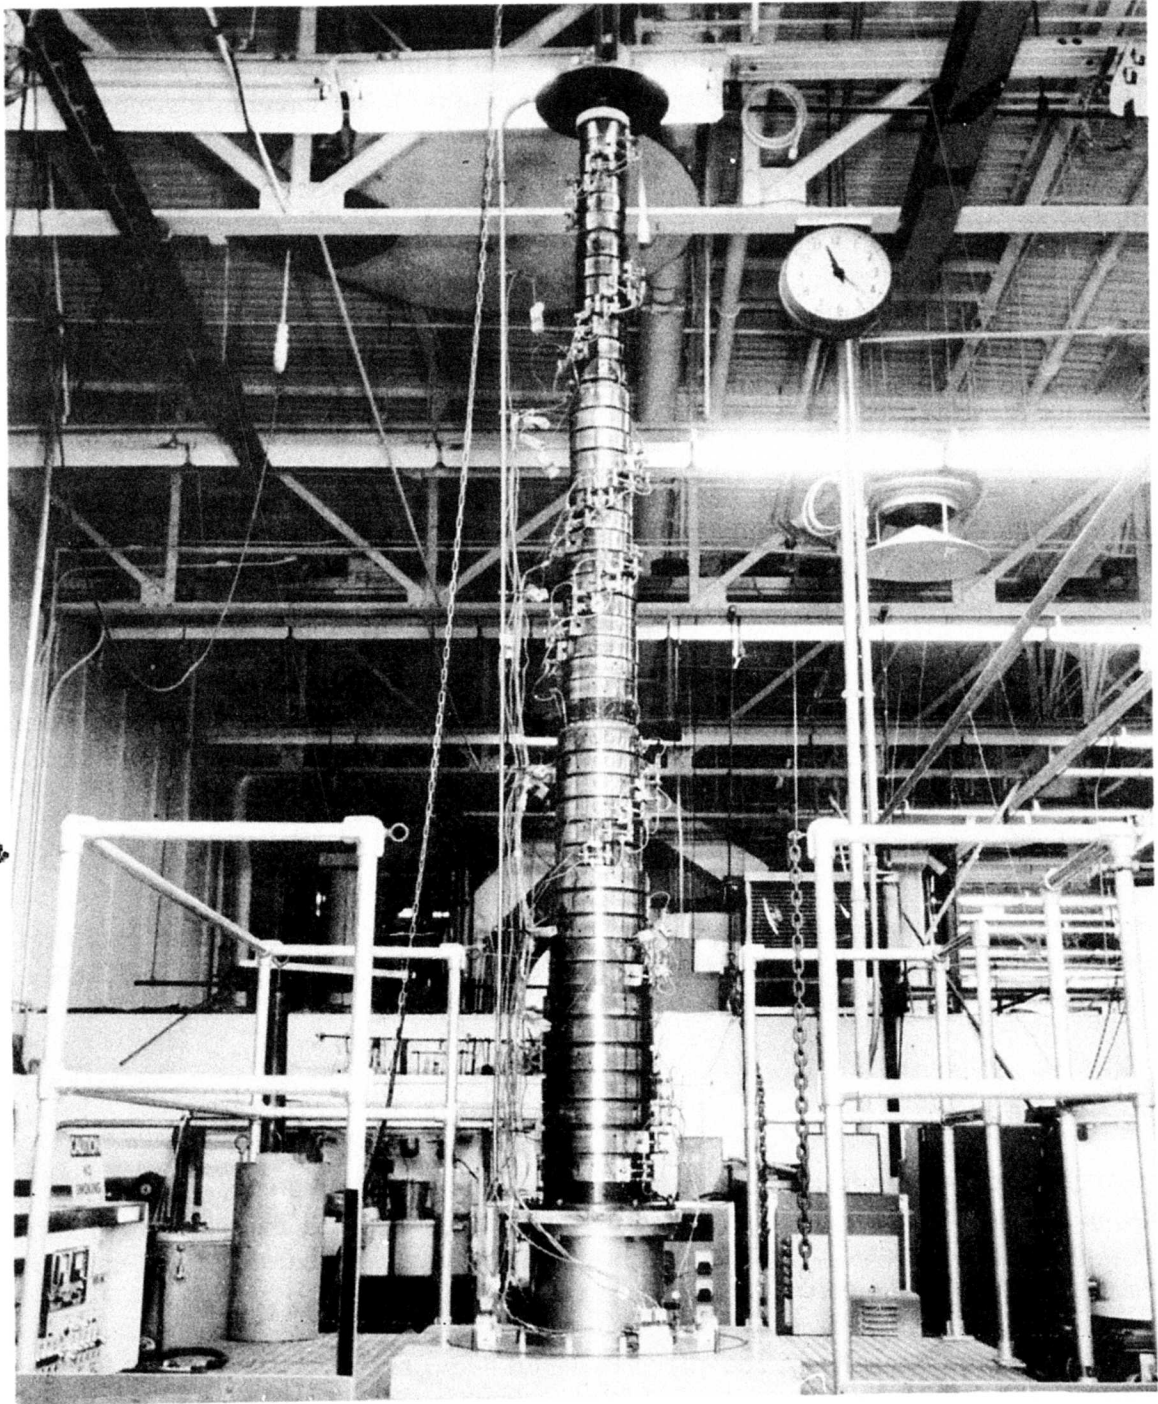
FIGURE 7. ELECTRIC HEATERS ON OUTER DIE

The outer die was set in place over the conical specimen and bolted to a 10-inch spacer, which in turn was bolted to the base of the spar rig. Integral with the outer die was a series of electrical band heaters to obtain the required 1100°F to 1140°F temperature for braze bonding. See Figure 7.

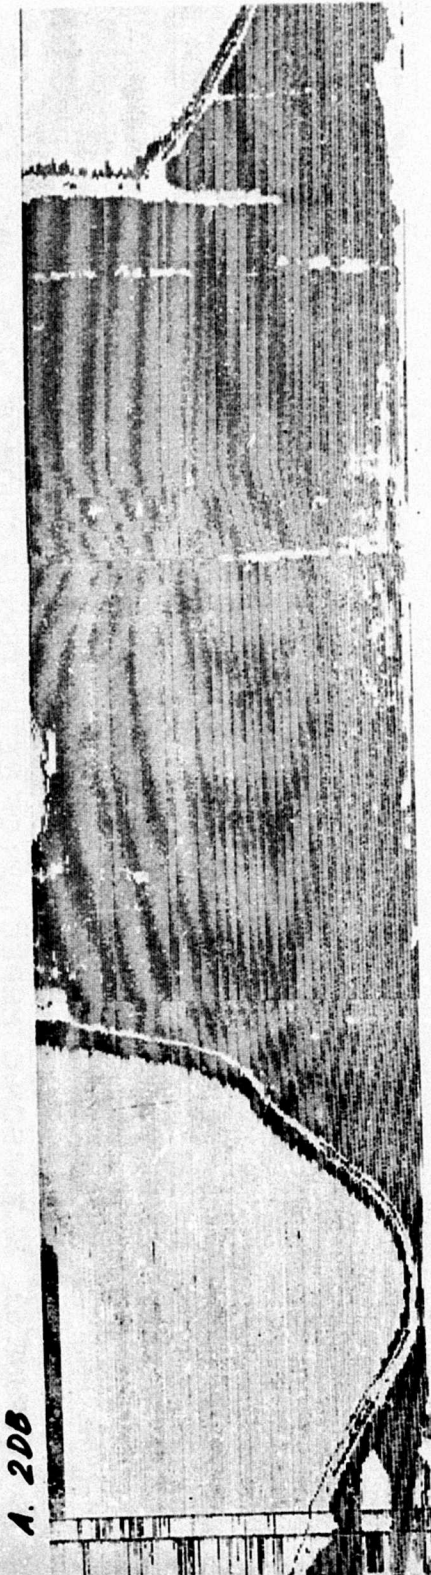
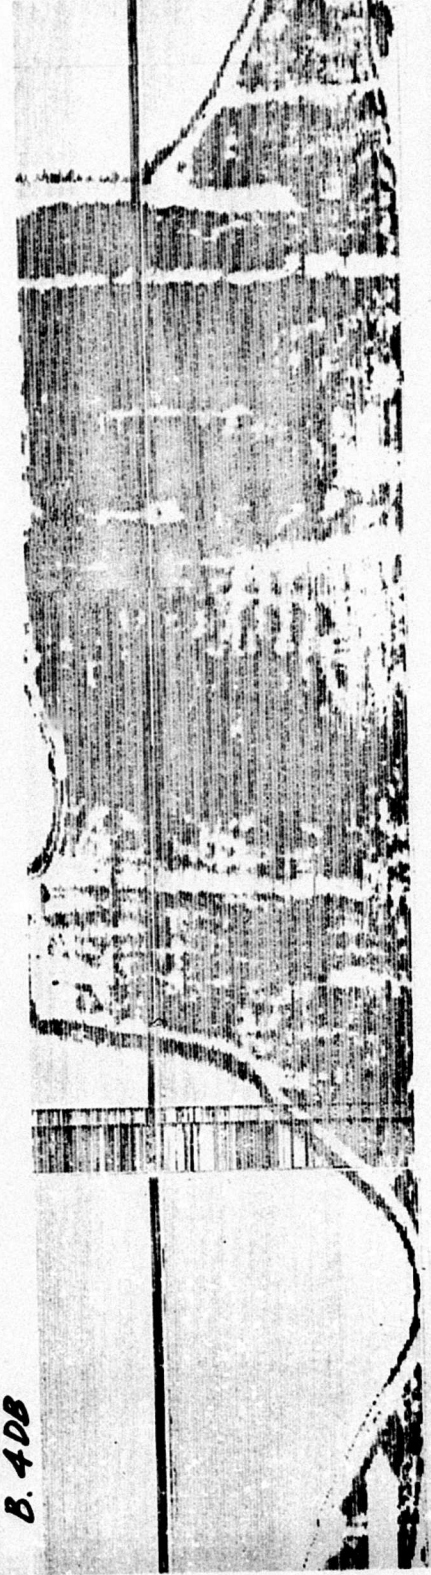
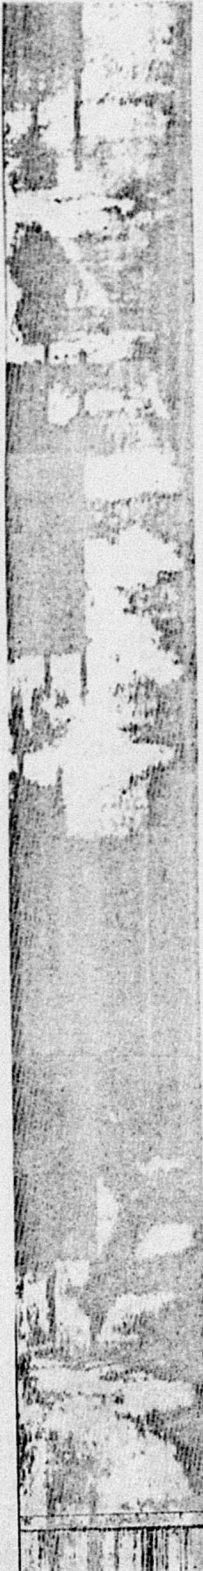
FIGURE 51. ULTRASONIC INSPECTION OF OUTBOARD SECTION OF SPAR NUMBER 5

Ultrasonic inspection scans of the outboard section of spar number five are shown in Figure 51. The dark areas indicate dense Borsic aluminum material that is relatively free of voids or inclusions, while the light areas indicate defective material. From past experience, 4Db scans are usually representative of the true condition of the material. On this basis, Figure 51 reveals that 75 to 80% of the outboard cross section contains no defects.

SETTINGS:
FREQUENCY: 2 1/4 MHZ.
SENSITIVITY: 3
TRANSDUCER: 3/4"
PULSE LENGTH: MINIMUM

REJECT: 9 O'CLOCK
CLIPPER: 5
STONE: 9
PRINT: POSITIVE
DATE: 5/9/74

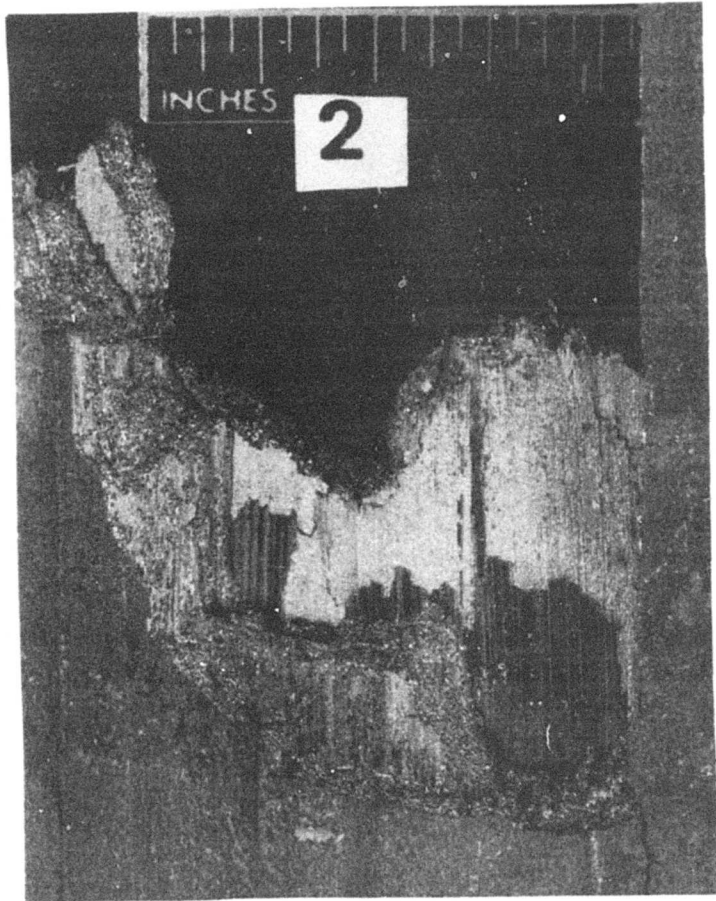
FIGURE 118. CONTINUED

Close views of two of the points of impact area shown in Figure 118. Again, considerable interply delamination had occurred in the area of impact. Figures 118a and 118b are external and internal views, respectively, of the impact site. Figure 118c is an internal impact view, while 118d is an external view at a second impact site.

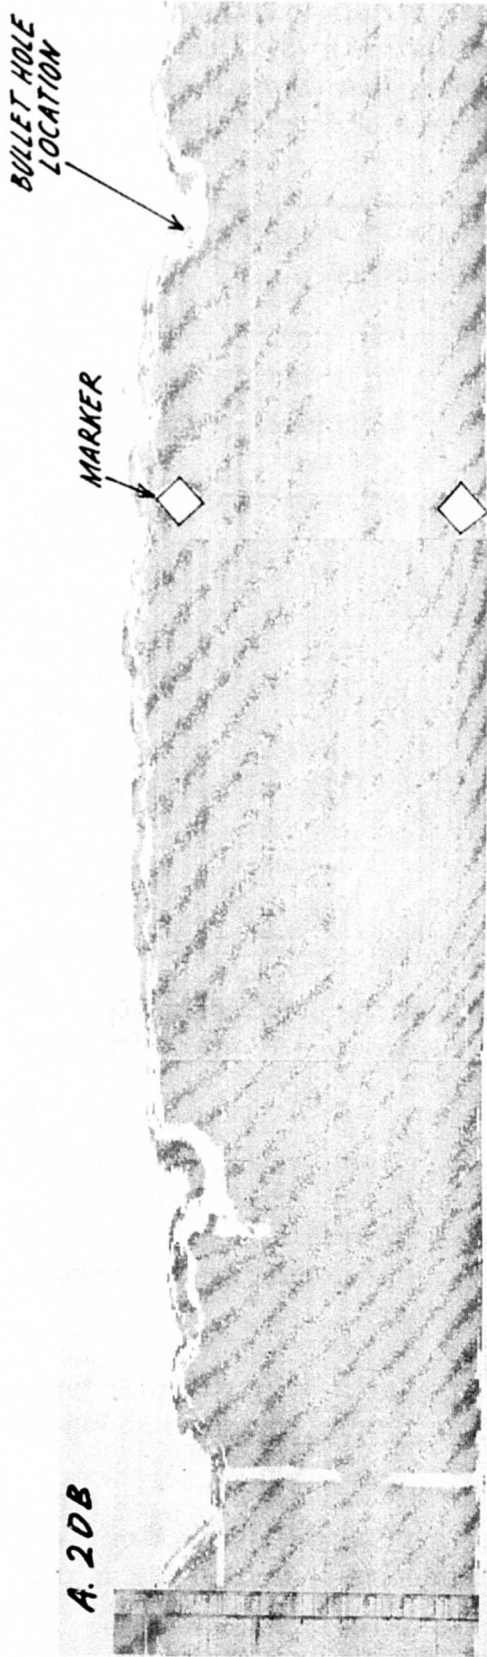
FIGURE 122. ULTRASONIC INSPECTION OF OUTBOARD SECTION OF BALLISTIC SPECIMEN NUMBER 1

Figure 122 shows a comparable section of specimen number one. Based on the 4 Db scan, this spar is more porous than number four. An estimated 85% of the cross section contained detectable defects.

SETTINGS:
FREQUENCY: 2 1/4 MHZ
SENSITIVITY: 3
TRANSDUCER: 3/4"
PULSE LENGTH: MINIMUM

REJECT: 9 O'CLOCK
CLIPPER: 5
tone: 9
PRINT: POSITIVE
DATE: 5/9/74

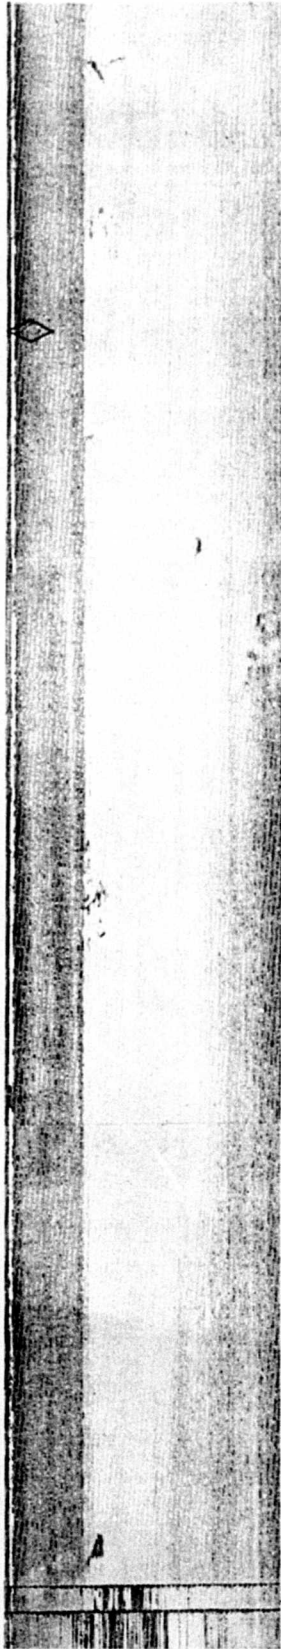
FIGURE 123. ULTRASONIC INSPECTION OF RETENTION SECTION OF BALLISTIC SPECIMEN NUMBER 2

OTHER SETTINGS
FREQUENCY: 10 MHZ
TRANSDUCER: 3/8
PULSE LENGTH: MINIMUM
REJECT: 8 O'CLOCK
*SENSITIVITY: .6 * 10*

CLIPPER: 8
tone: 4
PRINT: NEGATIVE
DATES: 4/22/73, 4/23/73

Figure 123 shows a comparable section of specimen number two.
