Air Force Packaging Evaluation Agency

DSPS REPORT NO. 76-18
AFPEA PROJECT NO. 72-P7-17(6A)

OUTDOOR EVALUATION--STUDY
MEANS OF ASSURING MIL-D-6054
STEEL DRUMS ARE HERMETICALLY SEALED

May 1976

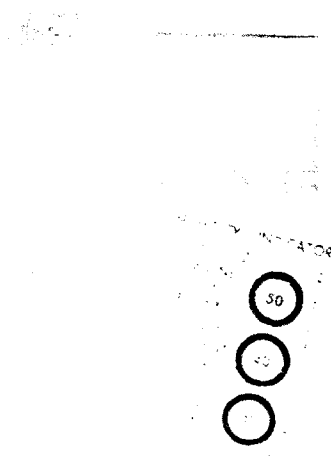
Figure 4. The Two Humidity or Corrosion Identifiers

Ten reconditioned drums were used in this field test study. In the side of each drum, near the bolt lugs, a 29/64-inch standard hole was drilled and a special low profile "racing valve" was inserted to permit air pressurization and pressure measurement of the container (see Figures 1, 2, and 3). Two humidity or corrosion identifiers were introduced into each drum to detect adverse environmental conditions. One of the detectors was a cobaltous chloride spot card humidity indicator and the other was a 1-1/2" x 4-1/2" x 1/8" thick polished piece of mild steel (see Figure 4). Two units of desiccant were also added to each drum to conform to MIL-P-116, Method IId requirements.
