USAAMRDL-TR-76-8

## HIGH-SURVIVABLE TRANSMISSION SYSTEM

Bell Helicopter Company  
P. O. Box 482  
Fort Worth, Tex. 76101

Final Report for Period January 1974 - August 1975

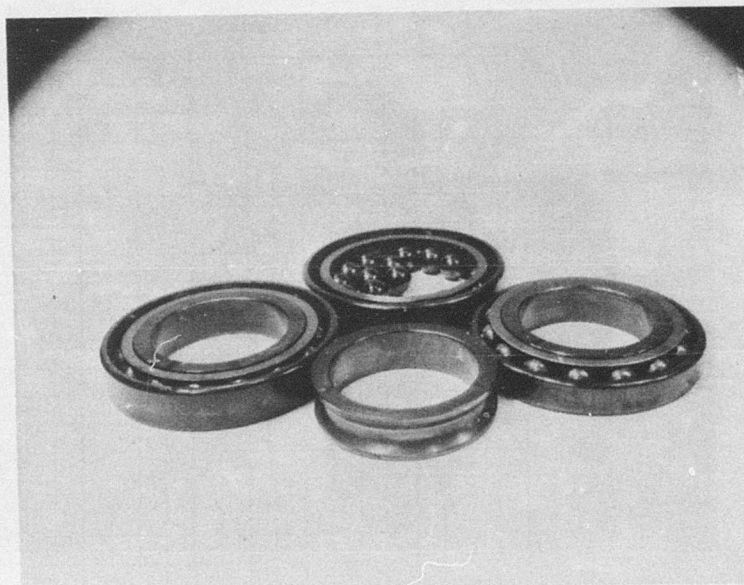
Figure 75. Main input triplex bearing following 4.0-hour emergency lubrication run.
