# U. S. NAVAL AIR ENGINEERING CENTER

NAEC-ENG 7898

04 Jun 1976

INFLUENCE OF WIRE PROPERTIES  
ON THE FATIGUE PERFORMANCE  
OF ARRESTING GEAR PURCHASE CABLE

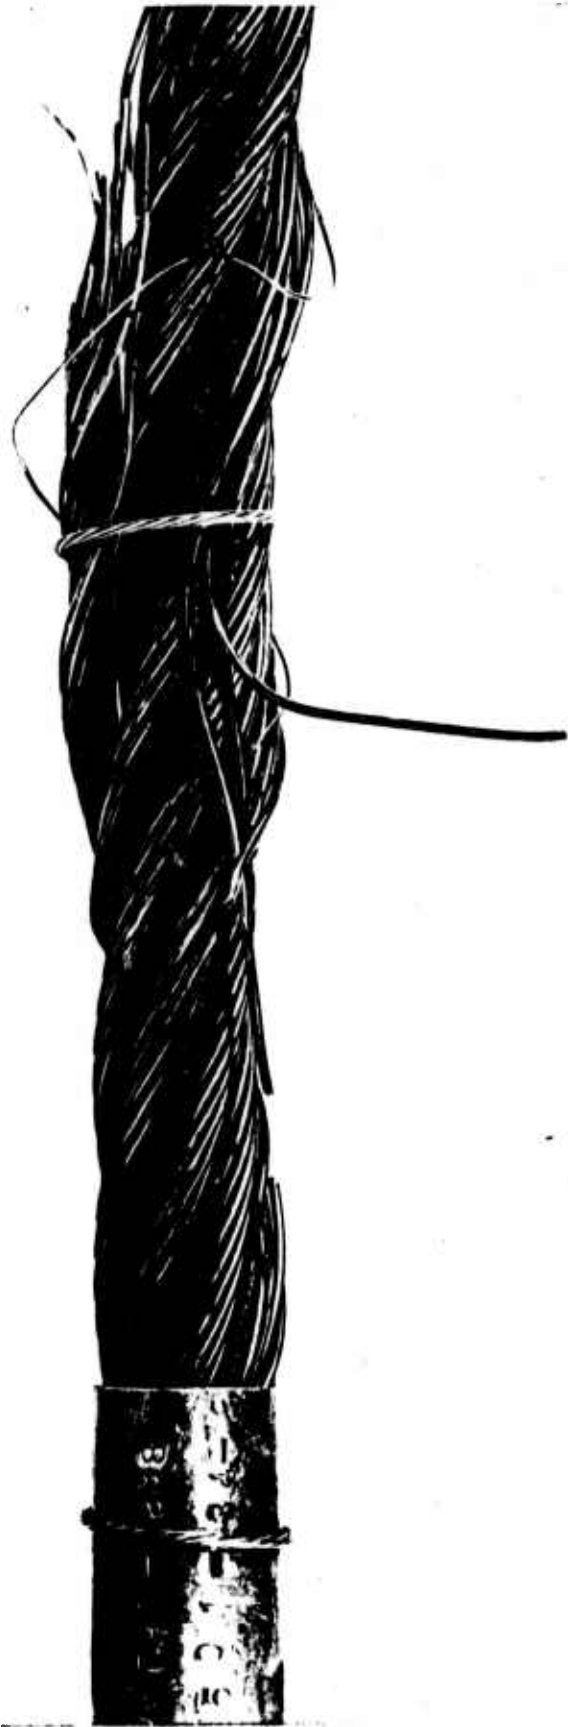
FIGURE 1

A typical break in wire rope that failed in fatigue is shown in Figure 1. This sample is from N-501-34-2 which failed after 7481 cycles. The fatigue test is stopped after the first sharp report indicating the breaking of one strand, but oft times, a second strand might partially or completely break.

Wire Rope That Failed in Fatigue

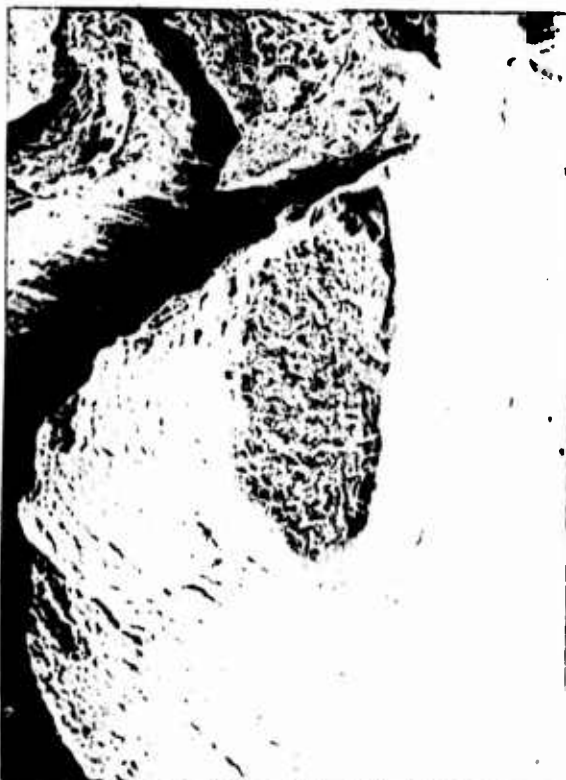
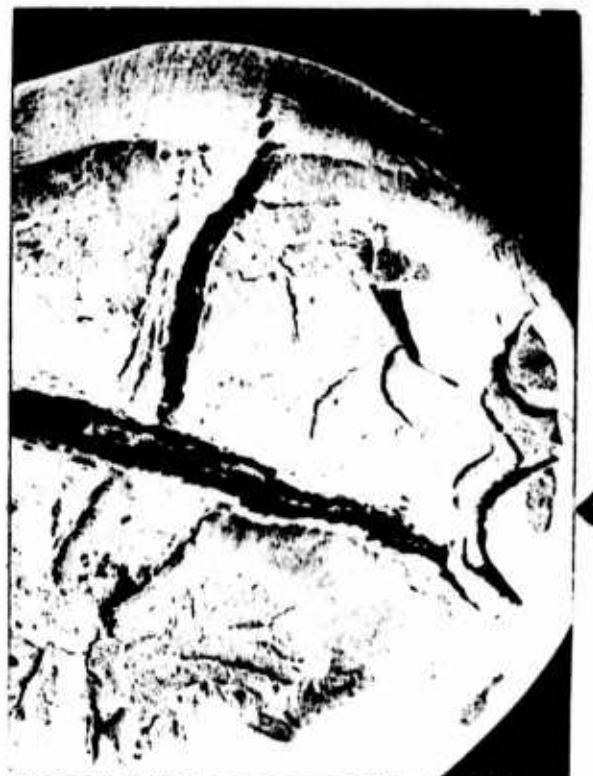
MODE 3A<sub>2</sub>: Showing Fatigue  
FIGURE 4

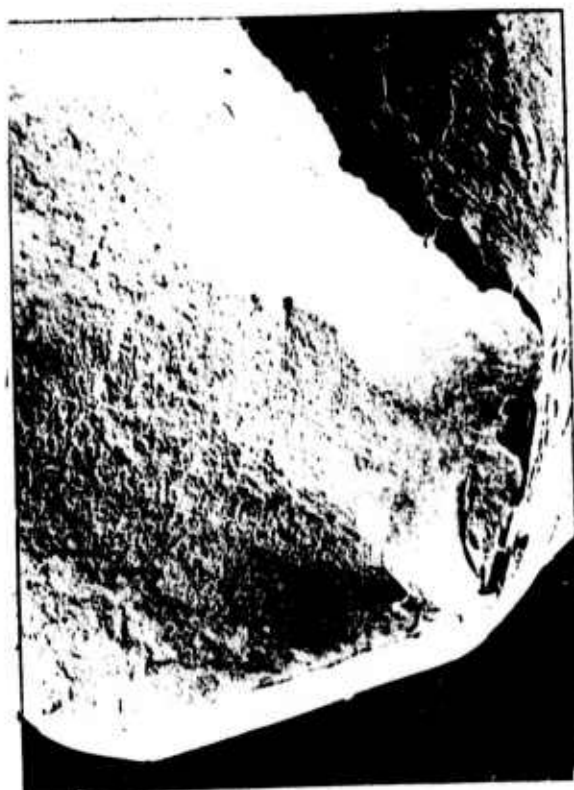
FIGURE 6

MODE 1A: Showing No Fatigue (1975 Contract outer lay wire)

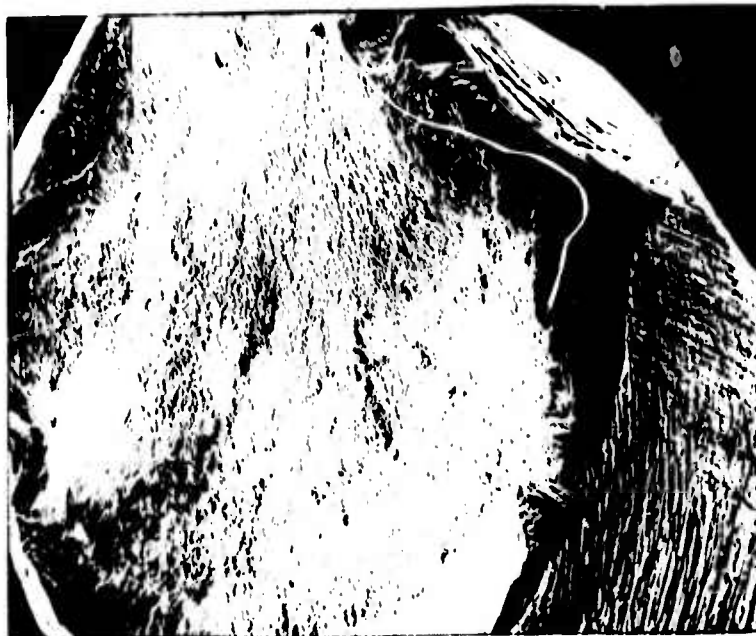
FIGURE 7

MODE 1B: Shows No Fatigue (1975 Contract Outer Lay Wire)

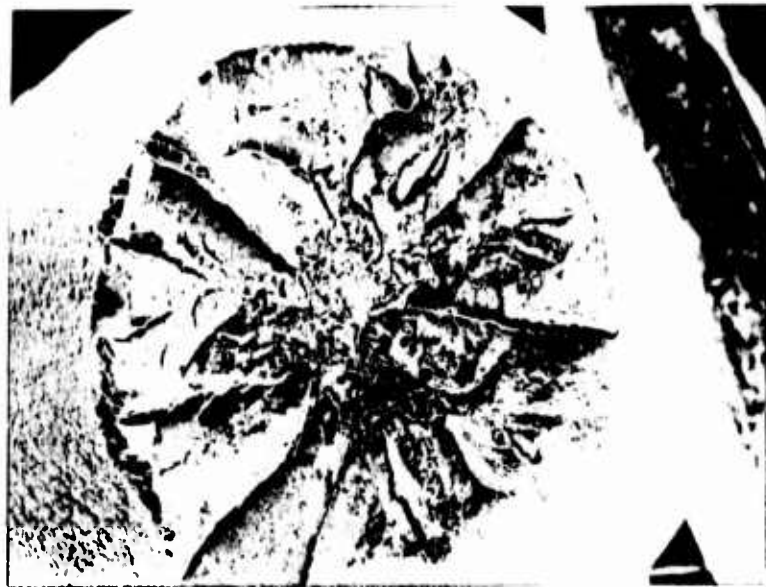
FIGURE 9

MODE 3A<sub>1</sub>: Showing No Fatigue

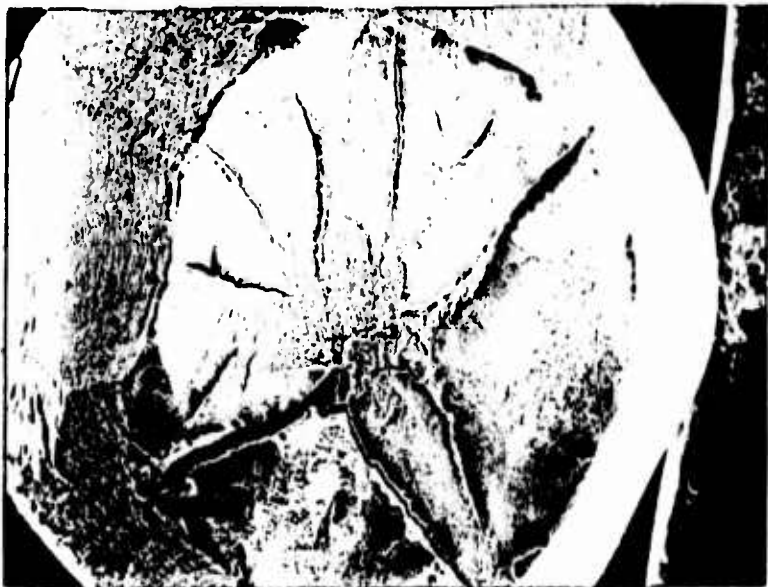
MODE 3A<sub>2</sub>: Showing No Fatigue  
FIGURE 10

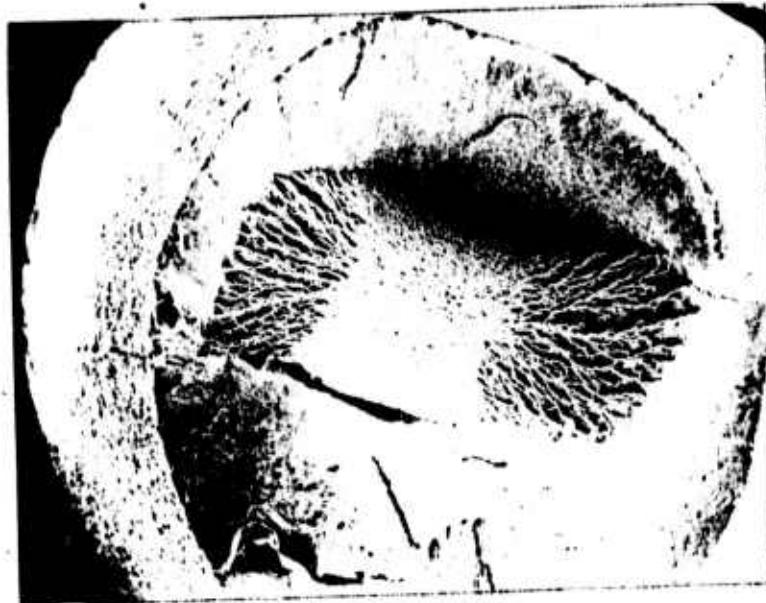
MODE 4A<sub>1</sub>: Showing No Fatigue (1975 Contract Outer Lay Wire)  
FIGURE 11.
