THE INFLUENCE OF INSULATION UPON FROST
PENETRATION BENEATH PAVEMENTS

COLD REGIONS RESEARCH AND ENGINEERING LABORATORY

Special Report 76-6

THE INFLUENCE OF INSULATION UPON FROST PENETRATION BENEATH PAVEMENTS

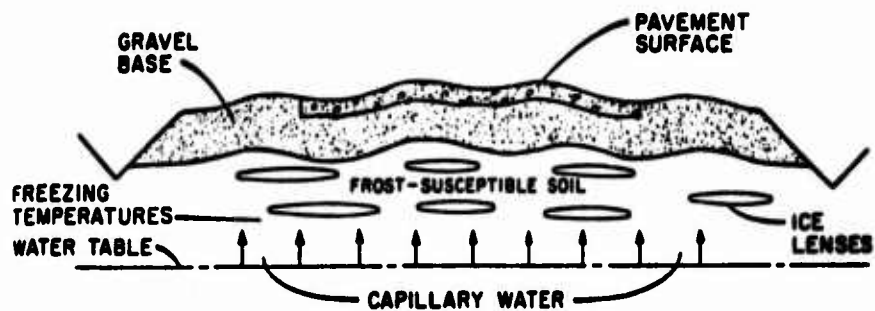
a. Frost heave

Frost action in soils causes pavement structures to heave because of ice lense growth during the freezing season (Fig. 1a). The loss of structural support in the spring caused by the melting of the ice lenses can precipitate pavement failure (Fig. 1b). Three factors necessary for deleterious frost action to occur are freezing temperatures, frost susceptible soil, and a source of water, all existing at the same time. In order to minimize differential frost heaving, granular material is placed on top of the frost-susceptible subgrade, with the thickness depending on the depth of frost penetration and desired protection. This method of protection can be costly depending on the amount of granular material required and its availability. A method of reducing the amount of granular material and heat loss from the subgrade is the use of a thermal insulating layer beneath all or part of the base course, thereby preventing freezing temperatures from reaching the frost susceptible subgrade (Fig. 2).

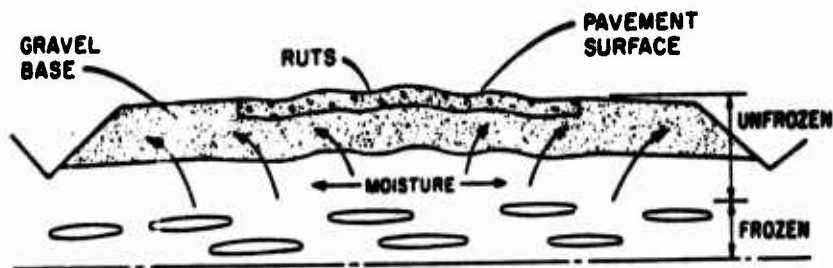
b. Spring break up

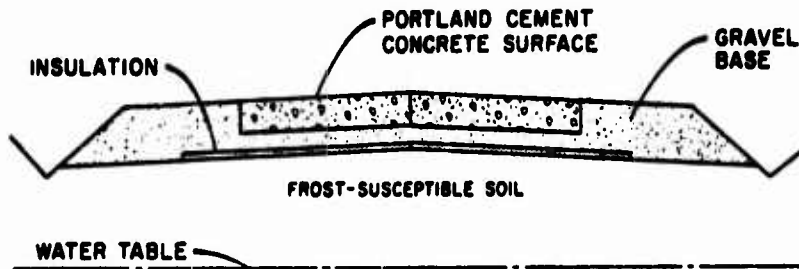
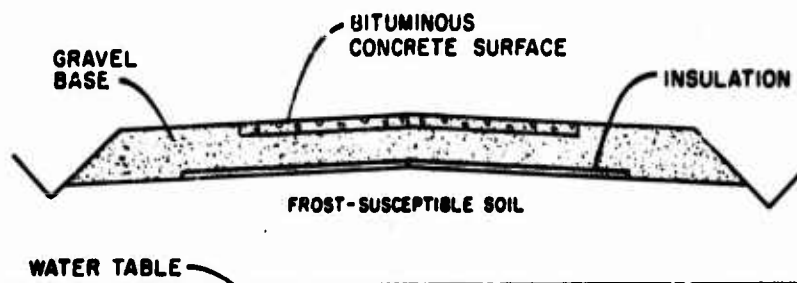
a. Portland Cement Concrete Surface

b. Bituminous Concrete Surface

Figure 2: Insulated pavement concept

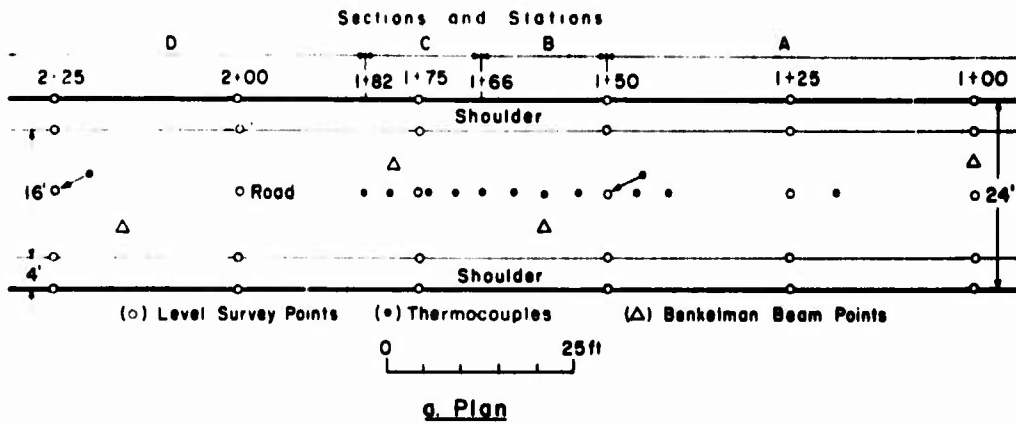
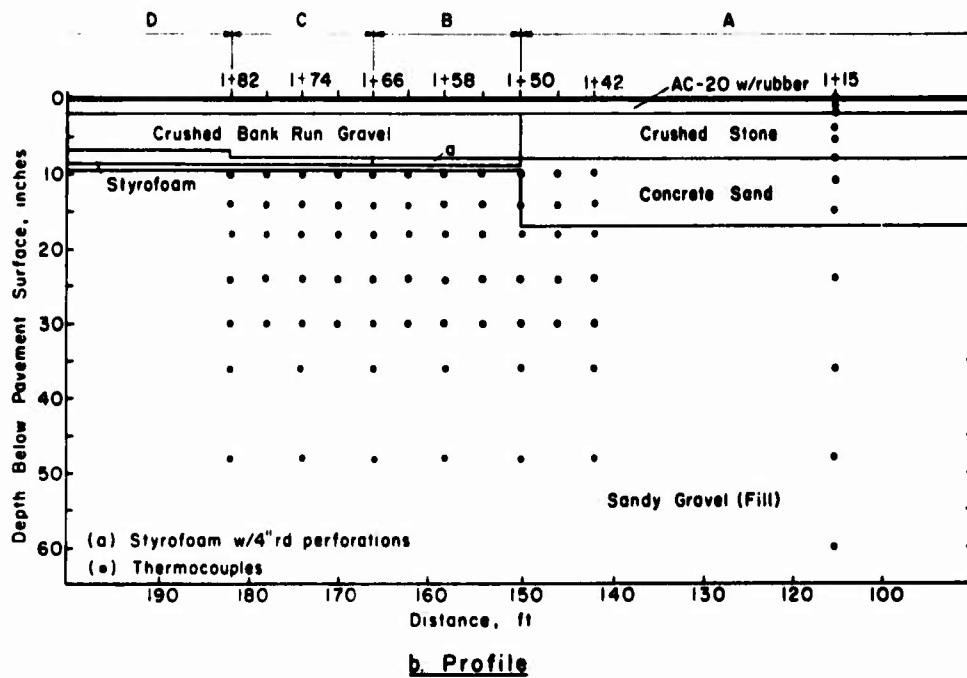
Figure 5: Plan and Profile of Insulated Transition

and Eaton 1974). This report will be concerned with the performance of the transition between the control section (Section A) and the "conventionally" insulated section (Section D) (see Fig. 5).

The transition section separates a control section (section A) consisting of 9 in. of concrete sand, 6 in. of 3/4-in. maximum size crushed stone, and 2 in. of asphalt concrete pavement; and an insulated section (section D) consisting of a 1/2-in. bedding and leveling course of concrete sand, a 2-in. layer of Styrofoam boards (35 psi compressive strength) measuring 2 ft. x 8 ft., 8 in. of 1-1/2-in. maximum size aggregate crushed bank-run gravel, and 2 in. of asphalt concrete pavement (see Fig. 5).

The transition section consists of 16 ft of perforated 1-in.-thick, 2-ft x 8-ft Styrofoam boards with 4-in. diam holes drilled on an 8-in. center-to-center grid, from station 1+50 to 1+66 (section B) and 16 ft. of solid 1-in.-thick, 2-ft x 8-ft Styrofoam boards from station 1+66 to 1+82 (section C).

The Benkelman beam test was used to measure the structural strength of the pavement. Test points were located at stations 1+00, 1+58, 1+78, and 2+15 (see Fig. 5a).

Level surveys were also conducted to measure frost heave. Five survey points were located transversely at every 25-ft station (see Fig. 5a).

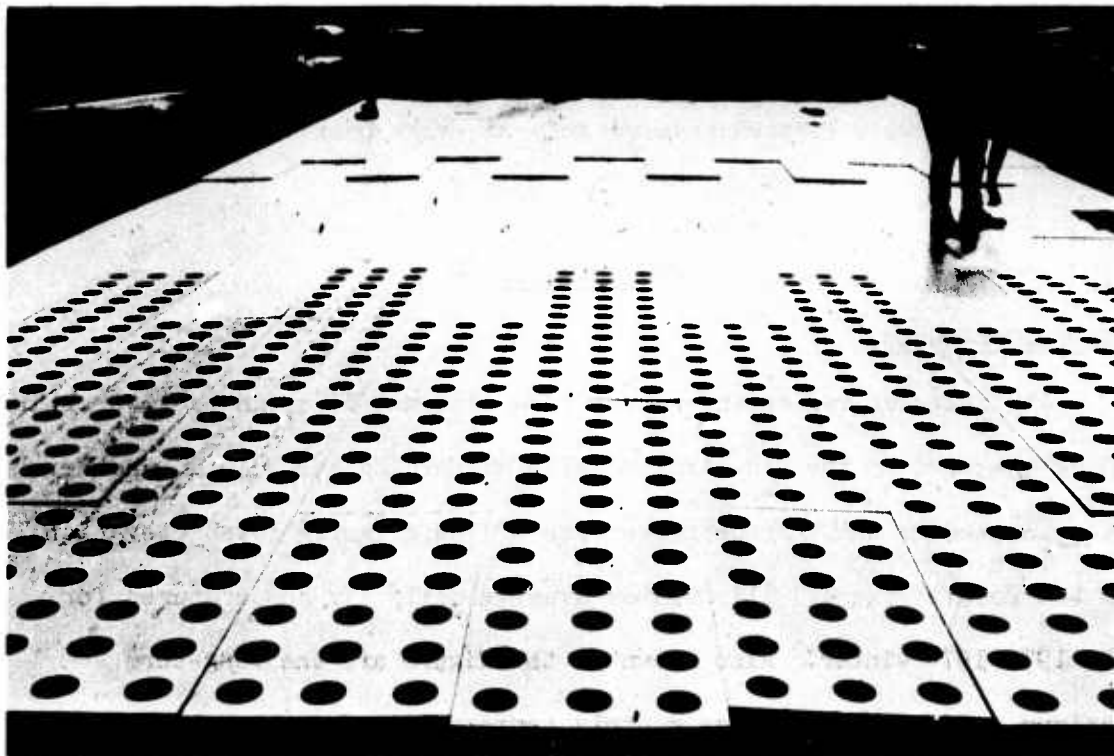
Figure 6. Transition insulation board placement.

The purpose of the perforated 1-in.-thick insulation was to create another step of lesser insulating thickness to provide an approximately 0 in., 1/2-in., 1-in., 2-in. step from the control, to a fully insulated section as recommended by Dow Chemical Company (Williams, 1968). An approximately 1/2-in. bedding and leveling layer of concrete sand was placed beneath the insulation and 9 in. of 1-1/2-in. maximum-size aggregate crushed bankrun gravel and 2 in. of pavement were placed on top of the insulation. Each board was anchored by driving a 1/2-in.-diam x 12-in. wooden dowel on a skew through each end of the board until it was flush with the top. The board placement was staggered to prevent transverse joint alignment (Fig. 6).

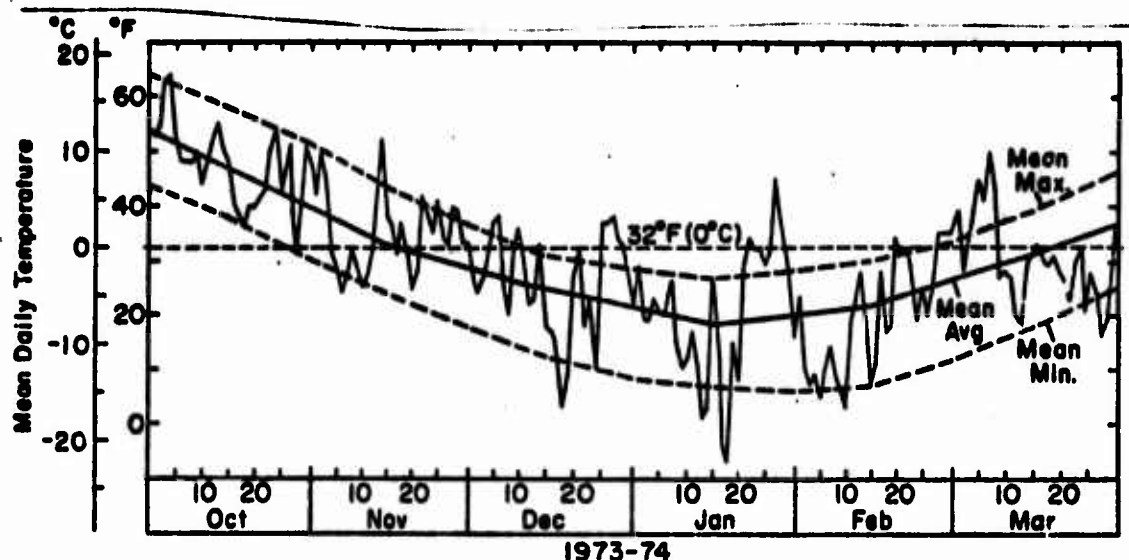
Figure 7. Average daily air temperatures.

Air temperatures at the access road site may be slightly lower than those measured by the U.S. Army Maynard Meteorological Team at another site located on CRREL property because of the slightly lower elevation of the road. Figure 7 illustrates average daily air temperatures for the 1973-1974 winter. Also shown on the figure are the long-term maximum, minimum and average monthly temperatures for the National Oceanic and Atmospheric Administration meteorological station in Hanover,

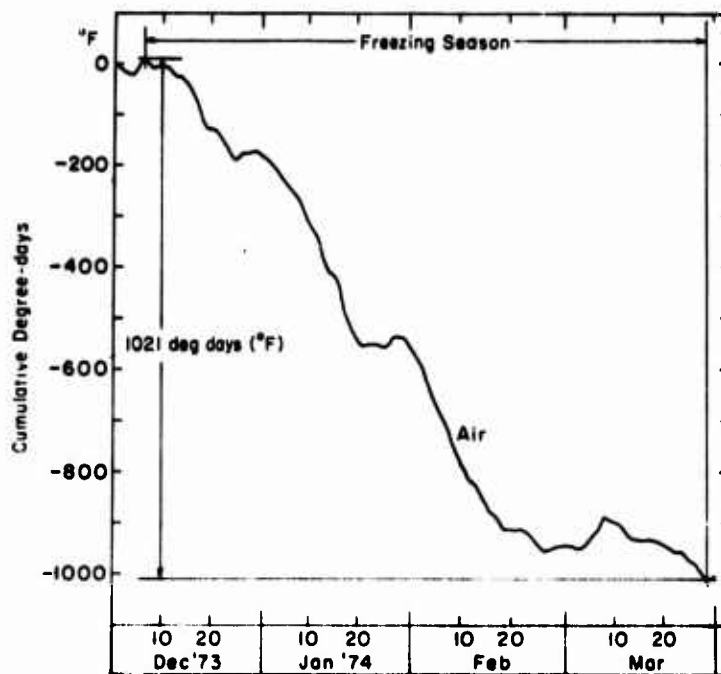
Figure 8. 1973-1974 Freezing index at USACRREL.

The air freezing index measured at CRREL during the 1973-1974 winter is presented in Figure 8 and was 1021°F days. The mean freezing index for the Hanover meteorological station is 1060°F days and the design freezing index is 1820°F days, based on the average of the three coldest years in thirty (Gilman 1964). Thus, the 1973-1974 winter was slightly lower than the mean for this area.

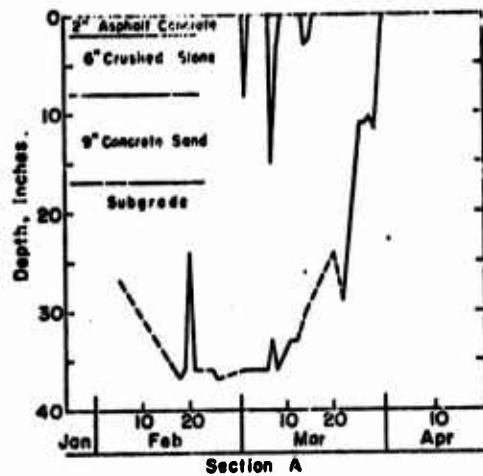
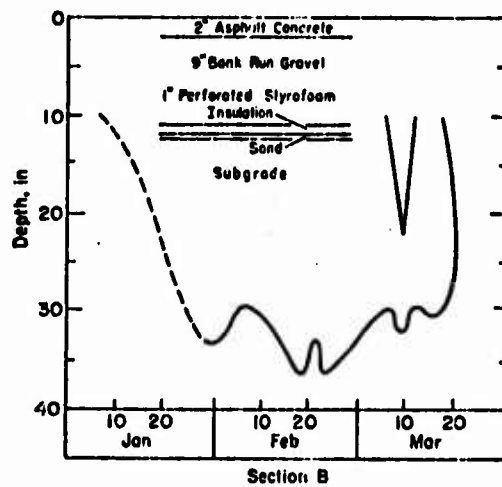
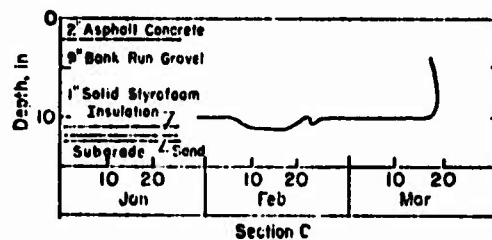
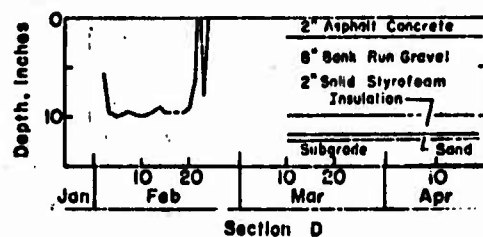
Figure 9. Penetration of 32°F Isotherm.

Figure 9 illustrates penetration of the 32°F isotherm in sections A, B, C, and D based on the daily 1200-hour readings. Sections C and D (the two solid insulated sections) had the shallowest frost penetrations. Section D, with the 2-in.-thick solid insulation, prevented frost from

reaching the frost-susceptible subgrade. Section C, with 1-in.-thick solid insulation, permitted only 1 in. of frost penetration into the subgrade beneath the insulation. Section B, with 1-in.-thick insulation, with 4-in.-diam holes on 8-in. centers, permitted frost penetration to 36 in. Section A, the control or uninsulated section, permitted frost to penetrate to a 37-in. depth. From these data it is apparent that the 1-in.-thick perforated insulation in section B served no useful purpose and did not hinder or slow frost penetration.

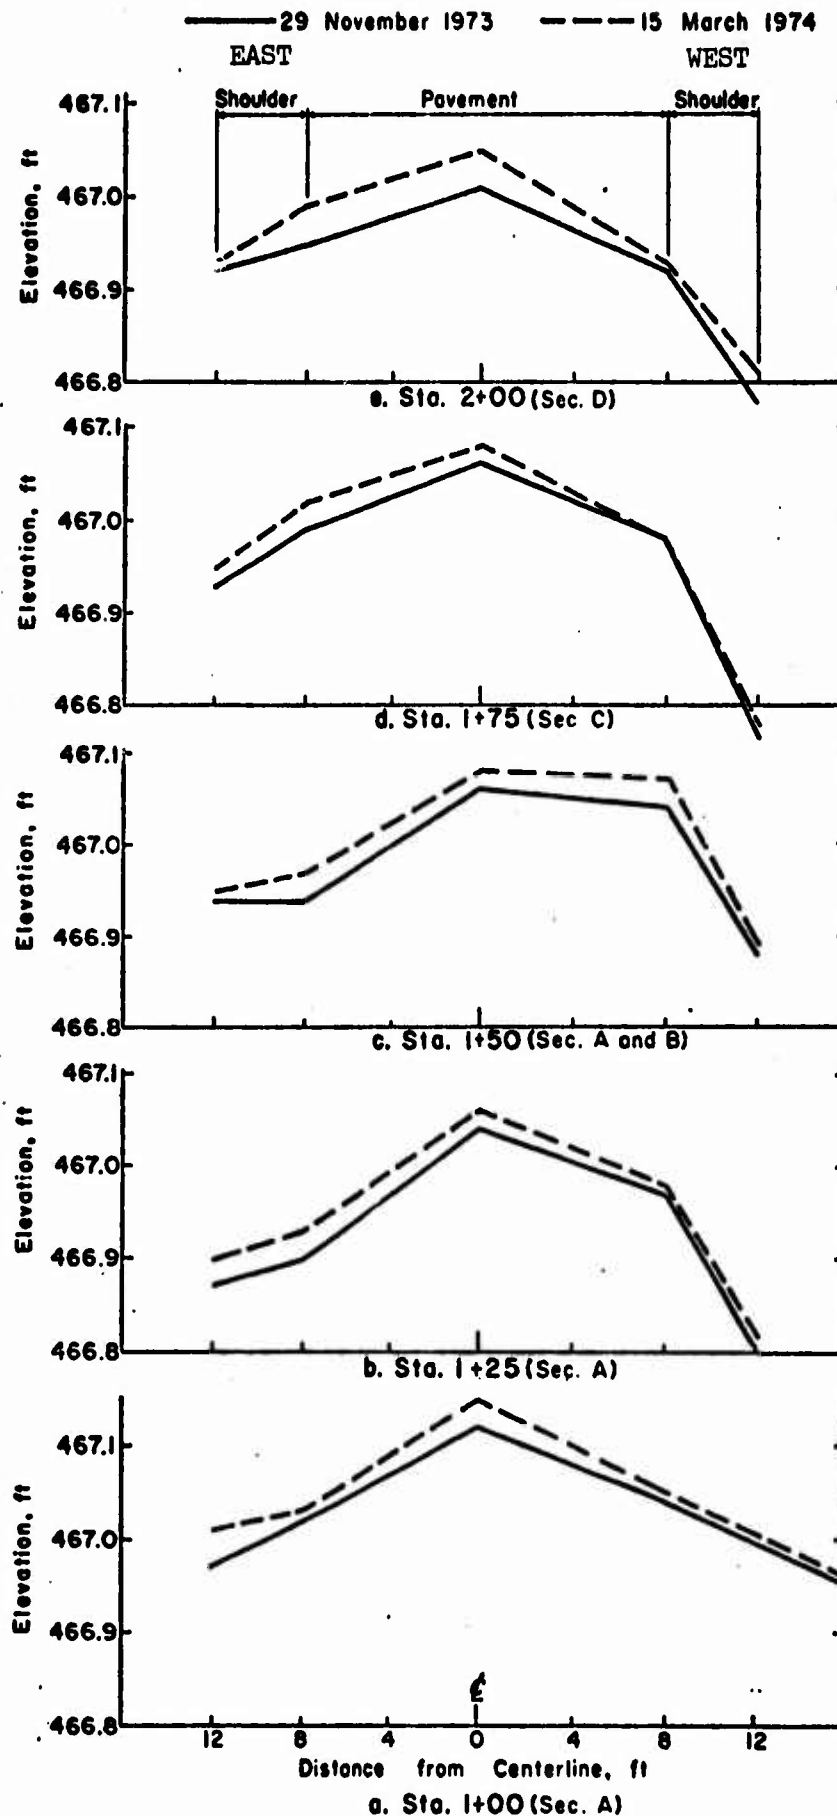
Figure 10. Transverse Frost Heave

Figure 10 illustrates these differences on a greatly expanded scale. The largest frost heave is at station 2+00 on the left side of centerline.

A possible explanation for this could be contamination of the gravel above the insulation during construction. This could have been caused by traffic using a ramp, located on the left side of the road at station 2+00, and bringing mud or dirt from the side of the road onto the gravel. This contamination in turn would cause the gravel to become frost susceptible (by adding fines) and result in minor heave.

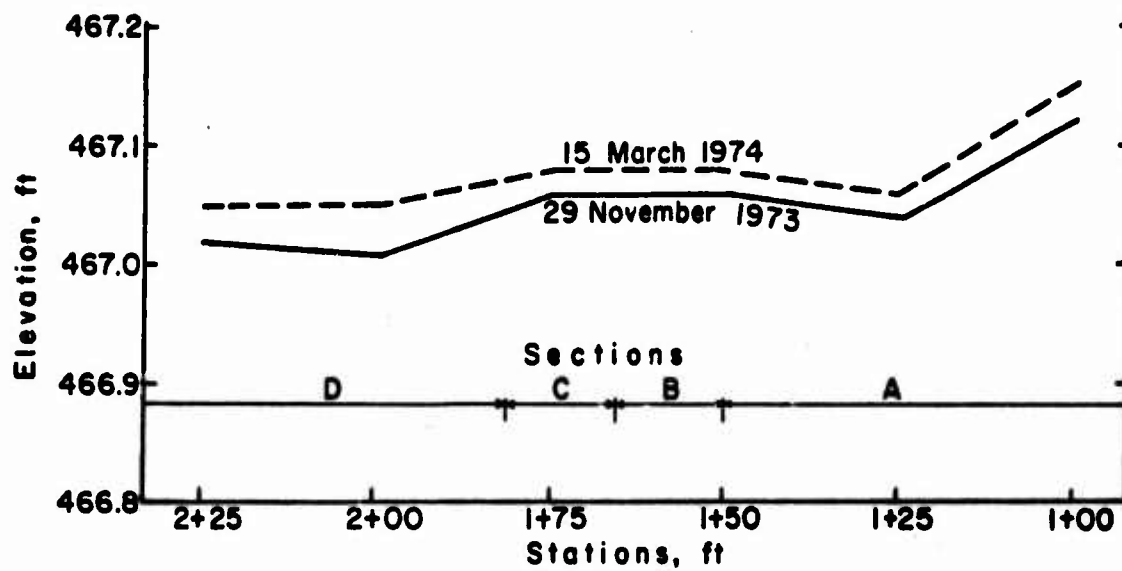
Figure 11. Frost heave along centerline.

Figure 11 shows the centerline frost heaves, also on a greatly expanded scale. As shown on Table II, the station 2+00 centerline elevation

difference is .04 ft or 1/4 in. greater than the other stations centerline elevations. The possible reasons for this have been previously described. The relatively uniform frost heave can be attributed to the fact that the frost was contained within the sandy gravel fill between the section and highly frost-susceptible in situ subgrade.

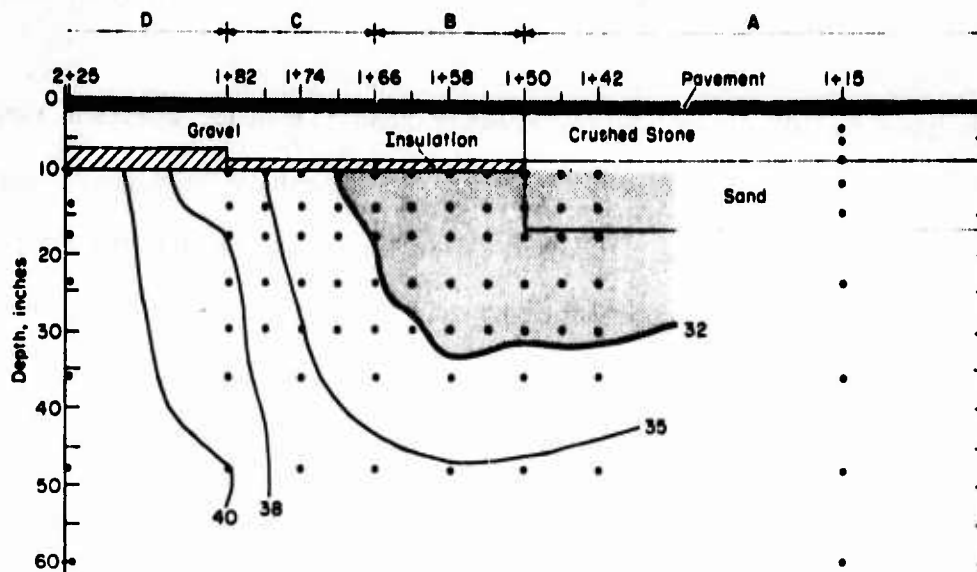
Figure 12a. 29 January 1974 isothermal profiles.

As shown in the first profile, 29 January 1974, the 32°F isotherm was approximately the same depth below the pavement in sections A and B. The solid 1-in. insulation in section C, and the 2-in. solid insulation in section D both resisted frost penetration.

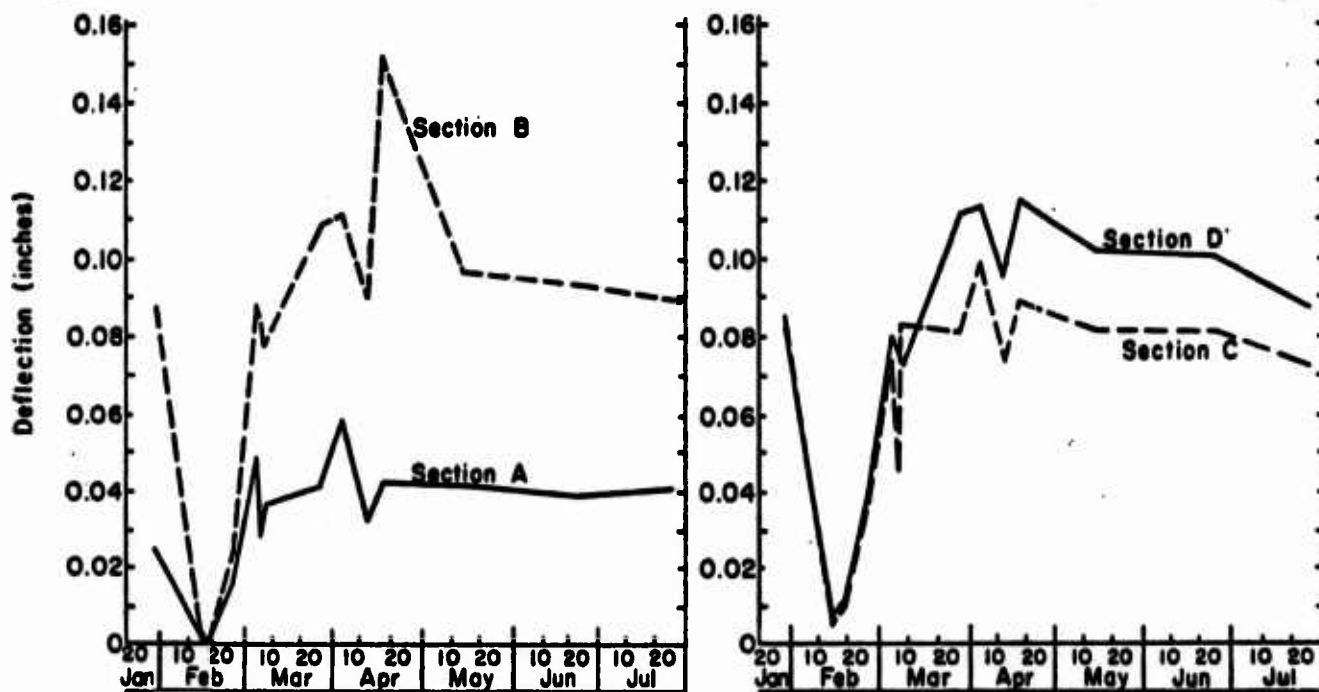
Figure 13. Benkelman beam deflections, 1974.

The results are shown in Table III. Figure 13 shows a plot of deflection versus time for each section. The two points in sections A and D (stations 0+50 and 1+00, and 2+15 and 2+60, respectively) were averaged to give one value for each day the test was run.

Figure 13 and Table III show that on the first test date, 29 January 1974, the amount of deflection, 0.0275 in. in section A, the control section, was less than one-third that of any other section. Sections B, C, and D had approximately the same initial value of 0.086 in. The crushed stone and sand base in section A was a stronger material than the gravel base and insulation in sections B, C, and D.

During the middle of February, when the subgrade had maximum frost penetration, all sections displayed minimum deflections. Sections A and B, which had frost penetration to a depth of 36 in., exhibited practically no deflection at all. Section C, which had frost penetration

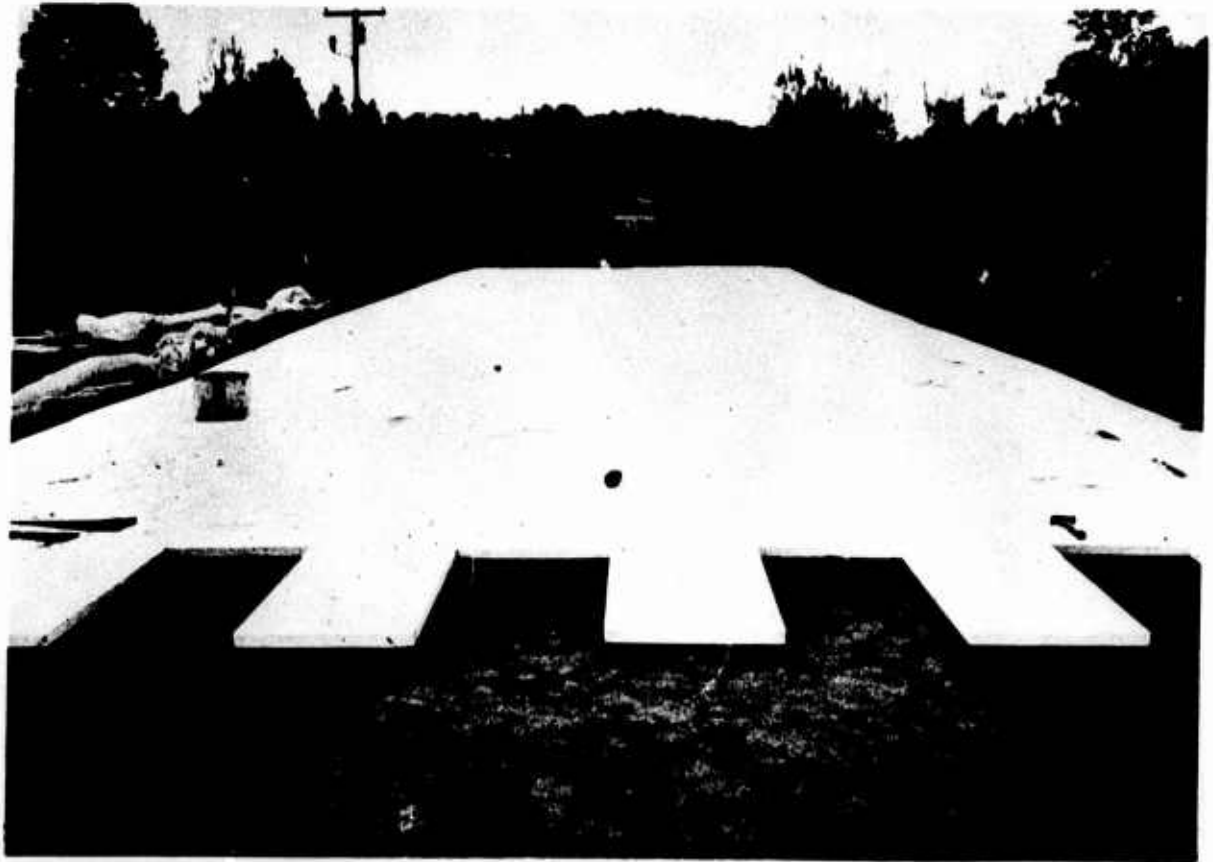
Figure A1. Two-in. thick insulation in section D.

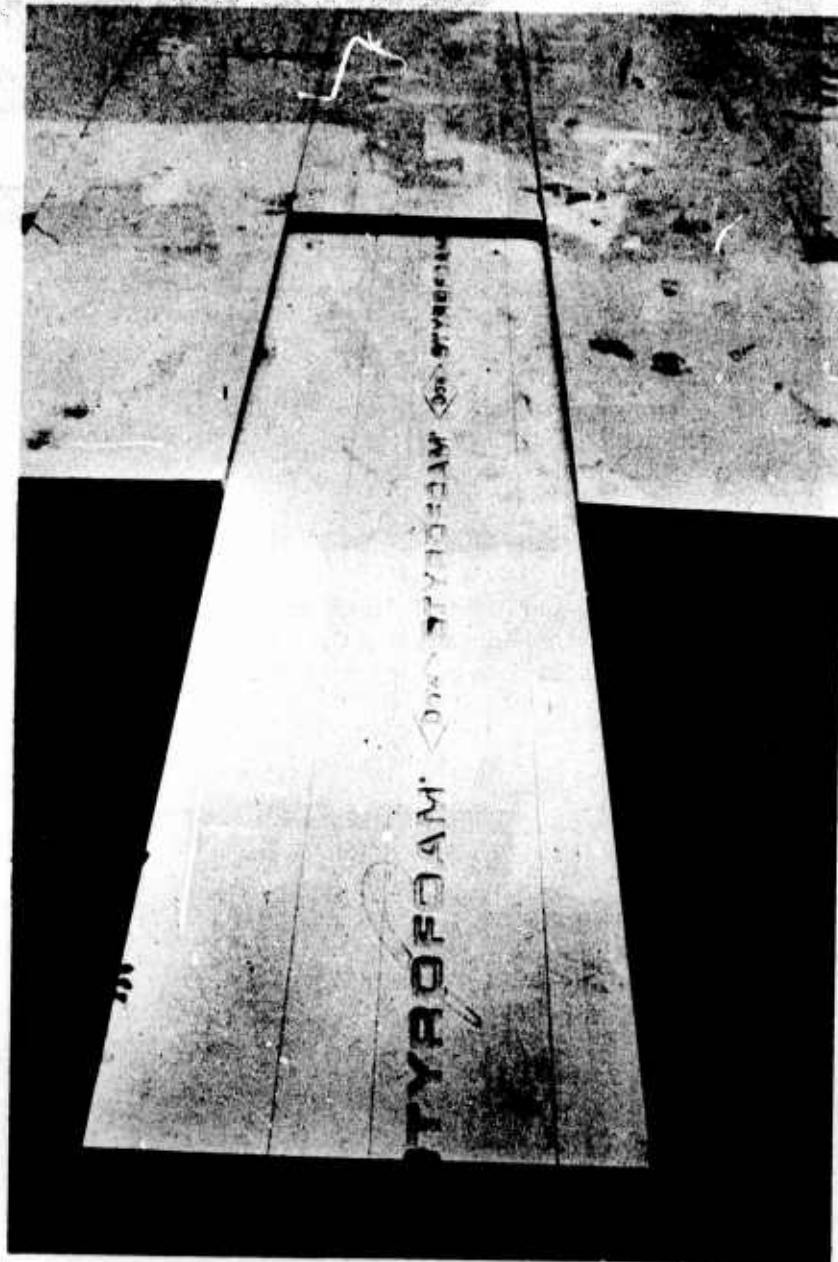
Figure A2. One-in. thick solid insulation in section C in foreground.

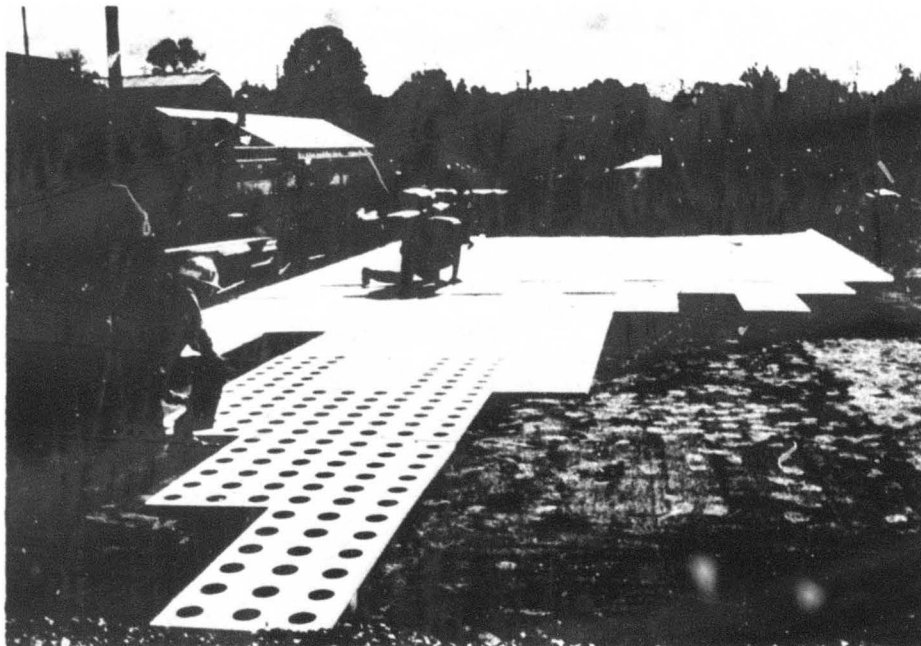
Figure A3. One-in. perforated insulation in section B; 1-in. solid insulation in section C; and 2-in. solid insulation in section D.

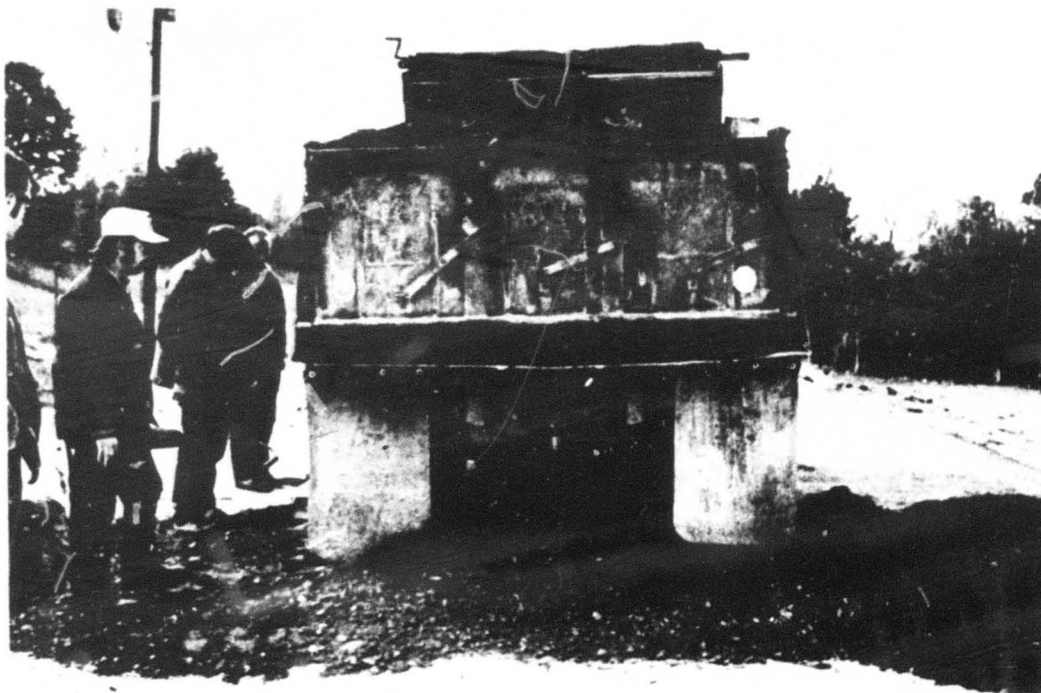
Figure A4. End dumping 8 in. of crushed bank-run gravel on 2-in. insulation.

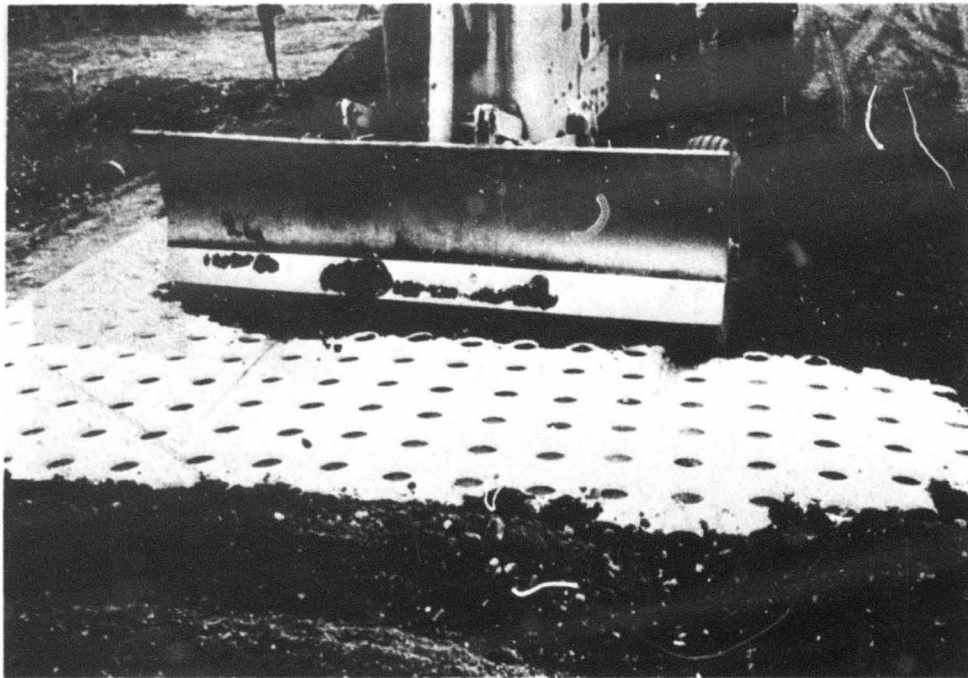
Figure A5. Leveling gravel on insulation.

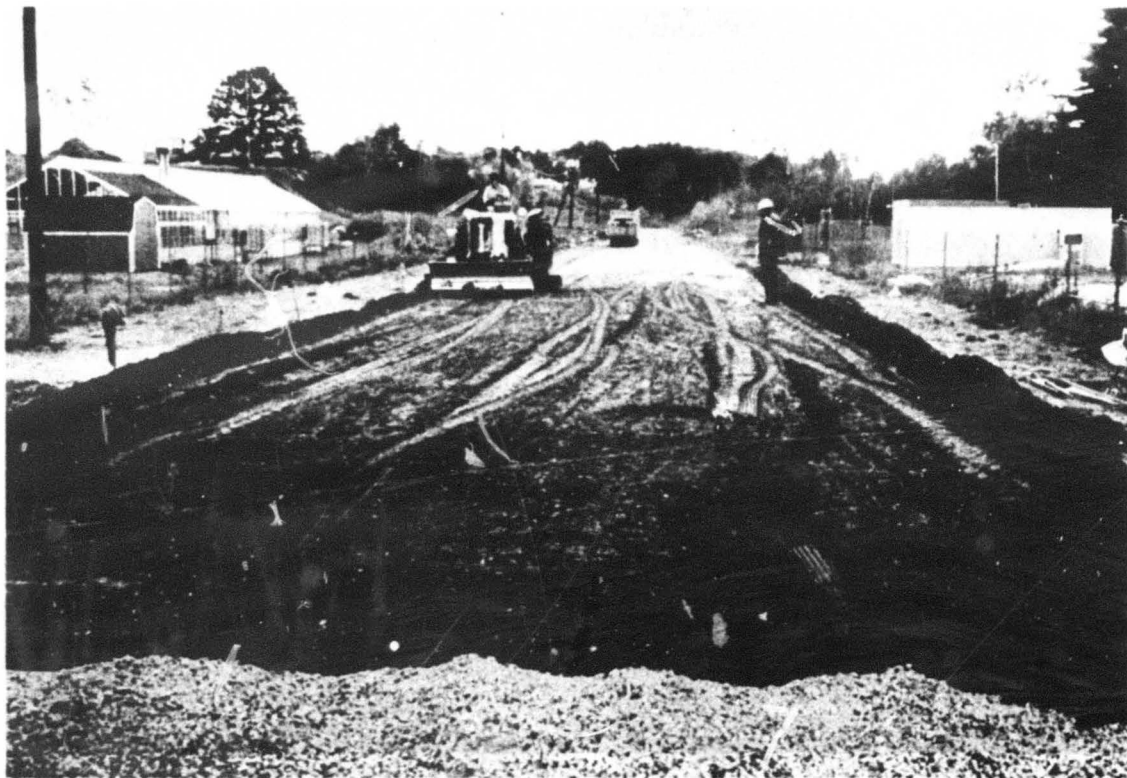
Figure A6. Gravel lift over insulation meets crushed stone in section A in foreground.

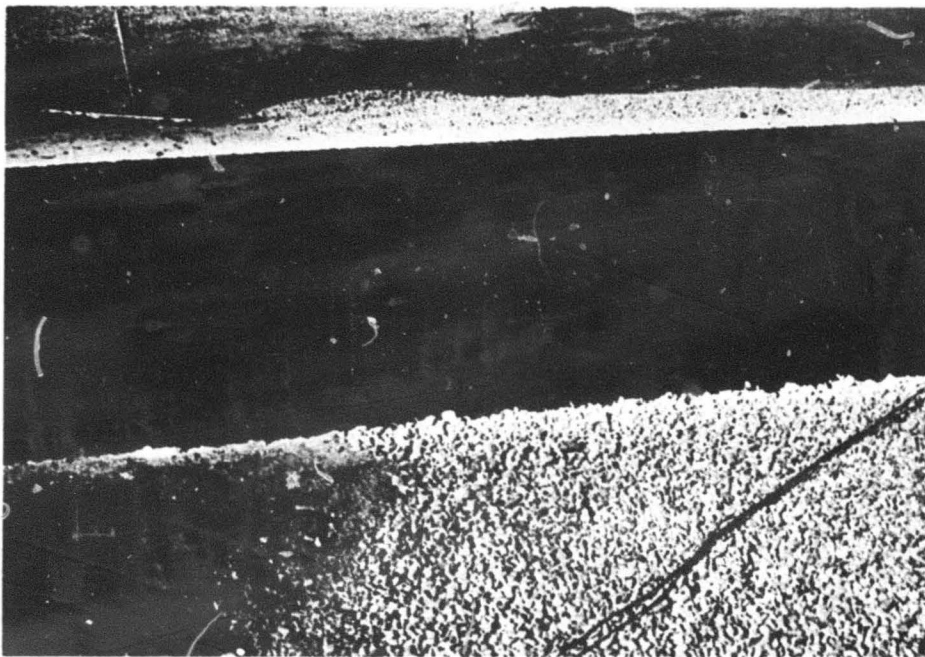
Figure A7. 2-in. asphalt concrete over section A crushed rock on right and section B bank-run gravel on left.

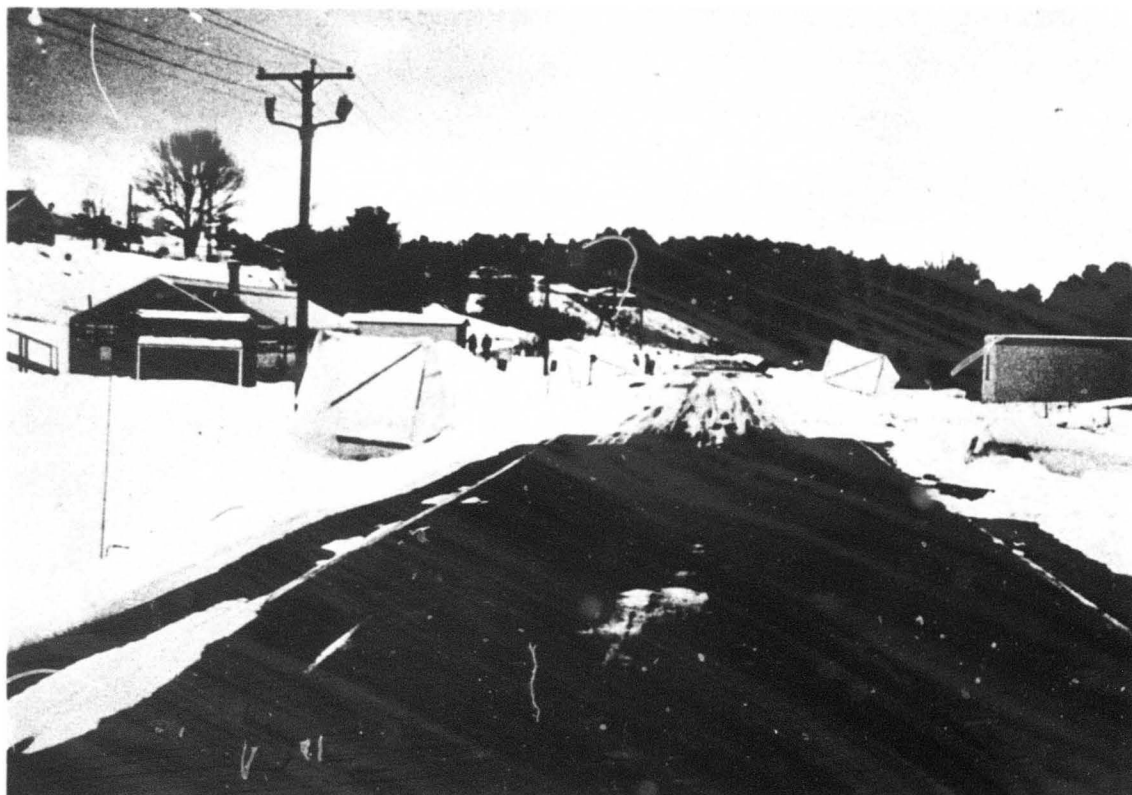
Figure A8. Bare section A in foreground with ice-covered transition and section D in background.

Surface differential icing did occur between the noninsulated control section and the 2-in. insulated section.

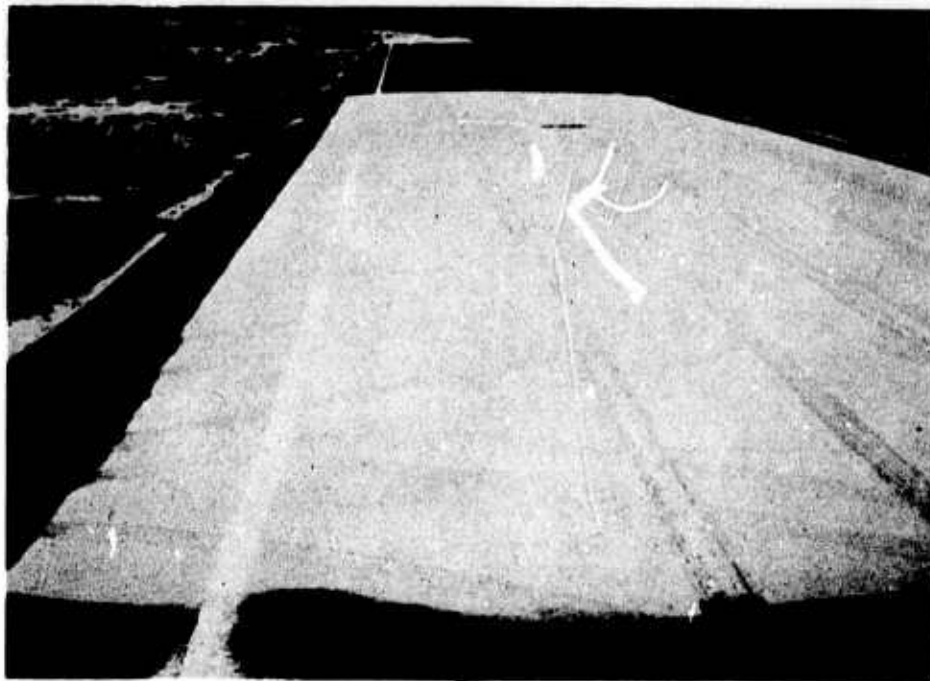
Figure A9. Closeup showing differential ice between insulated section in foreground and noninsulated section in background.

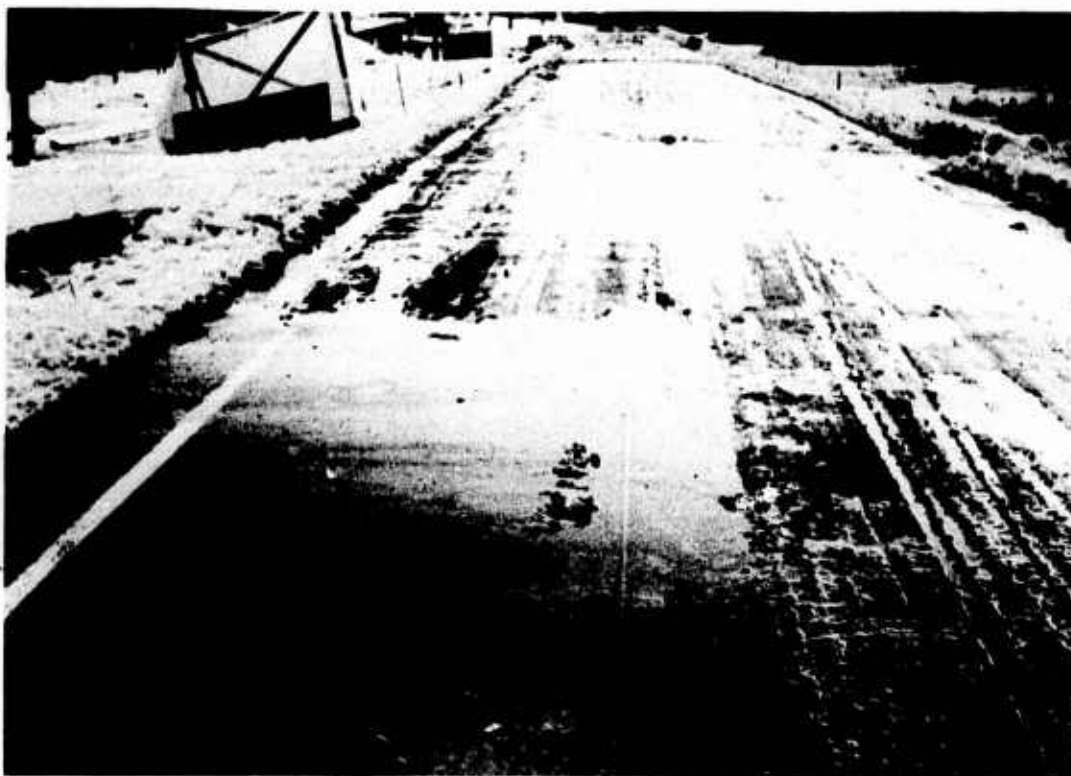
Figure A10. Partially thawed section C in foreground and solid ice on section D in background.
