WVT-TR-76029

ENVIRONMENTAL EFFECTS OF A STEARATE COATING
ON THE FRACTURE BEHAVIOR OF GUN STEEL

BENET WEAPONS LABORATORY
WATERVLIET ARSENAL
WATERVLIET, N.Y. 12189

TECHNICAL REPORT

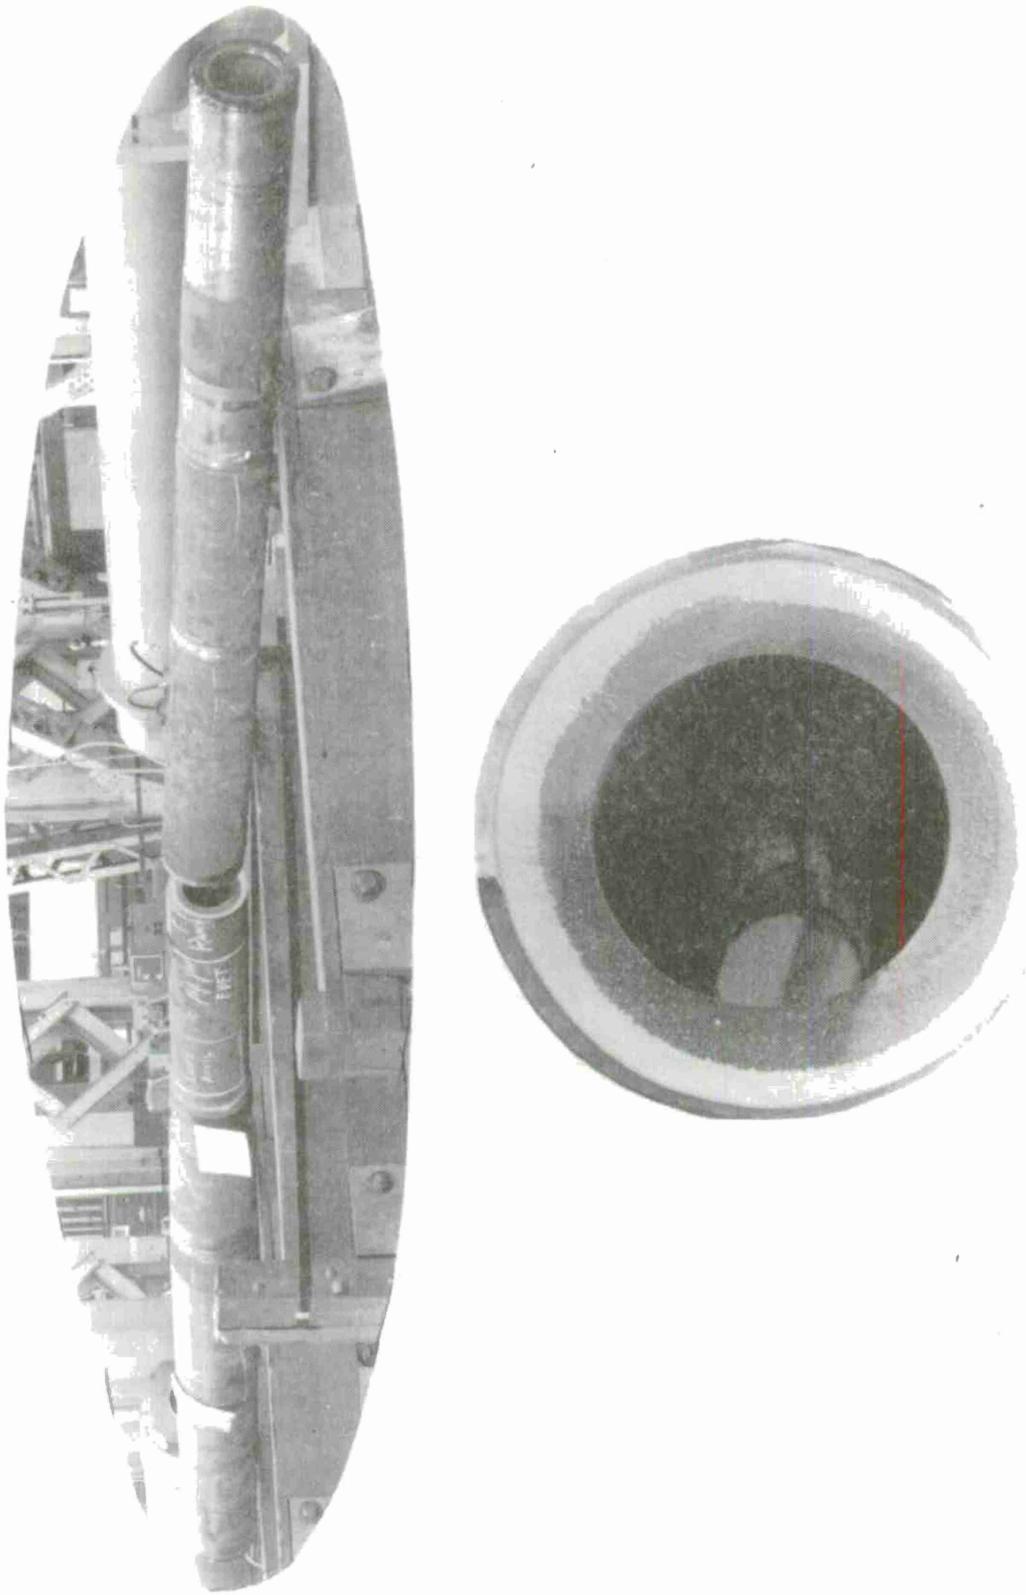
Fig. 1. Lead coated gun tube which broke brittley in two pieces after heat treatment at 675°F for 4 hrs.

Lead electroplated inside the bore of a gun tube has historically been used as a lubricant for the mechanical swage autofrettage process. After the post-autofrettage thermal treatment at 675°F for four hours, occasional transverse cracks were observed. In instances, these cracks were around the entire circumference and nearly through the wall thickness and resulted in complete fracture during subsequent gun tube straightening⁽¹⁾ (figure 1). Recent study has shown that this cracking phenomena is due to liquid metal embrittlement; the liquid lead acting as embrittling species in combination with high longitudinal tensile residual stresses present in the bore surface of the cannon.

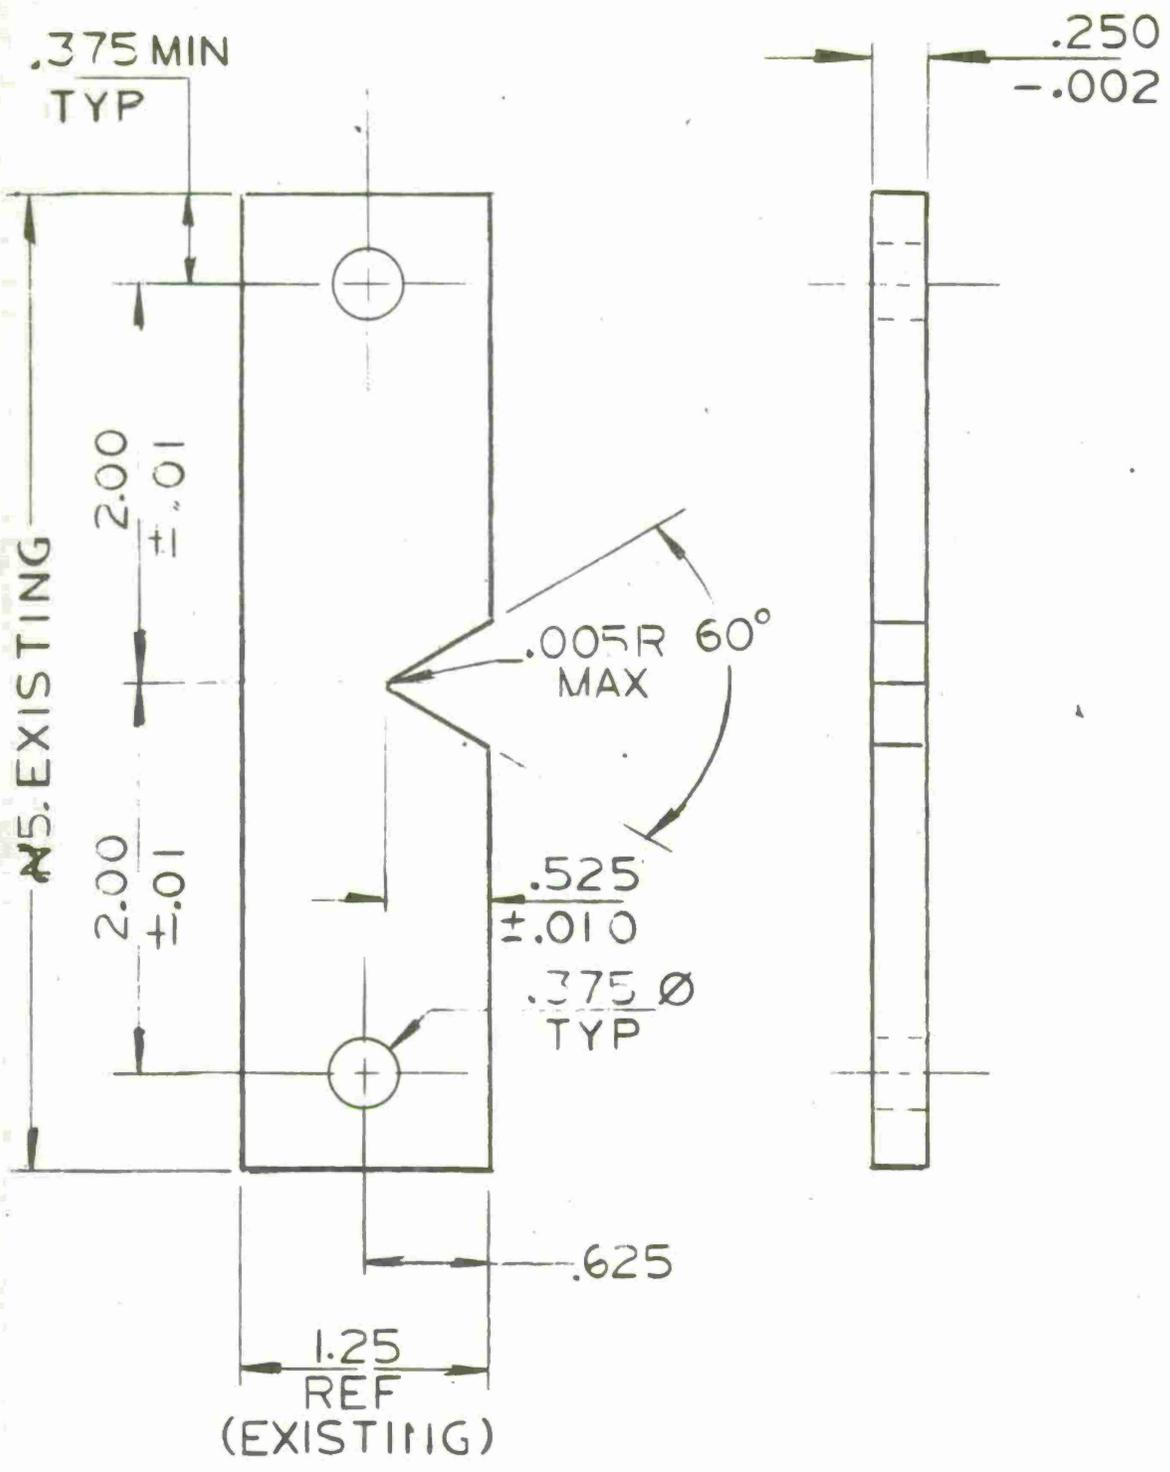
Fig. 2
 SINGLE EDGE NOTCHED FATIGUE TENSION
 TEST SPECIMEN

(b) Crack Propagation Studies: Crack propagation studies, were carried out with single edge notched, flat tensile specimen shown in Figure 2. (3) The specimens were first compression loaded to 2700 lbs. Subsequently, these were mounted in a fatigue testing machine and a fatigue crack was produced at room temperature at 1800 rpm using a tensile load of 1950 lbs. The number of cycles to produce the crack and its approximate crack length was measured. The precracked specimens were then coated with lubricant using the procedure described

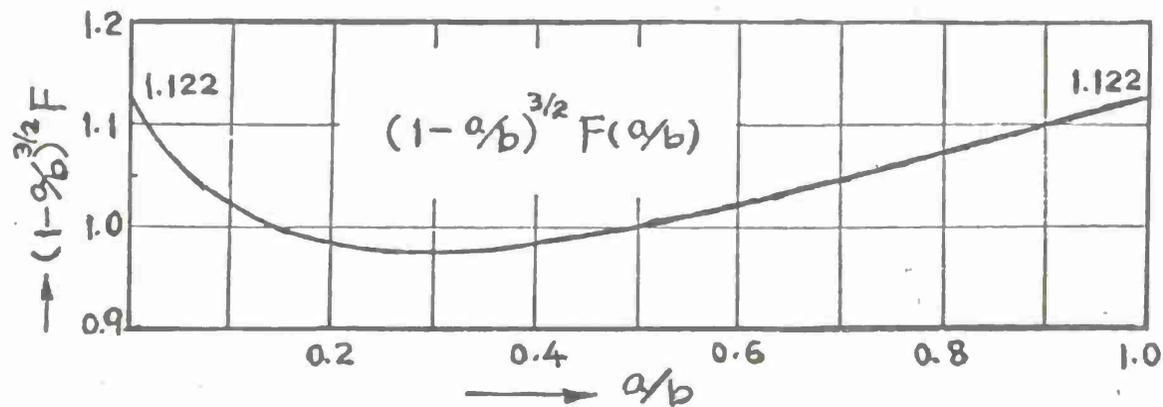
Fig. 3. CALIBRATION CURVE FOR SINGLE EDGE NOTCHED TENSION FATIGUE TEST SPECIMEN

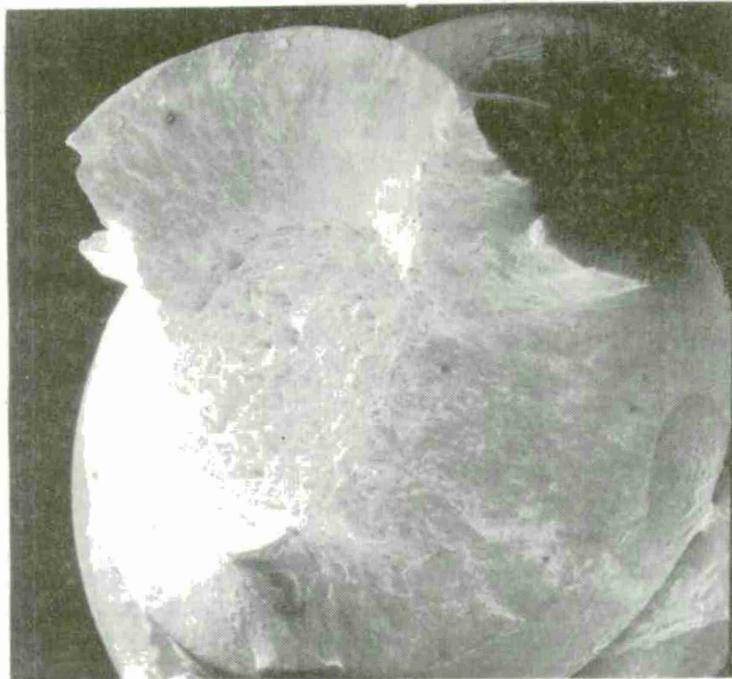
Fig. 4. Ductile failure of smooth specimen tested in tension at 675°F in argon, mag 10X

Scanning electron micrographs of fracture surfaces of smooth and fatigue tested specimens are shown in Figures 4 thru 7 and 8 - 21 respectively.

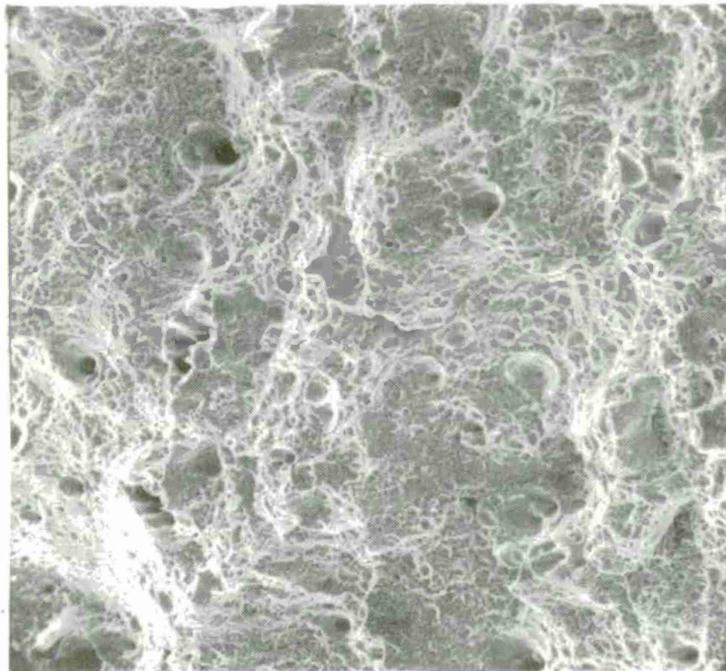
Fig. 5. A high magnification micrograph (mag440X), showing ductile failure of the fracture of specimen in Fig. 4.

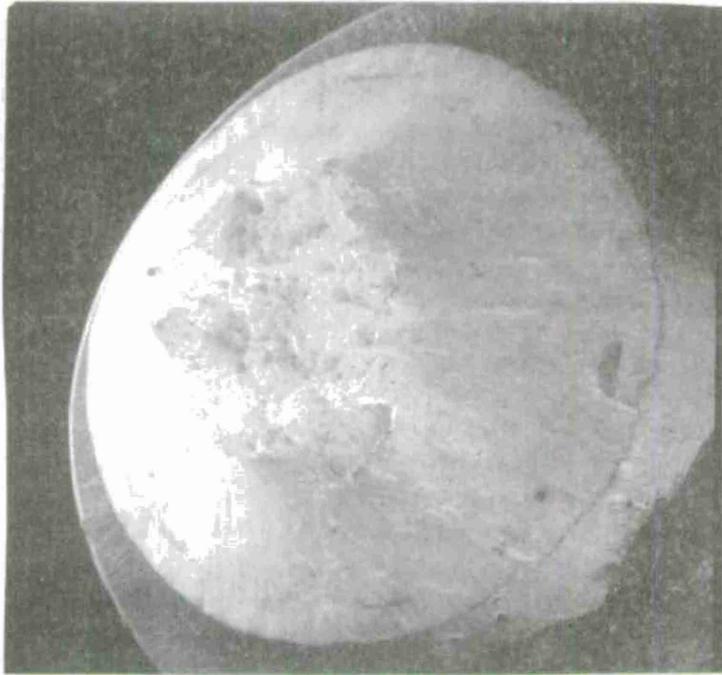
Fig. 6. Ductile failure of smooth specimen tested in tension at 675°F in zinc stearate environment, mag 10X.

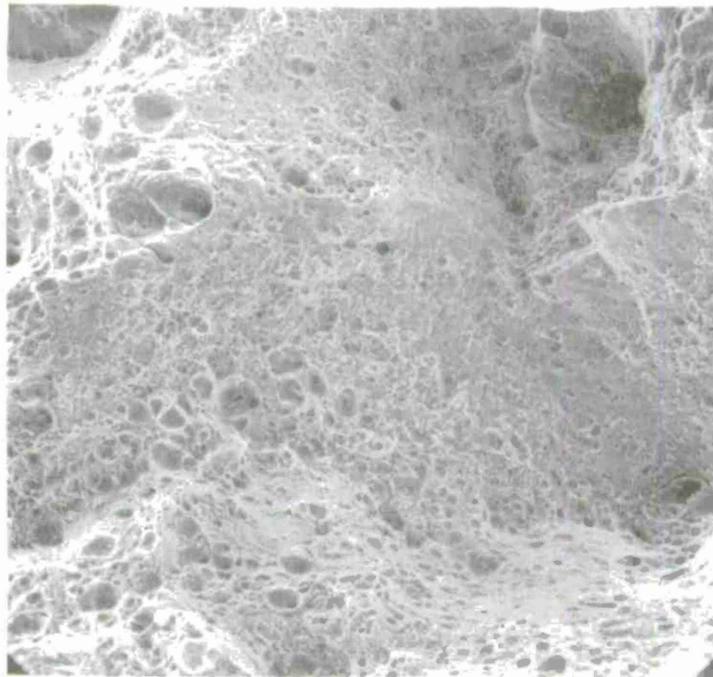
Fig. 7. A high magnification micrograph (mag 440X) showing ductile failure in specimen shown in Fig. 6.

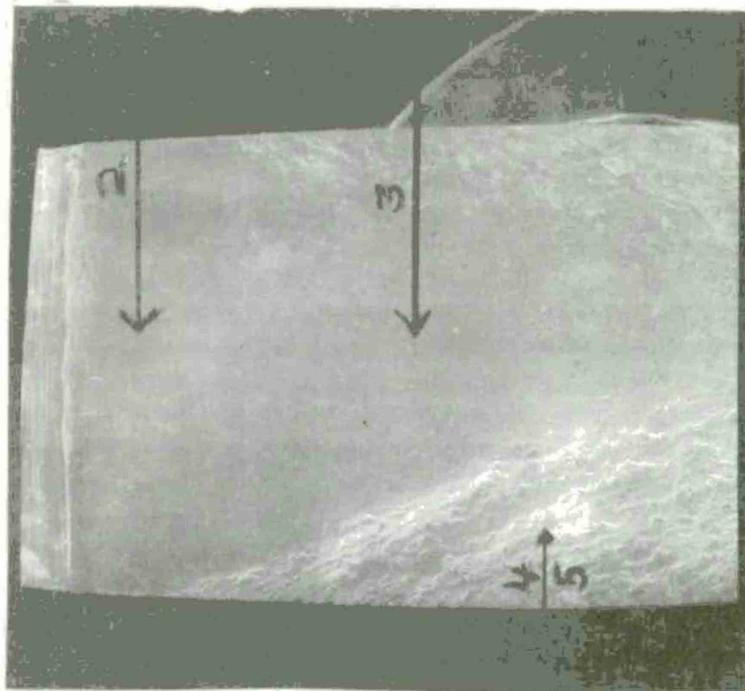
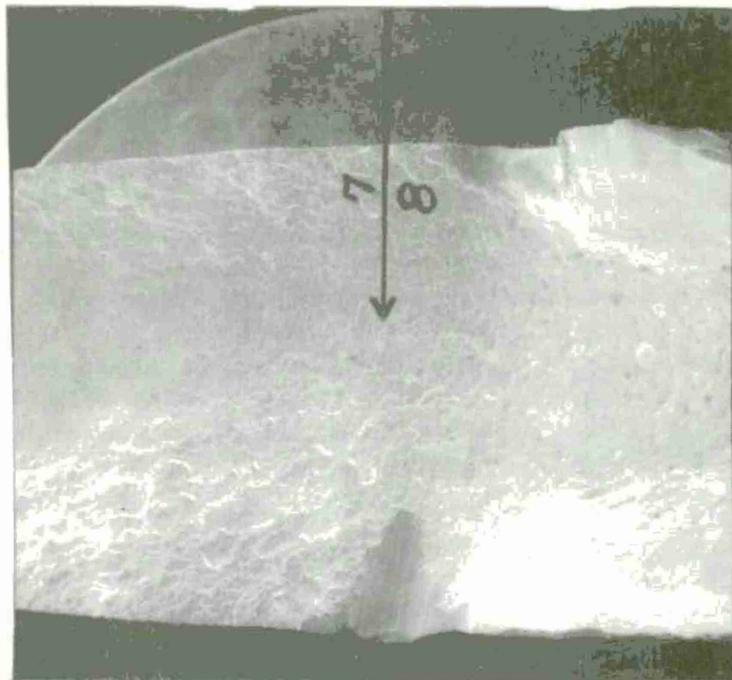
Figs. 8 & 9. Show regions at crack front and away from the crack front for a specimen tested in argon at 675° , which were examined at higher magnifications.

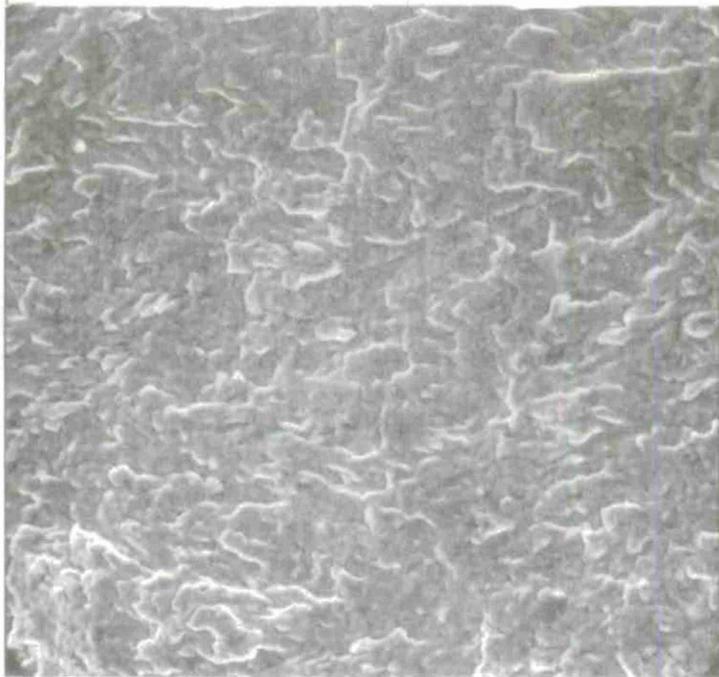
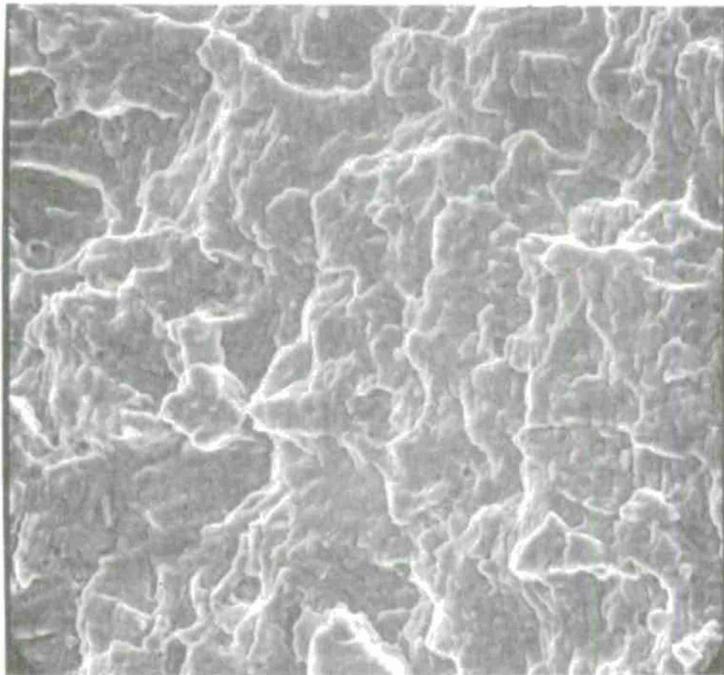
Figs. 10 & 11. These micrographs show that in regions 2 and 3 on the fracture surface in Fig. 8, are essentially ductile, Mag 960X.

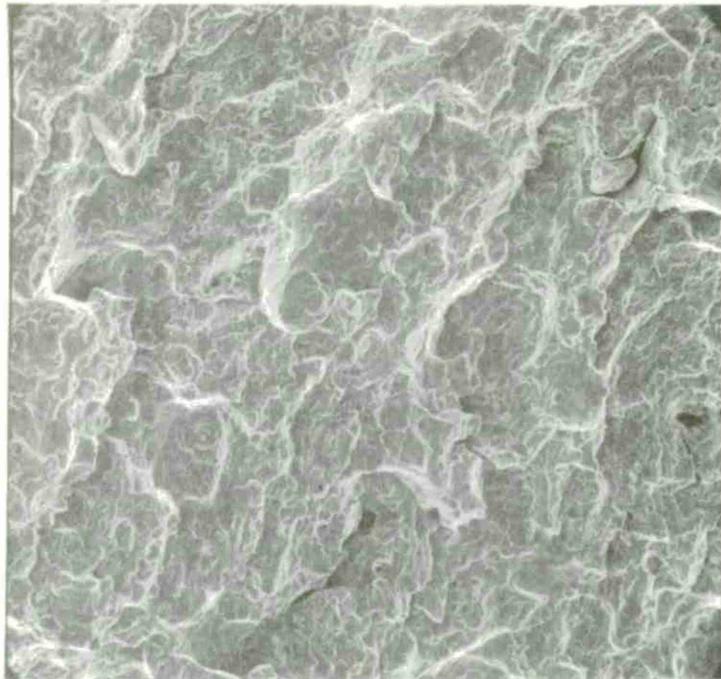
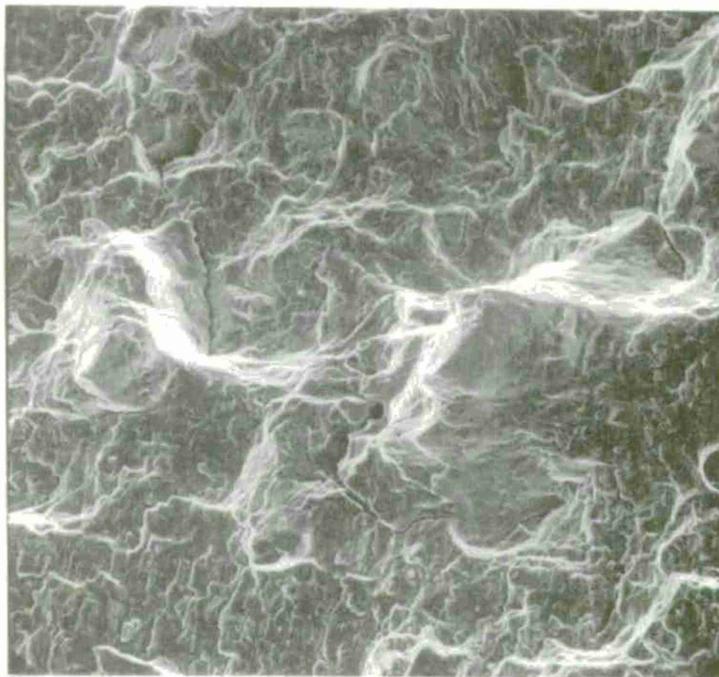
Figs. 12 & 13. These micrographs show intergranular cracks in region 7 and 8 in Fig. 9.

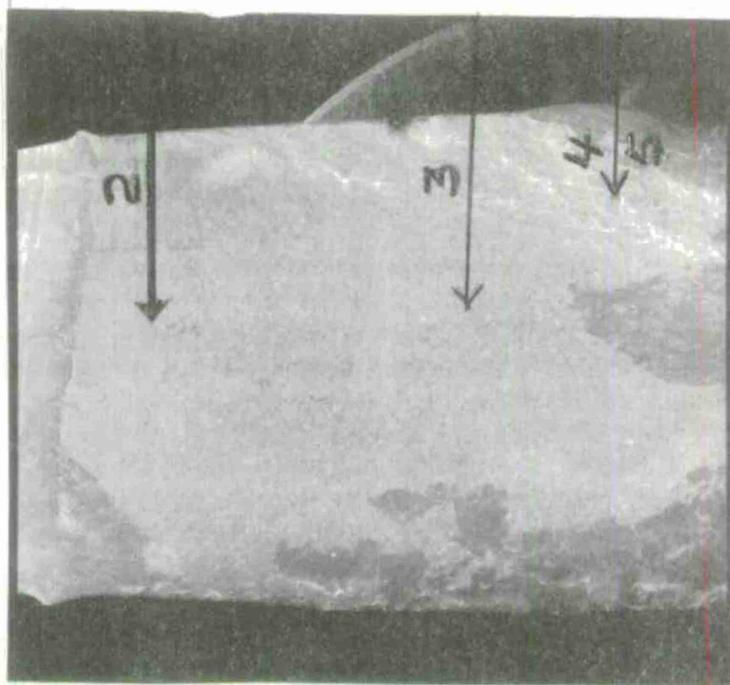
Fig. 14. Fracture surface showing various regions which were examined at high magnification for a specimen tested in fatigue at 675°F in sodium stearate.

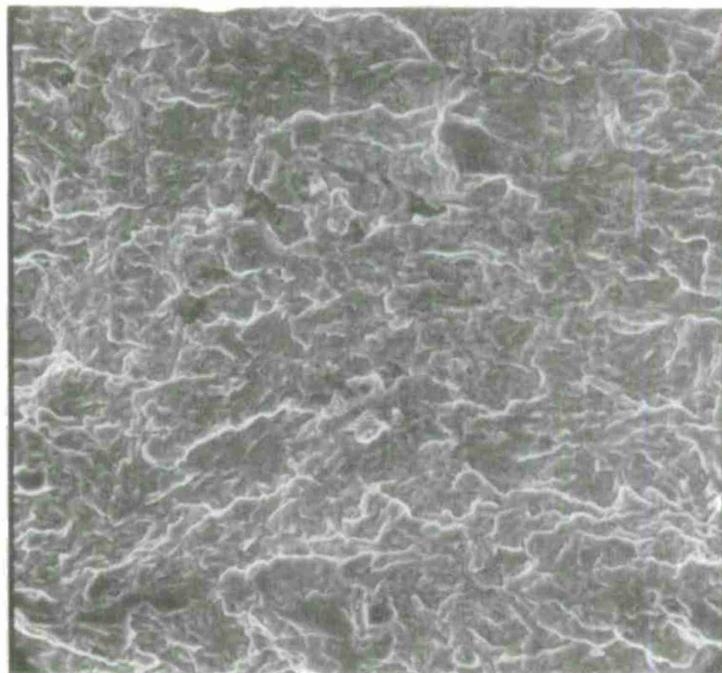
Fig. 15. Shows ductile failure in region 2, in Fig.14, near the fatigue crack front, mag 960X.

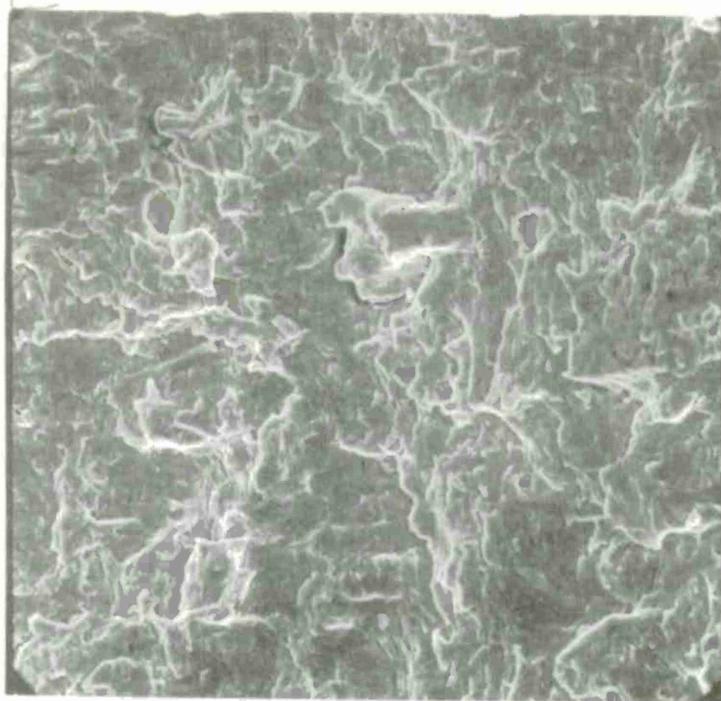
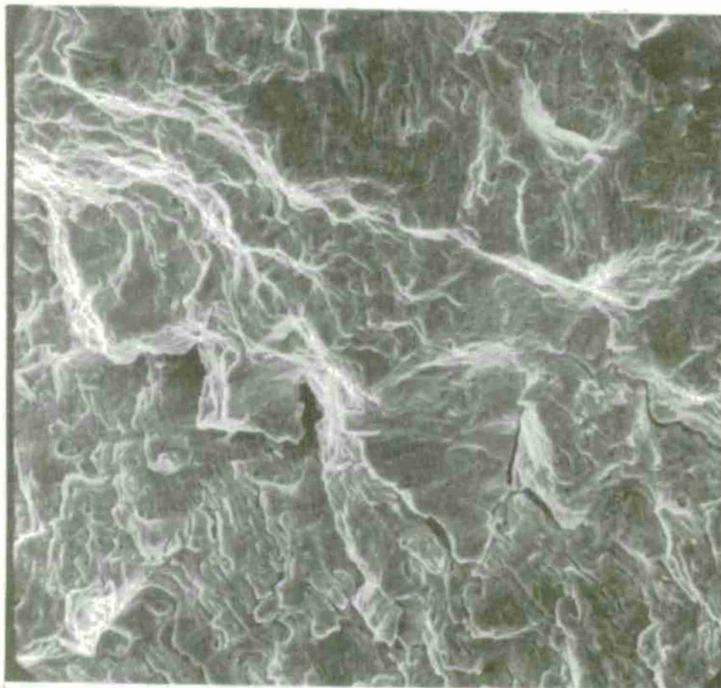
Figs. 16 & 17. Show the fracture surface in regions 3 and 5 in Fig. 14. Notice that fracture is mixed, i.e. ductile with intergranular cracks mag 960X.

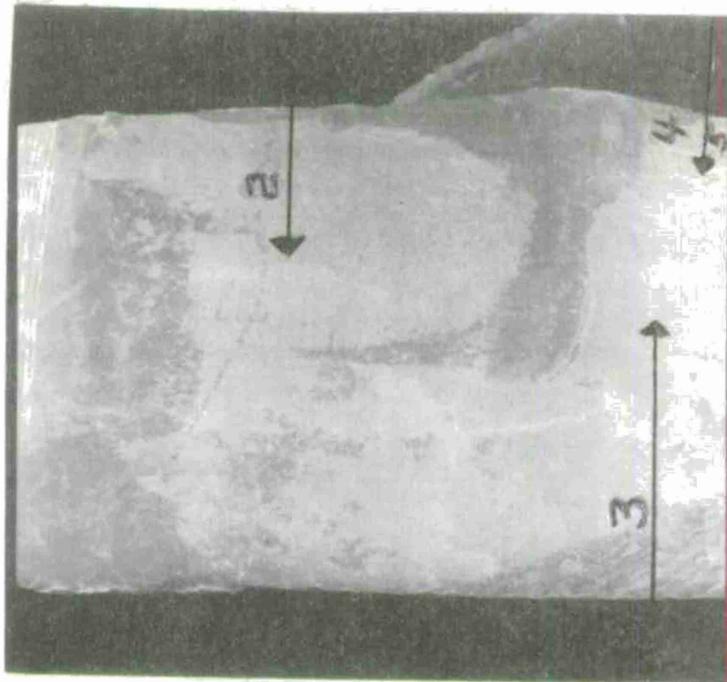
Fig. 18. Fracture surface showing various regions which were examined at highest magnification for a specimen tested in fatigue in zinc stearate at 675°F.

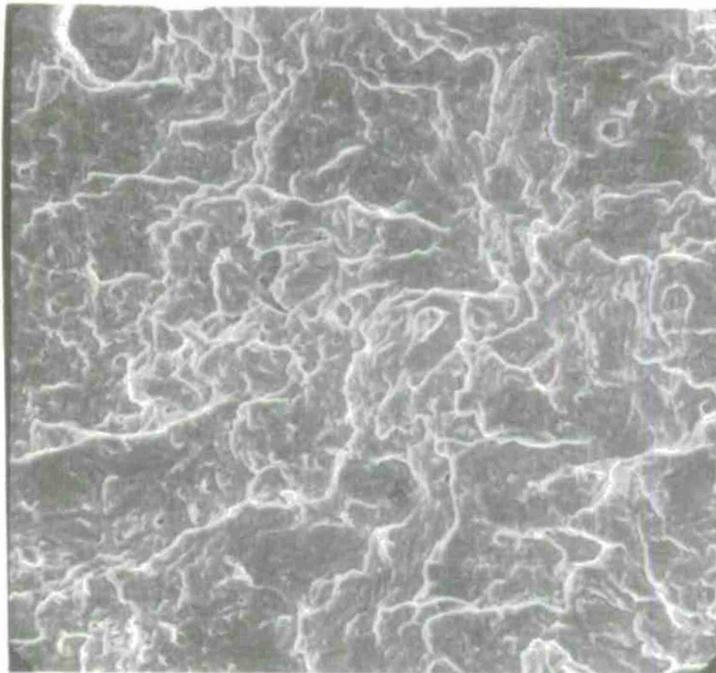
Fig. 19. This figure shows essentially ductile failure in region 2 near the fatigue crack front, mag 960X.

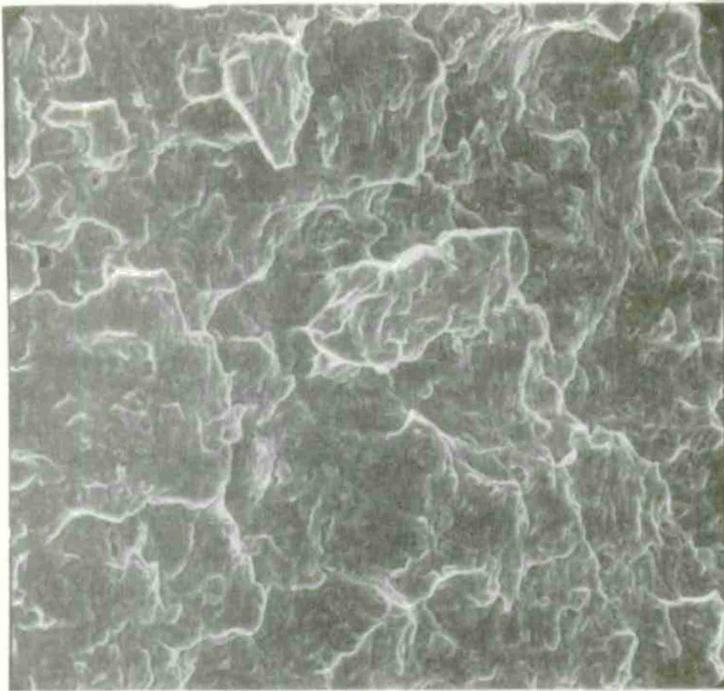
Fig. 20. Shows the fracture surface appearance in region 3 which is similar to that in Fig. 19, 960X.

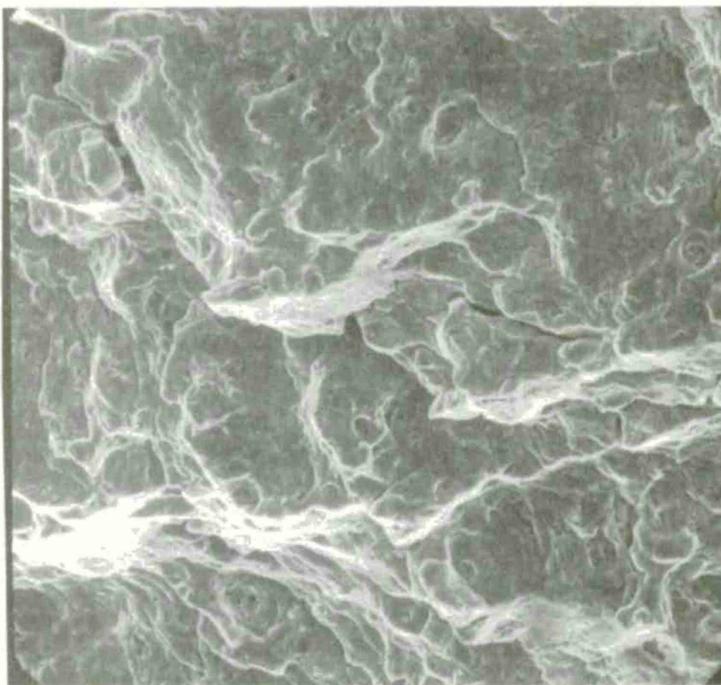
Fig. 21. The fracture surface in region 5, showing mixed ductile and intergranular failure, mag 960X.

The results cited above show that the fatigue and fracture behavior of gun steel is not effected by any of the environments of concern and the propensity towards any embrittlement is minimal. This is further borne out by the characteristic features of the fracture surfaces, i. e. whether cracking is brittle or ductile. Figures 8 thru 13 show the scanning electron micrographs of the fracture surface of specimens tested in argon at 675°F at the crack front and at various regions away from it. It is seen that fracture is predominantly ductile with some intergranular cracks. Similarly, Figures 14 thru 21 show ductile failure with intergranular cracks for specimen tested in sodium and zinc stearate. A comparison of the Figures 8 through 21 shows that the characteristic of the fracture surfaces in both argon and stearate environments are essentially identical. A possibility of embrittlement exists near the edge of the specimen tested in stearate where

intergranular cracks were observed, Fig. 21. These cracks may be caused by hydrogen or methane gases which are known to embrittle steel. These gases may be produced by degradation of stearate heated to 675°F. However, cracking in these environments is slow crack growth controlled and will not be as catastrophic and severe as that observed in liquid lead environment.
