**USAAMRDL-TR-76-14**

**WEAR-INDICATING ROD END BEARING**

**Kaman Aerospace Corporation  
Old Windsor Road  
Bloomfield, Conn. 06002**

**Final Report for Period June 1975 - May 1976**

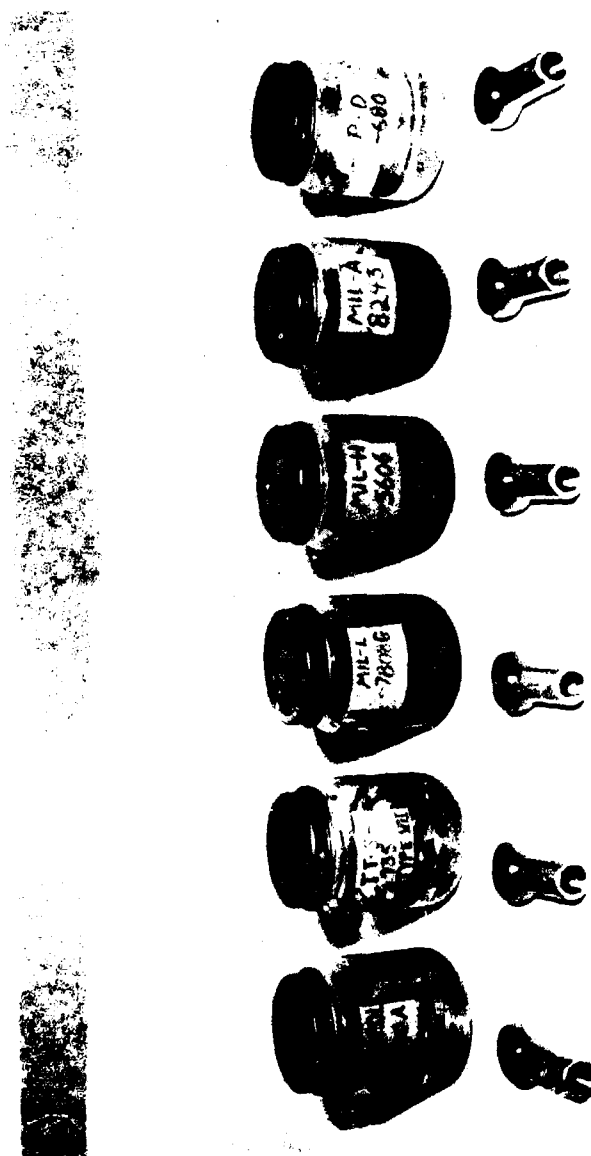
Figure 5. Bearings Before Immersion in Contaminants a through f.
