UNITED STATES ARMY AVIATION BOARD
Fort Rucker, Alabama

REPORT OF TEST

PROJECT NR AVN 2260 ✓

HELICOPTER-MOUNTED SS-11 ANTI-TANK GUIDED MISSILE SYSTEM

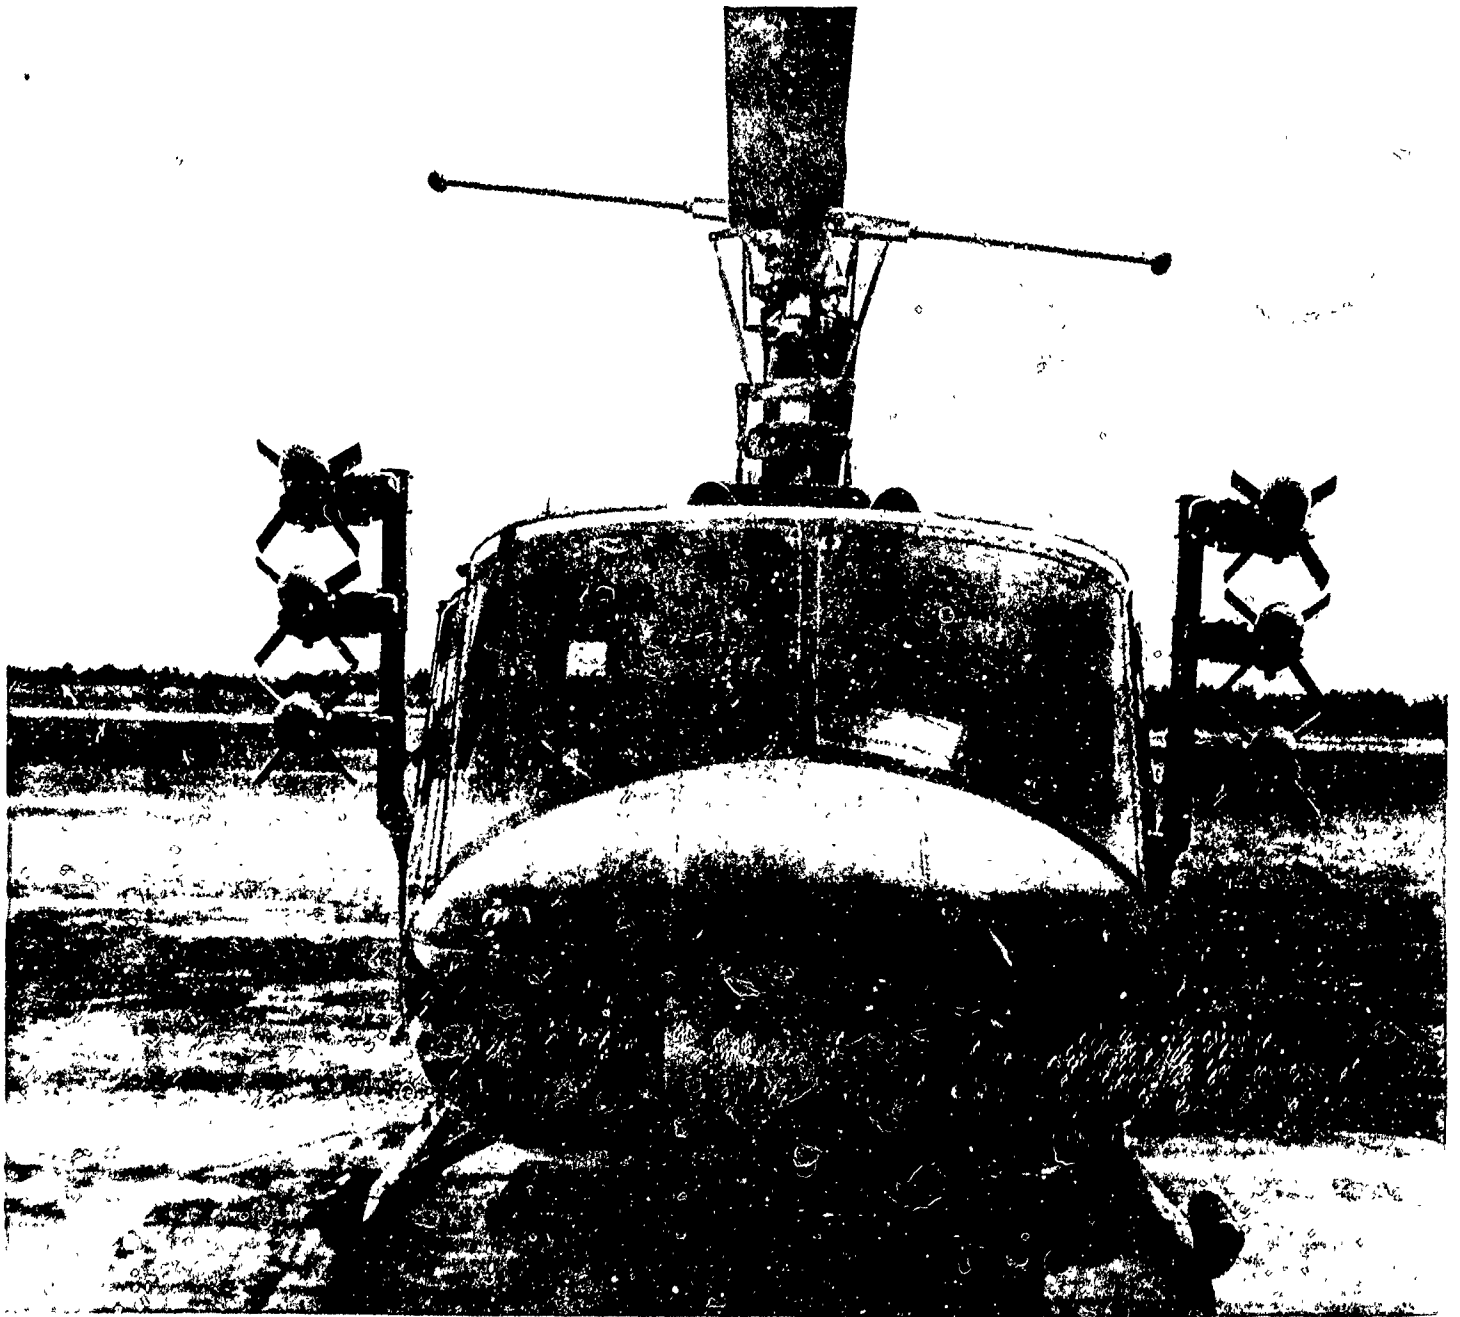
Figure 2. Launcher booms in the stowed position

a. Six missile launchers (three on each side, mounted on horizontal booms) were installed on the helicopter. The launchers can be jettisoned from the helicopter individually or simultaneously in an emergency. The launcher booms can be readily removed or folded vertically to the stowed position (see figure 2).

c. With outboard missiles in place, the installation extended 4 feet 10 inches from the sides of the fuselage, and was easily stowed vertically by removing four bolts. With missiles installed on the launchers, minimum ground clearance was one foot six inches. The inboard missiles (numbers 5 and 6) cleared the fuselage by 11½ inches.

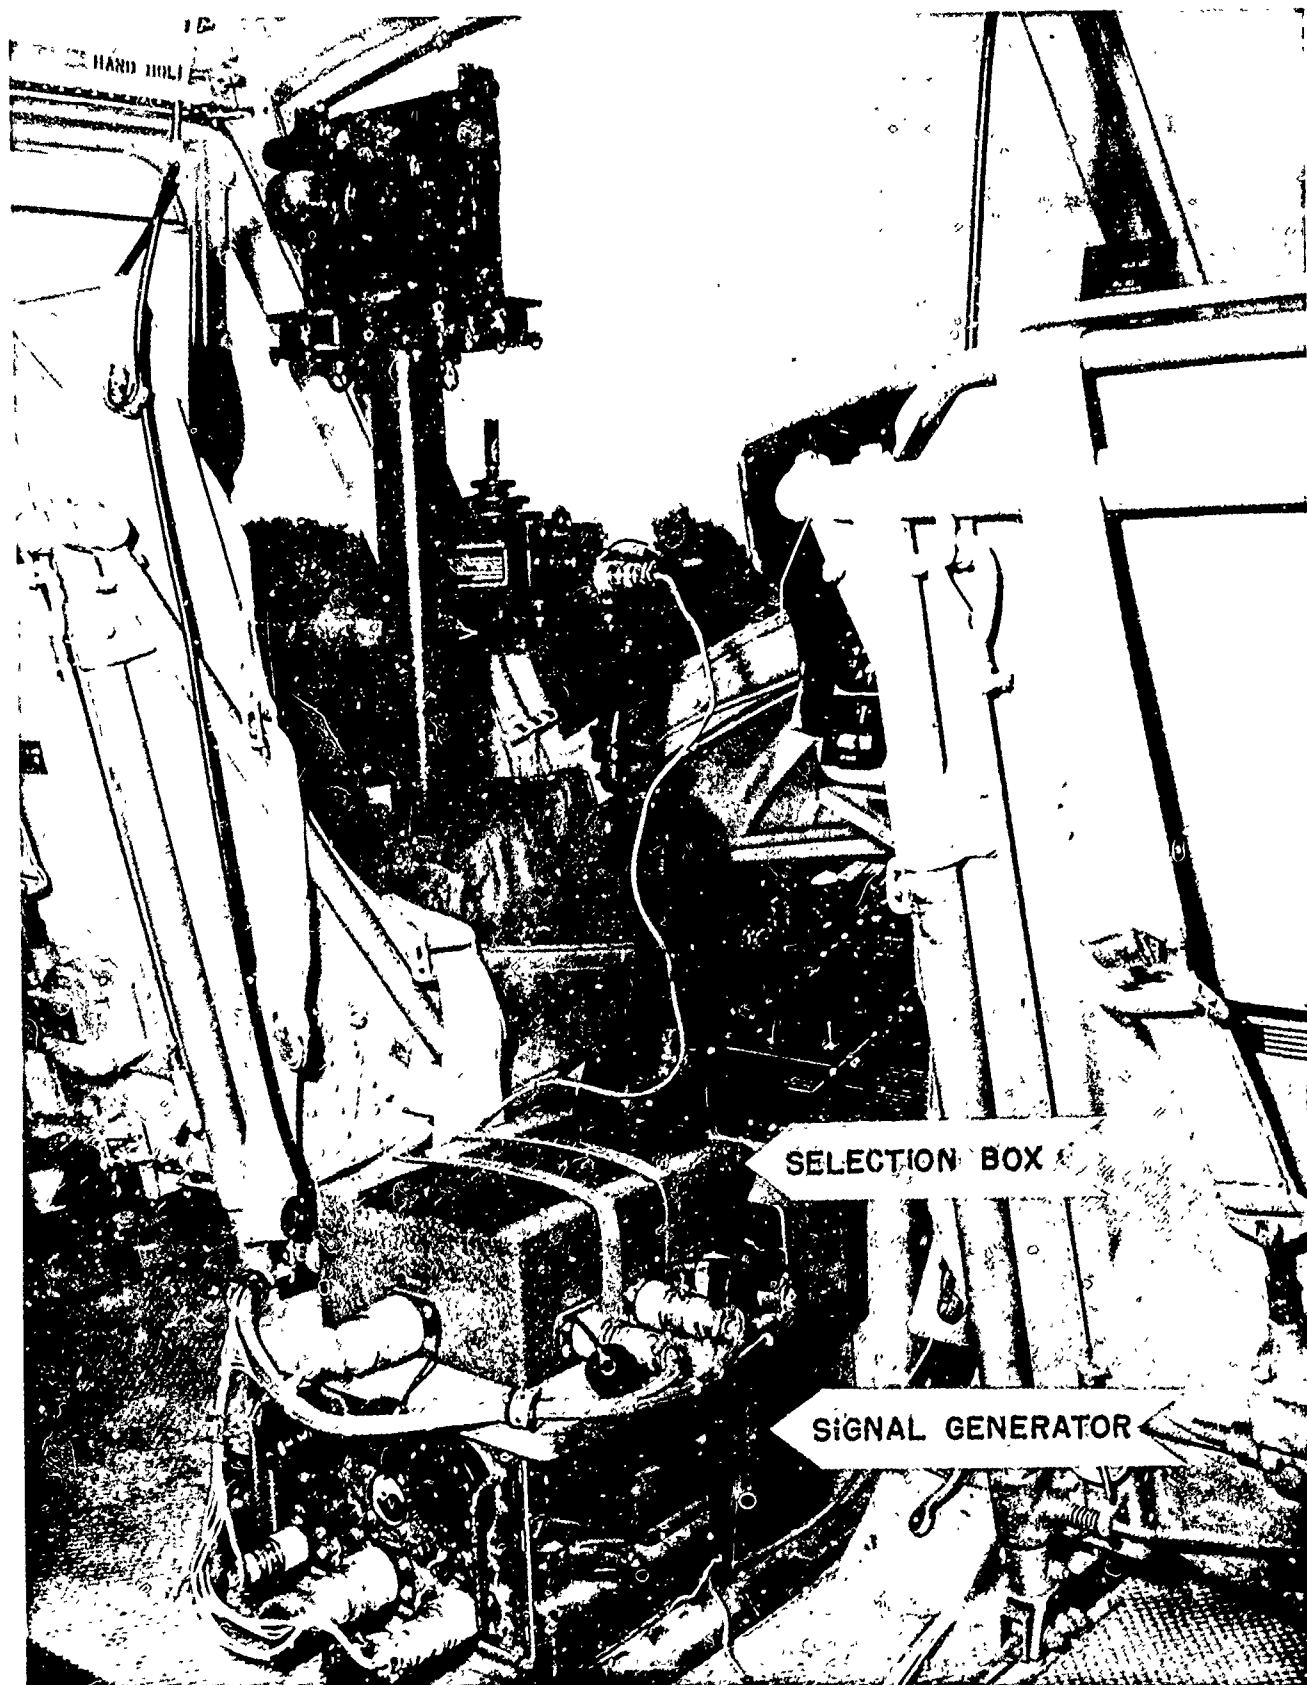
Figure 7. Location of the selection box and the signal generator in the test helicopter

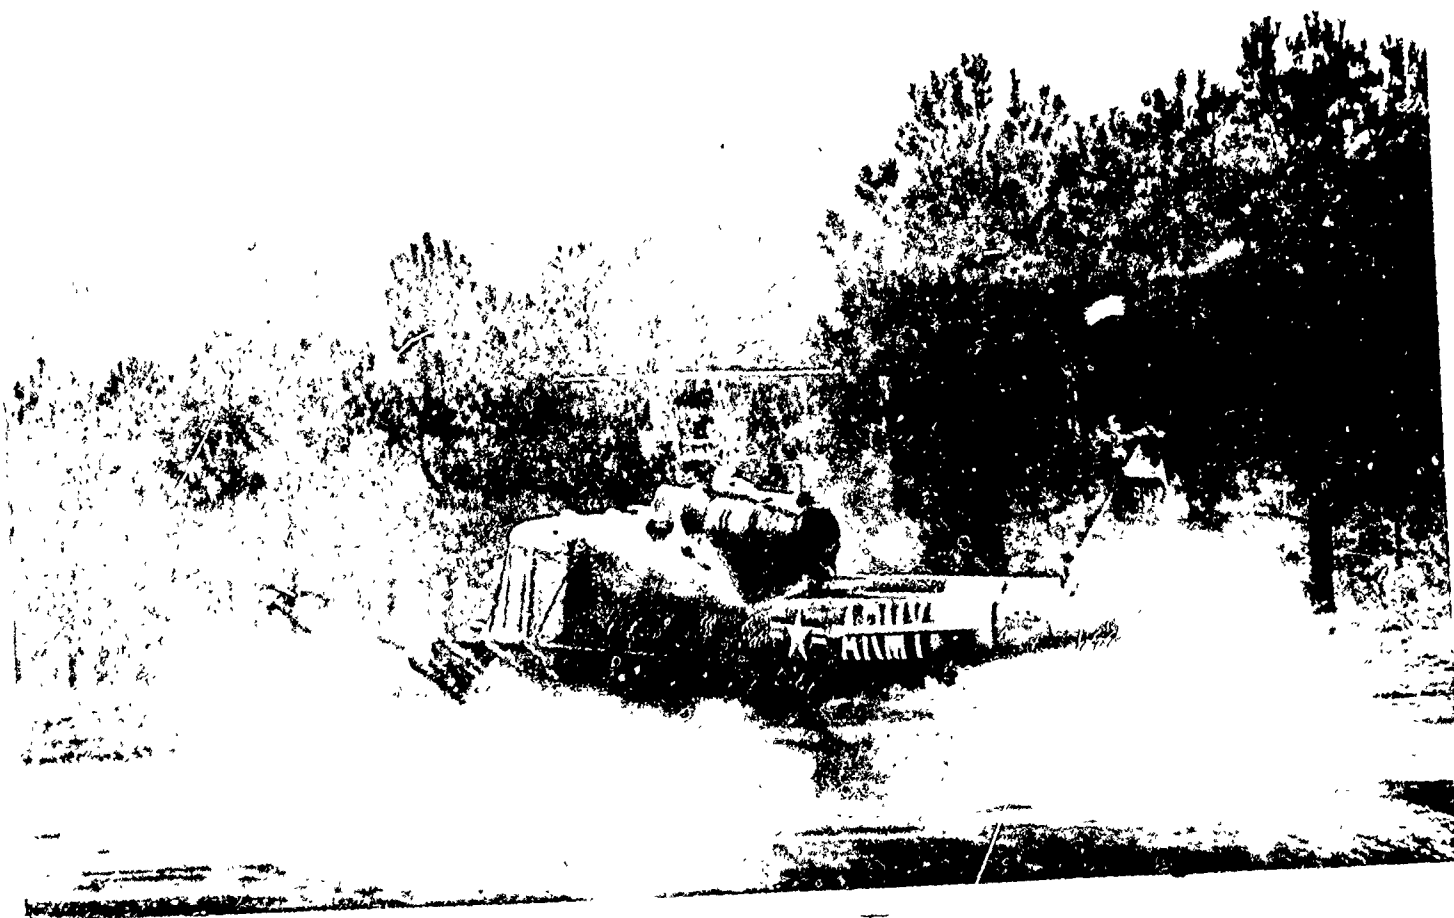
Figure 11. SS-11 firing from HU-1 helicopter
operating on the ground

3. (C) Test No. 3 - Accuracy. 40 missiles were fired from the HU-1 helicopter at stationary targets at ranges from 800 to 3000 meters, from flight altitudes of 0 to 500 feet, at airspeeds from 0 to 75 knots. Moving targets were not available. Missiles were fired while the helicopter was operated in three general flight regimes, i.e., in cruising flight at various altitudes and airspeeds, in hovering flight at various altitudes, and on the ground with the engine and rotors turning at operating r.p.m. (see figures 9, 10, and 11). Tank-type targets were used.

(1) The percentage of hits obtained from firings while the helicopter was operated on the ground was 92 percent (11 hits out of 12 firings).
