# Evaluation of Parameters Affecting Horizontal Stability of Landing Mats

TECHNICAL REPORT S-76-10

# EVALUATION OF PARAMETERS AFFECTING HORIZONTAL STABILITY OF LANDING MATS

Soils and Pavements Laboratory  
U. S. Army Engineer Waterways Experiment Station  
P. O. Box 631, Vicksburg, Miss. 39180

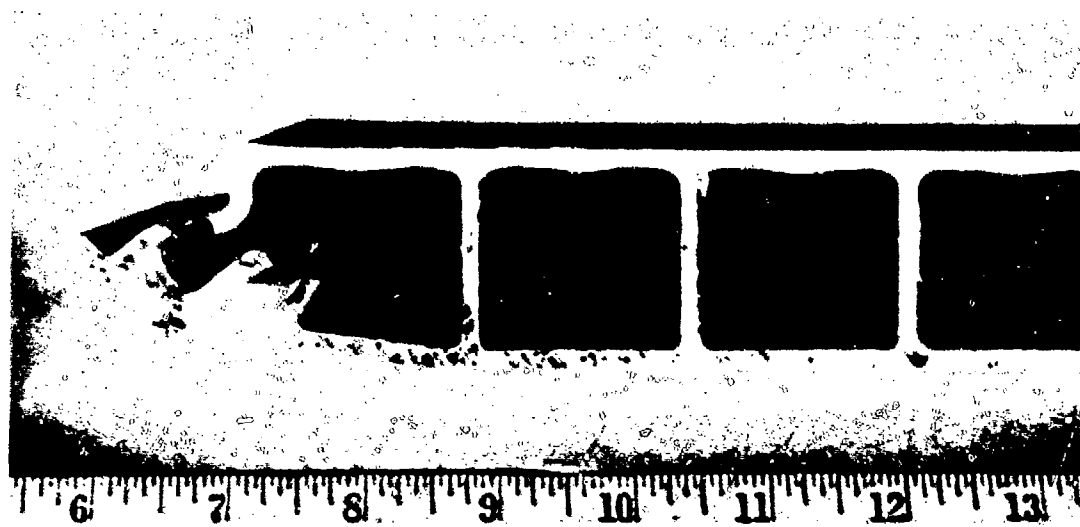
Figure A10. Cross section of mat showing mat failure from buckling

b. The failure of the male rail caused the joint failure. The first failure was in the top skin of the male rail; then the lower skin failed.
