6
COMPARATIVE TEST
of
THE OH-6A ENGINE INLET FILTER
AND PARTICLE SEPARATOR.

9
Final Report of Test
by

11
1 April 1968

DEPARTMENT OF THE ARMY
UNITED STATES ARMY AVIATION TEST BOARD
Fort Rucker, Alabama 36360

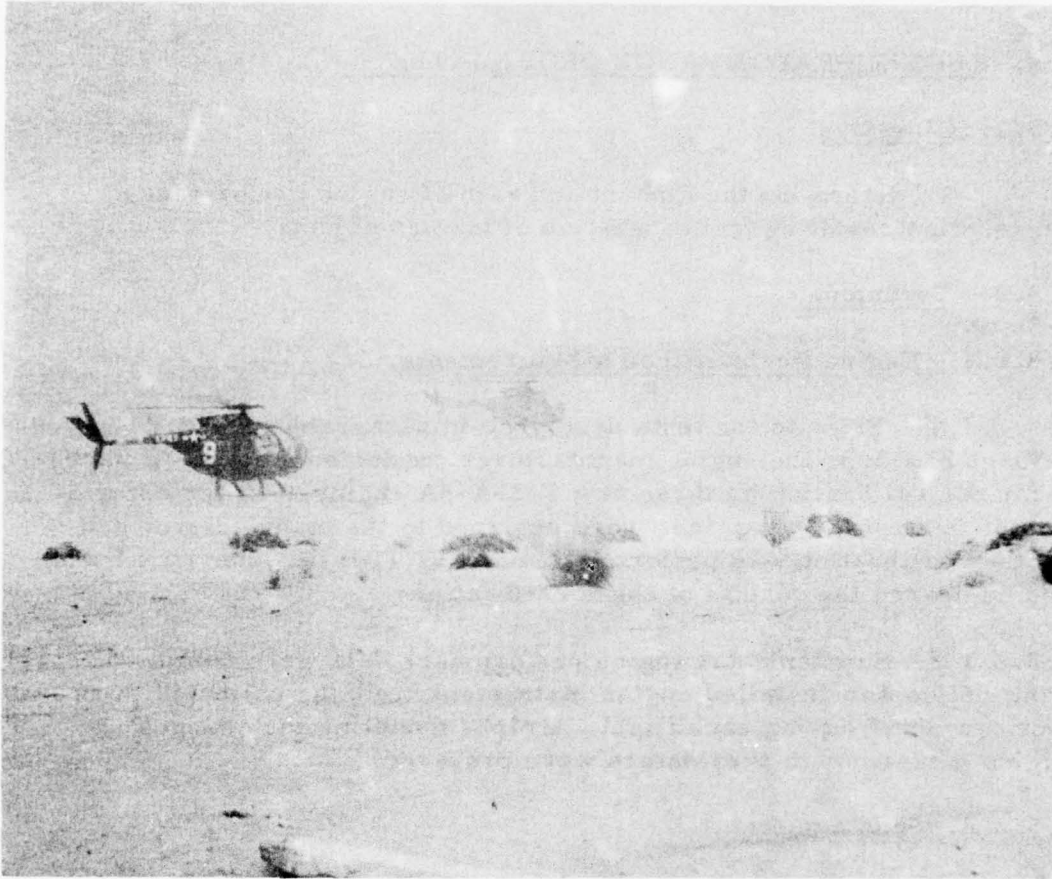
Figure 23. The OH-6A Helicopters, with protective systems installed, hovering over sand surface.

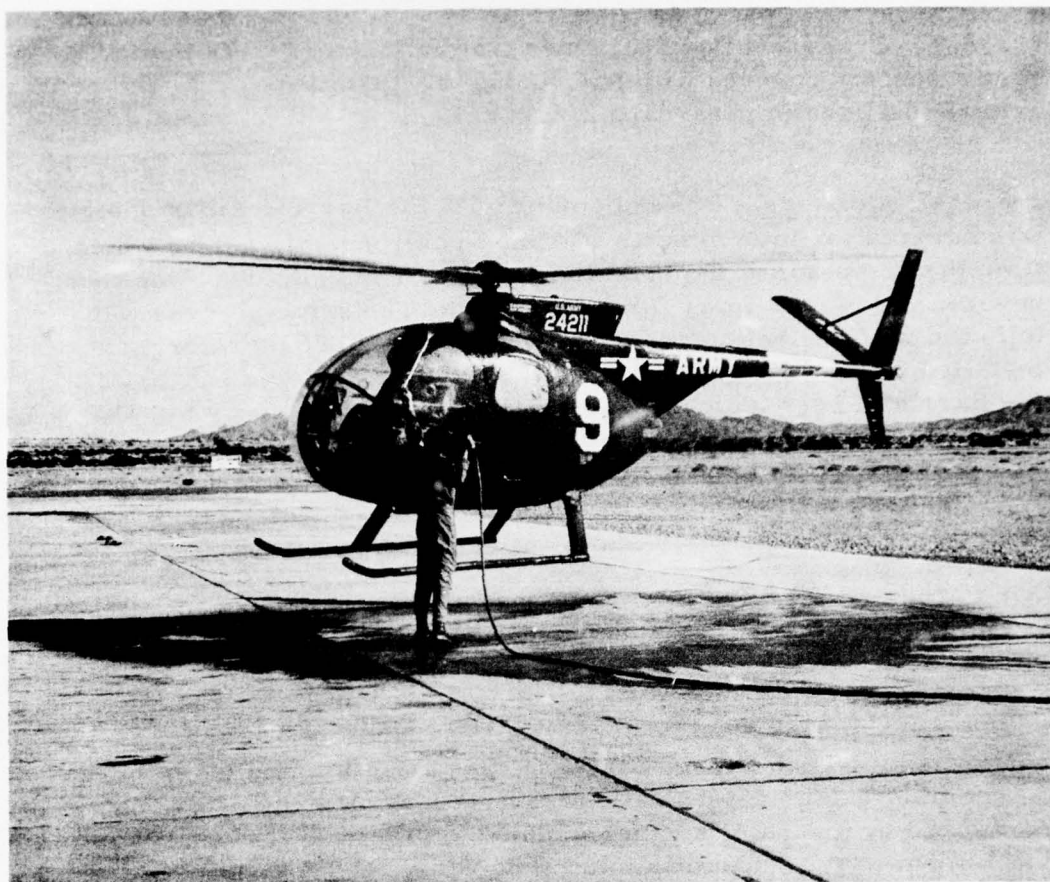
Figure 24. The OH-6A, with protective system installed, hovering in water spray.

2.3.2.4. Moisture. The helicopter with the Barrier Filter installed was hovered for four minutes in a dust environment, during which time the Δp reached the maximum limit. The helicopter was then hovered in a water spray for 10 minutes. The same process was followed with the helicopter on which the Particle Separator was installed (engine S/N 400191). With a clean filter element installed, the Barrier Filter helicopter was hovered in water spray for 10 minutes and then hovered in dry air until the Δp stabilized. Again, this procedure was duplicated by the Particle Separator helicopter in order to keep the engine environmental exposure equal. (See figure 24.)

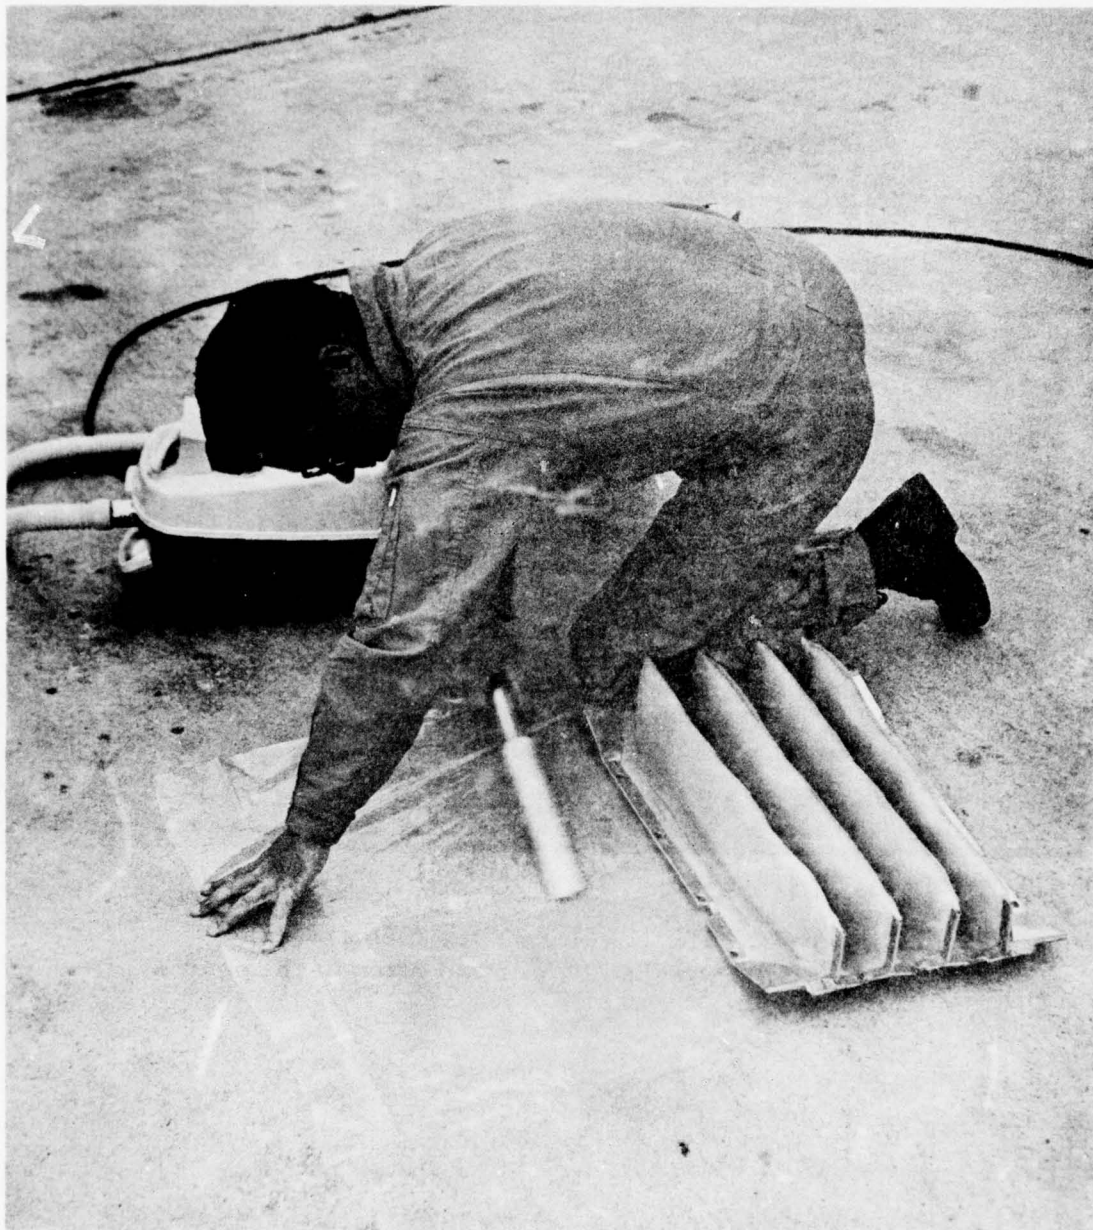
Figure 26. Collecting samples from Barrier Filter element after hover in sand and dust environment.
