CERAMIC MATERIALS IN ROLLING CONTACT BEARINGS

FINAL REPORT

Contract N0019-75-C-0197
15 March 1975 to September 15, 1976

NORTON COMPANY
INDUSTRIAL CERAMICS DIVISION
NORFOLK, MA 01901

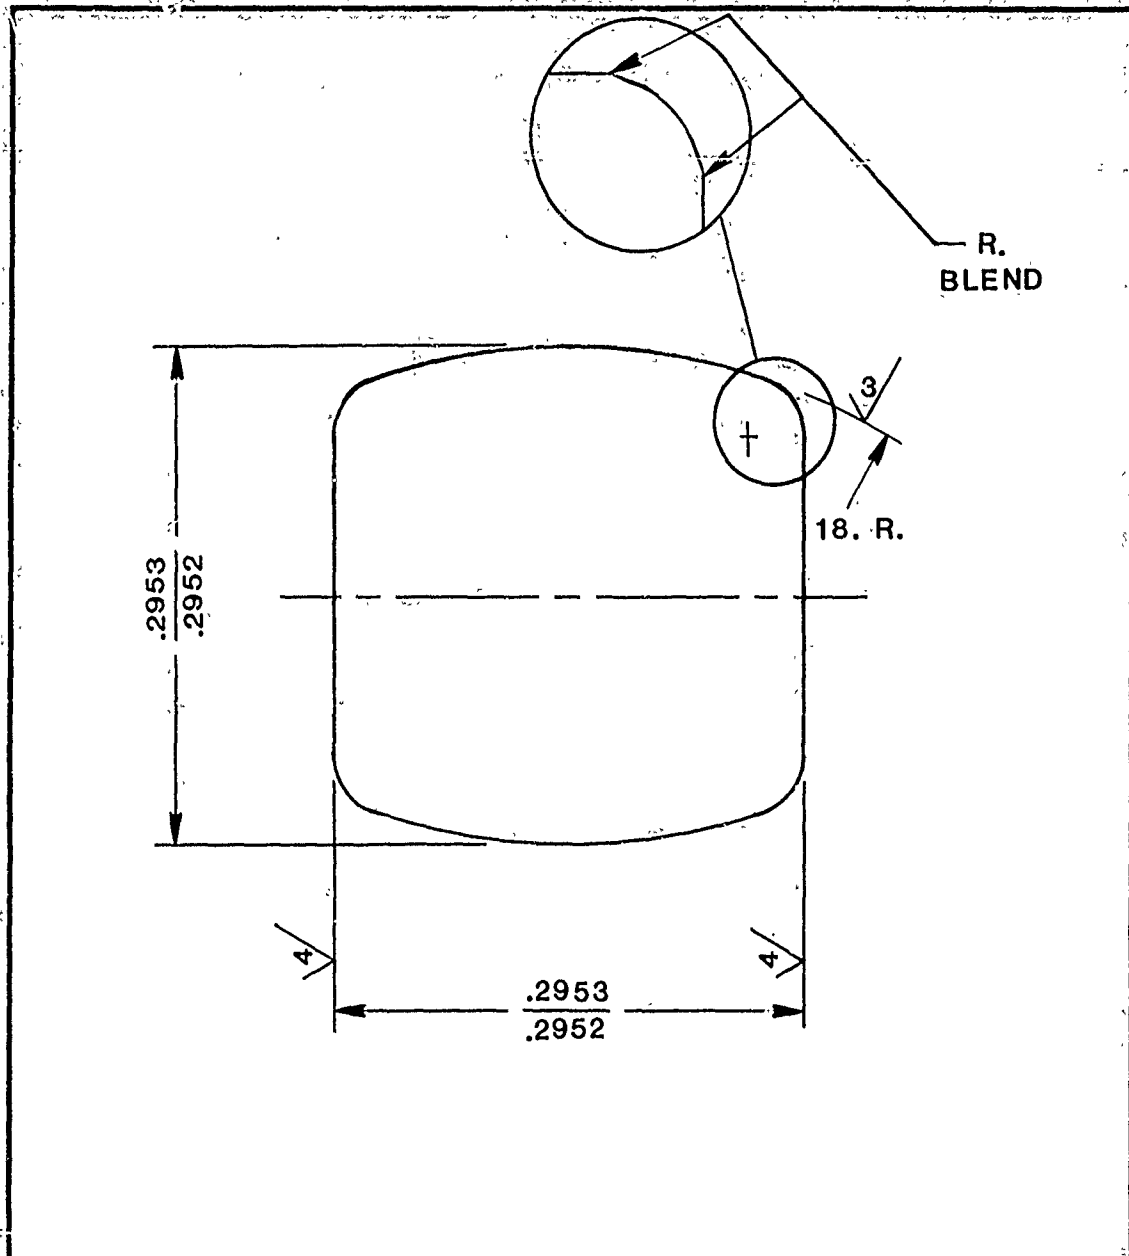
The detail of the silicon nitride roller geometry is shown in Figure 2. A fully crowned roller was chosen to avoid premature race failure due to a stress concentration possibly developing at the intersection of a partial roller crown and the flat. This occurrence is potentially more likely with silicon nitride elements because of its relatively high modulus (thus causing

14 ROLLERS REQUIRED PER BEARING
 MATERIAL: SILICON NITRIDE NC-132
 DIAMETER VARIATION NOT TO EXCEED .000050
 LENGTH VARIATION NOT TO EXCEED .0001
 O.D. ROUND WITHIN .000025

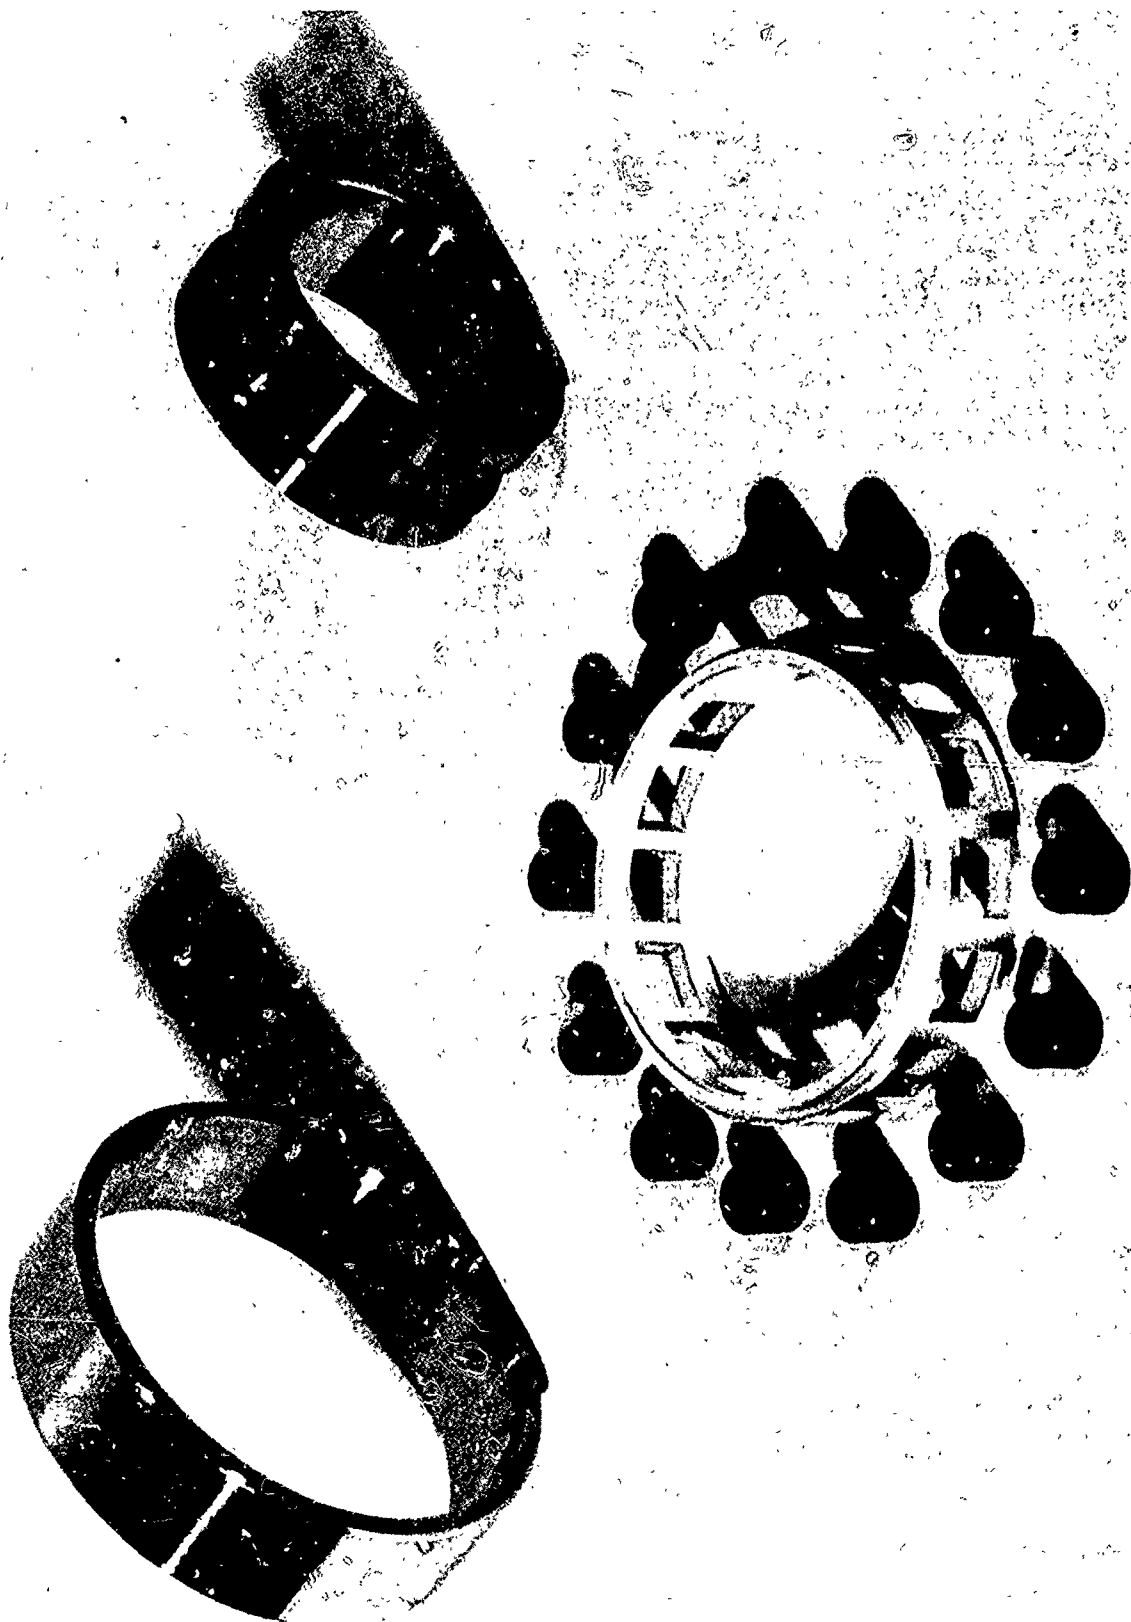
FIGURE 25 - Si₃N₄ roller bearing before testing

The bearing components are shown in Figure 25 before testing and in Figure 26 after testing. Upon initial visual examination, the bearing appeared to be in good condition. However, closer examination showed that an axial crack had formed in the steel inner race surface. As will be seen, the crack was caused by a combination of a dent from a contaminate particle and the microstructure of the steel and was not related to the presence of the silicon nitride.
