DESIGN, FABRICATION, AND TESTING OF AN ADVANCED
COMPOSITE AH-1G TAIL SECTION (TAIL BOOM/VERTICAL FIN)

Hughes Helicopters, Division of Summa Corp.
Centinela and Teale Streets
Culver City, Calif. 90230

November 1976

Final Report for Period July 1973 - February 1976

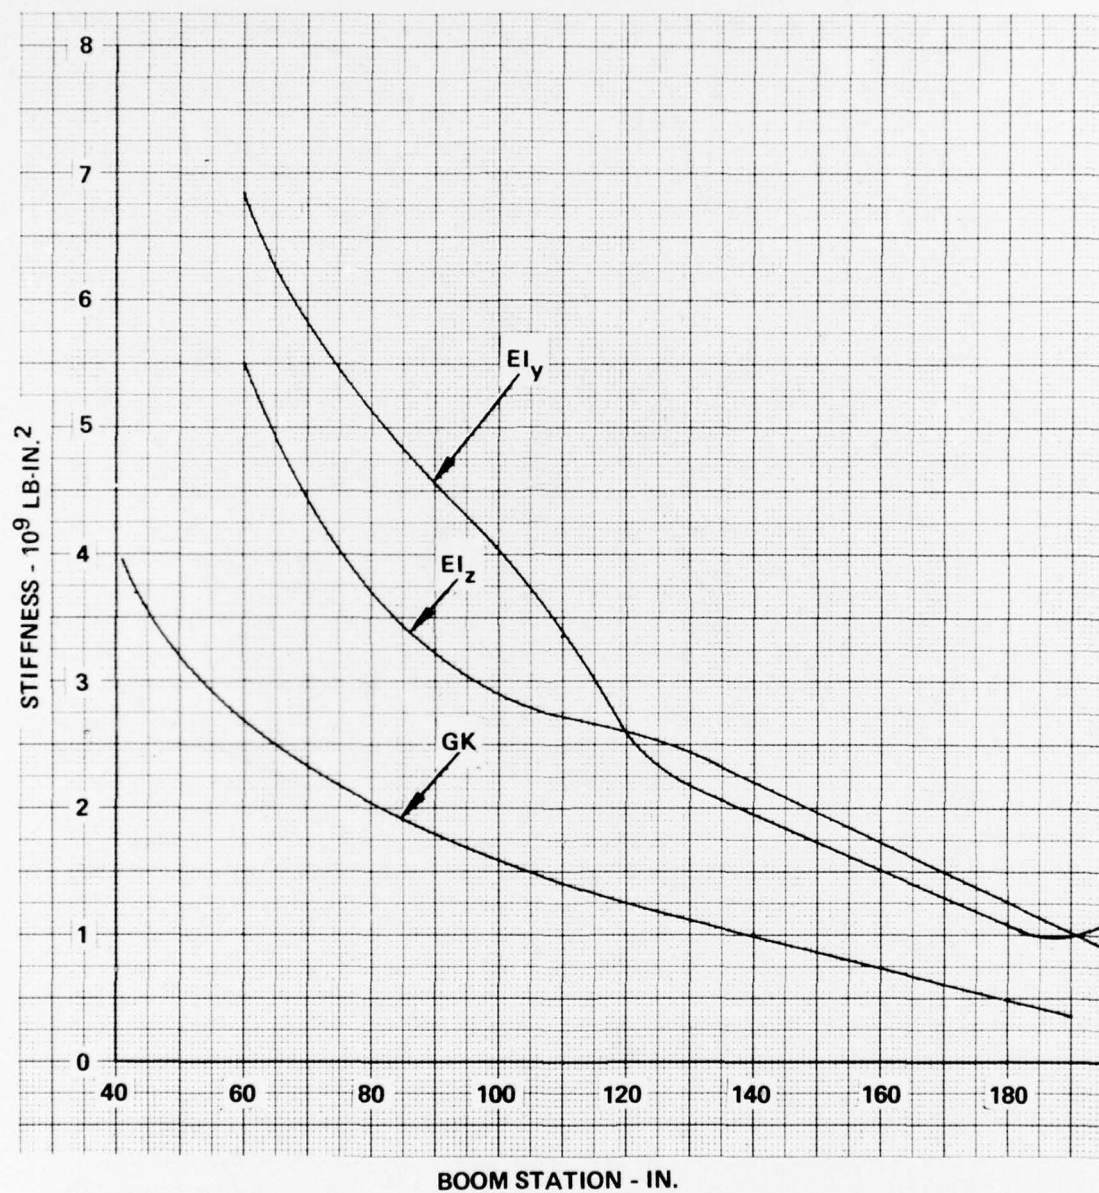
Figure 1. Section Properties for Existing Boom.

The bending and torsional stiffness are taken from Reference 2 for the AH-1G metal tail boom and vertical fin, and are shown in Figures 1 and 2.

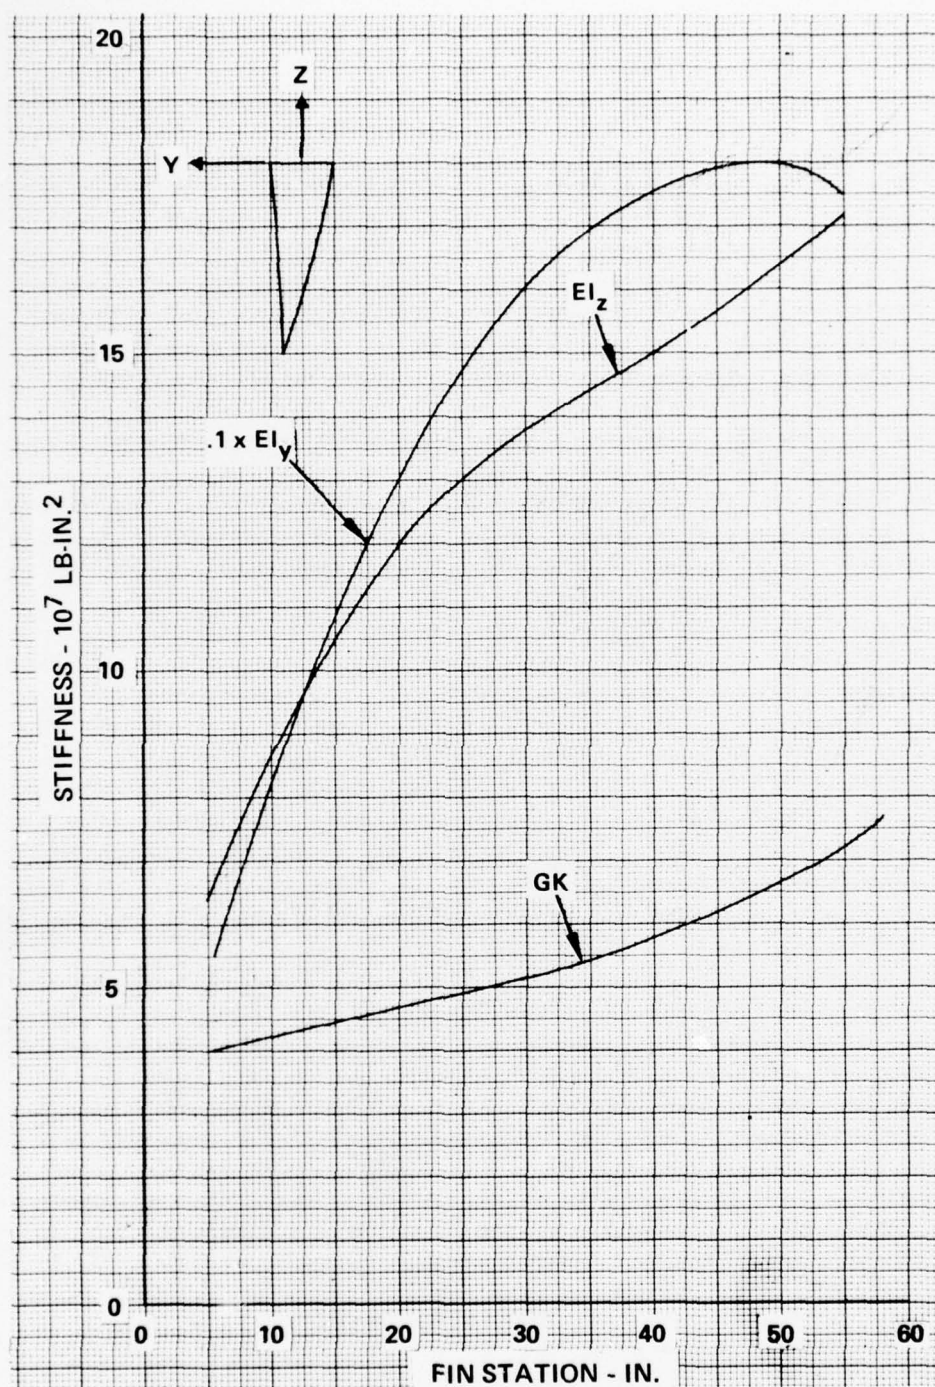
Figure 2. Section Properties for Existing Fin.

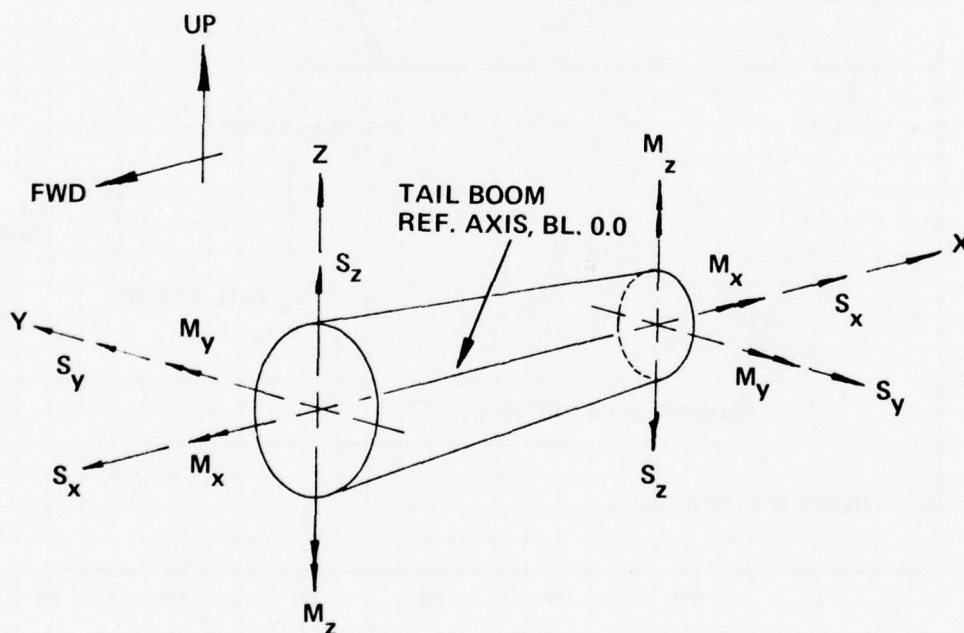
Figure 3. Sign Convention.

The composite tail boom was required to have the strength equivalent to or greater than the standard AH-1G tail boom. Figures 3, 4, and 5 and Tables 1 and 2 (taken from Reference 1) show the sign convention and the maximum design limit loads. Unless otherwise noted, the ultimate loads are 1.5 times that of the limit loads.

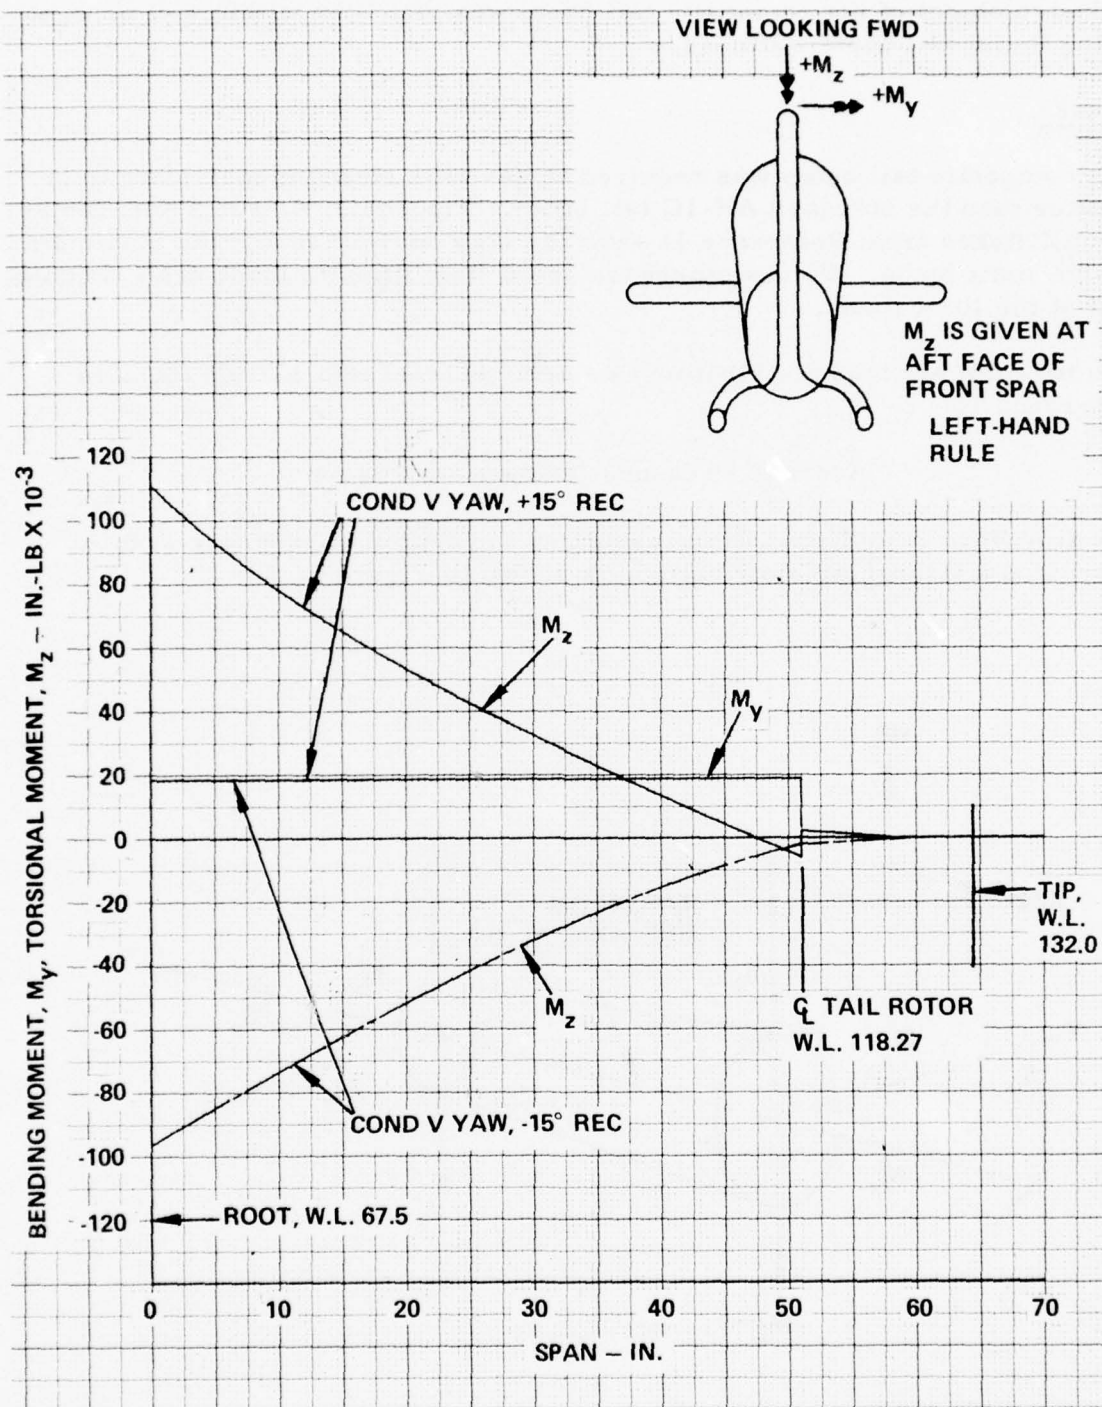
Figure 4. Vertical Fin Chordwise Bending and Torsional Moments.

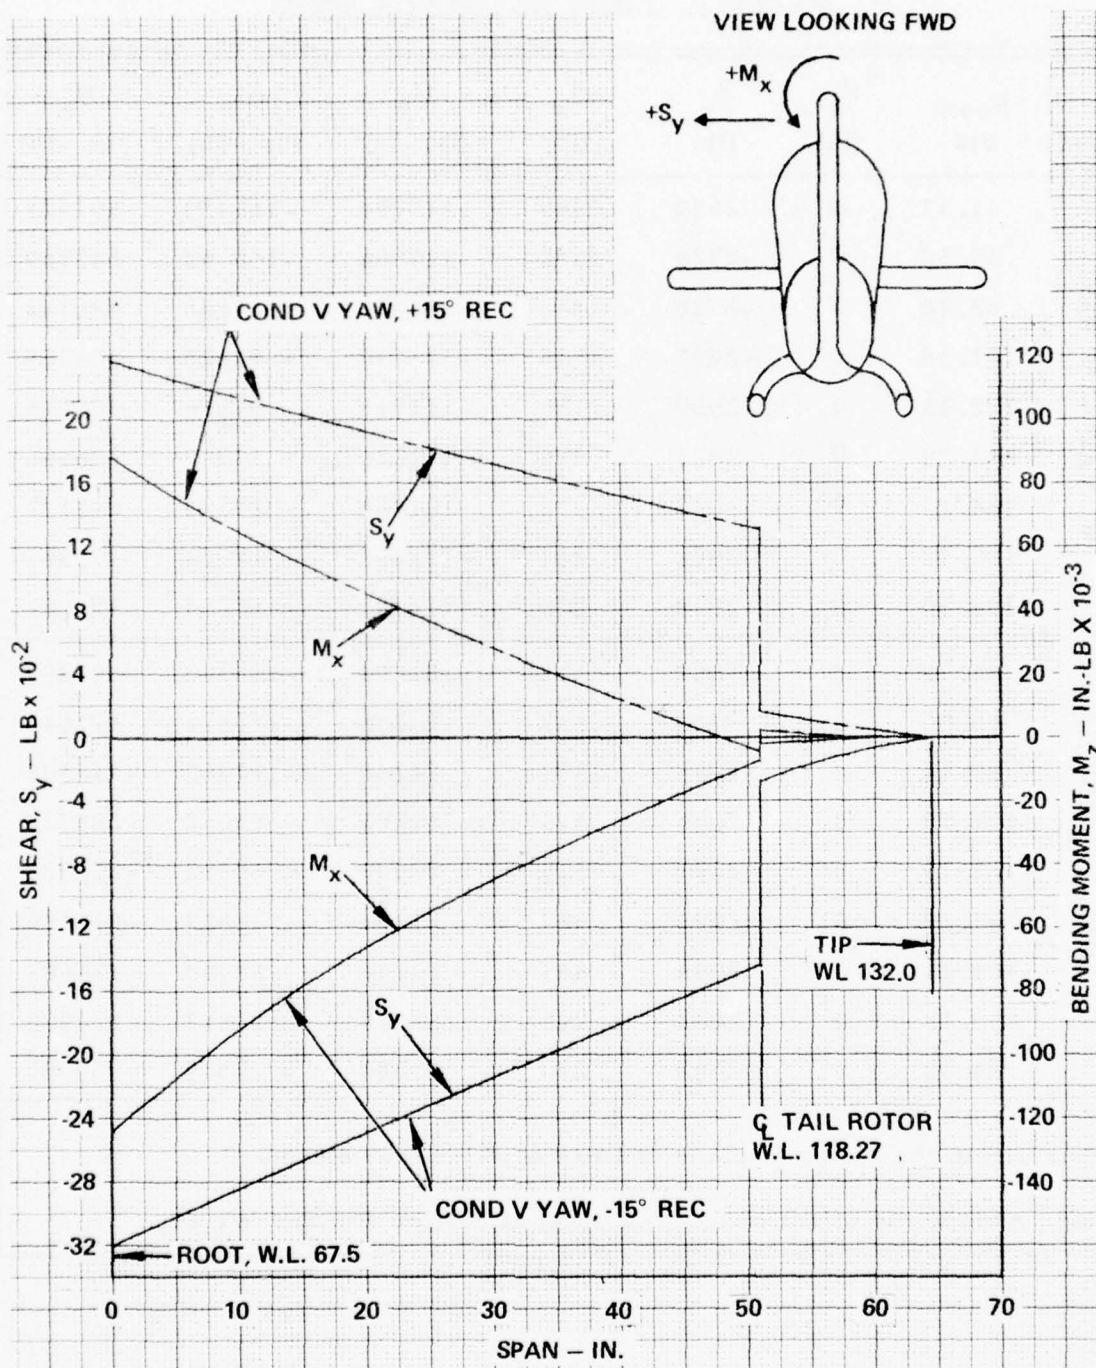
Figure 5. Vertical Fin Spanwise Shear and Bending Moment.

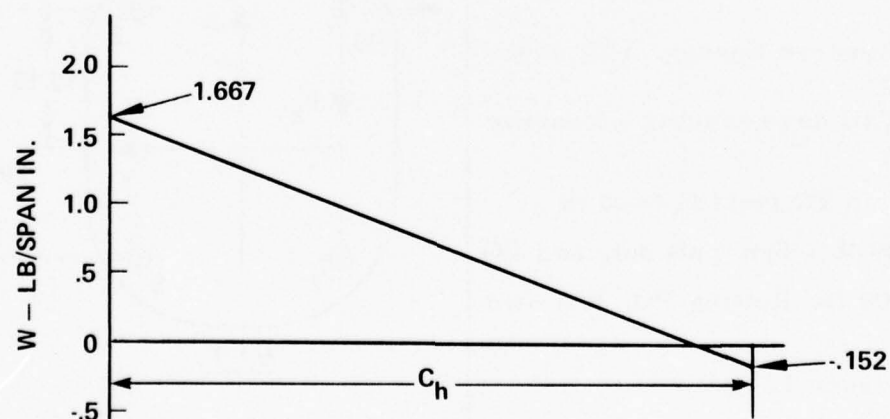
Figure 6. Fin-Chord Load Distribution.

The fin-chord load distribution, assuming the center of pressure at 0.30 chord and a triangular distribution, is shown in Figure 6.

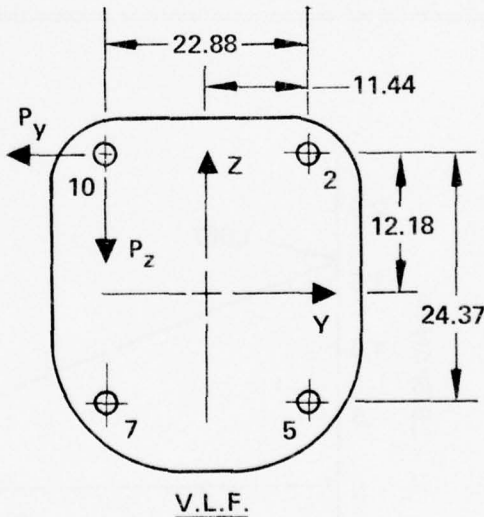
Diagram illustrating the geometry and loading of a rectangular attachment plate (V.L.F.) with four bolts (2, 5, 7, 10). The plate is centered on a coordinate system with Z pointing up, Y pointing right, and Pz pointing down. The dimensions are as follows:

- Horizontal distance between bolt centers: 22.88
- Horizontal distance from center to bolt 2: 11.44
- Vertical distance from center to bolt 5: 12.18
- Vertical distance from center to bolt 10: 24.37

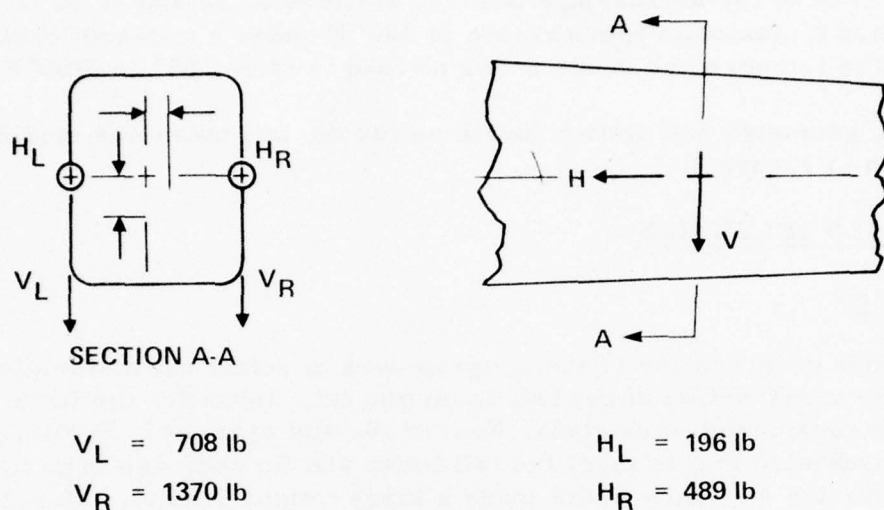
Figure 7. Synchronized Elevator Limit Loads.

The synchronized elevator limit loads taken from Reference 1 are shown in Figure 7. Bell's factor for the ultimate load is 2.25, (Reference 1); this includes a static fatigue factor of 1.5.

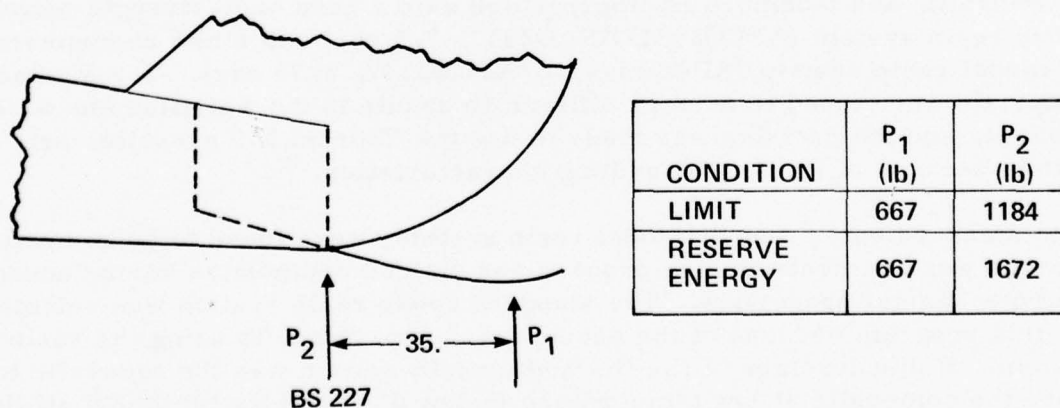
Figure 8. Tail Bumper Limit Loads.

The tail bumper limit loads are shown in Figure 8.

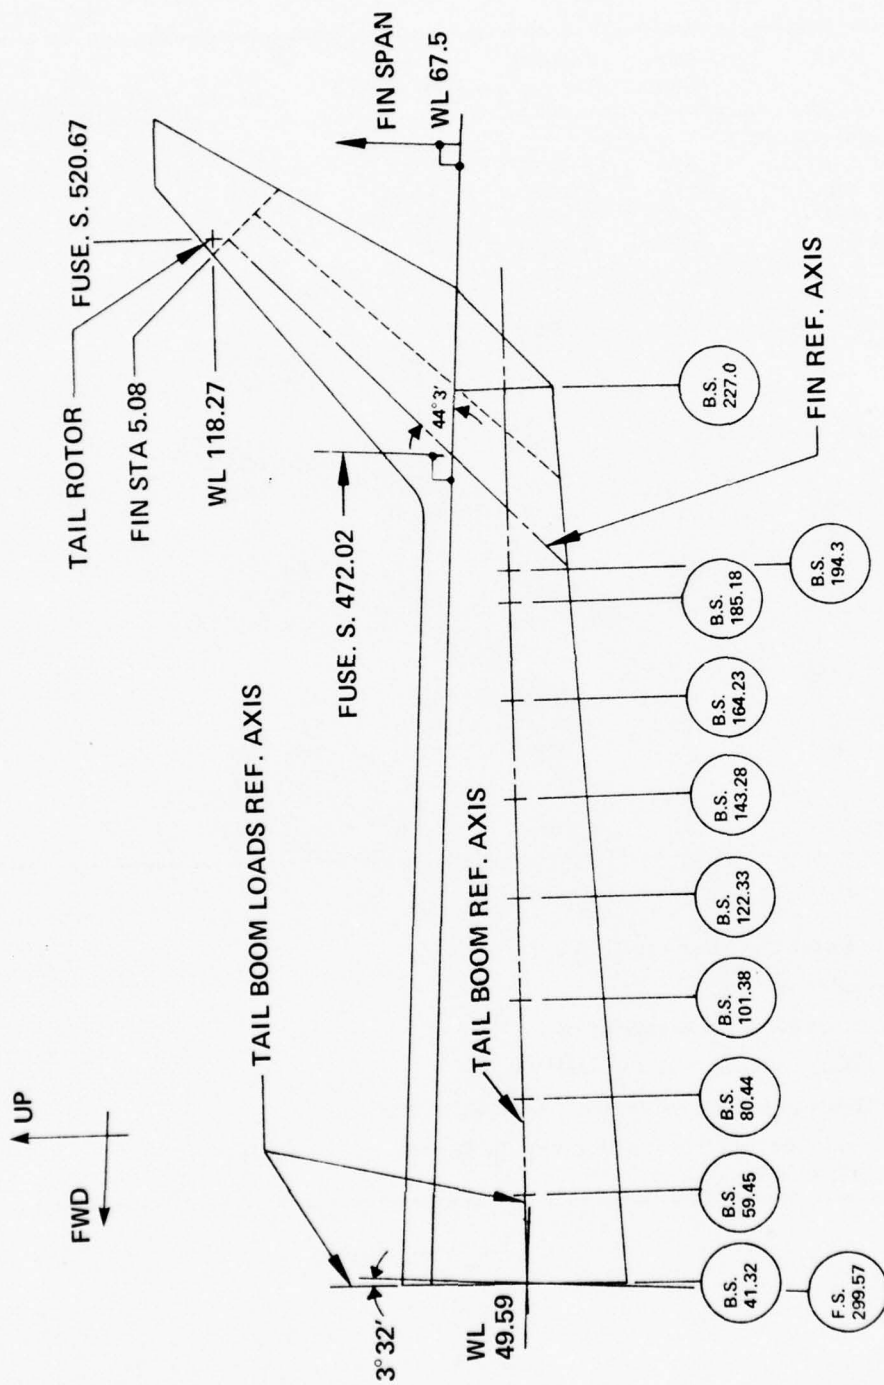
Figure 9. Geometry and Station Locations, Tail Boom and Vertical Fin.

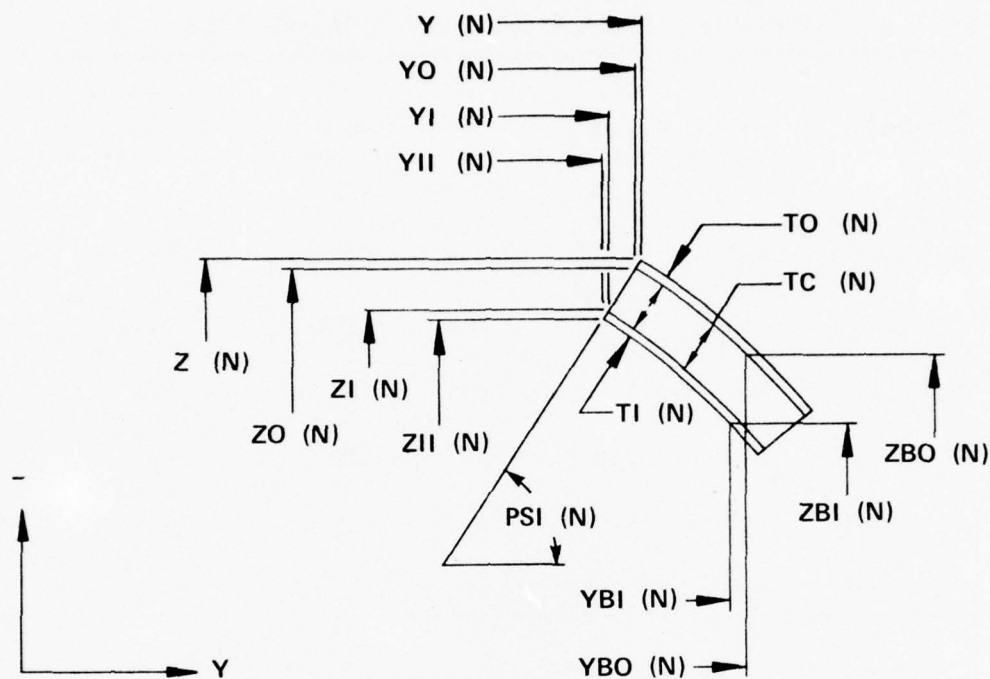
Figure 10. Computer Program "SECPRO" Nomenclature.

A computer program was developed to calculate the tail boom bending and torsional stiffnesses for sandwich wall configurations. The program was developed by Fiber Science, Inc. (FSI) and is entitled "SECPRO." The program nomenclature is shown in Figure 10, and a typical program run is included as Appendix A.

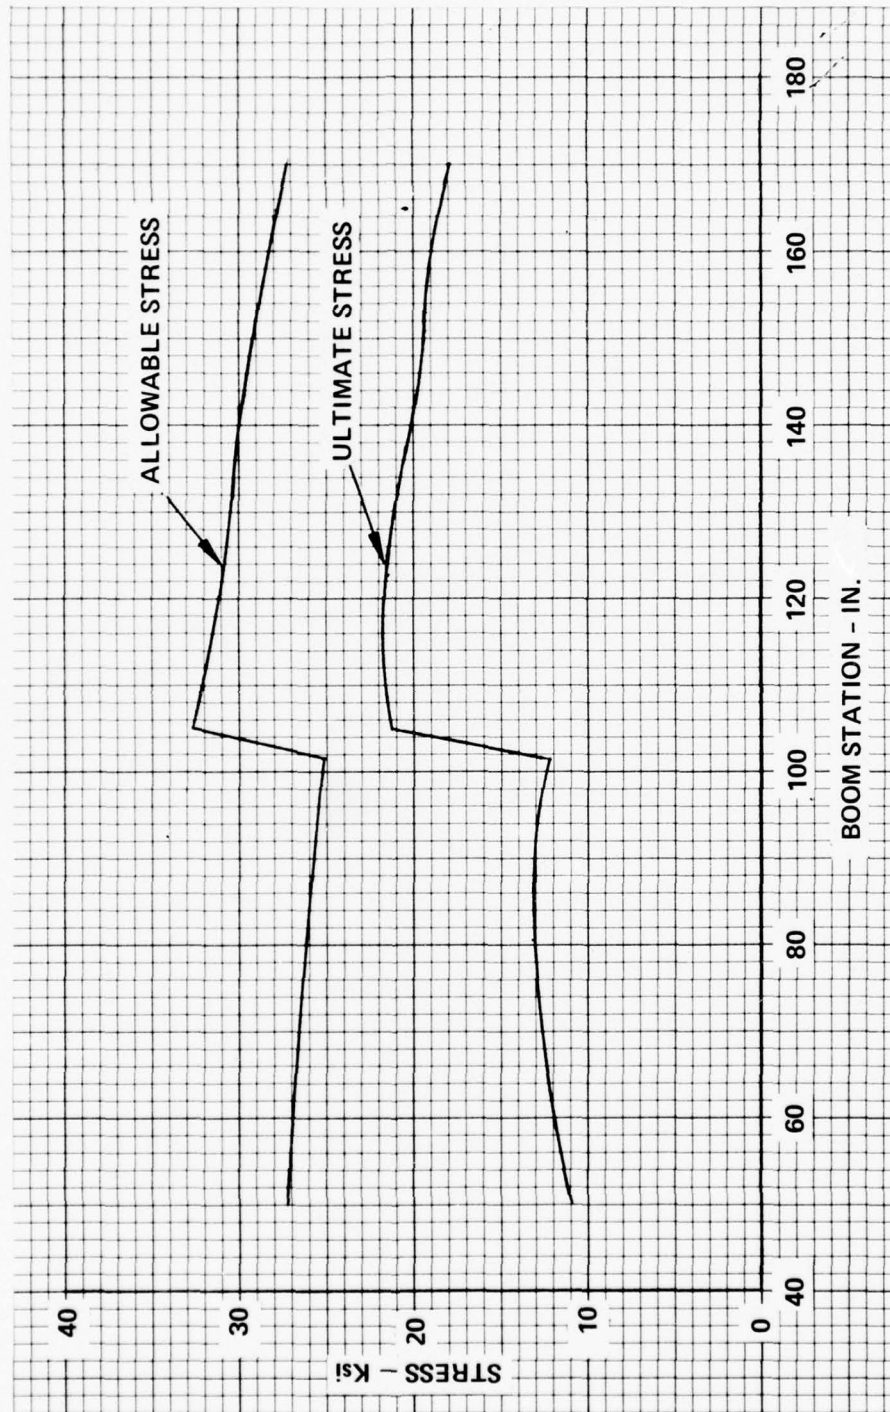
Figure 11. Comparison of Ultimate Compressive Stress to Allowable Stress - Outer Skin.

A computer program (Reference 7) was developed to determine the allowable compression and shear buckling stresses for various combinations of skins and cores. The computer program was based on the equations given in Reference 4. Figure 13 shows the notations for a sandwich composite.

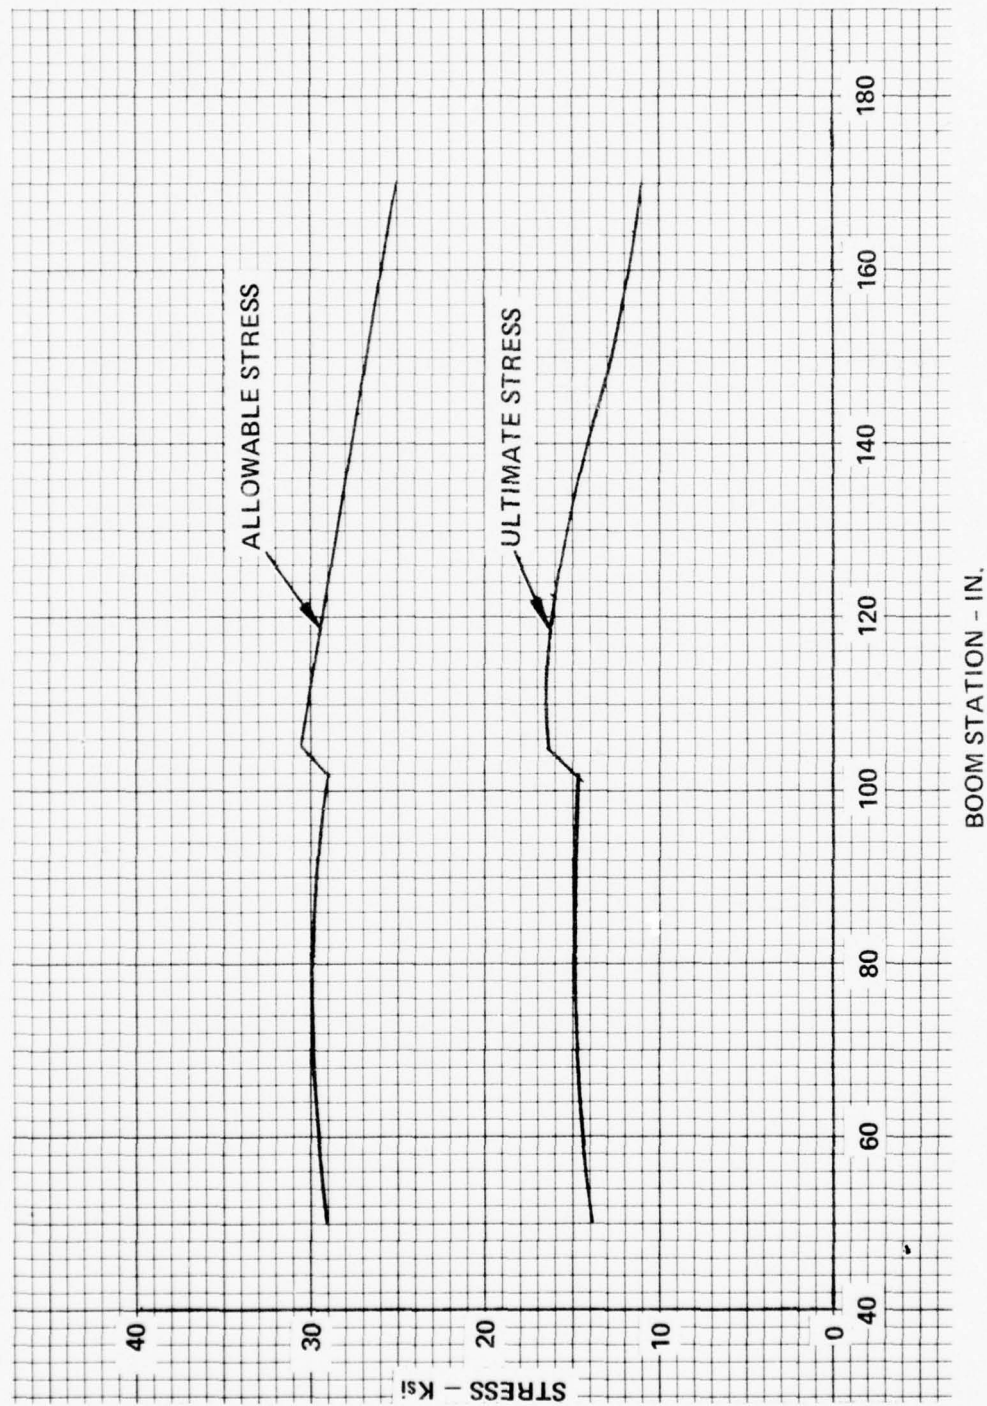
Figure 12. Comparison of Ultimate Compressive Stress to Allowable Stress - Inner Skin.

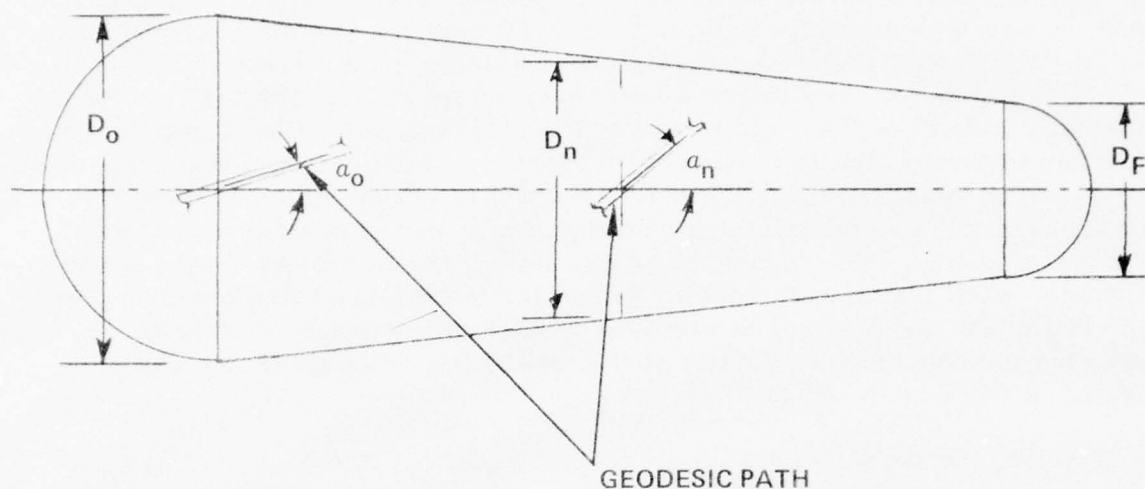
BASIC EQUATION
$$a_n = \sin^{-1} \left[\left(\frac{D_o}{D_n} \right) \sin a_o \right]$$

Figure 14. Geodesic Path.

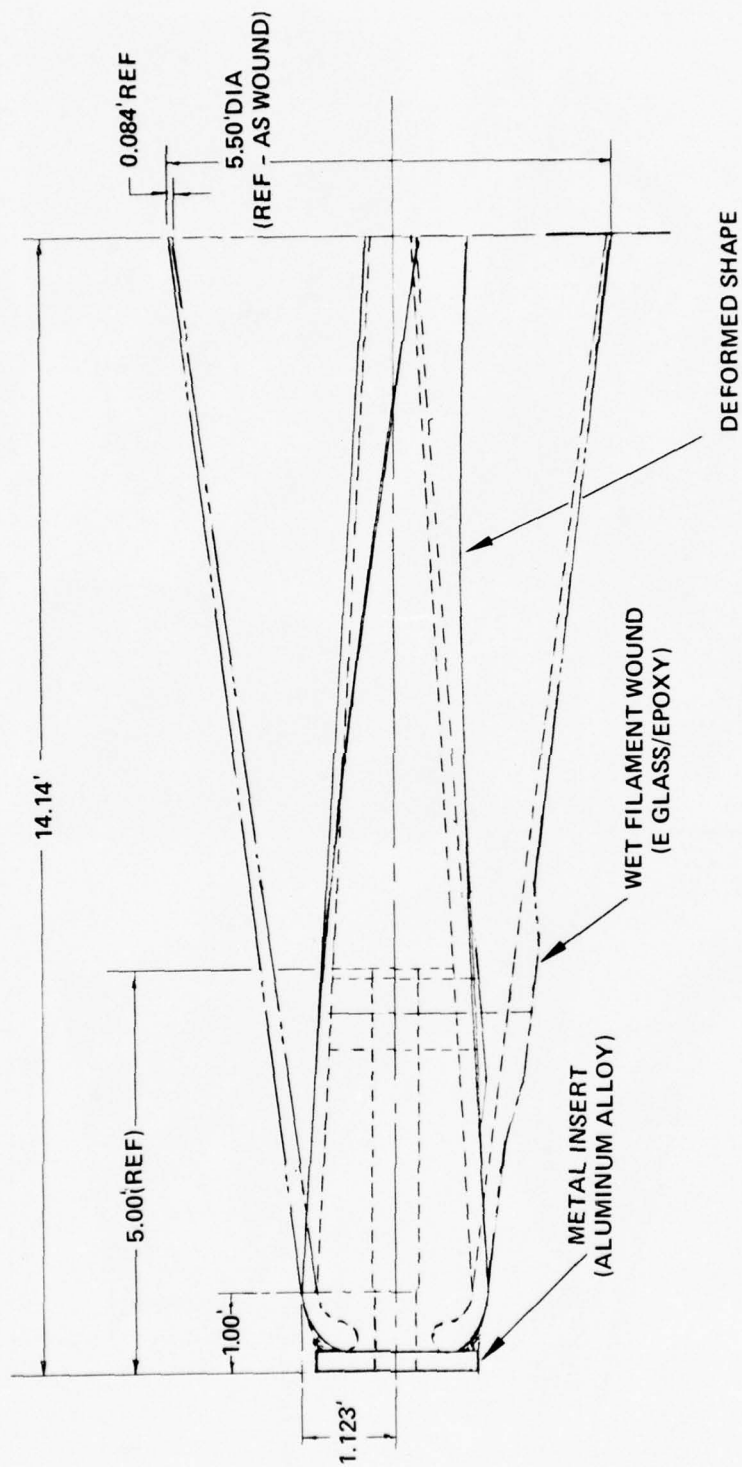
Figure 15. Forward Attachment Fitting.

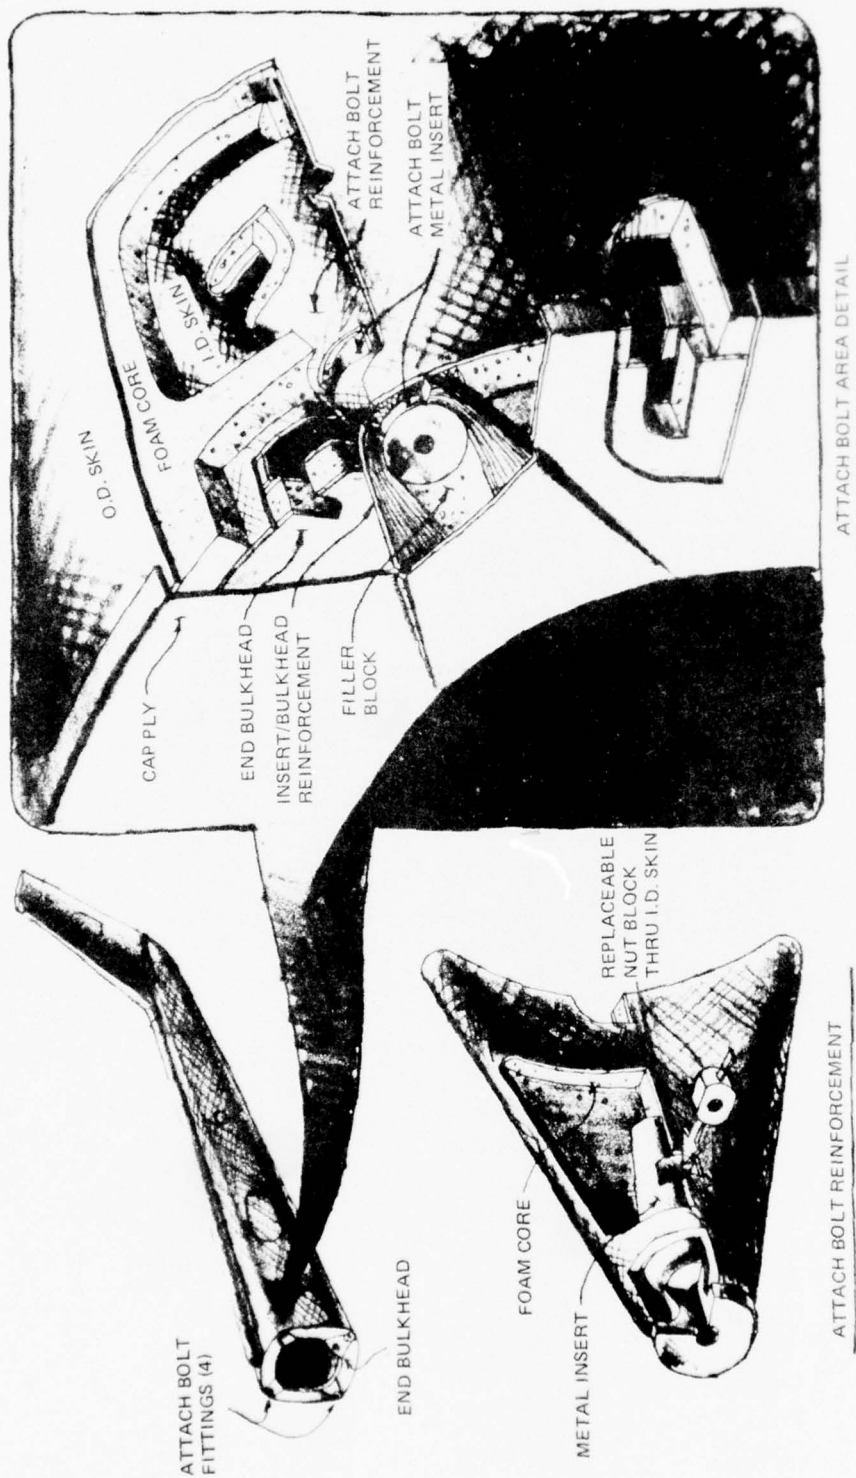
Figure 16. Composite Tail Boom Forward Attachment Assembly.

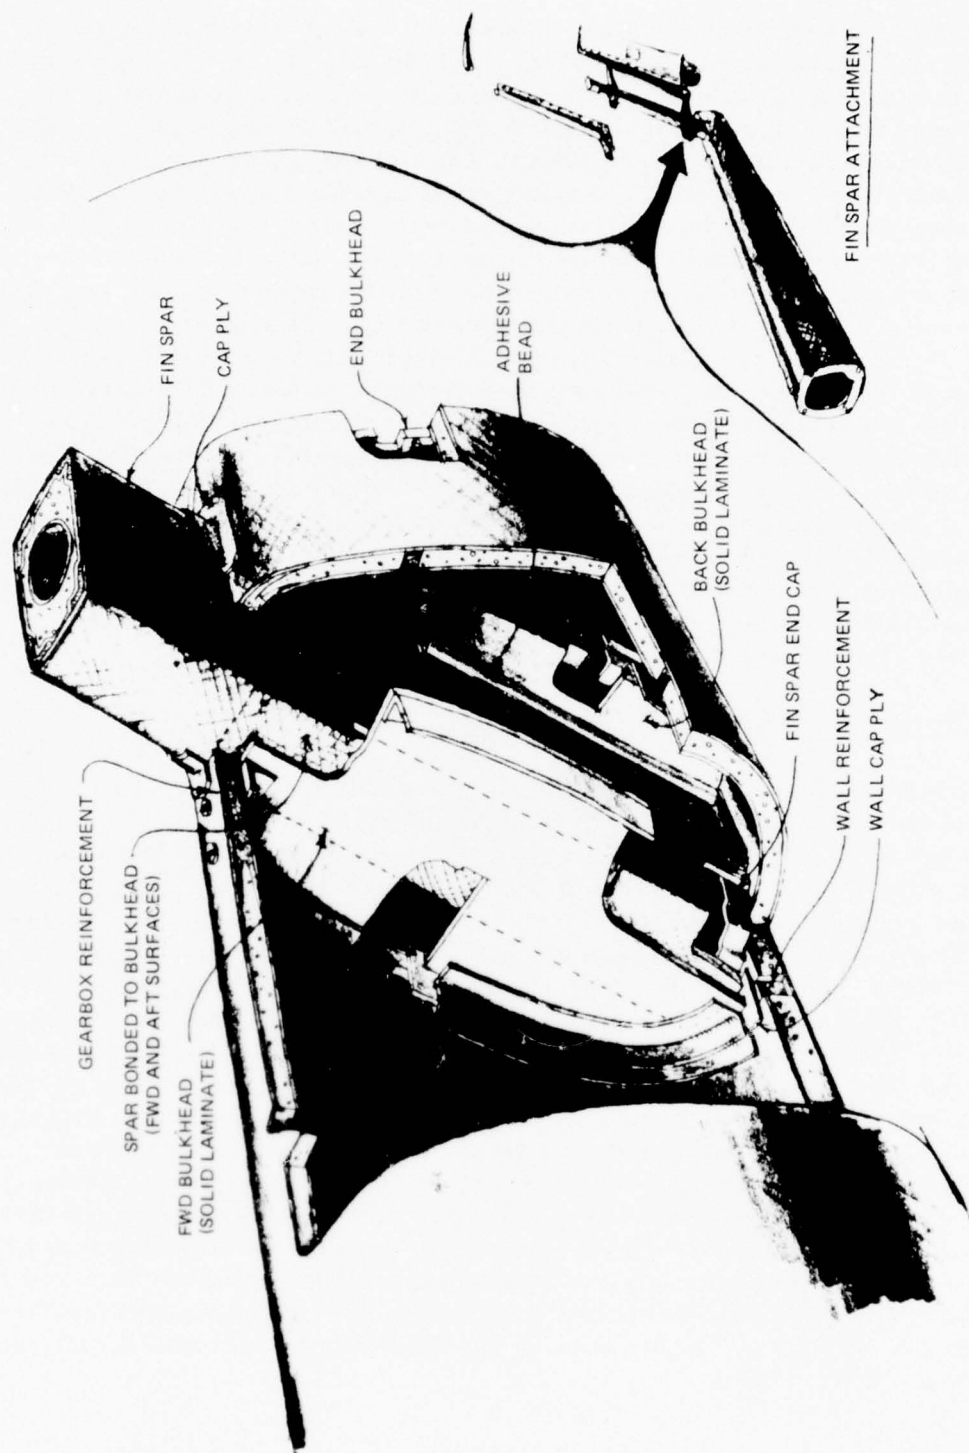
Figure 17. Composite Tail Boom Fin Spar to Boom Assembly.

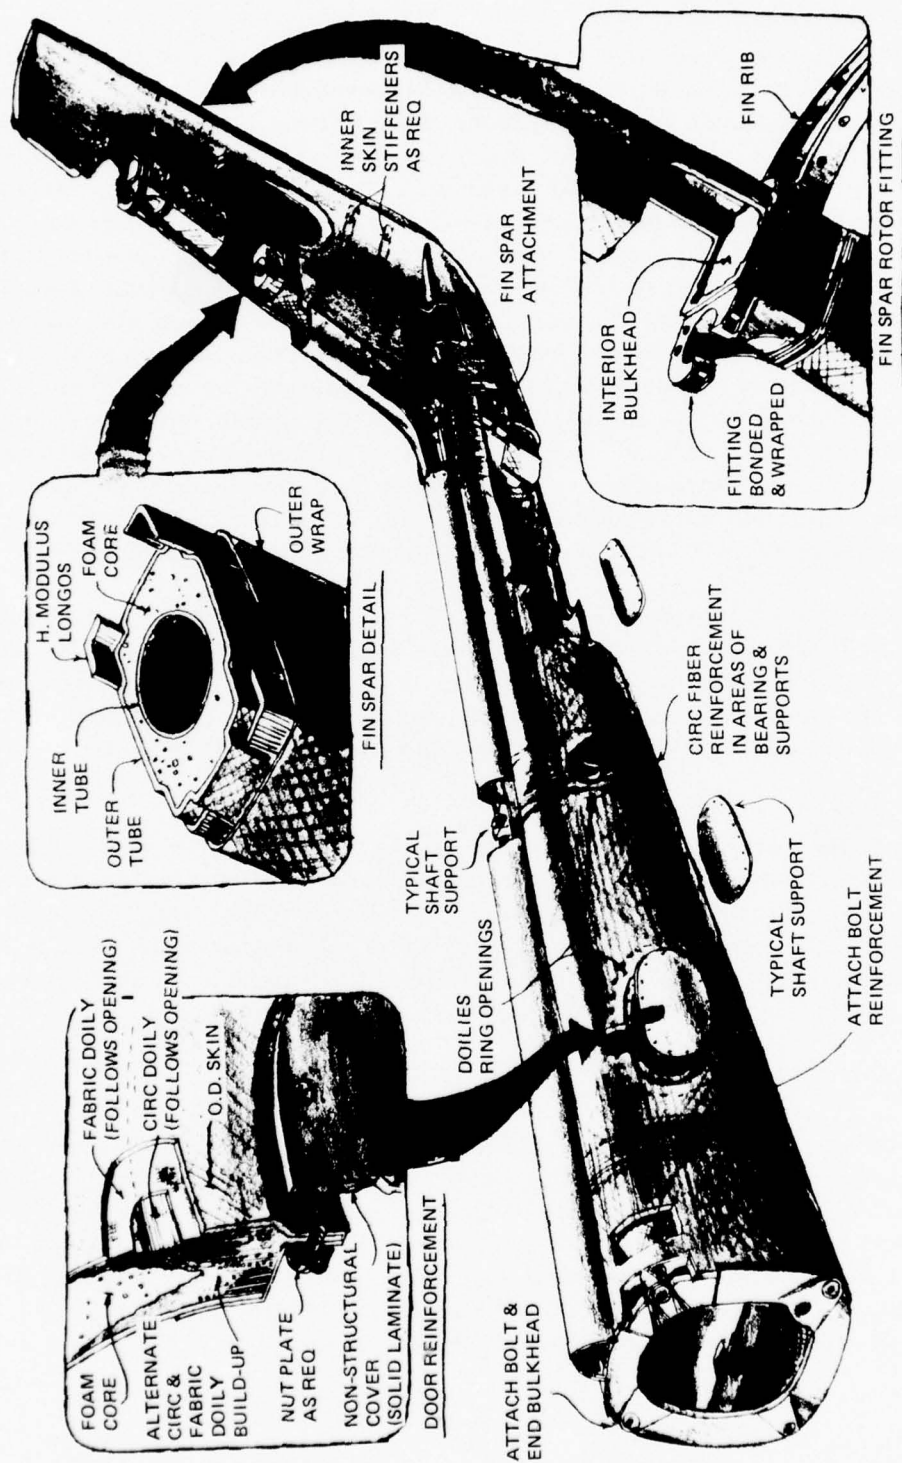
Figure 18. Composite Tail Boom Assembly.

The initial spar configuration selected for fabrication has an approximate trapezoidal cross section. The skin consists of three wraps of ± 30 -degree orientated graphite fibers (Thornel 300), with the thickness varying from 0.054 inch thick at Fin Station 70 to 0.065 inch thick at Fin Station 5.08. Four corner angles composed of unidirectional graphite fibers were added to meet overall strength and stiffness requirements. The corner graphite thickness varies from 0.016 inch thick at Fin Station 5.06 to 0.134 inch thick at Fin Station 70. The skin with added corner fibers was cured in a female mold at elevated temperature and pressure. A rigid foam (polystyrene) and an inner tube of S-glass fibers were added to the inside of the skin to create a sandwich construction; the fibers were ± 45 degrees and 0.010 inch thick. The purpose of the foam and inner tube was to stabilize the spar skin and corner angles for compression and shear loads, thereby obtaining the maximum strength of the graphite fibers. The spar was then to be wrapped circumferentially with one ply of glass fiber. The purpose of the wrap was to prevent peeling of the corner unidirectional graphite fibers and to improve the bonding to the fin skins and tail boom bulkheads. The fin spar construction is illustrated in Figure 18; also shown in the figure are additional details of the tail boom construction.

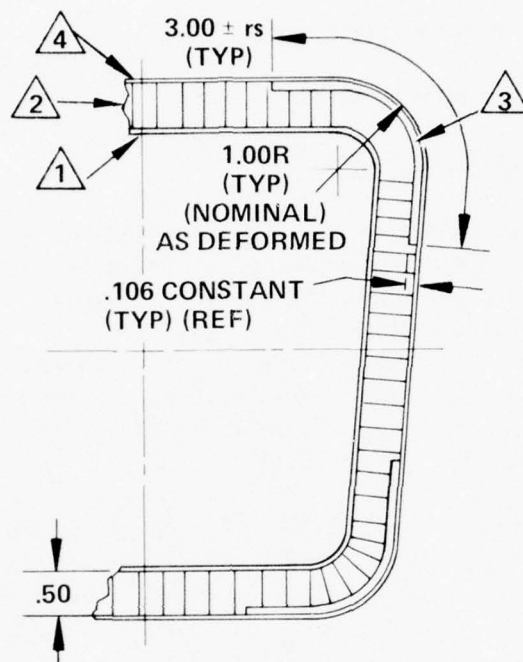
- ① Inner skin consists of one helical layer at $\alpha = \pm 45^\circ$ and one circumferential ply.
- ② Core is Nomex honeycomb (HRH 10/0X-3/16-3.0)
- ③ Corner angles are unidirectional graphite fibers. (longos)
- ④ Outer skin consists of two helical layers at $\alpha = \pm 45^\circ$ and one circumferential ply.
- ⑤ Skins and longo material is Thornel 300 graphite and epoxy resin. Fiber volume is 50 percent.

The forward bulkhead is trimmed to fit the inner skin mold line and metal inserts of the attachment fittings. Aluminum plates are added at each attachment fitting to distribute shear loads to the bulkhead. The bulkhead is bonded to the tail boom inner and outer skins with plies of 181 fiberglass and APCO 2450/2340 adhesive.

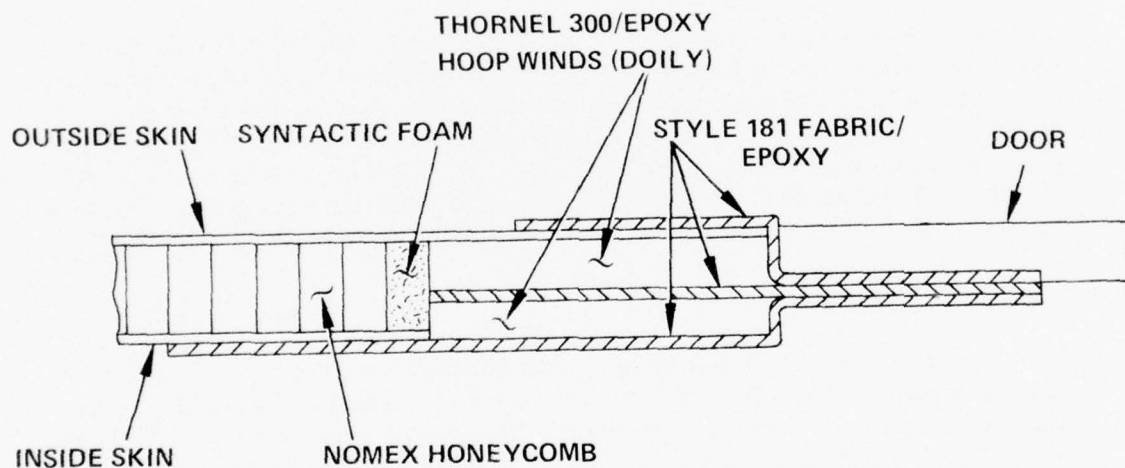
Figure 22. Typical Reinforcement Doily.

All doors were designed to be nonstructural, and the openings were reinforced by replacing the sandwich-wall core material with a combination of graphite fibers and glass fabric (Figure 22). The forward attachment fittings were designed around a manufacturing process of winding the conical shells that are configured in a mold while in the uncured condition. These configured, wound fittings replaced the sandwich-wall core material locally and were bonded to the inner and outer faces over a large area.

The method of assembling the doilies consists of trimming back the inner skin and honeycomb to accept the doilies. Two doilies are fabricated for each opening and are installed with three plies of 181 fiberglass between the doilies. The overall thickness of the doilies and 181 fiberglass is equal to the thickness of the Nomex honeycomb core plus the inner skin. The honeycomb around the cutout is cleaned and filled with a syntactic foam consisting of a thixotropic mixture of APCO 2434/2340/glass microballoons to provide uniform transition from the doilies to the honeycomb. Three plies of 181 fiberglass are added that cover the doilies and extend over the inner and outer boom skins. The opening reinforcement is vacuum bagged and allowed to gel at room temperature.

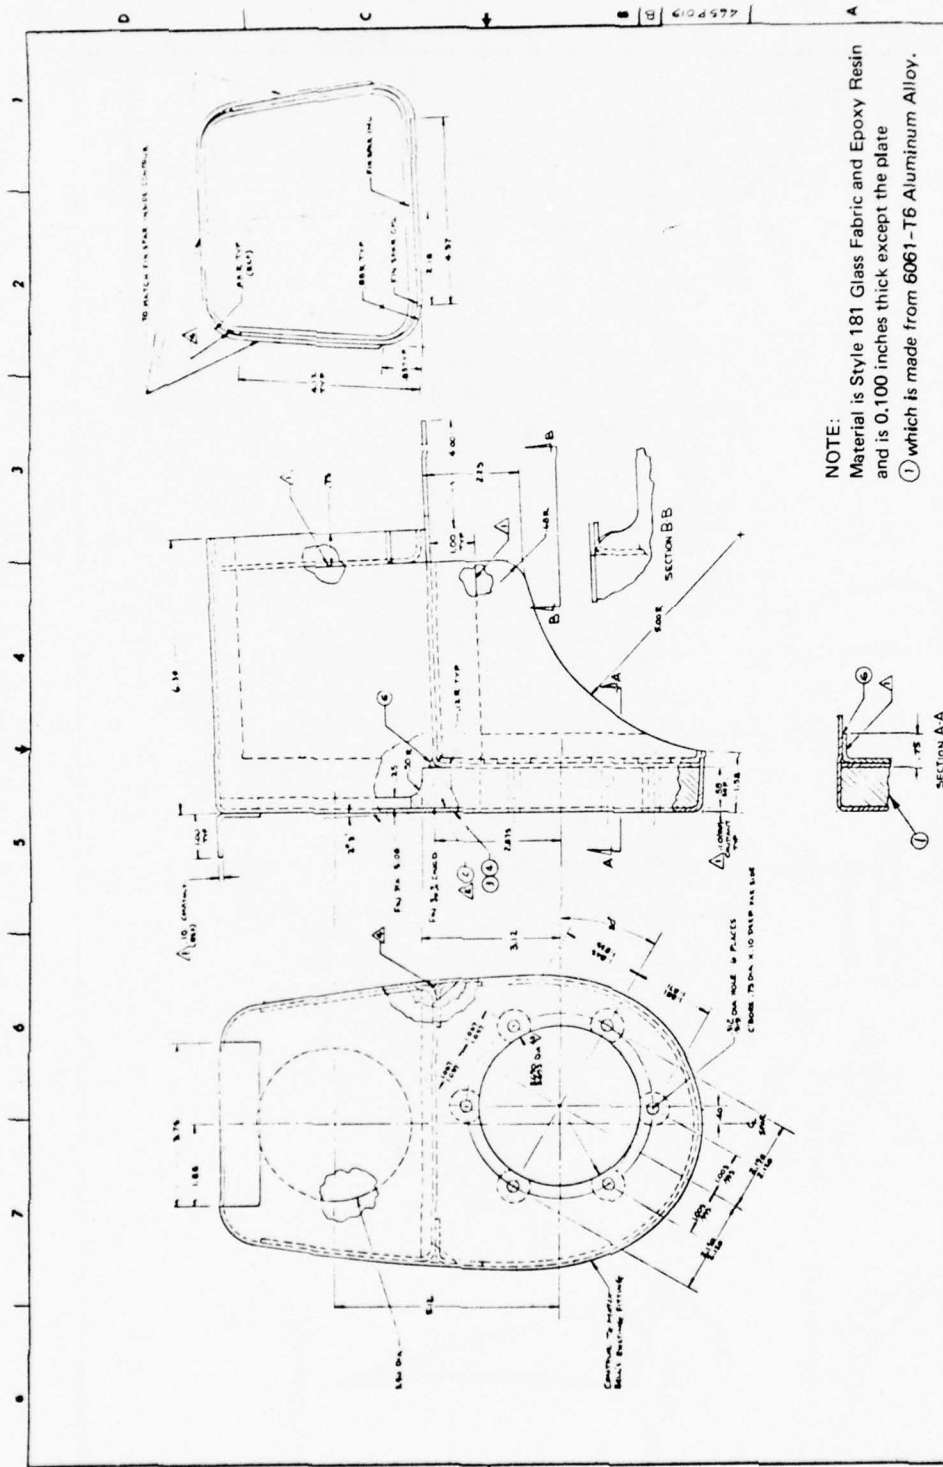
Figure 23. Tail Rotor Gearbox Mounting Bracket.
