DESIGN, FABRICATION, AND TESTING OF AN ADVANCED
COMPOSITE AH-1G TAIL SECTION (TAIL BOOM/VERTICAL FIN)

Hughes Helicopters, Division of Summa Corp.
Centinela and Teale Streets
Culver City, Calif. 90230

November 1976

Final Report for Period July 1973 - February 1976

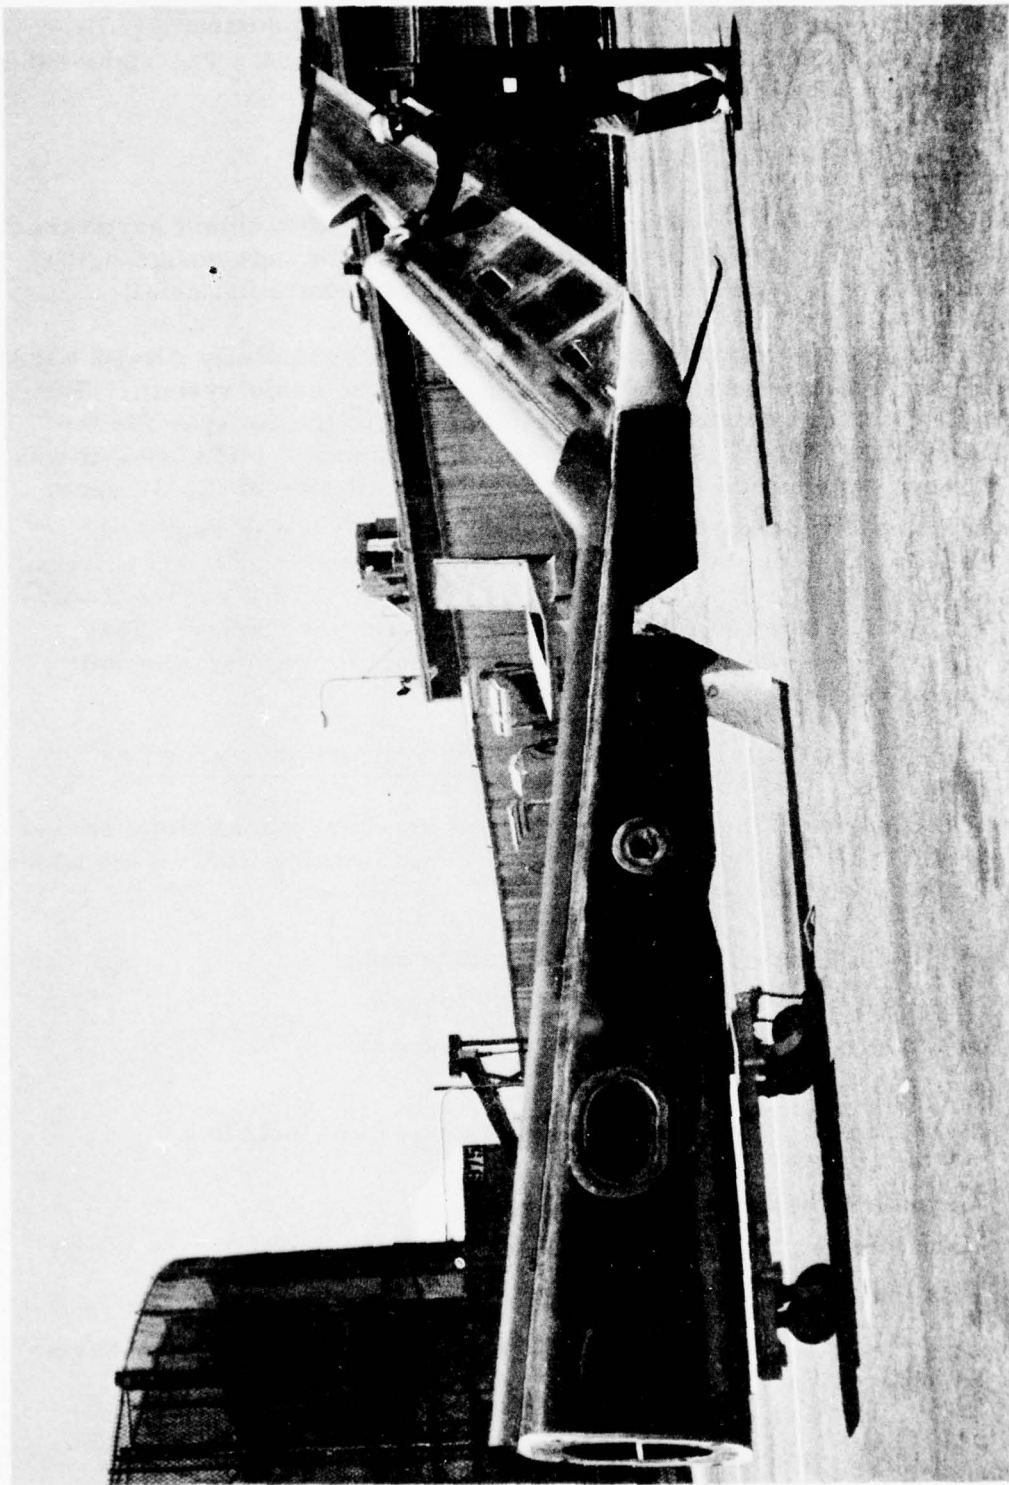
Figure 25. Flight Test Tail Section

The fabricated flight test tail section is shown in Figure 25, and the design details are shown in Figures 26 and 27.

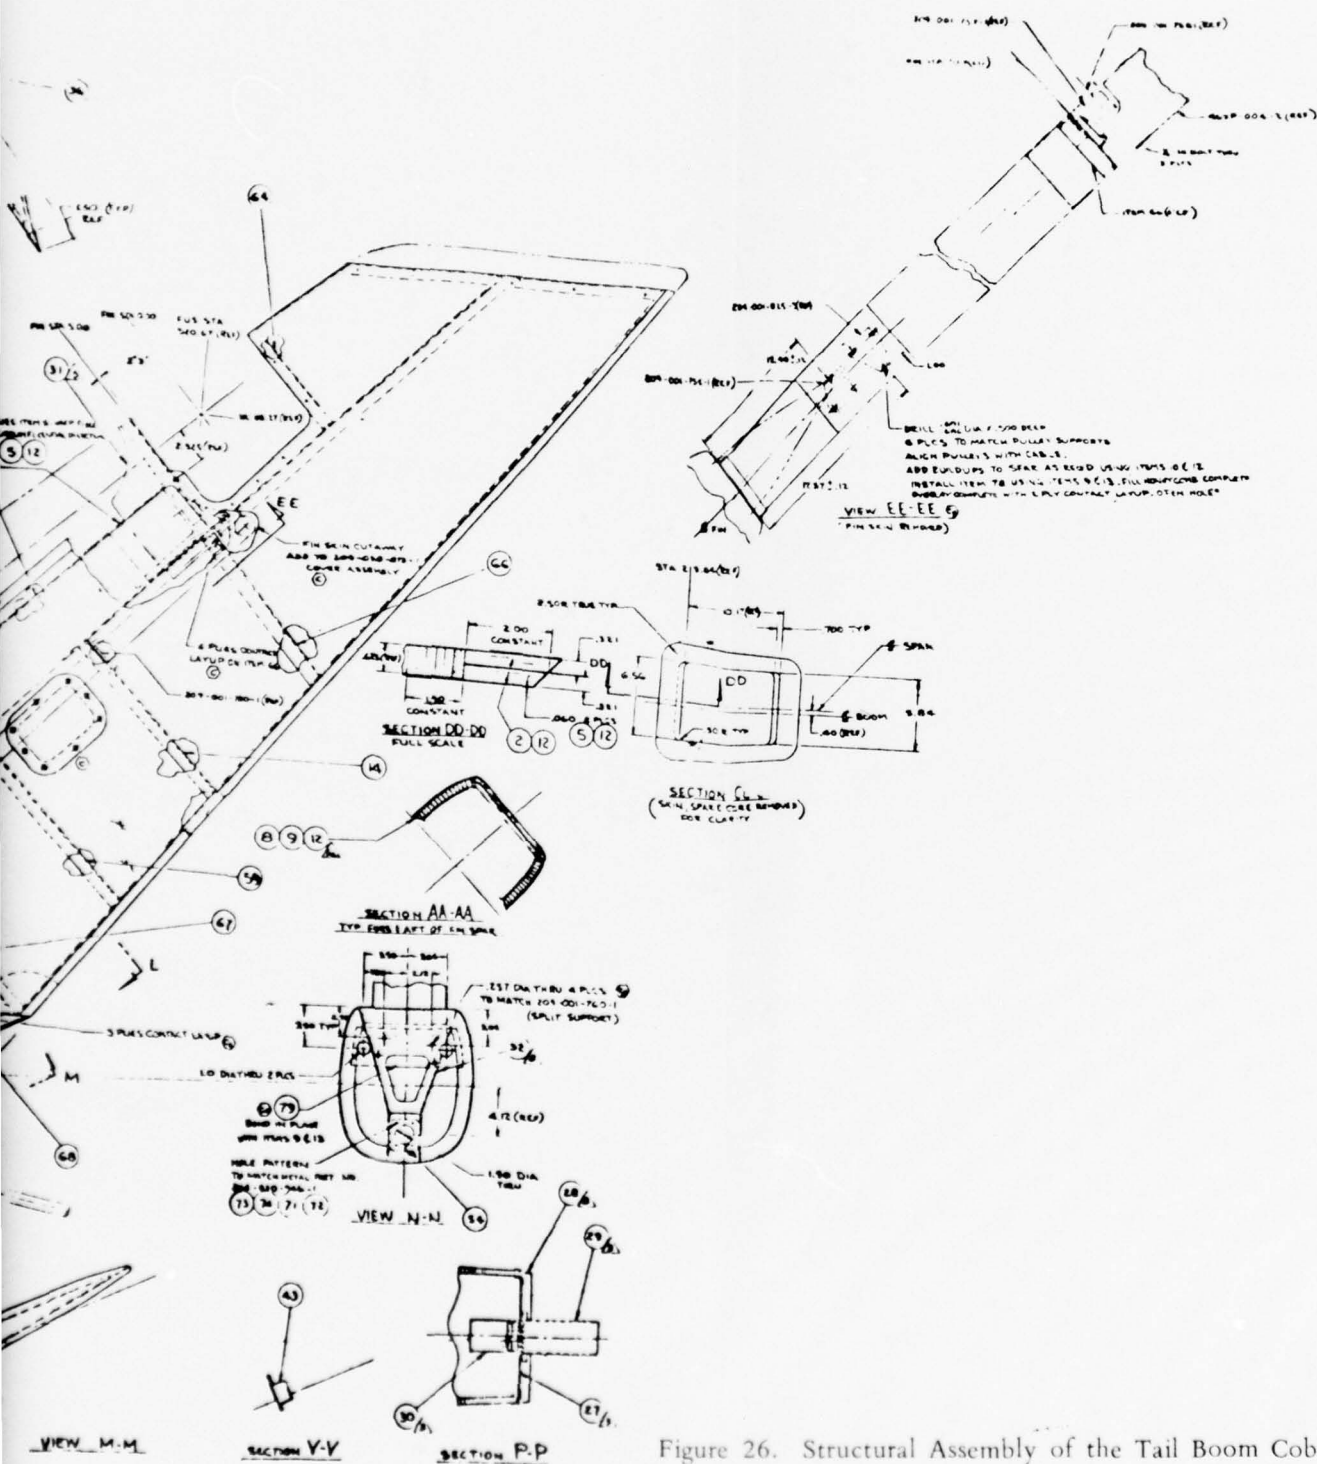
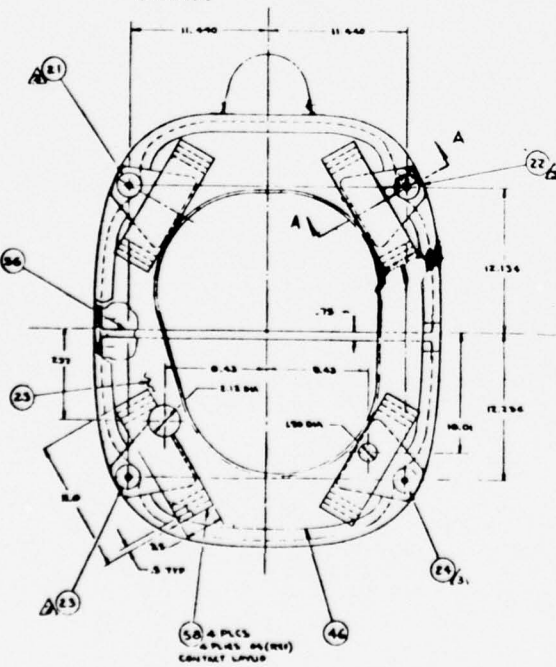
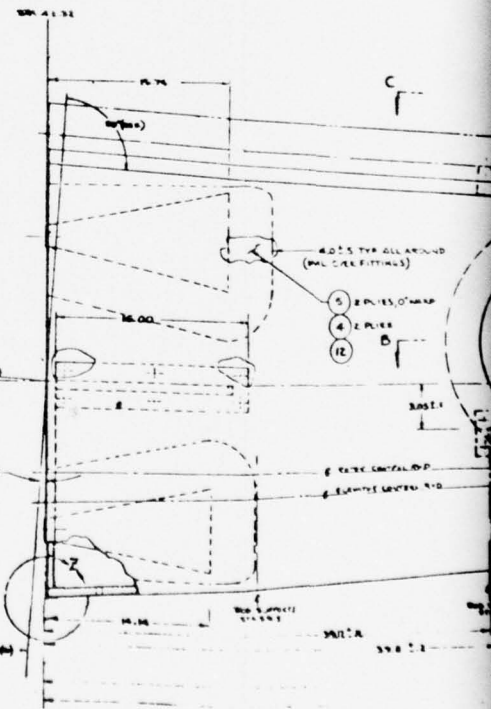
Figure 26. Structural Assembly of the Tail Boom Cobra AH-1G.

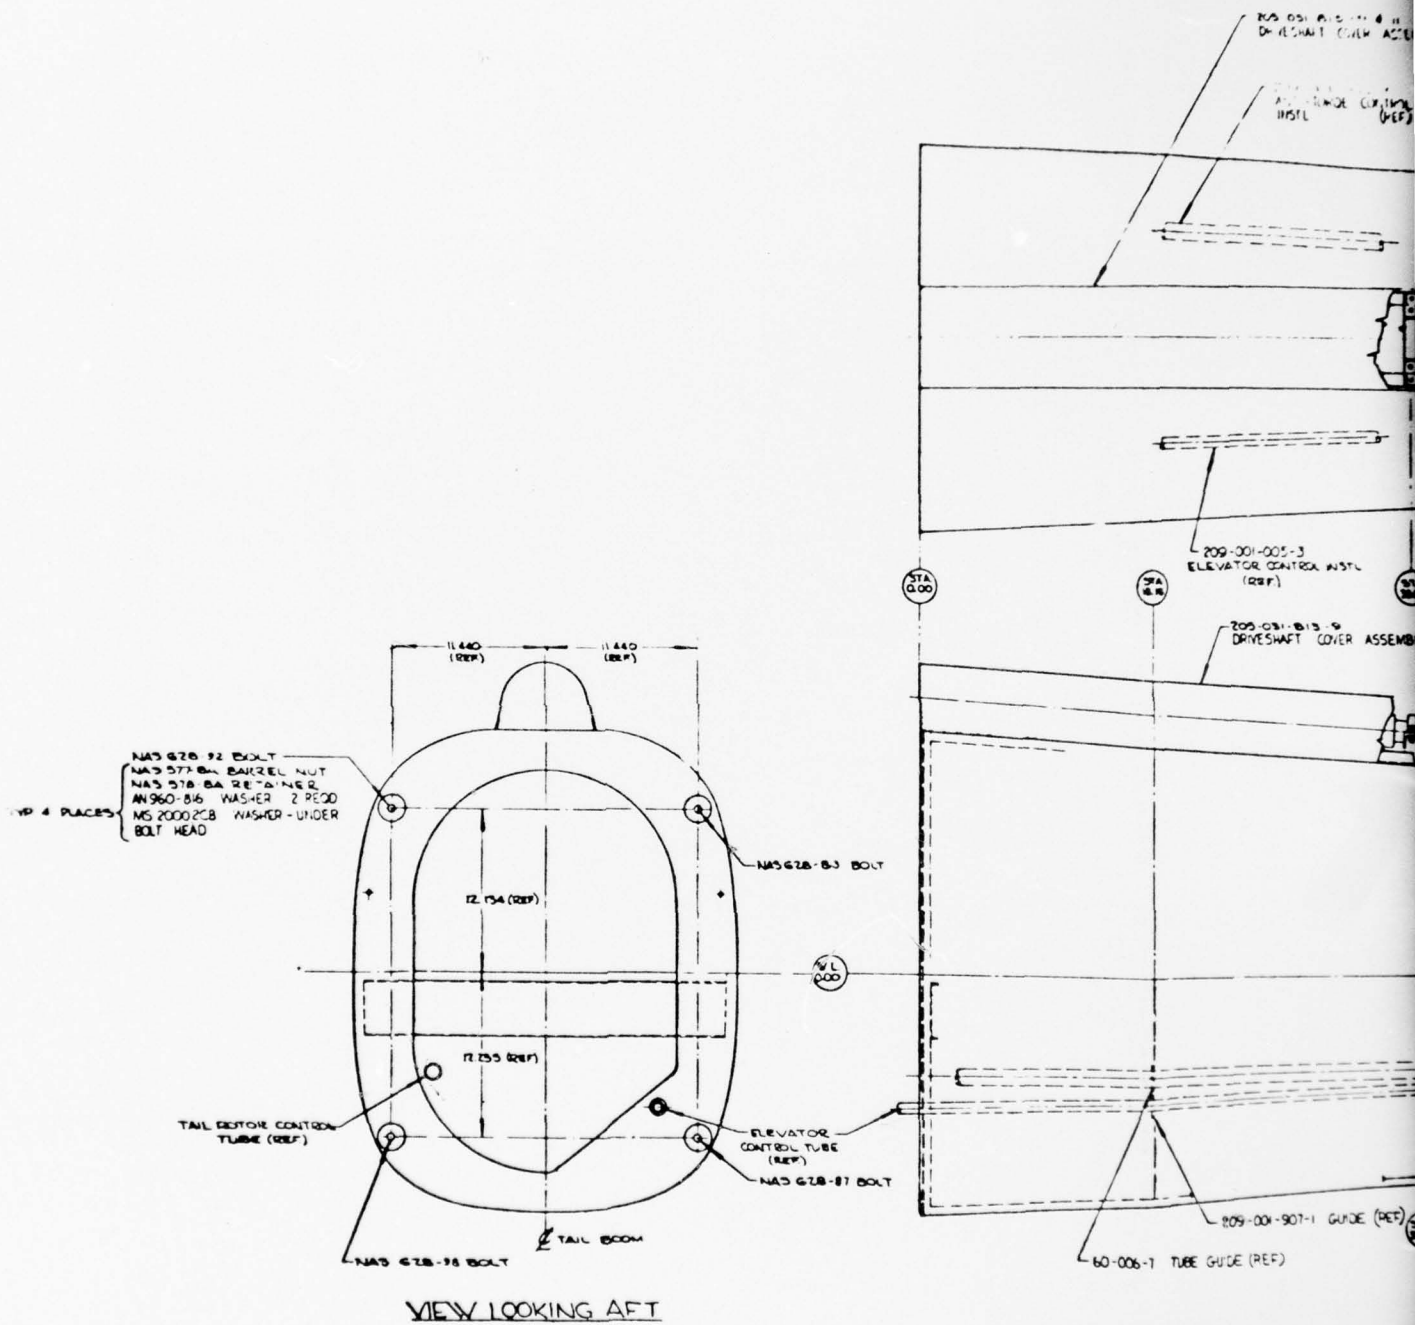
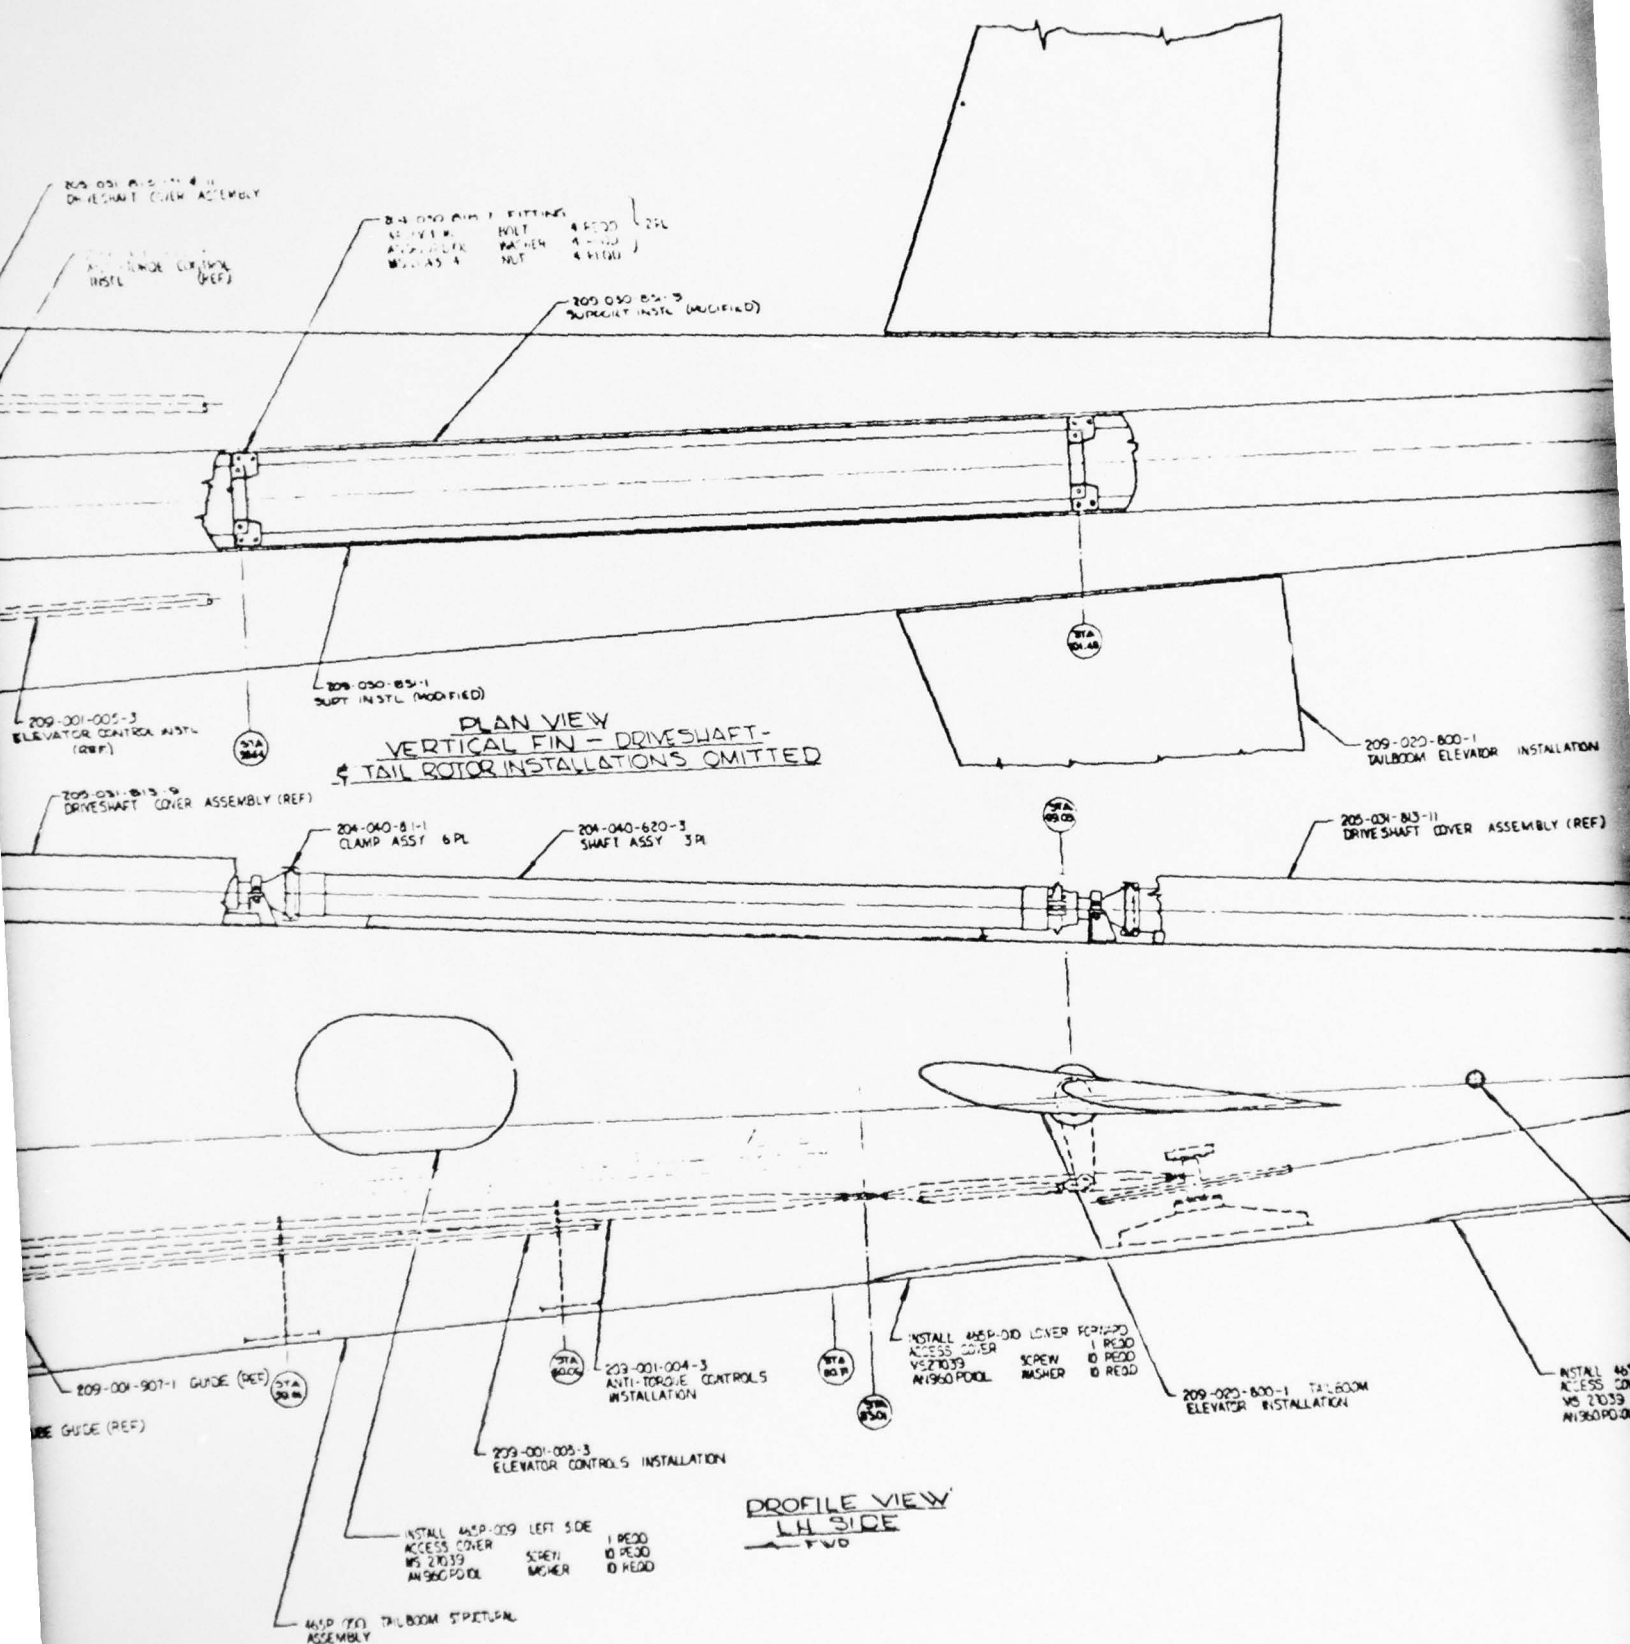
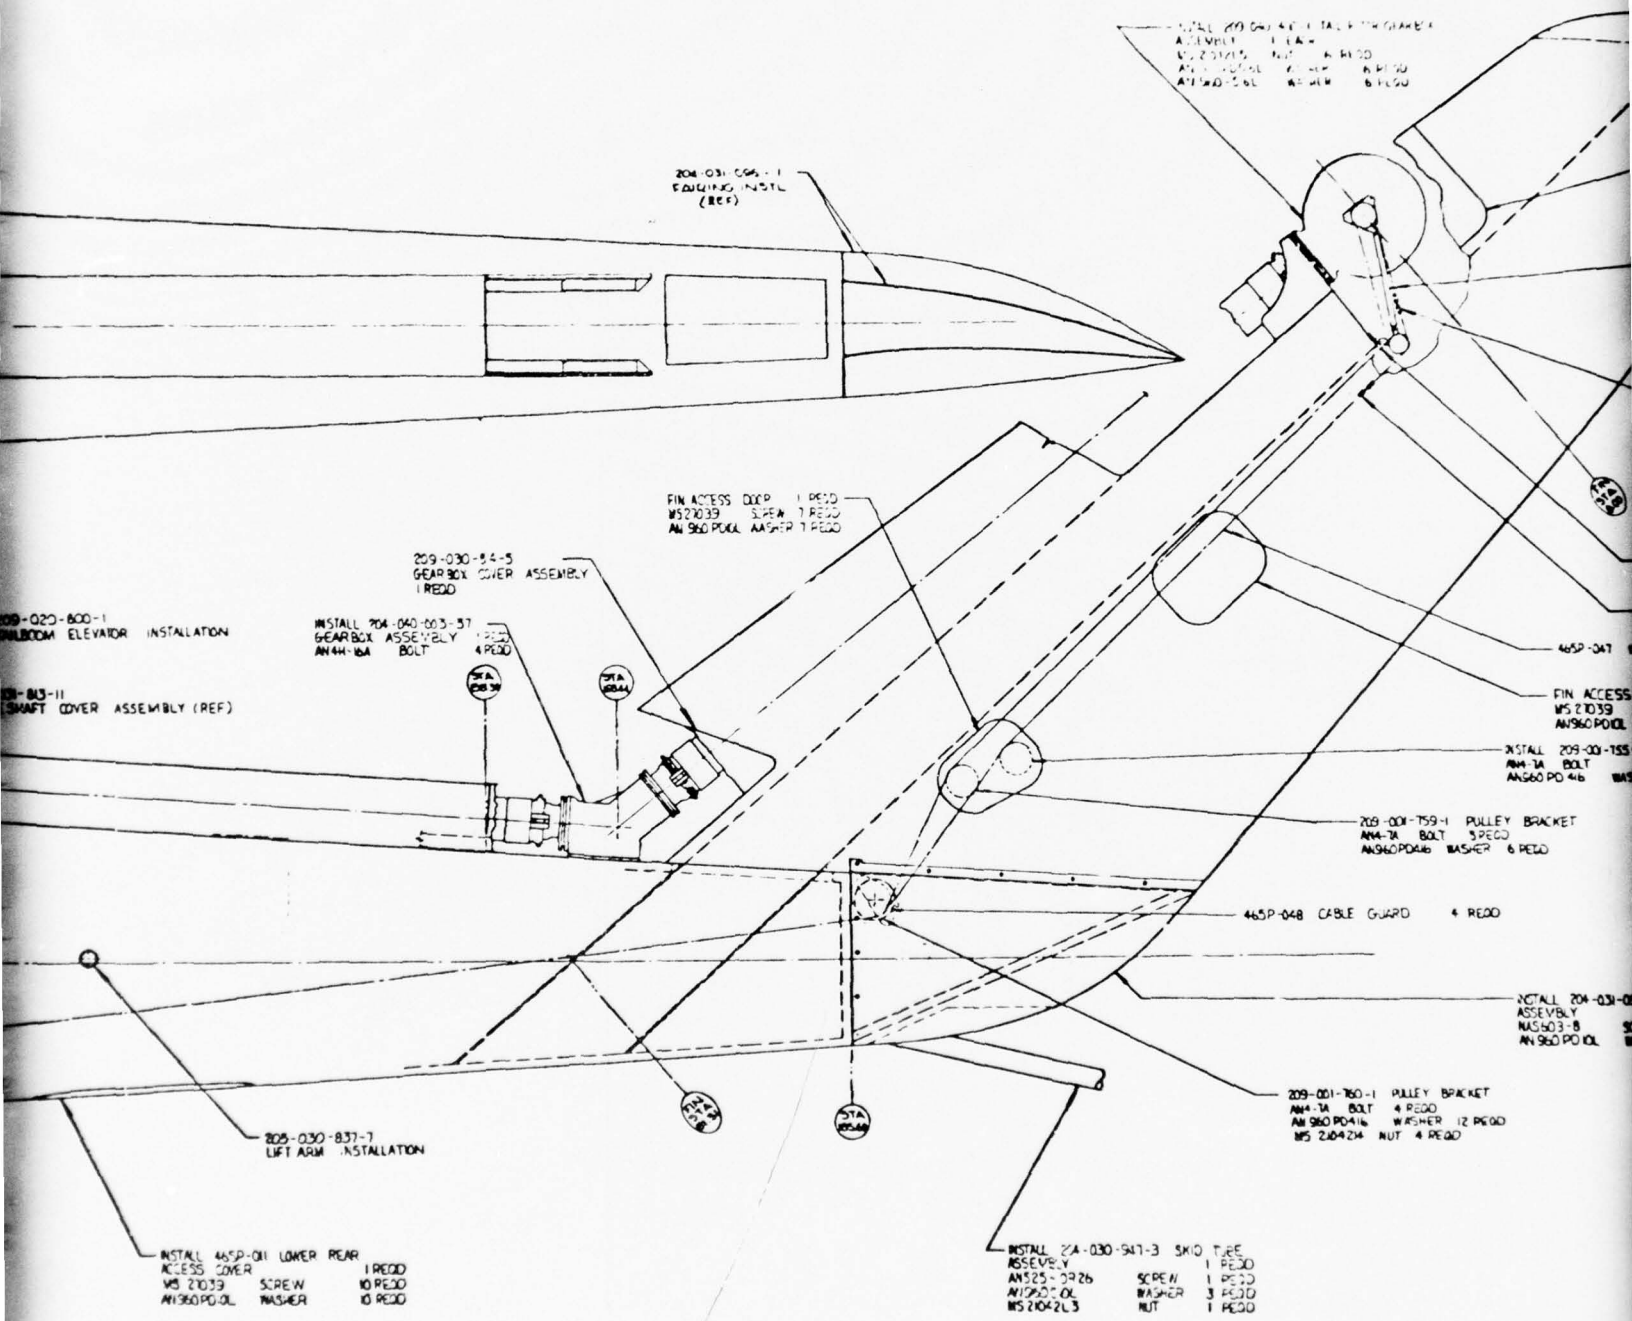
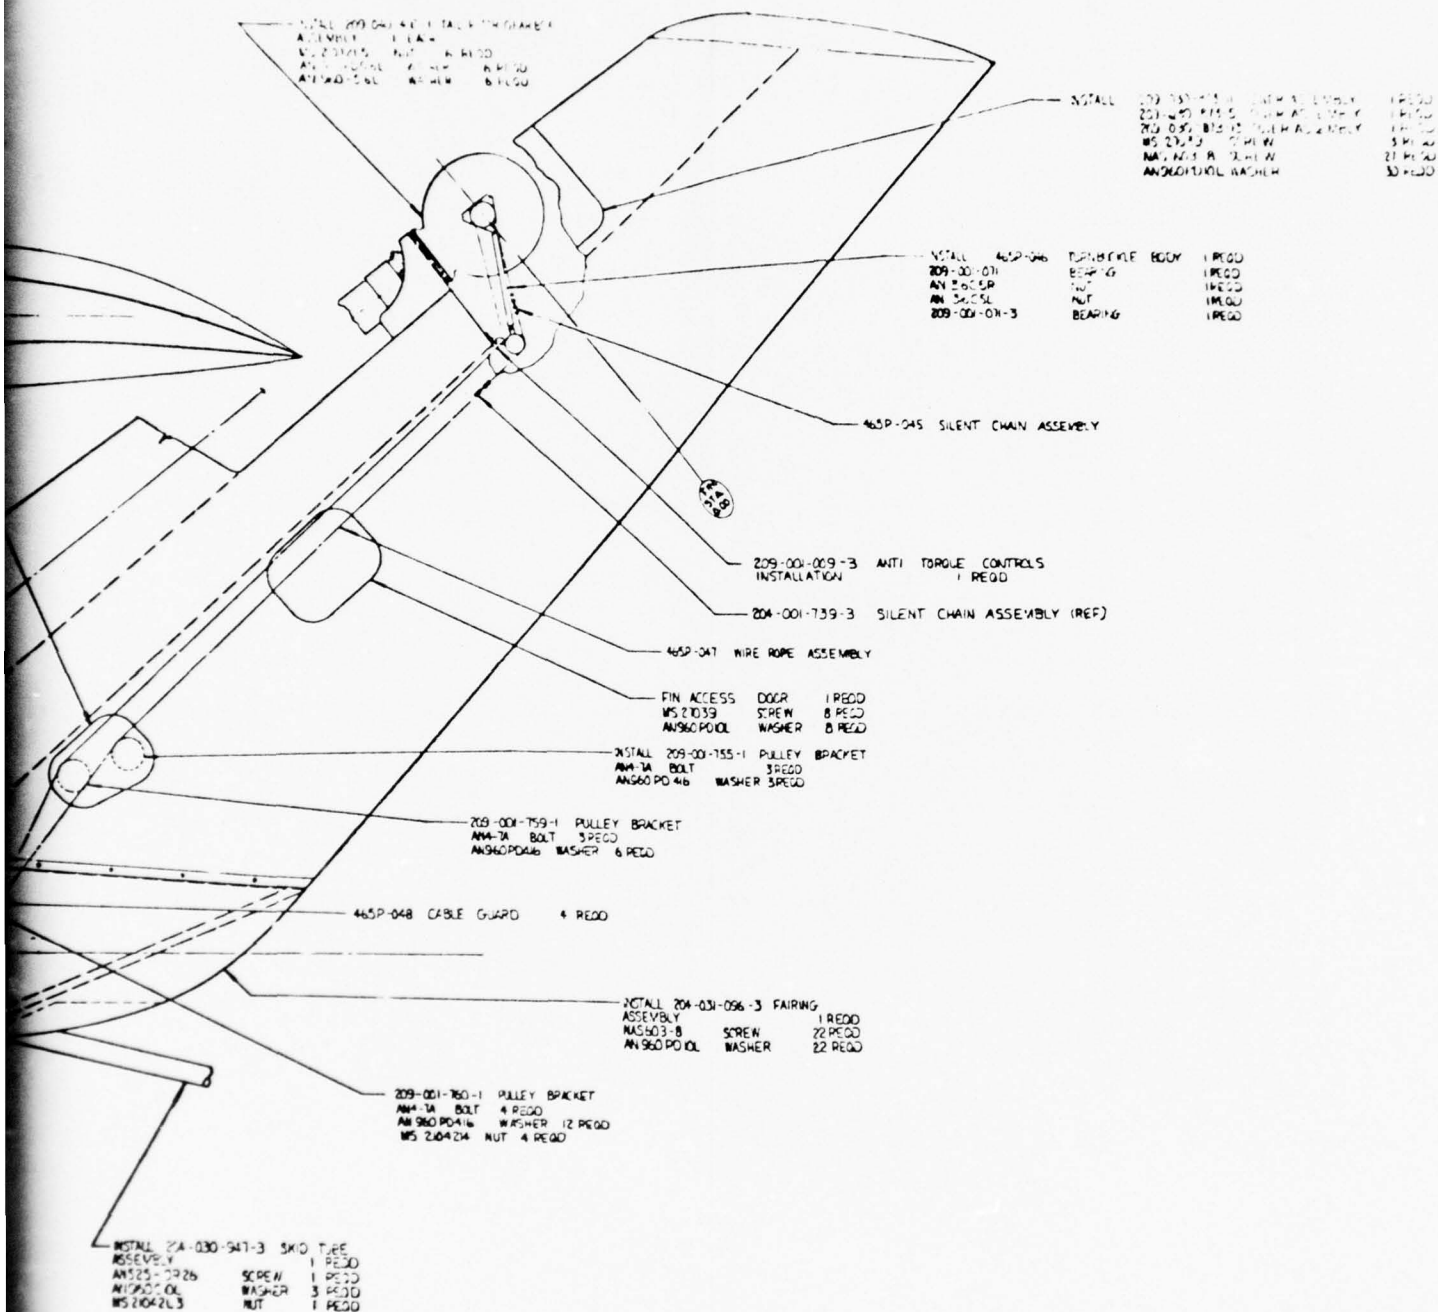
Figure 27. Tail Boom Assembly and Installation.

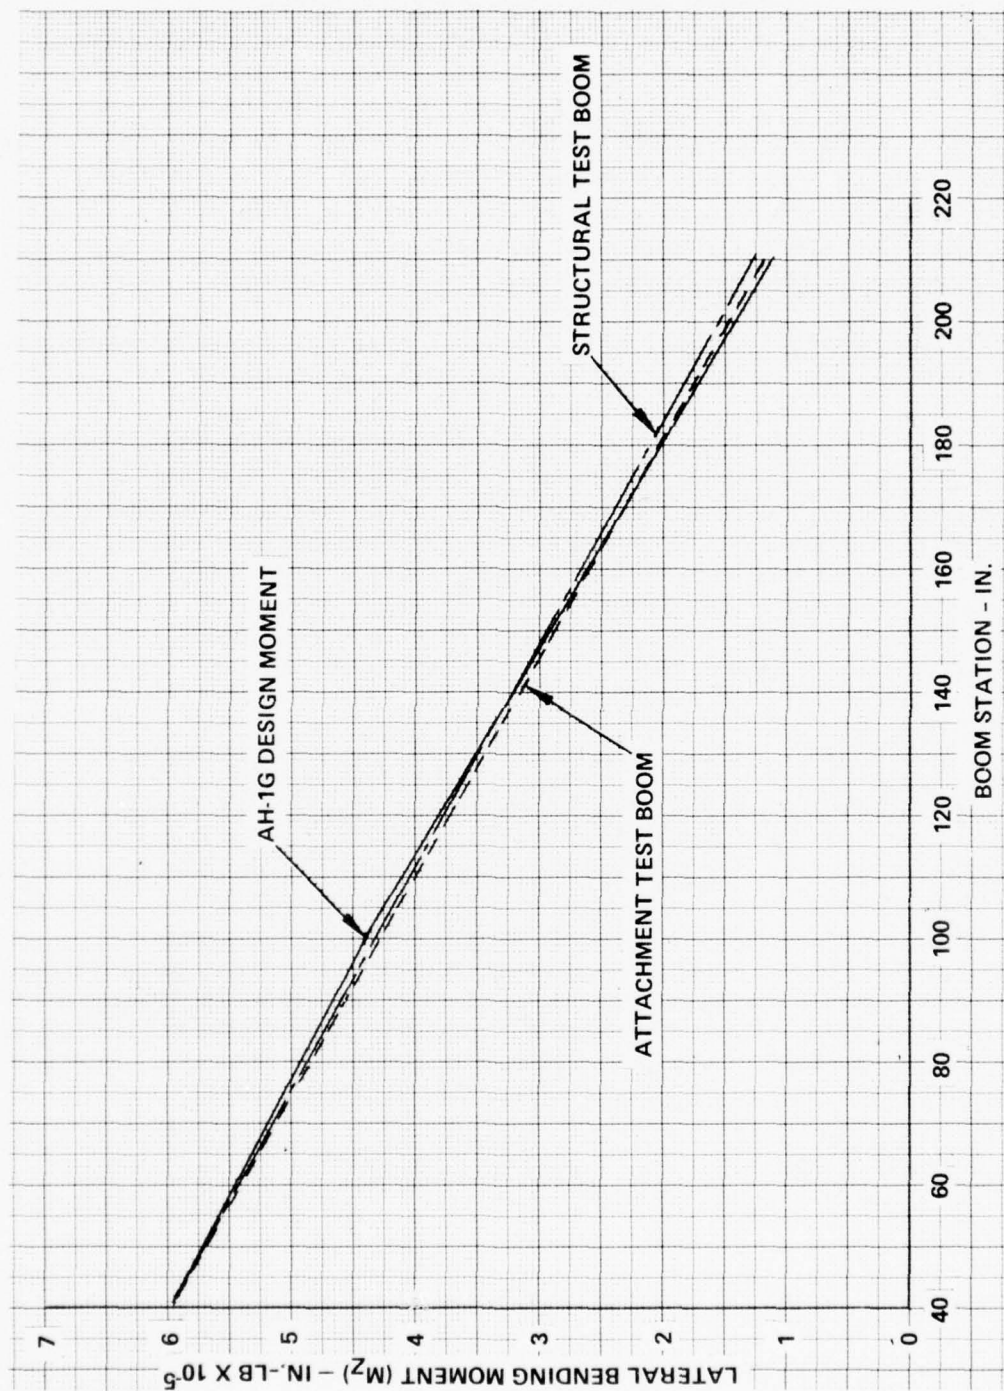
Figure 28. Comparison of Tail Boom Lateral Bending Moments (M_z) for Condition V, +15 degrees Yaw, Recovery.

Figures 28, 29, and 30 show the comparison between the boom test bending moments and torques and the design limit moments for the most critical design condition (Cond. V, +15 degrees Yaw, Recovery). The comparison of test to design moments is similar for the other conditions tested. An unsymmetrical load was applied at the sync elevator attachment fittings (BS 140.3) to reduce the test torque to more closely approximate the design torque; however, the delta torque was applied to increase the boom torque, resulting in a conservative test.

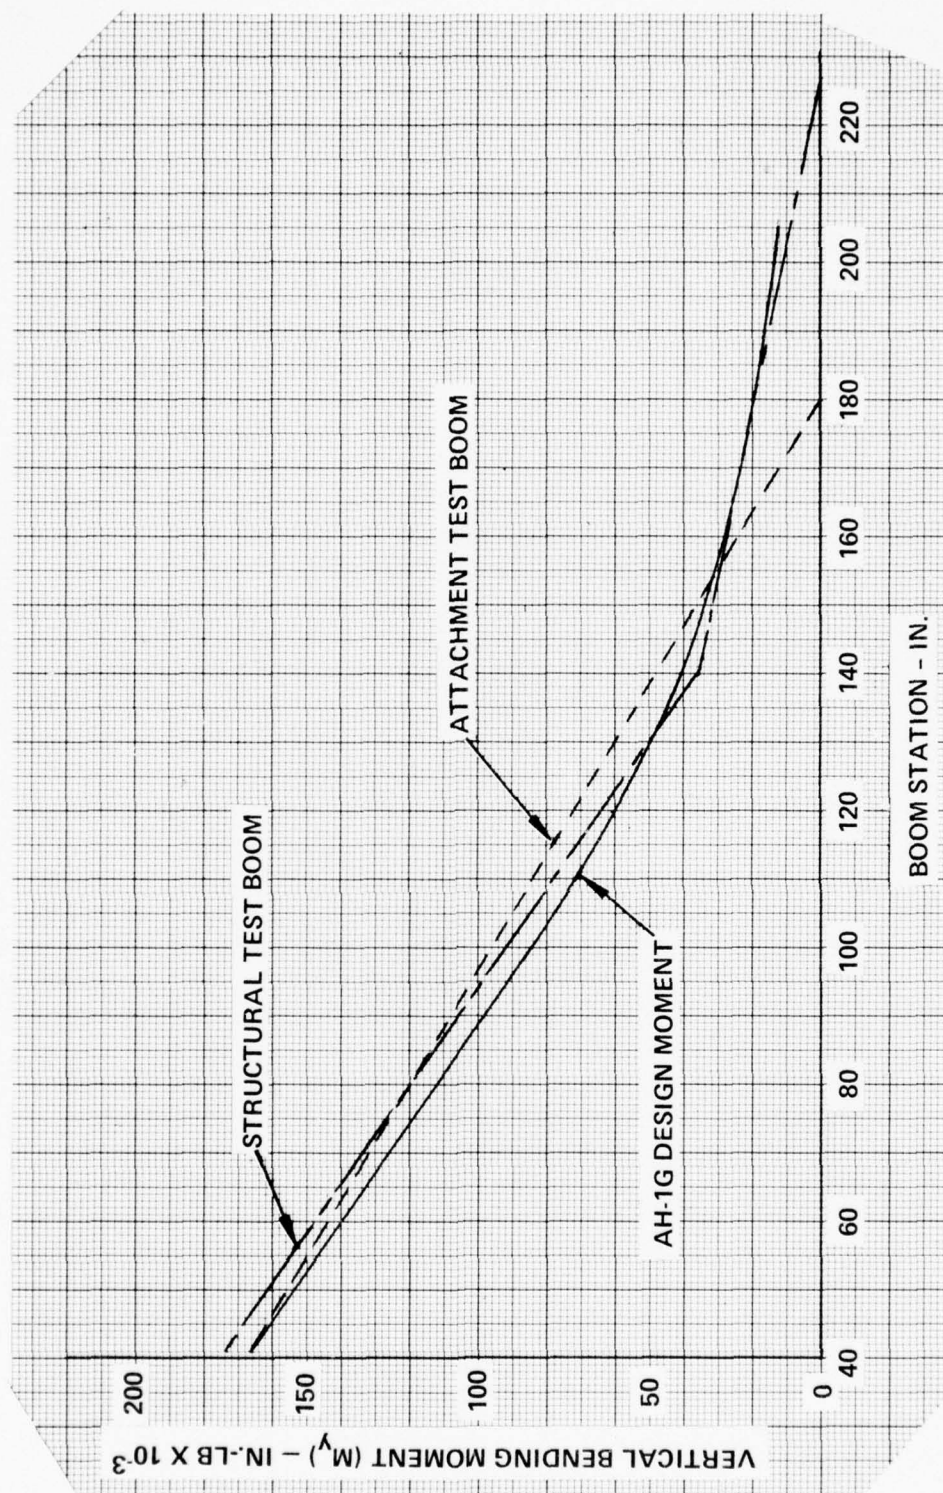
Figure 29. Comparison of Tail Boom Vertical Bending Moments (M_y) for Condition V, +15 degrees Yaw, Recovery.

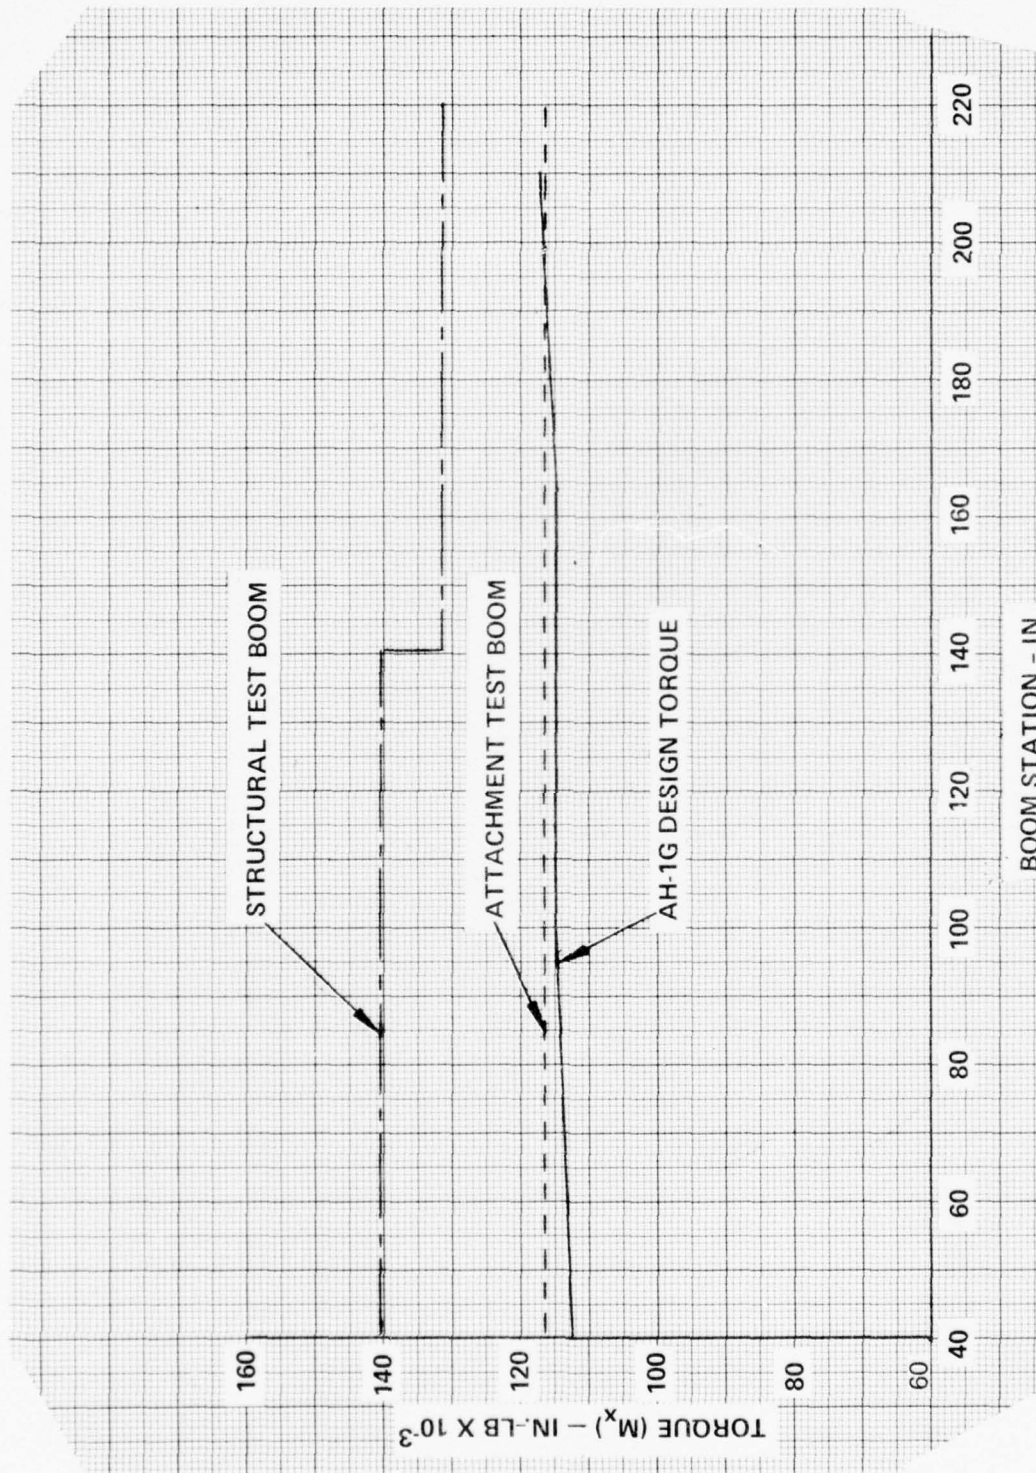
Figure 30. Comparison of Tail Boom Torque (Mx) for Condition V, + 15 degrees Yaw, Recovery.

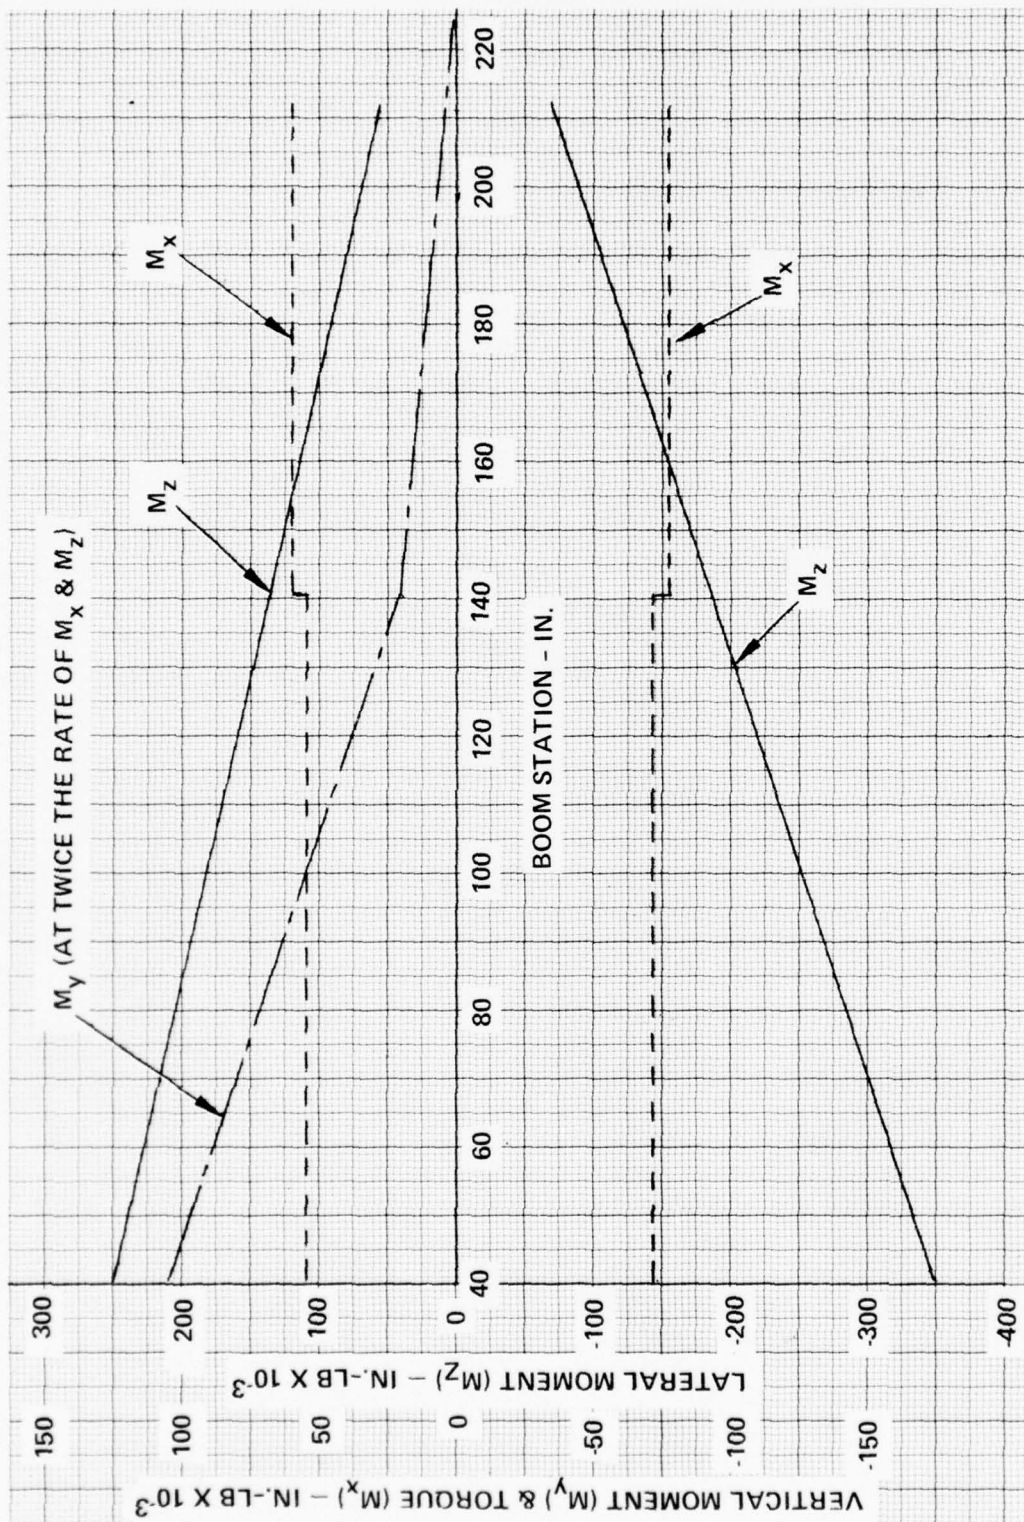
Figure 31. Structural Test Tail Boom Fatigue Loading.

Sixty percent of these design loads were selected as the test fatigue load spectrum. The tail boom moments are shown in Figure 31. It was assumed that these fatigue loads would occur on the AH-1G helicopter in service at a rate of three per flight hour. This frequency was derived from a comparison of the tail boom loads for other maximum design limit load conditions together with a review of the flight conditions flown to establish fatigue lives of other structural components (Reference 13).

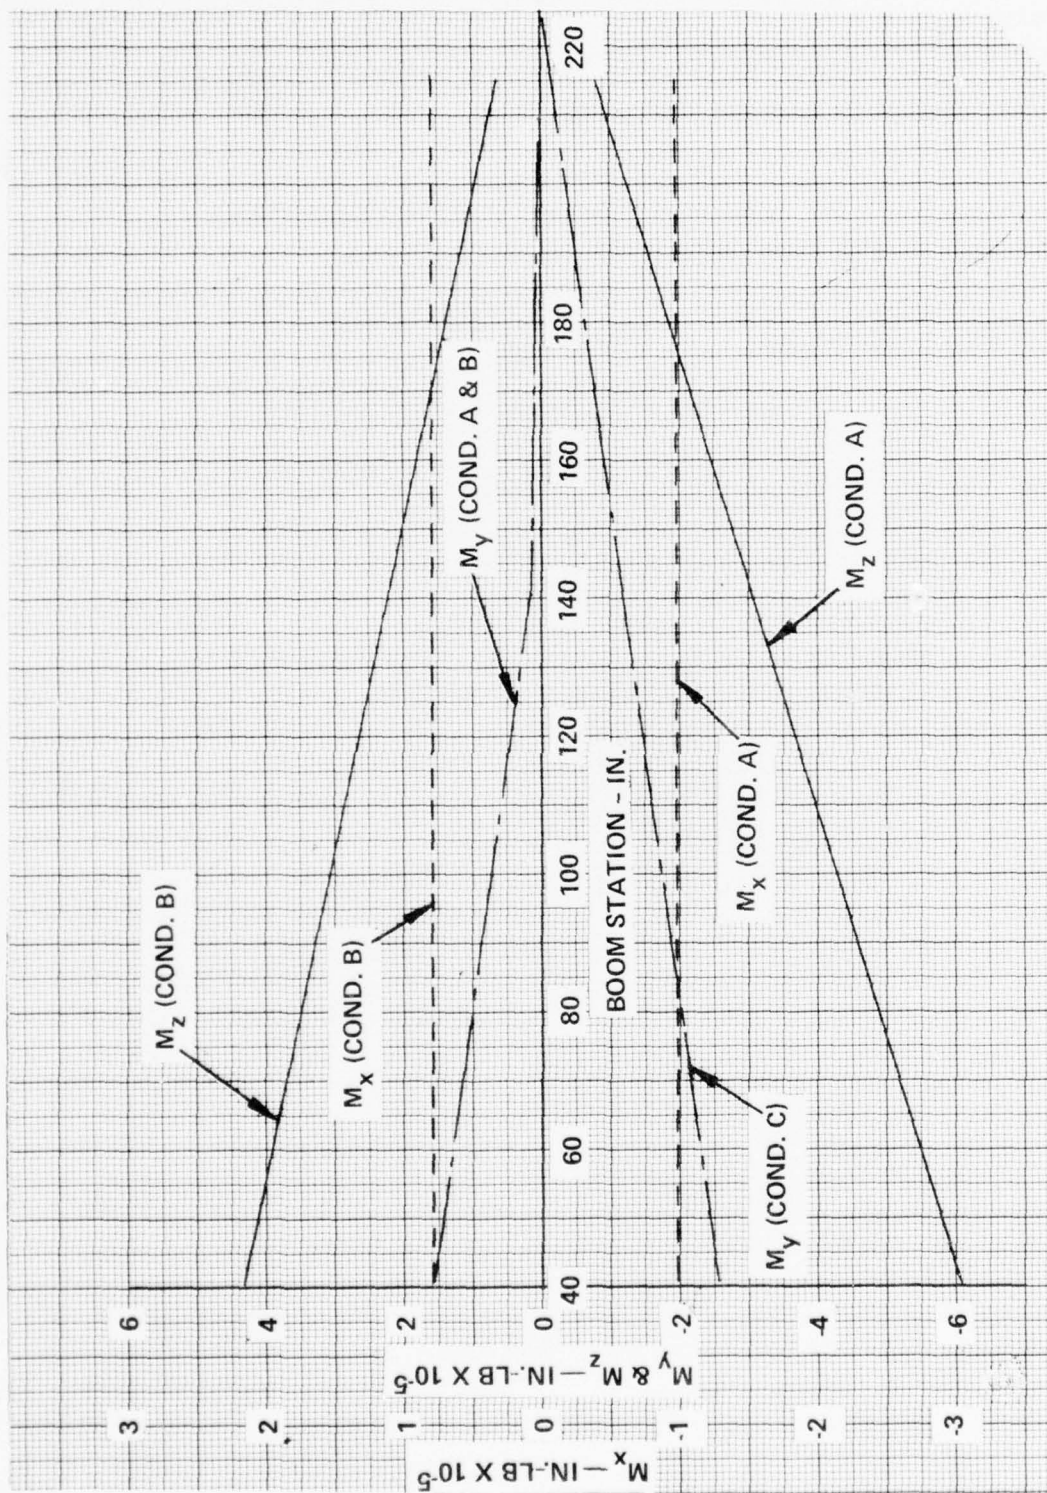
Figure 32. Proof Loading for Flight Test Tail Boom.

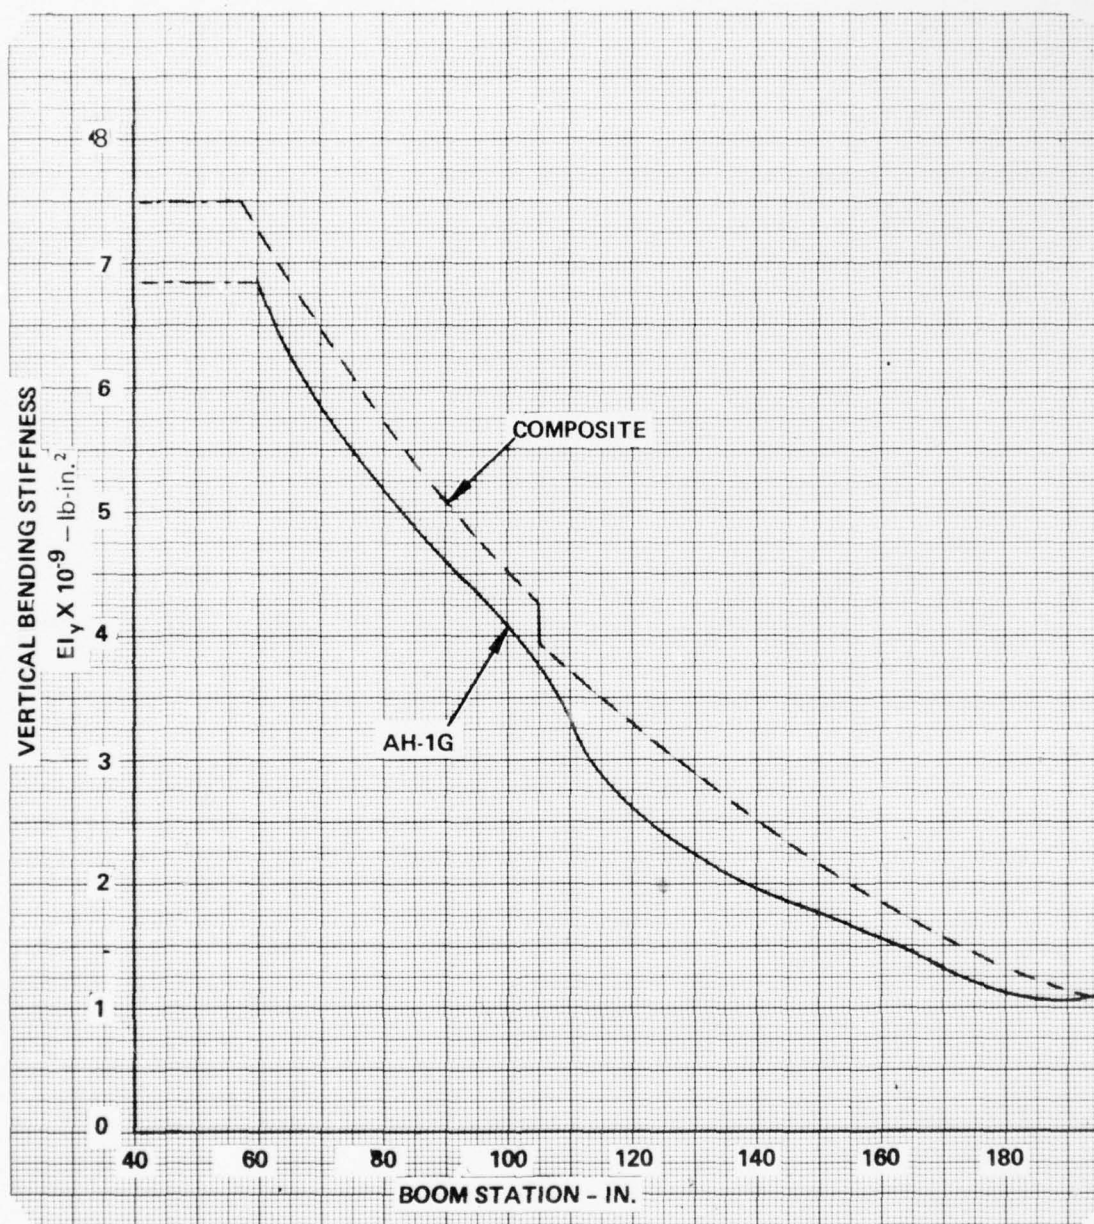
Figure 33. Comparison of Vertical Bending Stiffness of AH-1G Structure to Composite Structure.

The curves presented in Figures 33, 34, and 35 show the comparison of stiffness for the composite structure to the existing metal structure. The stiffness curves for the composite structure are based on the curve shapes derived from the cross-sectional properties computer program (Appendix A) and are adjusted to produce the deflections recorded during the proof loading of the flight test tail boom (Appendix D).
