DESIGN, FABRICATION, AND TESTING OF AN ADVANCED
COMPOSITE AH-1G TAIL SECTION (TAIL BOOM/VERTICAL FIN)

Hughes Helicopters, Division of Summa Corp.
Centinela and Teale Streets
Culver City, Calif. 90230

November 1976

Final Report for Period July 1973 - February 1976

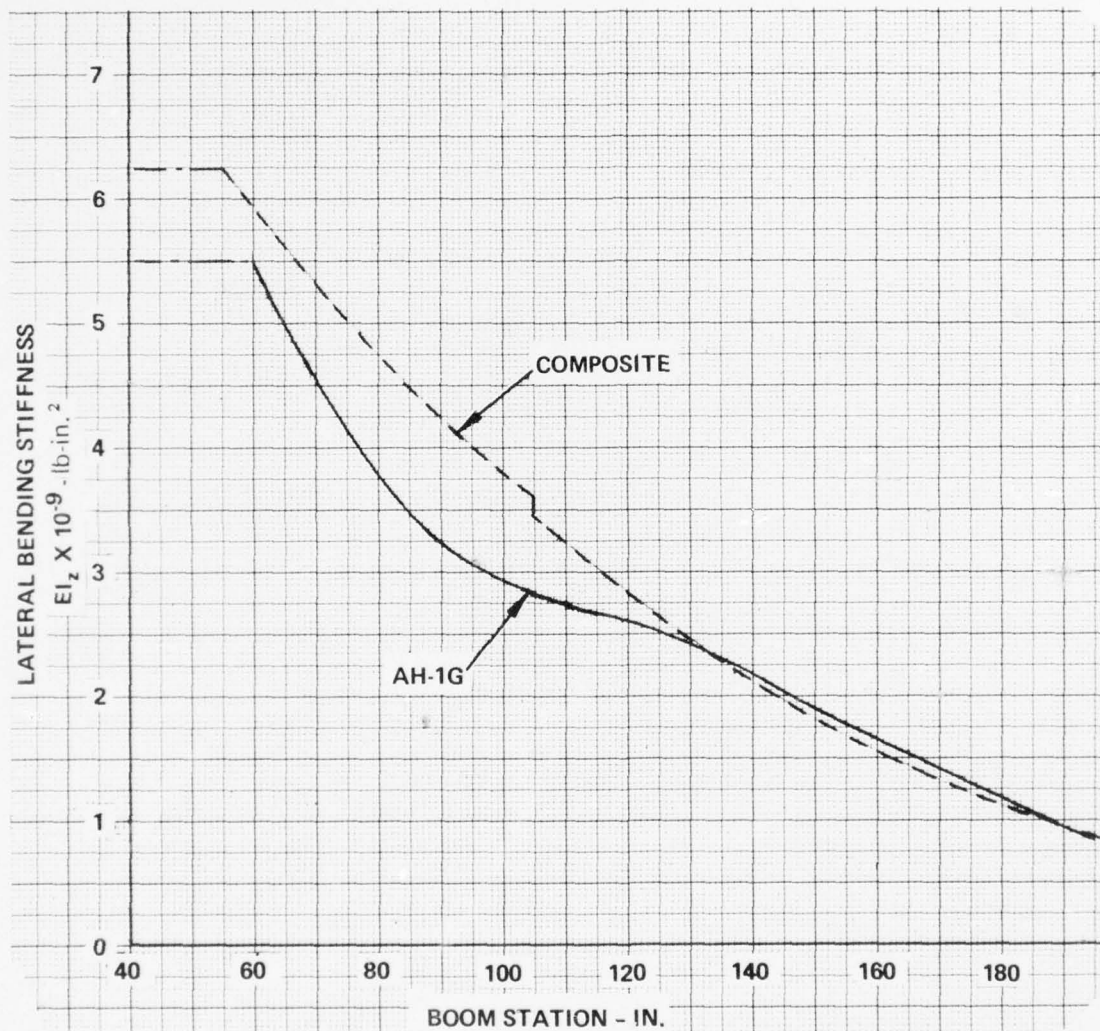
Figure 34. Comparison of Lateral Bending Stiffness AH-1G Structure to Composite Structure.

The curves presented in Figures 33, 34, and 35 show the comparison of stiffness for the composite structure to the existing metal structure. The stiffness curves for the composite structure are based on the curve shapes derived from the cross-sectional properties computer program (Appendix A) and are adjusted to produce the deflections recorded during the proof loading of the flight test tail boom (Appendix D).

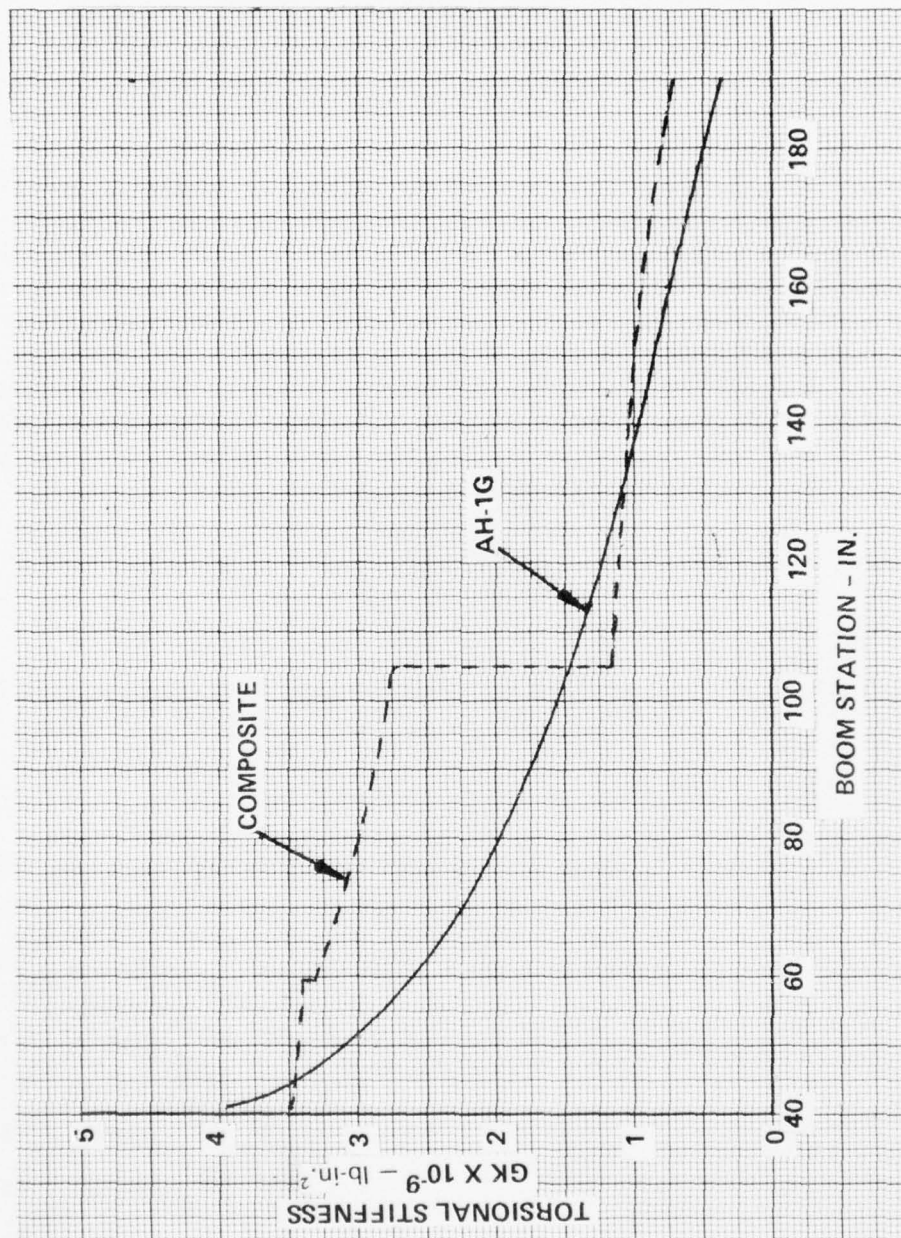
Figure 35. Comparison of Torsional Stiffness of AH-1G Structure to Composite Structure.

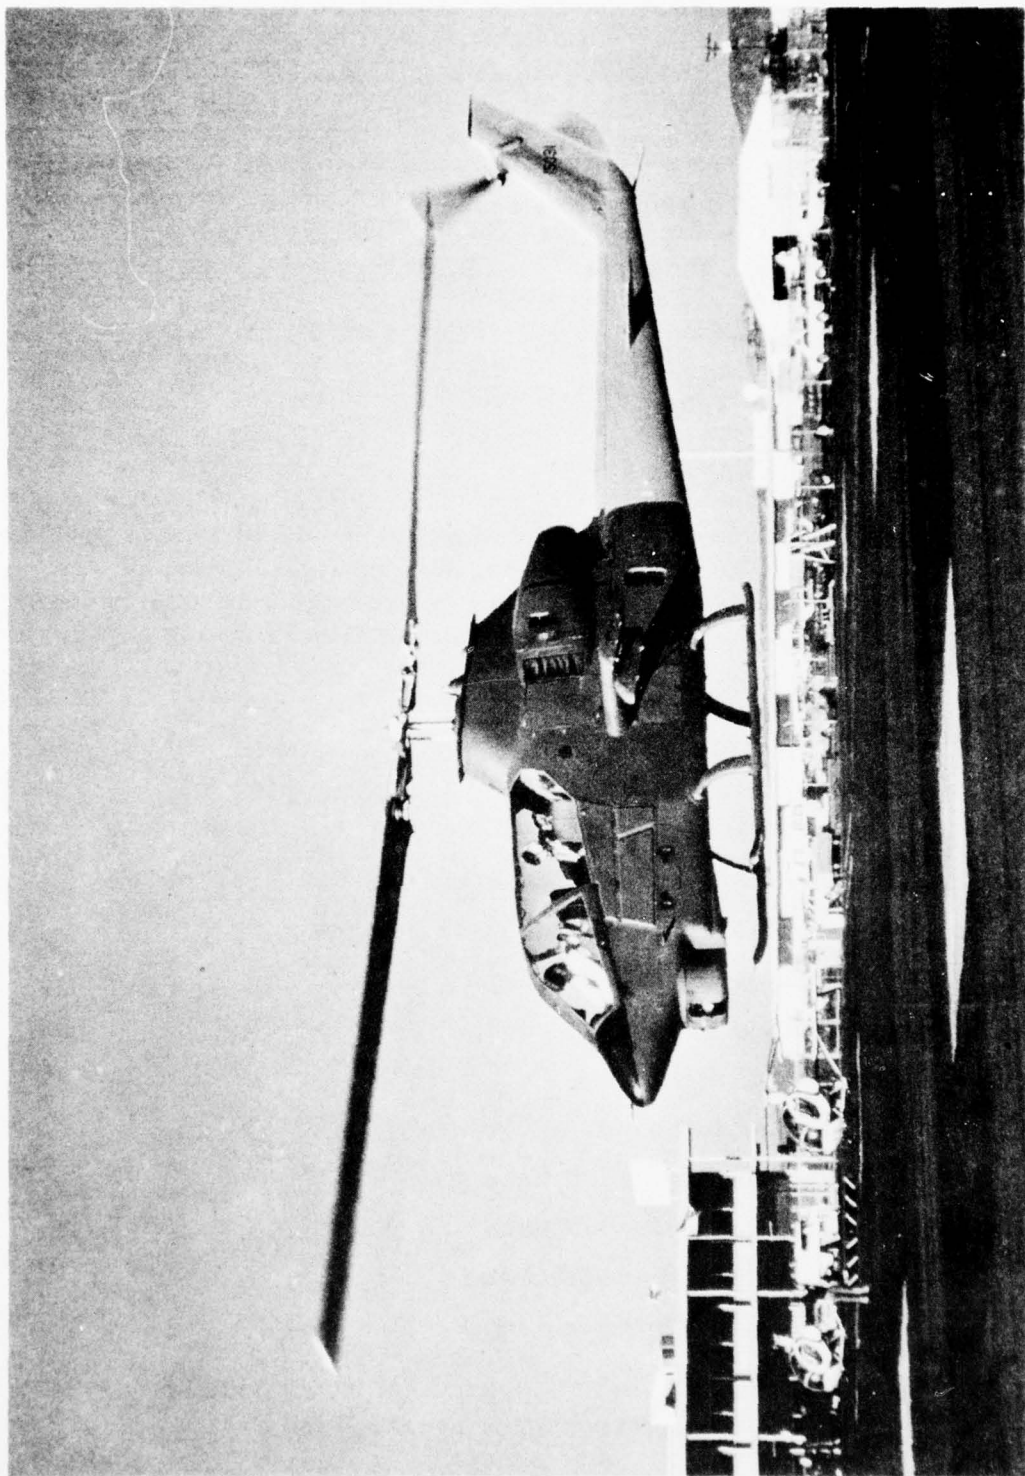
Figure 36. Composite Tail Section in Flight

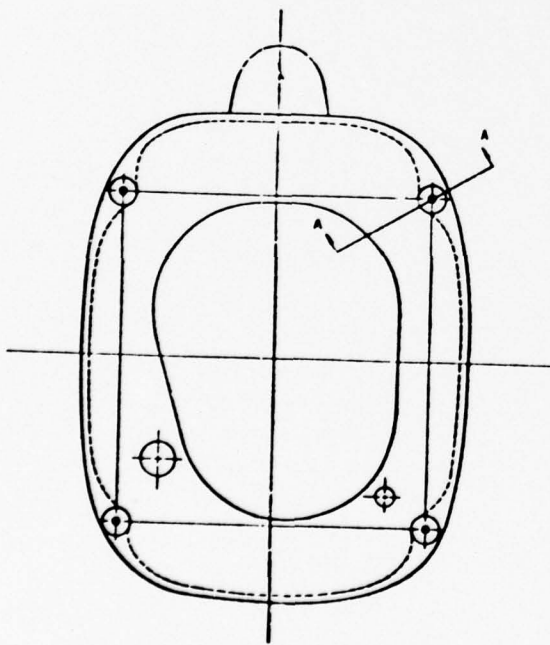
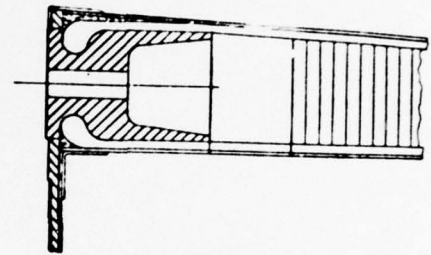
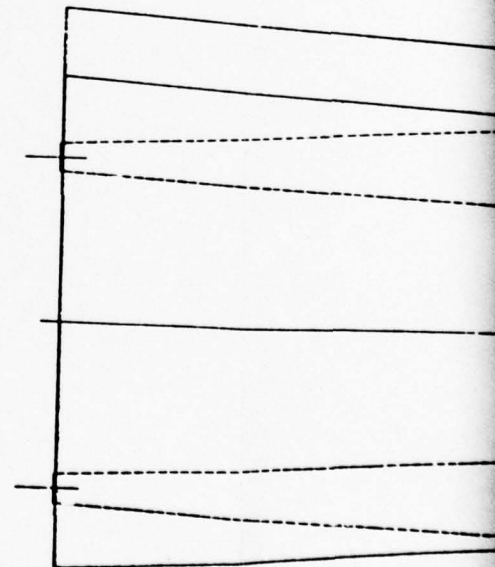
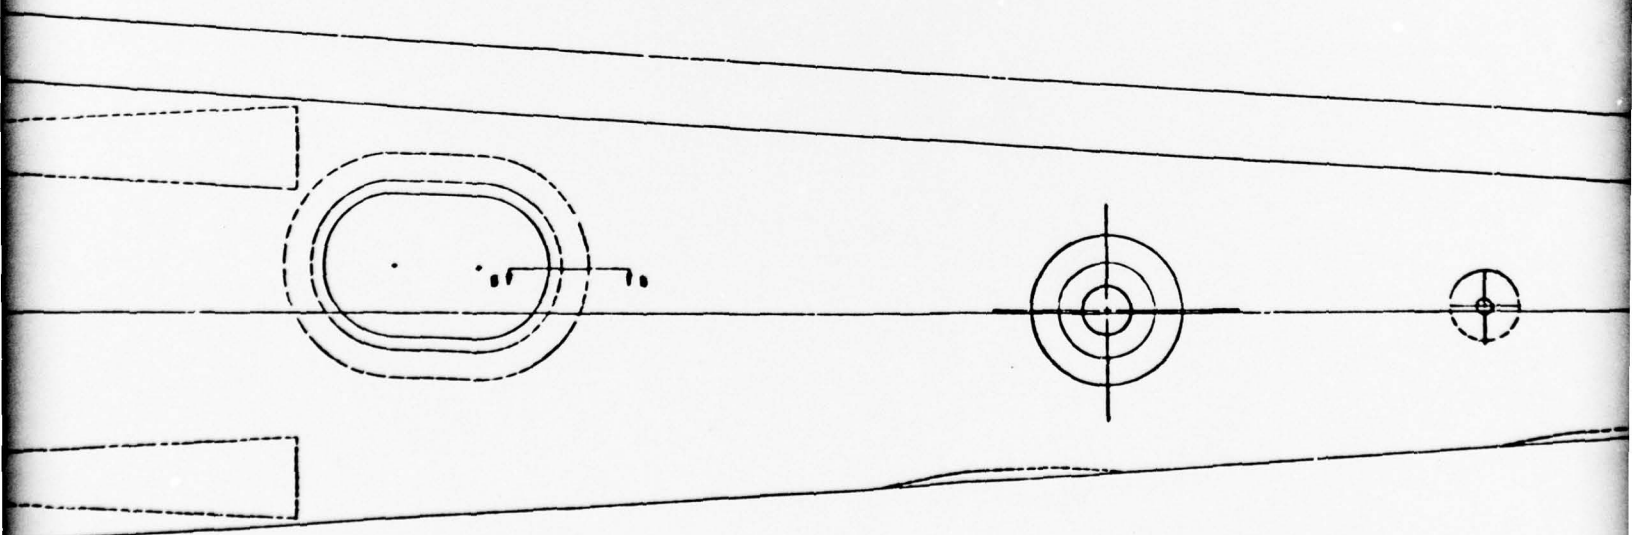
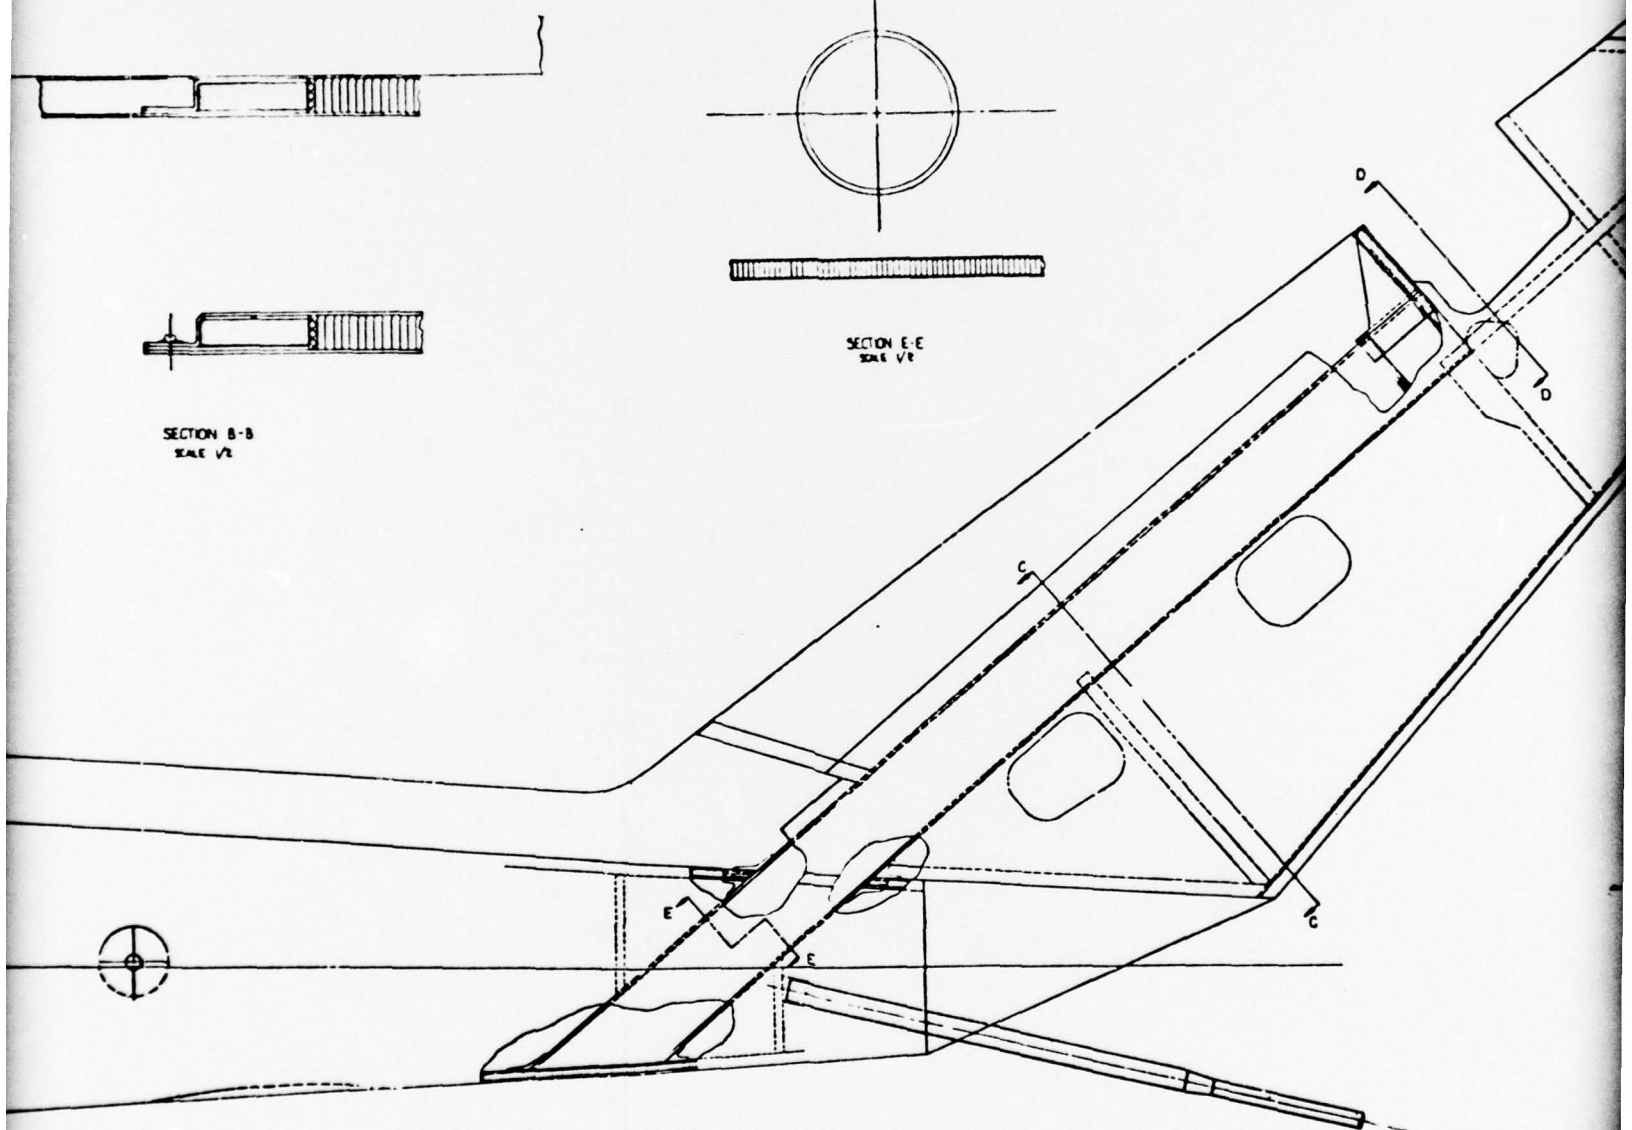
Figure 37. Advanced Tail Boom Design.

The fin spar is redesigned to a constant diameter tube that will provide several fabrication advantages. It eliminates the requirement for a female forming mold. The present support structure for the gearbox is composed of four separate components that are required to be fitted and bonded to each other and to the fin spar (refer to Figure 23). By using a constant diameter tube, a single aluminum support fitting for the gearbox could be attached to the spar while still on the winding mandrel (see Figure 37). The fin spar

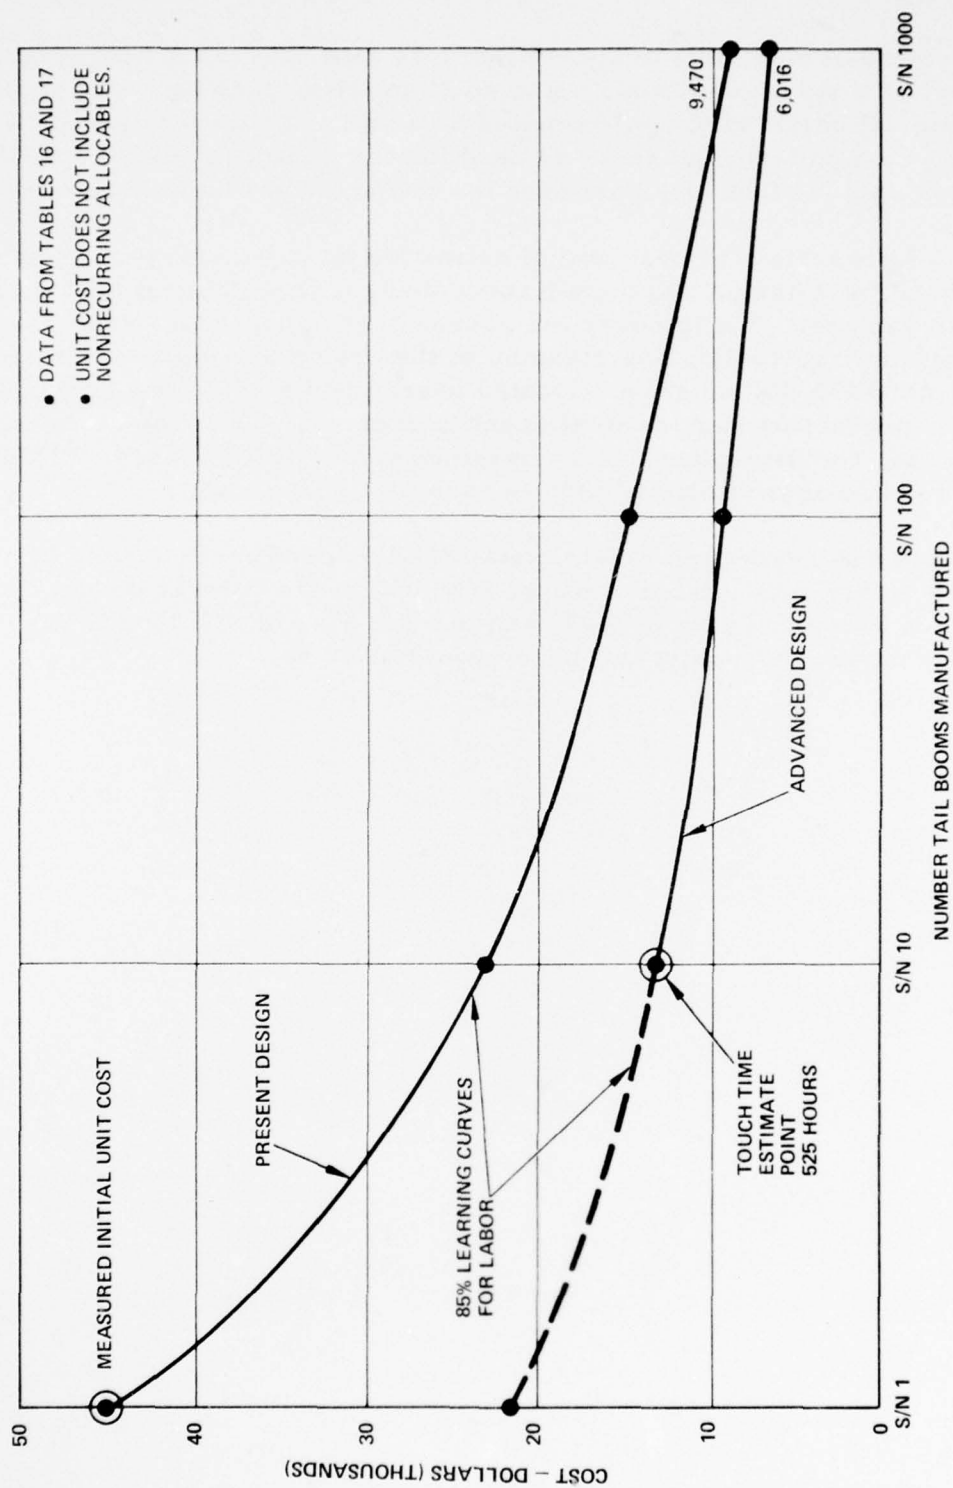
Figure 38. Manufacturing Unit Cost Estimates - Composite Tail Boom.

For comparison with the present metal AH-1G boom shell, quoted by the Army to be \$17,000, the unit cost of S/N 1000 of the current design composite tail boom would be \$9,470, and the unit cost of S/N 1000 of the advanced design composite tail boom would be \$6016.

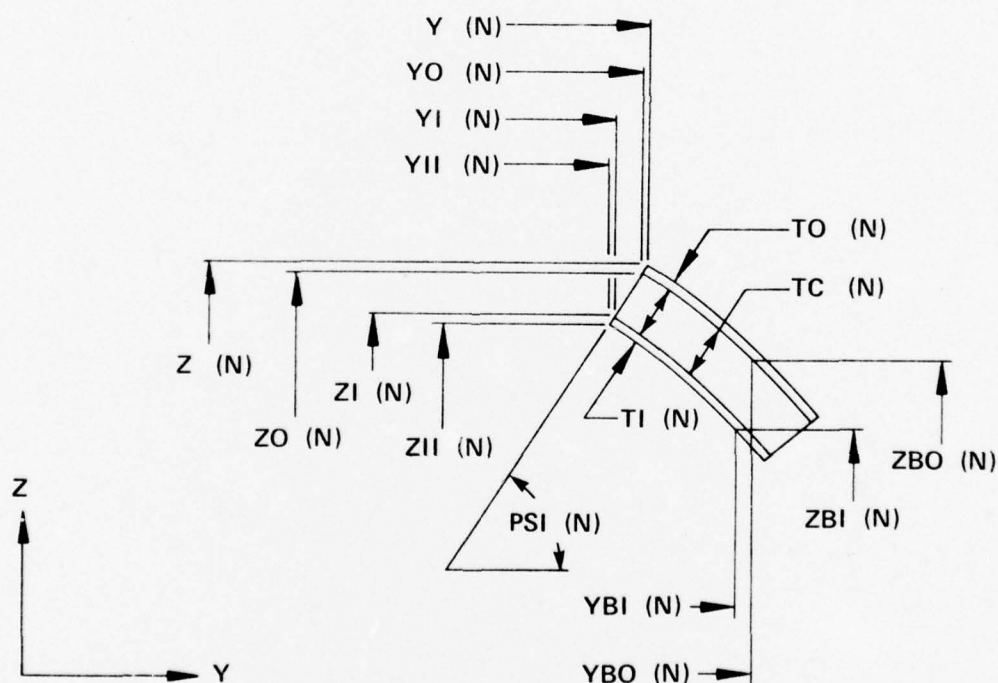
Figure A-1. Computer Program "SECPRO" Nomenclature.

A computer program was developed to calculate the bending and torsional stiffness of closed structures made of sandwich wall construction. The program was developed by Fiber Science, Inc. and is entitled "SECPRO." The computer program nomenclature is given in Figure A-1. Typical elements of a cross section are given in Figure A-2. Typical input data for the structure cross section are given in Table A-1 and the resulting output data are given in Table A-2.

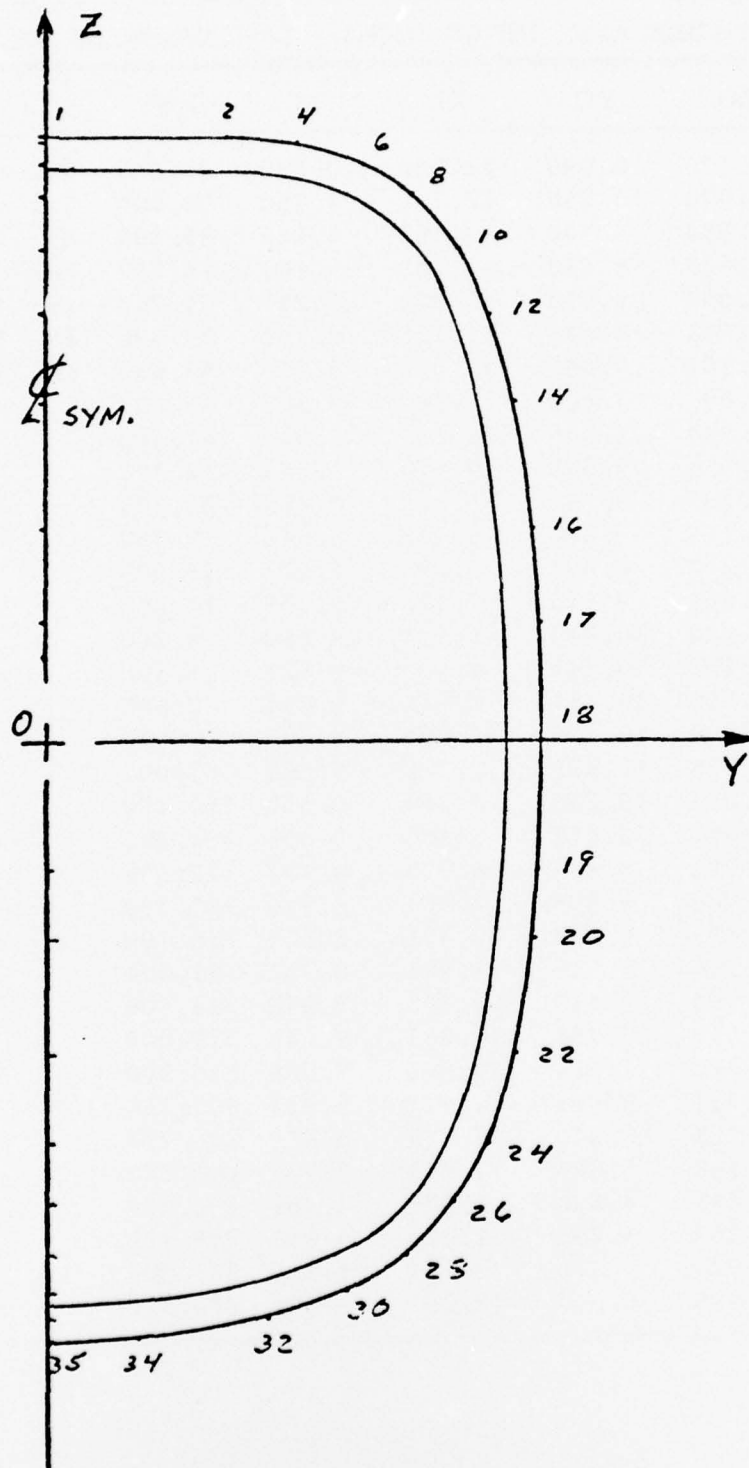
Figure A-2. Section Elements BS 122.33.

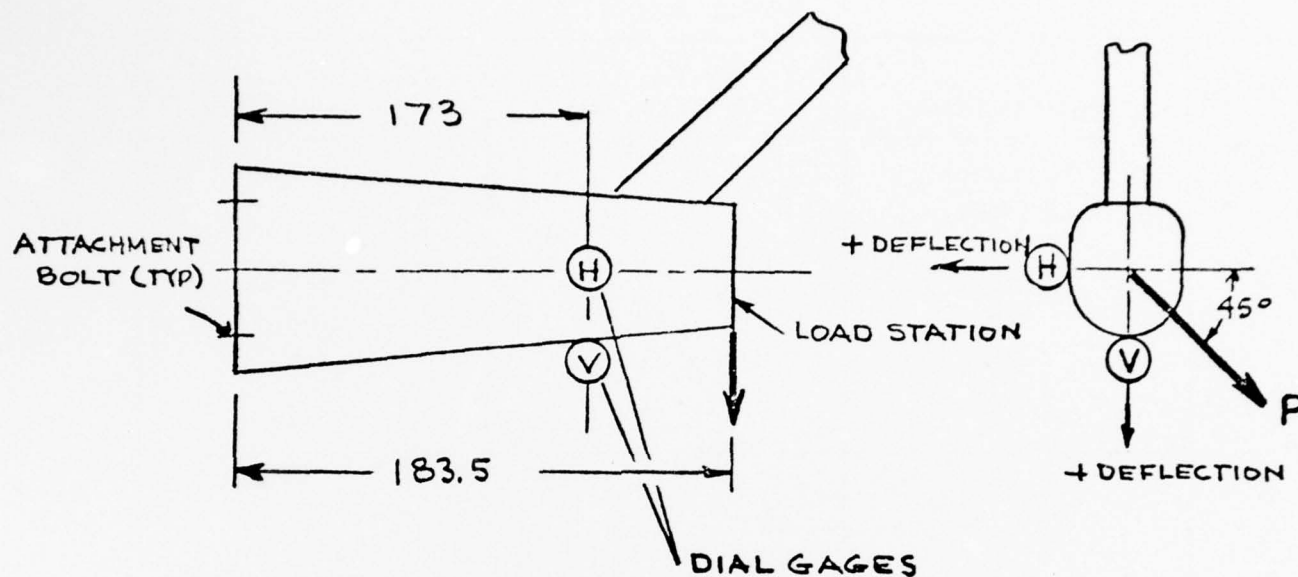
TEST LOAD P (LBS)	DEFLECTION ~ INCHES	
	H	V
0	-	-
500	0	0
1000	-.21	.34
1500	-.47	.52
2000	-.69	.90
2500	-.92	1.15
2700	-1.02	1.26
3000	-1.18	1.42
3195	FAILURE

Figure B-1. Test Load and Deflection Locations and Test Results, Tail Boom Specimen 'A'.

The boom failed at a resultant bending moment of $3195 \times 183.5 = 586,300$ inch-pounds or $-M_y = M_z = 586,300 \times .707 = 414,600$ inch-pounds at the forward attachment bolts. The following simplified method of analysis is used to compute bolt loads for comparing the applied test loading to the maximum design limit load. Using the bolt nomenclature and geometry of Table 2, the equations for the bolt axial loads are

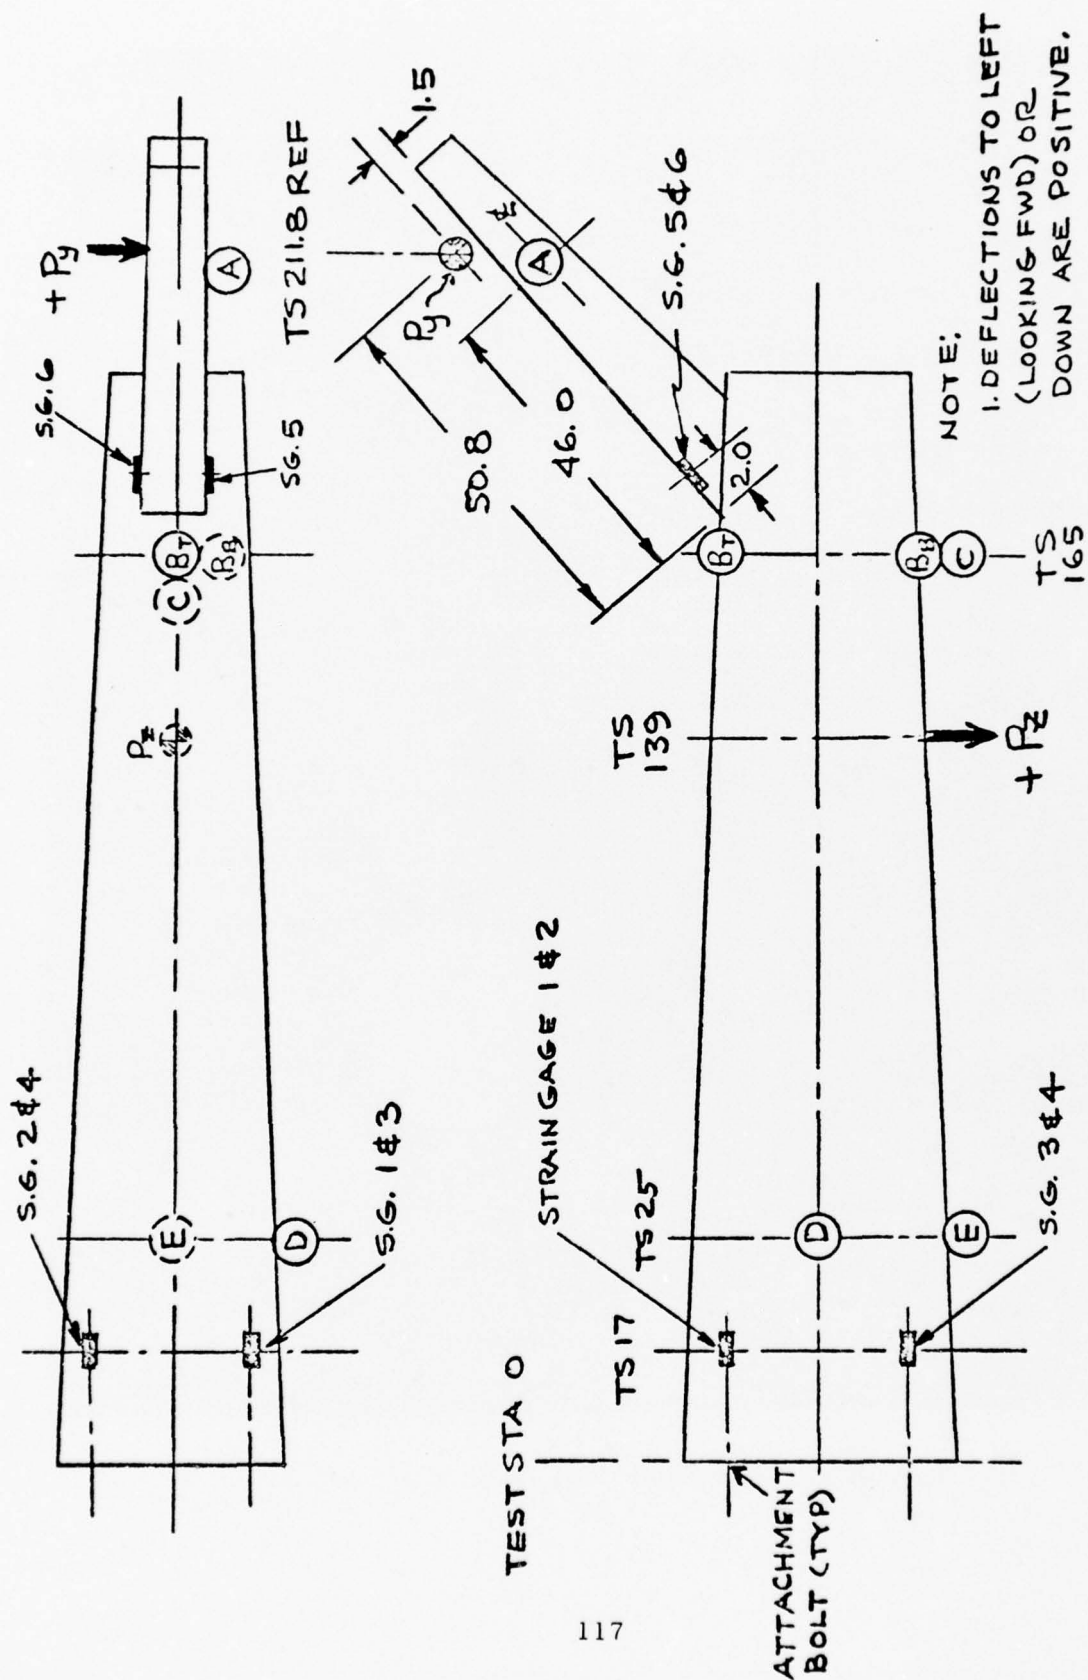
Figure B-2. Load Stations and Instrumentation, Tail Boom Specimen "B".

Test Condition	A +15° Yaw, Rec	B -15° Yaw, Rec
Deflection Inches		
A	-5.30	3.68
B _T	-2.29	1.62
B _B	-1.91	1.37
C	.53	.53
Strain* μ-in./in.		
1	1300	-510
2	-825	1150
3	970	-1155
4	-1620	600
5	2850	-2200
6	-2830	2250
<p>*Positive strains are tension. Deflection and strain gages are identified in Figure B-2.</p>

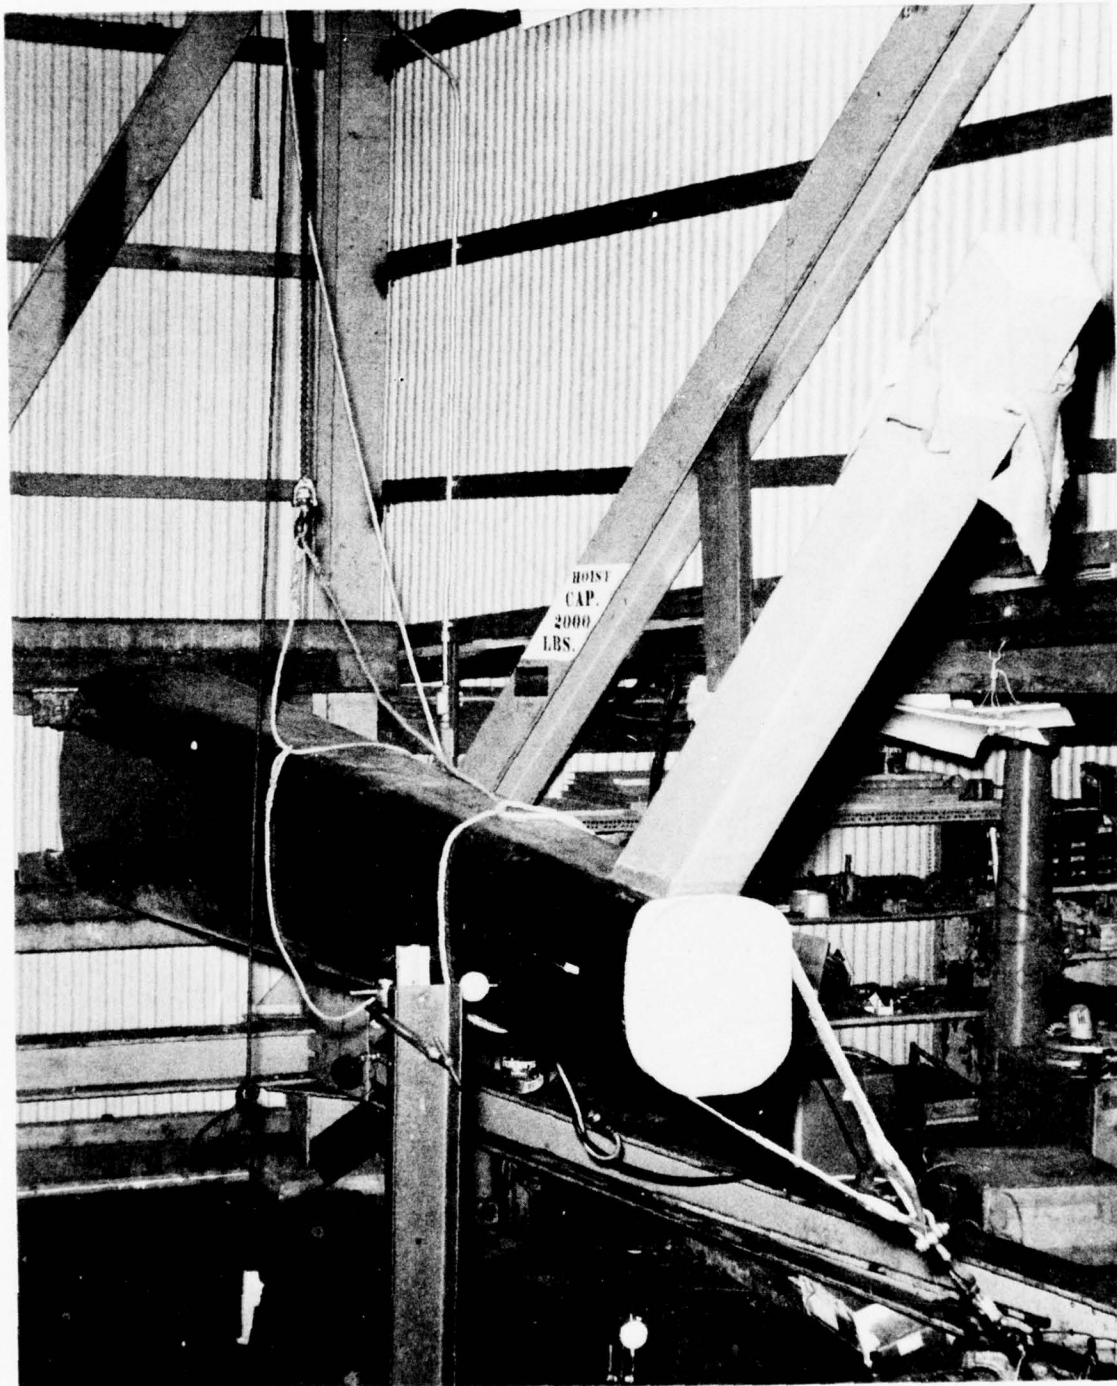
Figure B-3. Test Setup Tail Boom Specimen A.

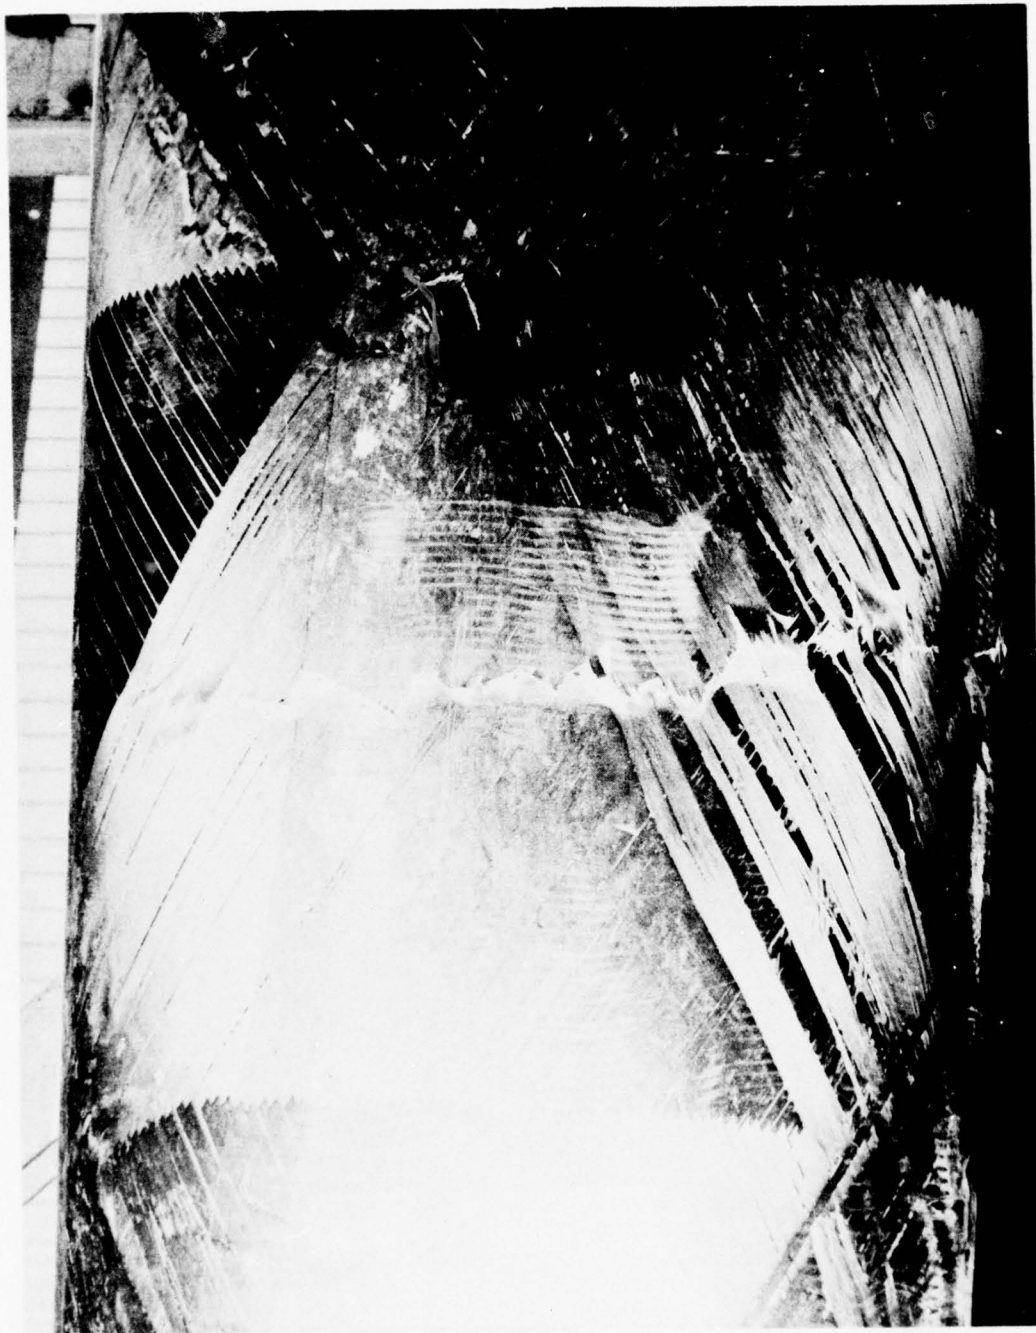
Figure B-4. Failure Tail Boom Specimen A.

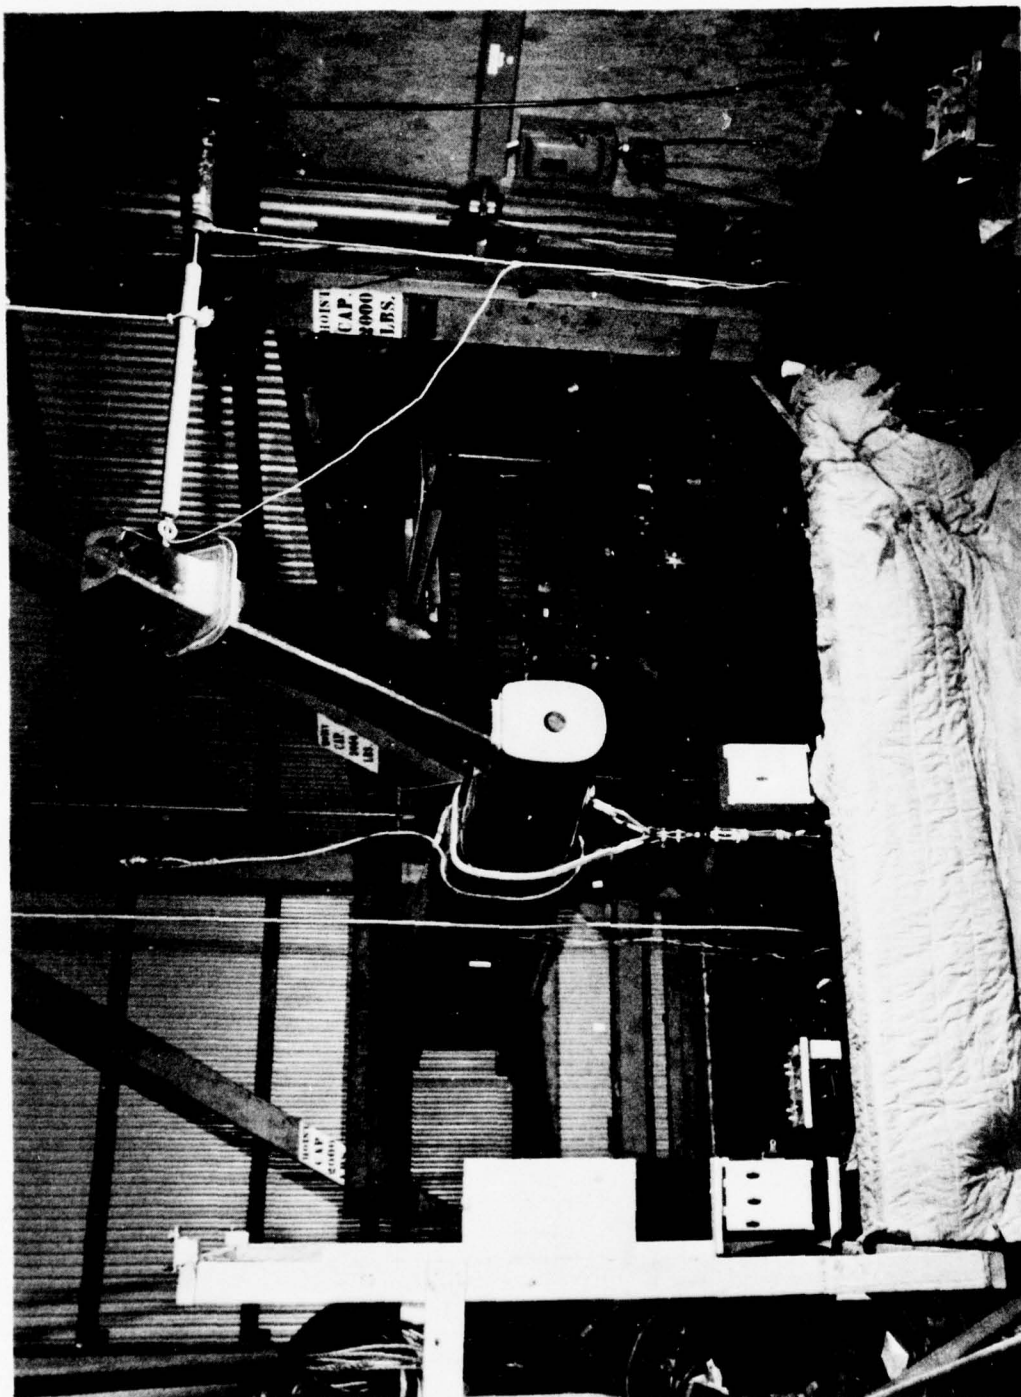
Figure B-5. Test Setup, Tail Boom Specimen B.

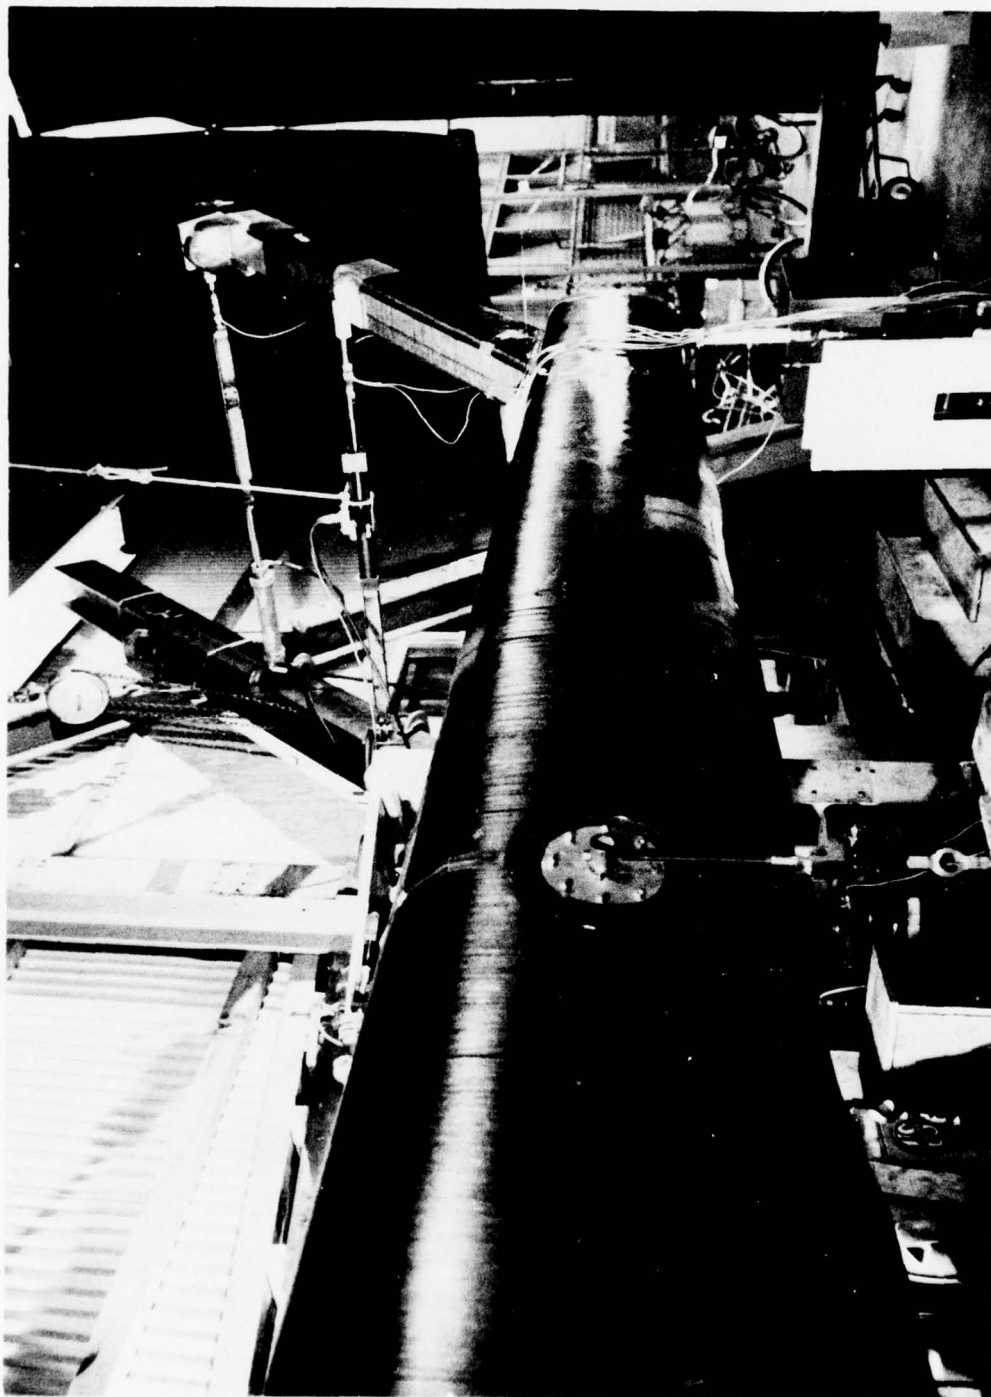
Figure C-1. View of Test Setup of AH-1G Basic Test Tail Boom
(Configuration II) Structural Tests.

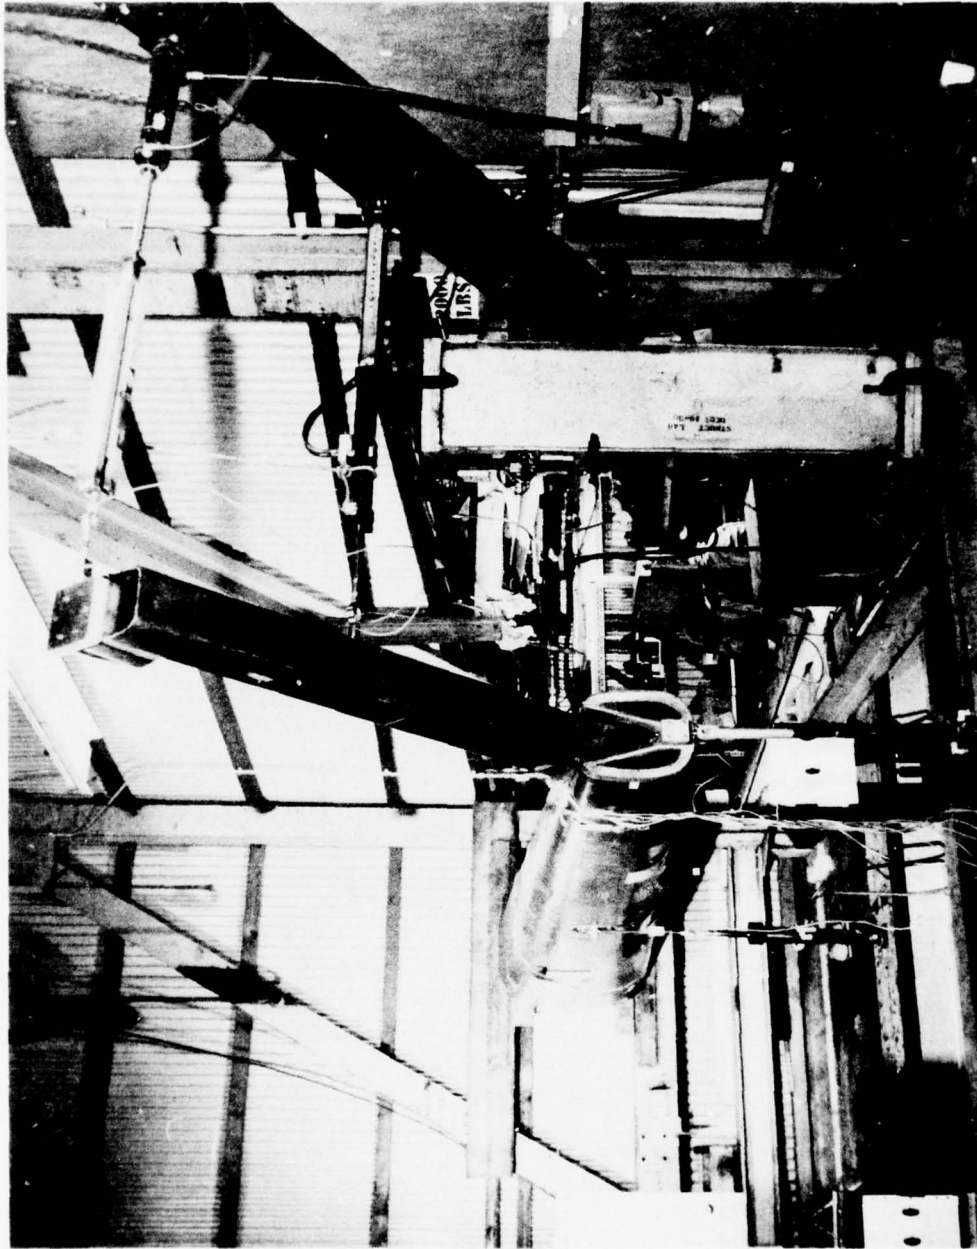
Figure C-2. View of Test Setup of AH-1G Basic Test Tail Boom
(Configuration II) Structural Tests.

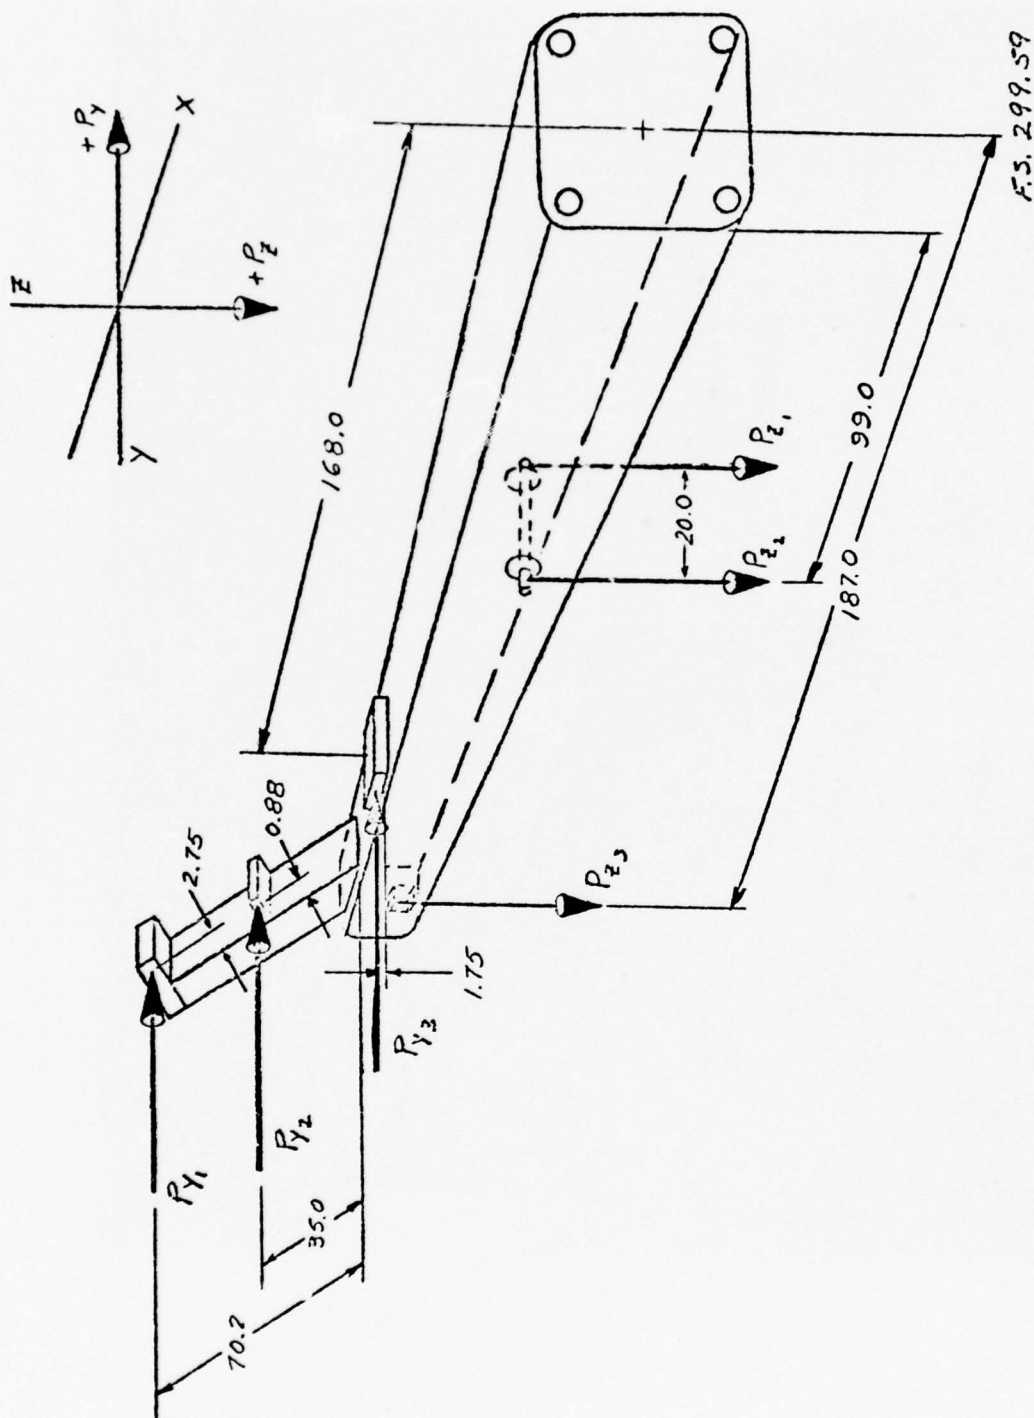
Figure C-3. Schematic Representation of Load Point Locations and Load Direction for the AH-1G Basic Test Tail Boom Structural Tests.
