DESIGN, FABRICATION, AND TESTING OF AN ADVANCED
COMPOSITE AH-1G TAIL SECTION (TAIL BOOM/VERTICAL FIN)

Hughes Helicopters, Division of Summa Corp.
Centinela and Teale Streets
Culver City, Calif. 90230

November 1976

Final Report for Period July 1973 - February 1976

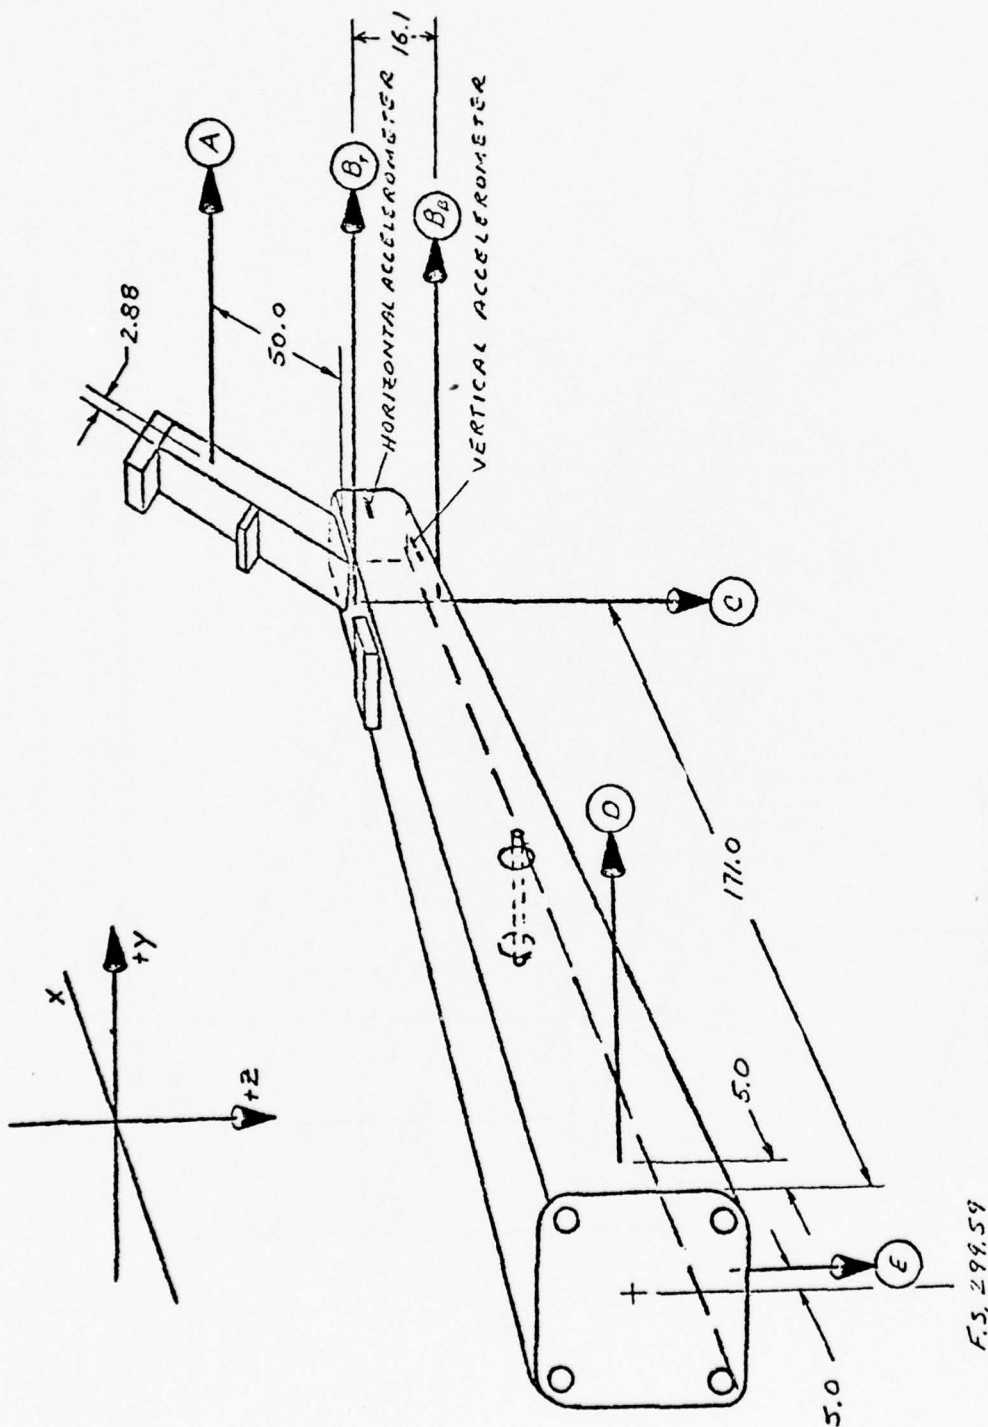
Figure C-4. Schematic Representation of Deflection and Accelerometer Locations for AH-1G Basic Test Tail Boom Structural Tests.

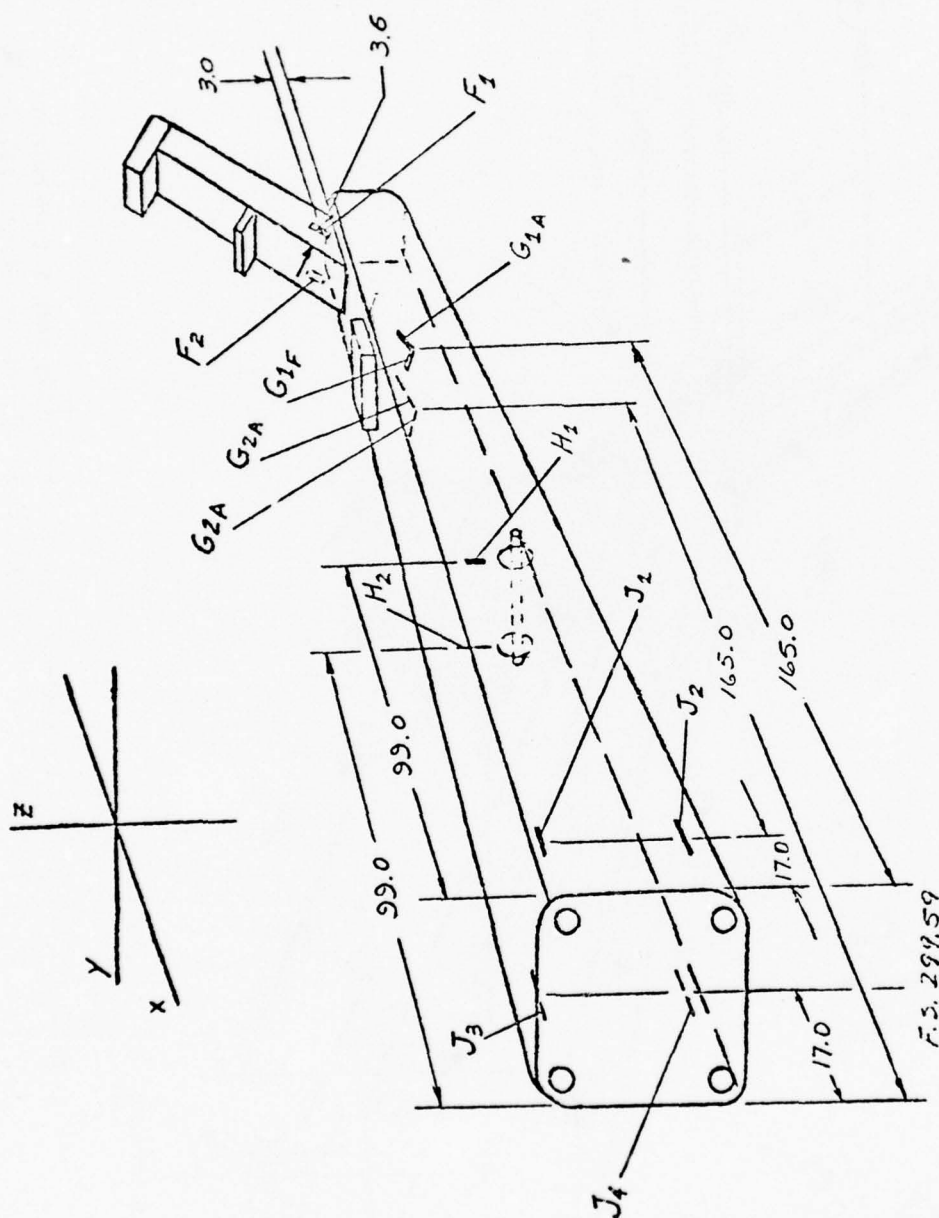
NOTE: F, H, and J gages were used to measure strain, and G gages were used to measure shear.

Figure C-5. Schematic Representation of Strain Gage Locations for the AH-1G Basic Test Tail Boom Structural Tests.

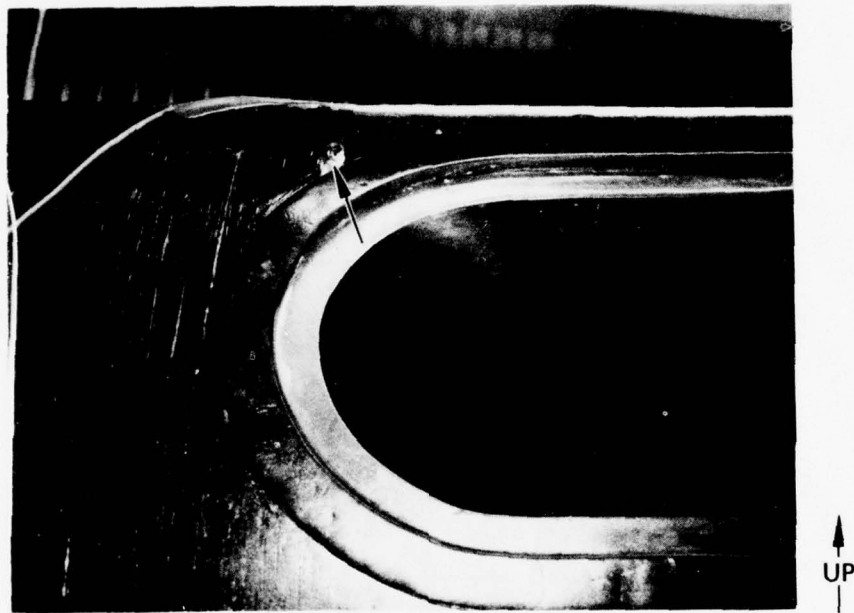
(ARROW) DRILLED IN SIDE OF TAIL BOOM
FOR BULLET HOLE DAMAGE STATIC TEST

Figure C-6. View of Both 0.50-Inch Diameter Holes.

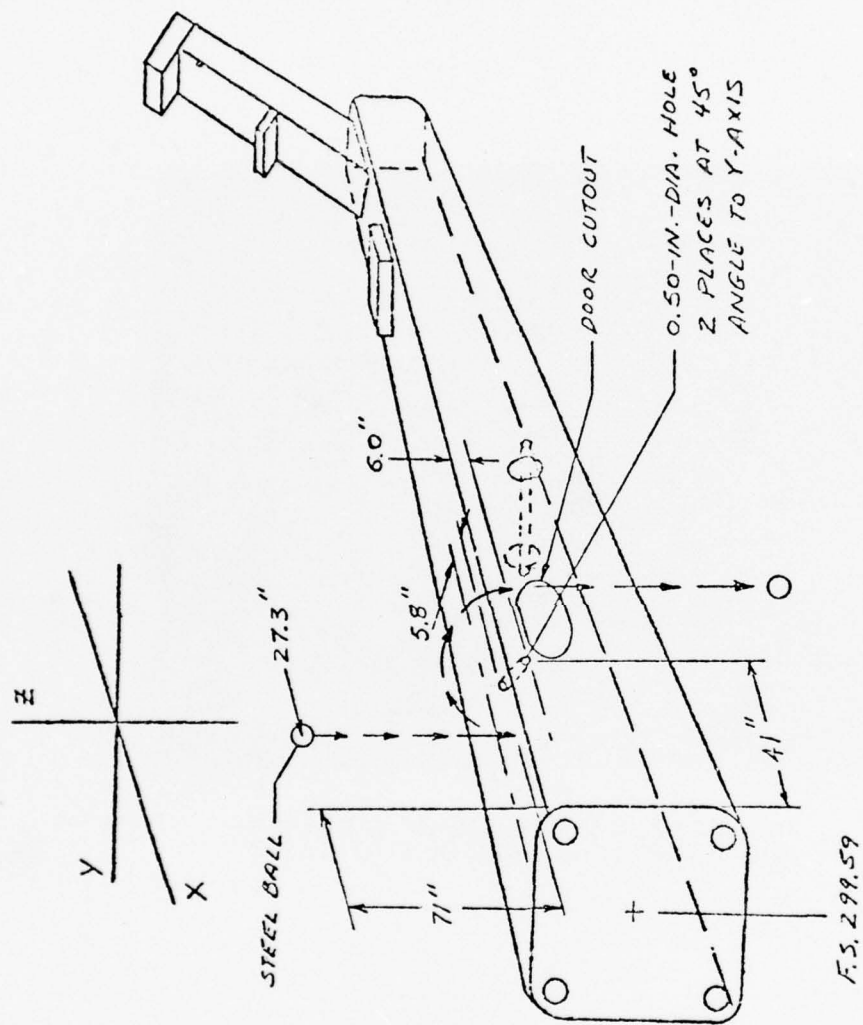
Figure C-7. Schematic Representation of the Location of the 0.50-Inch-Diameter Holes and the Path that the Steel Ball Traveled.

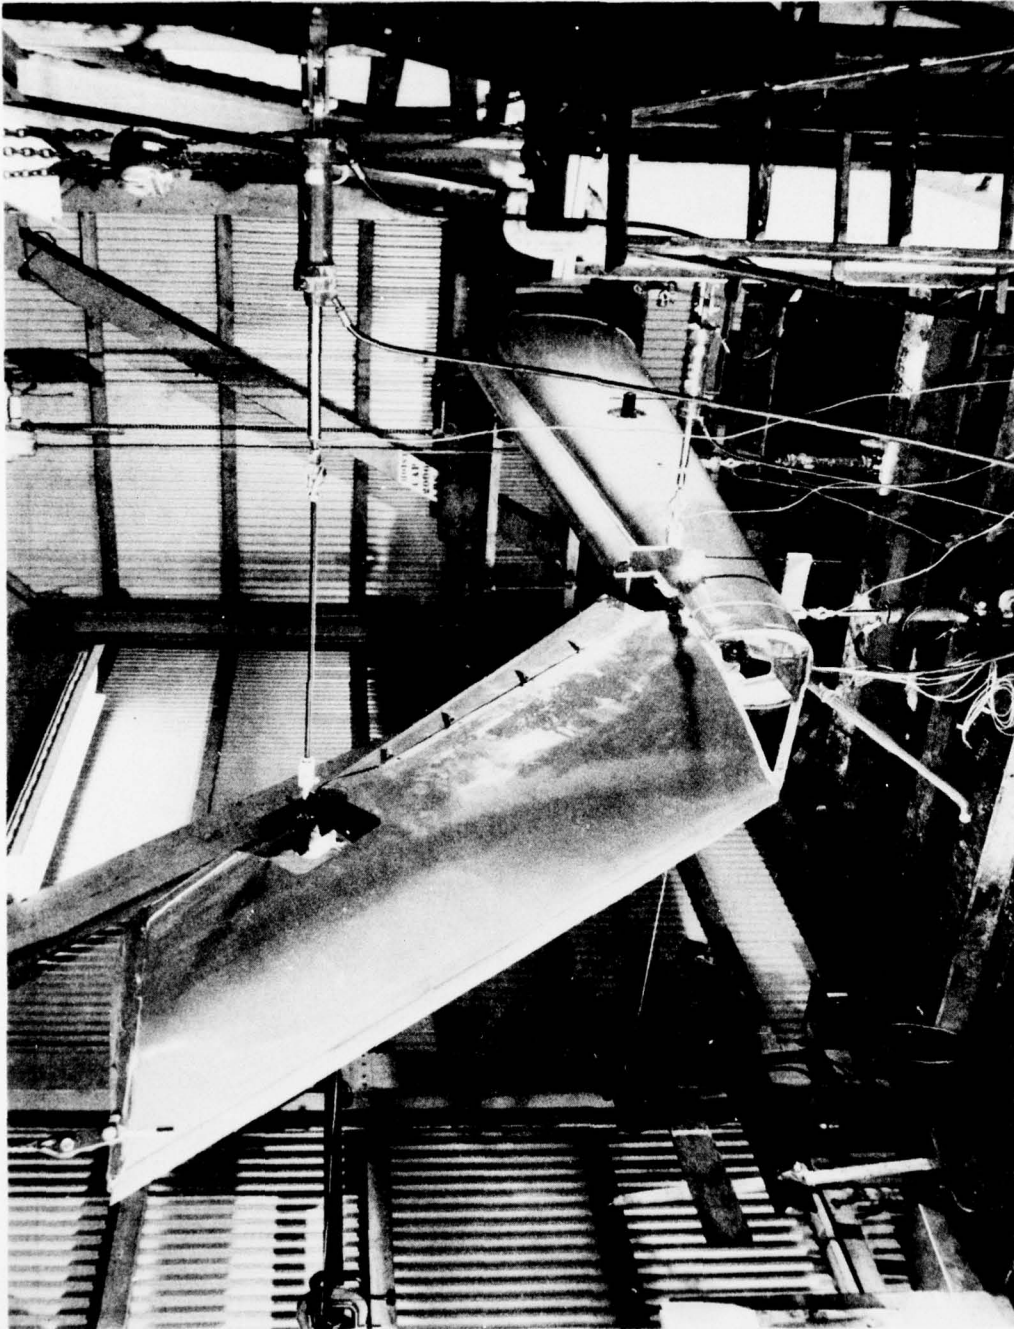
Figure D-1. View of Test Setup of AH-1G Flight Test Tail Boom Static Proof Test.

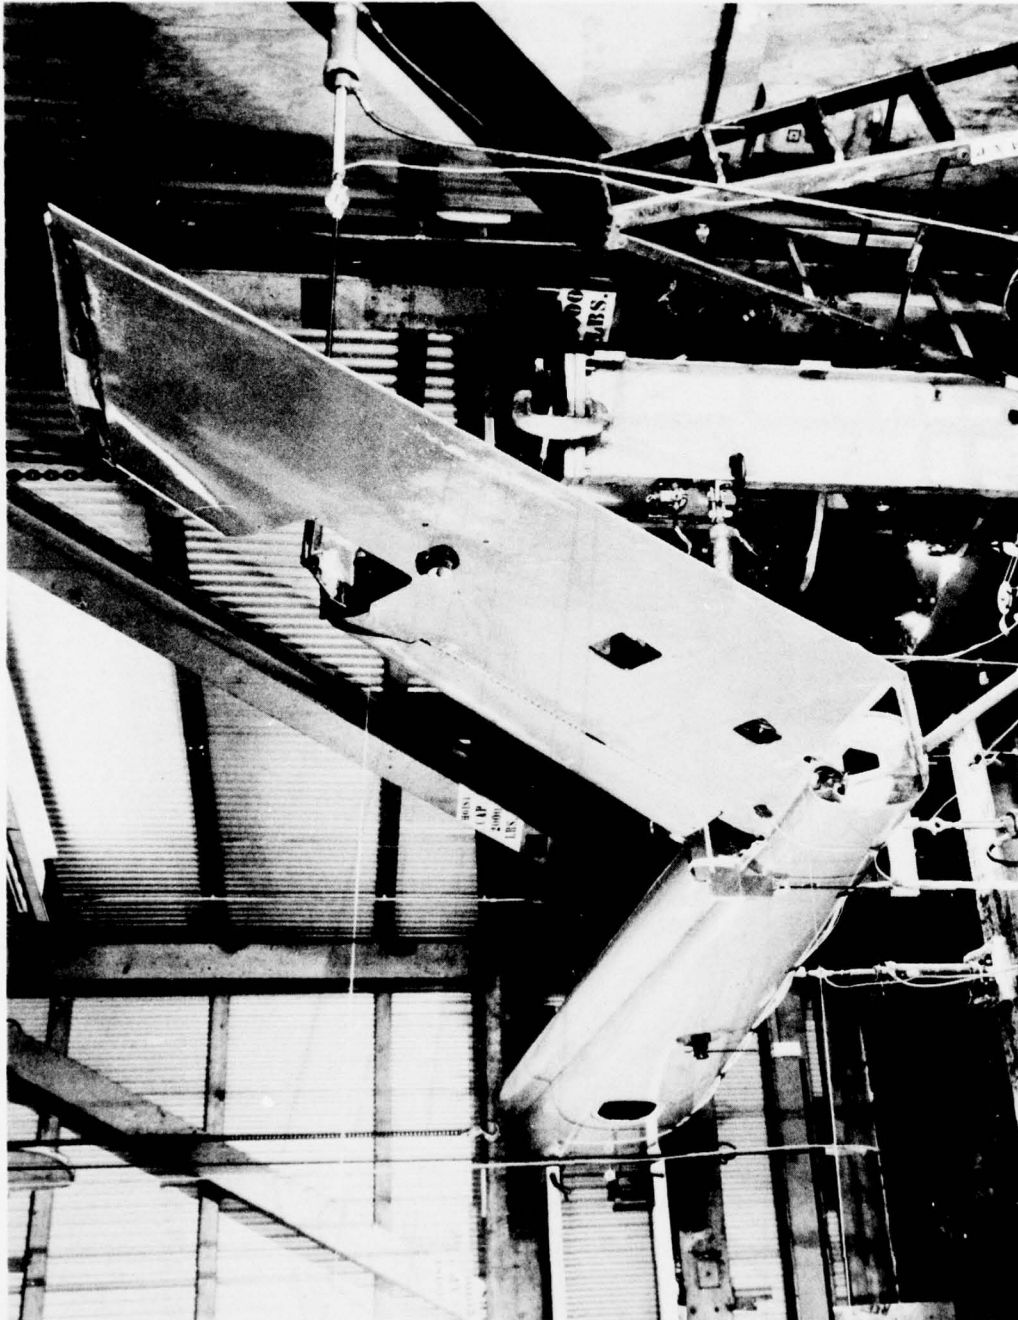
Figure D-2. View of Test Setup of AH-1G Flight Test Tail Boom Static Proof Test.

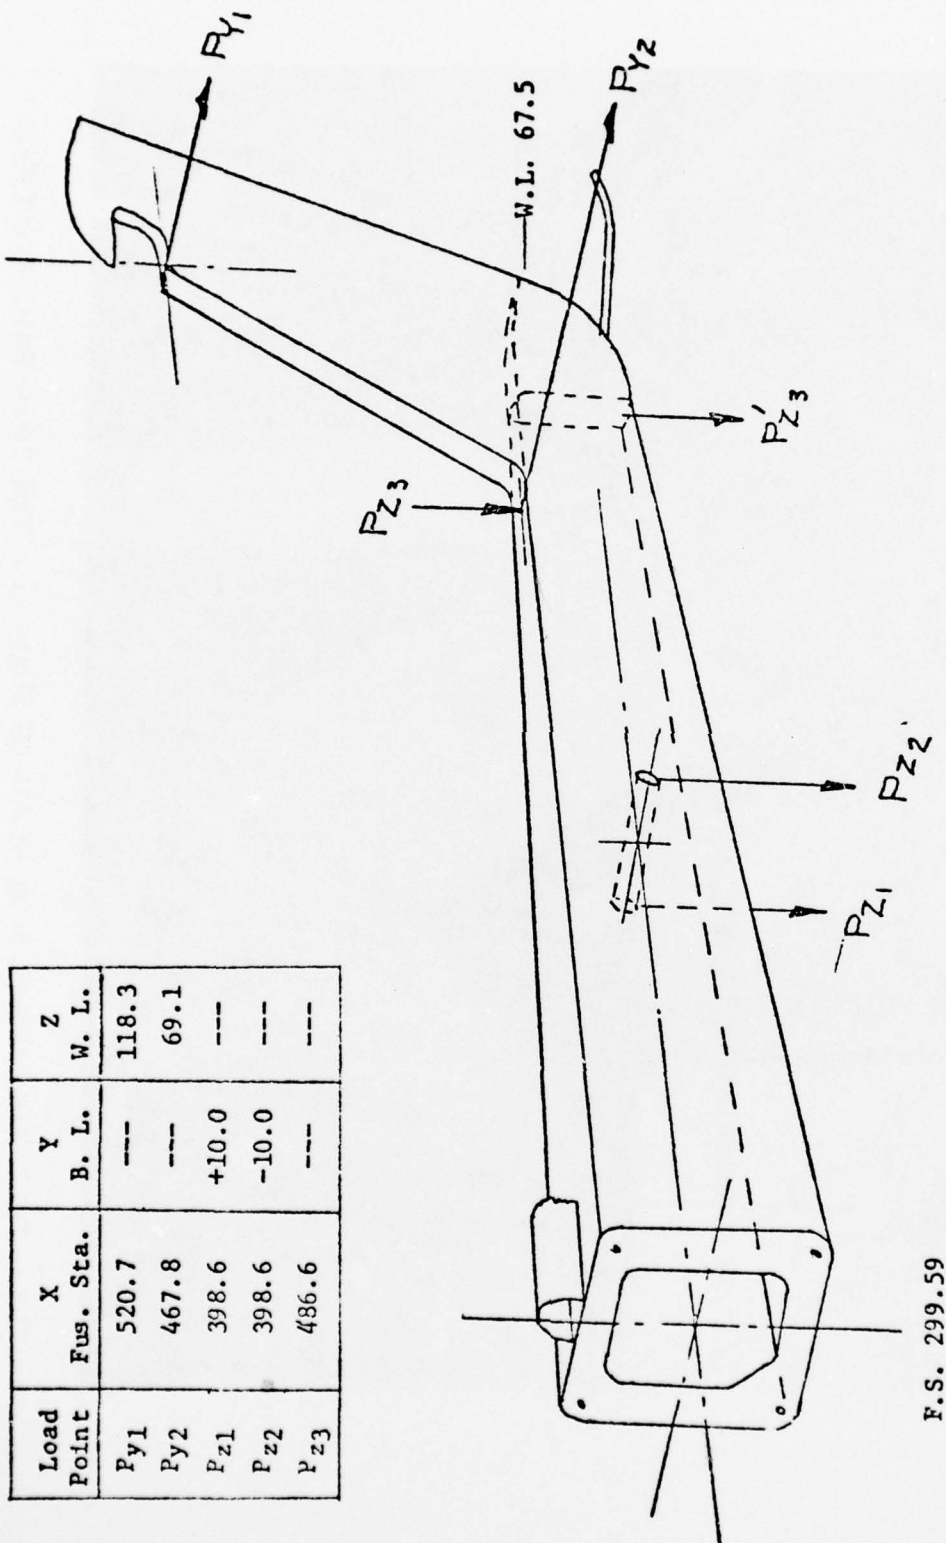
Figure D-3. Schematic Representation of Load Point Locations and Load Direction for the AH-1G Flight Test Tail Boom Structural Test.

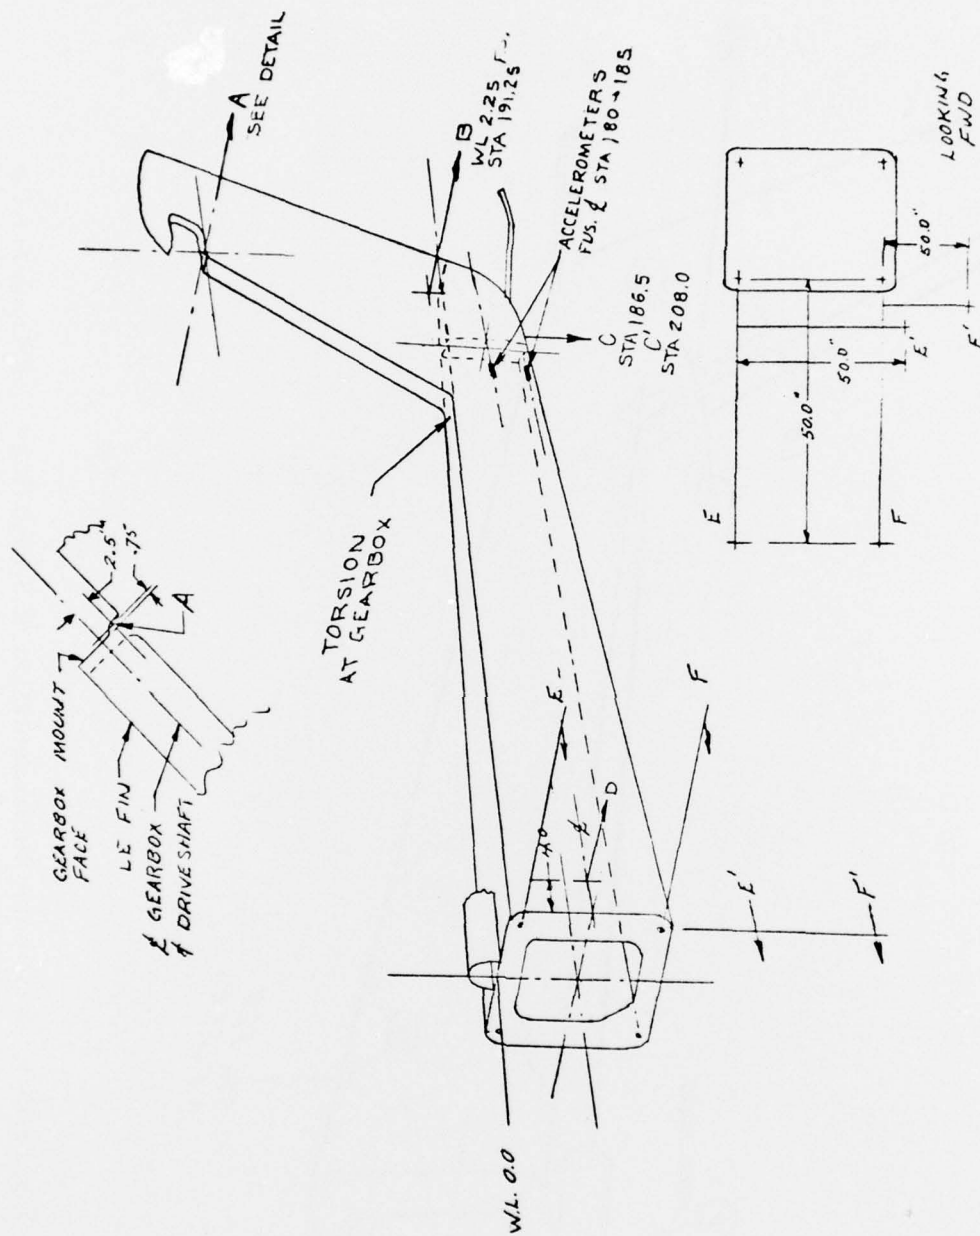
Figure D-4. Schematic Representation of Deflection and Accelerometer Locations for the AH-1G Flight Test Tail Boom Structural Test.

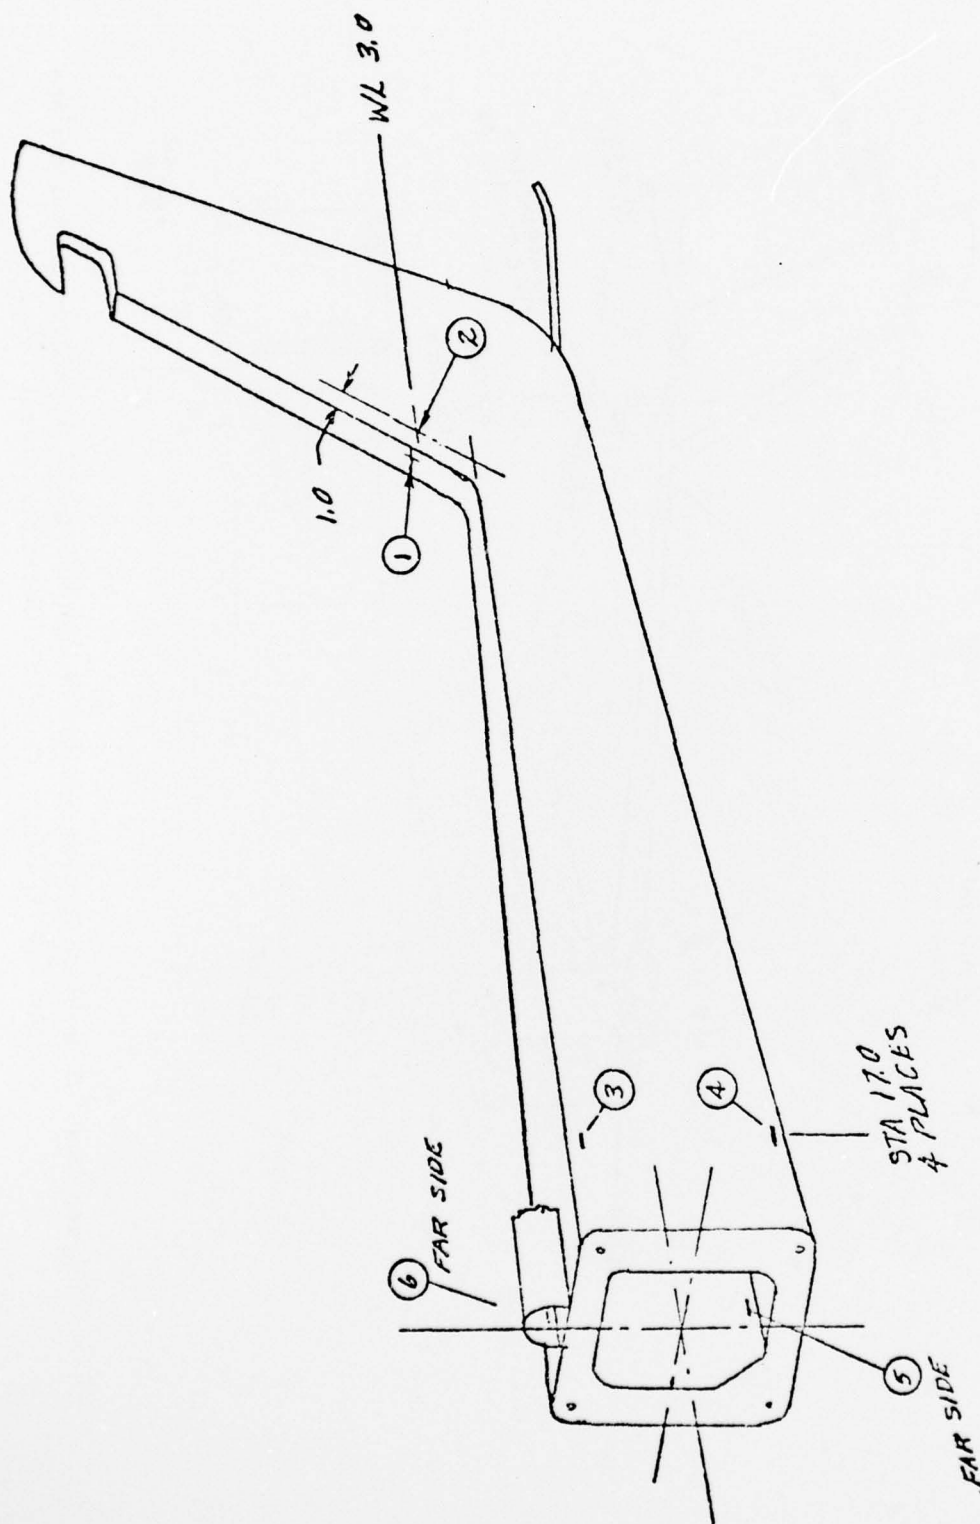
Figure D-5. Schematic Representation of Strain Gage Locations for the AH-1G Flight Test Tail Boom Structural Test.

③ See Figure D-5 for location of strain gages - positive indicates tensile strain.
