IMPACT DAMAGE IN CARBON/CARBON COMPOSITES

Technical Report

7. AUTHOR(s) A. G./Evans, W. F./Adler and J. C./Chesnutt		6. PERFORMING ORG. REPORT NUMBER SC5076.2TR
9. PERFORMING ORGANIZATION NAME AND ADDRESS Rockwell International, Science Center, Thousand Oaks, CA 91360		8. CONTRACT OR GRANT NUMBER(s) N00014-76-C-0854

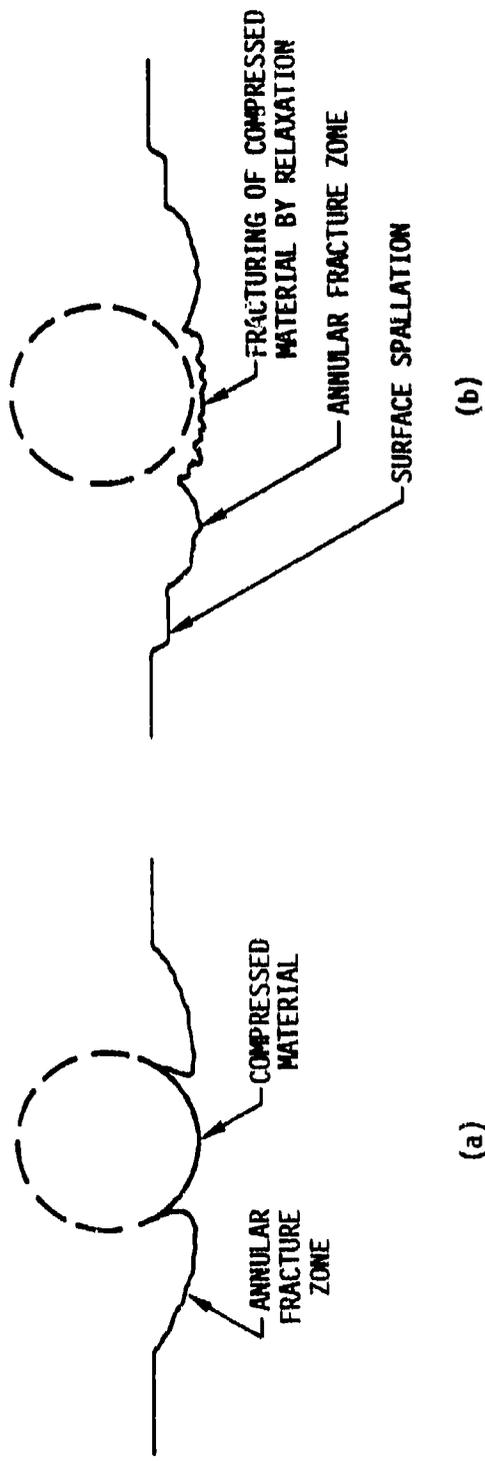
Fig. 1

1000 $\mu$ m Nylon Bead Impacting ATJ-S Graphite at 6 kfps

For ATJ-S graphite at low impact velocities (a 1 mm glass bead impacting at 300 m/s) the collision produces an annular fracture zone surrounding what appears to be a pedestal of compressed material (Figure 1a). In some cases a portion of the material in the annular fracture zone remains in place (displaying a petaled appearance) but is nearly completely separated from the bulk material. At slightly higher velocities the central pedestal begins to be removed and the configuration of the cross section changes, as shown in Fig. 1b. A relatively smooth annular region can be identified in most cases (to be referred to as surface spallation) surrounding the deeper fracture annulus. The high speed photographic sequence in Fig. 2 shows the development of an outward conical spray of material from the surface and a schematic representation of how this configuration may come about is shown in Fig. 3.

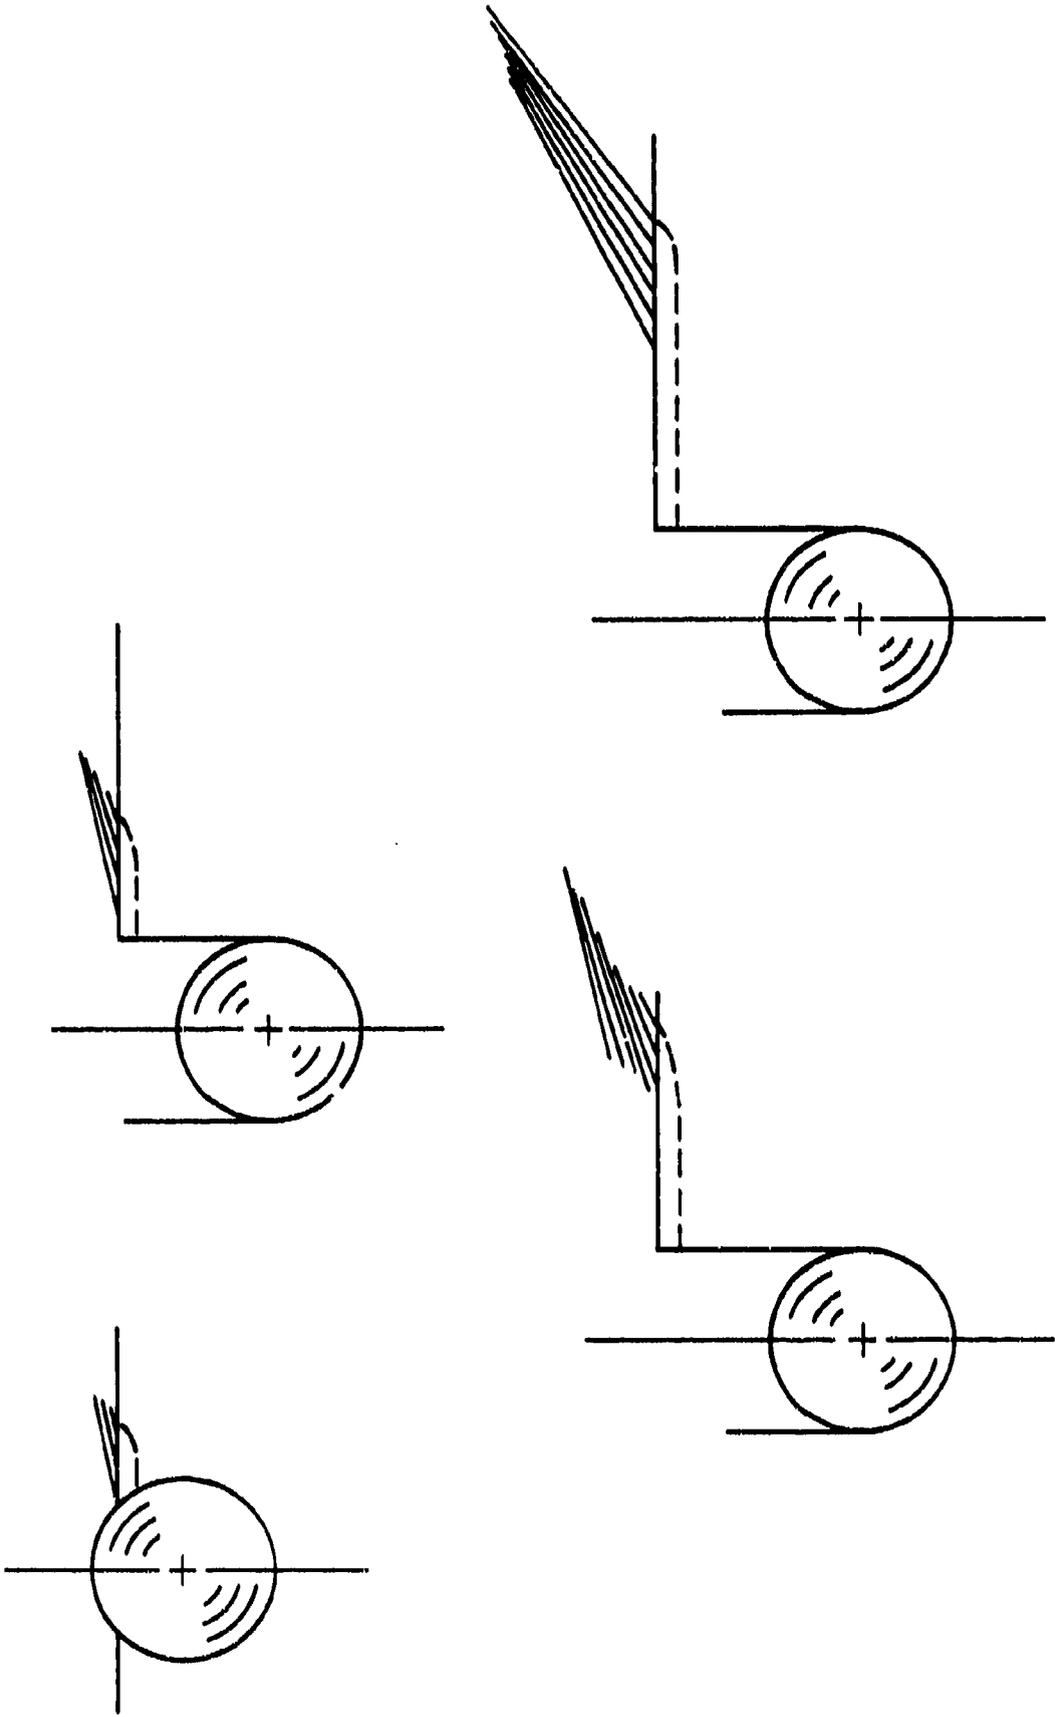
Fig. 3

- Fig. 3. A schematic of the temporal development of the spalled region for ATJ-S graphite.
- Fig. 4. A schematic of the penetration dynamics after the formation of the spalled region.

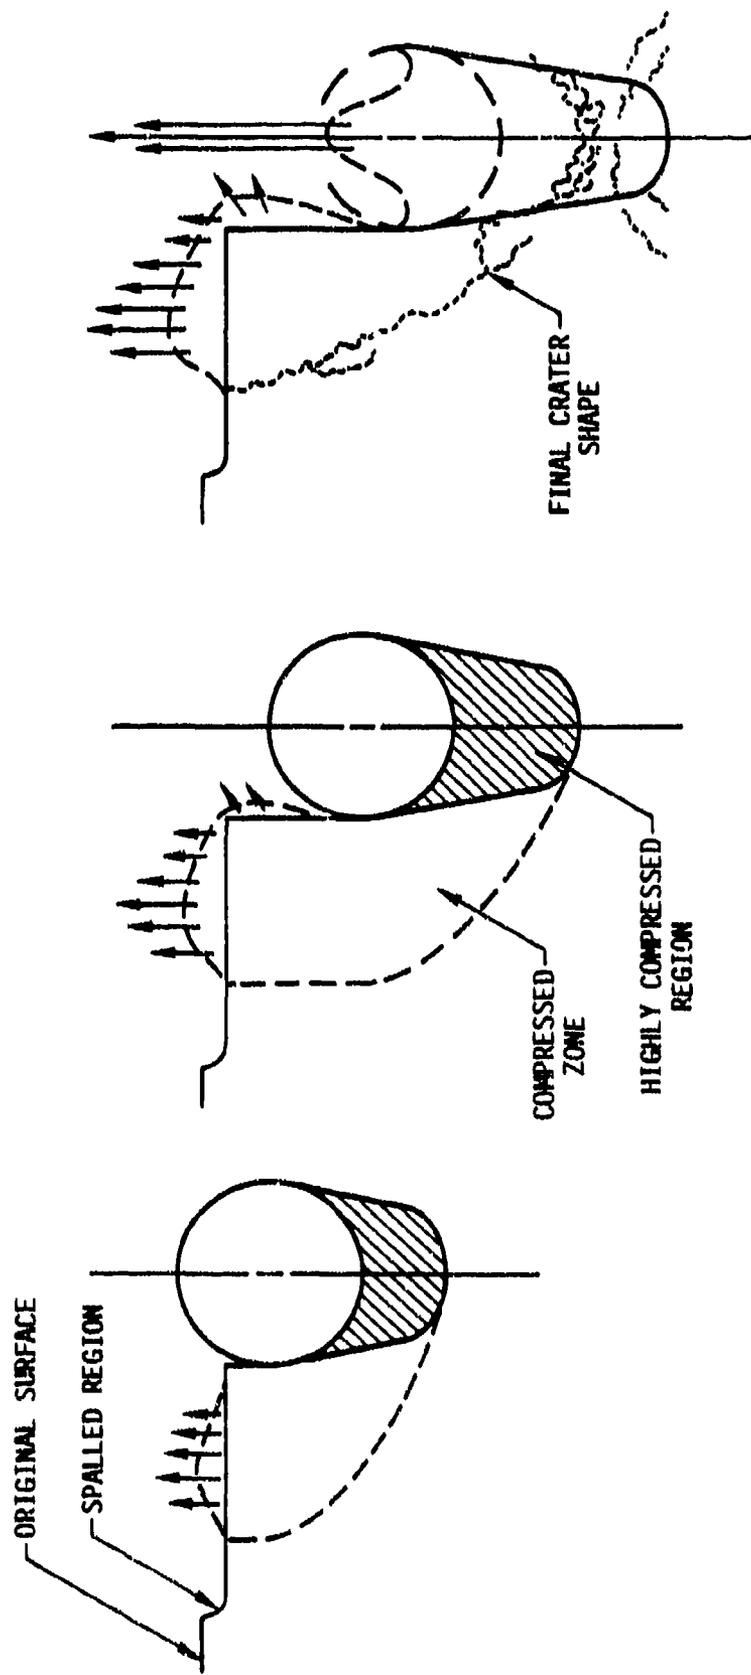
Fig. 4

PENETRATION DYNAMICS

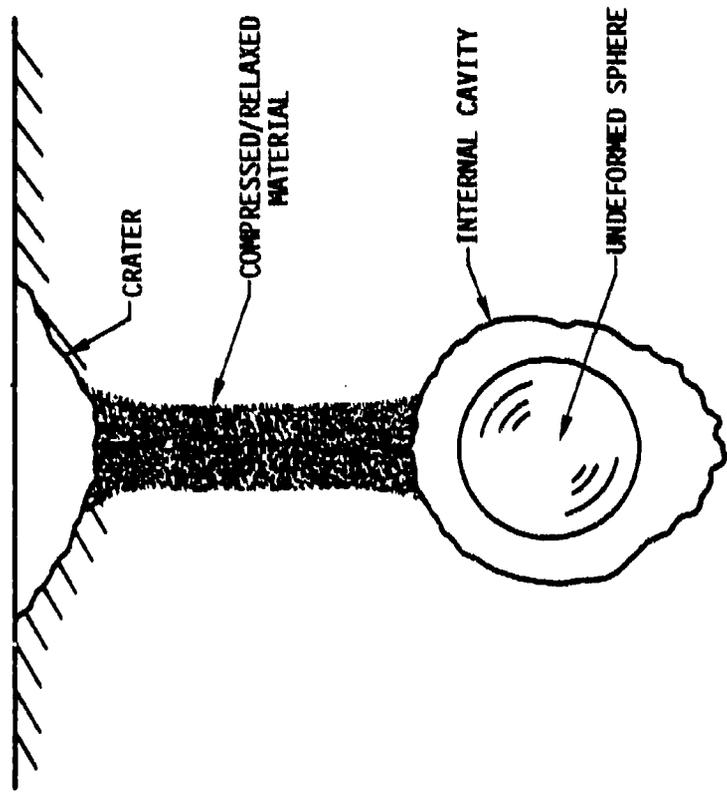
Fig. 5

1000 $\mu\text{m}$  Nylon Bead Impacting ATJ-S Graphite at 6 kfps

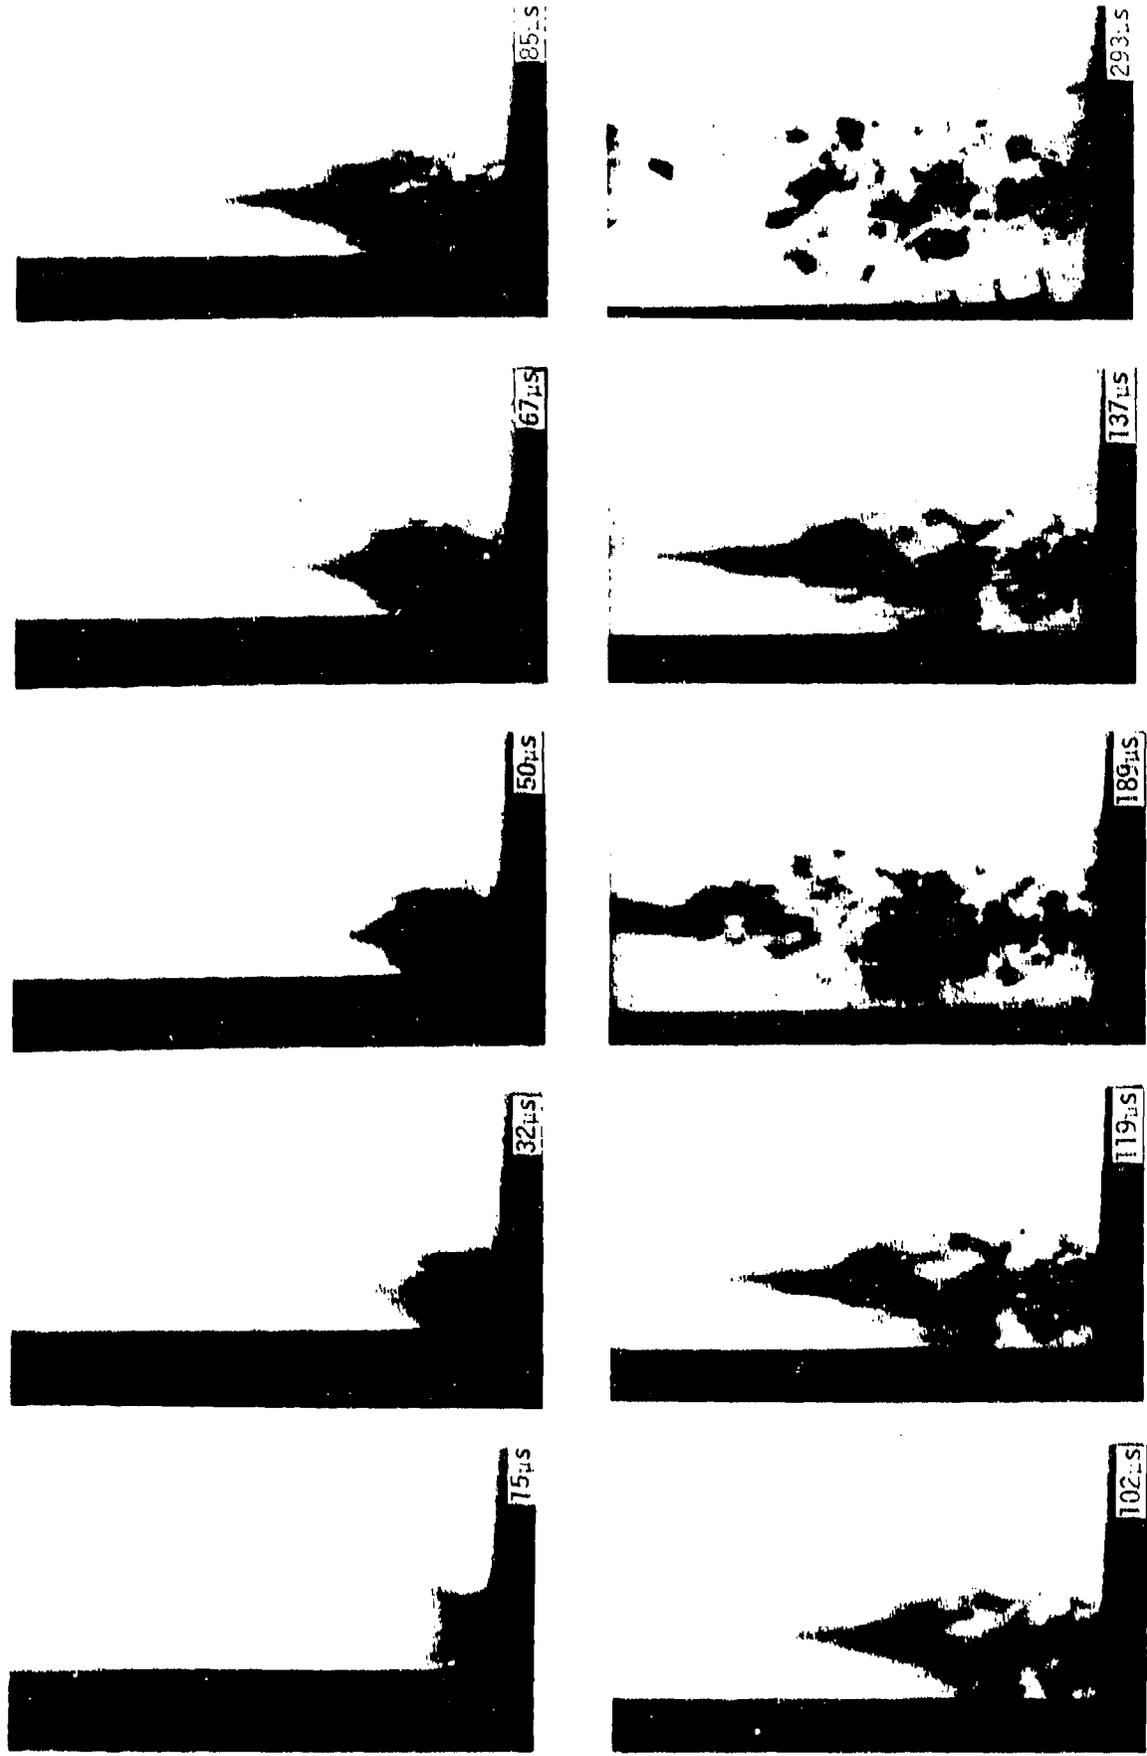
Figure 6

The high speed photographs show an outpouring of material along the perpendicular to the surface of the target as depicted in Fig. 6. This phase of crater formation becomes more important as the velocity increases; but, even at relatively low impact velocities (e.g.,  $2000 \text{ ms}^{-1}$  for a 1 mm glass sphere impacting ATJ-S), it continues for more than an order of magnitude longer than the particle spray phase described earlier. Tensile stresses sufficient to produce cohesive failures in the target exist at depths well below the penetration depth; however, not all of the material affected by the impact becomes ejected before the material in the vicinity of the impact zone can relax to its new equilibrium state. Fractured but non-ejected material is seen below the crater on microradiographs of X-ray opaque impregnated sections of ATJ-S graphite.

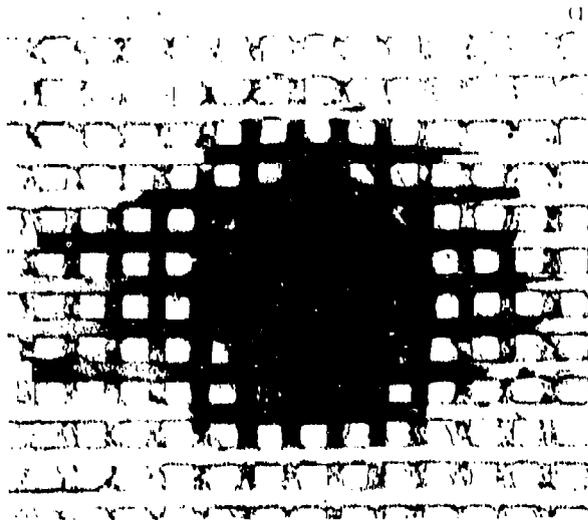
Figure 12

- Fig. 12. An optical overview of the damage to 223 carbon-carbon impacted at  $3700 \text{ ms}^{-1}$  by a 1 mm glass sphere, (a) polished, (b) polymer impregnated and polished.

The surface spallation observed for ATJ-S graphite takes on a very preferential nature for 223 carbon-carbon as shown in Fig. 12 and is now manifested as a stripping of the surface fibers. The longitudinal wave speeds in the fibers are higher than those for the laminated series of transverse fibers and matrix material. In 223 the set of lateral fibers exposed on the surface will be subjected to this stripping action. The specimens shown in Fig. 12 were specially prepared. The specimen in Fig. 12(a) was metallographically polished and the specimen in Fig. 12(b) was thoroughly impregnated with epoxy and then metallographically

polished. These same surface features occur in normally prepared specimens but the fiber stripping is less uniform. By filling the voids and general defects in the composite's microstructure with epoxy an excellent pattern is achieved showing the extent of the damage due to surface shock interactions. Both of these surfaces were photographed prior to impact. In both cases the extent of the damage appears to be quite localized and no fine-scale damage was observed beyond the area encompassed by the fiber stripping boundary.

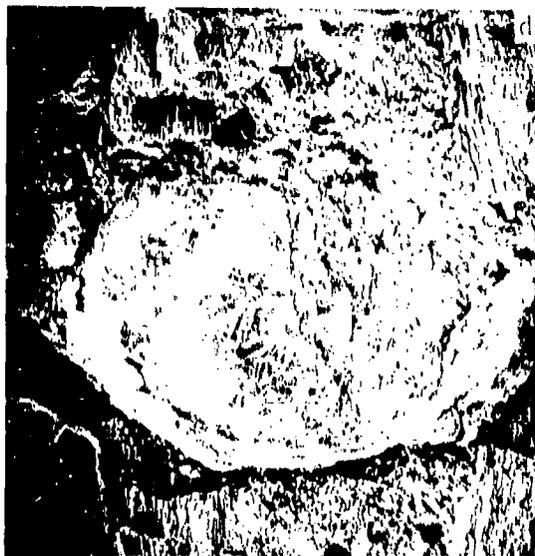
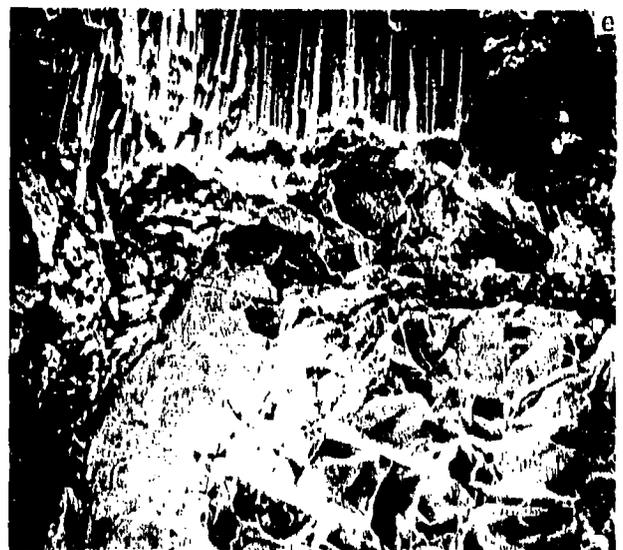
Figure 13

- Fig. 13. Scanning electron micrographs of the damage on the impact surface on 223 material created by 1 mm glass projectiles, (a) a  $1300 \text{ ms}^{-1}$  impact showing the retained projectile, (b) a  $2000 \text{ ms}^{-1}$  impact showing a larger central

damage zone, (c) a  $2700 \text{ ms}^{-1}$  impact showing the formation of the outer ledge, (d) an enlargement of (a) showing the fragmentation of the glass projectile, (e) a further enlargement of (a) showing the accommodation of the projectile by the target material.

A sequence demonstrating the development of the impact damage at low temperatures (0 - 2500°C), as a function of projectile velocity (for 1 mm glass projectiles), is presented in Figs. 13,14. At velocities below  $\sim 2000 \text{ ms}^{-1}$  the projectile is retained by the target (Figs. 13,a,b,d,e) and the crater consists primarily of a central zone that accommodates the penetration of the projectile (Figs. 13,d,e). However, at higher velocities (Figs. 13c,14a,b) the projectile is ejected, and the crater contains an outer ledge in addition to a more deeply penetrating central zone. Also, as already noted, surface stripping of the lateral bundles (Fig. 14a) is an additional damage mode that becomes manifest at the higher velocities. Close inspection of the central zone (Fig. 15) indicates the existence of accommodation damage; this clearly suggests that the central zone is related to the penetration of the projectile (as at the lower velocities). An initial evaluation of the effect of microstructure (see Table I) on the damage morphology (Fig. 16) indicates that the central penetration zone tends to increase in depth, while the outer ledge diminishes in width, as the proportion of longitudinal fibers increases. Kinking of certain lateral fiber bundles near the crater periphery is also apparent in certain microstructures (Fig. 17a), and the presence of short lengths of longitudinal fibers laterally displaced away from the impact center (Figs. 17b) is commonly observed on longitudinal bundles in the crater ledge.

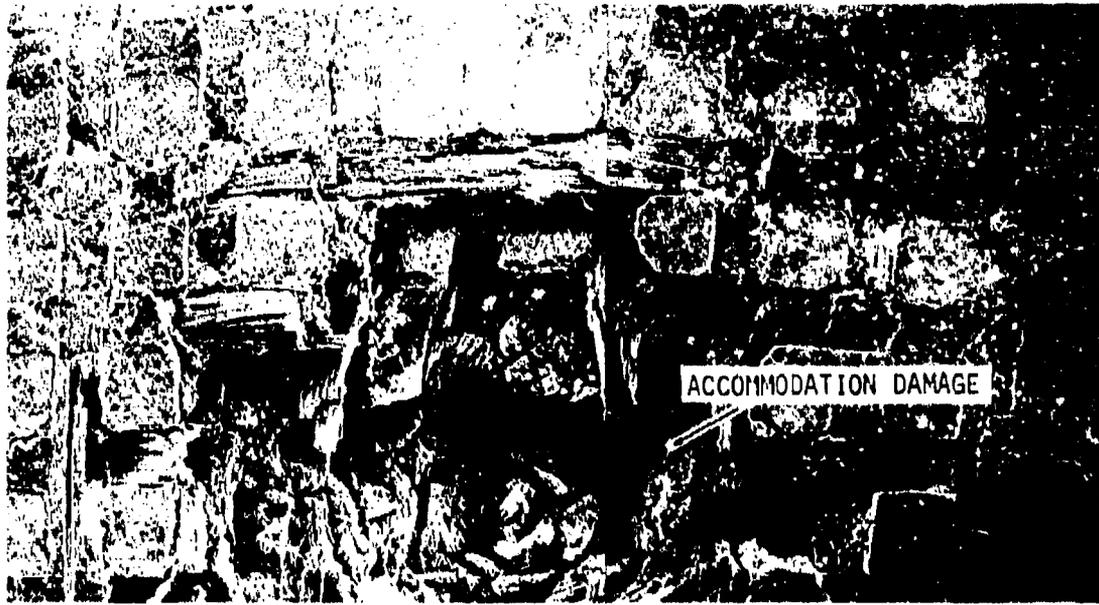
Figure 15

- Fig. 15. A scanning electron micrograph of a  $4,000 \text{ ms}^{-1}$  impact on 223 material illustrating the accommodation damage at the base of the central penetration zone.

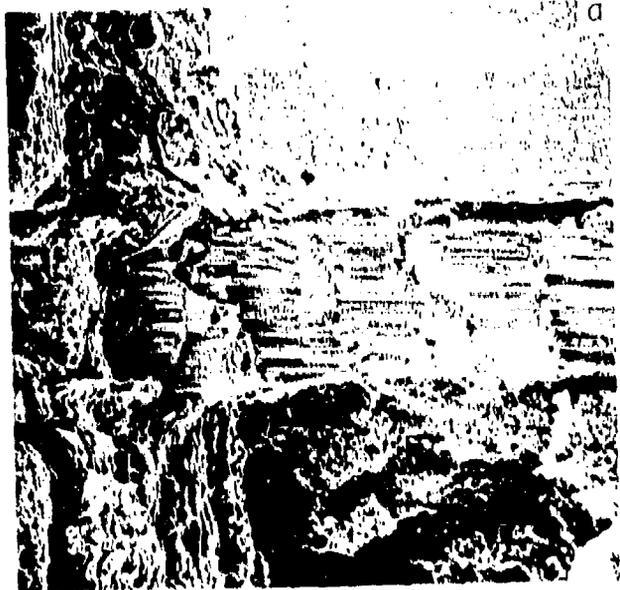
Figure 17

- Fig. 17. Scanning electron micrographs of damage details, (a) lateral fiber bundle kinking in 115, (b) fractured fibers observed on the longitudinal bundles in the outer ledge.

The peak tensile stress,  $\sigma_m$ , occurs at two locations (A or A' in Fig. 42). However, the fracture process would dominate at one of these locations, leaving a partial fracture at the other location. This process may account for the short fiber segments observed on the fractured longitudinal fibers in the outer ledge (Fig. 17b). The magnitude of the peak tensile stress is given by:<sup>14</sup>

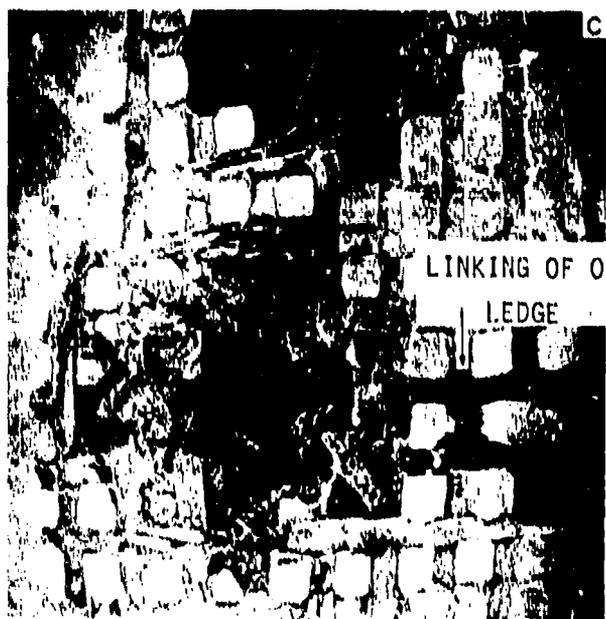
Figure 18

- Fig. 18. Impact damage on 223 material created by deformable projectiles, (a) 1 mm Nylon projectiles at  $2700 \text{ ms}^{-1}$ , (b) water drop at  $4000 \text{ ms}^{-1}$ , (c) three adjacent water drops at  $4000 \text{ ms}^{-1}$  showing the linking between damage zones.

The damage created by deformable projectiles (water or Nylon) has most of the same features (Fig. 18), although there is little evidence of accommodation damage in the central zone. Under multiple impact conditions (Fig. 18c), linking of the outer ledge damage zones occurs at closely spaced impacts.

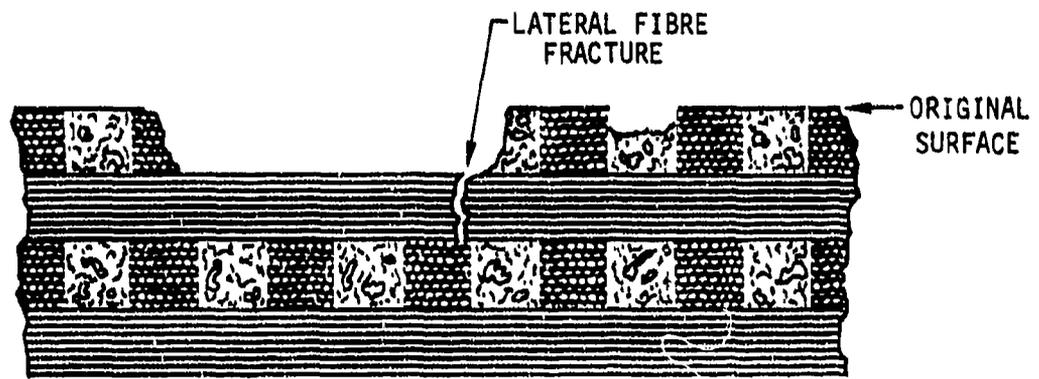
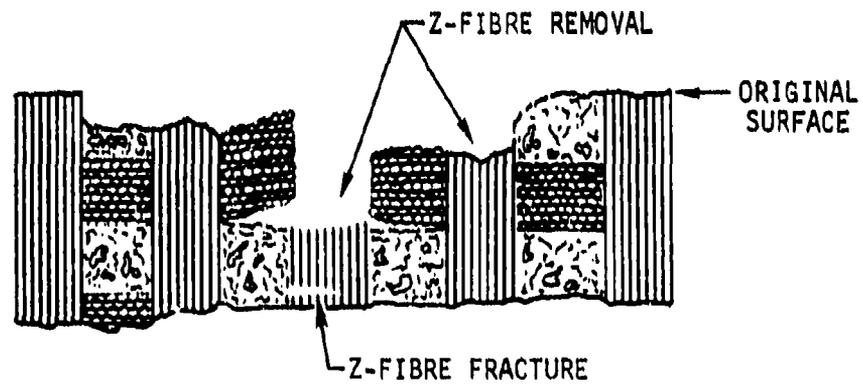
Fig. 22

Near the crater periphery, the damage is quite different (Fig. 22). There is no apparent kinking, but two modes of fracture occur. Firstly, the lateral fibers fracture on planes near the surface (Fig. 27). Secondly, the longitudinal fibers fracture (Fig. 28) almost invariably at sites adjacent to an in-plane lateral bundle/matrix interface. The fractures are apparent on planes adjacent to (Fig. 28a) and below (Fig. 28b) the crater surface.

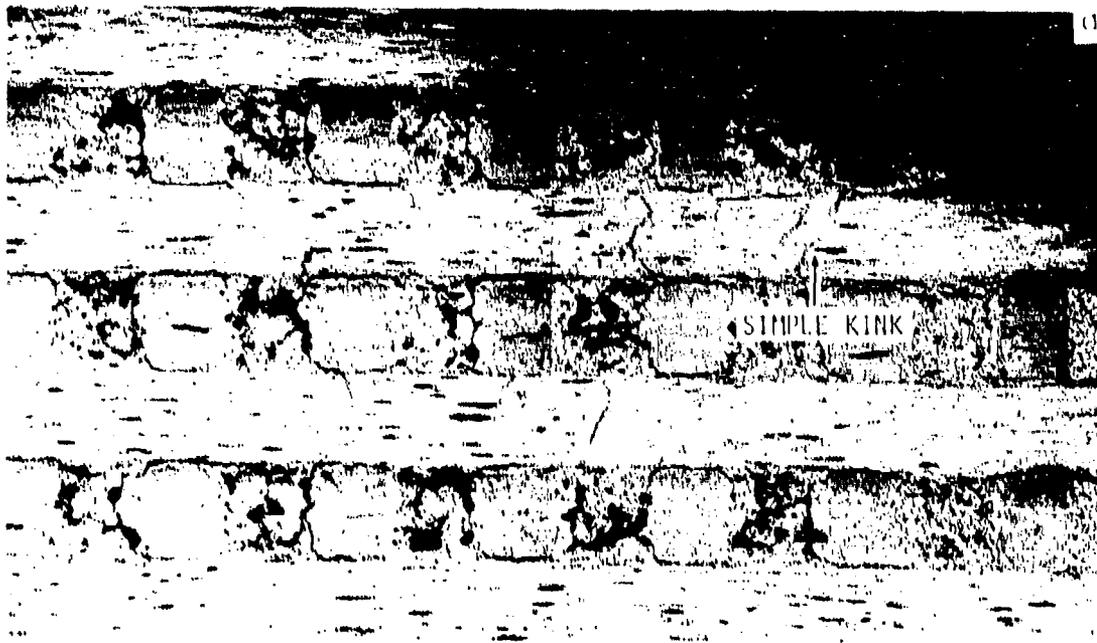
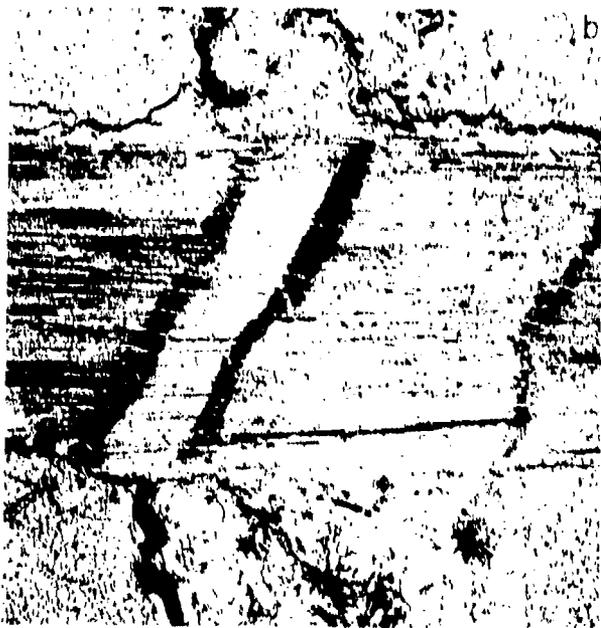
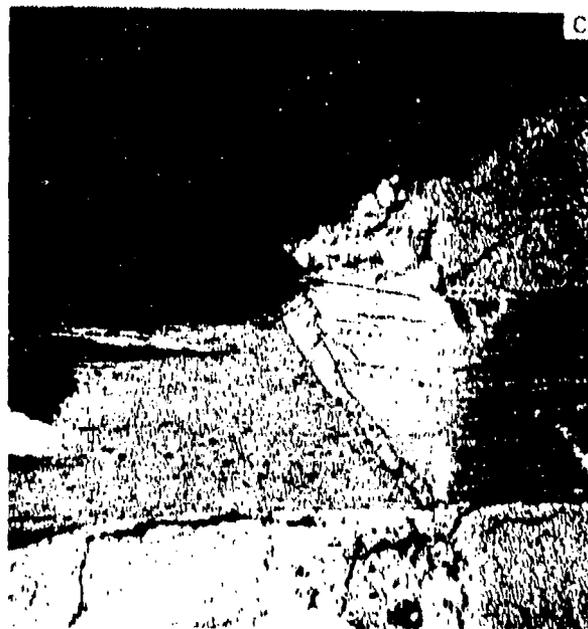
Figure 25

- Fig. 24. A schematic of the kink morphologies.
- Fig. 25. Polarized reflected light micrographs of kinked lateral fibers adjacent to the crater in 223 material.

Kinking occurs when a buckling instability develops.<sup>18</sup> This generates tensile bending stresses in the fiber which exceed the fiber fracture stress at various (statistically distributed) locations along the fiber (Fig. 40). The micromechanics tests have indicated (Section 3.3) that an evaluation of the kinking phenomena in carbon composites might be performed by regarding the bundles as single entities. Further, since the small strain compliance of the lateral fiber bundles and matrix are essentially the same (Section 3), the foundation modulus for small lateral end deflections of the bundles can be considered constant and the buckling problem for the longitudinal bundles can be treated as buckling on an elastic homogeneous foundation. This is consistent with the observations (Fig. 23) that there are no clear relations between the kinking mode and the lateral bundle locations. However, the end deflections for the lateral bundles are larger and an analysis of lateral buckling might require that the orthogonal lateral bundles be regarded as positions of higher stiffness. This might account for the significant proportion of kinks that initiate adjacent to the corners of orthogonal lateral fiber bundles (Fig. 25).

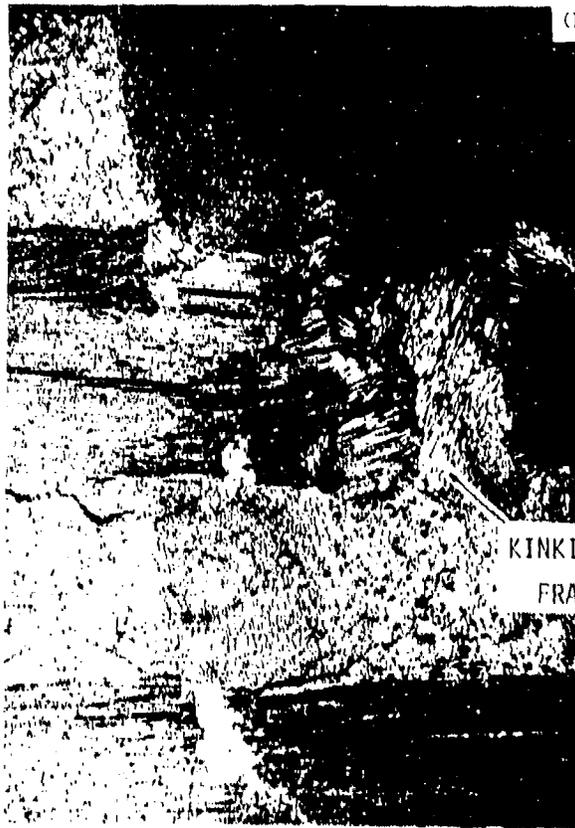
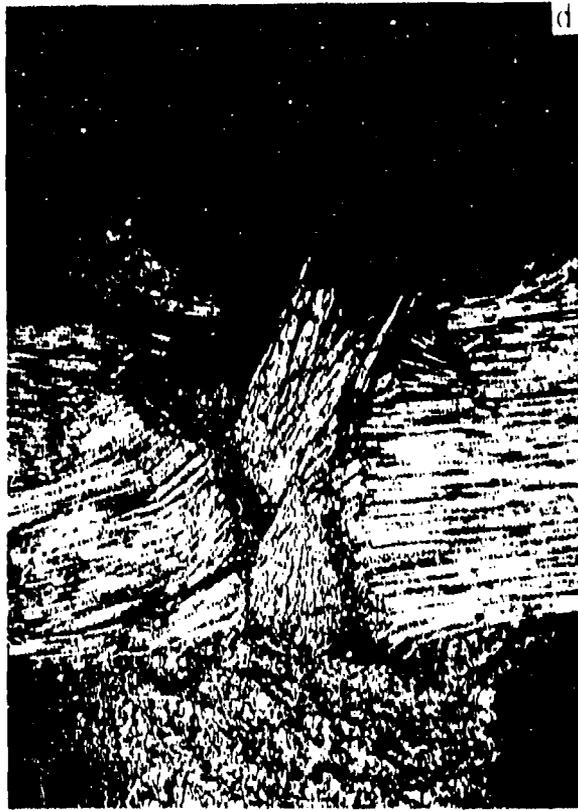
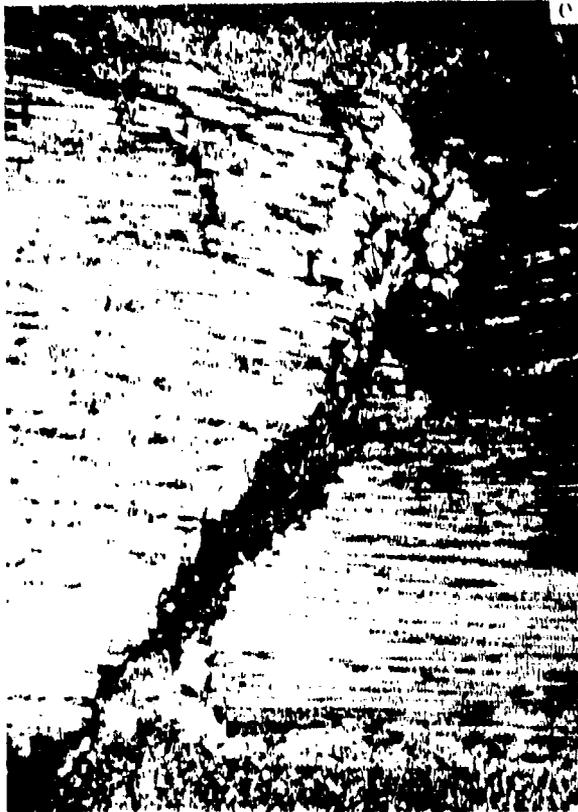
Figure 26

- Fig. 26. Polarized reflected light micrographs of the lateral fiber damage created under the impact center in 223 material.
- Fig. 27. Lateral fiber fractures in 223 material near the crater periphery, (a) a scanning electron micrograph of the uppermost lateral bundle, (b) a scanning electron micrograph of the second lateral bundle, (c) a reflected polarized light micrograph of a section through (a).

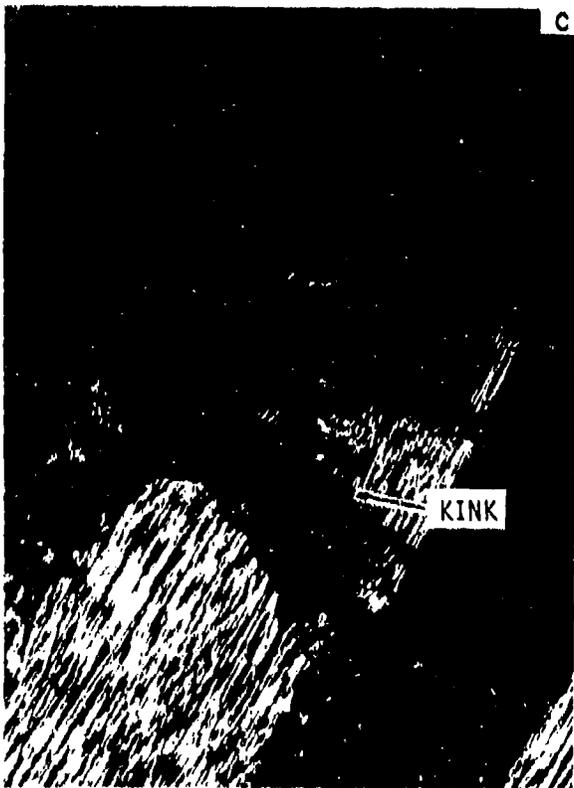
Figure 29

The damage created at low velocities ( $\approx 2500 \text{ ms}^{-1}$ ) has many of the same characteristics as the high velocity damage, except that the kinking is less extensive and different in character. Specifically, the kinking of the lateral fibers is confined to a small zone around the impact center (Fig. 29a) and usually, these kinks do not extend across the entire bundle (Fig. 29b).

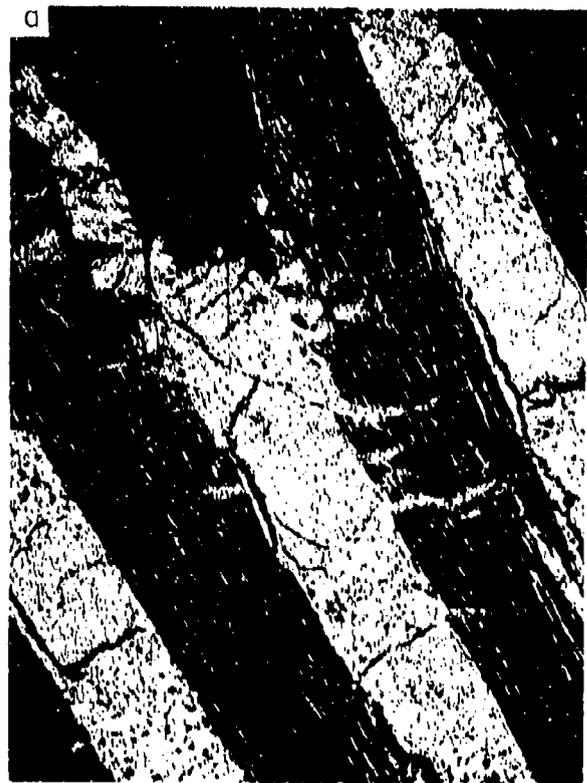
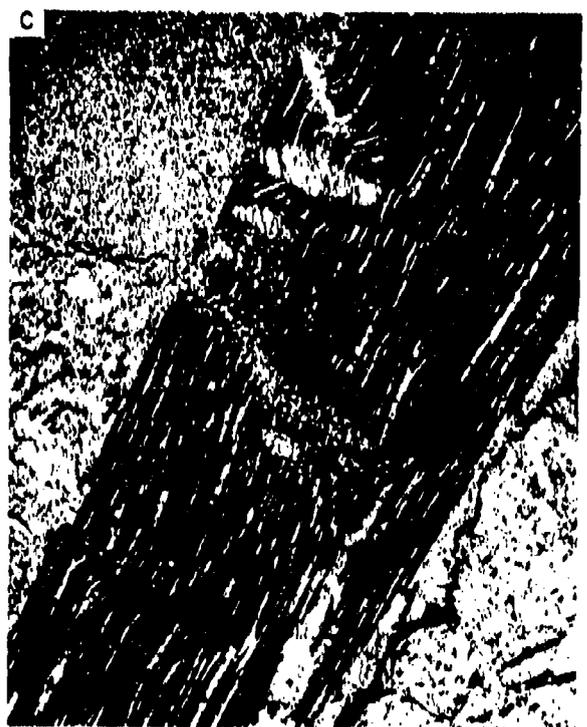
Figure 31

- Fig. 31. Polarized light micrographs of a section through a 223 material impacted at 3600°C by a 1 mm glass projectile at 4000 ms<sup>-1</sup>, (a) overview near the base of the crater, (b) a region to the side of the central zone, (c) a region beneath the central zone.

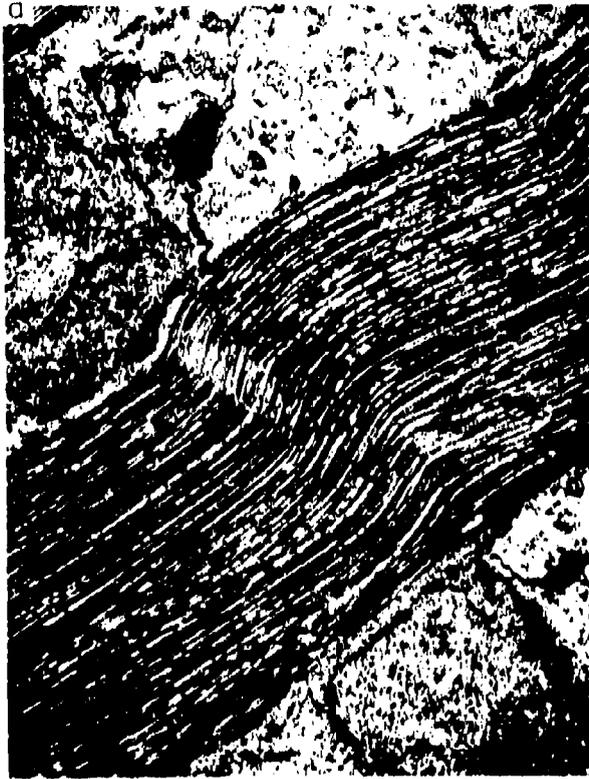
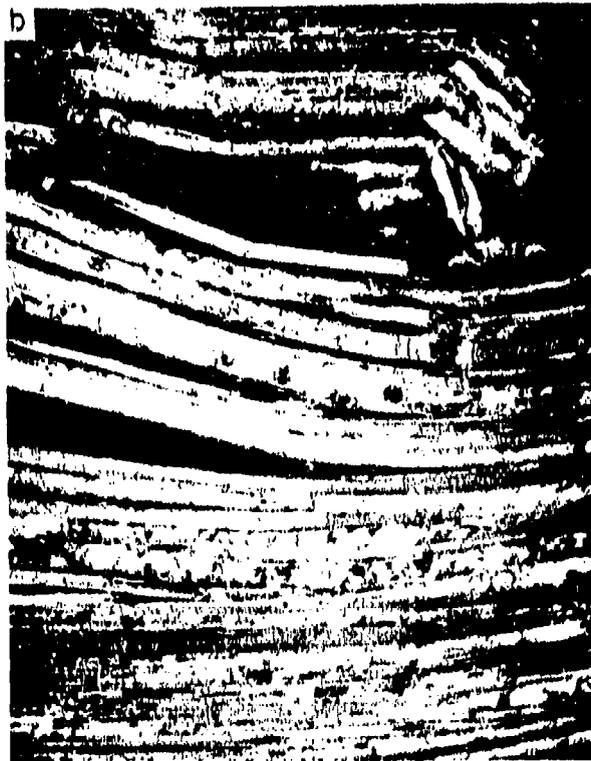
Figure 32

- Fig. 32. Higher magnification view of kinks from the sample depicted in Fig. 31, showing that (a) large localized distortions are accompanied by deformation and fracture, and (b) smaller distortions can occur without fracture.

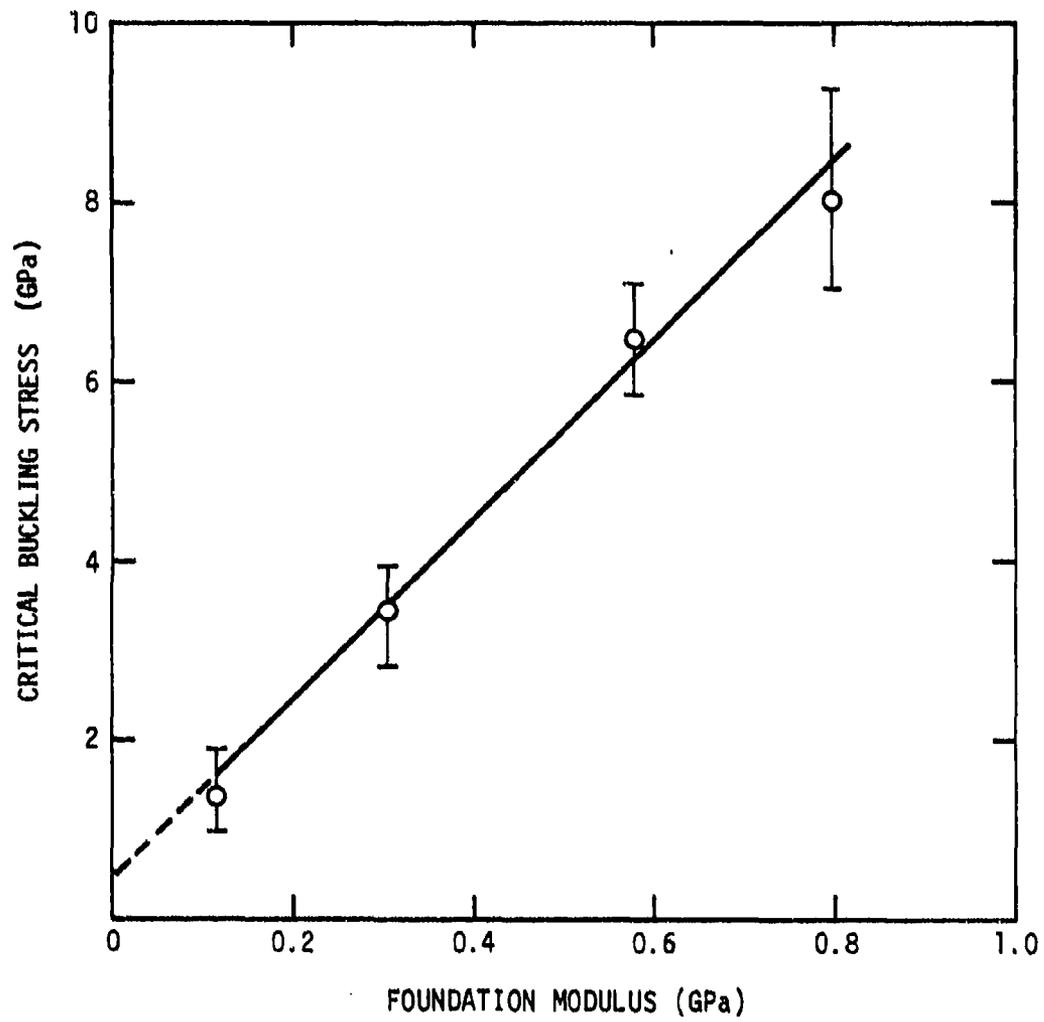
Fig. 39

For complex problems, such as the present impact damage problem, a possible approach for evaluating the effects of microstructure on the primary damage modes is to perform simulated micromechanics tests that allow each damage mode to be studied independently, under well defined boundary conditions. Such an approach has been initiated herein by separating fiber bundles from the composite (to retain the exact state of impregnation experienced within the composite), and then setting individual bundles, or arrays of bundles, into specified matrices. The bundle separation has been achieved using a  $75 \mu\text{m}$  thickness dicing saw with a microscopic aligning system. Initially, individual bundles have been set into epoxy matrices and buckling, under conditions of uniform compression, has been examined. Critical buckling stresses  $\sigma_b$  were obtained by direct optical observation. The relation between the buckling stress and the matrix modulus obtained for a range of matrices is plotted in Fig. 39.

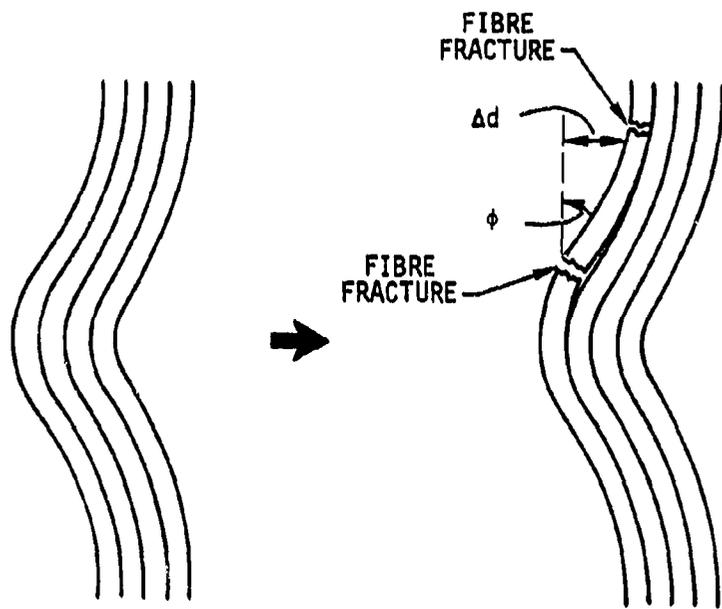
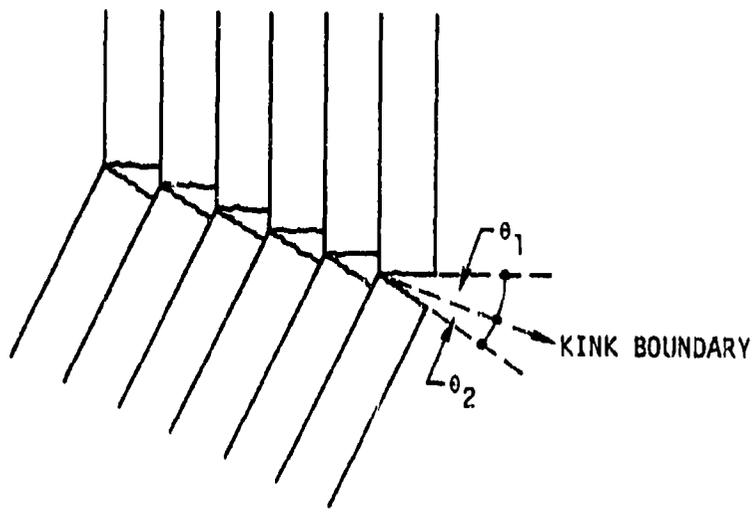
Fig. 41

Fig. 41. A schematic of the buckling and kinking process, (a) the initial buckled configuration, (b) kink initiation by fiber fracture at the interface, (c) kink propagation by sequential fiber fracture.

a) BUCKLED CONFIGURATION

b) KINK INITIATION

c) KINK PROPAGATION

Firstly, examine the kink initiation process (Fig. 41b). The initial fiber fracture essentially establishes the kink orientation and thus, determines the strain energy due to kinking that resides in the matrix; at this stage, the strain energy changes that occur in the fiber bundle are relatively small. To illustrate the analysis a preliminary two-dimensional approximation for the kink orientation  $\phi$  is derived by evaluating the orientation which yields the maximum release of shear strain energy within the matrix. The matrix shear strain energy,  $U_b$ , in the initial buckled state, for a sinusoidal buckle in a through-thickness fiber (or laminate) of unit thickness is (Appendix II)

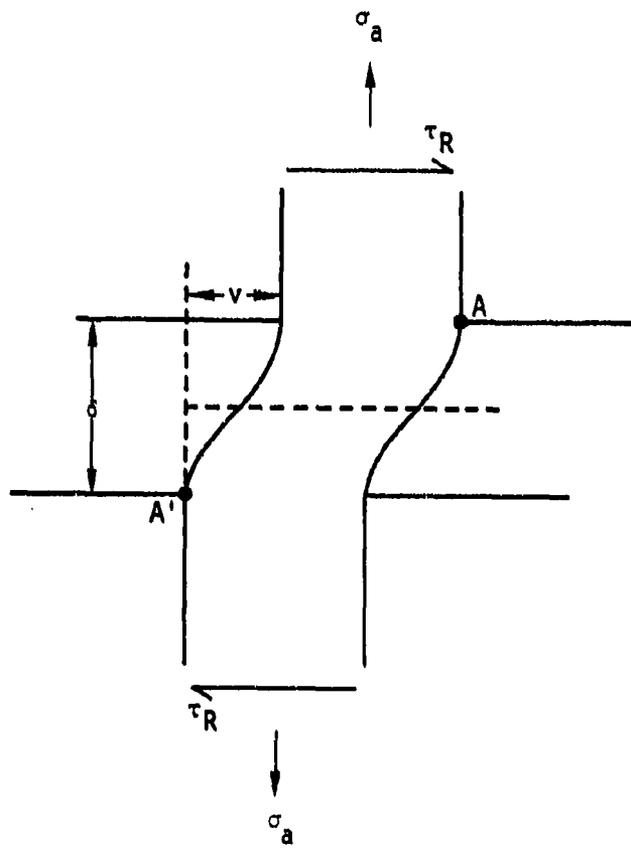
Fig. 42

Fig. 42. The deformation of a beam subjected to combined shear and tensile loading.
