AFRPL-TR-76-95

STORABILITY INVESTIGATIONS OF WATER
LONG-TERM STORAGE EVALUATION
THIRD ANNUAL REPORT

AEROJET LIQUID ROCKET COMPANY
SACRAMENTO, CALIFORNIA

DECEMBER 1976

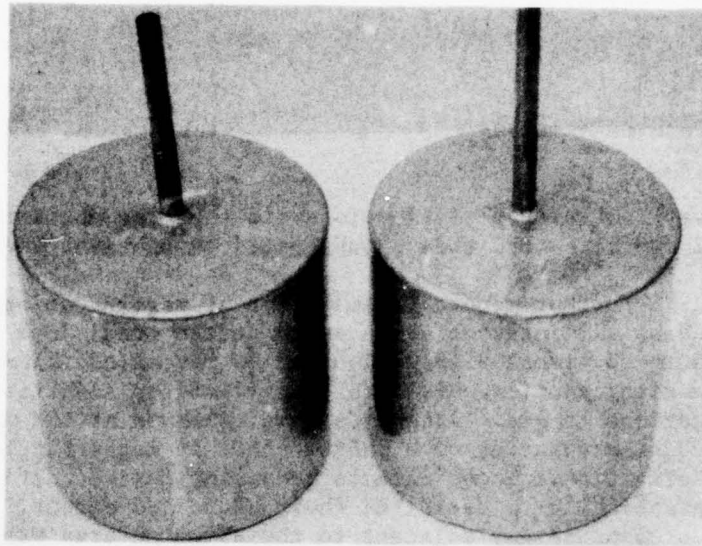
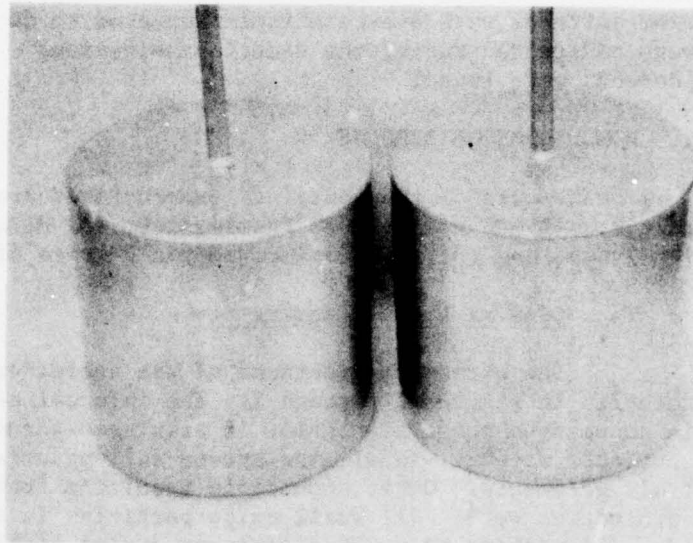
Figure 1. 304 Stainless Steel Containers, Magnification 1/3X

The external appearance of the containers is documented photographically in Figures 1 through 5. The internal appearance of the containers is documented photographically in Figures 6 through 15. Examination of these surfaces without visual aids showed full penetration for the full length of all weldments. Other conditions resulting from fabrication and cleaning procedures were: (1) small oxide particles in the 304 stainless steel welds, (2) etching of A-286 containers during pickling; (3) roughened surface from pickling, a tightly adherent smut, and isolated shiny deposits of material in one of the 17-4 PH stainless steel containers; (4) a tightly adherent smut in the Inconel 718 containers; and (5) isolated areas of titanium oxide and localized circular areas of attack in one of the 6Al-4V titanium containers.

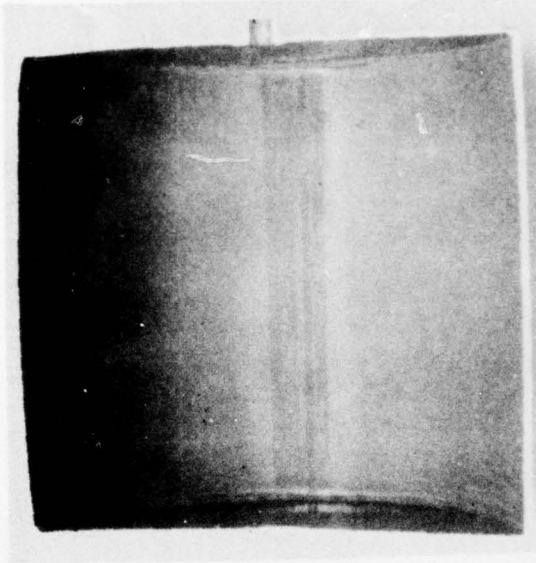
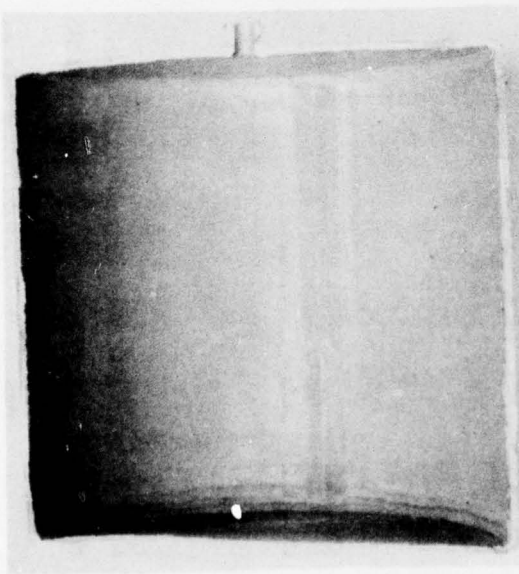
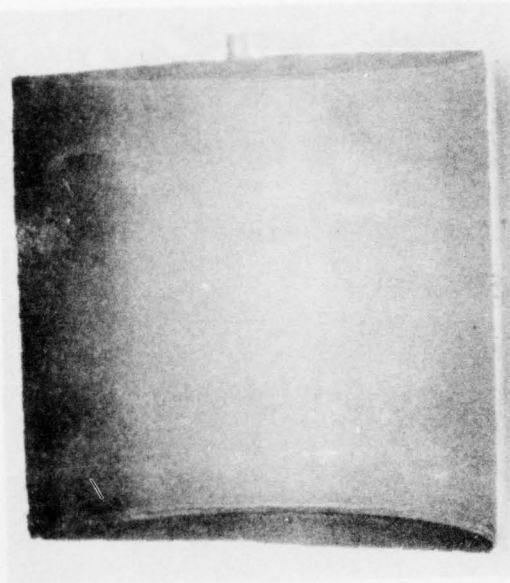
Figure 6. Interior of 304 Stainless Steel Containers after Exposure in Oxygen Free Water, Magnification 3/5X

The interior of the container exhibited a dull appearance relative to the exterior surfaces of the containers. This condition is attributable to inadequate hydrogen gas coverage in the tank during the annealing process after welding. The oxide particles in the welds were found to be present as in the examination of the six and twelve month exposure tanks and the particles are shown in Figure 16.

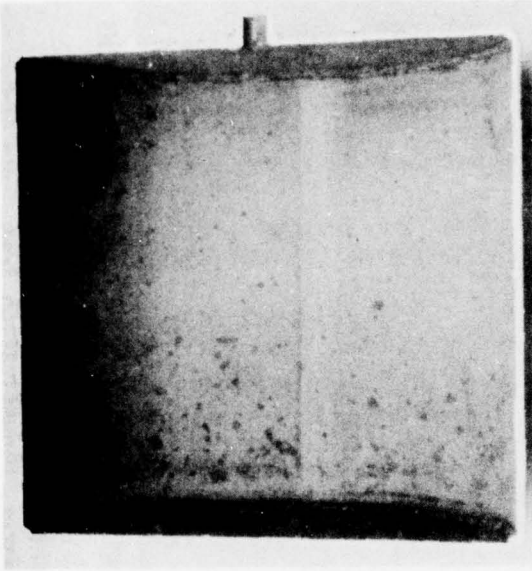
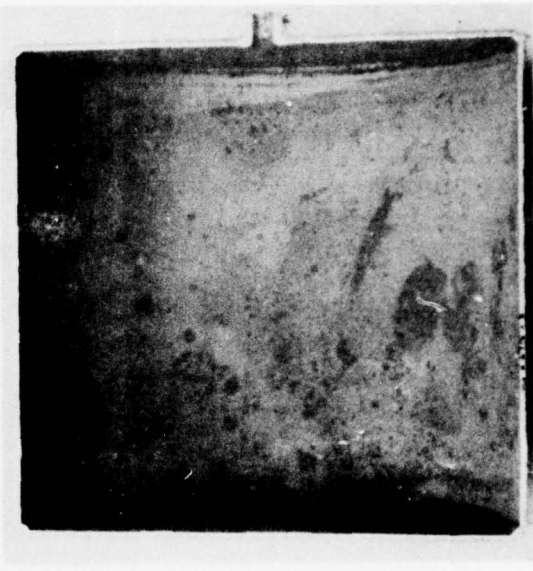
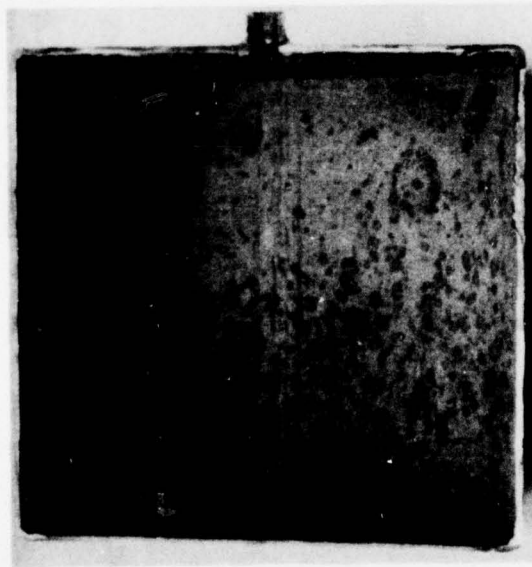
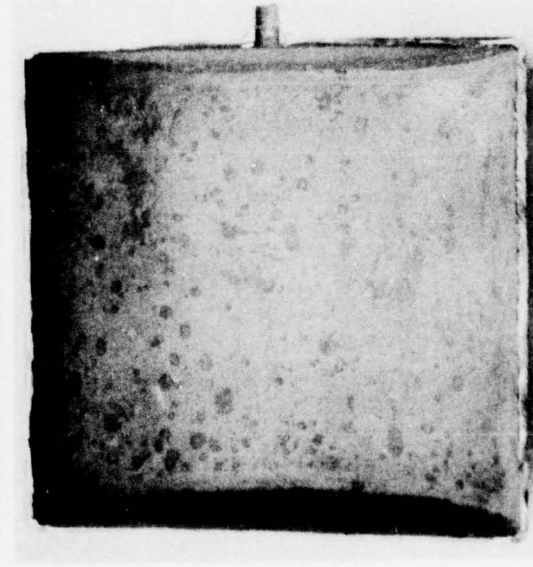
Figure 10. Interior of 17-4PH H-1025 Stainless Steel Containers after Storage in Oxygen Free Water, Magnification 3/5X

All of the containers exhibited the same condition found in some of the previously examined containers; i.e., localized roughening of the surface due to scale removal during the pickling procedure. The tightly adherent metallic particles found in all previously examined containers and identified as 17-4PH stainless steel was also found in three of the four containers examined during this year. Because this contaminant is identical in appearance to those previously analyzed, a chemical analysis was not performed. The conditions are documented in Figures 18 and 19. Weld cracks were also found in three of the four tanks examined during the current year. A representative photomacrograph and photomicrograph of these cracks is shown in Figure 20. These cracks occurred during welding and are not the result of the storage of water.

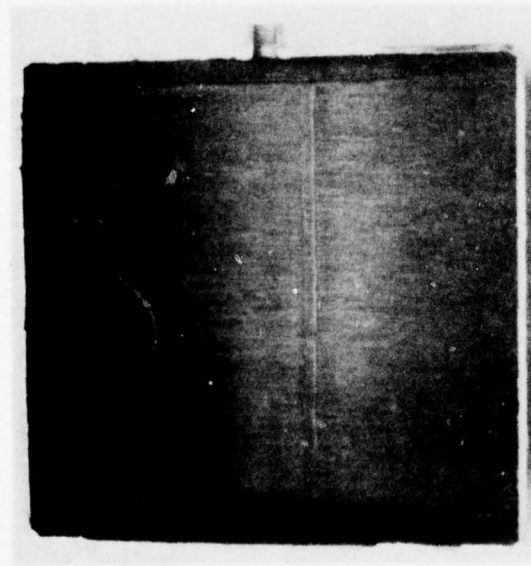
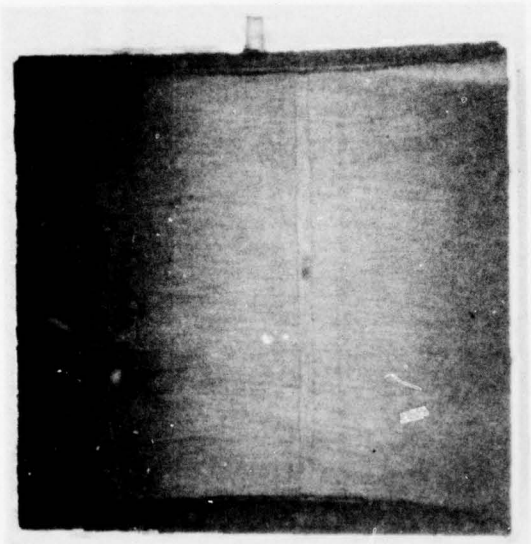
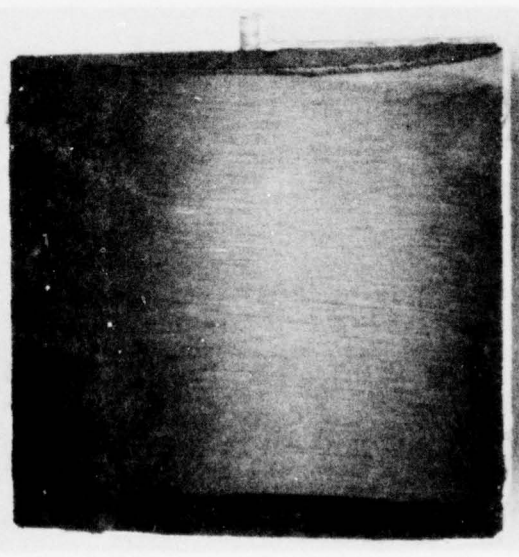
Figure 12. Interior of Inconel 718 Containers after Exposure in Oxygen Free Water, Magnification 3/5X

As with the previously examined containers, examination of the interior surfaces at moderate magnification revealed a dark, porous area at the edge of all closure weldments as shown in Figure 21. This condition is caused by selective attack during pickling; the entrapped oxides

present because of inadequate inert-gas coverage during welding are removed by the pickling process. The condition is not attributable to the storage of water. All of the tanks displayed a tightly adherent smut as a result of the pickling procedure.

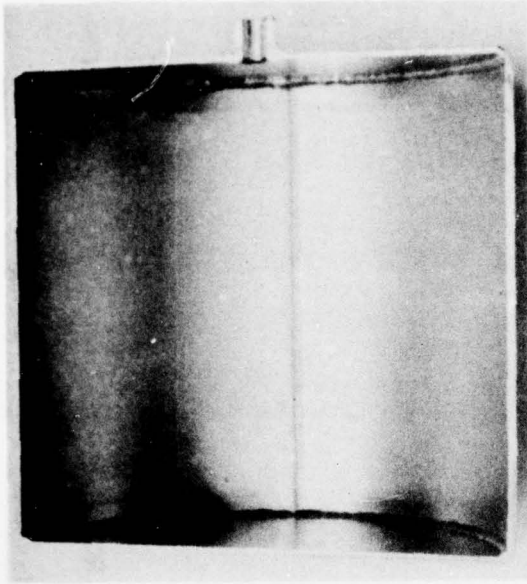
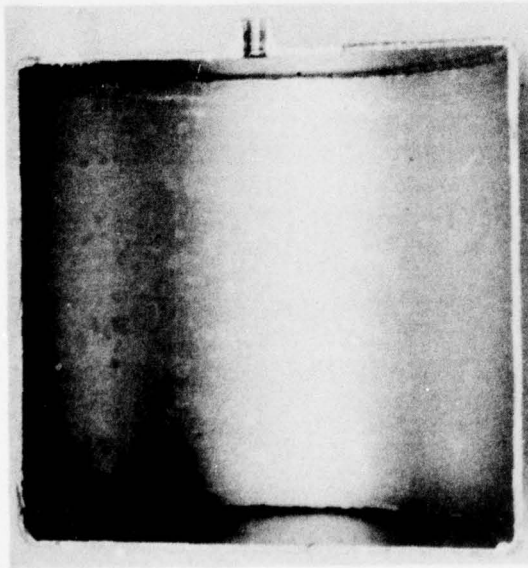
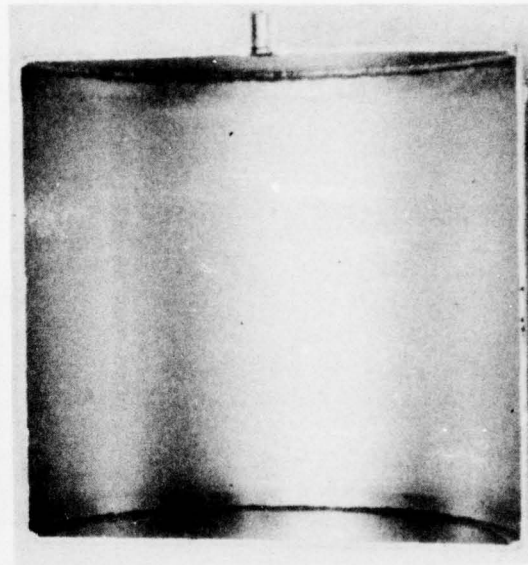
Figure 14. Interior of 6Al-4V Titanium Alloy Containers after Exposure to Oxygen Free Water, Magnification 3/5X

All of the containers except one exhibited small isolated areas of titanium oxide in the interiors caused by the heat treatment (aging) and the areas were not removed during the pickling procedure. Examination of mottled areas at low magnifications revealed that these areas are primarily stains. Portions of the stained surfaces contained crater-like areas outlined by knife-life corrosion as shown in Figure 22. Metallographic examination of sections taken through these areas revealed no detectable depth to the corrosion effects associated with the stained areas. This condition is attributed to inadequate cleaning of the container interiors prior to heat treatment. No defects attributable to the storage of water were found.

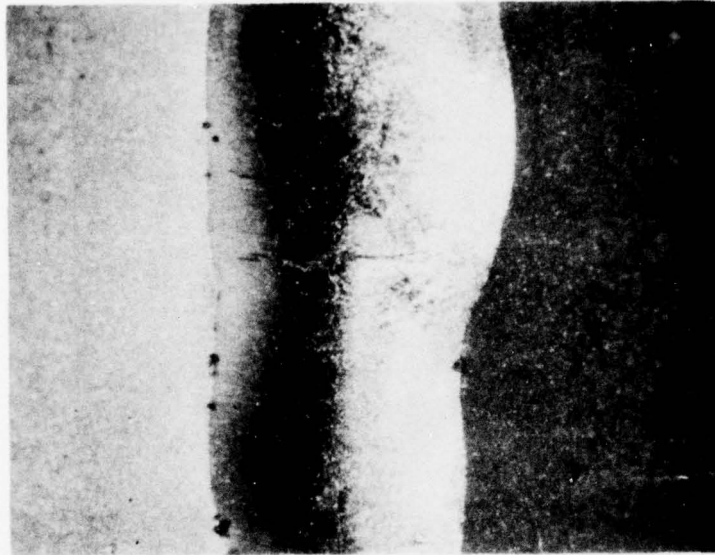
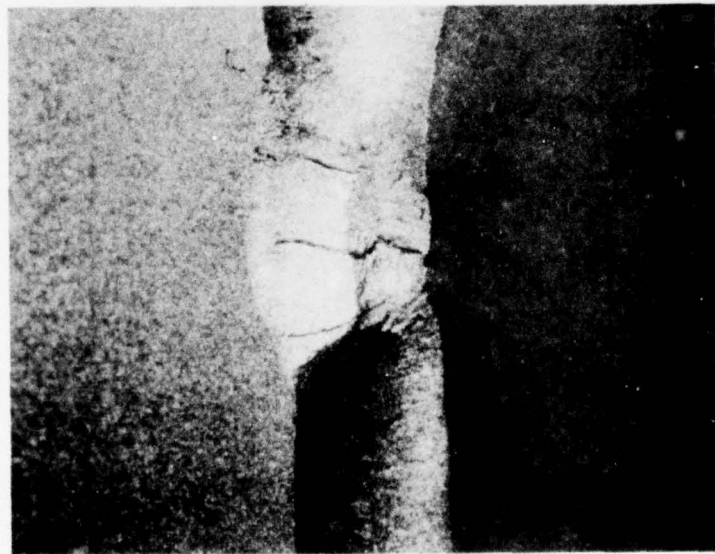
Figure 17. Weld Cracks in A-286 Containers

Three weld shrinkage cracks were found in the containers. Two of the cracks are shown in Figure 17, and they are similar to those found in the tanks which were opened previously. Slight localized etching caused by pickling was found on all the tank interiors. No evidence of corrosion resulting from storage of water could be found.

The presence of contaminants in the titanium alloy containers prior to heat treatment and the weld cracks found in the A-286 and 17-4PH stainless steel containers are attributable to inadequate process control on the part of the container supplier. In spite of the presence of the contaminants, the functional quality of this water was not impaired.
