6  
TEST AND EVALUATION  
OF  
CONTAINER MK 618 MOD 0  
FOR  
HARPOON ROCKET MOTOR SECTION  
P/N72/P250001-1103  
USED FOR BOOSTERS A/B44G-2 AND A/B44G-3.

NWHC REPORT 7679  
10 November 1976

TEST AND EVALUATION  
OF  
CONTAINER MK 618 MOD 0  
FOR  
HARPOON ROCKET MOTOR SECTION P/N72P250001-1103  
USED FOR BOOSTERS A/B44G-2 AND A/B44G-3

This report details the test and evaluation of a prototype Container MK 618 MOD 0 designed to protect a HARPOON Rocket Motor Section P/N72P25001-1103 for fleet use. Test results indicated that the container is suitable for its intended purpose.

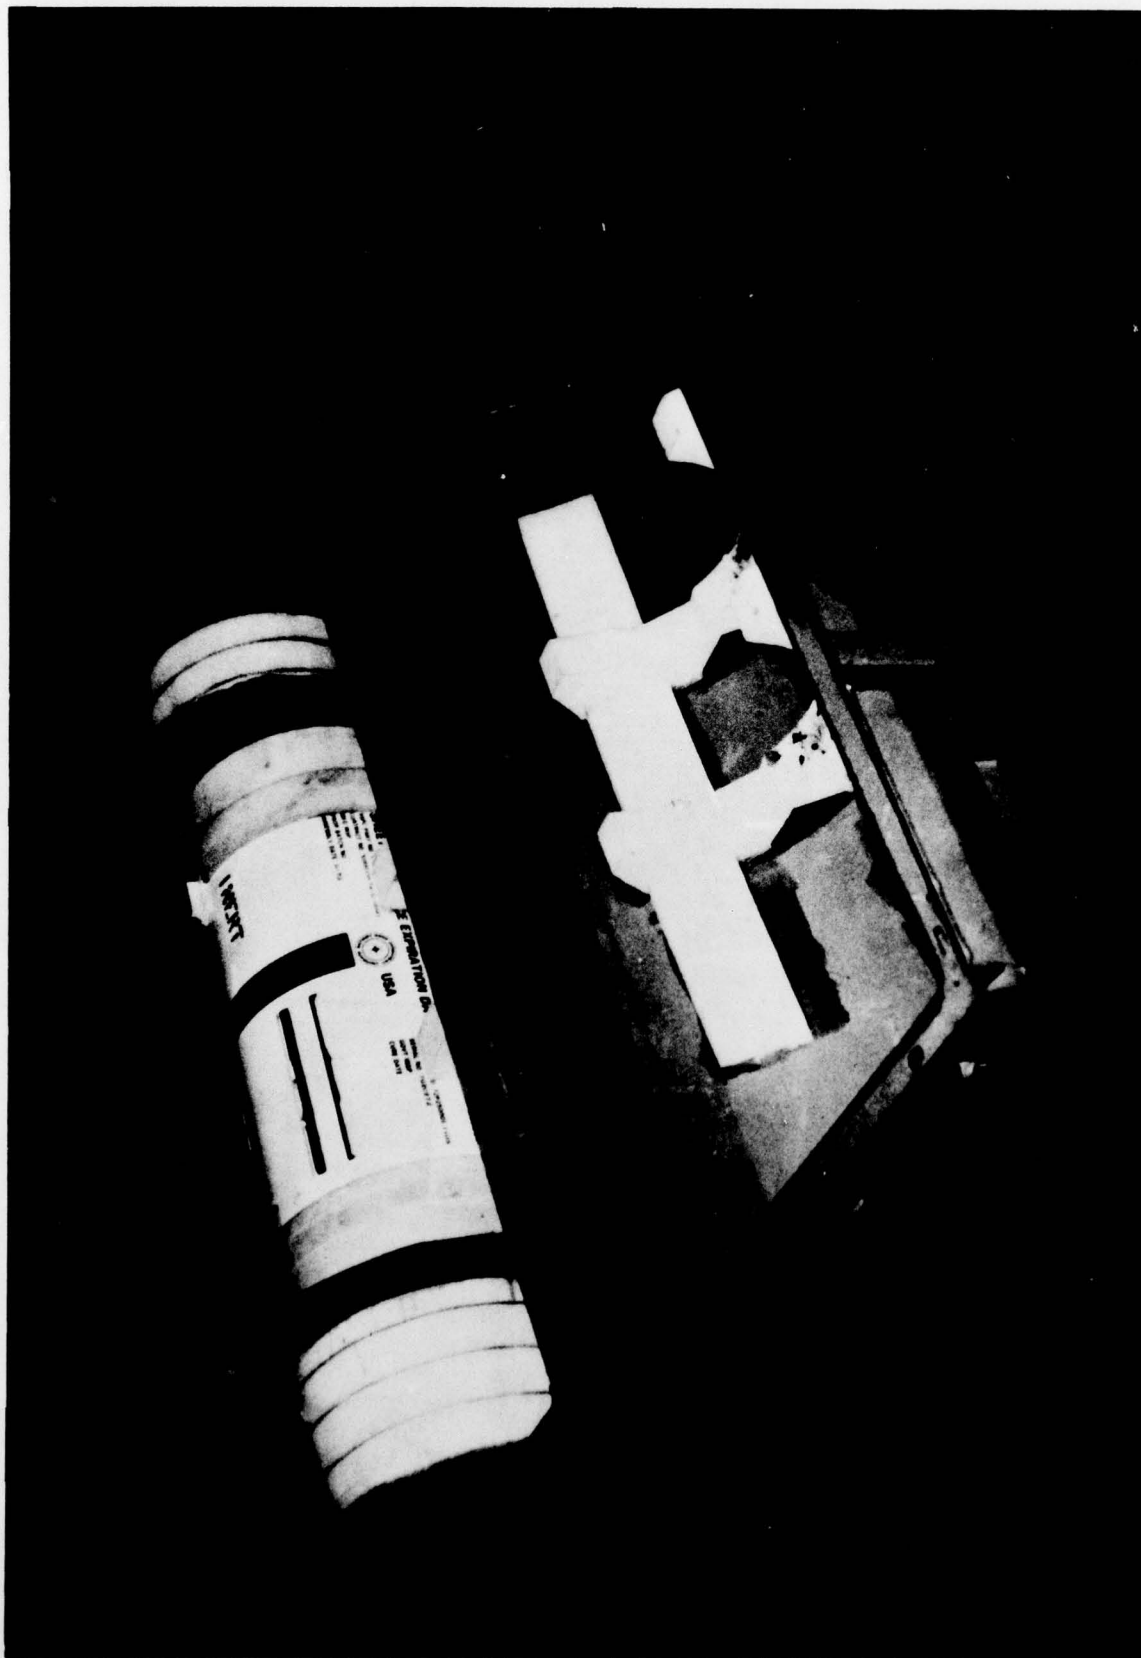
**FIG. 3 PACKAGED ROCKET MOTOR.**

rocket motor is shown assembled in the container, Figure 3. The external overall dimensions of the container are 52" long x 23-7/8" wide x 25-7/8" high. The empty weight of the container (with cushion assemblies) is 277 pounds and the loaded weight (with the rocket motor) is 535 pounds. The rocket motor section tested, P/N72P250001-1103, is used in the subsequent assembly of Rocket Motor Section Booster A/B44G-2 or A/B44G-3.

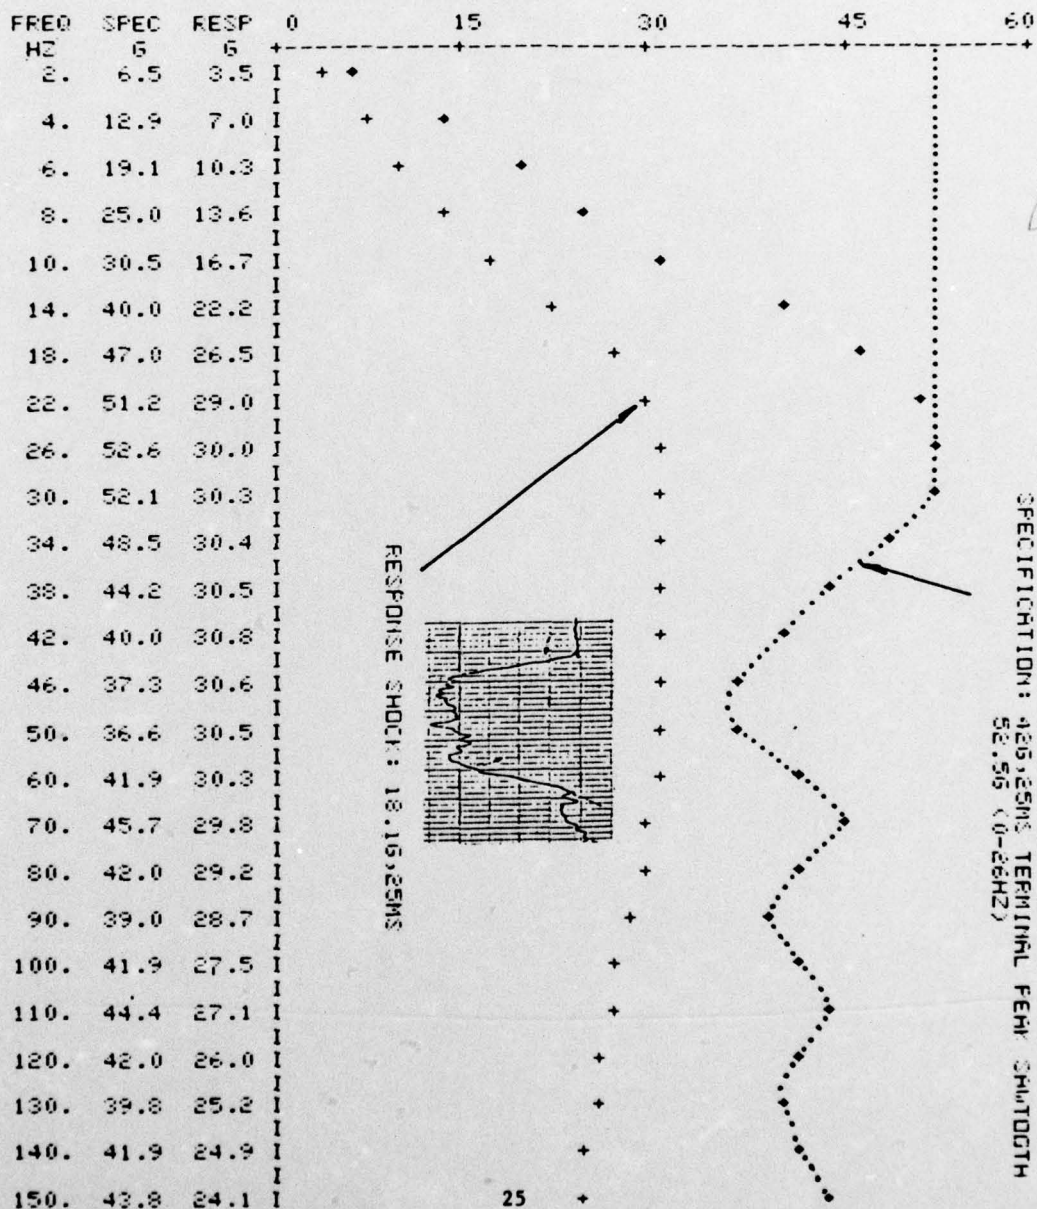
FIGURE 12  
CONTAINER NO. 618 MOD 0  
36 INCH ROTATIONAL CORNERWISE DPOF AT -20F

SHOCK SPECTRUM  
SPECIFICATION = ♦  
RESPONSE = +

Results - A summary of the shock results is presented in Table II and the major deceleration-time curves are shown in Figure II. The shock response spectrum of the largest shock was generated and compared to the allowable spectrum. This comparison presented as Figure 12 clearly shows that the spectrum of the response pulse is within the allowable spectrum. Shock spectra for other shocks were not computed because of their significantly lower amplitudes.
