REPORT NO. CG-D-125-76

SUMMARY EVALUATION OF THE OFFSHORE  
TARGET DETECTION CAPABILITIES OF APS-94D  
AND  
COR RADAR SYSTEMS

DECEMBER 1976  
FINAL REPORT

California Univ., Santa Barbara  
Geography Remote Sensing Unit

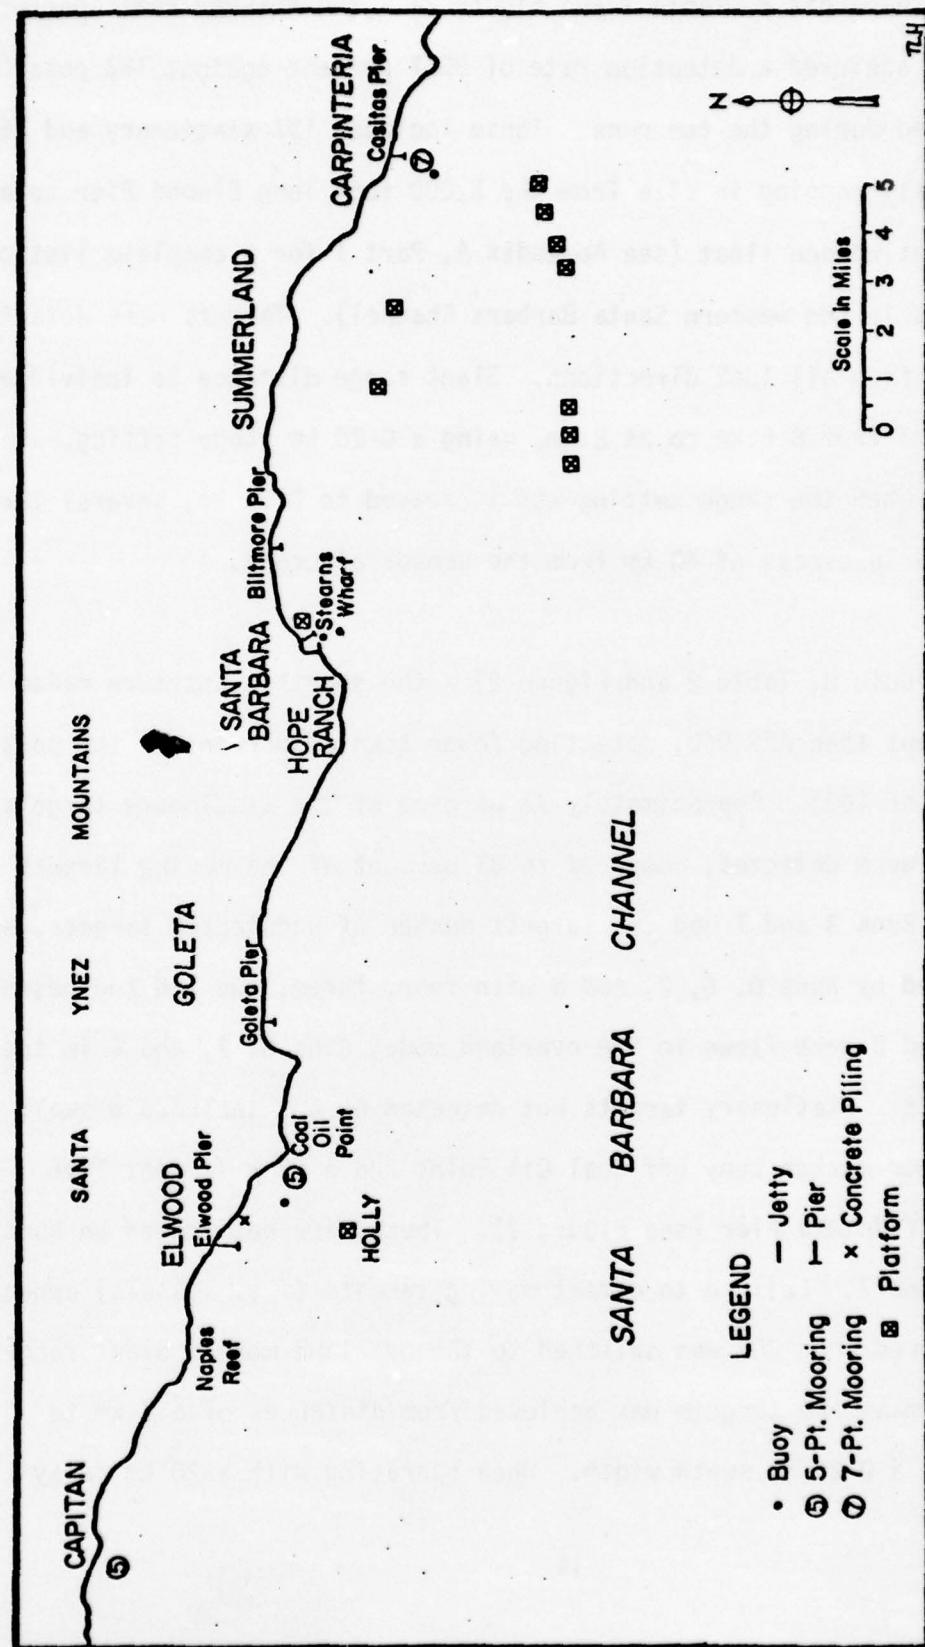
FIGURE 2

- COR (see Appendix B, Table 2 and Figure 2) - the synthetic aperture radar proved less consistent than APS-94D, detecting fewer than 75 percent of the possible targets (121 of 162). Approximately 73 percent of the stationary targets (101 of 138) were detected, compared to 83 percent of the moving targets (20 of 24). Runs 3 and 7 had the largest number of undetected targets, seven each, followed by Runs 0, 6, 2, and 8 with four, three, two and two respectively. Runs 3, 7, and 8 were flown in the overland mode; Runs 0, 2, and 6 in the overwater mode. Stationary targets not detected by COR included a small radar reflector marker buoy off Coal Oil Point and a 22 x 12 foot live bait float off Goleta Pier (see Figure 2). These were not imaged on Runs 0, 2, 3, 6, and 7. Failure to detect moving targets (i.e. vessels) appears to have occurred when COR was switched to the overland mode. Slant range detection of man-made targets was achieved from distances of 6.5 km to 24.6 km using a 0-25 km swath width. When operating with a 20 km delay

(20-45 km swath width) during Run 9, target detection range was increased to more than 40 km. Figure 3 compares the target detection performance of APS-94D and COR during Run 6.

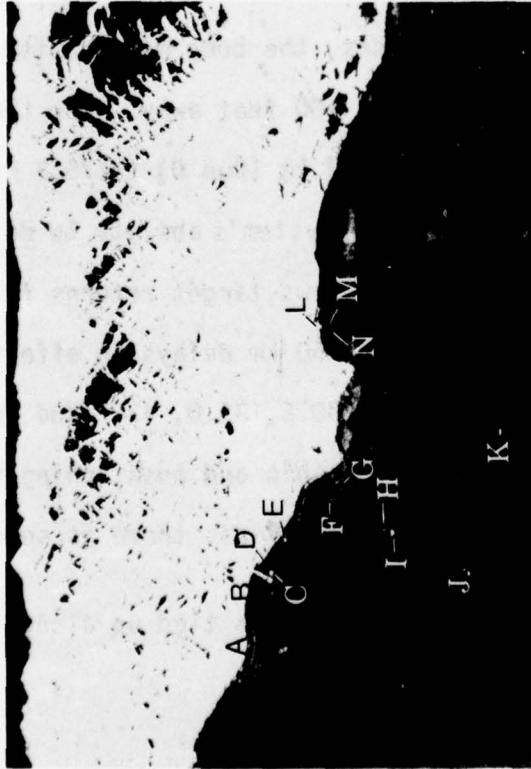
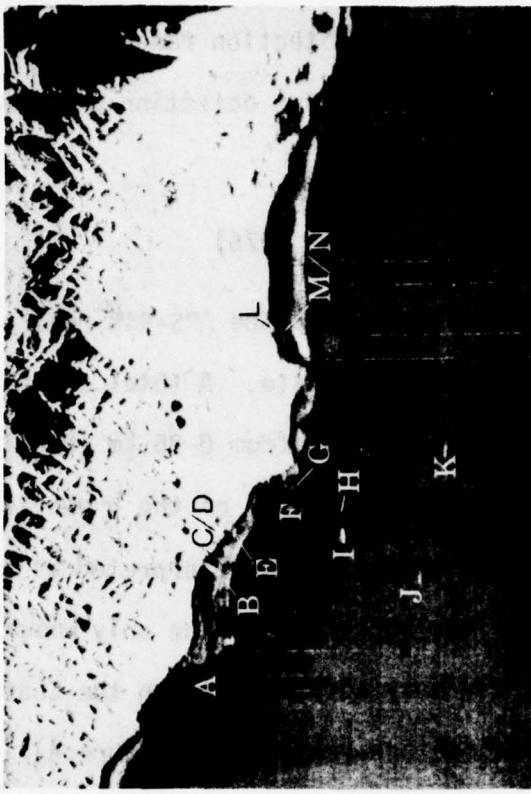
FIGURE 3

COMPARISON OF APPS-94D AND COR FOR DETECTION OF MAN-MADE TARGETS

Photographs show area of Santa Barbara Channel from Hope Ranch west to Capitan. Imaged concurrently by APPS-94D and COR during Run 6, May 19, 1976. Range for both radars was 0-25 km. Operating mode for APPS-94D was overland; COR was set for overwater. Known targets include: (A) 35' cabin cruiser off Naples Reef; (B) 2,000' long Elwood oil support pier; (C) 61' aluminum crewboat MALLARD; (D) 83' wooden ocean tug CONTENDER; (E) abandoned concrete and steel pier piling; (F) marker buoy with radar reflector; (G) 5-point tanker mooring at Coal Oil Point; (H) 61' steel crewboat JUNE TIDE underway; (I) oil drilling platform HOLLY; (J) 40' sailboat underway; (K) 83' steel USC&C PT. JUDITH underway; (L) 1,000' Goleta Pier; (M) 25' sailboat; and, (N) 22 x 12' live bait float. Targets not detected by COR located at (A), (F), (M), and (N). Those at (C), (D), and (E) on COR are extremely difficult to differentiate from background return of kelp beds.

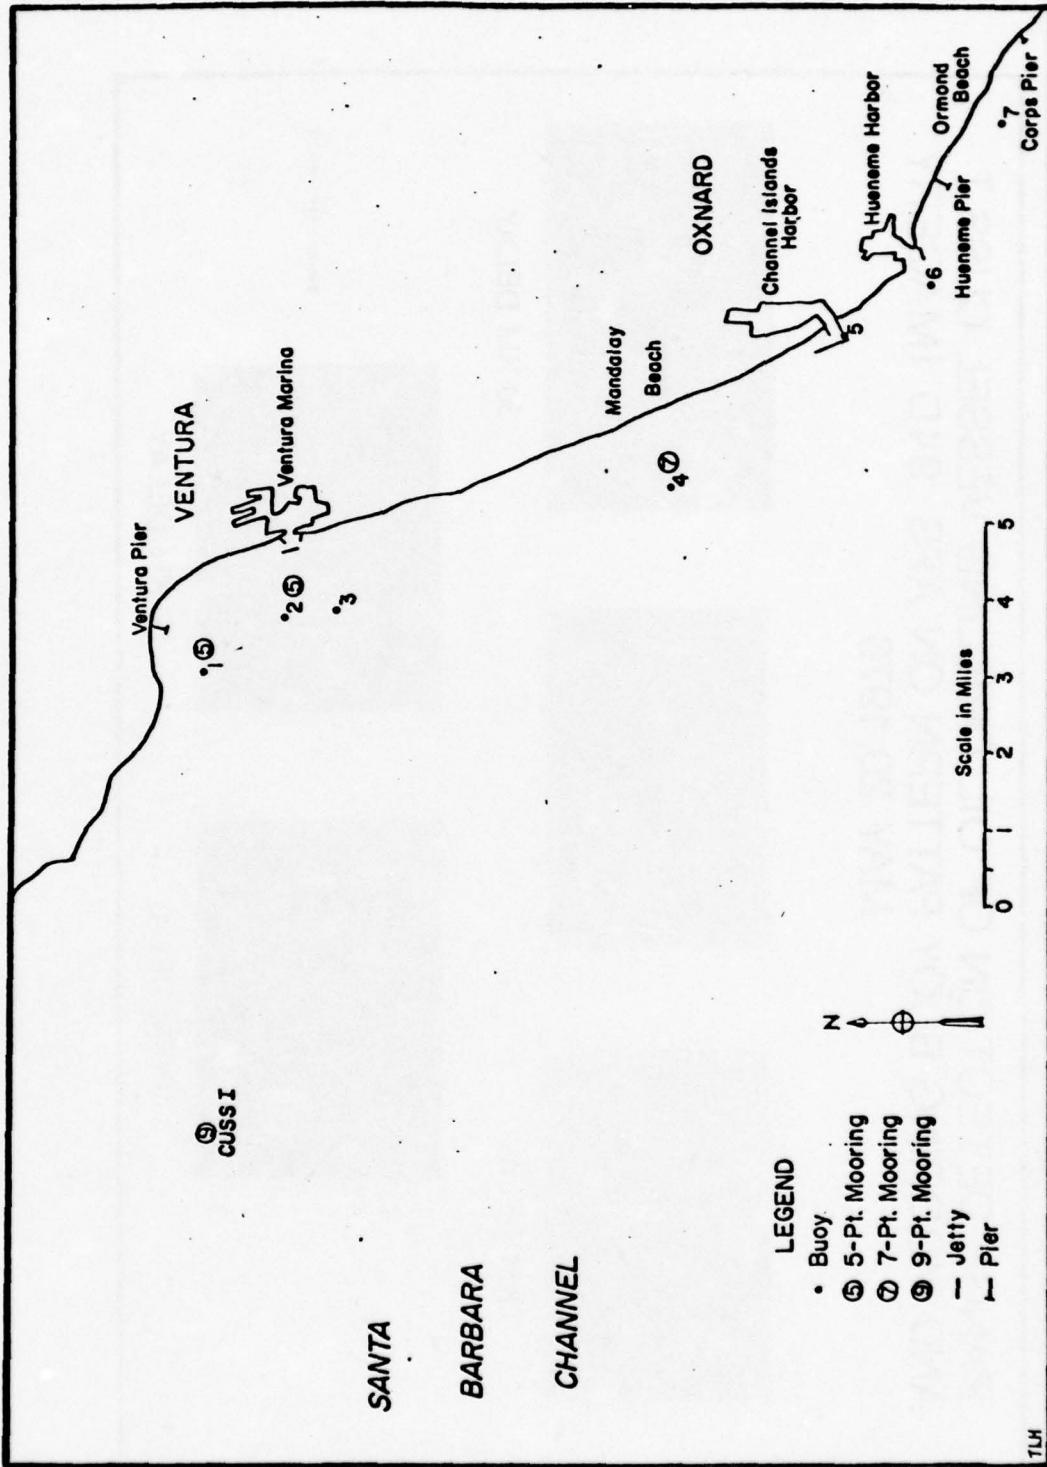
FIGURE 4

OXNARD-VENTURA-PORT HUENEME TEST AREA

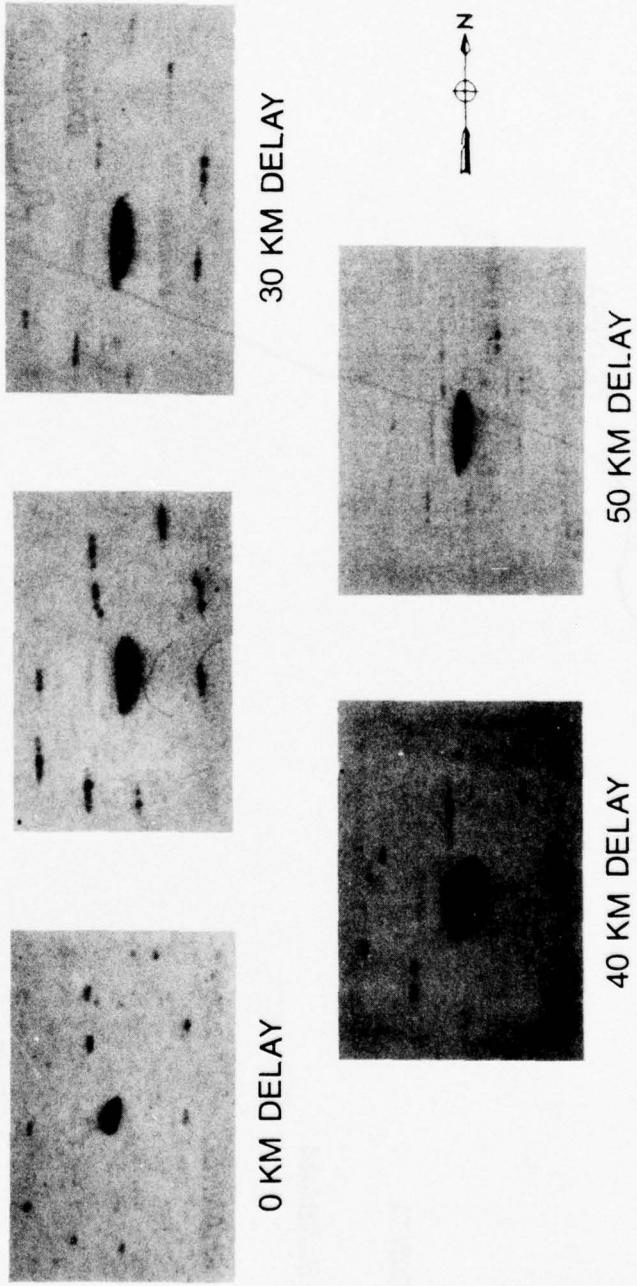
FIGURE 5

RANGE DETECTION OF OIL DRILLING VESSEL CUSS I  
AND MOORING BUOY PATTERN ON APS - 94D IMAGERY  
MAY 20, 1976

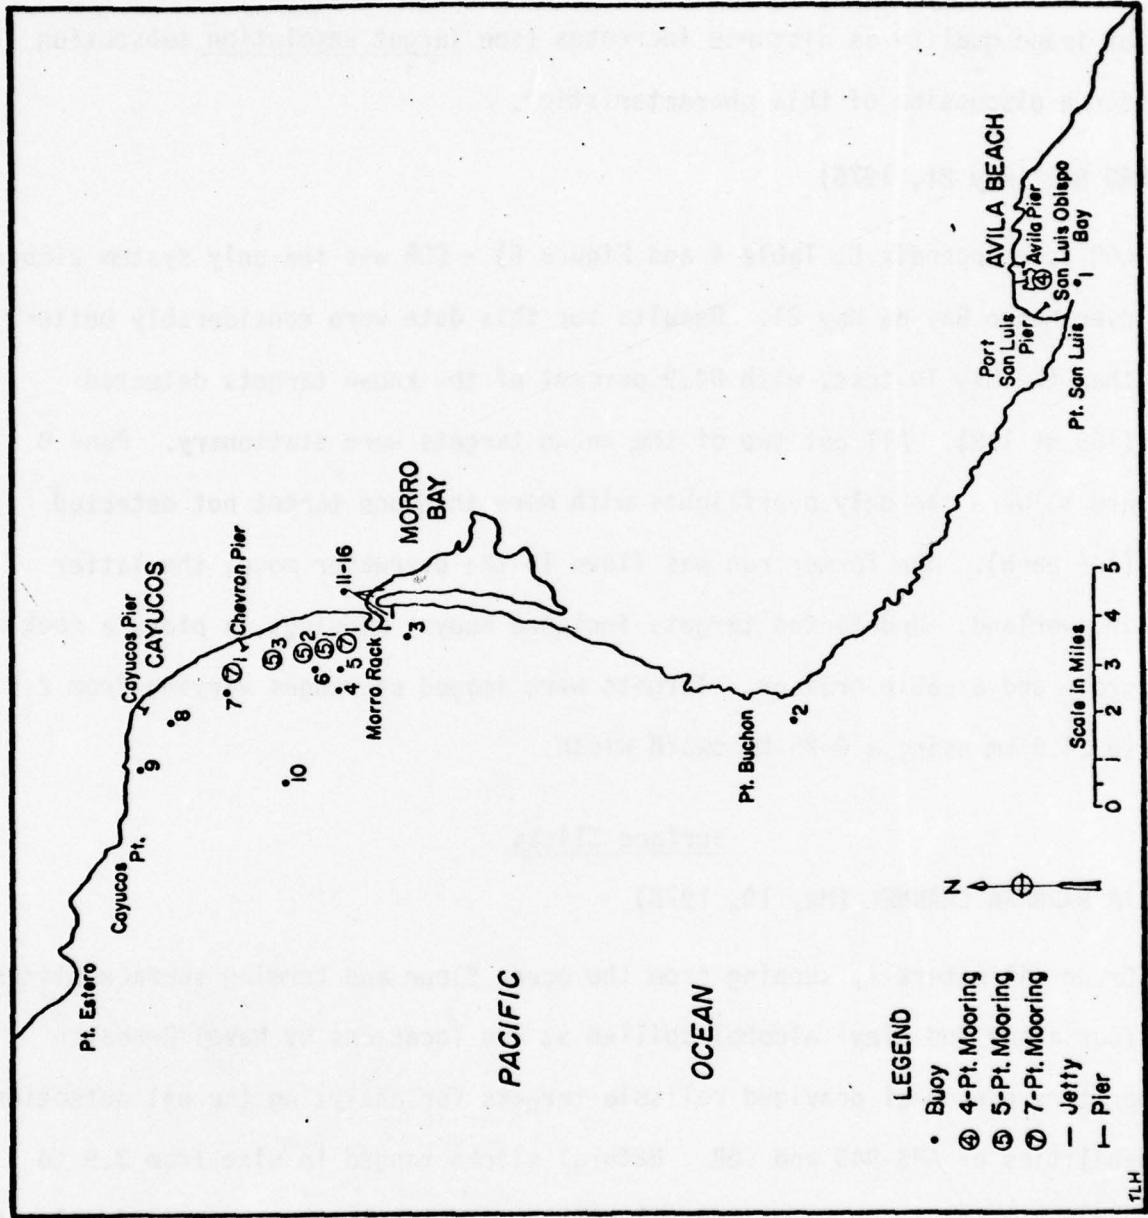
FIGURE 6

MORRO BAY TEST AREA

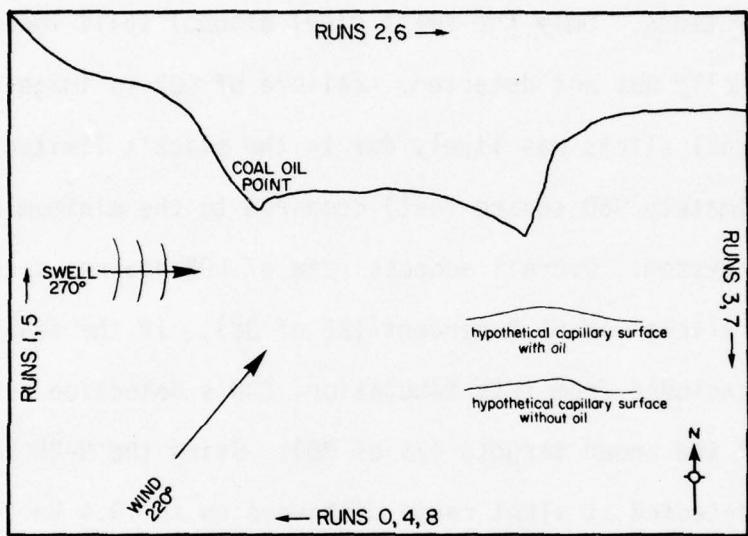
FIGURE 7

Sketch map depicting approximate wind and swell directions in the western Santa Barbara Channel, May 19, 1976. Look direction from APS-94D and COR perpendicular and to the right of the aircraft flight direction for each run.

good backscattering compared to oil covered areas where a dampening or flattening effect on capillary waves reduces surface returns (see sketch map Figure 7).

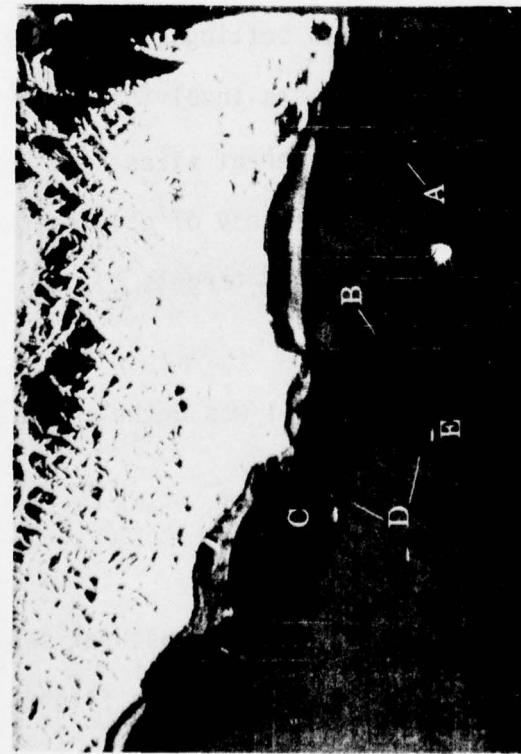
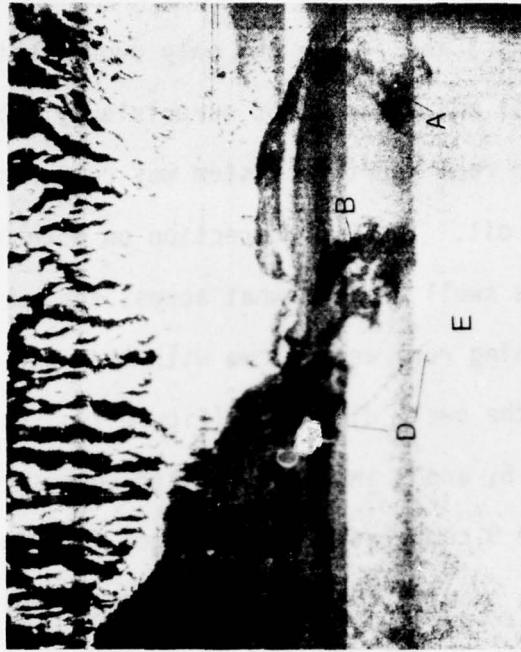
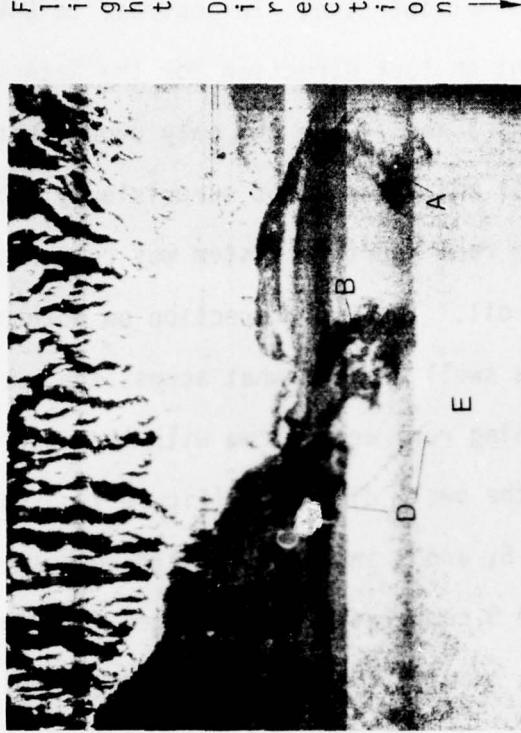
FIGURE 8

SURFACE SLICKS DETECTED BY COR (May 19, 1976)

Run 6 - Flown from west to east looking south toward Santa Barbara Channel. Range 0-25 km using the overwater mode. Three distinct natural seep oil slicks are visible (A, B, and C). Long slick from oleyl alcohol spill (D) being released behind 83' USCG Cutter PT. JUDITH (E) barely discernable. Slant range distances to oil slicks at (C), (B), and (A) are 11.5 km, 14.2 km, and 15.1 km respectively. Distance to PT. JUDITH is approximately 16.5 km.

Run 7 - Flown from north to south looking west. Range 0-25 km using the overland mode. Natural seep visible at (A), (B), and (C); long oleyl alcohol spill at (D). Slant range distances to (A)(B)(D) and (C) are 4.7 km, 12.2 km 17.7 km, and 14.0 km, respectively. PT. JUDITH (E), underway at 6 knots, not detected in overland mode. Note poor return and lack of contrast in lower half of photo.

- COR (see Appendix B, Table 2) - the COR consistently detected surface slicks associated with natural oil seepage and the long oleyl alcohol spill from all look directions. Only the small oleyl alcohol spill located southwest of platform Holly was not detected. Failure of COR to image the smaller of the two artificial slicks was likely due to the slick's limited surface area (i.e. approximately 960 square feet) compared to the minimum cell size resolution of the system. Overall success rate of COR against actual and simulated surface slicks was 65.8 percent (25 of 38). If the small oleyl alcohol spill is excluded from this tabulation, COR's detection rate increases to 83.3 percent of the known targets (25 of 30). Using the 0-25 km range setting, oil was detected at slant range distances up to 18.4 km from the sensor aircraft. With a 20 km delay (20-45 km range setting) in effect, the maximum slant range distance at which oil was imaged was 26.1 km. With the exception of Run 4, the vertically polarized COR synthetic aperture system provided excellent contrast between both the detectable natural and artificial surface slicks and the ocean surface. Figure 8 illustrates the oil detection capability of COR using imagery from Runs 6 and 7.

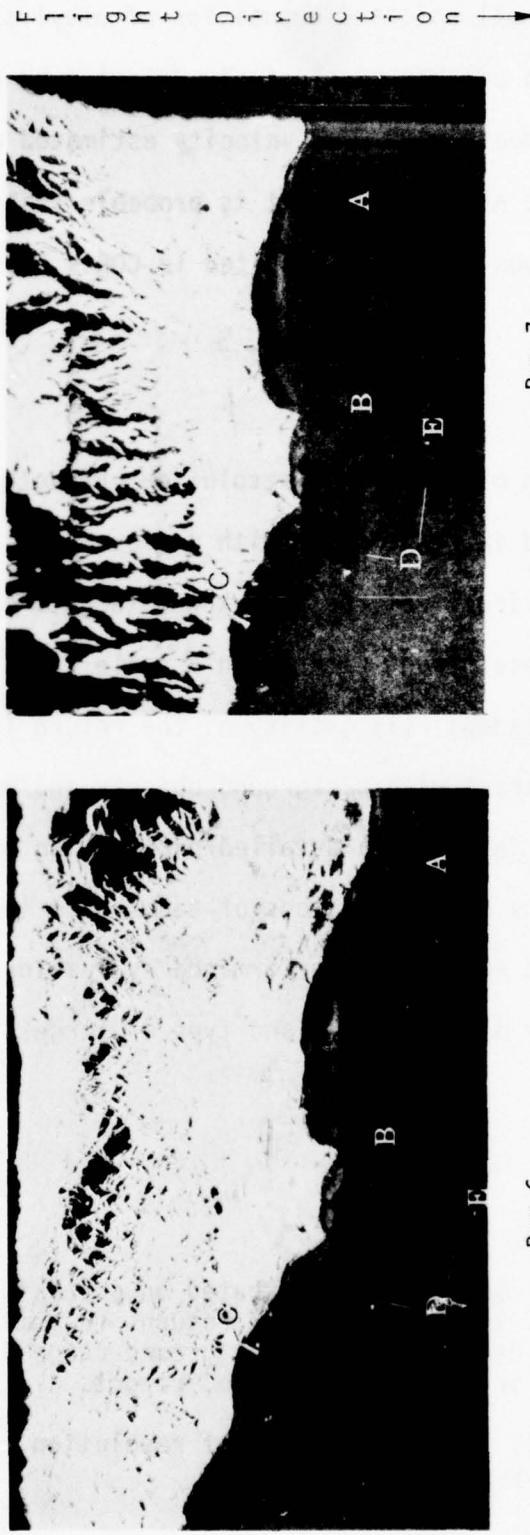
FIGURE 9

COMPARISON OF APS-94D OIL DETECTION PERFORMANCE FROM TWO LOOK DIRECTIONS (May 19, 1976)

Run 6 - Flown from west to east looking south over the Santa Barbara Channel. Range 0-25 km in the overland mode. Three natural seep-related oil slicks at (A), (B), and (C) and oleyl alcohol simulated oil slick (D) behind the USCG Cutter PT. JUDITH (E) not detected. APS-94D looking perpendicular (across) swells coming from 270°.

The small oleyl alcohol slick was not detected. In contrast to COR, APS-94D appeared to be extremely dependent on look direction for the detection of oil. During the May 19 test, Runs 3 and 7 were the only overflights which provided good contrast between oil and water. Not surprisingly, they also were the only runs where the real aperture system was comparable to COR in the accurate detection of oil. The look direction on both of these runs (3 and 7) was into the swell and somewhat across the surface wind direction. The eight remaining runs were flown with the look direction either perpendicular to or with the swell direction (Figure 7). No oil was detected on Runs 0, 1, 4, 5, 6, and 9 and only limited success was achieved on Runs 2 and 8. Figure 9 compares APS-94D images for Runs 6 and 7.

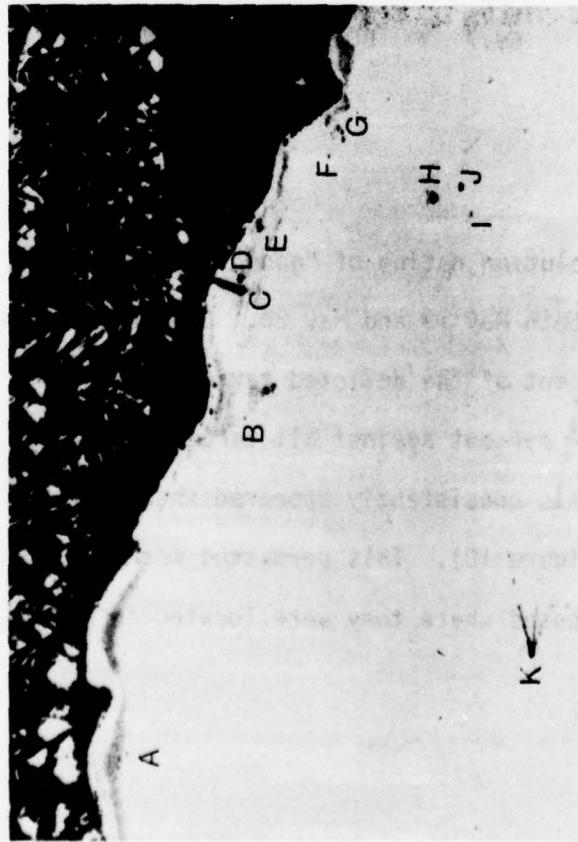
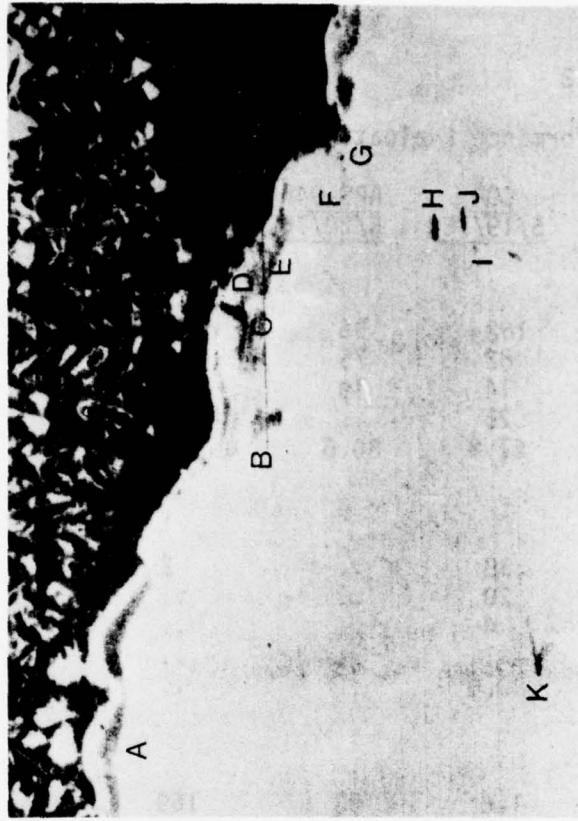
COMPARISON OF TARGET RESOLUTION PERFORMANCE: APS-94D AND COR (May 19, 1976)

Photographs show the offshore area from Coal Oil Point west to Capitan. Imaged by APS-94D (left) and COR (right) during Run 2 of the May 19, 1976 coincident overflights. Range for both radars 0-25 km. APS-94D operating in the overland mode; COR is the overwater mode. Targets include: (A) 5-point tanker mooring off Capitan; (B) small cabin cruiser ( $\approx 35'$ ); (C) 2,000' Elwood Pier; (D) 83' wooden ocean tug CONTENDER and 61' aluminum oil crewboat MALLARD anchored 30-40 meters apart; (E) abandoned concrete pier pilings; (F) marker buoy with radar reflector; (G) 5-point tanker mooring off Coal Oil Pt. with small center buoy; (H) oil drilling platform HOLLY; (I) 16 sq. ft. plastic and wooden float with radar reflector; (J) 83' USC G Cutter PT. JUDITH; and, (K) 75' wooden ocean tug underway. Note the sharpness and clarity of targets on the APS-94D compared to COR. Several targets detected by APS-94D not recorded by COR (A and F); others tend to blend into background on the latter (B, D, E, and G), making detection more difficult for the image analyst.

- \* Resolution - Target returns on APS-94D imagery were consistently sharper than those on COR. This permitted reliable discrimination of multiple targets in close proximity to one another or targets in areas with high background reflectance. Conversely, COR often merged closely spaced individual targets and failed to discriminate individual targets from other background returns.

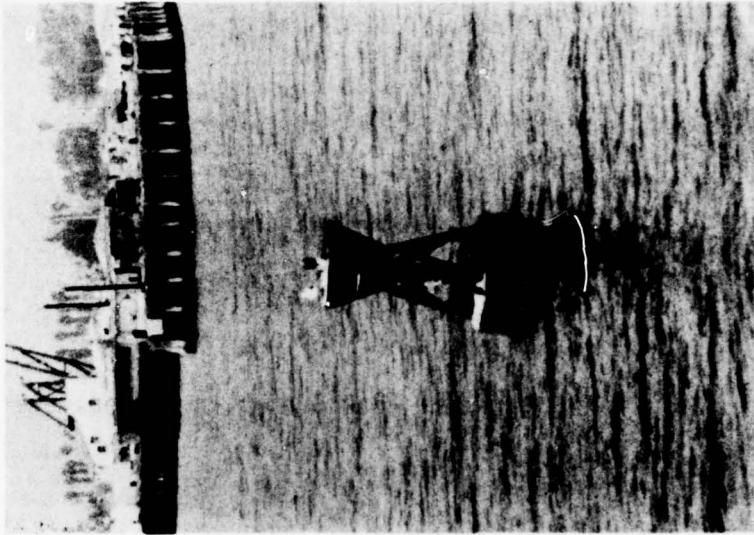
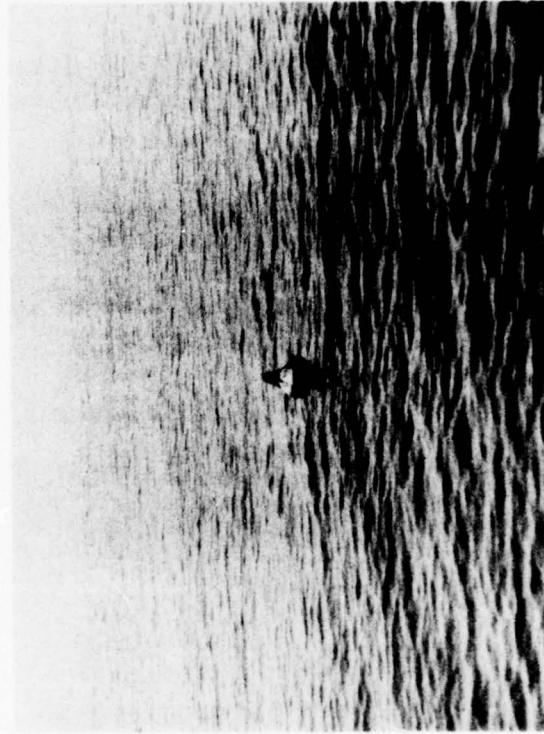
Navigation buoy located near the entrance to Santa Barbara Harbor. The steel construction buoy is equipped with radar corner reflectors. Photographed June 17, 1976.

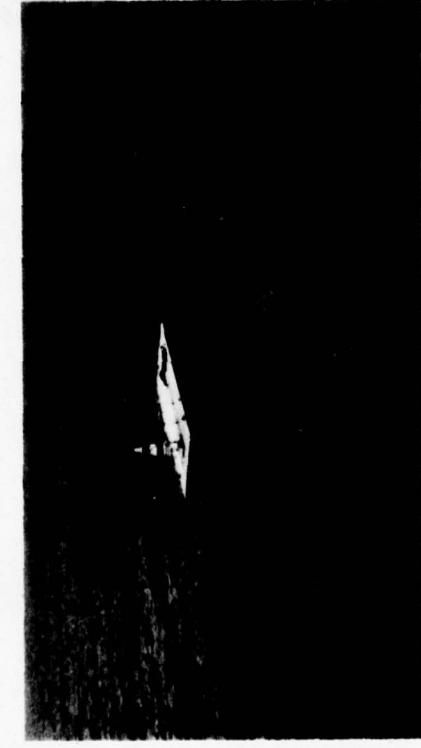
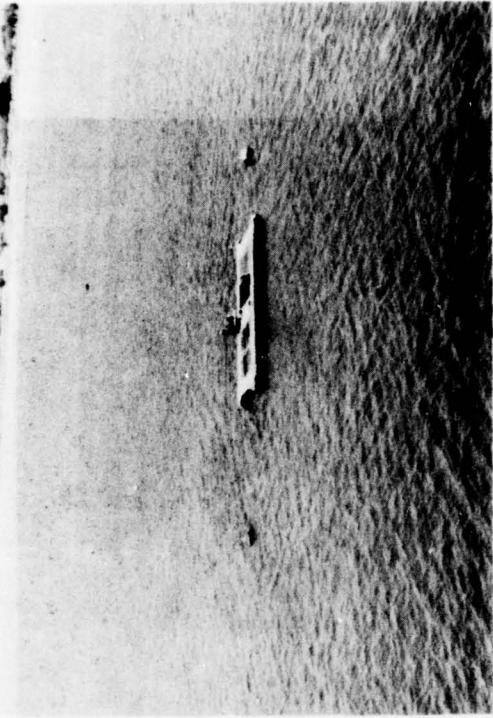
Small marker buoy with radar corner reflectors.  
Located west of the Burmah Oil 5-point tanker  
mooring off Coal Oil Point. Photographed  
June 17, 1976

Top left-  
Metal positioning float with radar reflector.  
One of eight temporary floats anchored SW of  
Capitan to mark the location of a new Exxon oil  
drilling platform. Photographed June 17, 1976.

Top right-  
Live bait float anchored off Goleta Pier.  
Float is of wood construction with steel rein-  
forcement along the sides. Photographed  
June 17, 1976.

Bottom left-  
Small wood and plastic float with radar reflec-  
tor. Used by the Coast Guard as a calibration  
target off Platform Holly on May 19 and Channel  
Islands Harbor on May 20. Photographed May 20,  
1976.

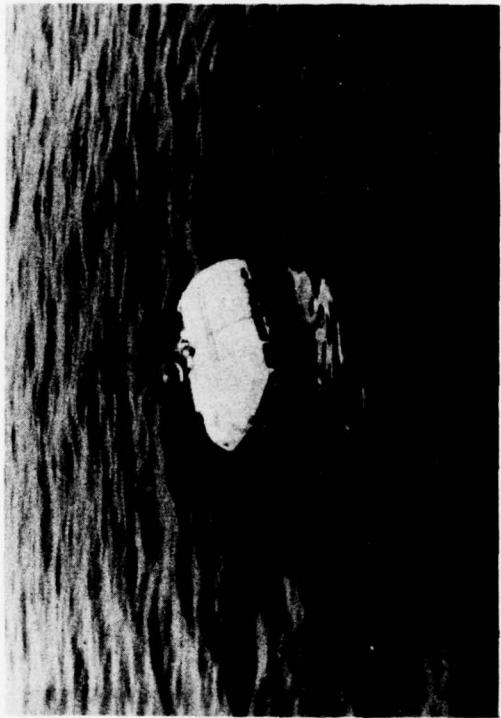
Seven point tanker mooring located NW of  
Morro Rock. Metal floats are spaced approxi-  
mately 100-150 feet apart. Photographed  
May 21, 1976 under low clouds.

Close up view of individual mooring  
float within 5-point tanker mooring  
off Coal Oil Point. Photographed  
June 17, 1976.

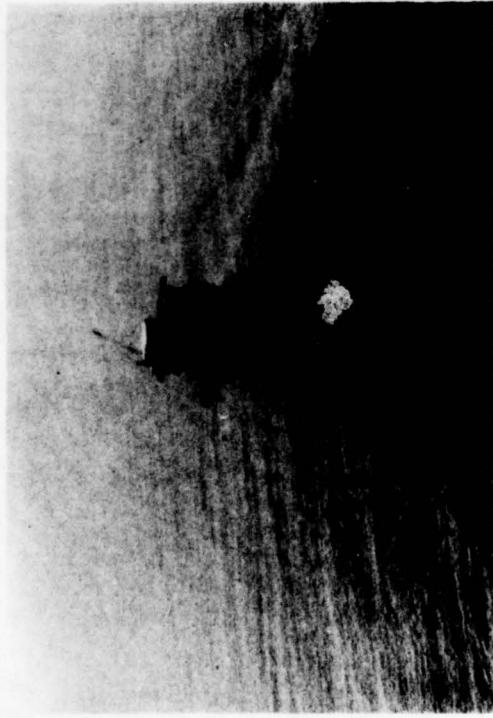
Oil drilling platform HOLLY. Located off Coal  
Oil Point, HOLLY is operated by Atlantic Richfield  
Company. Photographed June 17, 1976.

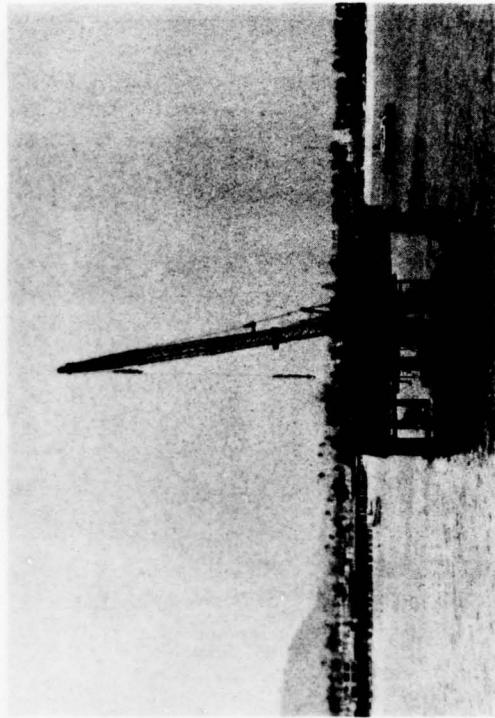
Healy Tibbits Construction Co.'s hydraulic  
platform SPIDER laying sewer pipeline east  
of Stearns Wharf (Santa Barbara). Photographed  
June 17, 1976.

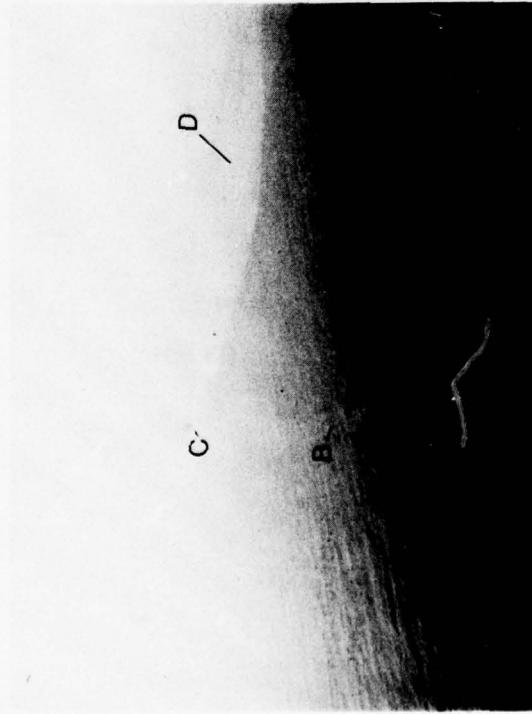
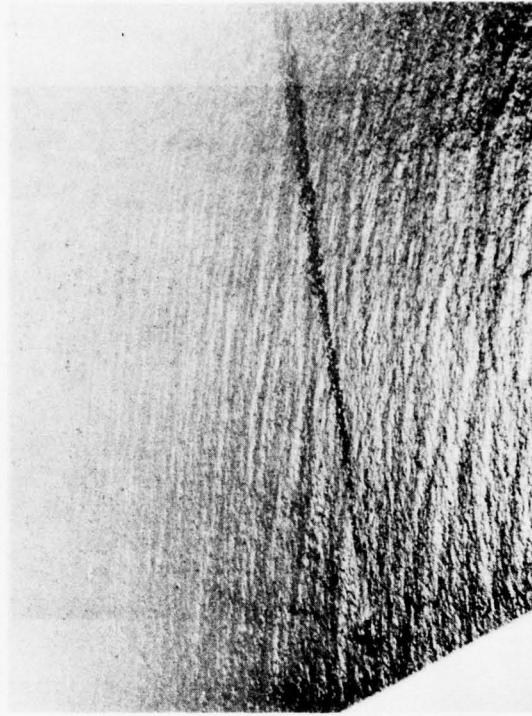
Top left- Cutter PT. JUDITH (A) dumping oleyl alcohol (B) off Platform HOLLY (C). Photo taken May 19, 1976. Note large area of natural oil seepage (D) visible through the haze.

Top right- Broadside view of PT. JUDITH releasing oleyl alcohol over the stern.

Bottom right- Small oleyl alcohol spill (A) with marker dye (B). Maximum area of the slick was approximately 100 feet x 60 feet. Slick was not observed on APS-94D or COR.

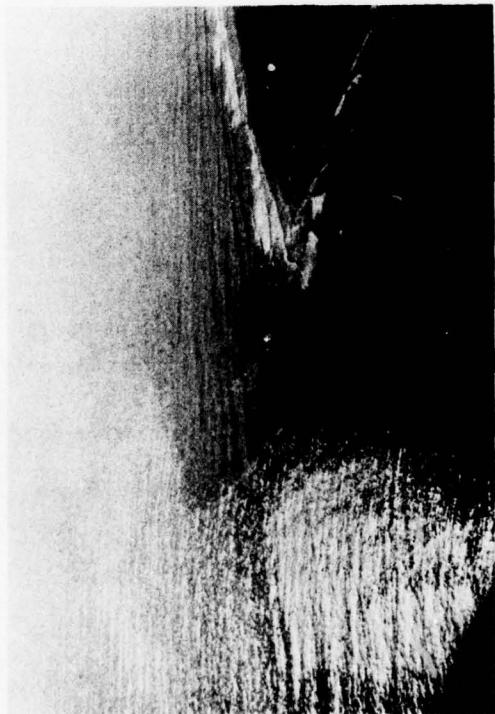
Natural oil seeps off Coal Oil Point. Sun  
glitter marks area of heavy surface concentra-  
tion. Photographed May 19, 1976.

Seep oil surfacing just east of Coal Oil Point.  
Photographed May 19, 1976.
