title: FLANGED ACRYLIC PLASTIC HEMISPHERICAL SHELLS FOR UNDERSEA SYSTEMS - Static and Cyclic Fatigue Life Under Hydrostatic Loading

author: J. D. Stachiw and R. Sletten

date: January 1977

CIVIL ENGINEERING LABORATORY

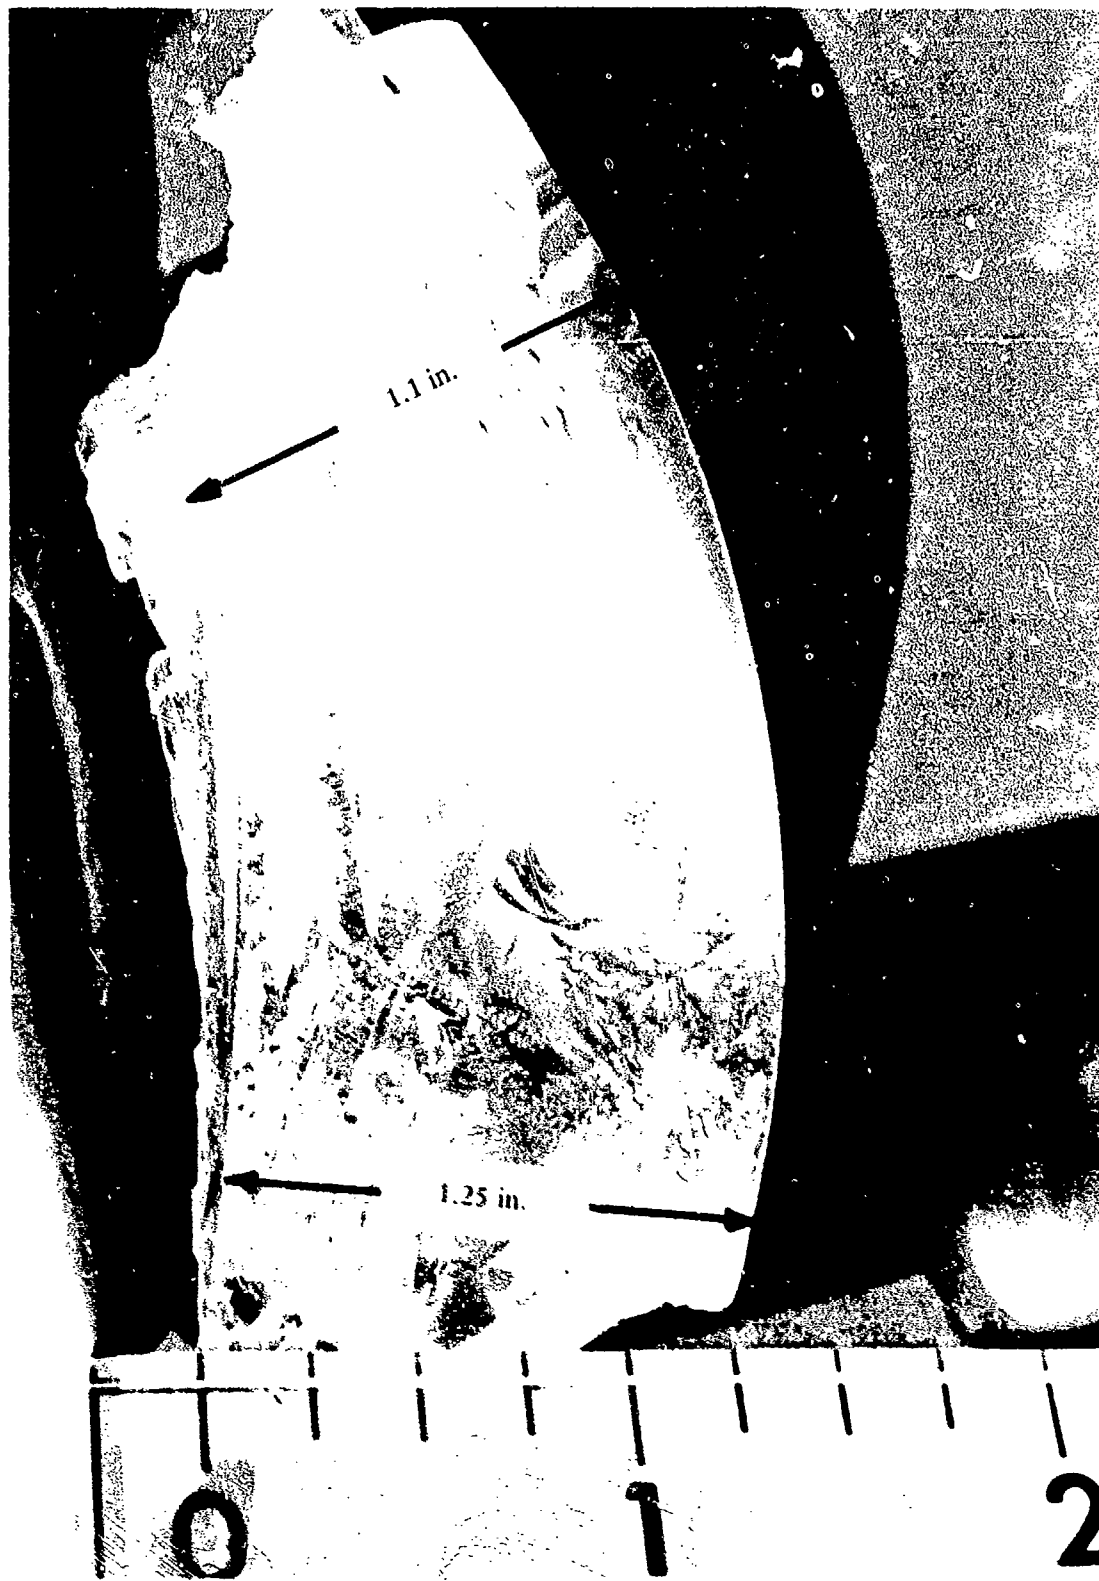
Figure 26. Window H, after 154 hours of sustained pressure loading at 8,100 psi; note the increase in wall thickness of the window near the flange due to plastic flow of acrylic under biaxial compression.

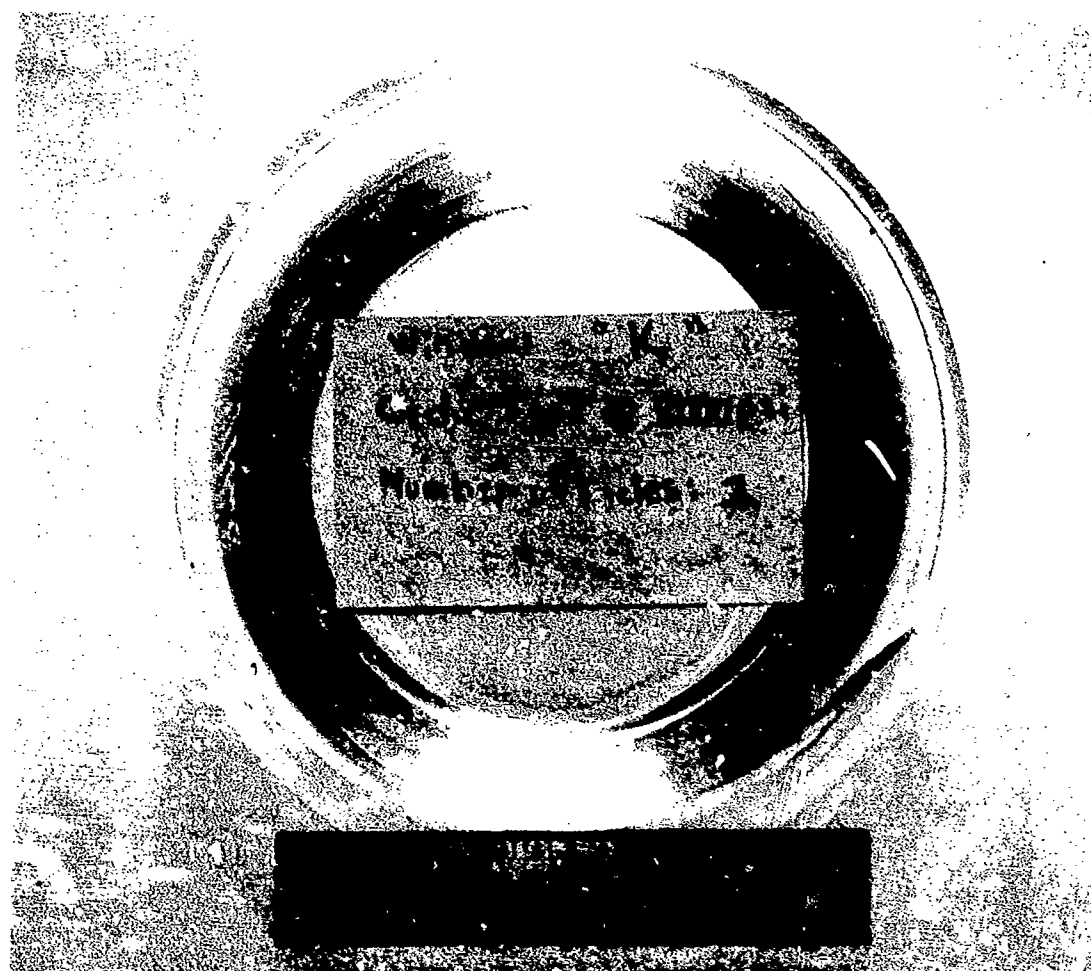
Figure 44. Typical cyclic fatigue cracks on the flange bearing surface; window K, Type I after one standard pressure cycle to 8,000 psi. Note major circumferential crack between the heel of the flange and the O-ring groove.

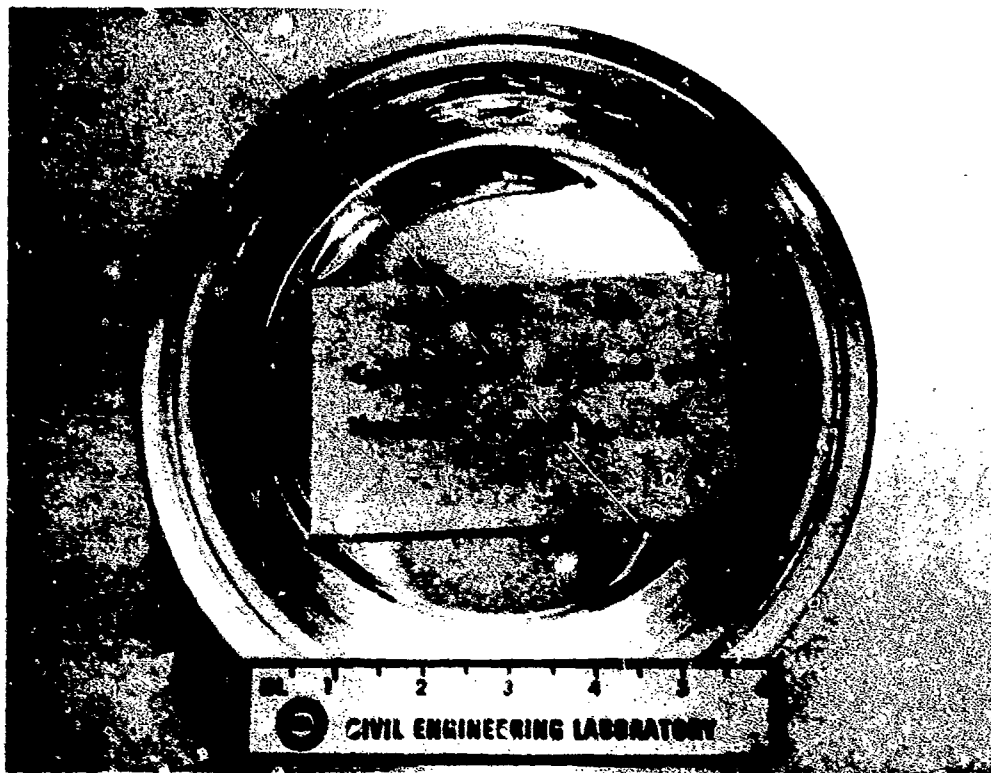
Figure 46. Typical cyclic fatigue cracks on the flange bearing surface; window BB, Type VI after two standard pressure cycles to 8,000 psi. Note many circumferential cracks between heel of the flange and O-ring groove.

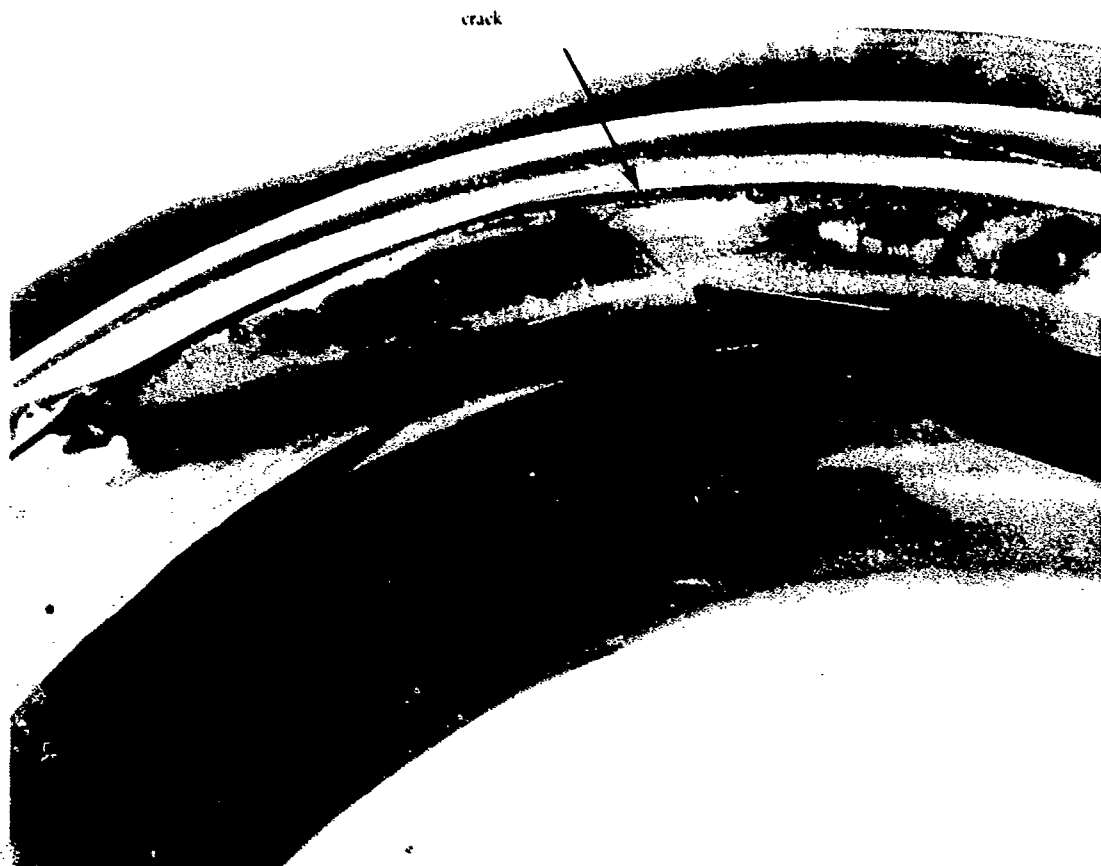
Figure 54. Typical cyclic fatigue circumferential cracks on the bearing surfaces of Type I flanges that cause the window to leak after a few pressure cycles; window K, Type I after one standard pressure cycle to 8,000 psi.
