FINAL REPORT  
ON

EFFECT OF LAPPING PARAMETERS ON GENERATION OF DAMAGE ON  
SILICON NITRIDE BALL SURFACES

DECEMBER, 1976

U. S. NAVY CONTRACT NO. N00019-76-C-0147  
S K F REPORT AL76TO26  
S K F CODE LC050  
S K F REG. 414 2

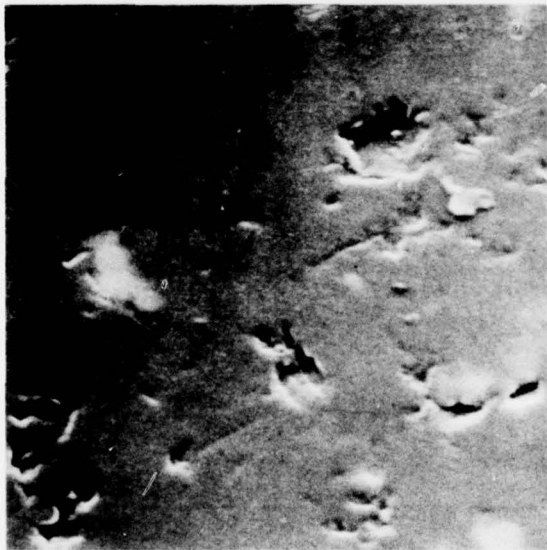
Figure 11. Surface Topography and Structure of a 7mm Silicon Nitride German Ball

For comparison, scanning electron micrographs of as-received,  $\text{Al}_2\text{O}_3$  polished, and 7 mm German ball are presented in Figures 9, 10 and 11, respectively. The surface topography of the

as-received ball is seen to be more pitted than the other two balls, as revealed in the secondary emission (SE) electron micrographs. Back-scattered electron (BSE) images of the same surfaces reveal the presence of microcracks on the as-received ball surface, not seen on the other two balls. The structural similarity of the  $\text{Al}_2\text{O}_3$  polished 17.5 mm ball and the 7 mm German ball is also evident from the BSE images of the ball surfaces.

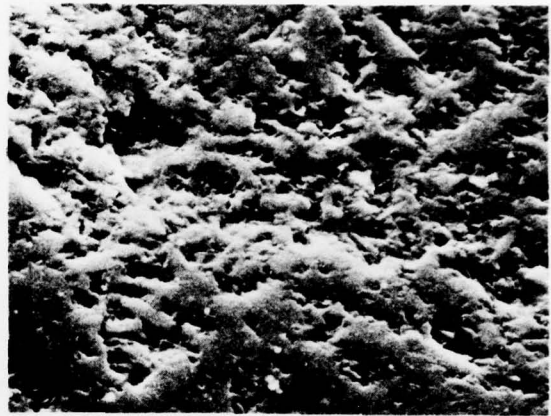
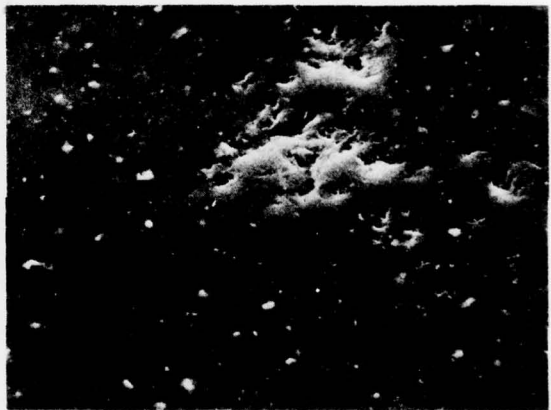
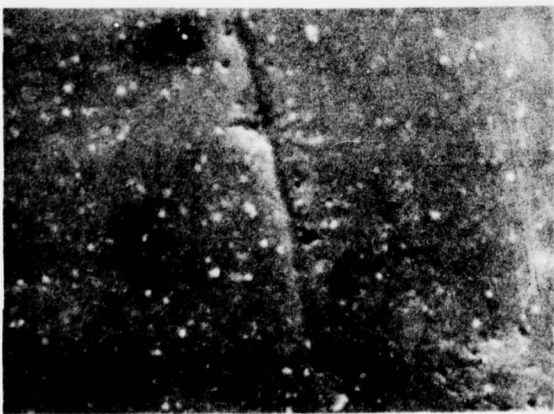
Figure 13. Surface Topography of Polished SiC Rough Lapped Balls (B2 - B4) Using Abundant Slurry.

Comparative photographs of the partially polished and finished A(A2-A4) and B(B2-B4) series balls are shown in Figure 12. It is clear from the polishing rate data that polishing proceeds by removing a greater amount of material from the higher spots and a smaller amount at the lower spots. The polishing of the high spots is particularly evident from the SEM micrographs of the B-series balls (Figure 13). Since the B-series balls are rougher initially, this is in agreement with the previous finding that a greater diameter reduction is required to produce the B4 balls of finished quality comparable to the A4 balls.
