TECHNICAL REPORT R-848

# SEAFLOOR CONSTRUCTION EXPERIMENT, SEACON II

AN INSTRUMENTED TRI-MOOR FOR EVALUATING UNDERSEA  
CABLE STRUCTURE TECHNOLOGY

CIVIL ENGINEERING LABORATORY  
NAVAL CONSTRUCTION BATTALION CENTER  
PORT HUENEME, CA 93043

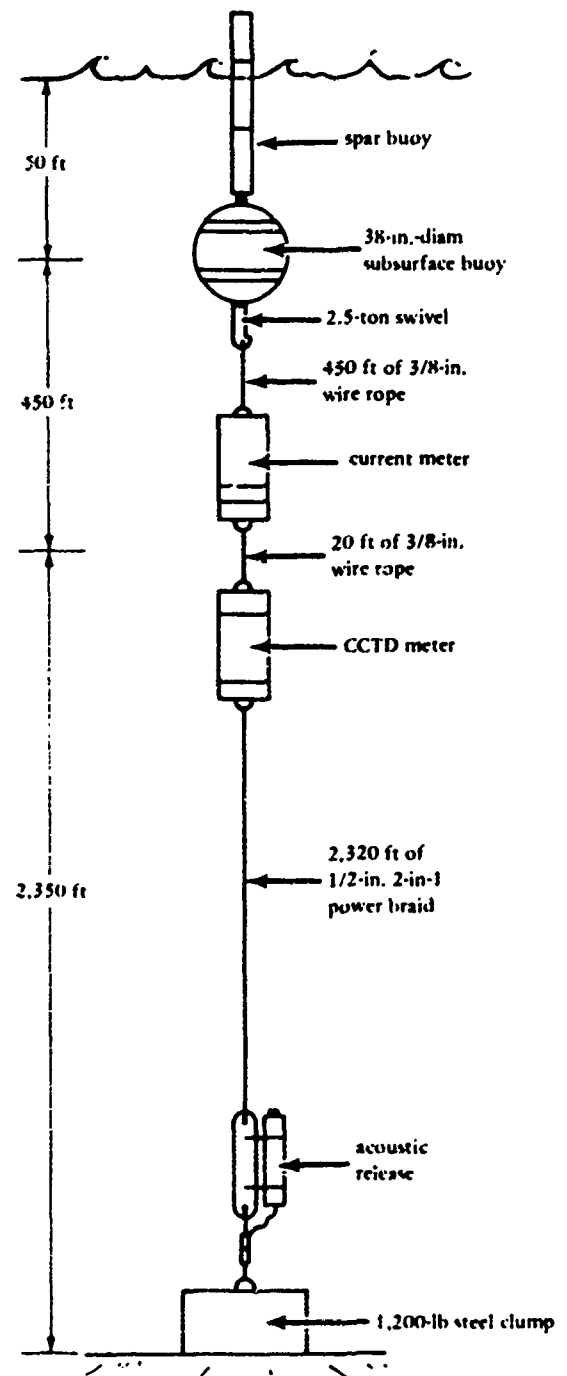
Figure 2-2. Current meter moor for detailed site survey.

A current measurement cruise was conducted on 29 to 30 November 1972 aboard the USNS *Bartlett*. The cruise had two phases to it, collection of real time data and implantment of a current meter moor. First, a single-point moor (Figure 2-2) with a current meter and a CCTD (current, conductivity, temperature, and depth) meter was to be installed 500 feet below the surface. This was to be a taut moor with a subsurface buoy and a surface spar buoy. When the deployment was nearly completed, it was found that the moor was about 150 feet too long. Since it would be difficult to recover the moor with the USNS *Bartlett*, it was decided to use the subsurface buoy as a surface float, collect data for 2 or 3 days, and then recover the moor with another vessel before the surface buoy parted or was cut loose.

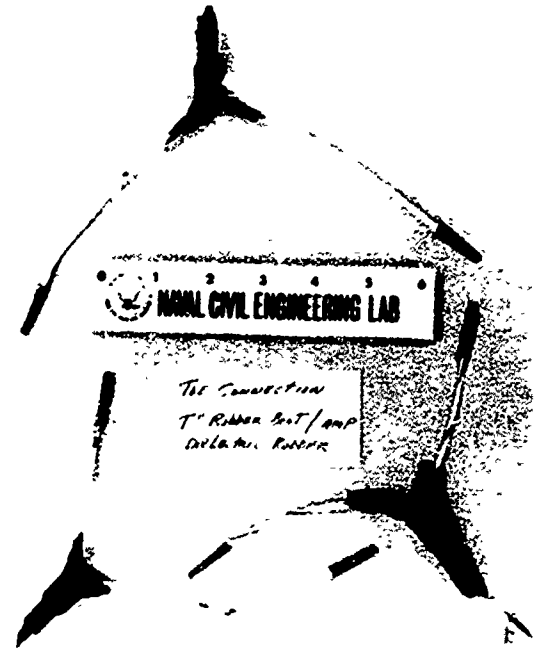
Figure 3-7. Tee splices made with dielectric sealing rubber.

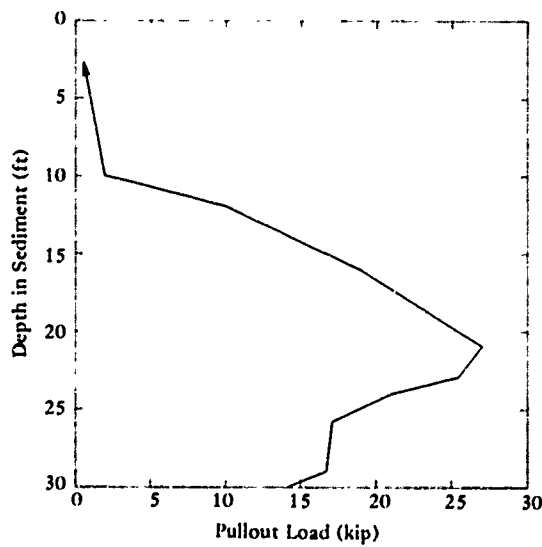
Figure 3-11. Load-displacement record for short-term pullout test on mooring line embedment anchor. Record indicates embedment depth is 30 feet and peak pullout load is 27,000 pounds.

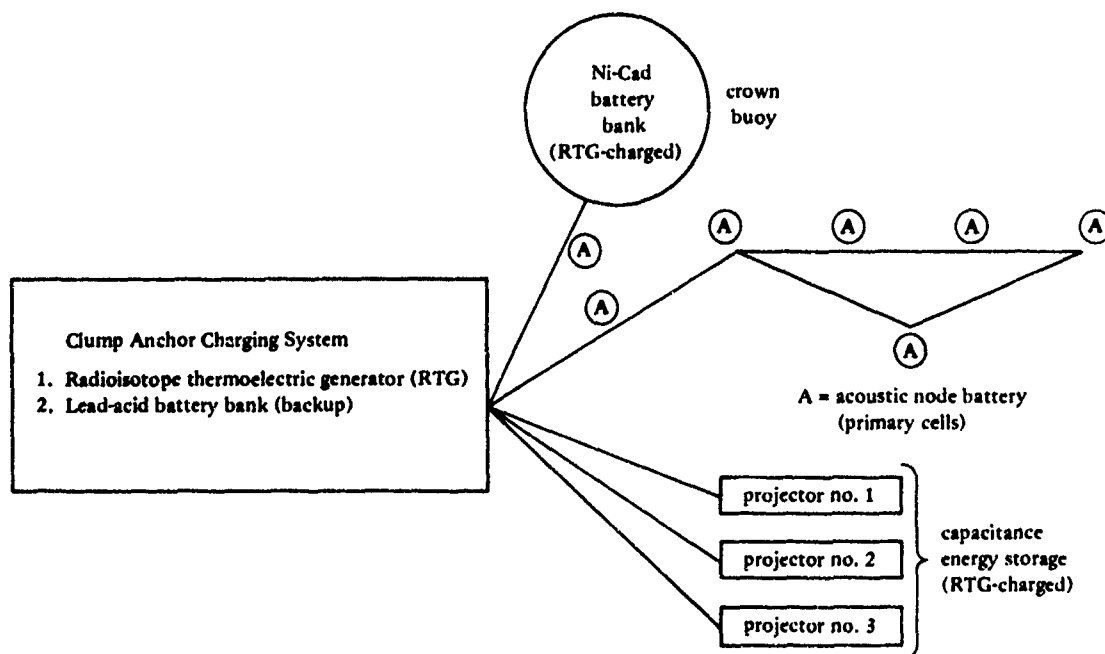
Figure 3-20. Power system for SEACON II.

The heart of the power system was a 10-watt radioisotope thermoelectric generator (RTG). The unit, which weighs 645 pounds, is a SNAP-21 supplied by the Naval Nuclear Power Unit. The generator is fueled by strontium 90 in titanate form and is contained in a 16-inch-diameter, 25-inch-high pressure hull with a pressure rating of 10,000 psi. Power is provided at 48 volts DC regulated.
